Attachment 2

**UP-DATED
PHOTOGRAPH
DESCRIPTIONS
2-15-08**

1. Meco building #4.

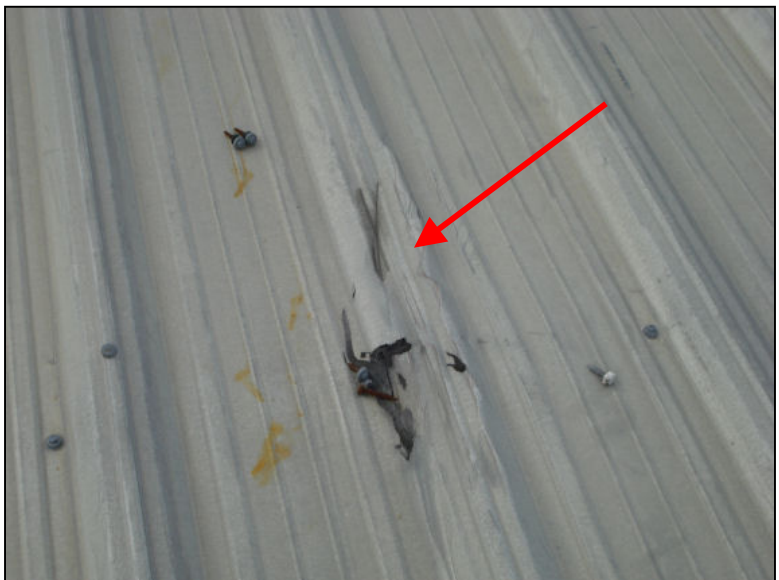
3. Damaged from flying debris.

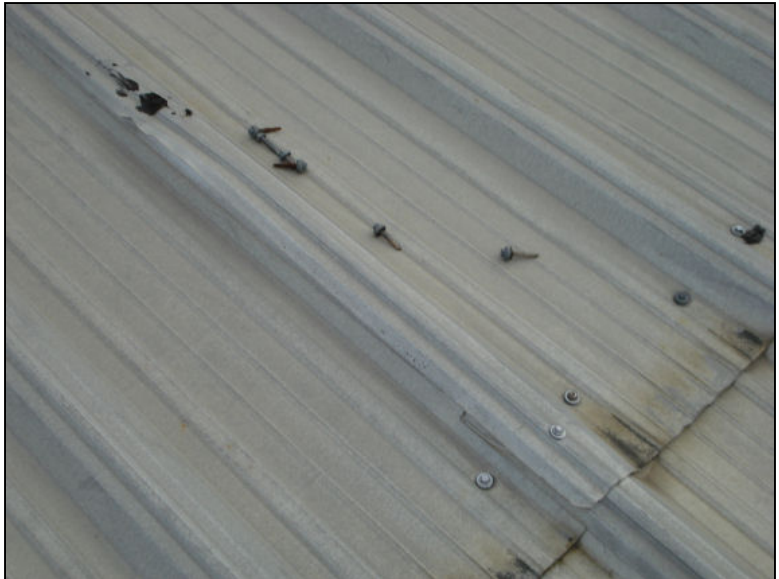
4. Loose screws.

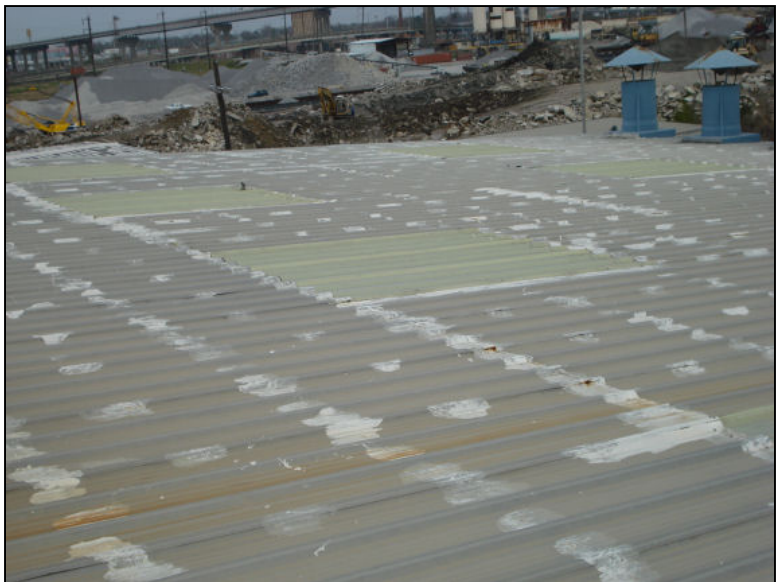
5. Seams and screws sealed.

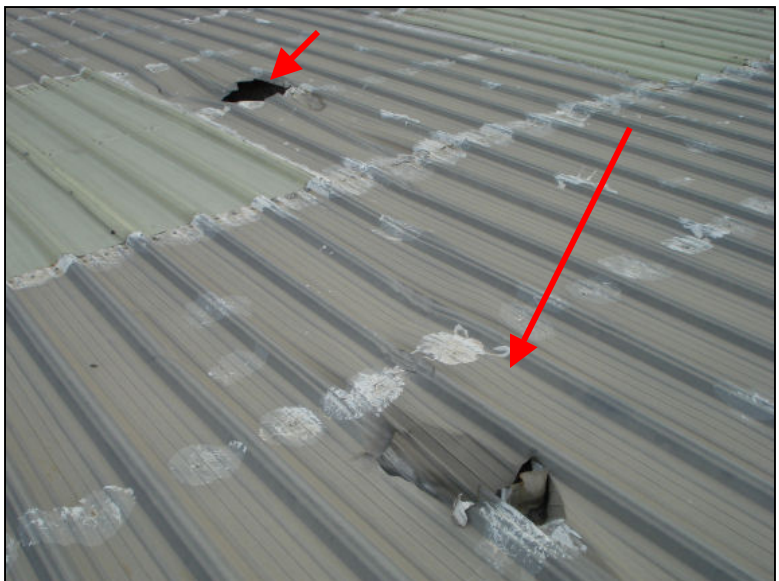
6. Punctured by flying debris.

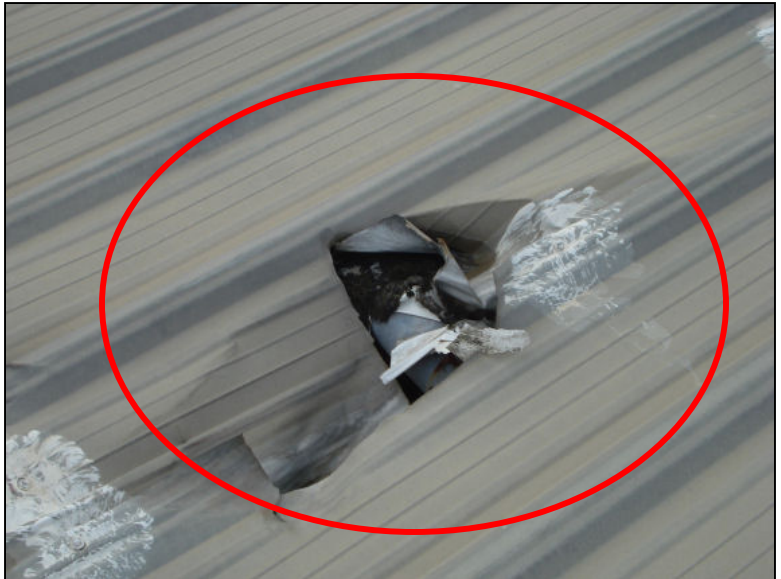
7. Hole from flying debris.

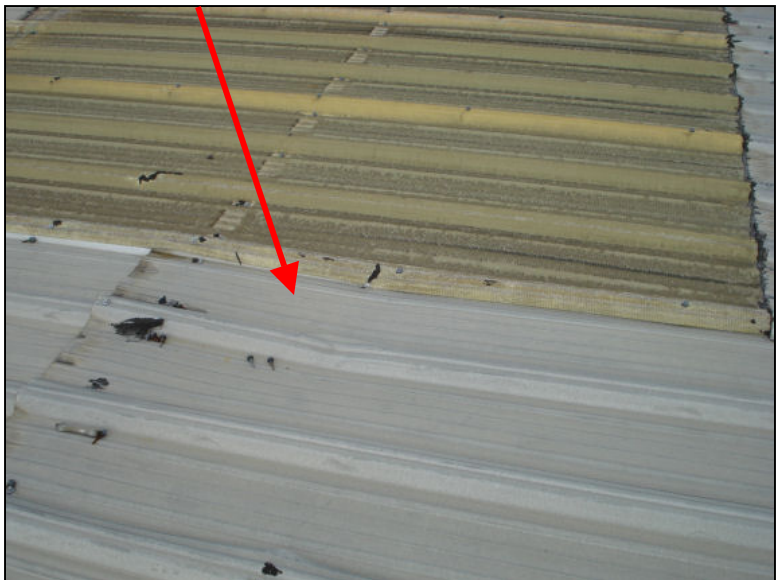
8. Buckled from flying debris.

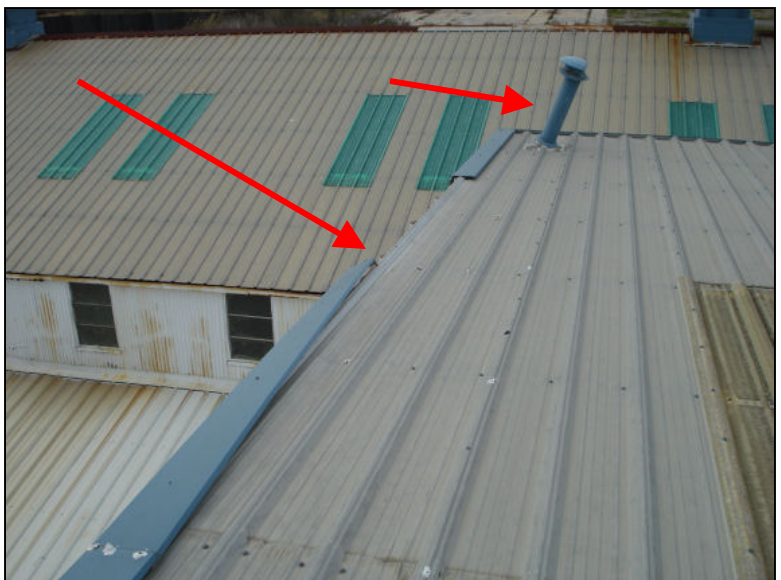
9. Missing rake trim also vent is damaged.

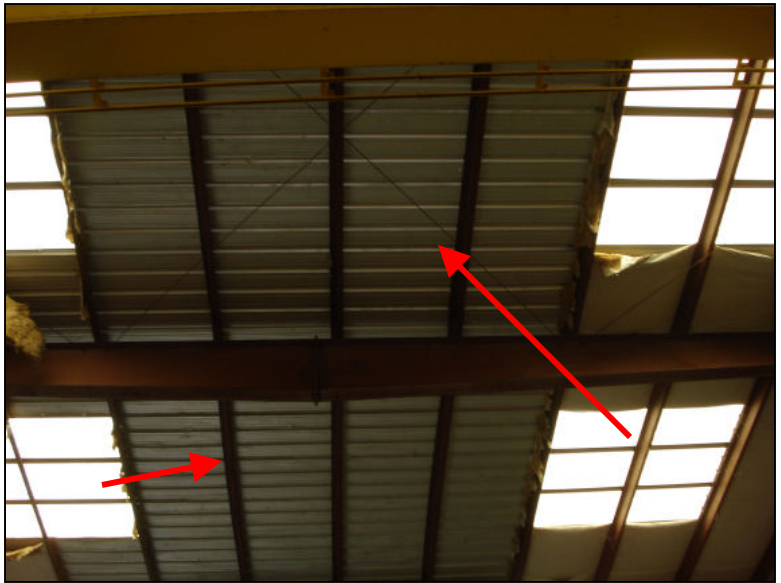
10. Missing insulation.
