**UP-DATED
PHOTOGRAPH
DESCRIPTIONS
2-15-08**

1. Meco building #5.

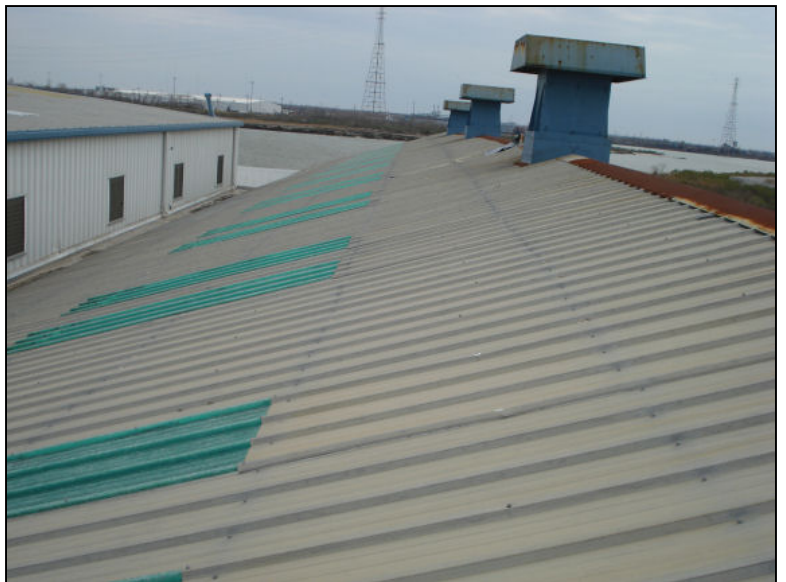
2. Overview of roof.

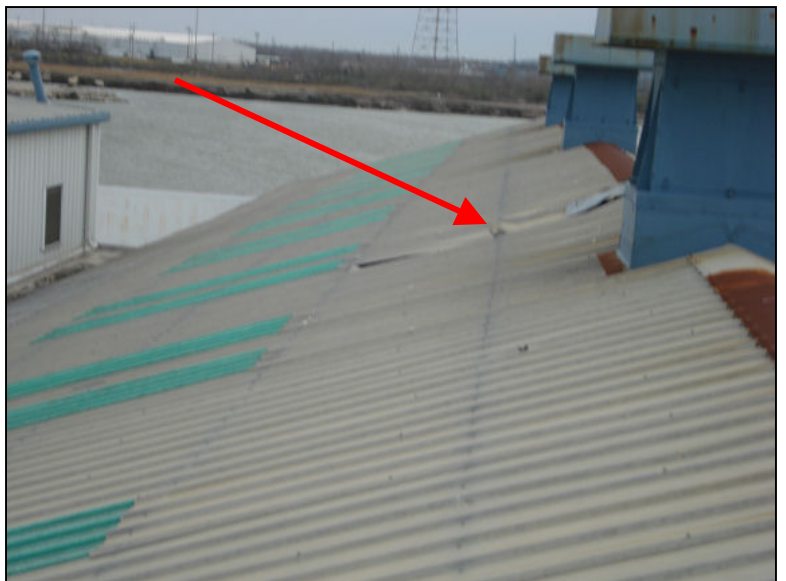
3. Damaged.

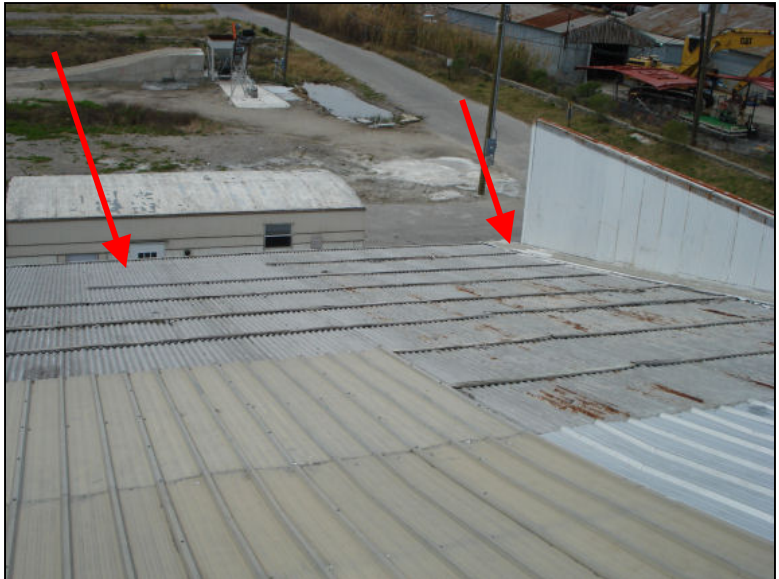
4. Missing panels over existing roof.

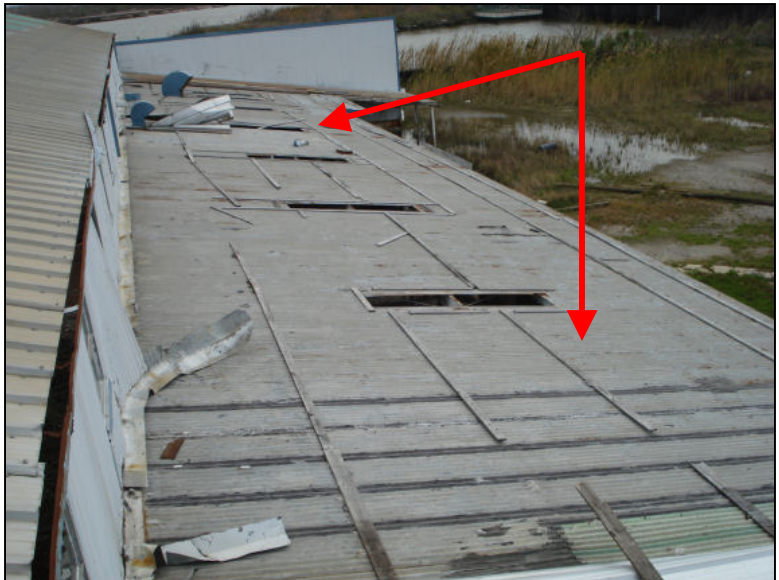
5. Lifted and missing panels over existing roof.

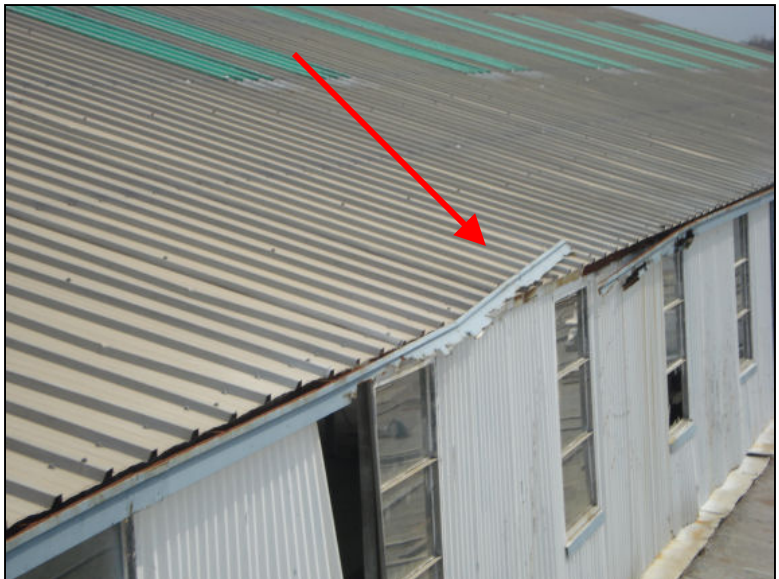
6. Detached eave trim.

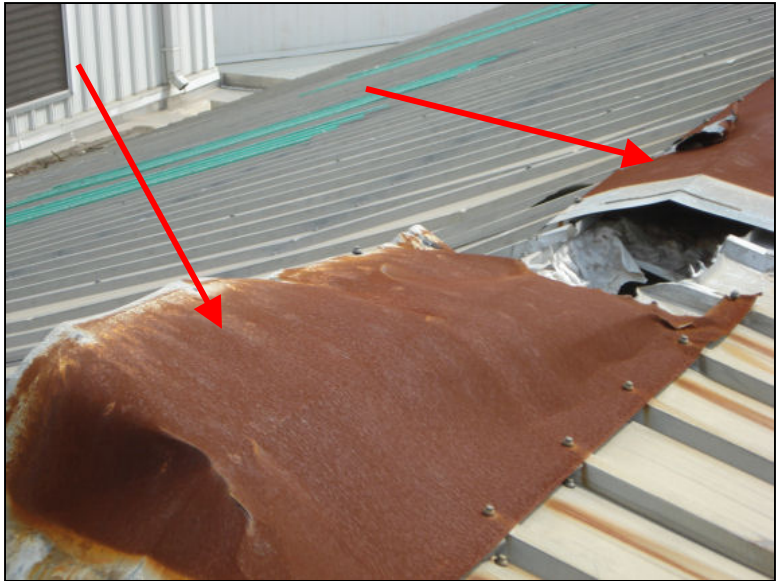
7. Buckled and torn.

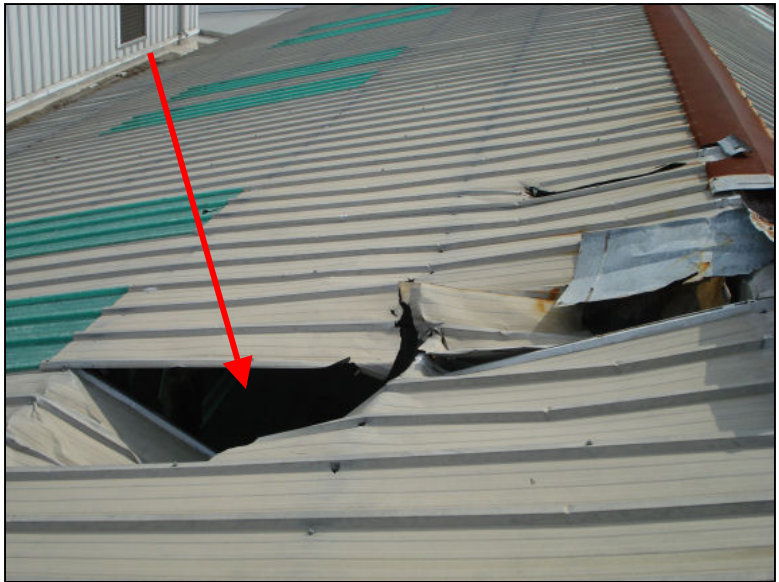
8. Impact from flying debris.

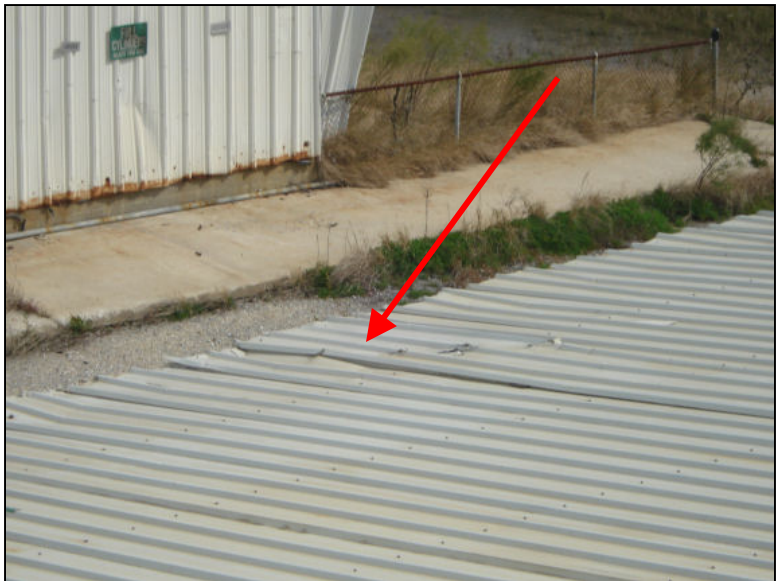
9. Damaged by flying debris.

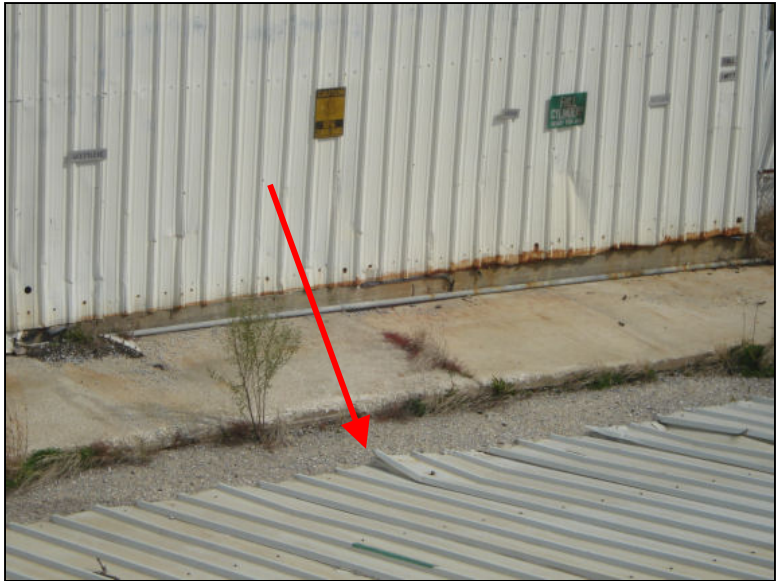
10. Damaged by flying debris.

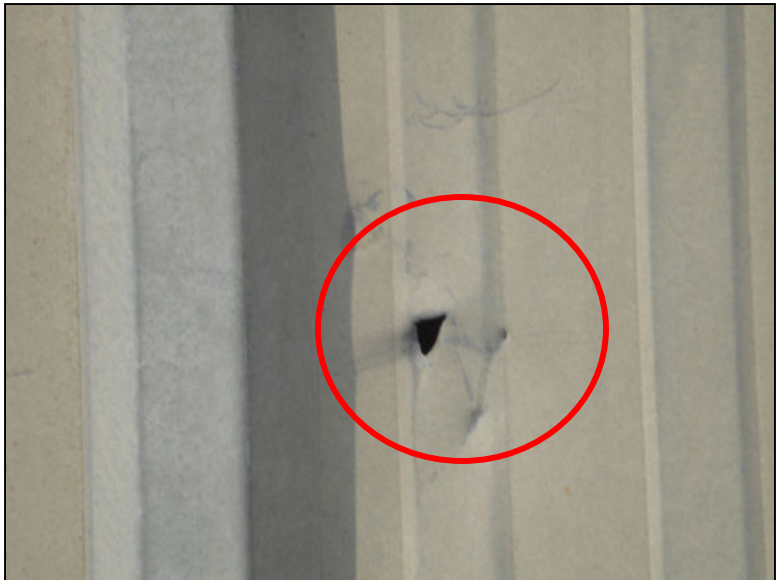
11. Hole from flying debris.

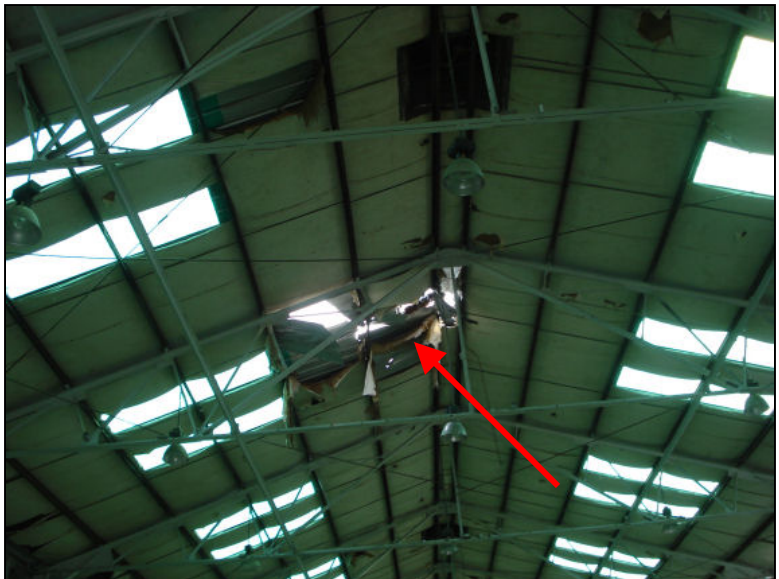
12. Roof panel and insulation damaged from flying debris.

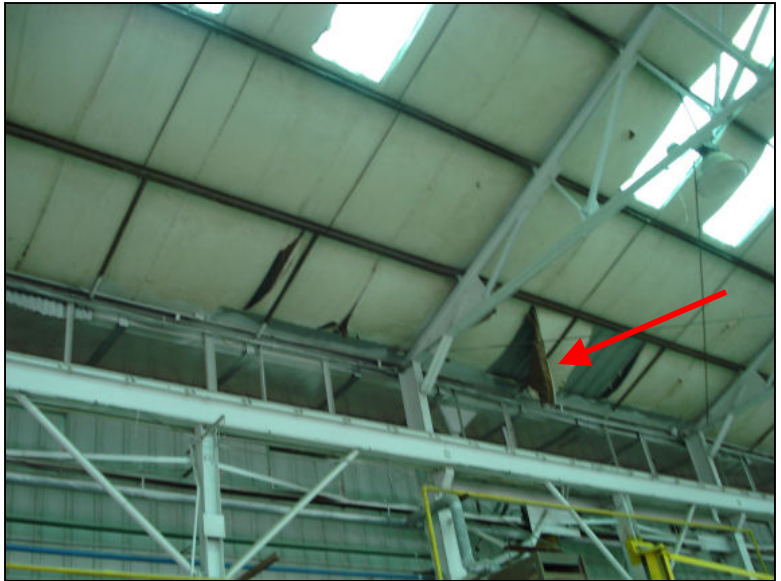
13. Detached insulation.

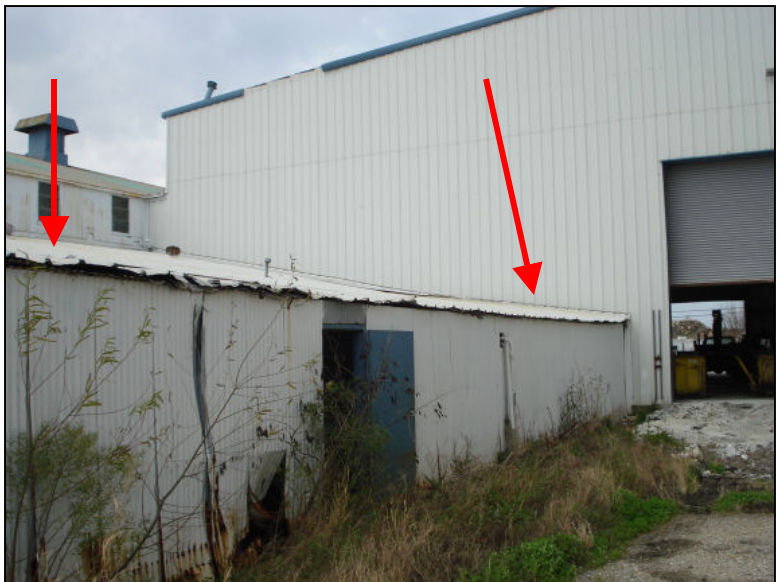
14. Damaged eave

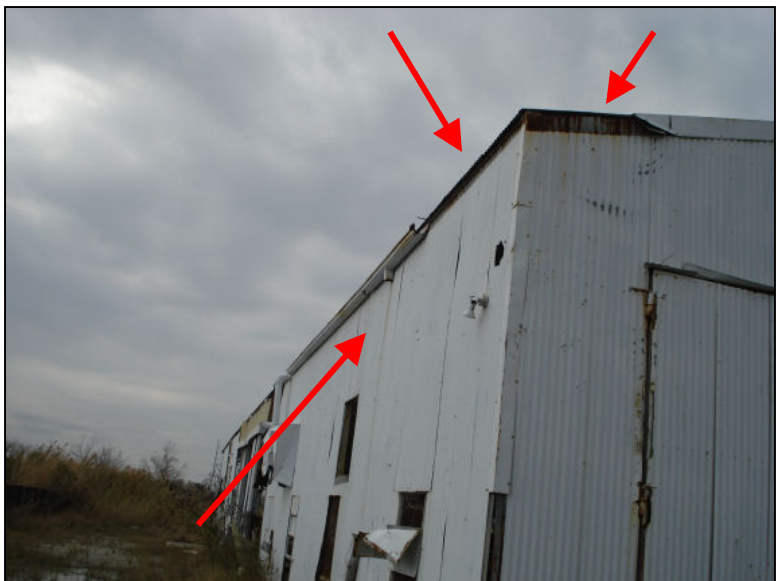
15. Missing eave and rake trim also down spout.

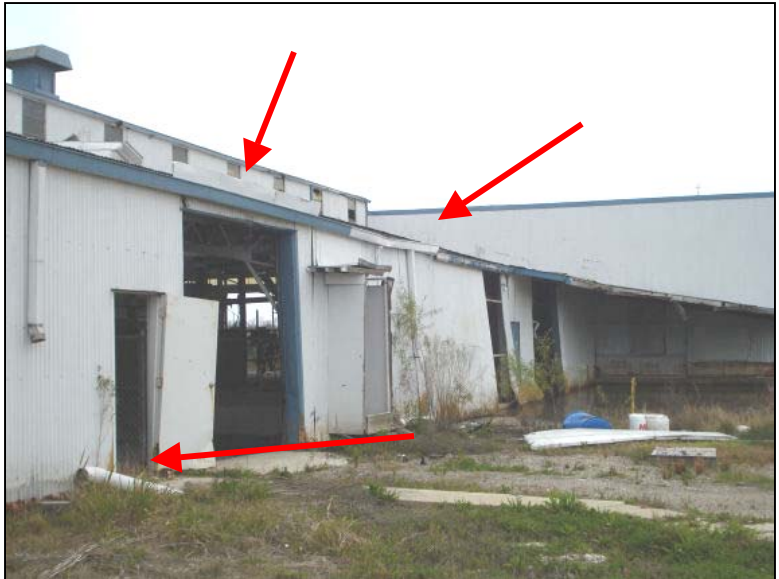
16. Damaged gutter and missing down spout.

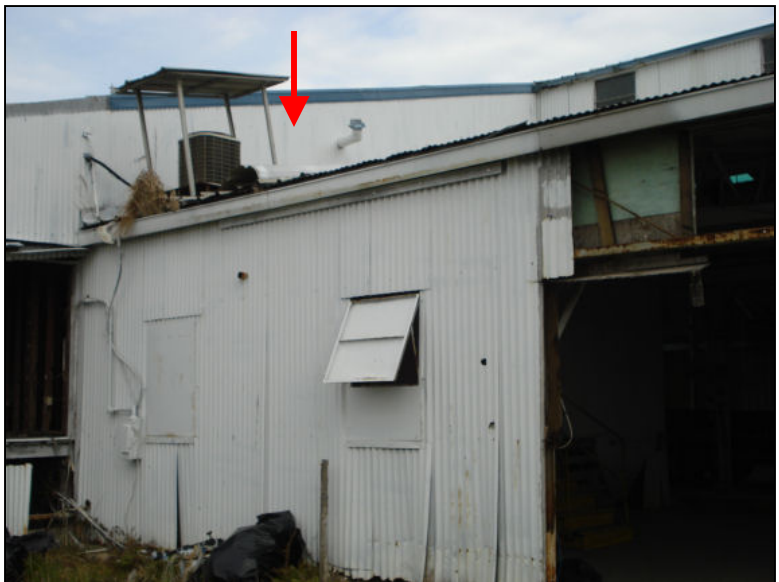
17. Detached.
