**BOARD OF COMMISSIONERS OF THE PORT OF NEW  
ORLEANS**

**ASBESTOS DAMAGE ASSESSMENT  
MECHANICAL EQUIPMENT CO. INC.  
(MECO)**

**3855 FRANCE ROAD  
NEW ORLEANS, LOUISIANA**

**APRIL 2008**

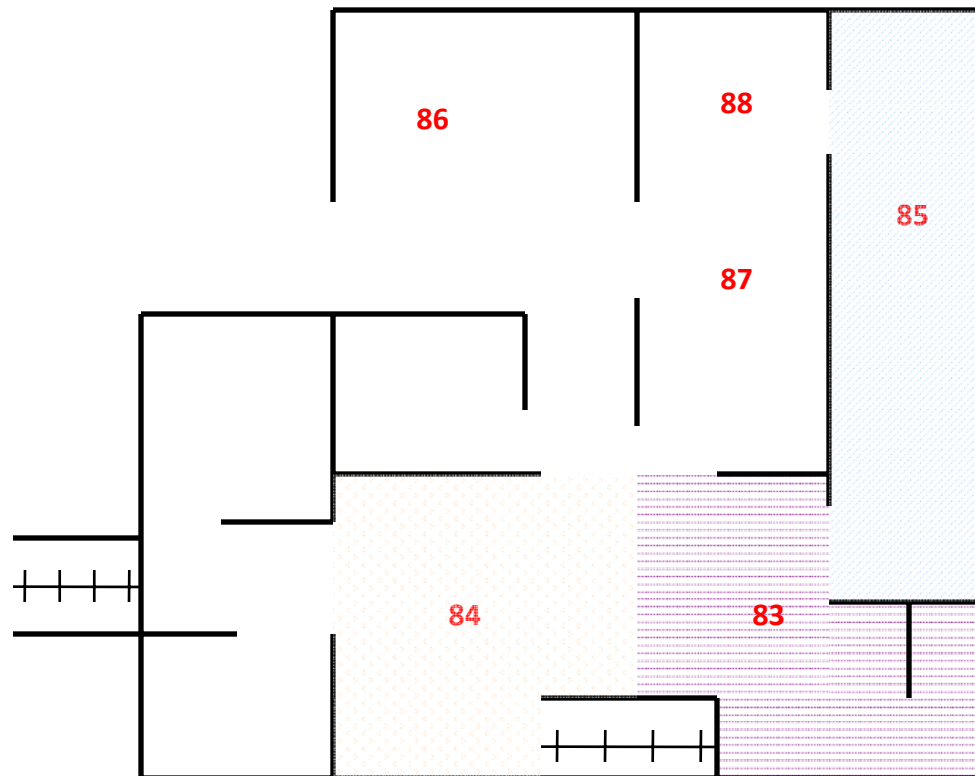
Mechanical Equipment Co.  
Building 1 First Floor  
Site Plan  
Orleans Parish, Louisiana

- The first floor has white, gray and yellow 12x12 vinyl floor tile with yellow and black mastic. All 12x12 vinyl floor tile and mastic were observed to be in poor condition, as evident by cracked, brittle and missing floor tile due to water damage.
- The interior walls have been gutted with wood studs still in place.
- Drop ceiling tile and drywall comprise the ceiling. Drywall and drop ceiling tile are in poor condition, as evident by water stains, fungal growth and missing drop ceiling tile and drywall due to water damage.

red numbers  
indicate sample  
locations

White Tile

Yellow Tile

Gray Tile
