RE: Principal: NATCO, Inc.
Obligee: St. Tammany Parish Department of Finance
Bond No.: 087-SB-104998055
Project: Administrative Complex (Towers Building)
Renovations

PCO #61 – Fire Stair Handrail Corrections

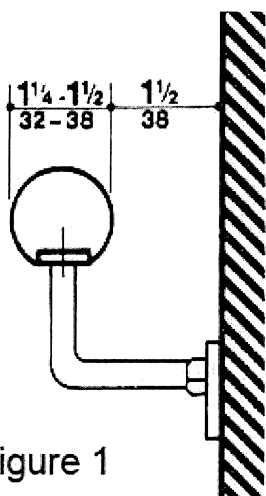
Landmark Reference 3

The sketch below shows in graphic form what is specified within the Contract Documents.

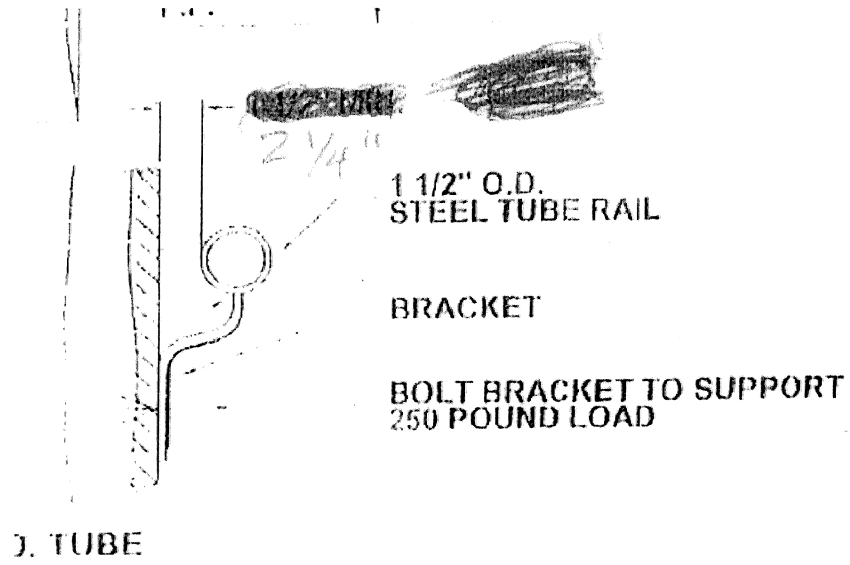
Landmark Reference 4

The local fire marshal brought this issue to our attention on November 15, 2010. Following the inspection, Dammon provided a marked up document, shown below (*Landmark Reference 4*), which calls out the requirement of $2 \frac{1}{4}$ clear between the wall and the handrail. The handrails and guardrails were already installed at this point and required field modifications to comply with the new design criteria.

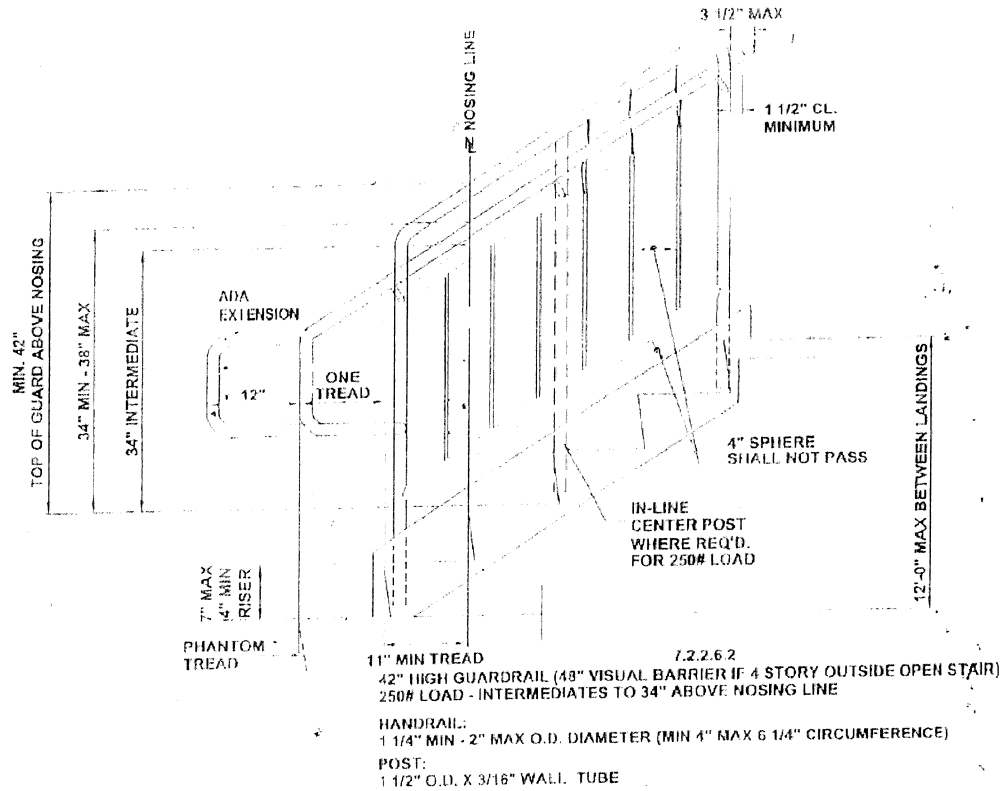
In the Fire Marshall's inspection report he indicated that the handrails which had been installed at approximately 32" height above the stair tread were not acceptable and needed to be repaired. Please refer to the inspection report which has been attached or item 7.2.2.4.4.1 which was copied from that document shown below.

The following is a copy of the detail provided by Dammon which reflects the which reflects this change.

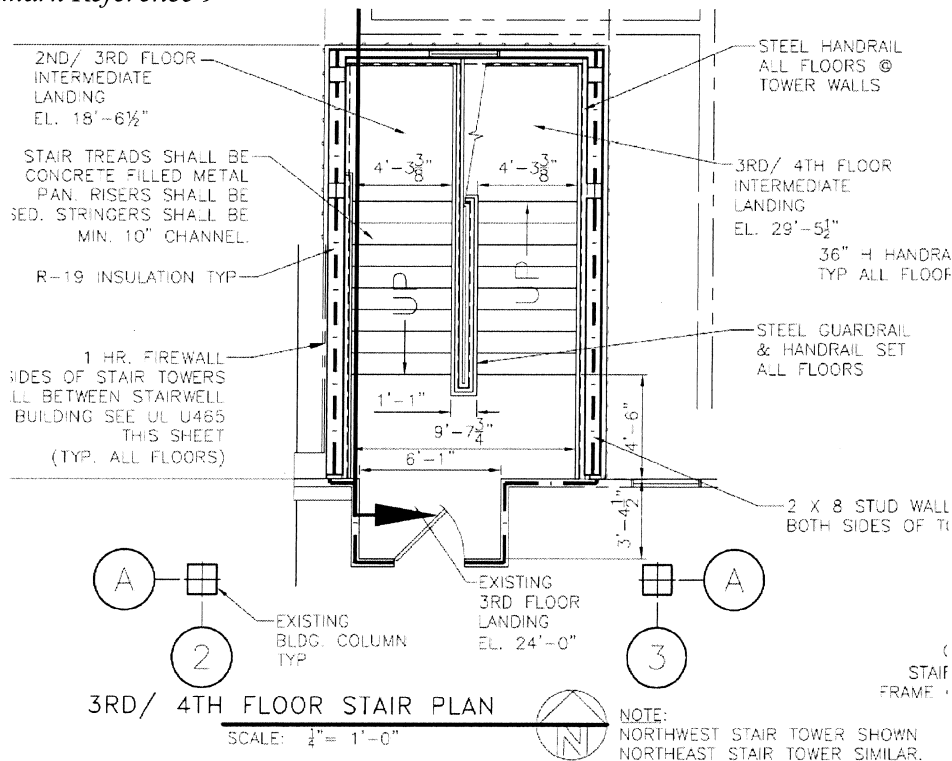
Landmark Reference 9

On sheet A.18 detail Sheet A.18, 3rd/4th Floor Plan shows the handrail to be continuous.

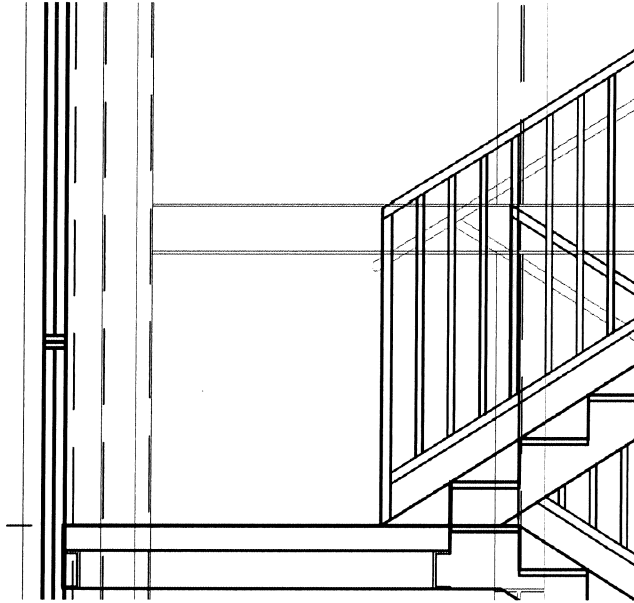
On the same sheet see Typical Section of Stair tower Sheet A.18, Detail SA/A18/A18 it shows a discontinuous handrail which is turned into the wall. *Landmarks Reference 10*

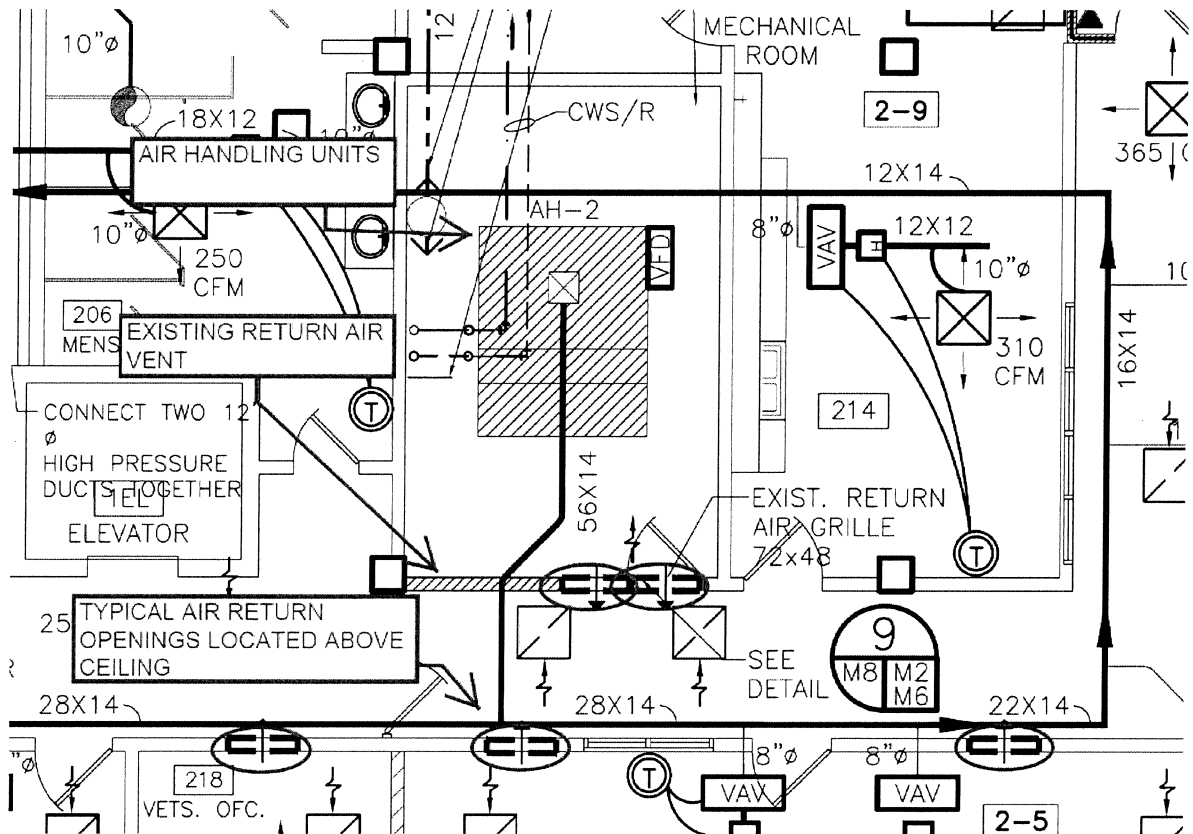
The air handling units (AHU) for the Towers Building are typically located within the mechanical room; adjacent to the central corridor on each floor. The AHU distributes air throughout the building by means of ductwork. The supply air then returns to the AHU by way of a return air plenum (plenum). Per design, the space between the acoustical ceiling and the floor deck above is utilized as a plenum. In some cases, it is necessary for the return air to travel through adjacent rooms before it can reach a given AHU. The return air travels from room to room by way of small openings cut through the walls above the ceiling. Reference 1 is a typical floor plan which shows some of these openings. The layout and location of the AHU depicted below is typical for all floors except for the first floor.

During the course of construction the City Mechanical Inspector questioned there being sufficient return air flow to allow for proper operation of the mechanical system. This issue was investigated by a registered engineer employed by Star Services and later determined to be a problem. Based on Star Services design calculations, it was determined that approximately 41 additional (200 Sq. Inch) openings were needed beyond that which is shown on the Takeover drawings.

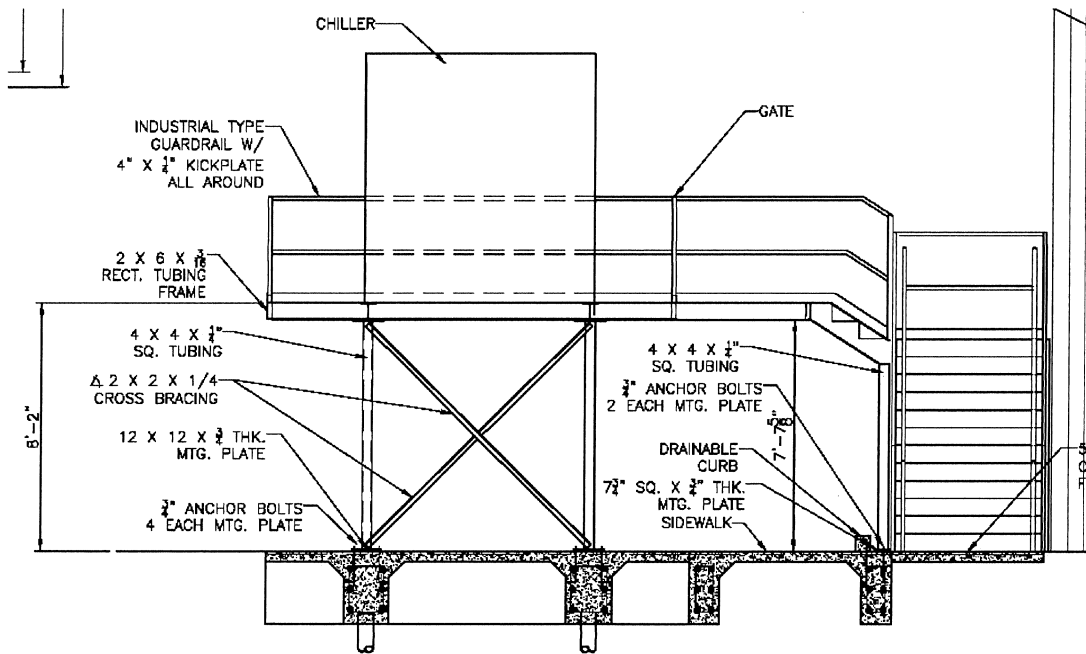
Landmark Reference 1

The large scale detail SF/S2/S6 located on sheet S-9 shows the design of both the guardrail on the landing and the rails along the south side of the steps leading up to the gate. Note the guardrail design matches that of the Chiller platform. The design shown here is identical to that constructed, which was rejected by the Fire Marshall.

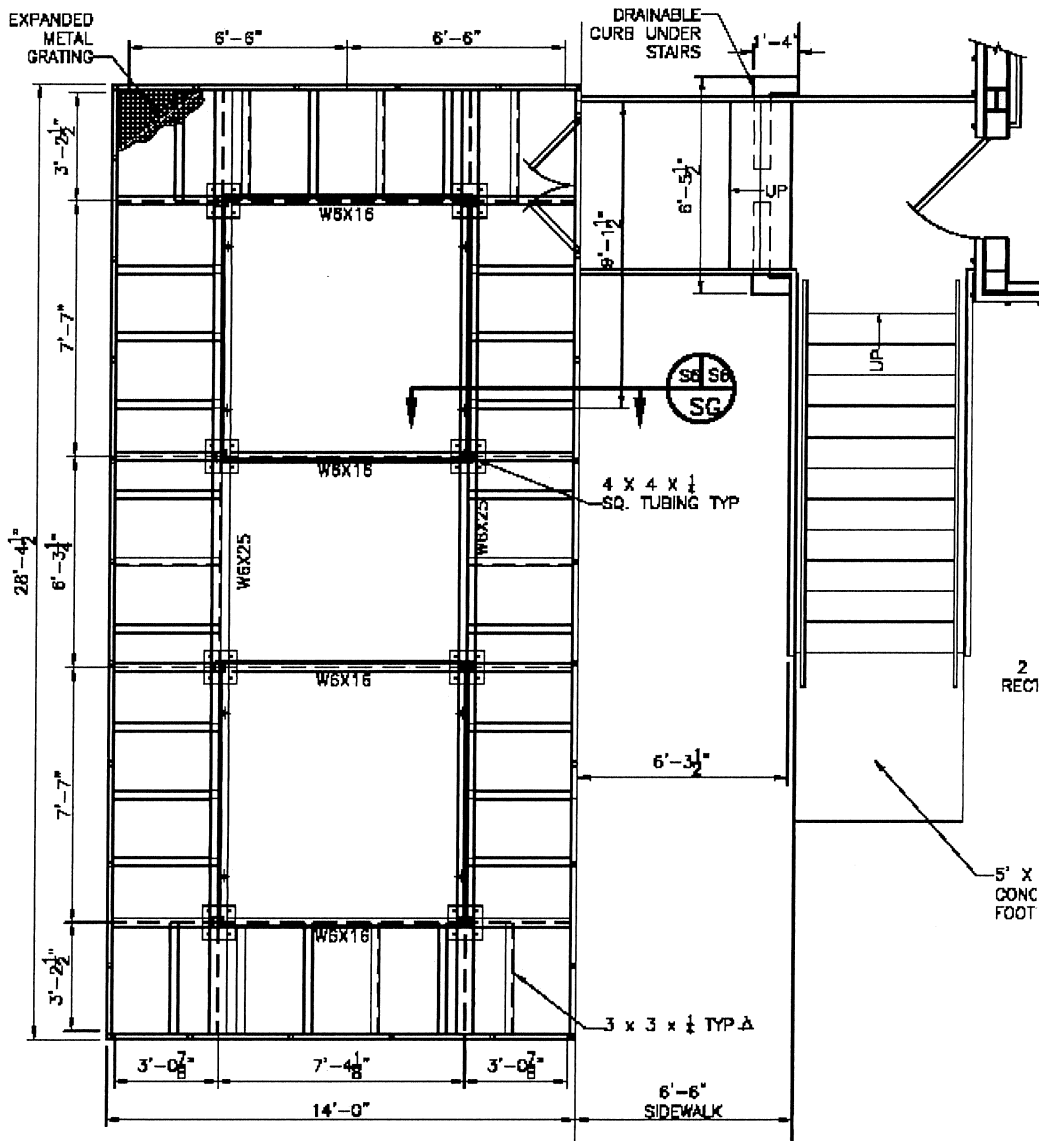
Landmark Reference 2

The gate location is shown in the detail above, however there is no information shown on the drawings anywhere that would indicate that it was to be designed any differently than the rest of the guardrails that run along the entire perimeter of the chiller platform. The only other information provided that would describe the gate is the chiller plan that is shown below.

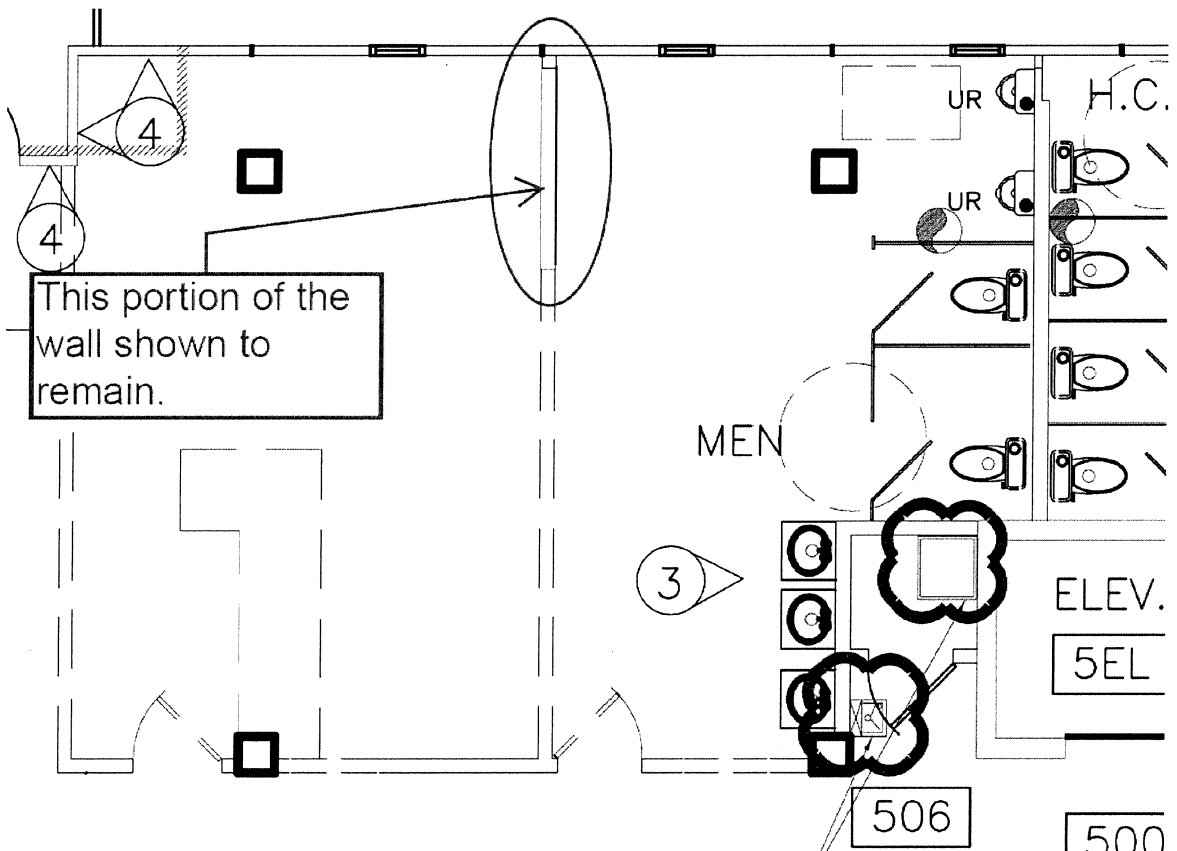
Constructing the disputed walls as shown on the drawings would reduce both the COC Break and Storage Rooms by approximately 64 sf each and would have been inconsistent with the design drawings.

Landmark Reference 1 – Existing condition in error.

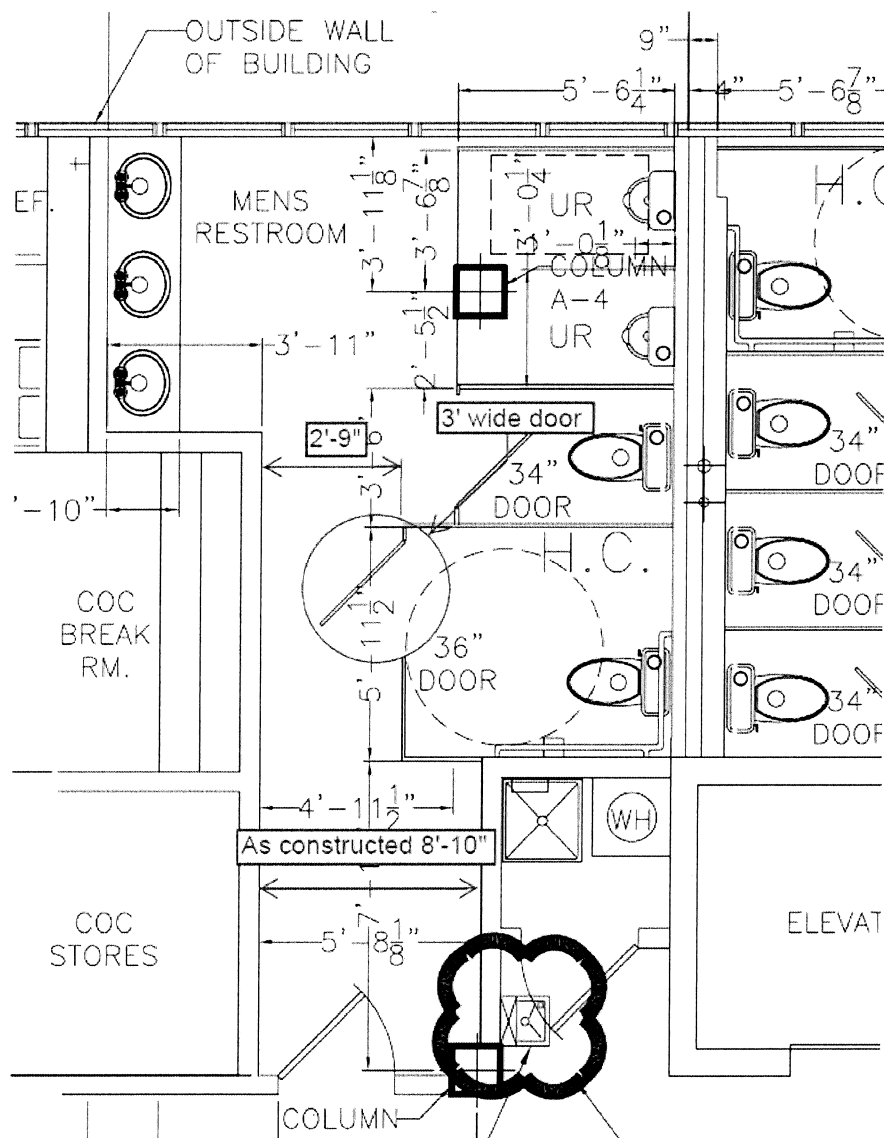
- The following detail was taken from sheet A.21 (Detail 6/A5/A2.1). Based on the design drawings, the handicapped stall door would not open all the way with design dimensions. The aisle way between the handicapped stall and the west wall would have been approximately 2'-9" wide. The aisle widths in the other bathrooms typically are about 5'-8". The as-built dimension at this location is 8'-10", providing approximately 3'-2" more clearance than is shown on the design drawing. The adjustment of this walls location provides for functionality within the restroom and supports the need to shift the disputed walls to the west of their design location.

Landmark Reference 2 – Toilet room not useable.

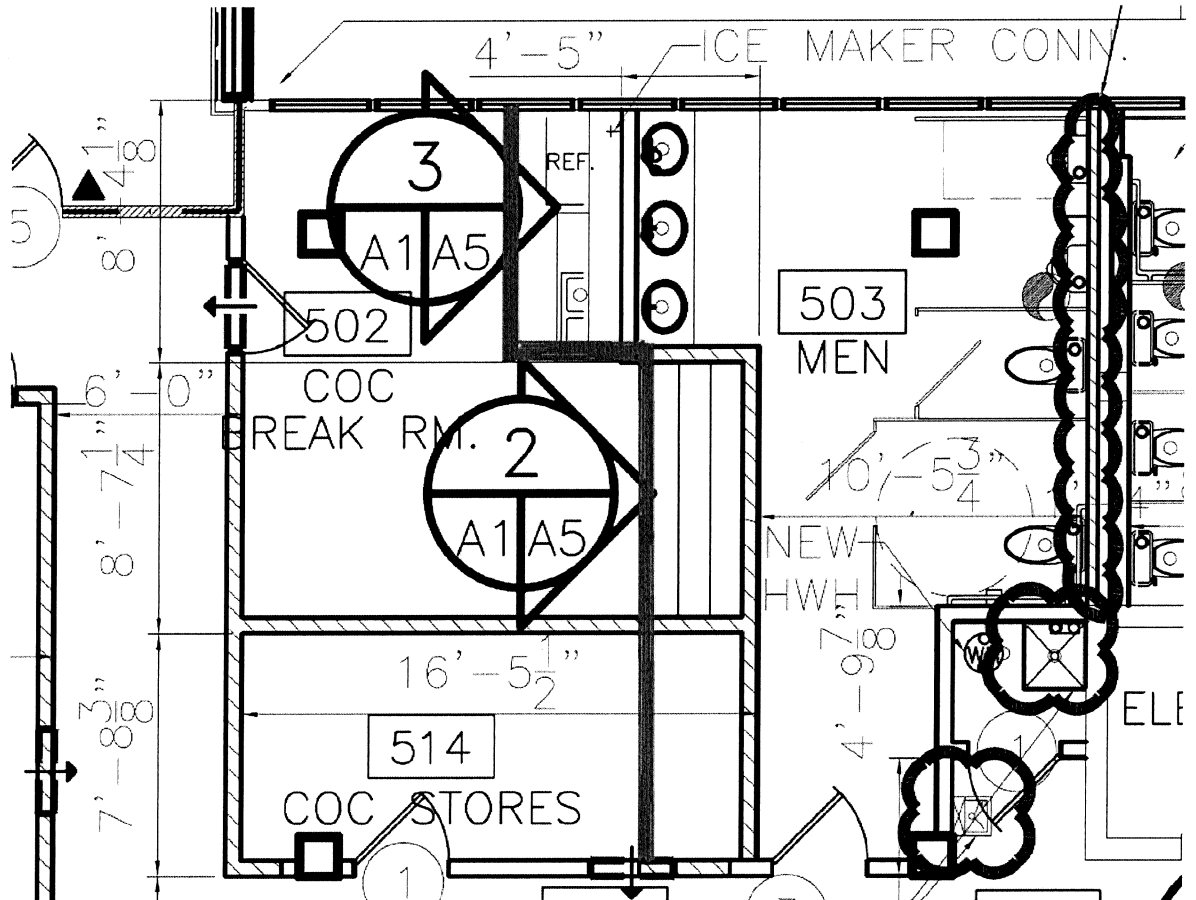
See below the actual location of the common wall between the Toilet Room 503 and Rooms 502 and 514.

Landmark Reference 3 – Red line shows the location of where the wall was actually located. Note the how it infringes on the space that was to be provided for these three rooms.
