## Structural Inspection

September 18, 2018

For: Parkview Condo HOA  
103 Parkview Blvd.  
Mandeville, La. 70471

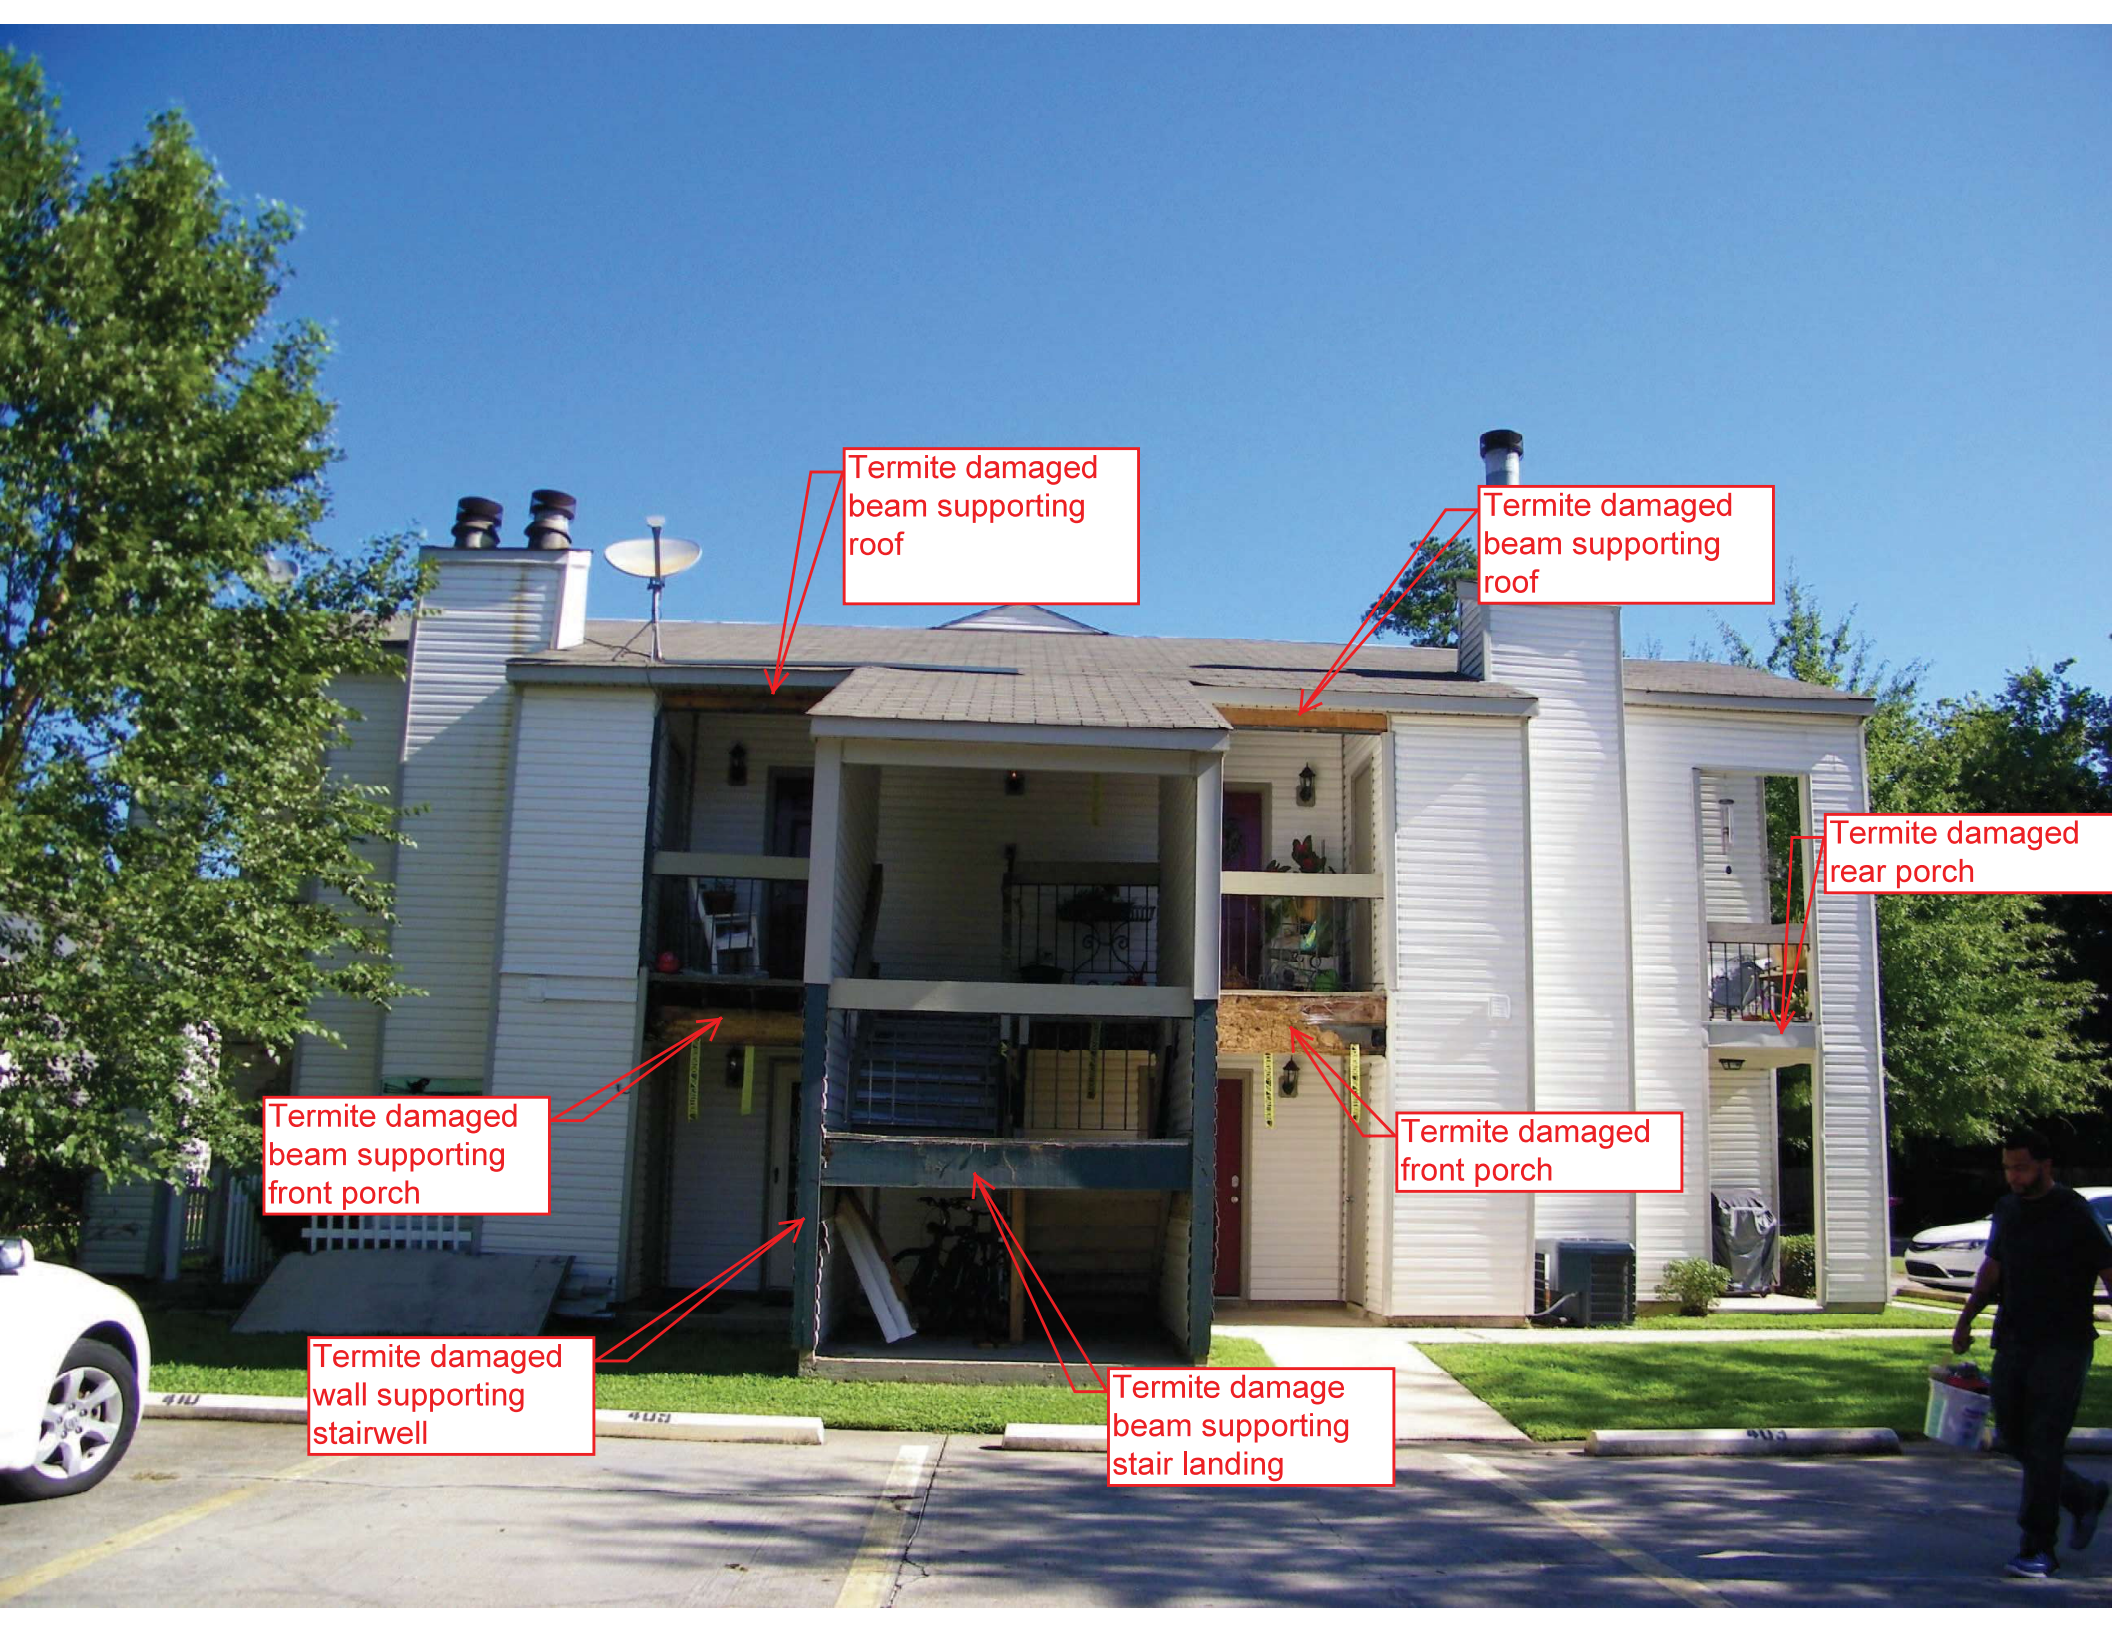
Termite damaged beam supporting roof

Termite damaged rear porch

Termite damaged beam supporting front porch

Termite damaged front porch

Termite damaged wall supporting stairwell

Termite damage beam supporting stair landing

Termite damaged  
stud wall  
supporting landing

Due to the extent of the damage it is recommend that the whole stairwell and porch's be removed and replaced with new treated wood and new lightweight concrete to allow for a complete sealed system. Please see the attached pictures for reference.

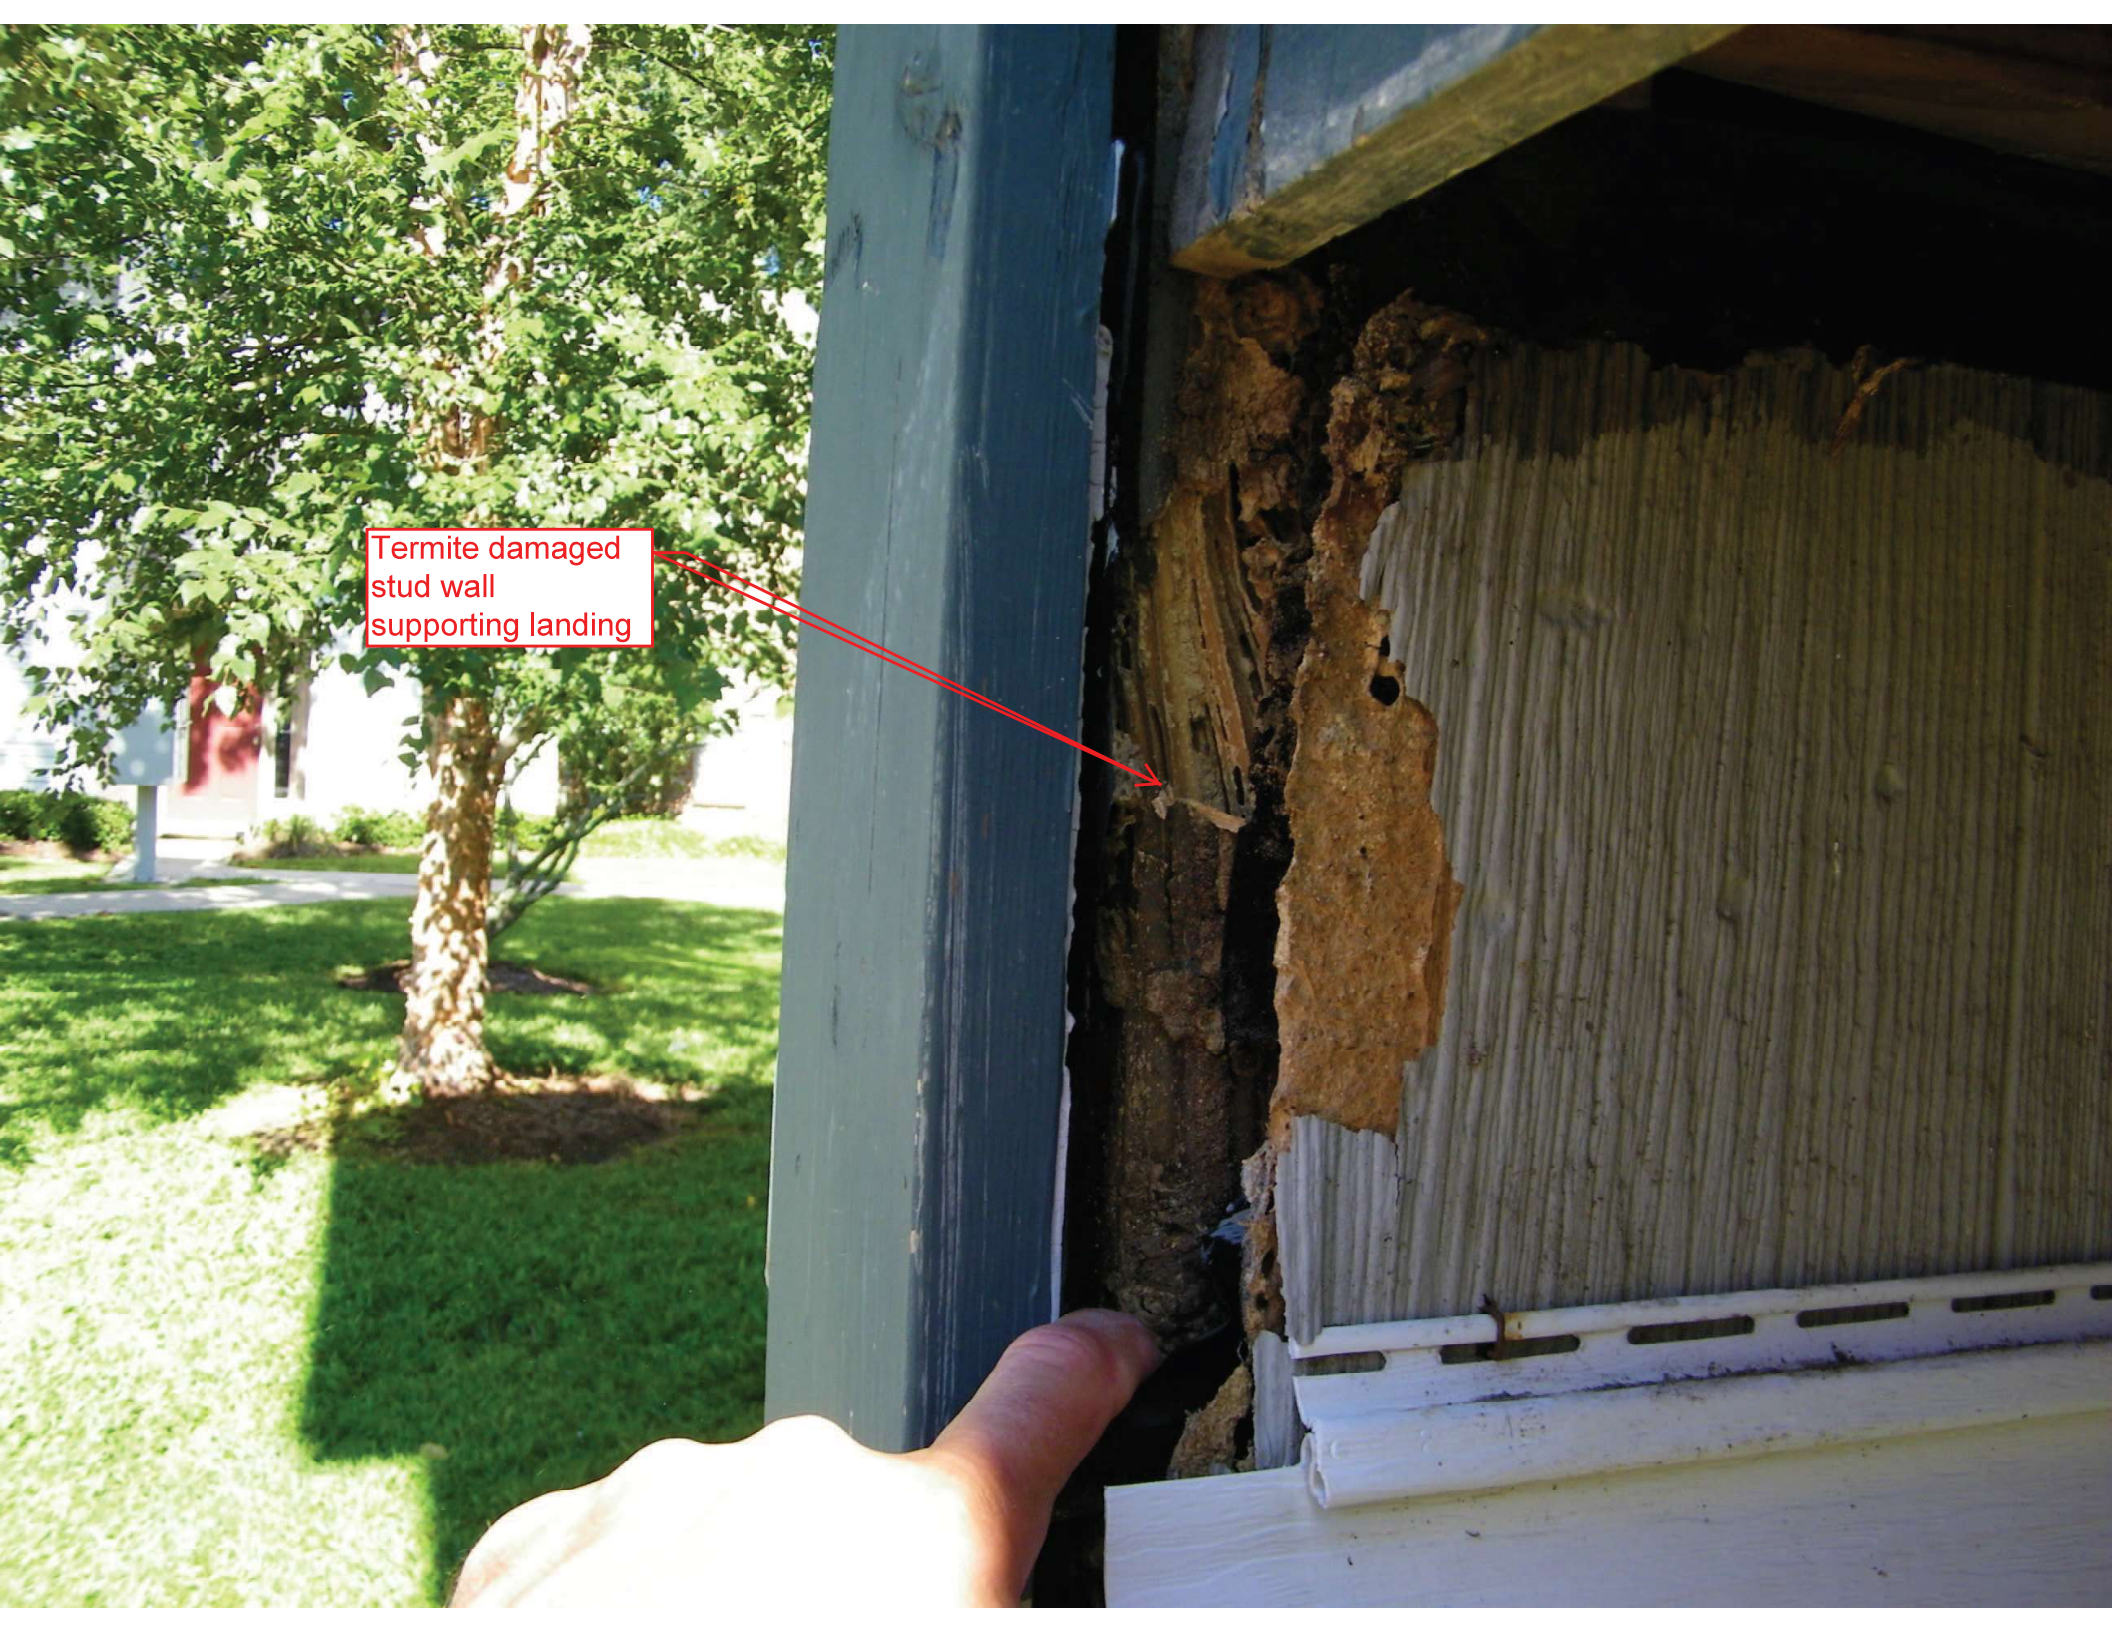
Termite damaged  
beam supporting  
stairs and front  
porch

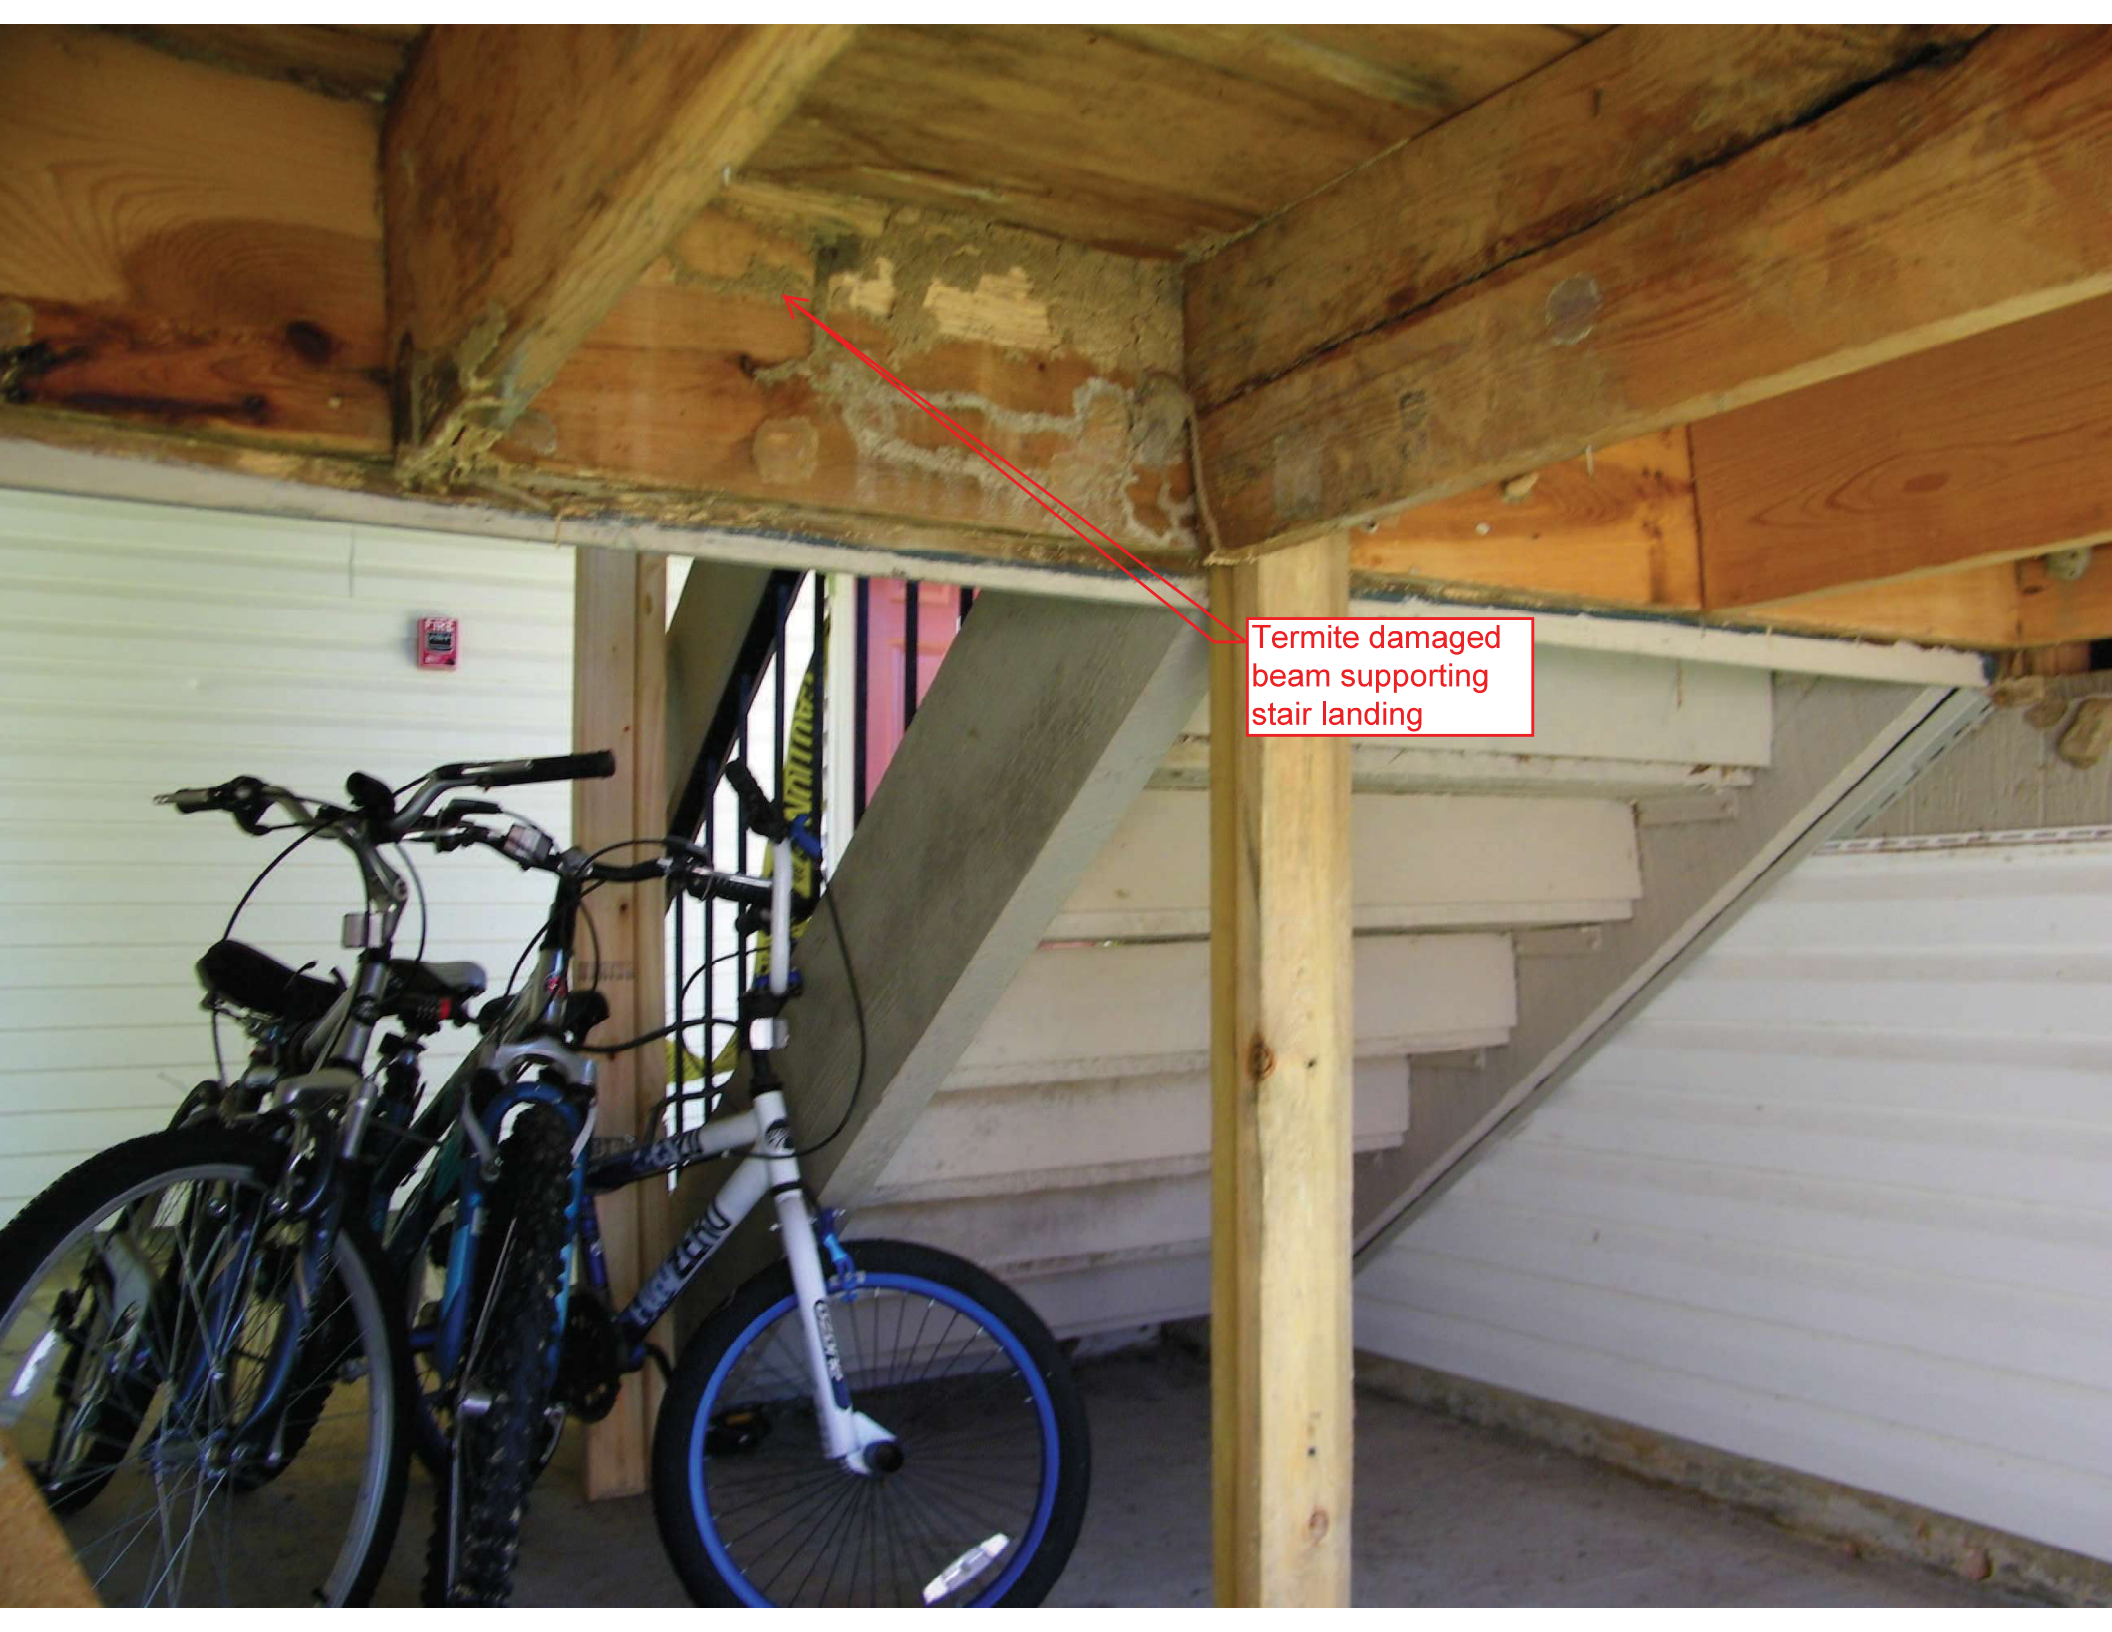
Termite damaged beam supporting stair landing

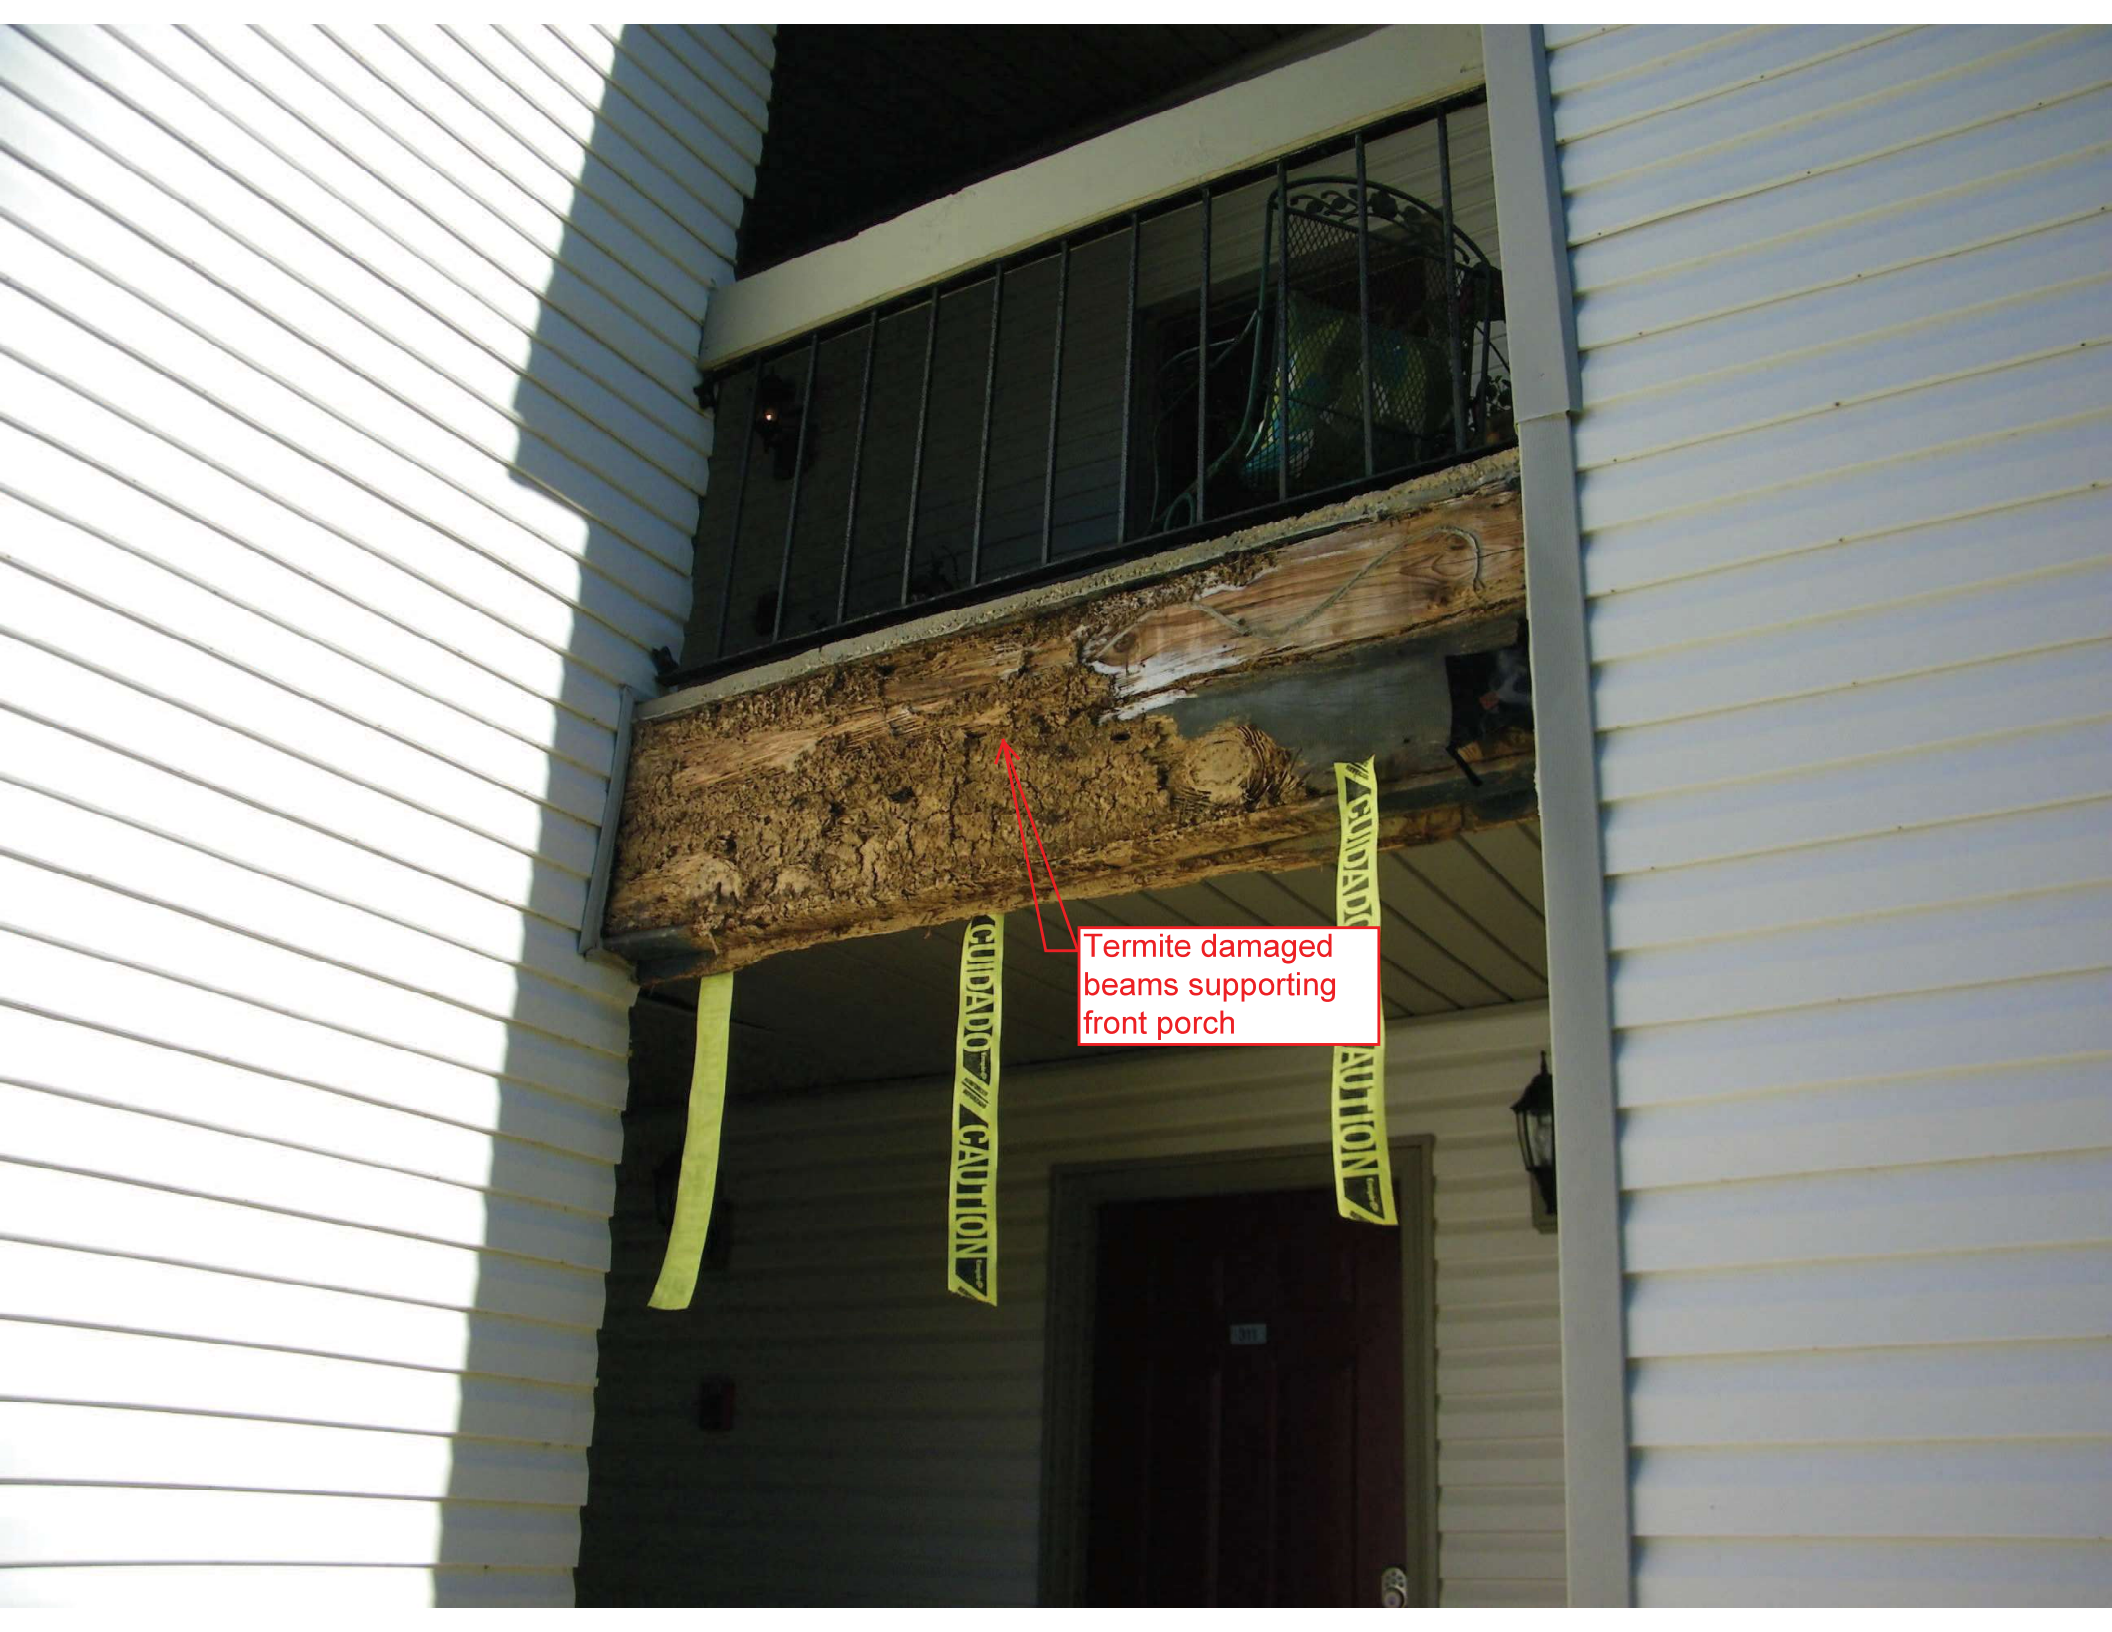
Termite damaged beams supporting front porch

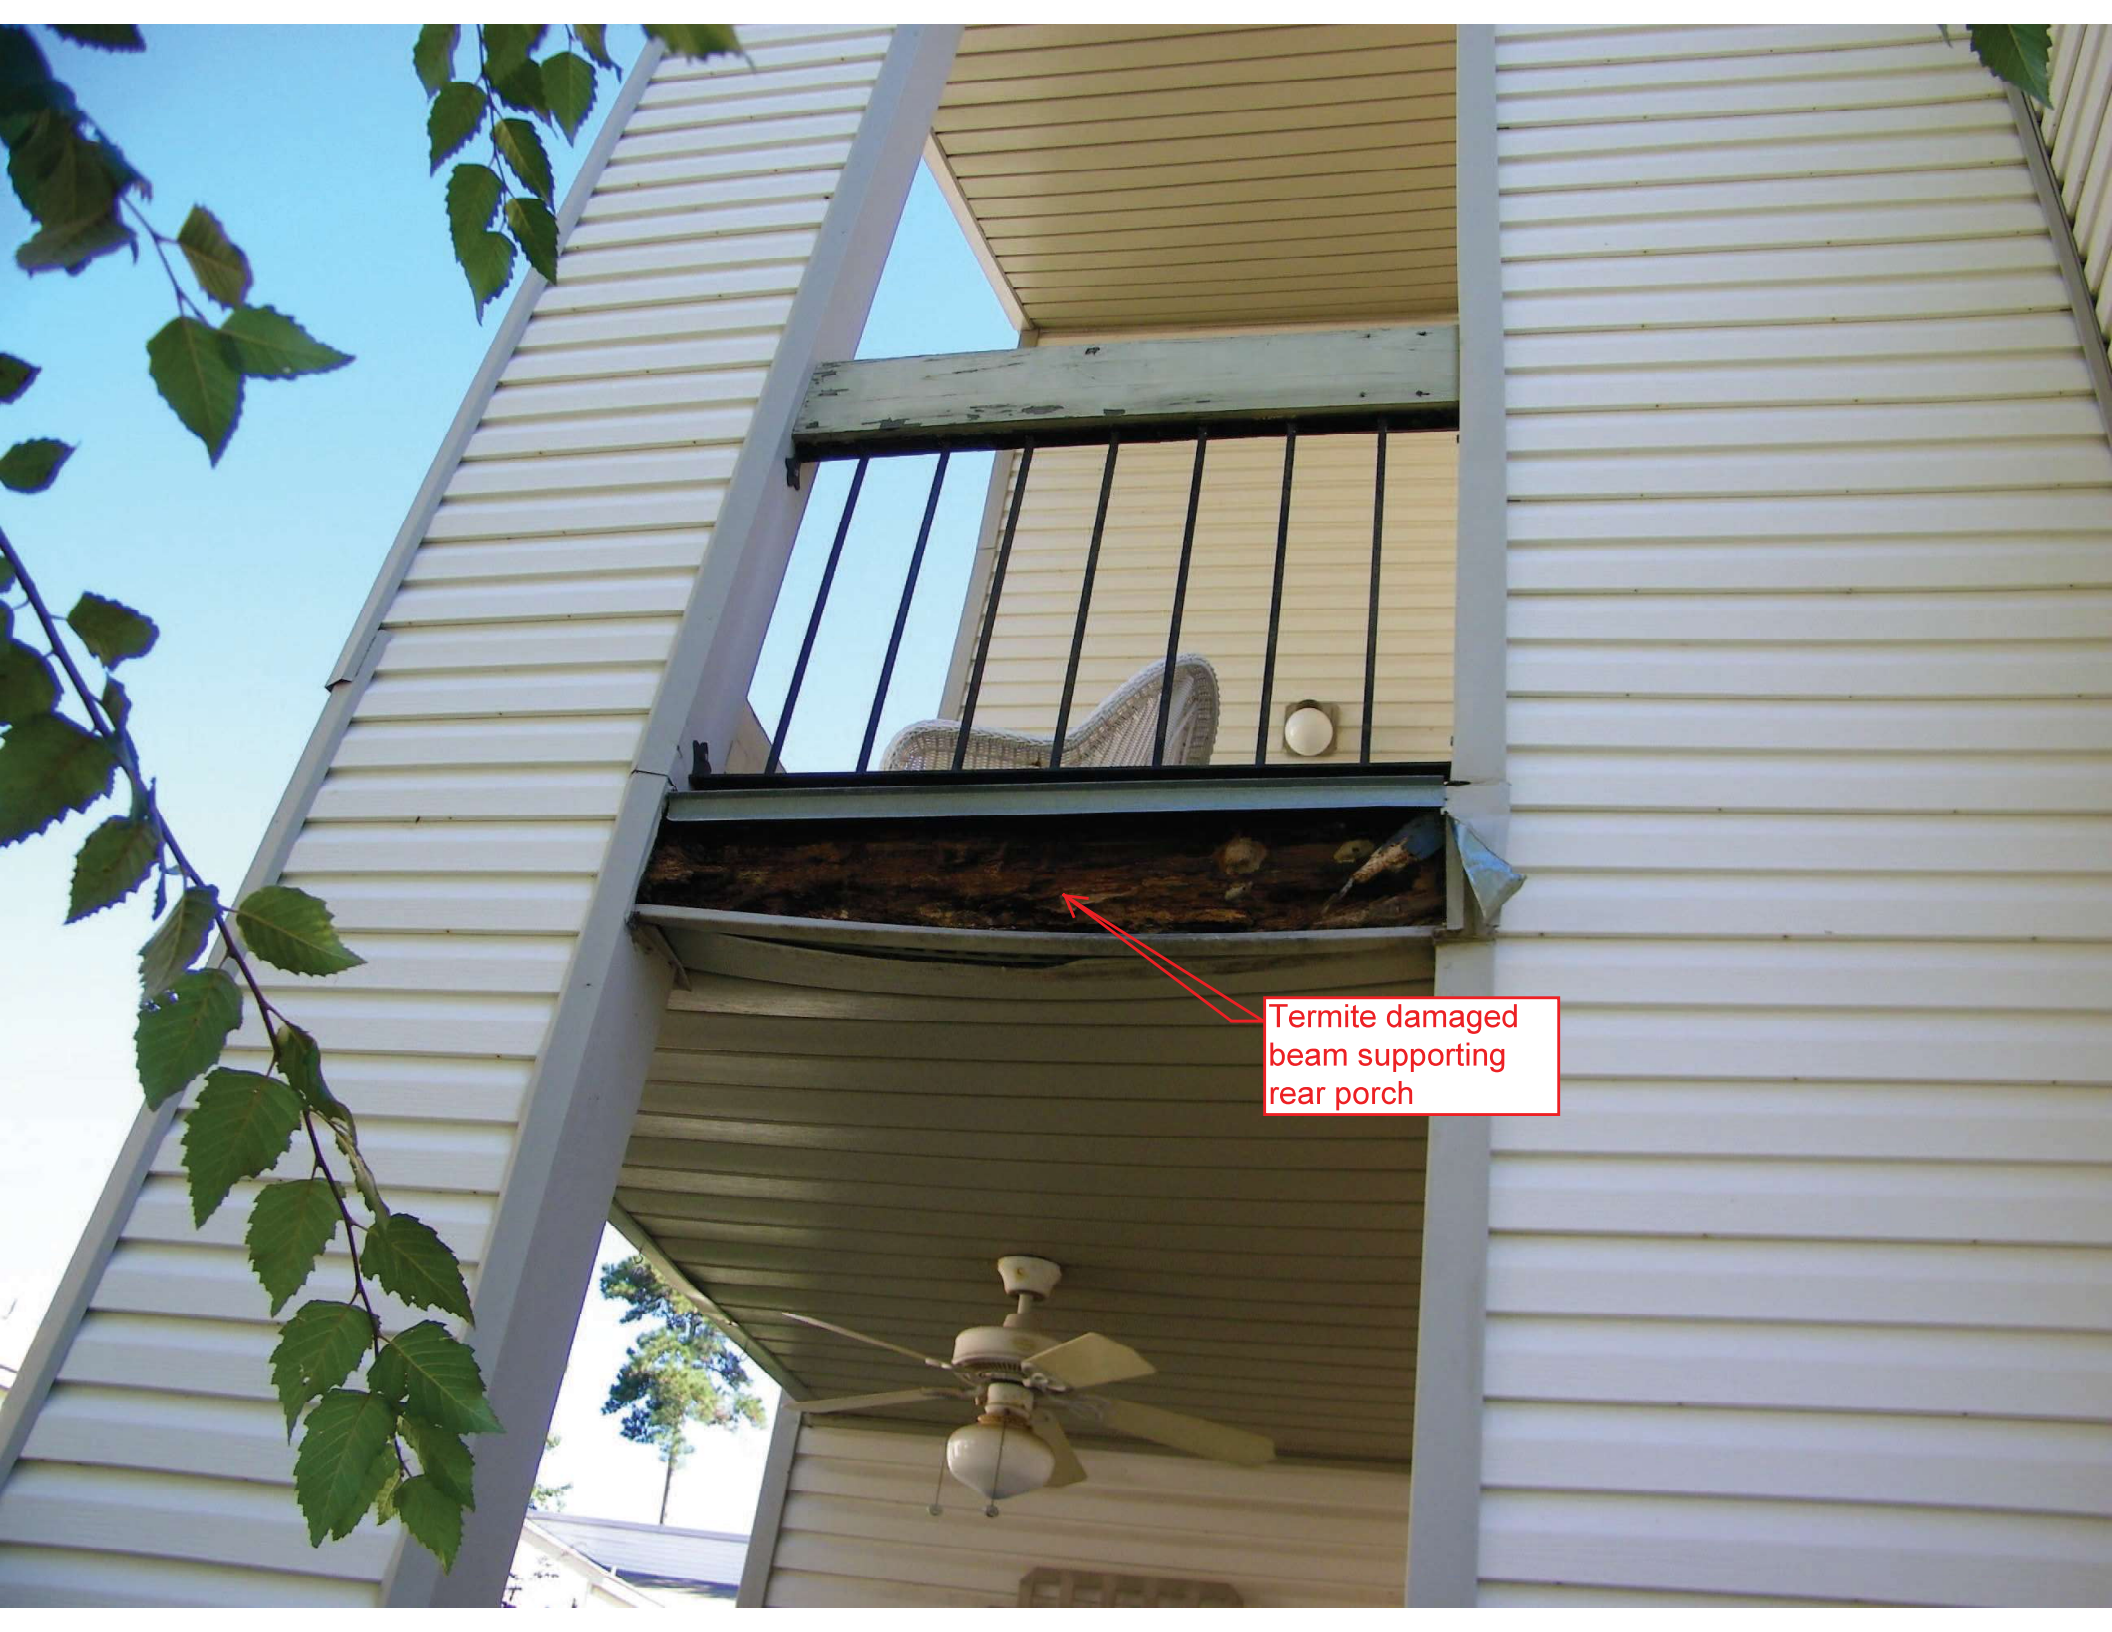
Termite damaged  
beam supporting  
rear porch

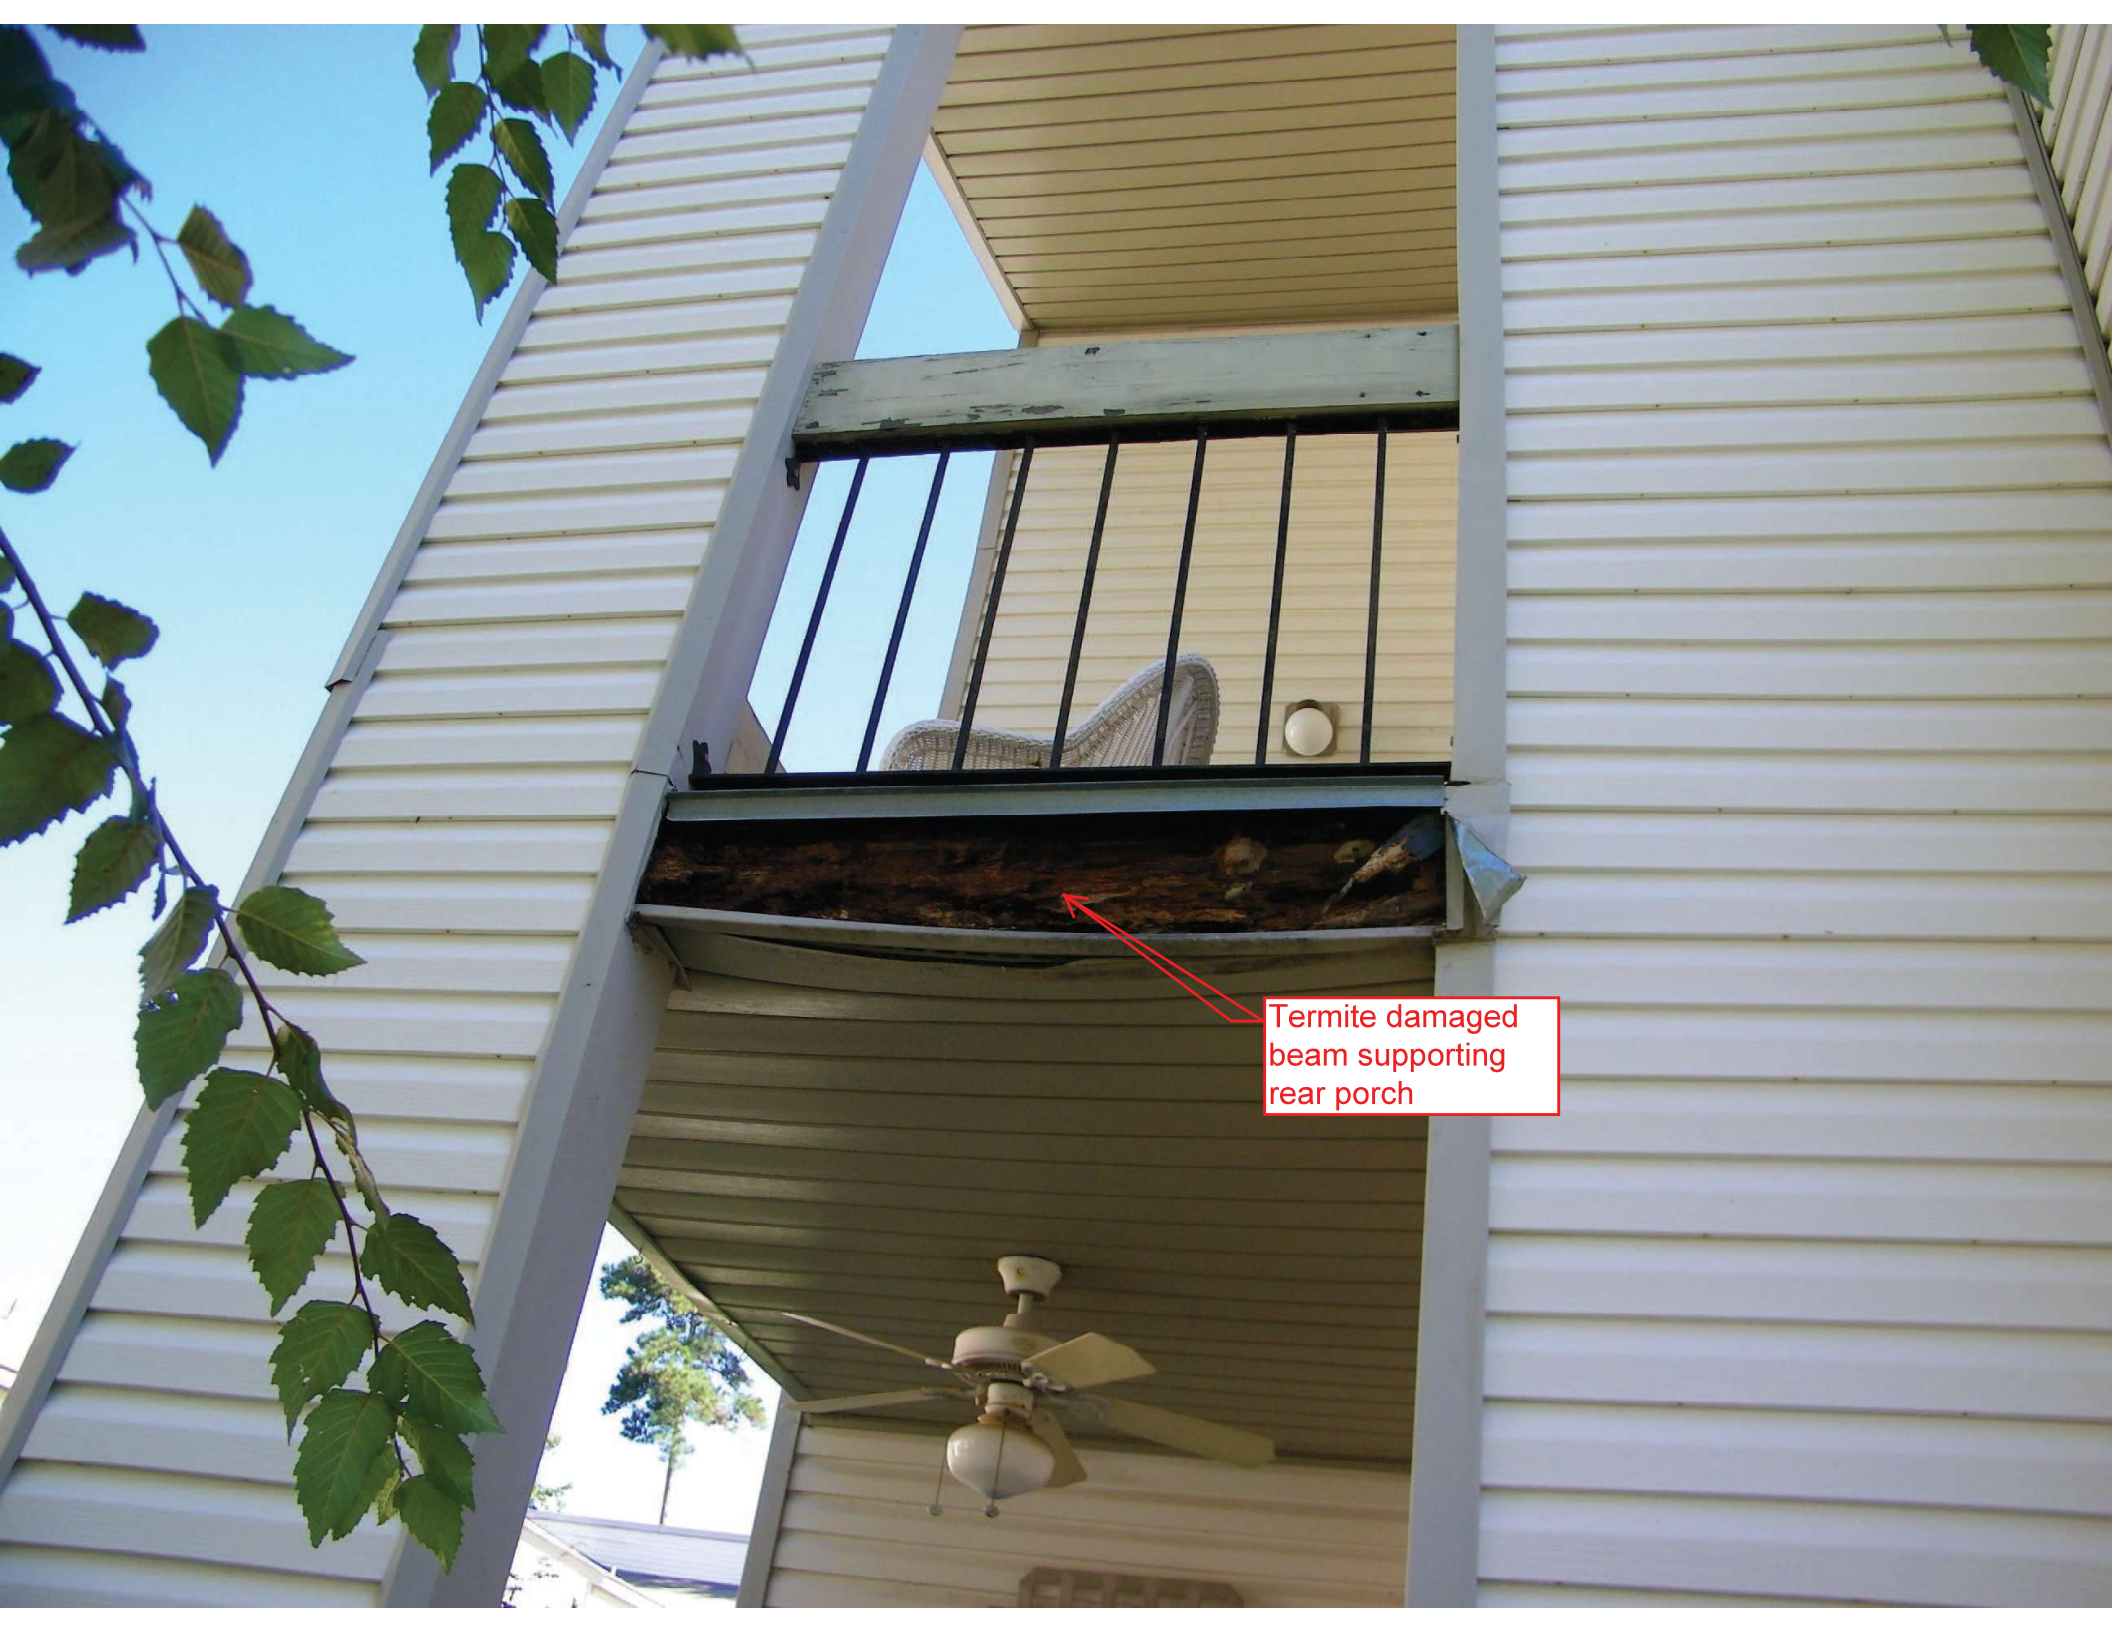
Termite damaged  
beam supporting  
rear porch
