## Structural Inspection

September 18, 2018

For: Parkview Condo HOA  
103 Parkview Blvd.  
Mandeville, La. 70471

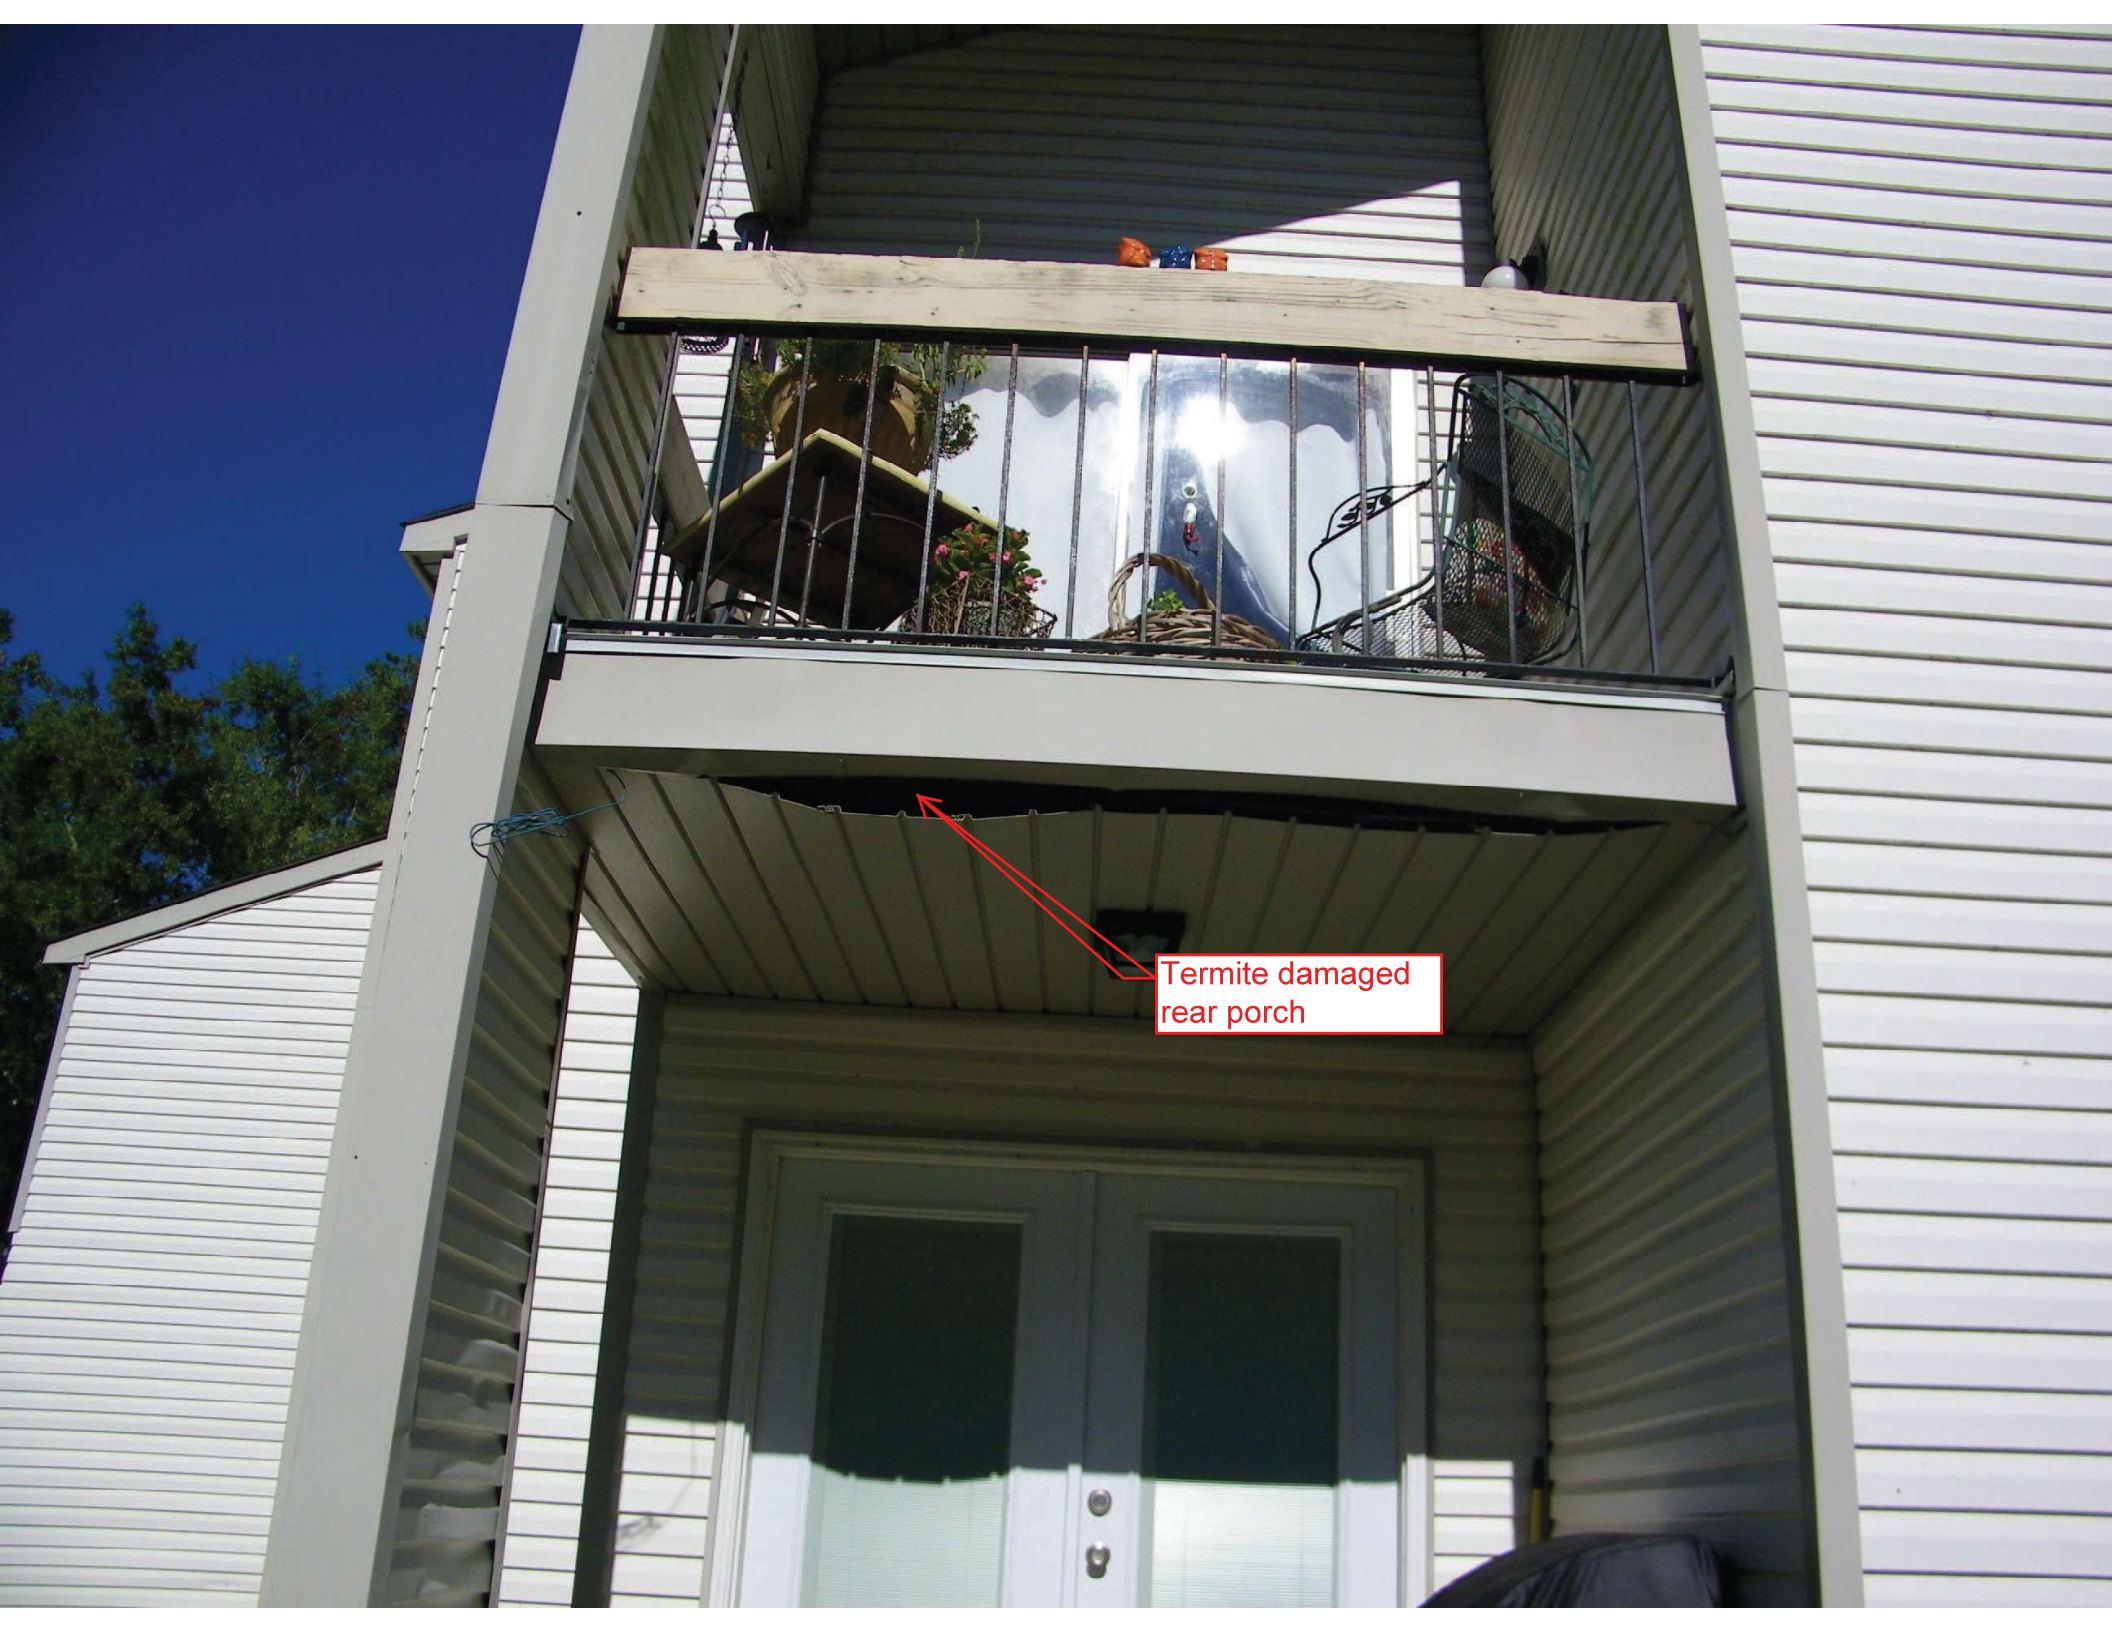
Termite damaged  
rear porch

Termite damaged  
beam supporting  
roof

Due to the extent of the damage it is recommend that the whole stairwell and porch's be removed and replaced with new treated wood and new lightweight concrete to allow for a complete sealed system. Please see the attached pictures for reference.

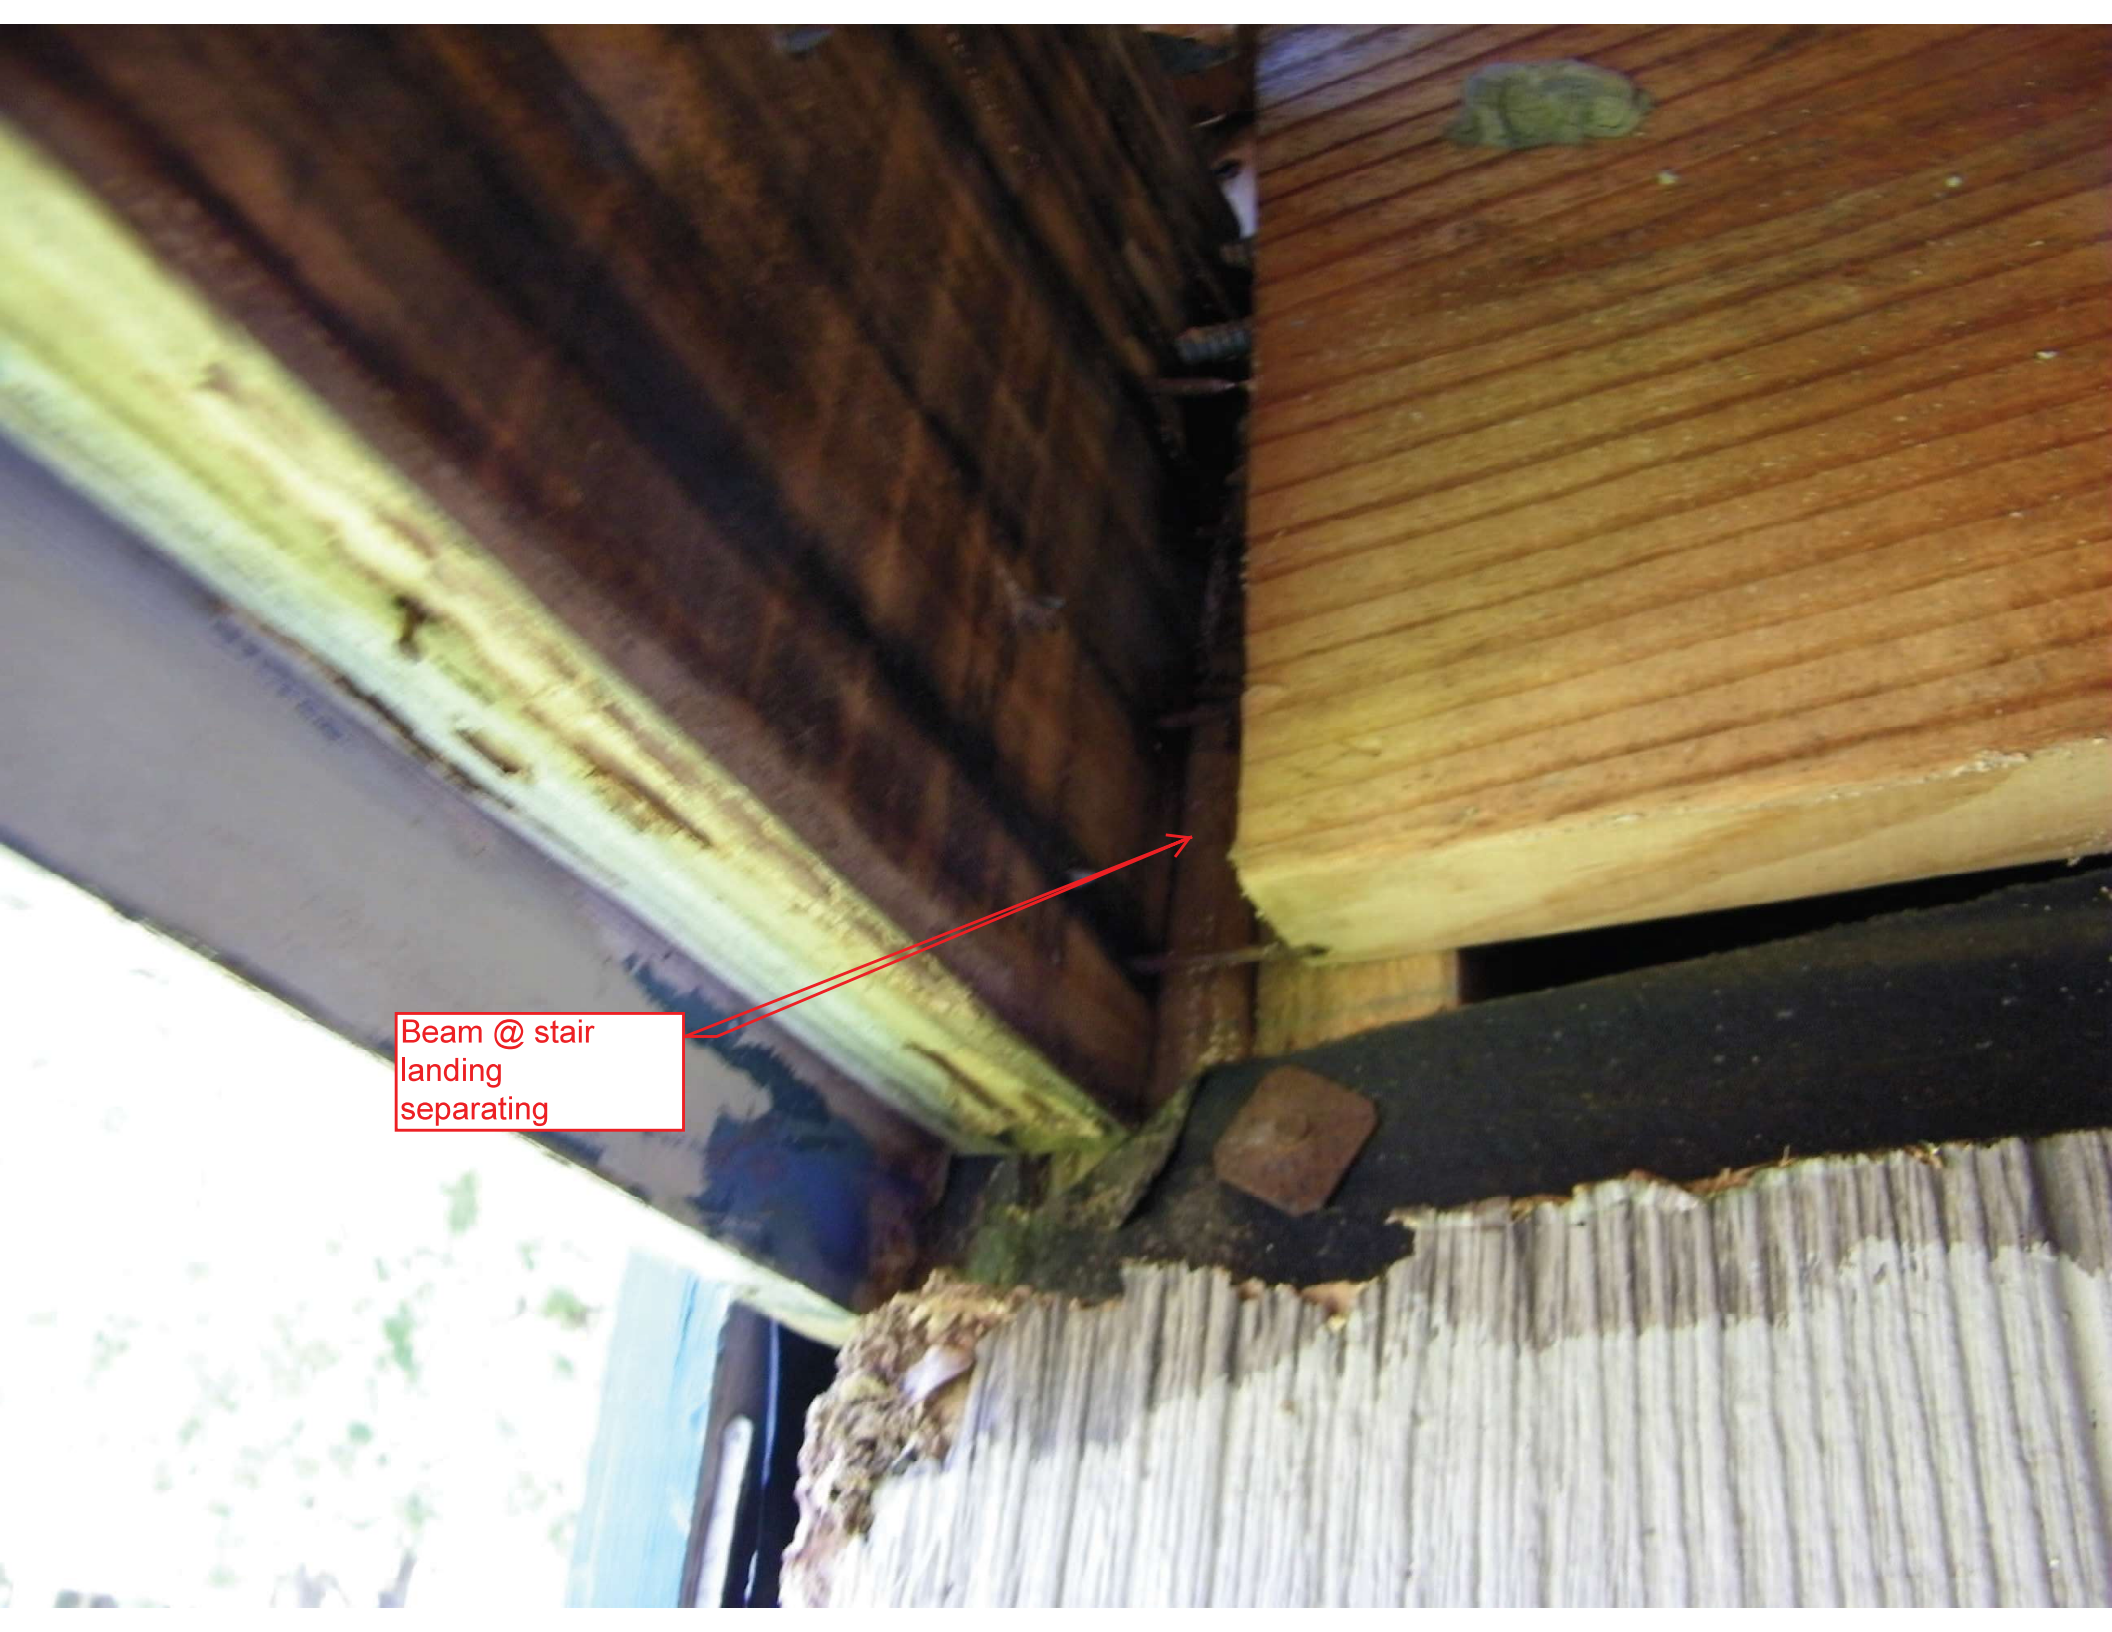
Beam @ stair  
landing  
separating

Termite damaged  
beam supporting  
stair landing is  
separating

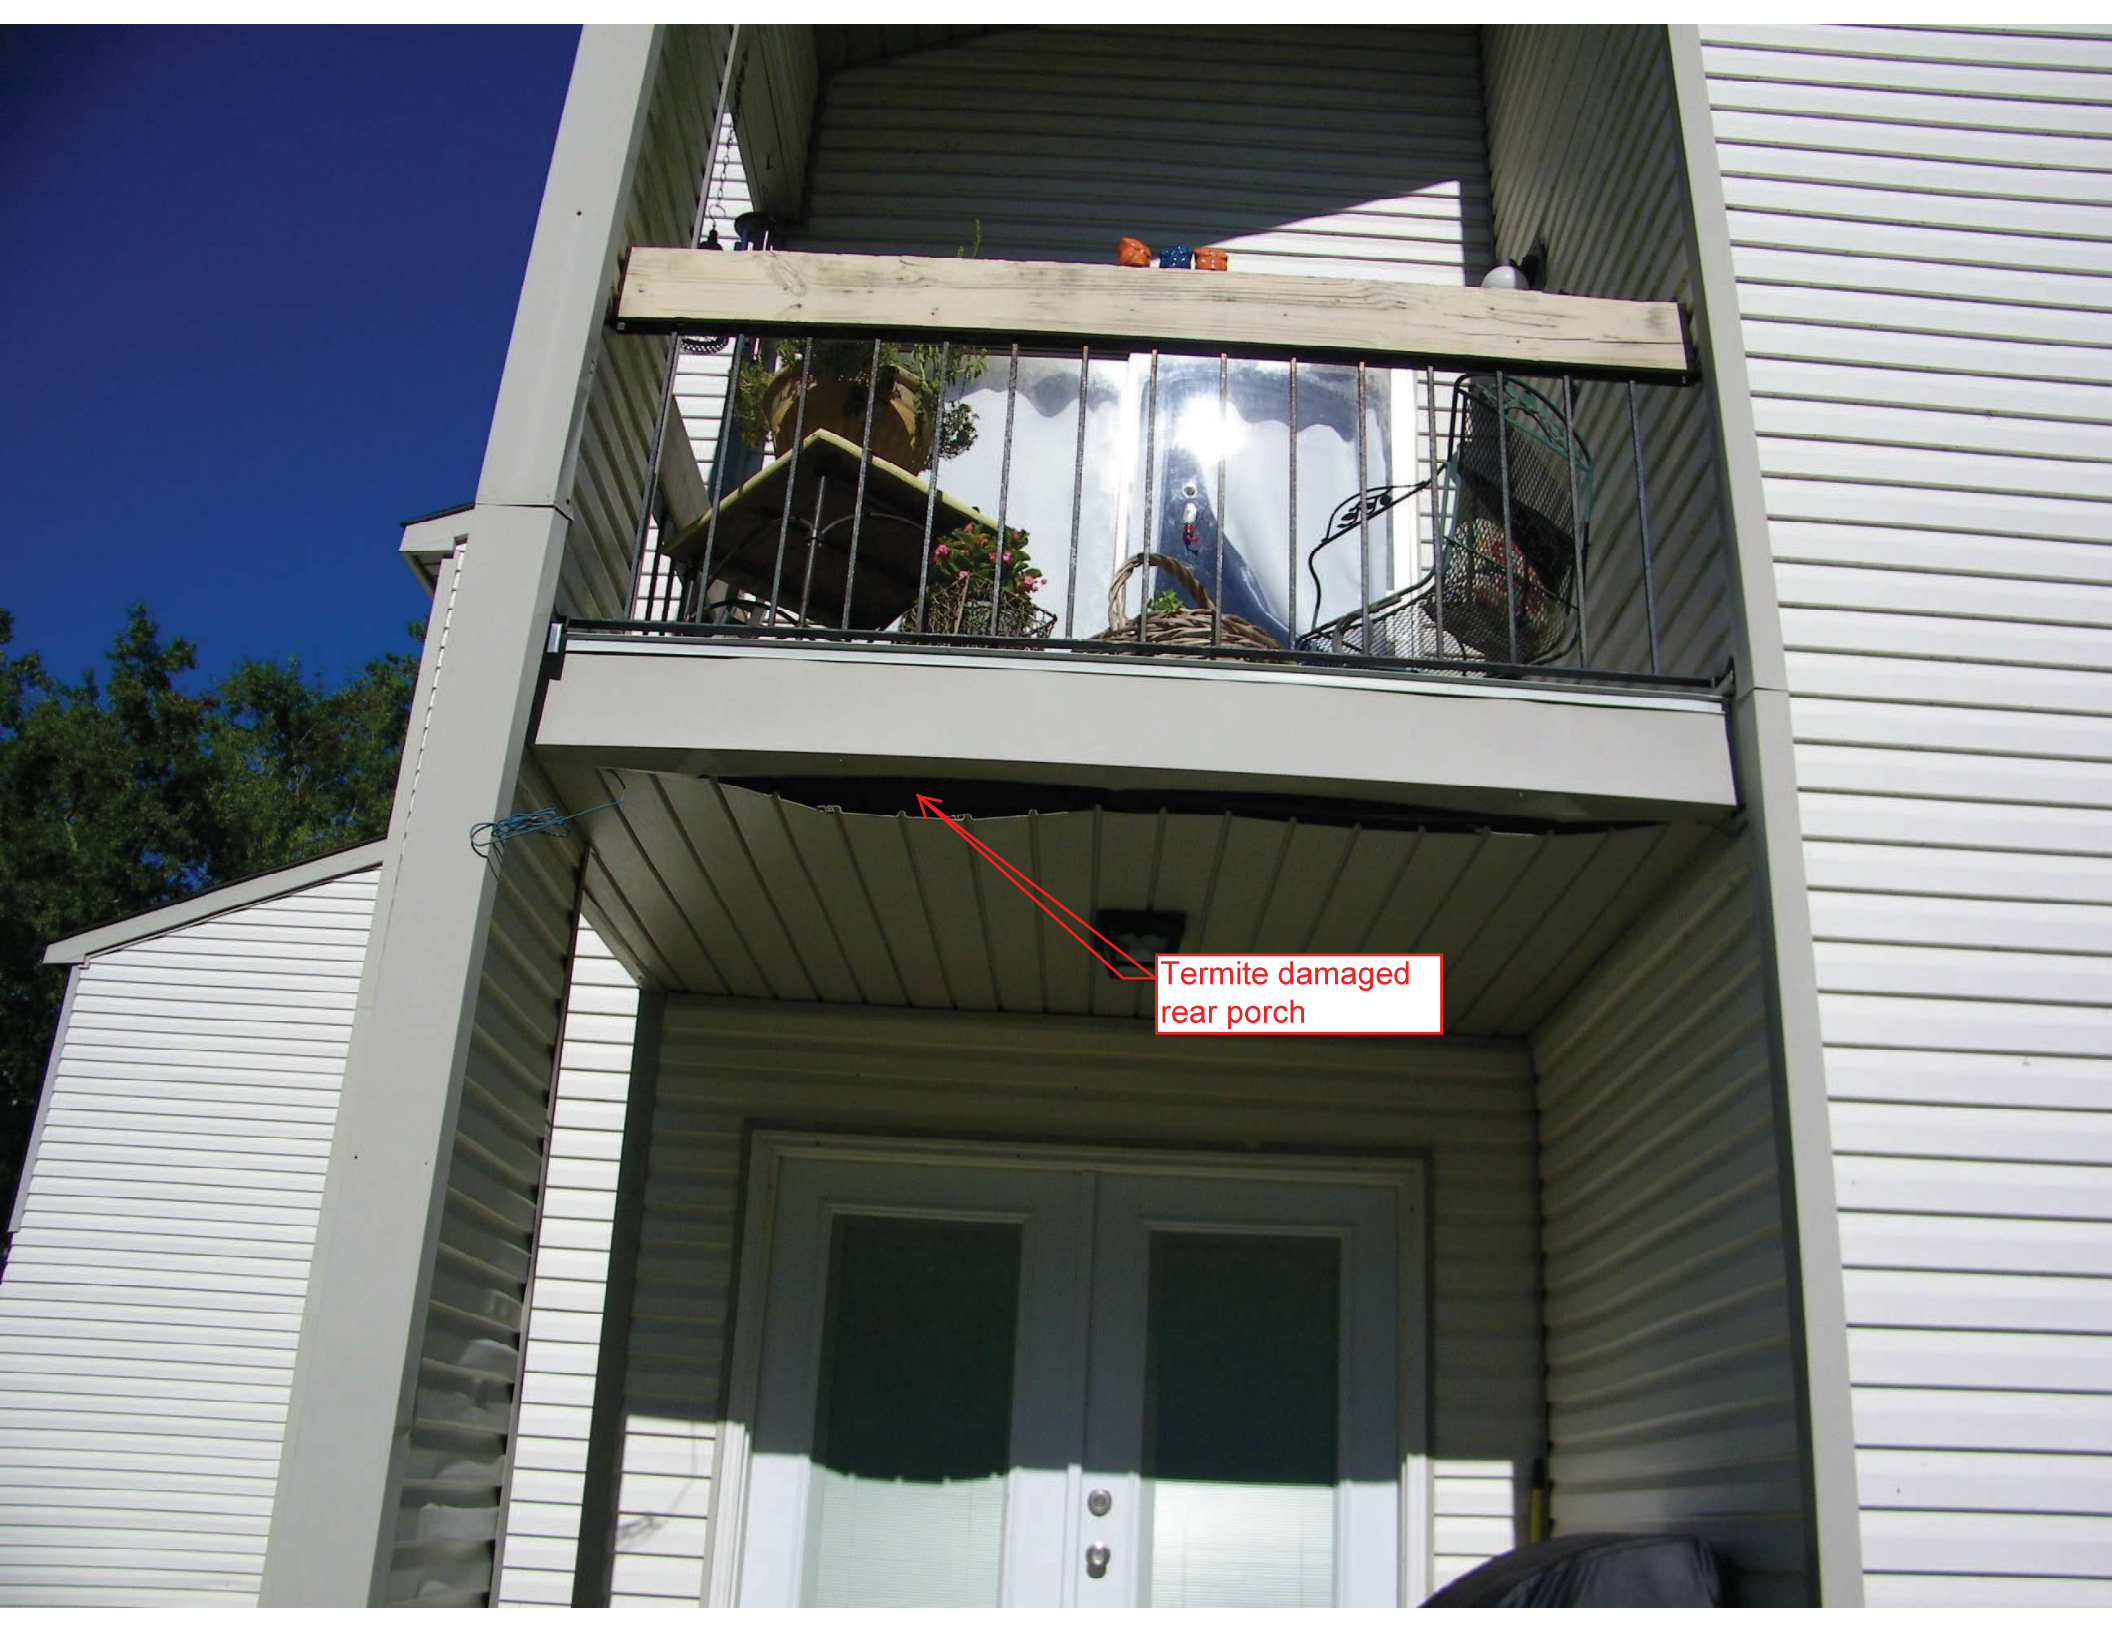
Termite damaged  
rear porch

Termite damaged  
beam supporting  
roof

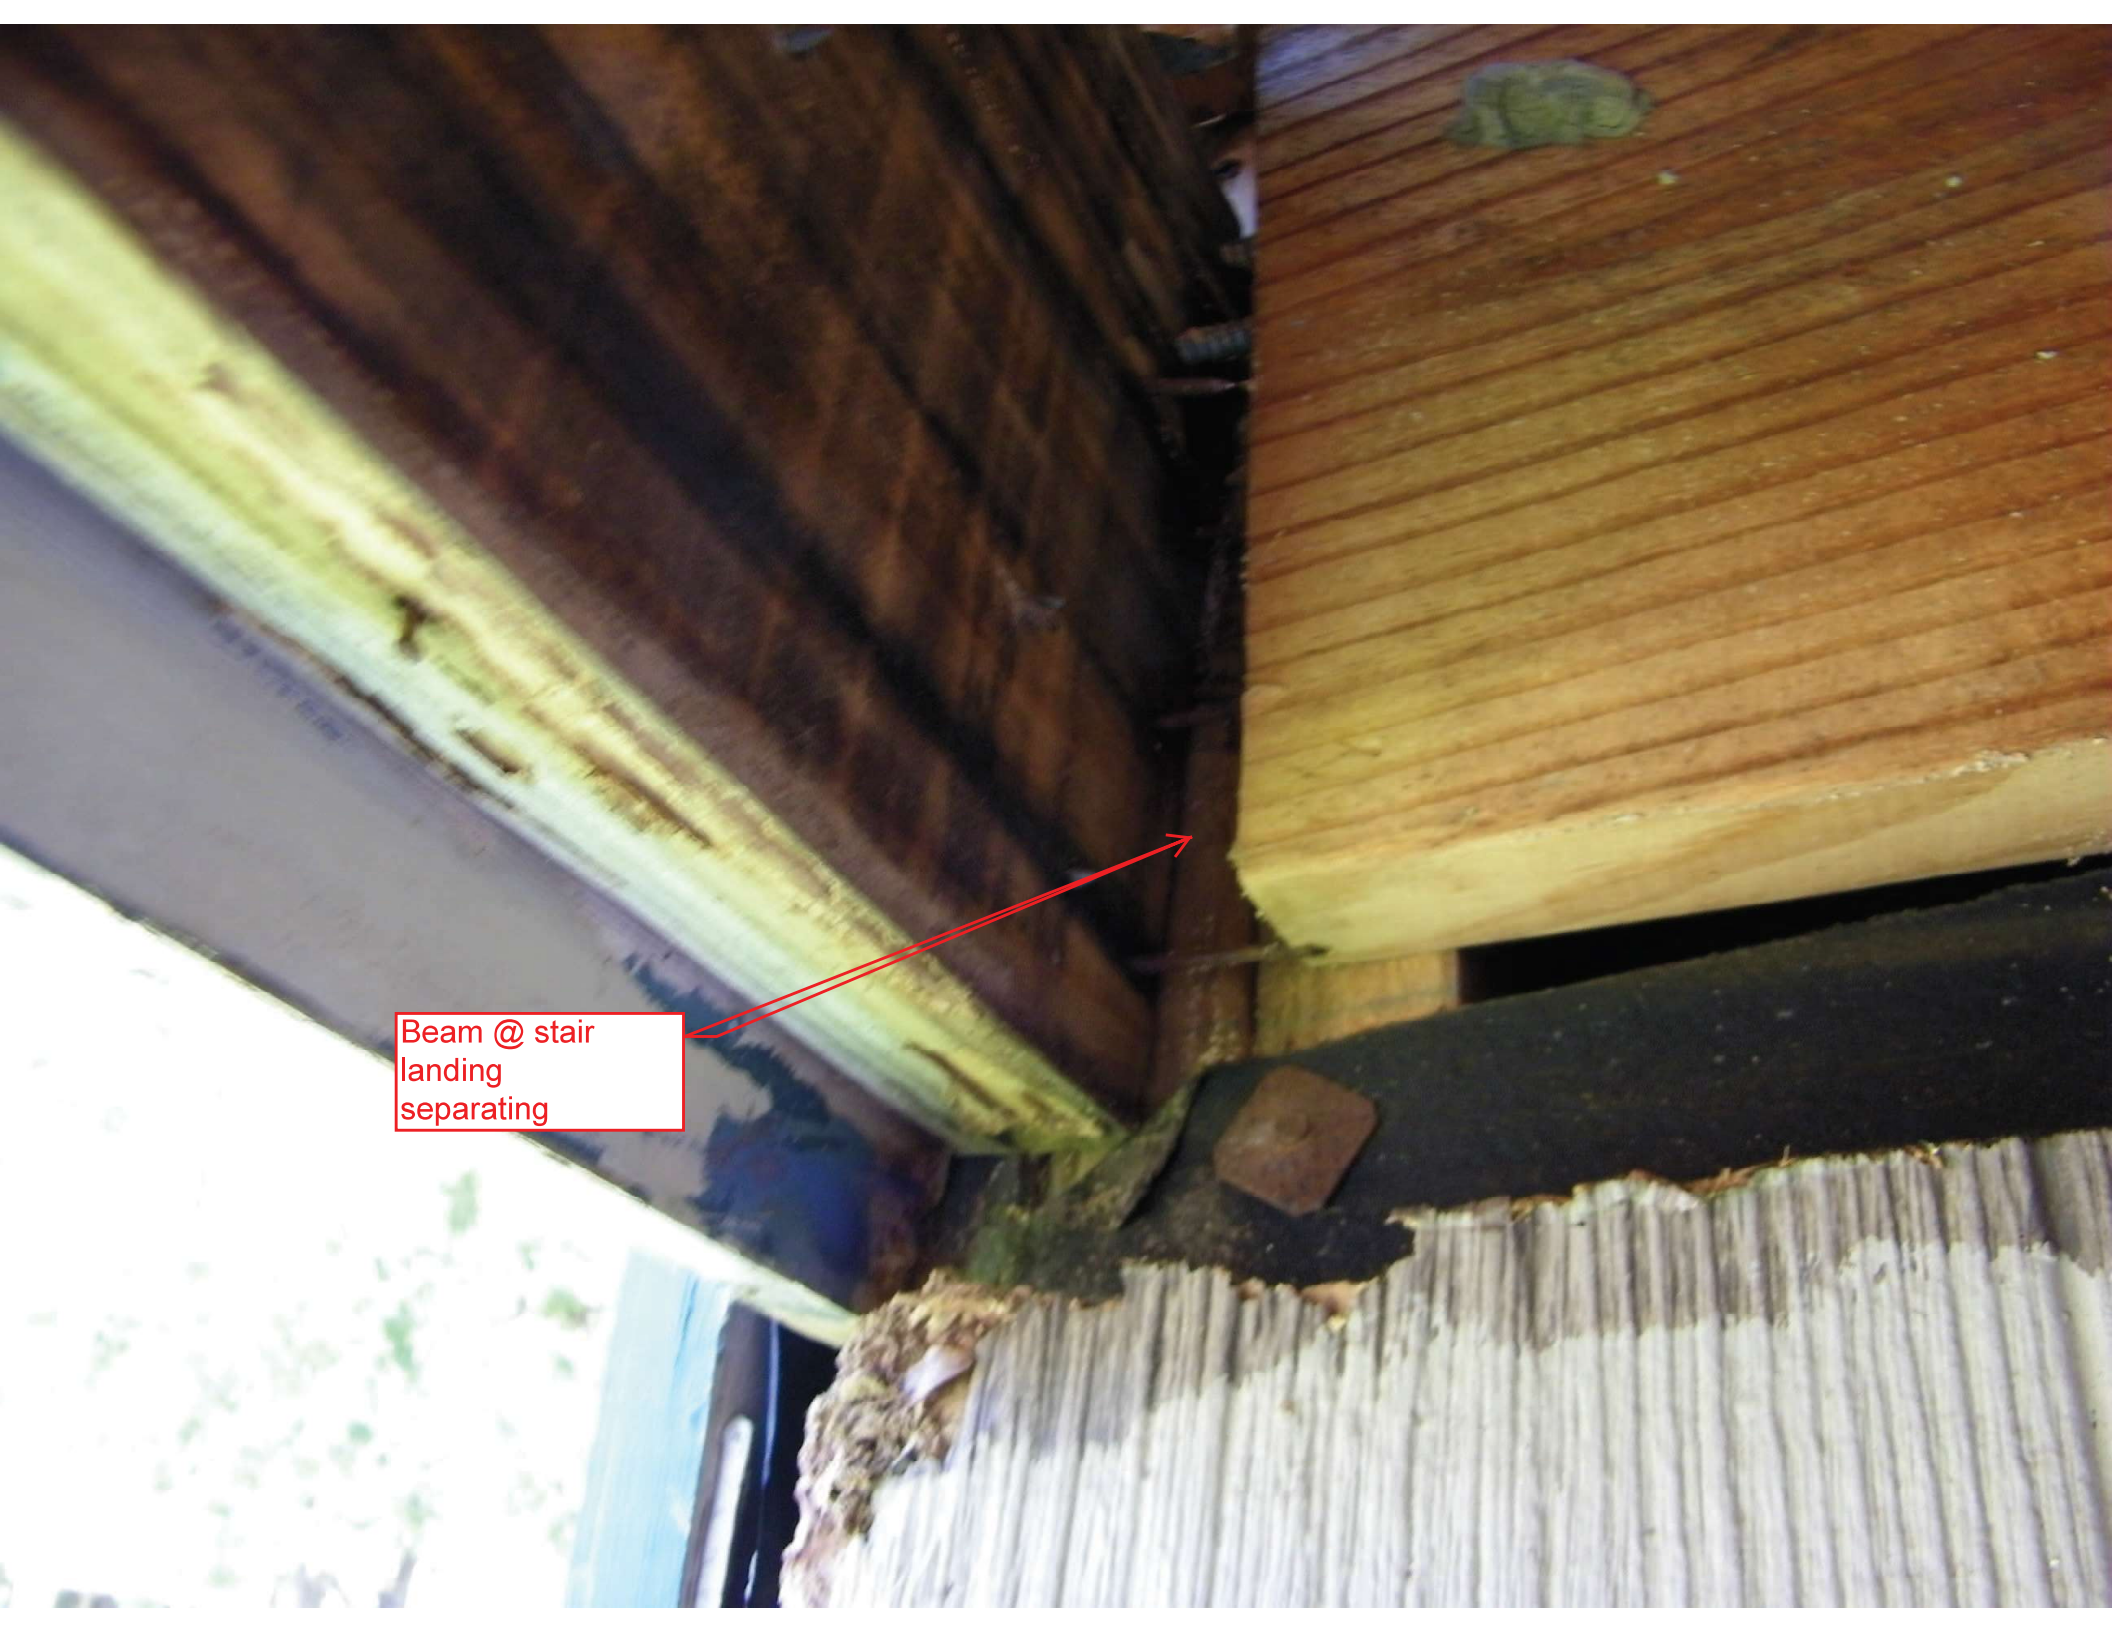
Beam @ stair  
landing  
separating

Termite damaged  
beam supporting  
stair landing is  
separating
