Inspection Connection

Home Inspection Report

**1099 Claire Drive
Slidell, LA 70461**

Inspected on Wed, May 31 2017 at 2:30 PM

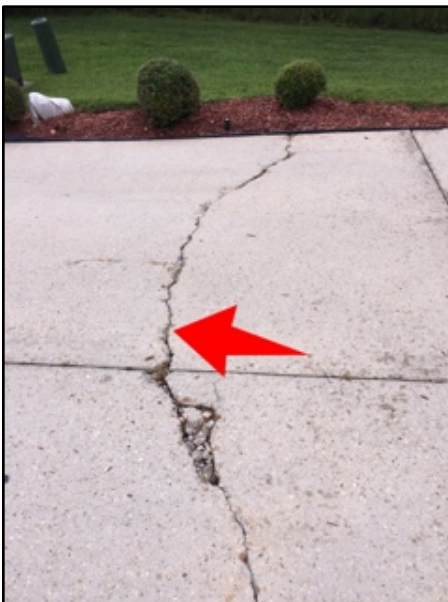
Figure 1-1

Major crack in the driveway noted. Recommend having this crack sealed to help prevent water from eroding away the ground underneath the concrete driveway.

1) Major crack in the driveway noted. Recommend having this crack sealed to help prevent water from eroding away the ground underneath the concrete driveway.

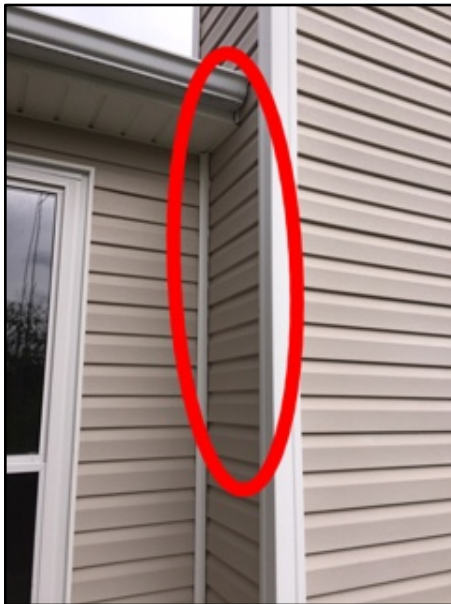
Figure 2-1

Moisture damage to the plywood behind the vinyl siding at the left side of the chimney. The roof to wall flashing is behind the vinyl siding versus being installed at the face of the vinyl siding. The other side of the chimney in this area may also have moisture damage to the plywood substrate behind the vinyl siding. Further evaluation is recommended and repair as needed.

2) Moisture damage to the plywood behind the vinyl siding at the left side of the chimney. The roof to wall flashing is behind the vinyl siding versus being installed at the face of the vinyl siding. The other side of the chimney in this area may also have moisture damage to the plywood substrate behind the vinyl siding. Further evaluation is recommended and repair as needed.

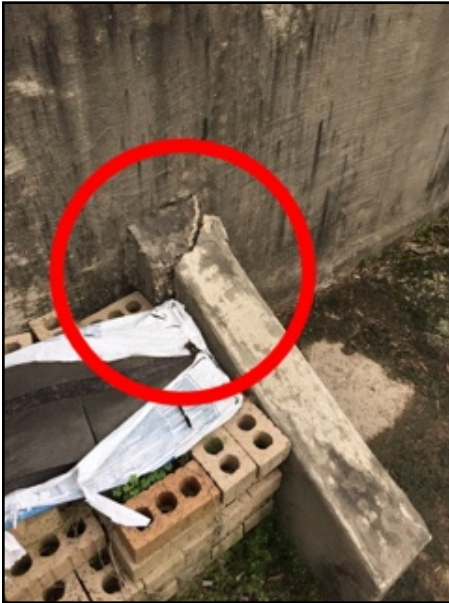
Figure 3-1

Cracked/damaged retaining wall support and the retaining wall is cracked in some areas. Further evaluation of the retaining wall is recommended by a qualified structural engineer.

3) Cracked/damaged retaining wall support and the retaining wall is cracked in some areas. Further evaluation of the retaining wall is recommended by a qualified structural engineer.

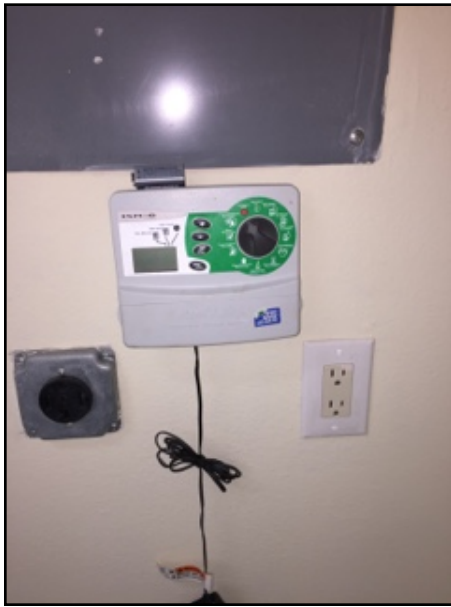
Figure 4-1

The sprinkler system was not inspected or operated. Recommend having owner verify that the sprinkler system is functional and no leaks exist.

4) The sprinkler system was not inspected or operated. Recommend having owner verify that the sprinkler system is functional and no leaks exist.

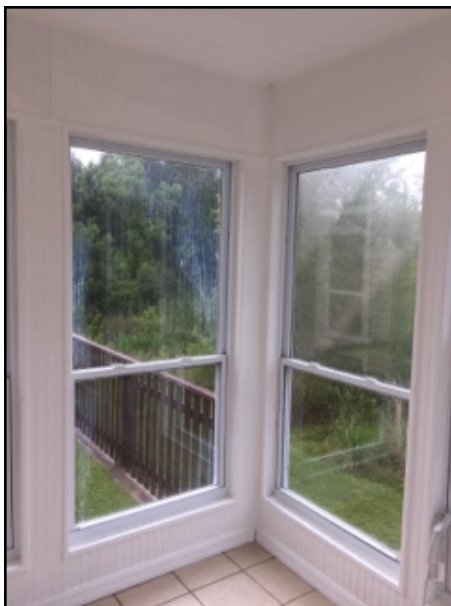
Figure 5-1

Several fogged/broken seals were observed at the windows during the course of this inspection. Recommend having window repair person examine all windows for this issue and replace as needed.

5) Several fogged/broken seals were observed at the windows during the course of this inspection. Recommend having window repair person examine all windows for this issue and replace as needed.

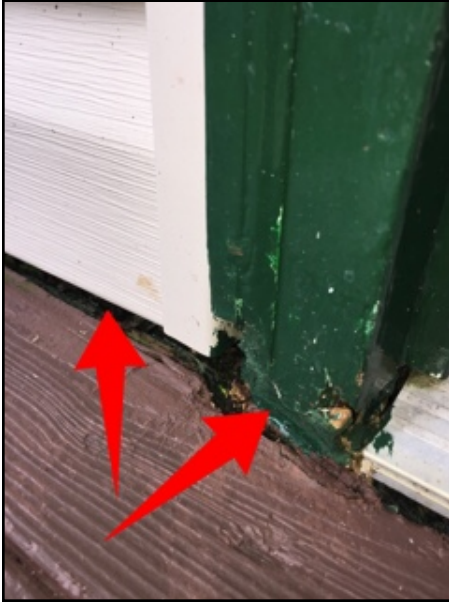
Figure 6-1

Moisture damage to the sunroom door frame and deck boards. The deck boards around the sunroom perimeter are moisture damaged.

6) Moisture damage to the sunroom door frame and deck boards. The deck boards around the sunroom perimeter are moisture damaged.

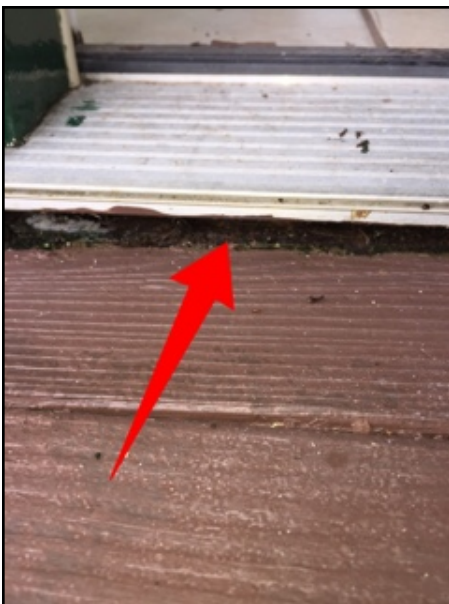
Figure 7-1

Moisture damage to the wood deck boards under the door threshold at the sunroom.

7) Moisture damage to the wood deck boards under the door threshold at the sunroom.

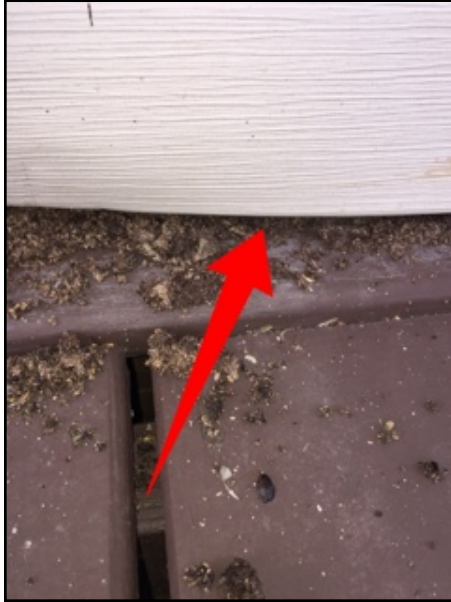
Figure 8-1

Moisture damage to the deck boards around the sunroom perimeter area and live termite activity was observed in some areas.

8) Moisture damage to the deck boards around the sunroom perimeter area and live termite activity was observed in some areas.

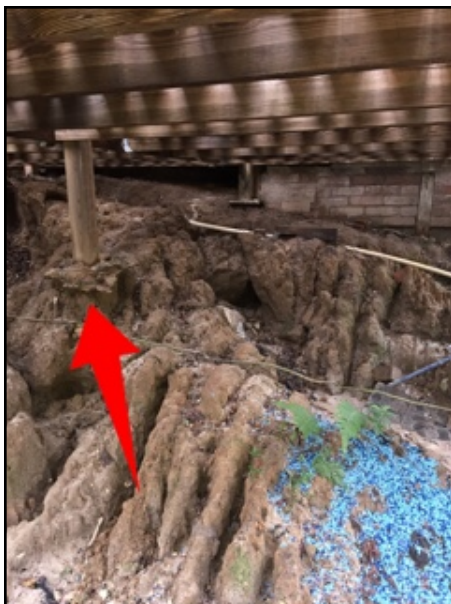
Figure 9-1

Major ground erosion is occurring under the wood deck. Further evaluation is recommended and repair as needed.

9) Major ground erosion is occurring under the wood deck. Further evaluation is recommended and repair as needed.

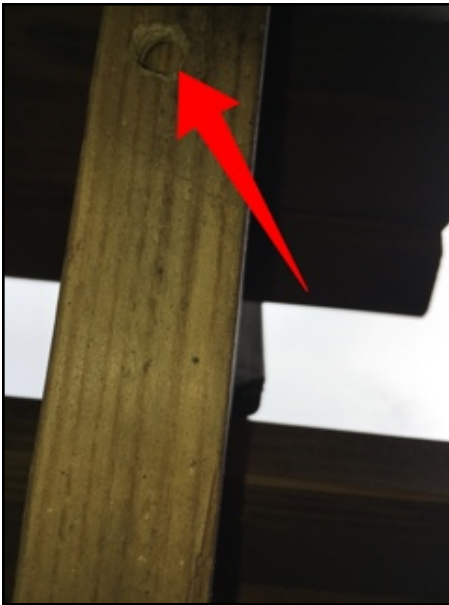
Figure 11-1

Wood boring insects were observed in several areas at the lower level wood deck.

11) Wood boring insects were observed in several areas at the lower level wood deck.

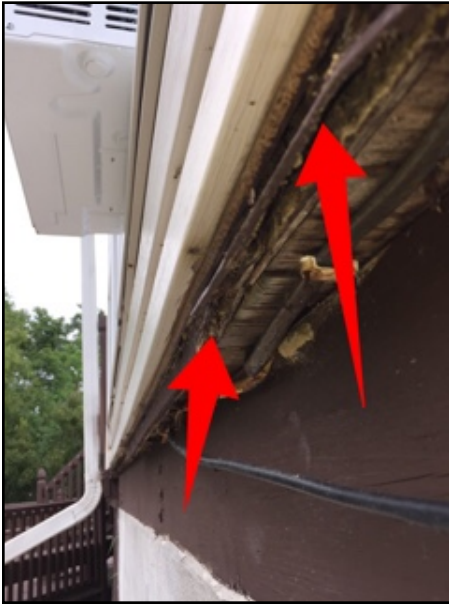
Figure 12-1

Moisture damage to the plywood substrate behind the vinyl siding at the back side of the sunroom noted with possible termite activity. Repair as needed.

12) Moisture damage to the plywood substrate behind the vinyl siding at the back side of the sunroom noted with possible termite activity. Repair as needed.

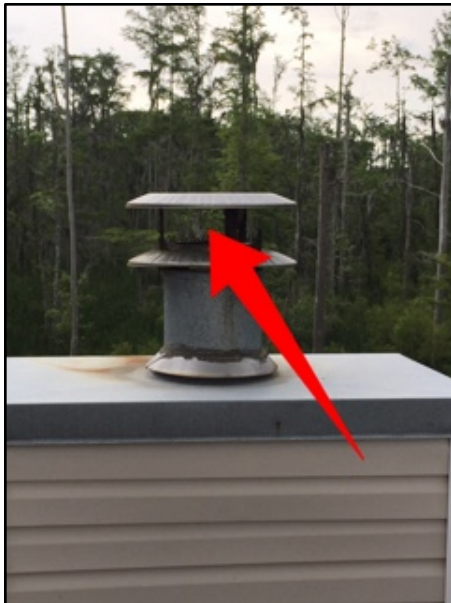
Figure 15-1

Comment 15:
The chimney screen is damaged/missing.

15) The chimney screen is damaged/missing.

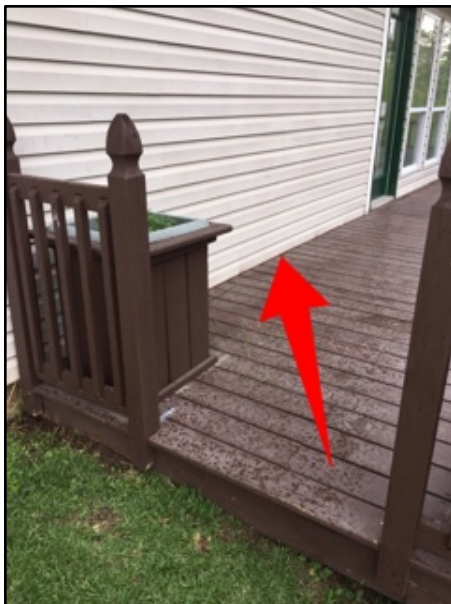
Figure 17-1

The concrete slab perimeter is not totally visible in some areas due to the wood deck which limits the visual inspection of the concrete foundation.

17) The concrete slab perimeter is not totally visible in some areas due to the wood deck which limits the visual inspection of the concrete foundation.

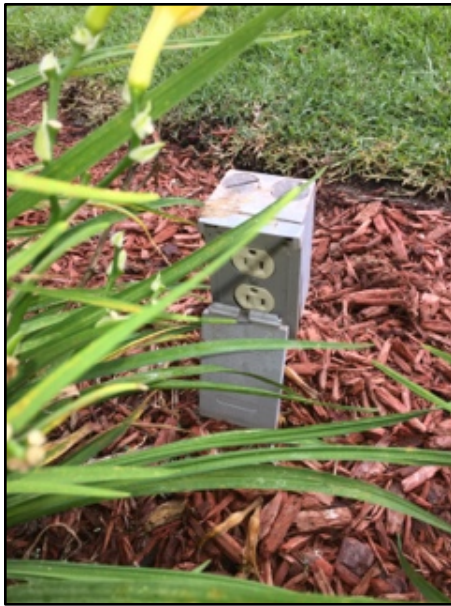
Figure 18-1

The front garden outlet covers are damaged/missing and these garden outlets are nonfunctional.

18) The front garden outlet covers are damaged/missing and these garden outlets are nonfunctional.

Recommend consulting with a licensed electrician for further evaluation of all the electrical issues and repair/replace as needed.

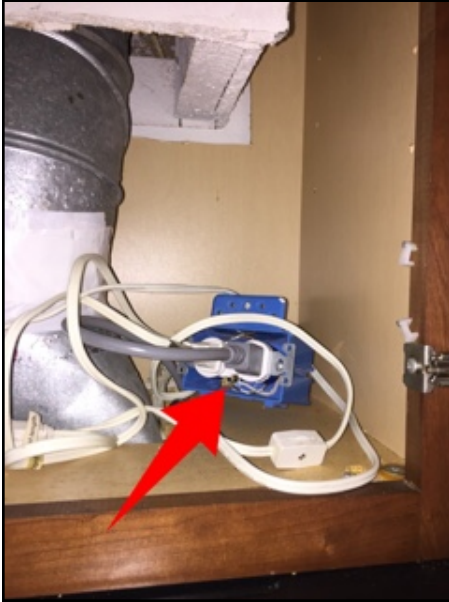
Figure 19-1

The electrical junction box in the cabinet above the cooktop is not properly secured and does not have a cover installed.

19) The electrical junction box in the cabinet above the cooktop is not properly secured and does not have a cover installed.

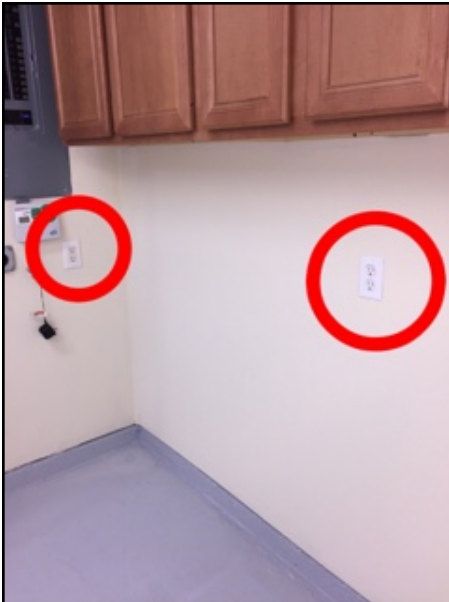
Figure 20-1

These two outlets in the garage are not GFCI protected.

20) These two outlets in the garage are not GFCI protected.

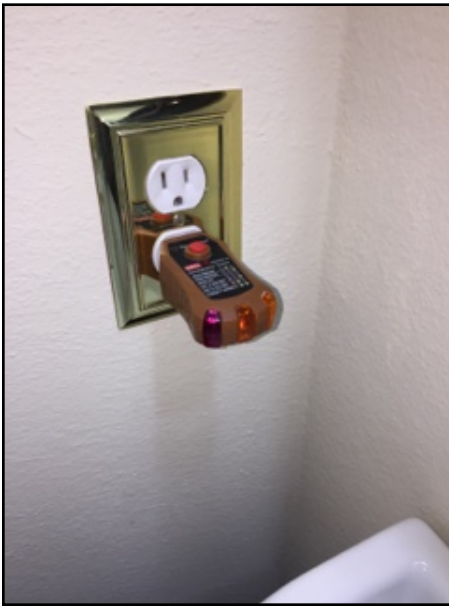
Figure 21-1

The half bath and the upstairs bathroom electrical outlets are not GFCI protected.

21) The half bath and the upstairs bathroom electrical outlets are not GFCI protected.

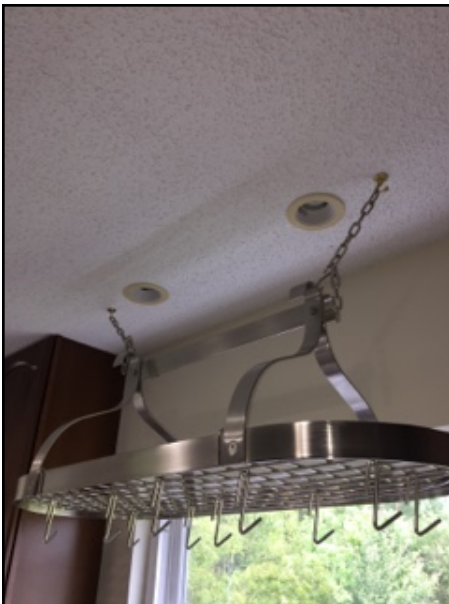
Figure 22-1

The two recessed lights above the kitchen sink were nonfunctional. Possible bulbs out.

22) The two recessed lights above the kitchen sink were nonfunctional. Possible bulbs out.

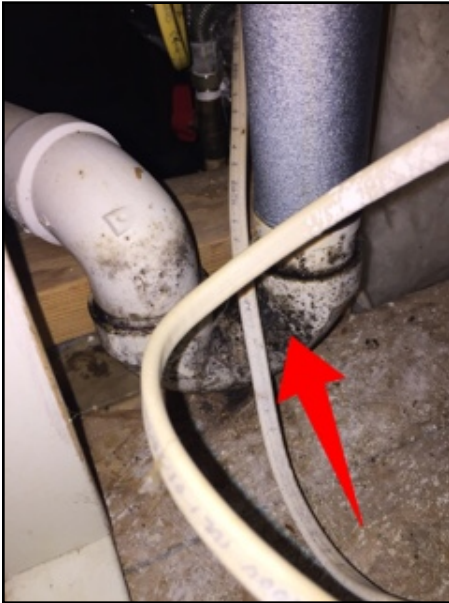
Figure 24-1

Visible mold at the AC main drain line P-trap in the upstairs closet noted. The P-trap is not properly insulated. Recommend cleaning and properly insulating the drain line/P-trap

24) Visible mold at the AC main drain line P-trap in the upstairs closet noted. The P-trap is not properly insulated. Recommend cleaning and properly insulating the drain line/P-trap

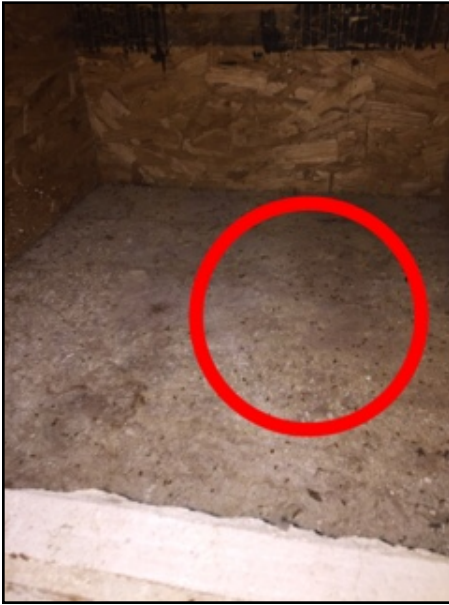
Figure 25-1

Small dead bugs were observed in the air return box at the upstairs AC unit and in the attic space. Further evaluation is recommended by a qualified pest control technician to properly identify these small bugs.

25) Small dead bugs were observed in the air return box at the upstairs AC unit and in the attic space. Further evaluation is recommended by a qualified pest control technician to properly identify these small bugs.

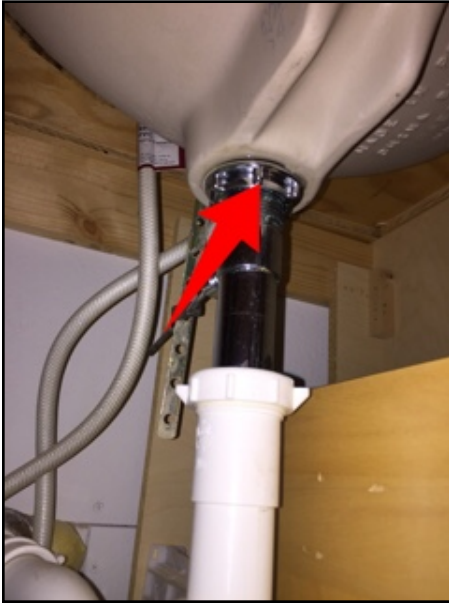
Figure 26-1

Drain line leak under the right side master bathroom sink.

26) Drain line leak under the right side master bathroom sink.

Recommend consulting with a licensed plumbing contractor for further evaluation of all the plumbing issues and repair/replace as needed.

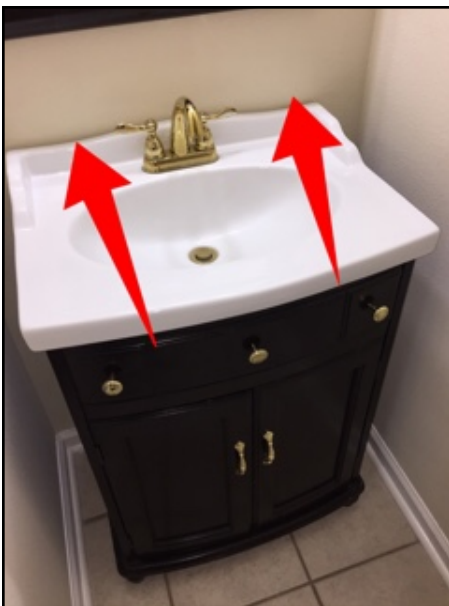
Figure 27-1

The sink top at the half bath is not properly secured to the wall.

27) The sink top at the half bath is not properly secured to the wall.

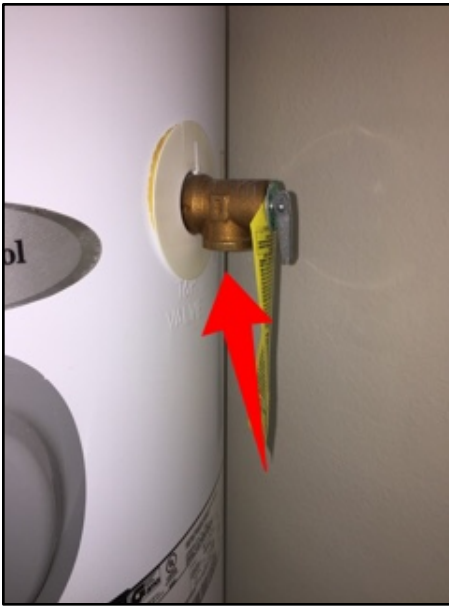
Figure 29-1

Missing drain line at the pressure relief valve at the water heater noted.

29) Missing drain line at the pressure relief valve at the water heater noted.

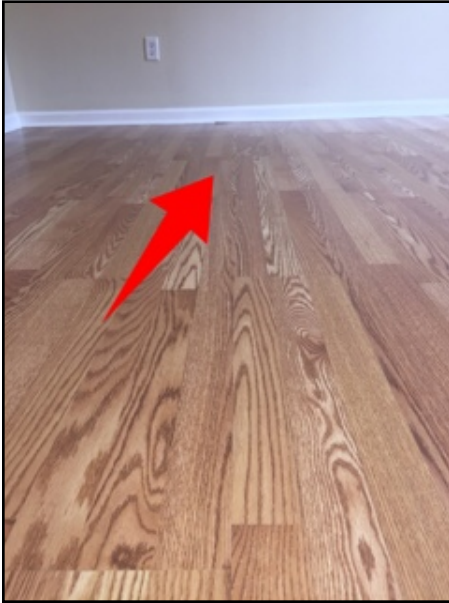
Figure 30-1

The wood laminate flooring material in the master bedroom is loose in some areas.

30) The wood laminate flooring material in the master bedroom is loose in some areas.
