Insured: Kevin and Andrea Schneider  
Address: 21 Briar Hollow Drive  
Covington, LA 70433  
D/O/L: 08/30/21  
Your File No.: 80128336  
FCNA File No.: 103636

Please accept this letter as a supplement to the report dated October 20, 2021, prepared by Frank Andrade, P.E. for Forensic Consultants of North America (FCNA).

This supplemental letter addresses my findings of a second site inspection completed on May 3, 2022 to address additional concerns reported by Mr. Schneider. Present at the residence during the second inspection were Mr. Schneider, Mr. Kevin Simon (Roofing Contractor), the independent adjuster, and me. At the time of the second inspection, Mr. Schneider reiterated that the exterior stucco-finished walls of the residence had been damaged from the high winds generated during the passage of Hurricane Ida in August 2021 and that the cracks did not exist before the storm. Furthermore, Mr. Schneider reported that the roof coverings on all the roof slopes over the residence had been recently replaced. Mr. Simon reported that the original field adjuster told him that there would be no issues to replace the entire roof and there was no need to get on the roof for an inspect

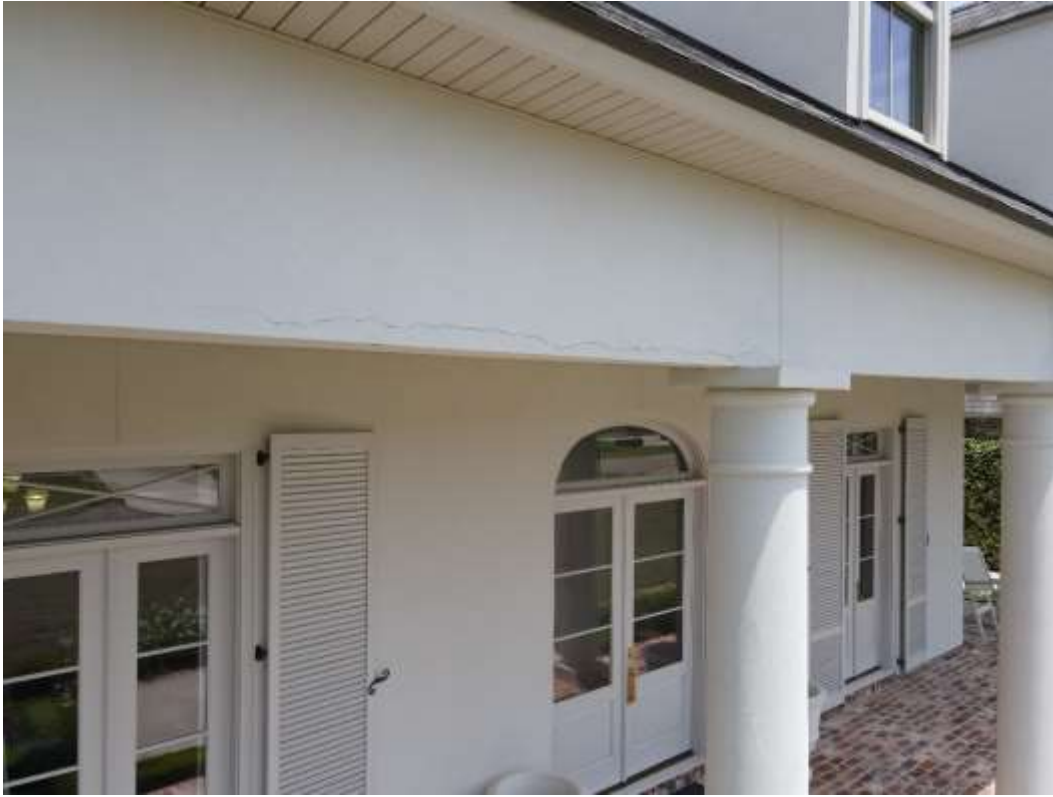
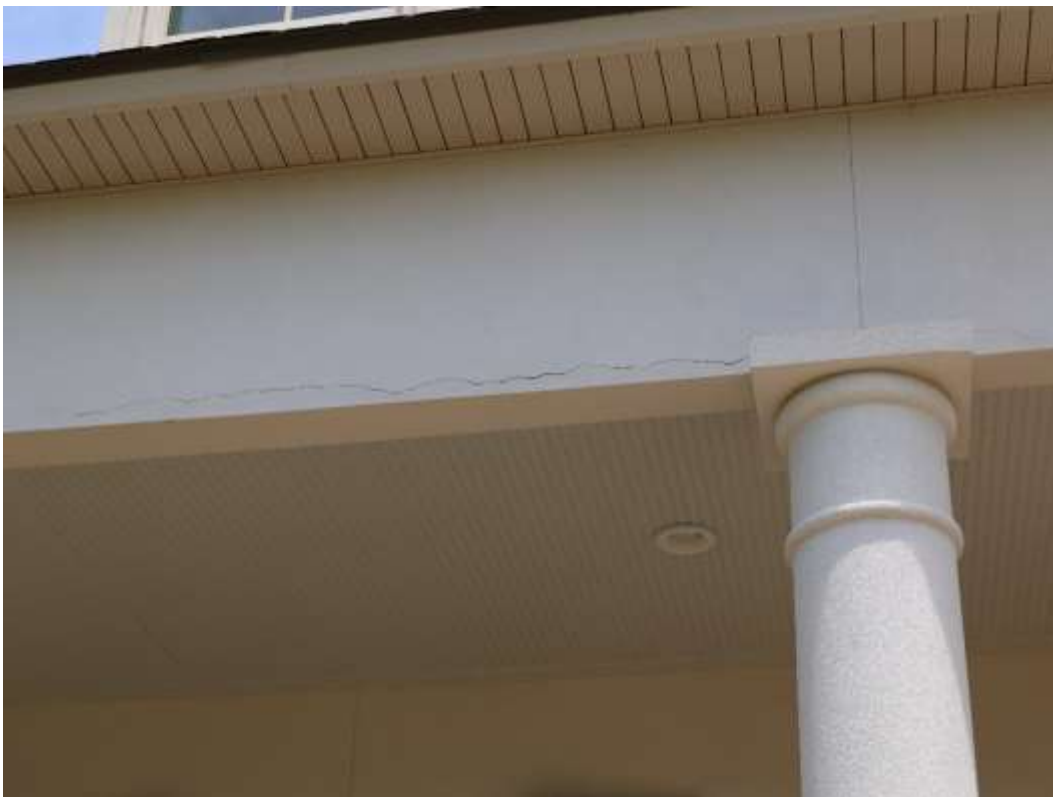
During the second site inspection, I observed the similar cracks in the stucco-finished wall with no drainage plane or weep holes (Photographs 1 and 2). The stucco-finished wall appeared to be installed on oriented-strand-board (OSB) or particle board exterior sheathing and not on a moisture-resistant material. There was no apparent moisture barrier between the stucco and the exterior sheathing (Photographs 3 and 4). The roof coverings appeared to have been recently replaced on the surfaces of all the roof slopes over the residence (Photographs 5 and 6).

From the second site inspection, the cracks in the stucco-finished walls were further examined. There was a long horizontal crack in the stucco-finished walls above the front porch between the vertical porch columns. There was no apparent drainage plane or weep holes in the stucco-finished walls at the location. This indicating an inability of moisture that penetrated the porous stucco material over time to drain from behind the walls. Furthermore, the stucco-finished wall appeared to be installed on oriented-strand-board (OSB) and particle board exterior sheathing and not on a moisture-resistant material like plywood, indicating a construction defect. These materials easily expand when exposed to moisture. The expansion of the exterior sheathing and framing members is a common cause of stucco cracks. Lastly, there was no apparent moisture barrier between the stucco and the exterior sheathing, indicating a possible construction defect

The observations and findings support the conclusion that the cracks in the stucco-finished walls on the various sides of the residence were not consistent with the high winds and/or wind-borne debris generated from Hurricane Ida. The cracks in the stucco-finished walls on the various sides of the residence were consistent with internal stresses due to shrinkage in the stucco material and expansion and contraction of the wood framing members supporting the stucco-finished walls. This condition was exacerbated by possible construction deficiencies.

Photograph #1 – View of the horizontal crack in the stucco-finished wall.

Photograph #2 – View of the horizontal crack in the stucco-finished wall.

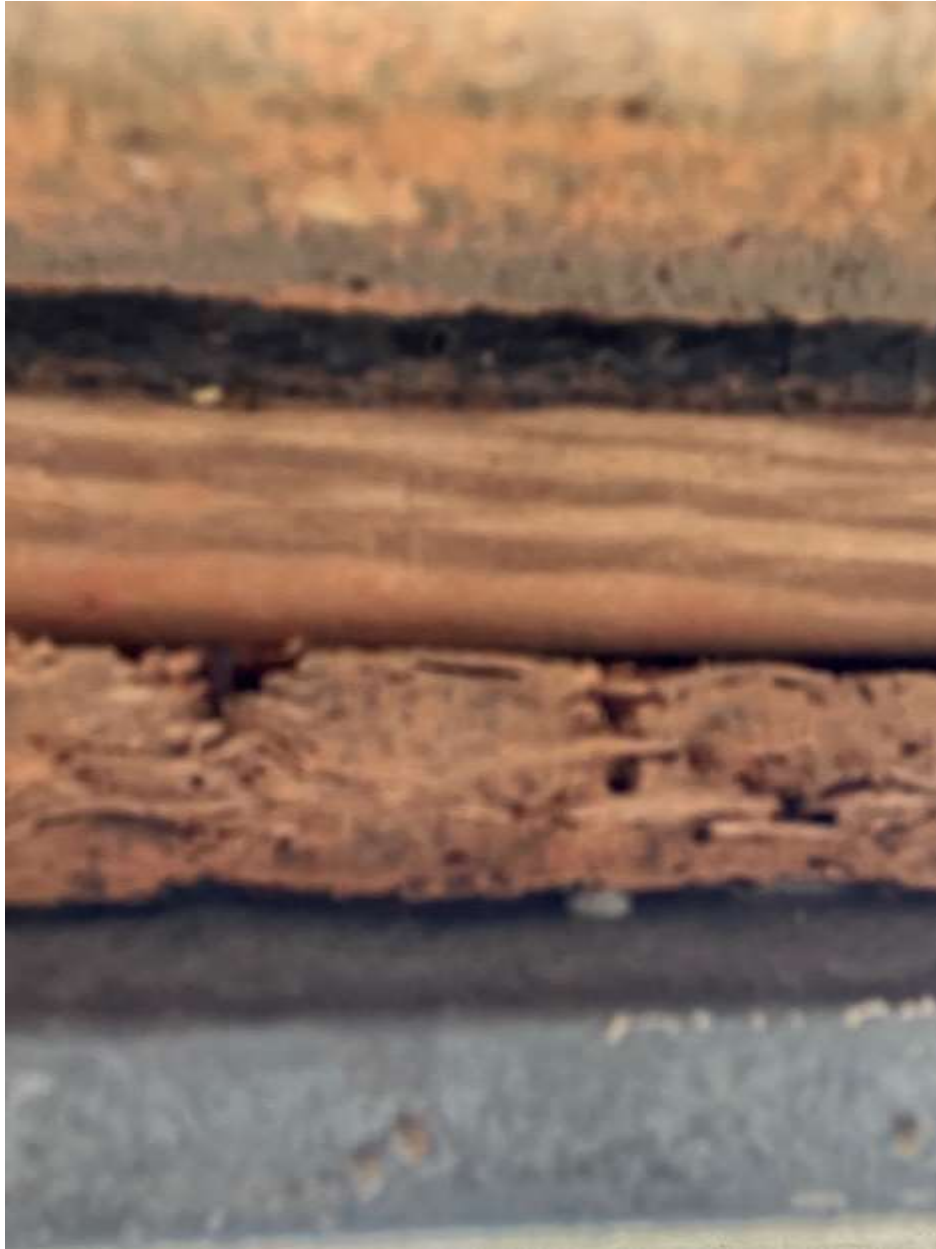
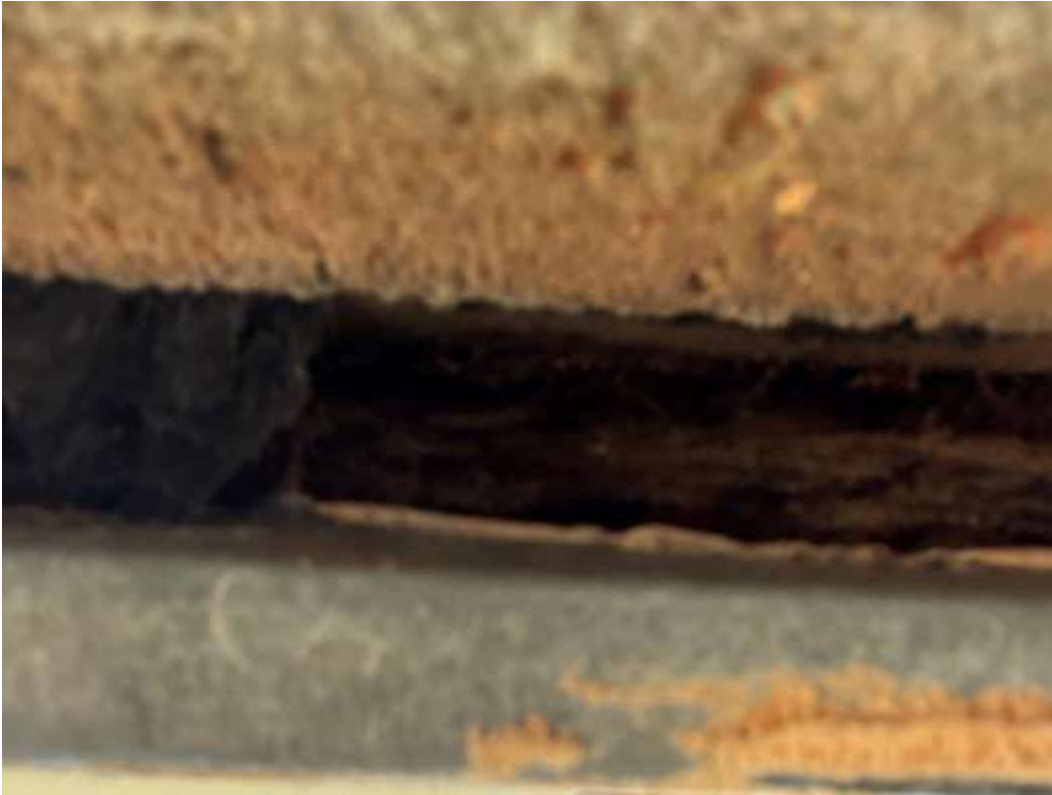
Photograph #3 – View of the exterior building material behind the stucco-finished walls.

Photograph #4 – View of the exterior building material behind the stucco-finished walls.

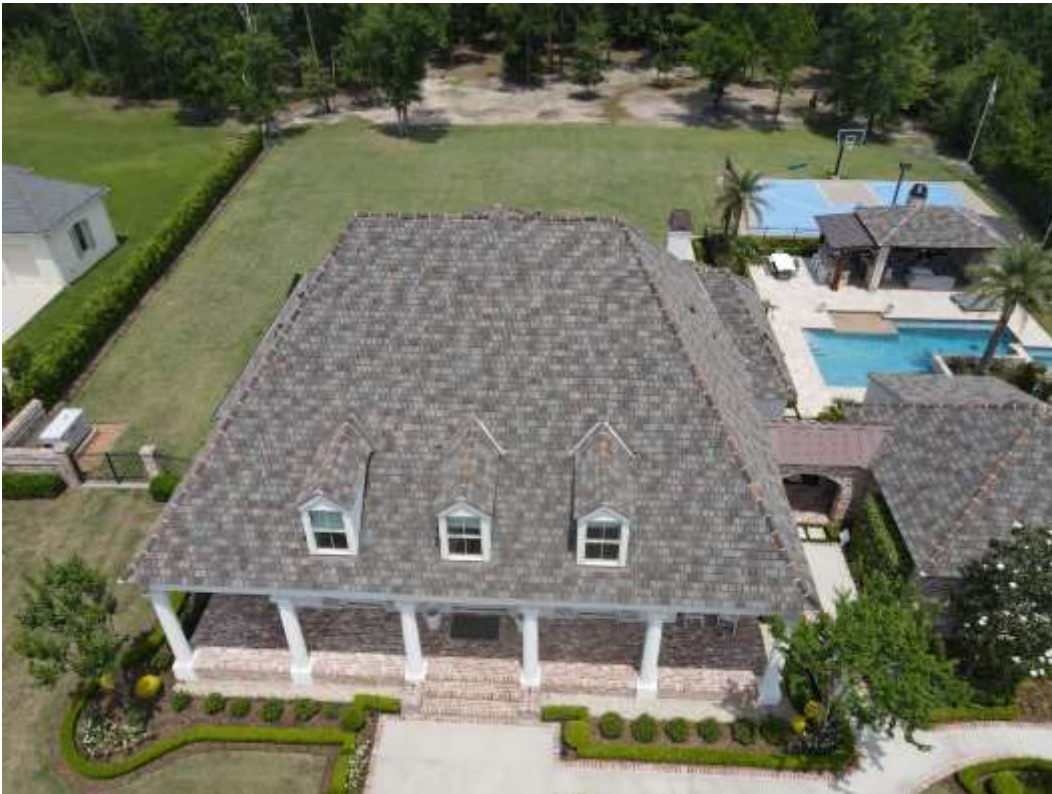
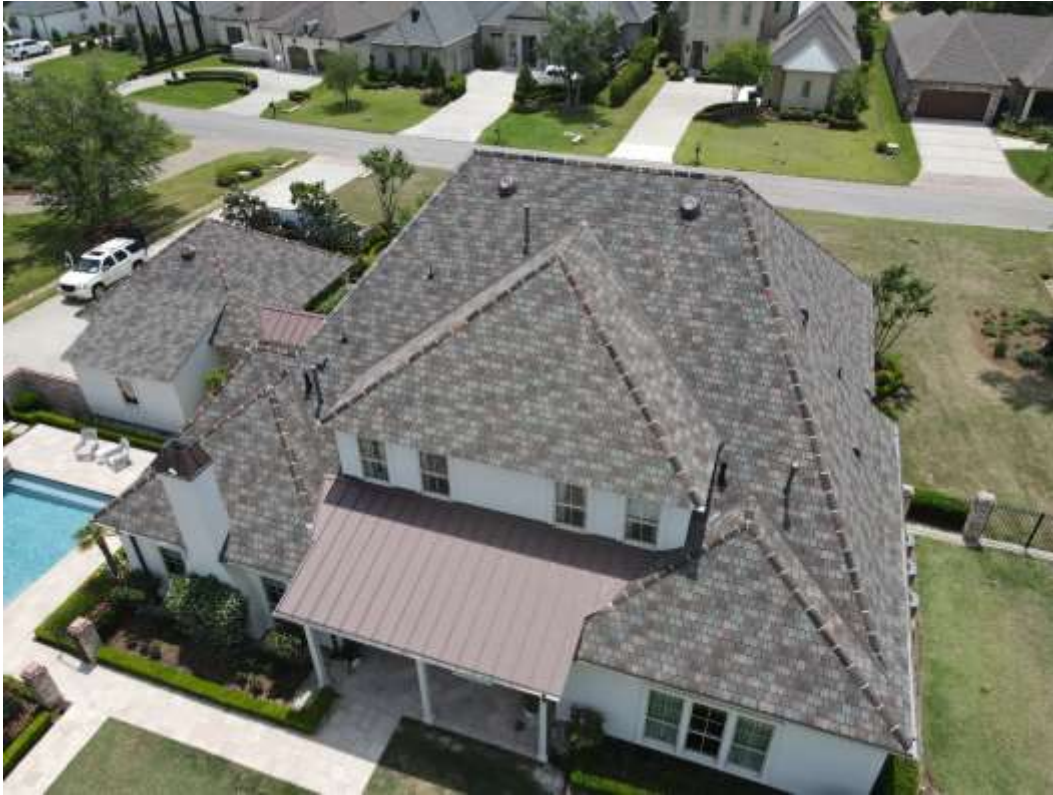
inspection, the roof coverings appeared to have been recently replaced on the surfaces of all the roof slopes over the residence.

Photograph #5 – Drone view of the various roof slopes over the residence.

Photograph #6 – Drone view of the various roof slopes over the residence.

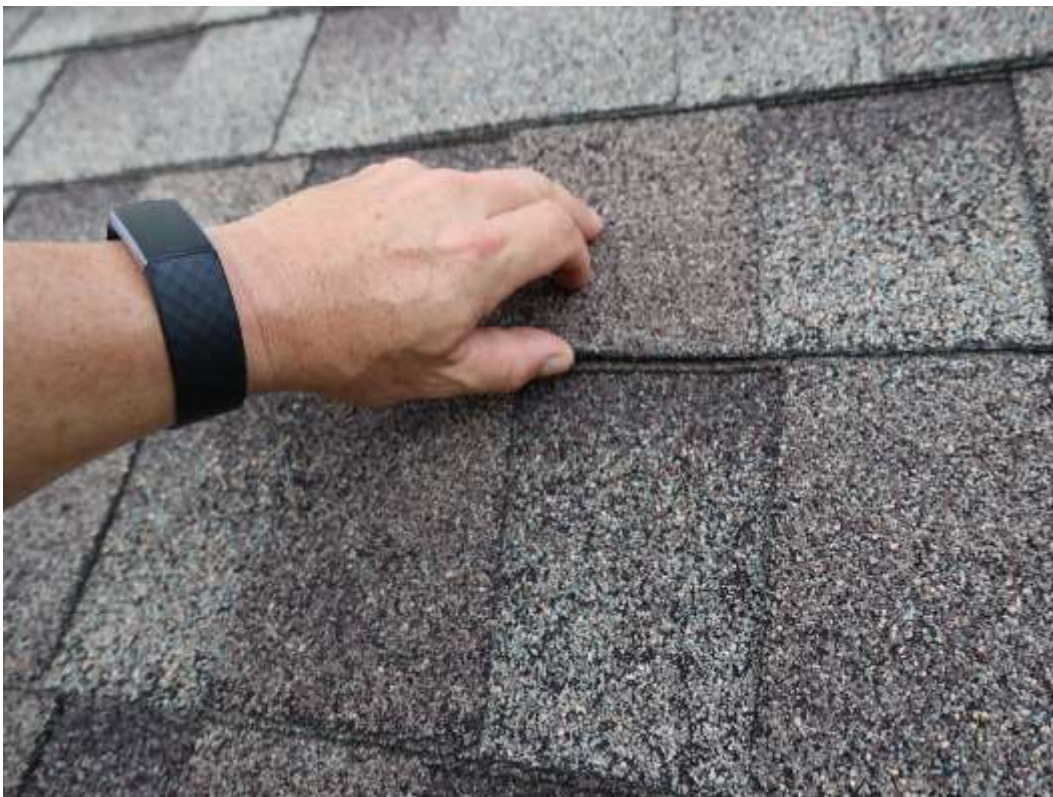
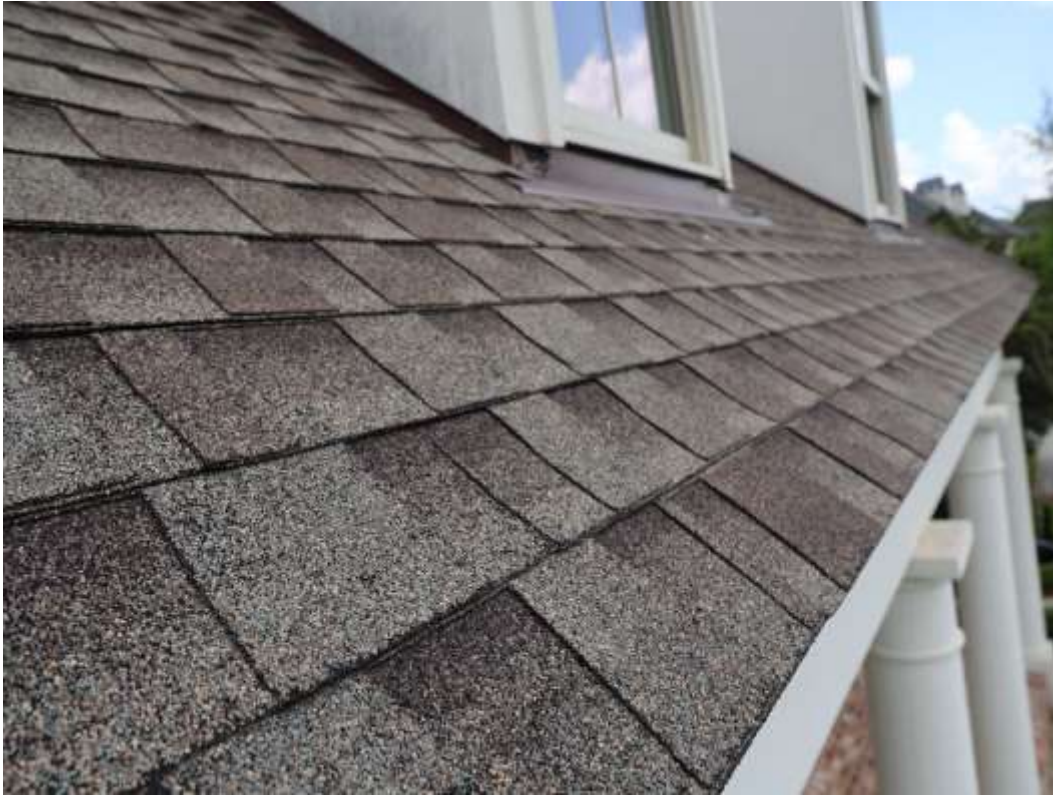
From the original site inspection, there were no tarpaulins (tarps) covering the various roof slopes of the residence. There were no apparent broken, displaced, missing or loose laminated asphalt-composition shingles on the surfaces of the various roof slopes over the residence. The tar seals for the laminated asphalt-composition shingles on the surface of the various roof slopes over the residence were not easily broken with hand pressure at the areas inspected. There was some granule loss on the laminated asphalt-composition shingles on the surface of the various roof slopes over the residence. There was granular debris in the gutters on the residence. Asphalt shingled roofs are a wearable surface and are expected to have granular loss over time due to wear-and-tear and exposure to weather. There were no displaced, loose and missing standing seam metal roof panels on the surfaces of the various roof slopes over the residence, indicating the lack of collateral damage that were observed at the residence. From the second site

The observations and findings from the original inspection support the conclusion that the water-shedding ability of the roof coverings was not compromised due to the high winds and/or wind-borne debris generated by Hurricane Ida.

Photograph #7 – View of the asphalt shingles (original inspection).

Photograph #8 – View of the asphalt shingles (original inspection).
