Structural Inspection

December 16, 2020

For: Thomas Bergens
3201 Rue Marcelle
Meraux, La. 70075

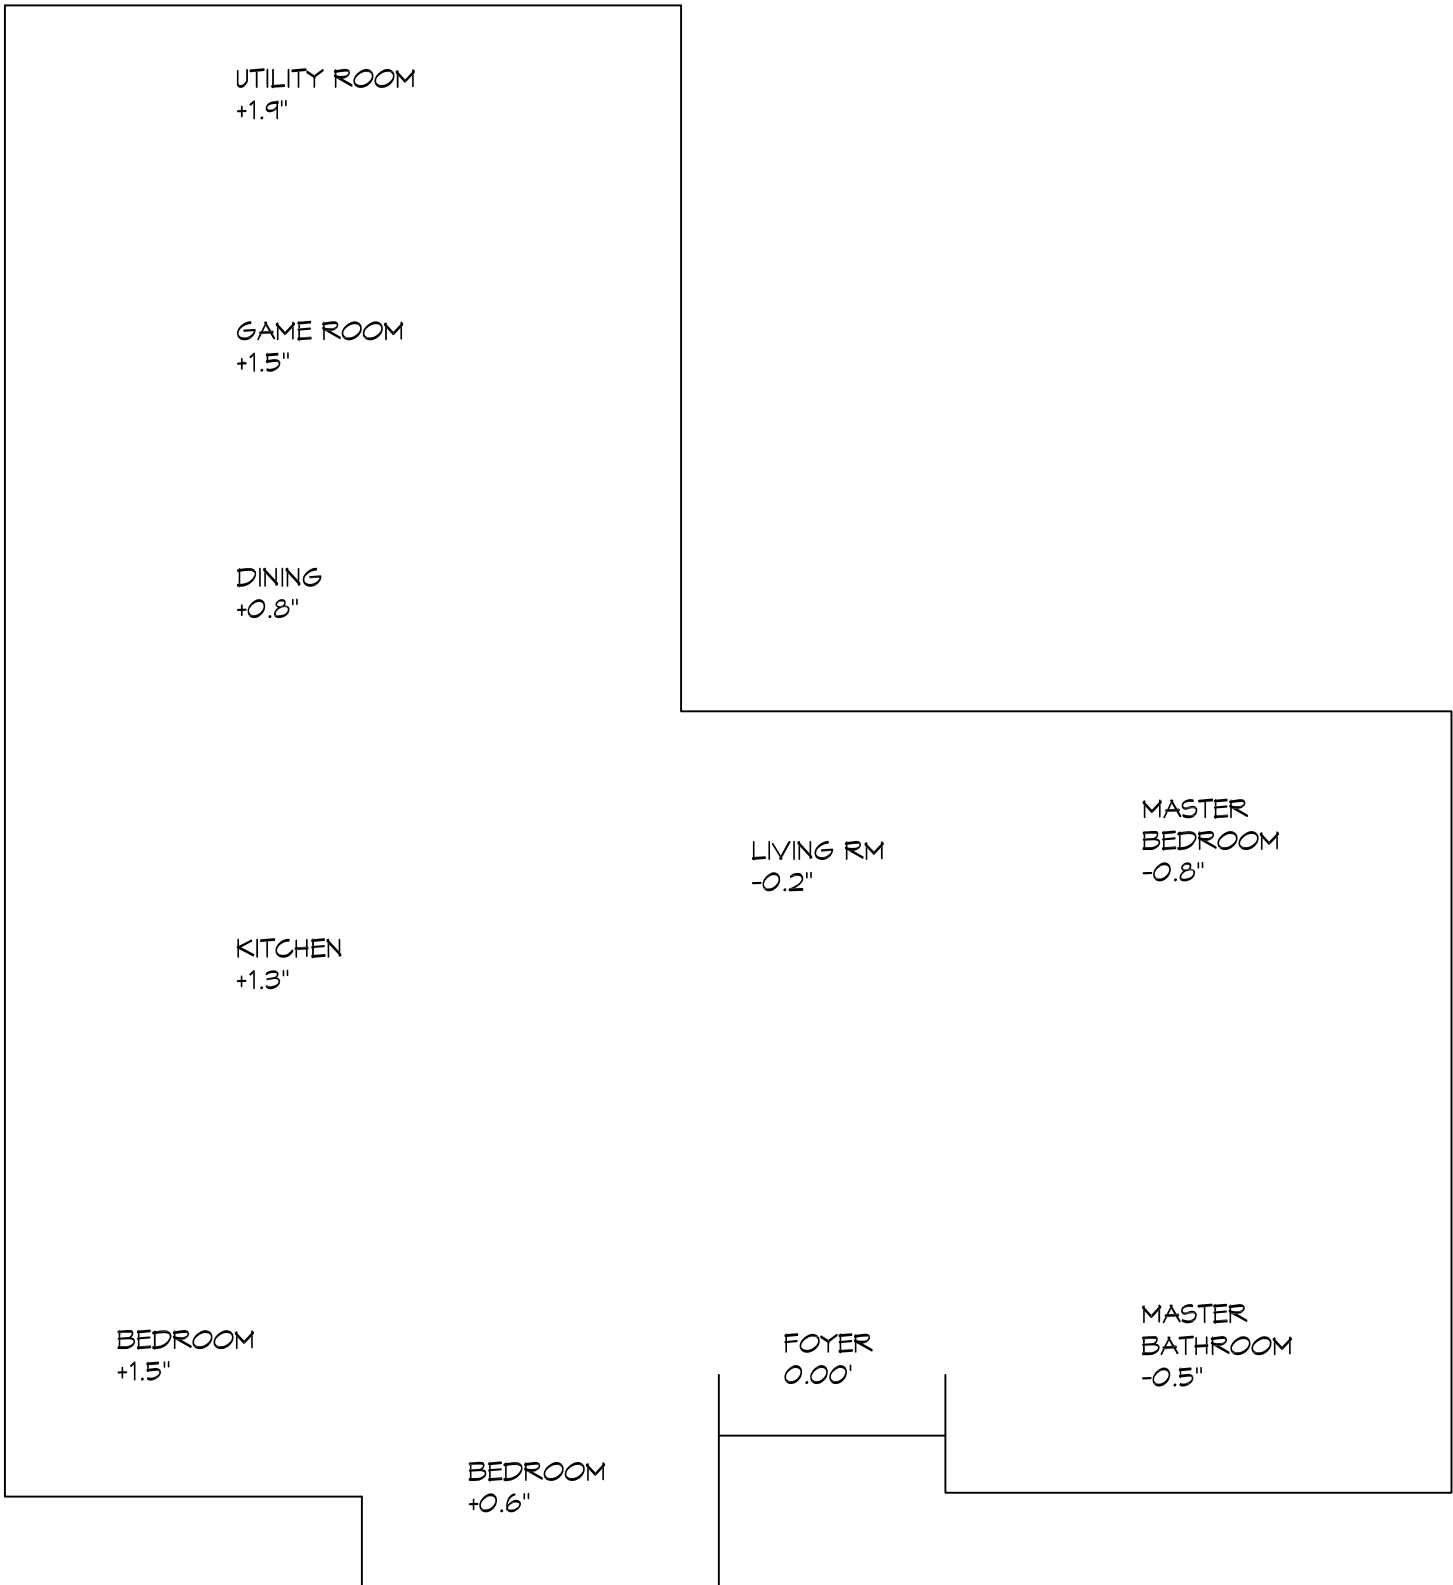
Upon inspection, a zip level was used to verify the floor height conditions inside the home. The level was set up in the foyer area at zero inches and measured throughout the home, there is a 1.9 inch difference noted from the foyer to the laundry room in the rear of the home. It is important to note that all floor height conditions are within acceptable tolerances.

UTILITY ROOM
+1.9"

GAME ROOM
+1.5"

DINING
+0.8"

KITCHEN
+1.3"

BEDROOM
+1.5"

BEDROOM
+0.6"

FOYER
0.00'

LIVING RM
-0.2"

MASTER
BEDROOM
-0.8"

MASTER
BATHROOM
-0.5"

The elevation difference does not appear to have compromised the structural integrity of the home. It is my opinion that the structural integrity of this home is currently sound, but the foundation will expand and contract with the ground movement and any standing water. It is recommended when there is more than a 3" elevation difference (tripping hazard) to have the home stabilized with screw pilings.
