## Structural Inspection

September 9, 2013

Re: La Mason Charles  
3801 St. Charles Ave., Unit #301  
New Orleans, La.

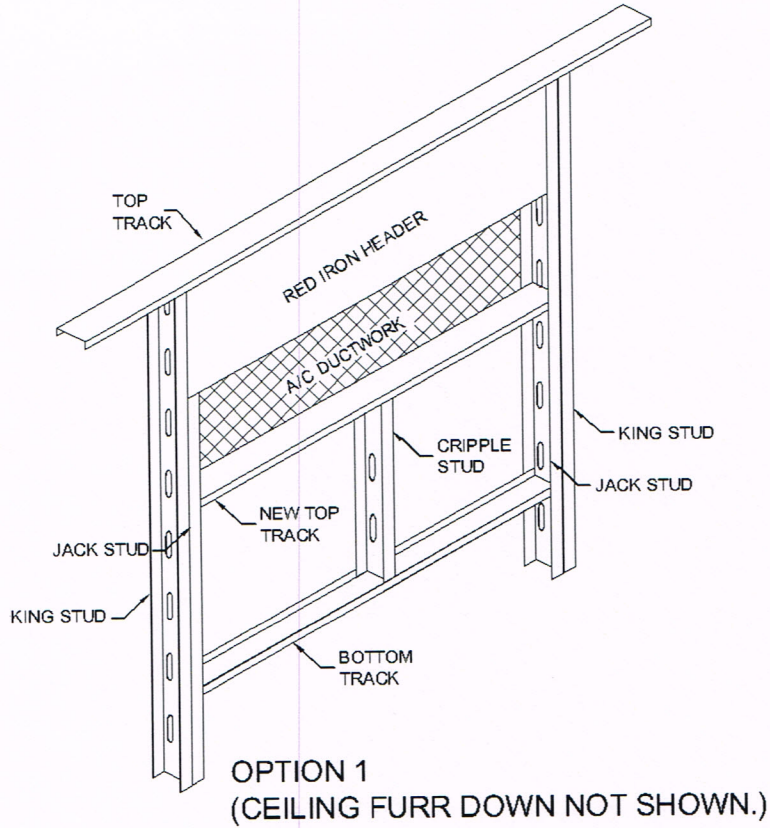
Upon inspection, the structure utilizes 10" Red Iron C-Channel joist supporting a light weight concrete floor. These 10" Red Iron C-Channels terminate into back-to-back Red Iron Channels and are supported by a 4" Red Iron stud wall. Each 10" Red Iron C-Channel terminates directly above a 4" Red Iron stud except where a doorway has been constructed. A door header has been installed to re-distribute the loads from 2ea 10" Red Iron C-Channel joists to King studs at the outside edge of the doorway. A single Cripple stud, nailing stud, has been installed to support sheetrock above the doorway, this Cripple stud is not structural. There are only 2 pieces of Red Iron installed as blocking devices in the middle of the room in front of the cantilevered patio.

Option #1: Replace the 2x4 wood support system for the fur down above the doorway with a 2x2 wood support system over the door frame. Next is to re-support the single Cripple stud at the top of the sheetrock with a top channel extended between the King studs. This would open a cavity measuring

approximately 6.5" x 38". Using a 1" thick duct board would allow for an open airway of 4.5"x36", 162 in<sup>2</sup>. This opening would allow for an approximate air flow of 850cfm @ 1000 fpm or 525cfm @ 600 fpm.
