Structural Inspection

October 15, 2021

Ref: Bayou Mason
4800 Pontchartrain Drive
Slidell, La. 70458

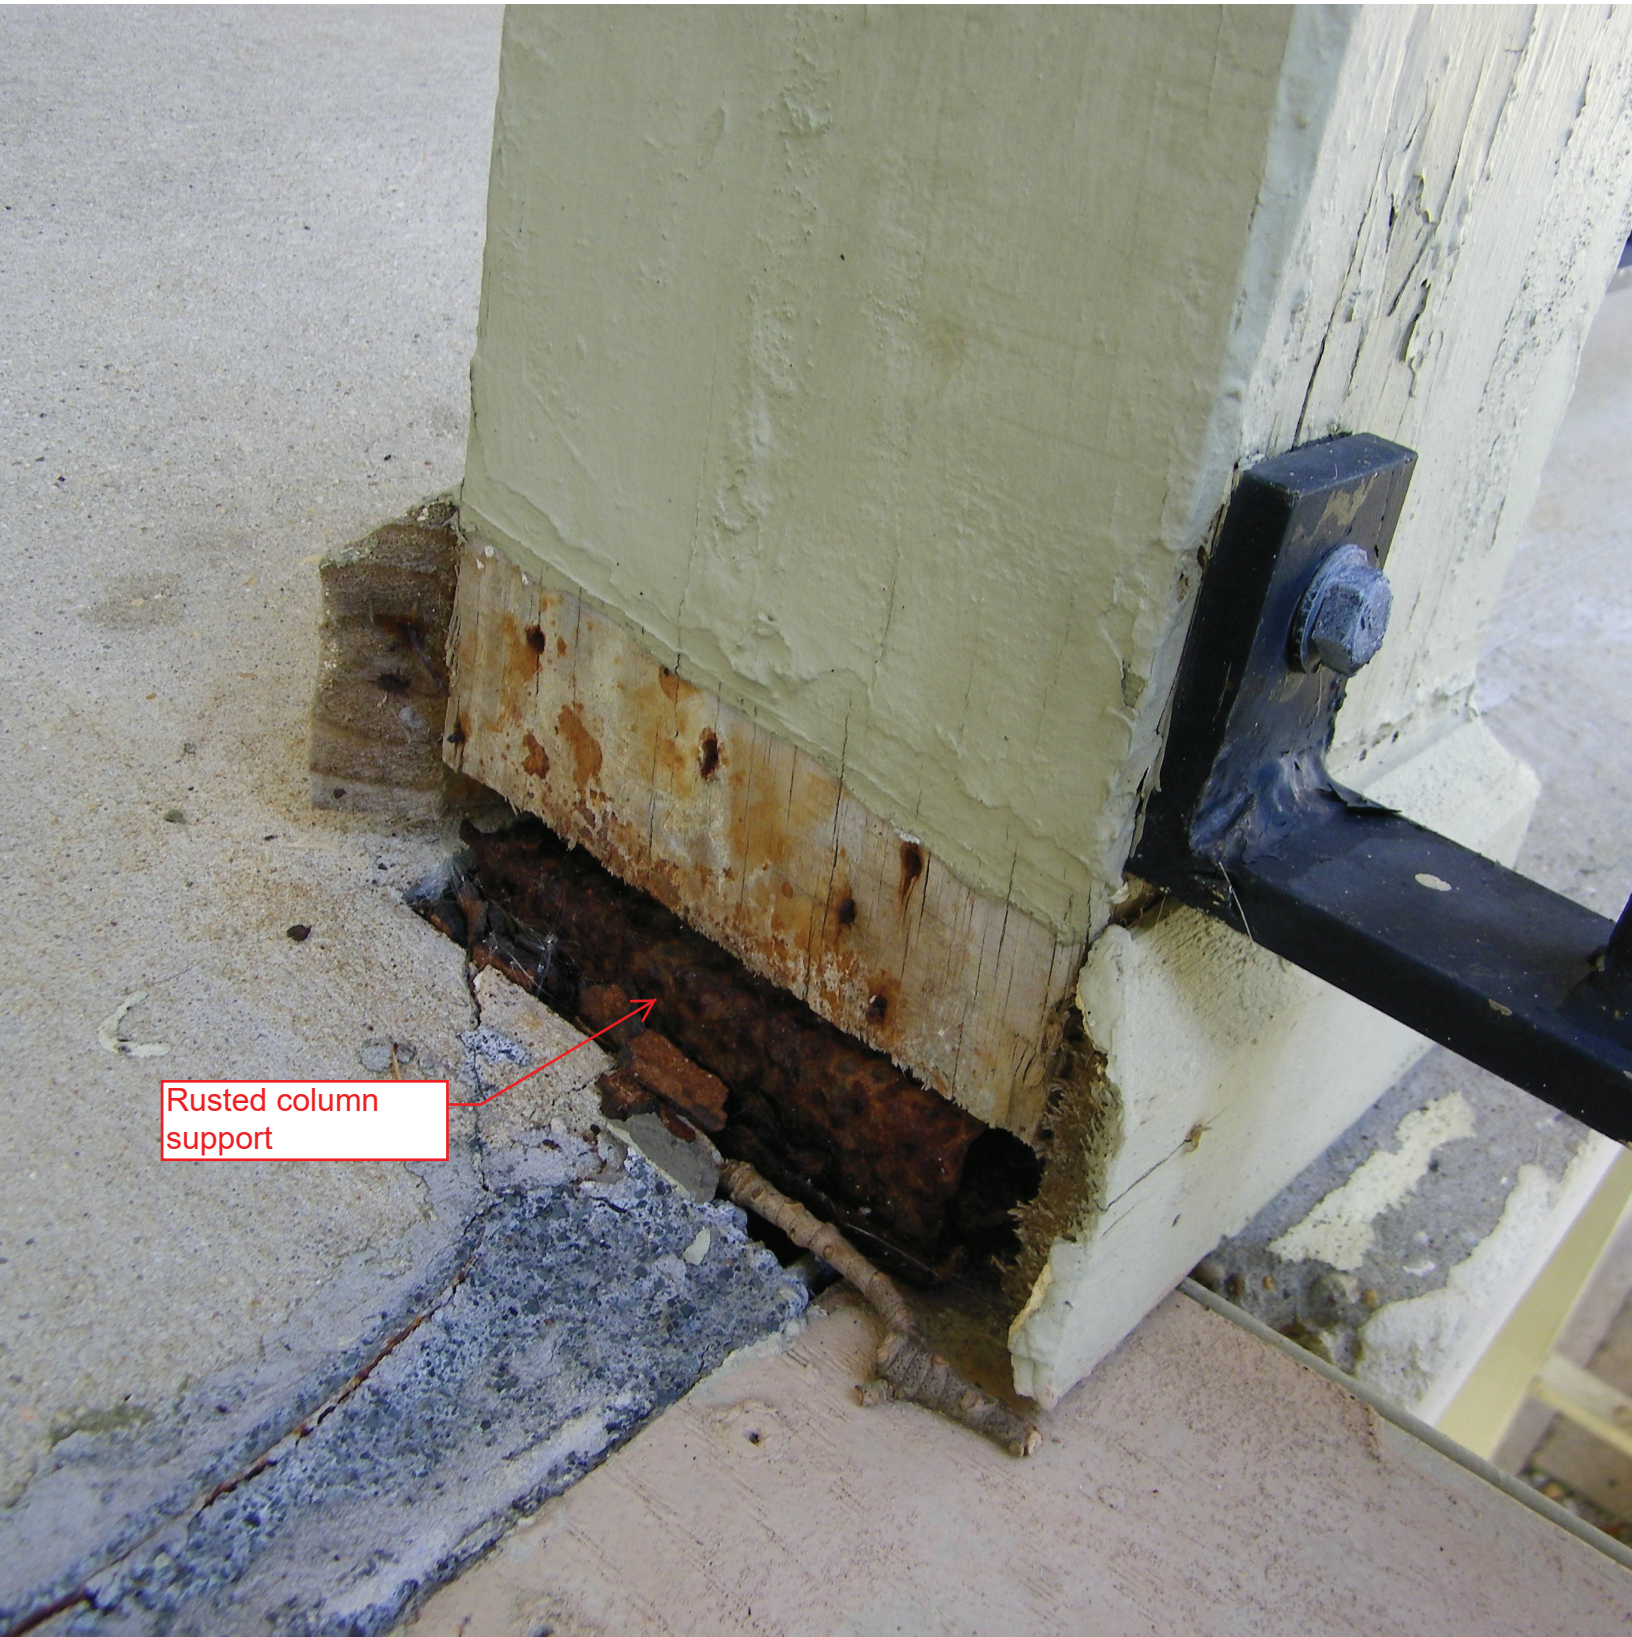
All the wood base columns supporting the walkways have connectors (ground floor and second floor) that have rusted away and provide no structural support. There are multiple areas that have cracked concrete walkways and are allowing water intrusion and rusting away all connections for the walkway.

Rusted column support

- 1) Remove and replace all wood connectors for the columns (ground floor and second floor)
- 2) Remove and replace all horizontal walkway wood supports that are rotten
- 3) Remove and replace all cracked concrete walkways that have more than 1" separation or jack up back in place
- 4) Remove and reinstall steel staircase
- 5) Seal all concrete walkways
- 6) Remove bulkhead and install new bulkhead

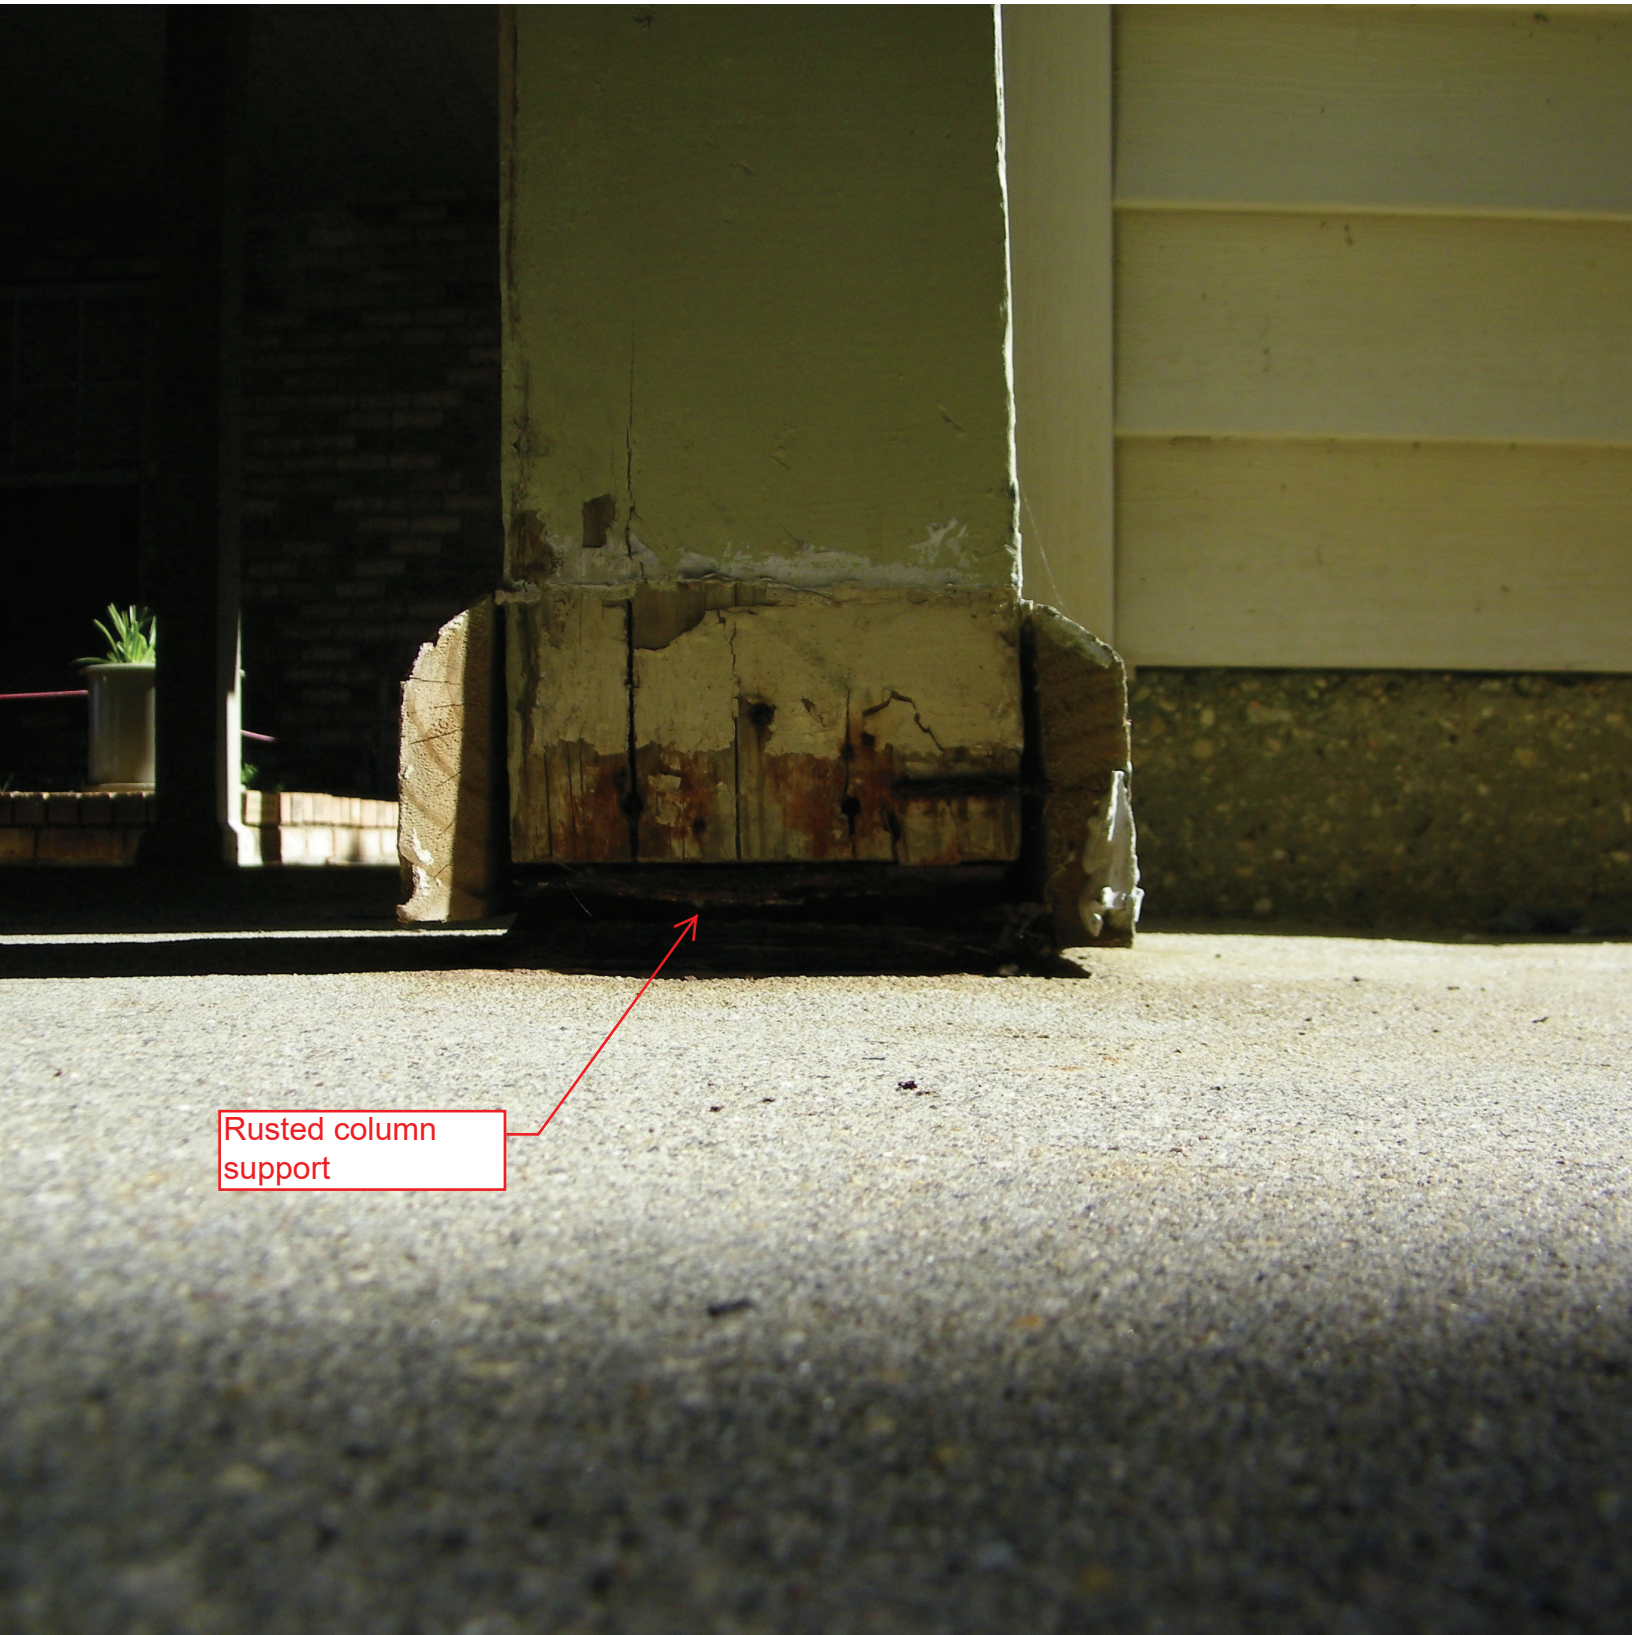
Rusted column
support

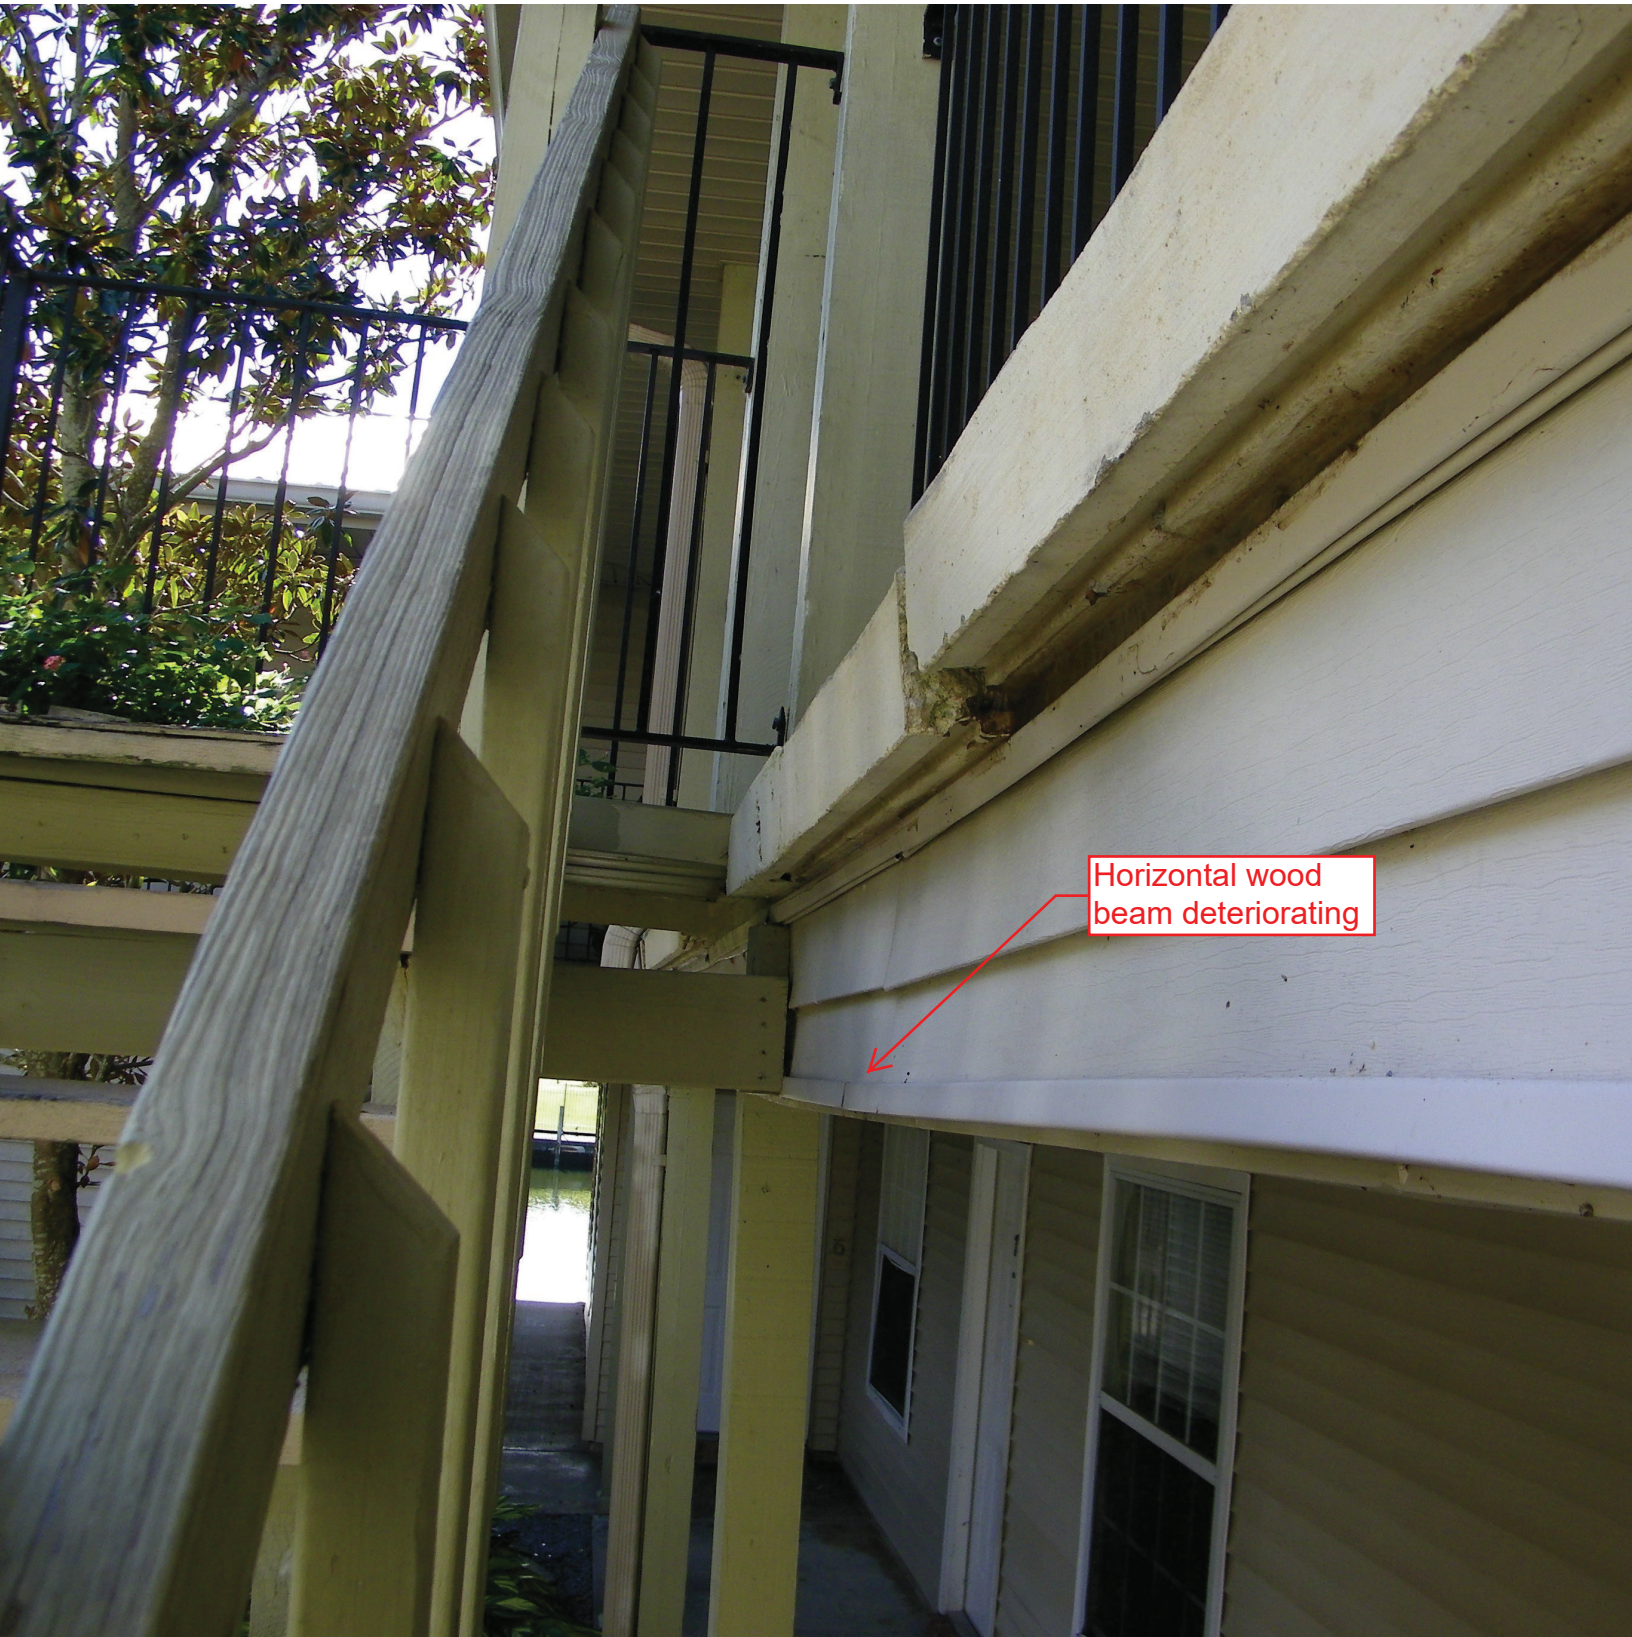
The right side staircase is in need of repair. Where the steel staircase attaches to the building itself it has deteriorated the horizontal wood support. The horizontal wood supports are sagging with the weight of the concrete walkways on top of it and stressing the concrete, therefore cracking it.

Horizontal wood
beam deteriorating

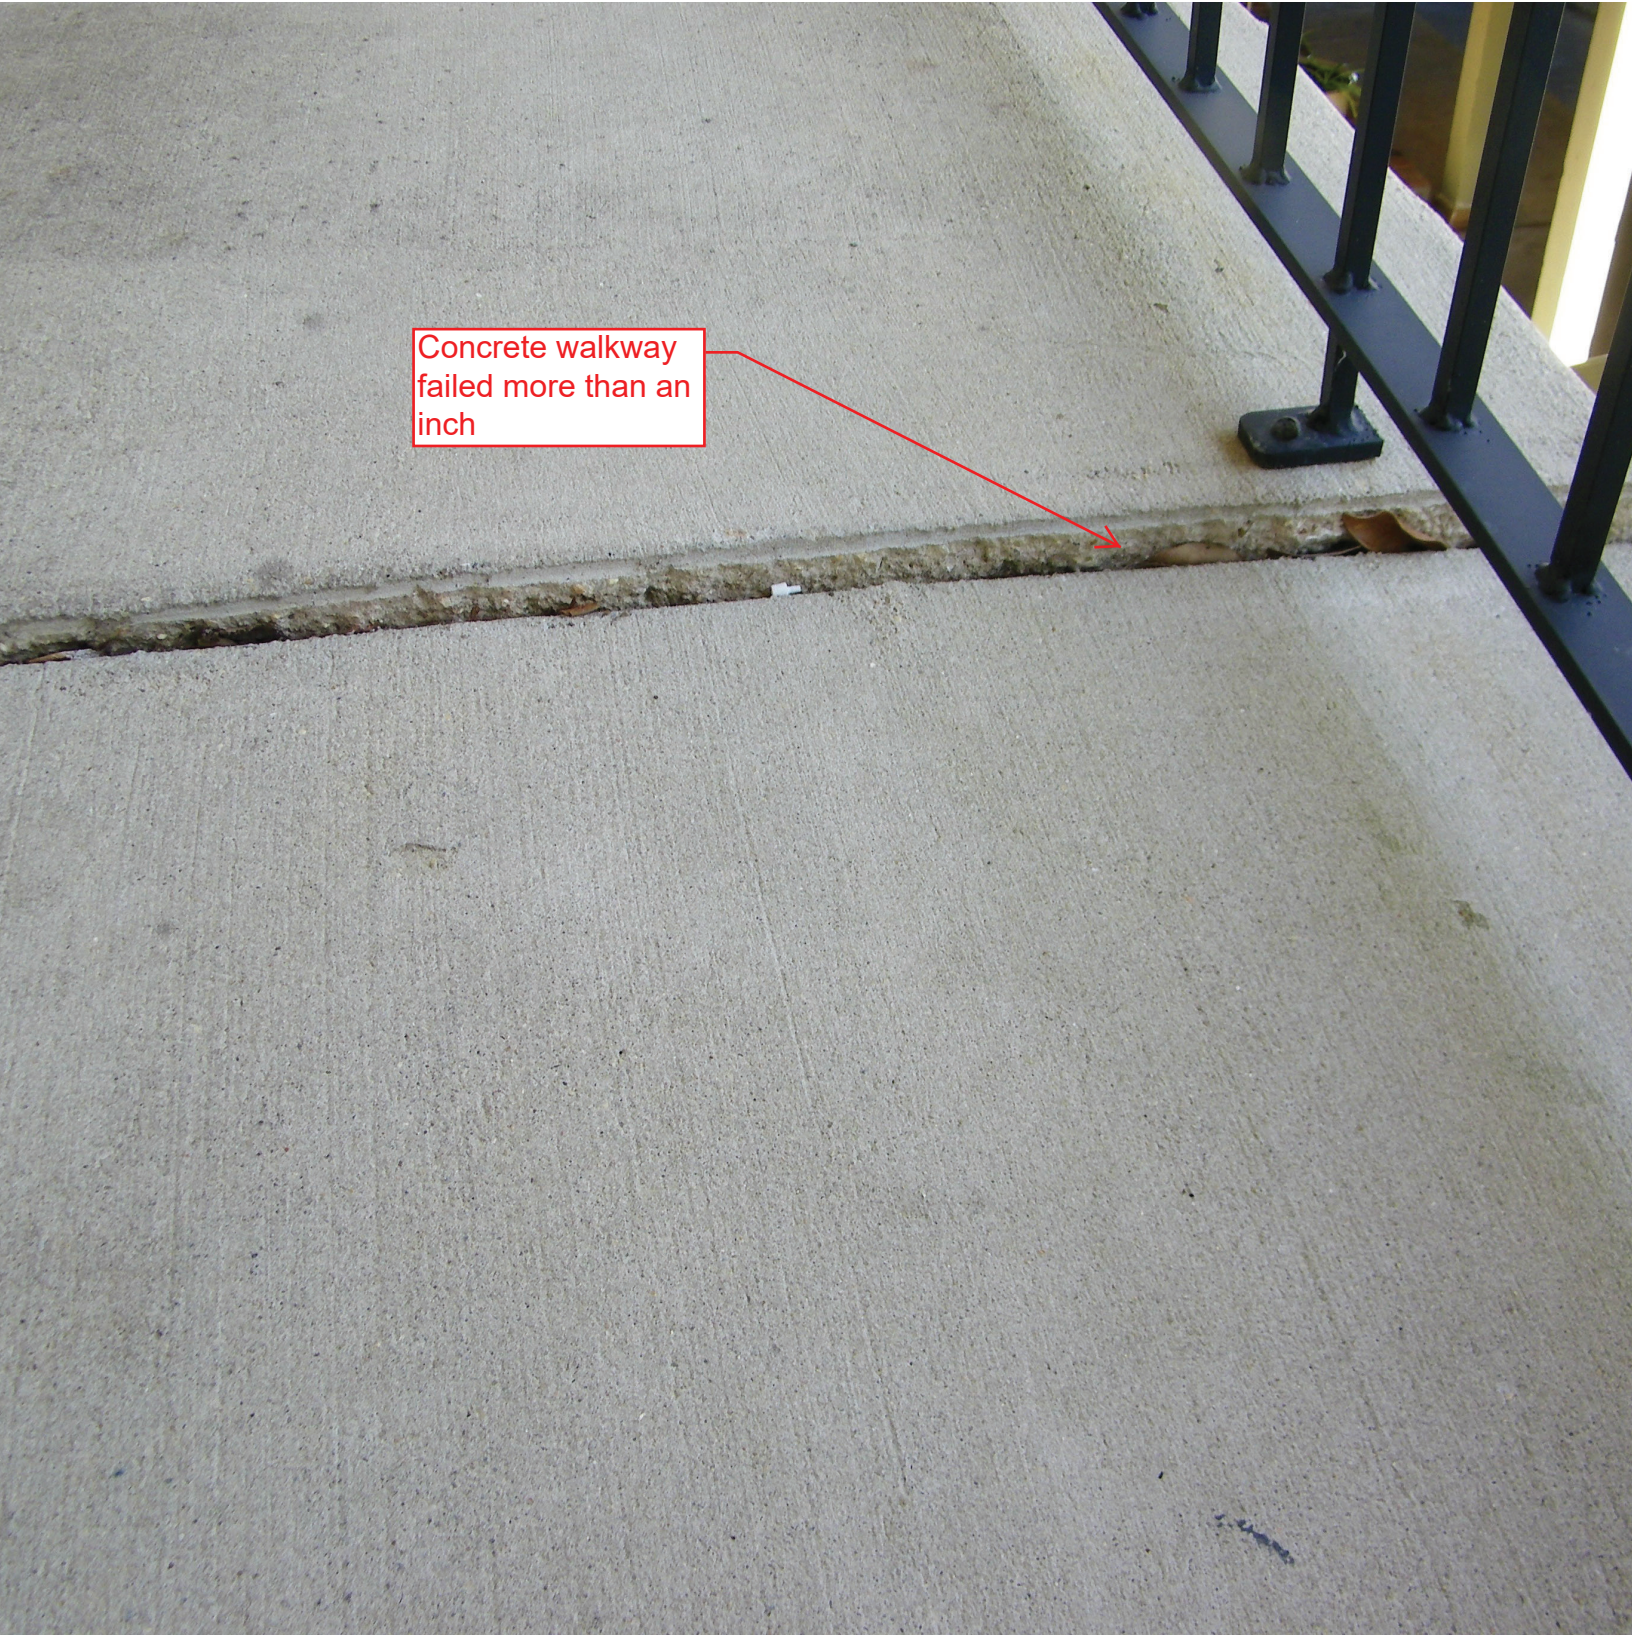
Concrete walkway
failed more than an
inch

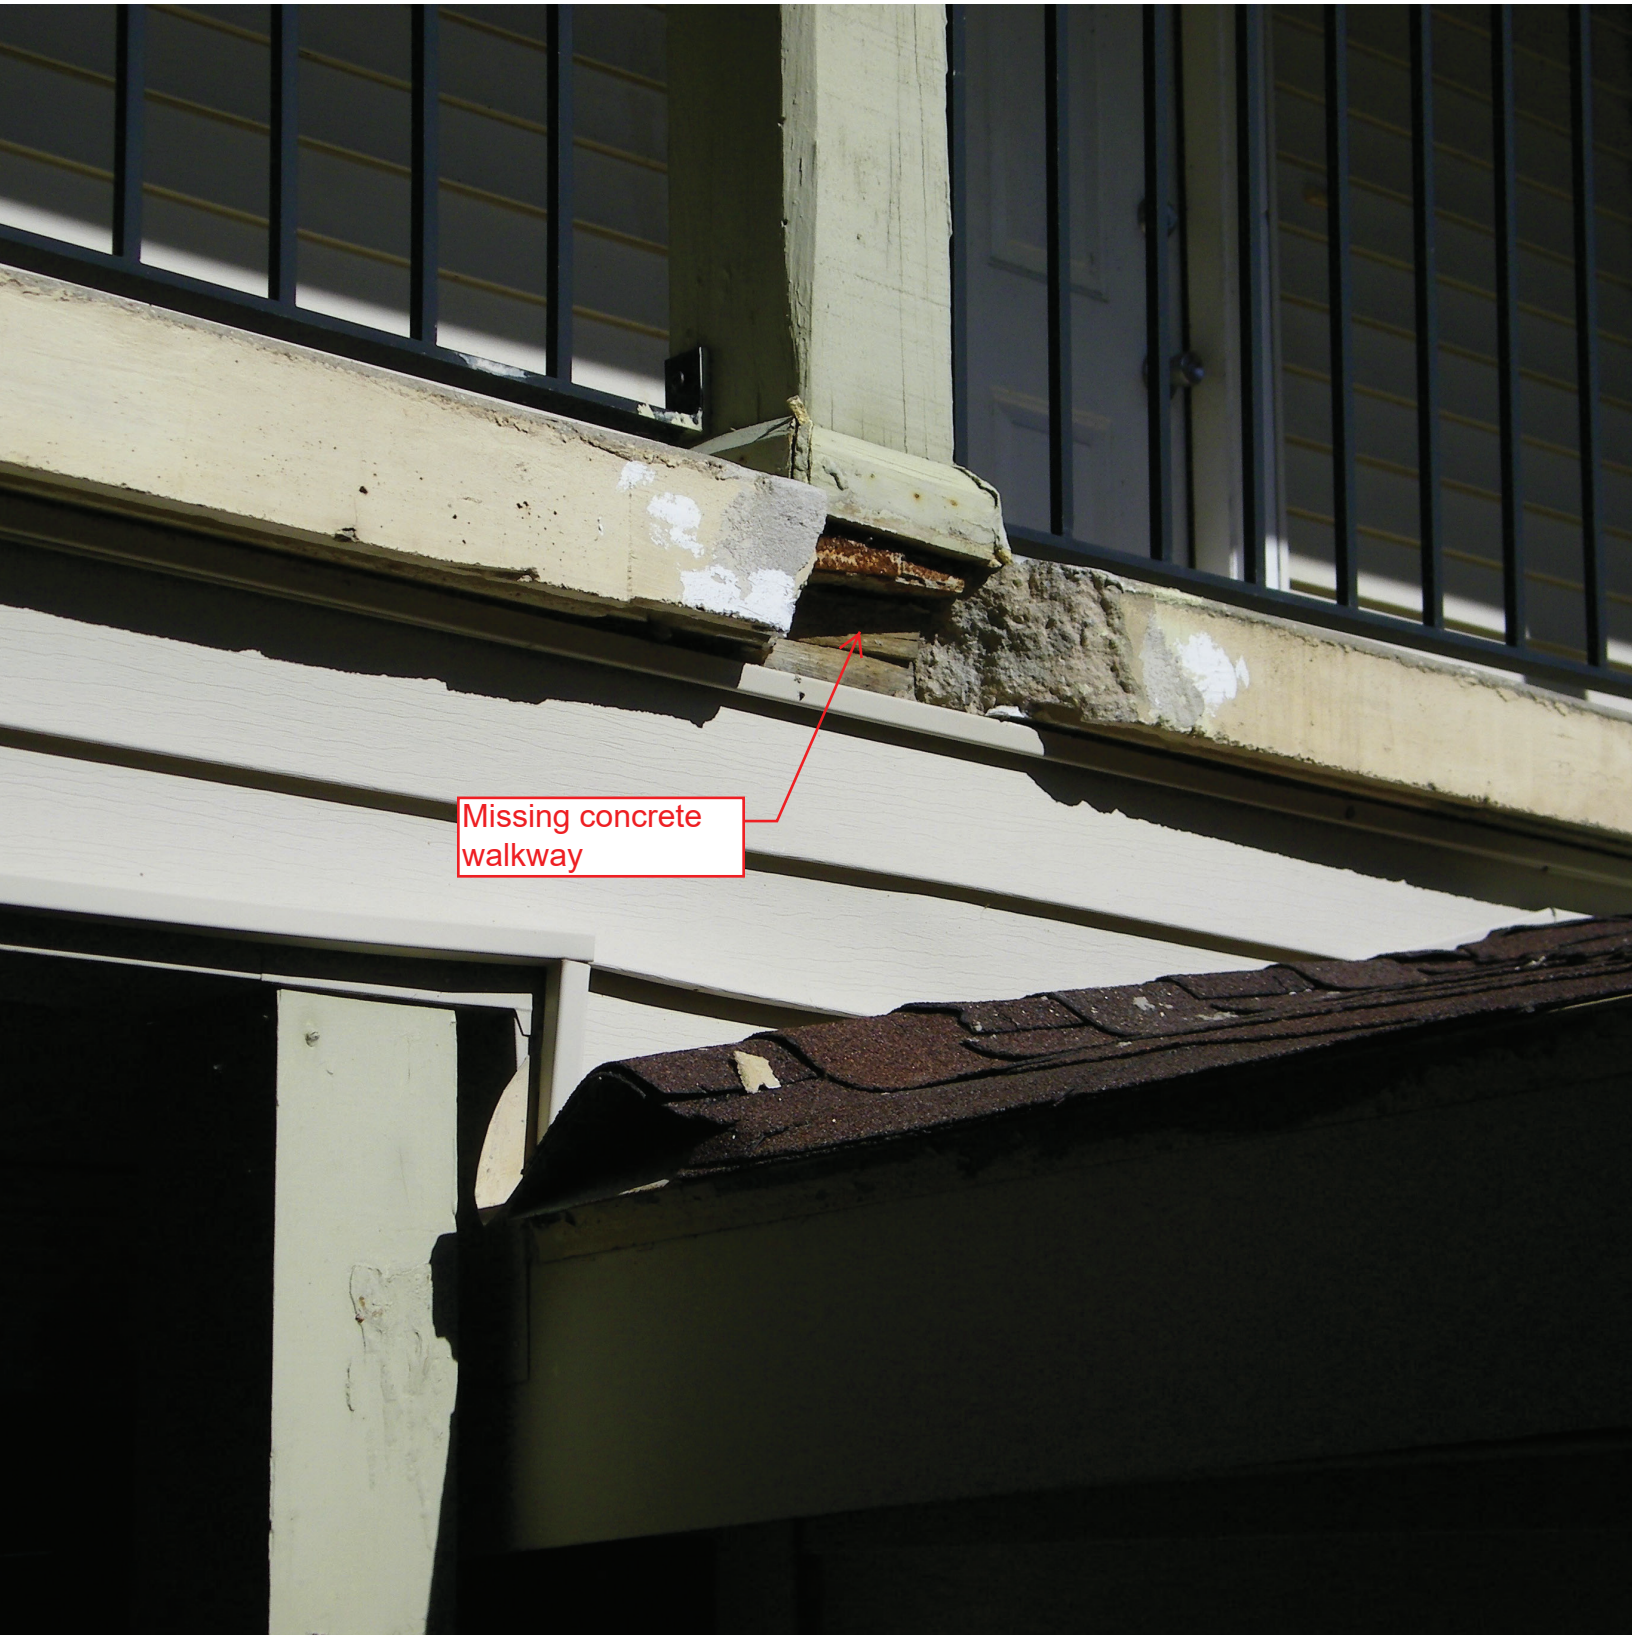
Missing concrete walkway

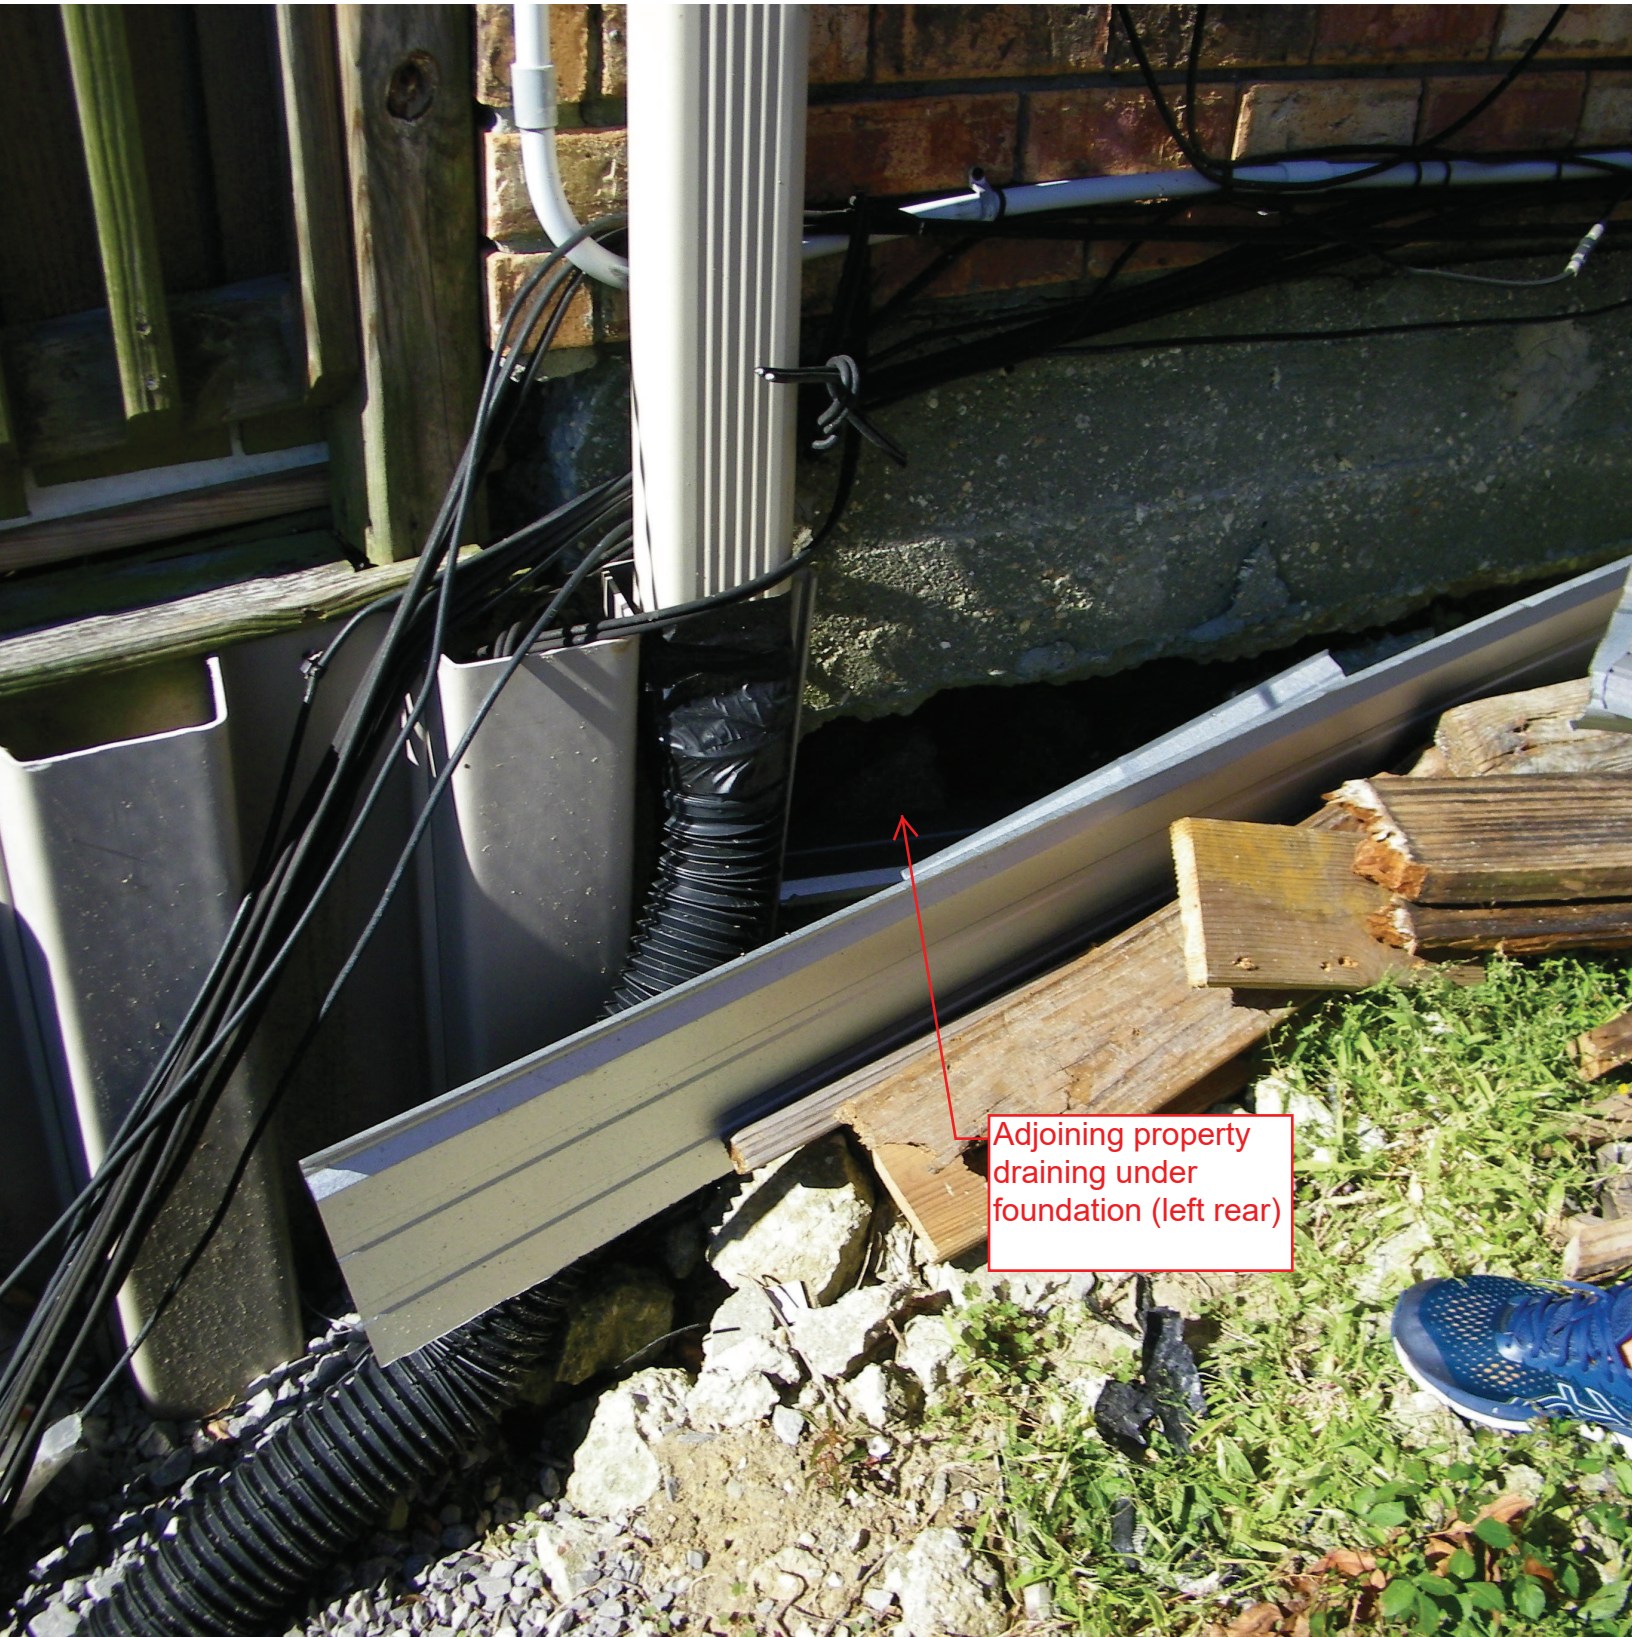
Some drainage concerns were noted also. The property on north side (left rear) of the building is draining into and under the foundation, bulkhead and dock area and causing erosion of the soil as it doesn't drain into the waterway.

Adjoining property
draining under
foundation (left rear)

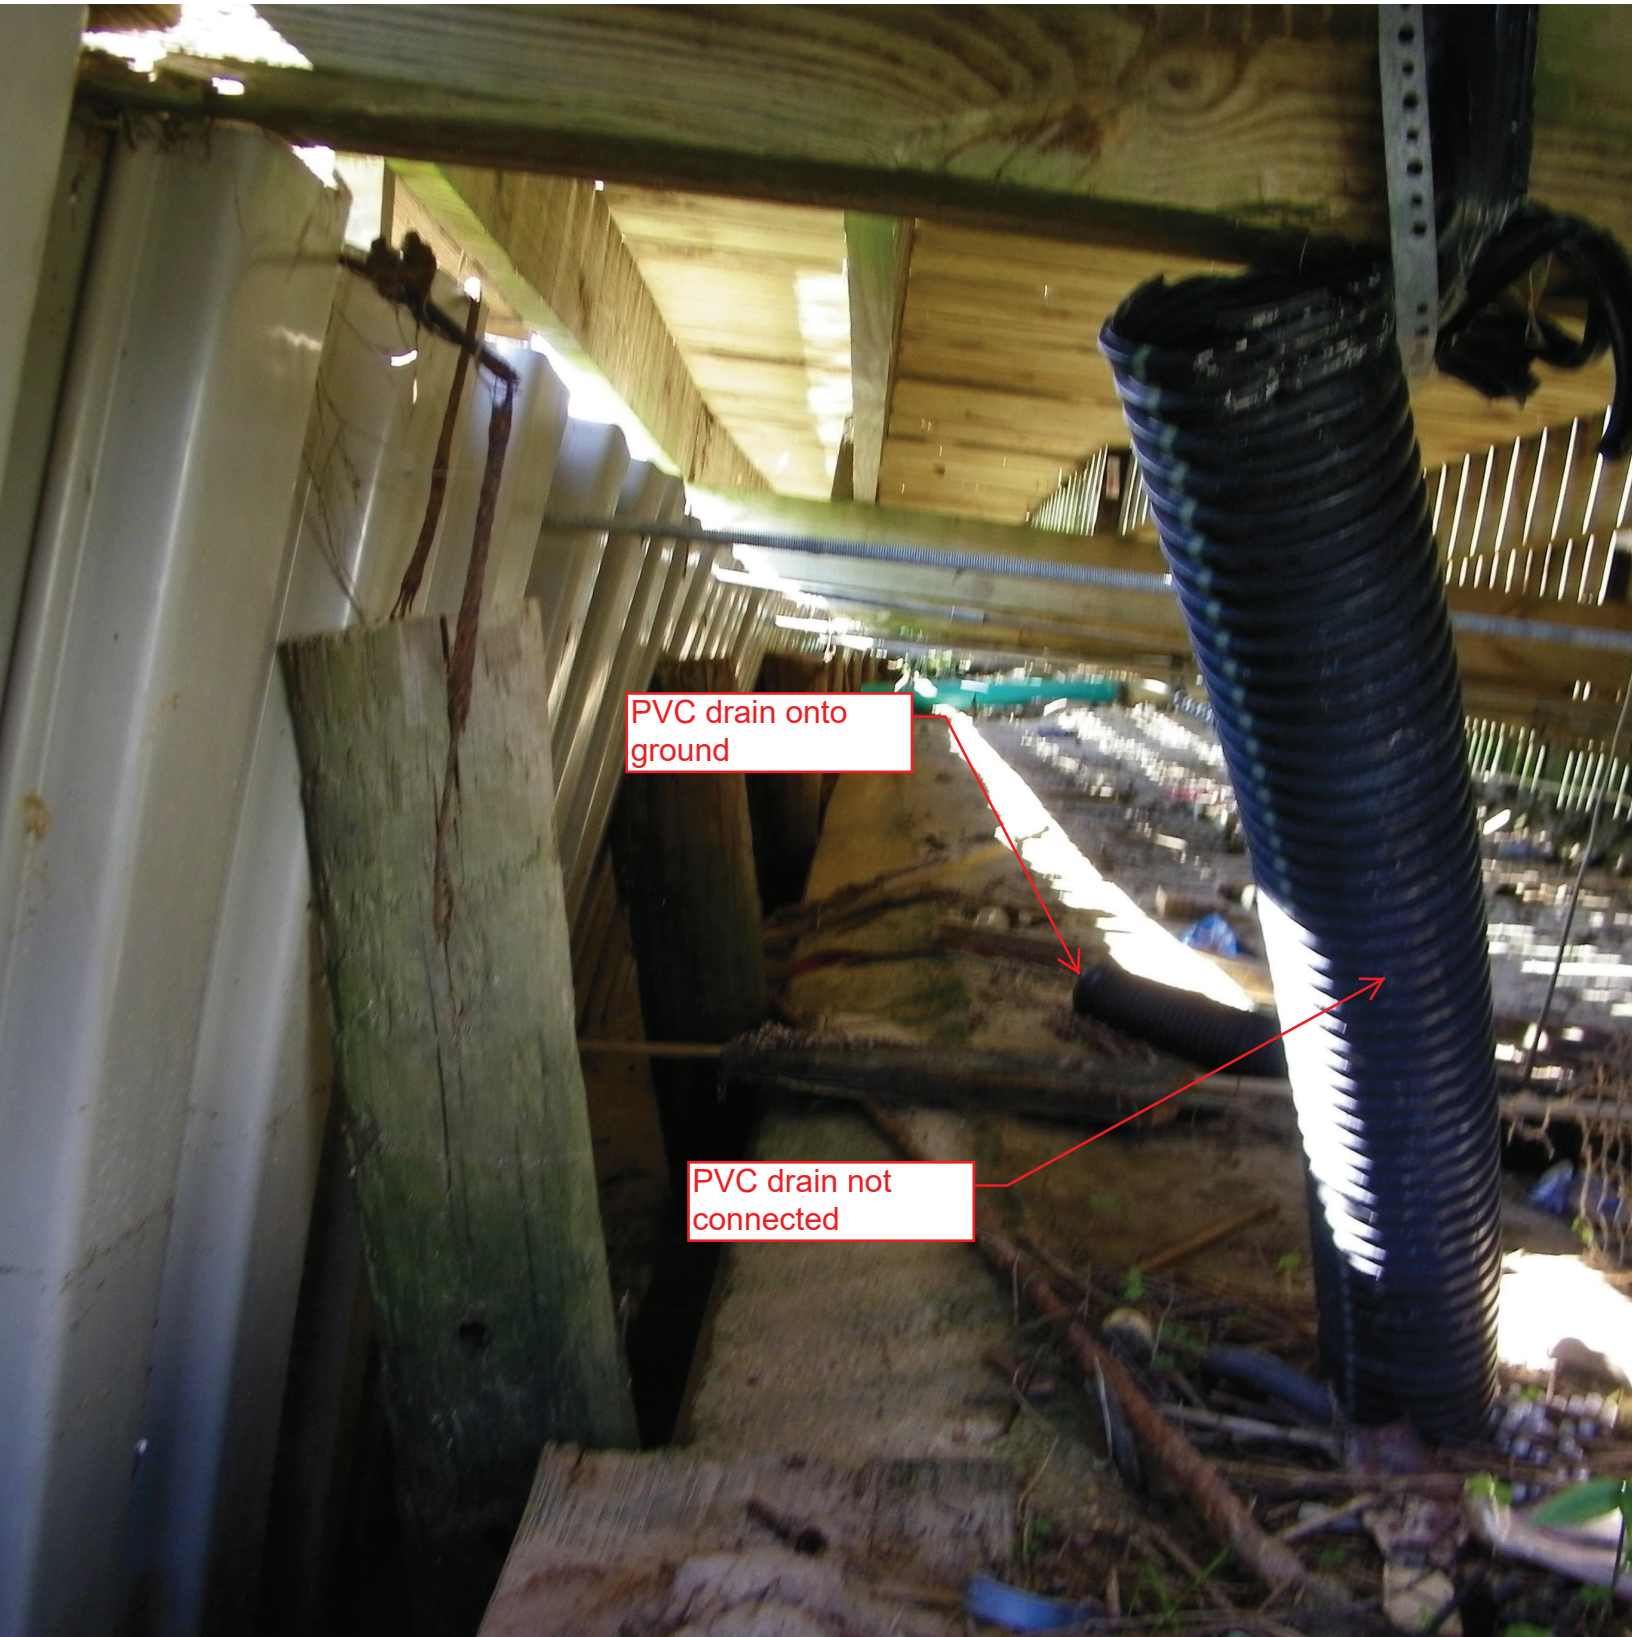
PVC drain onto ground

PVC drain not connected

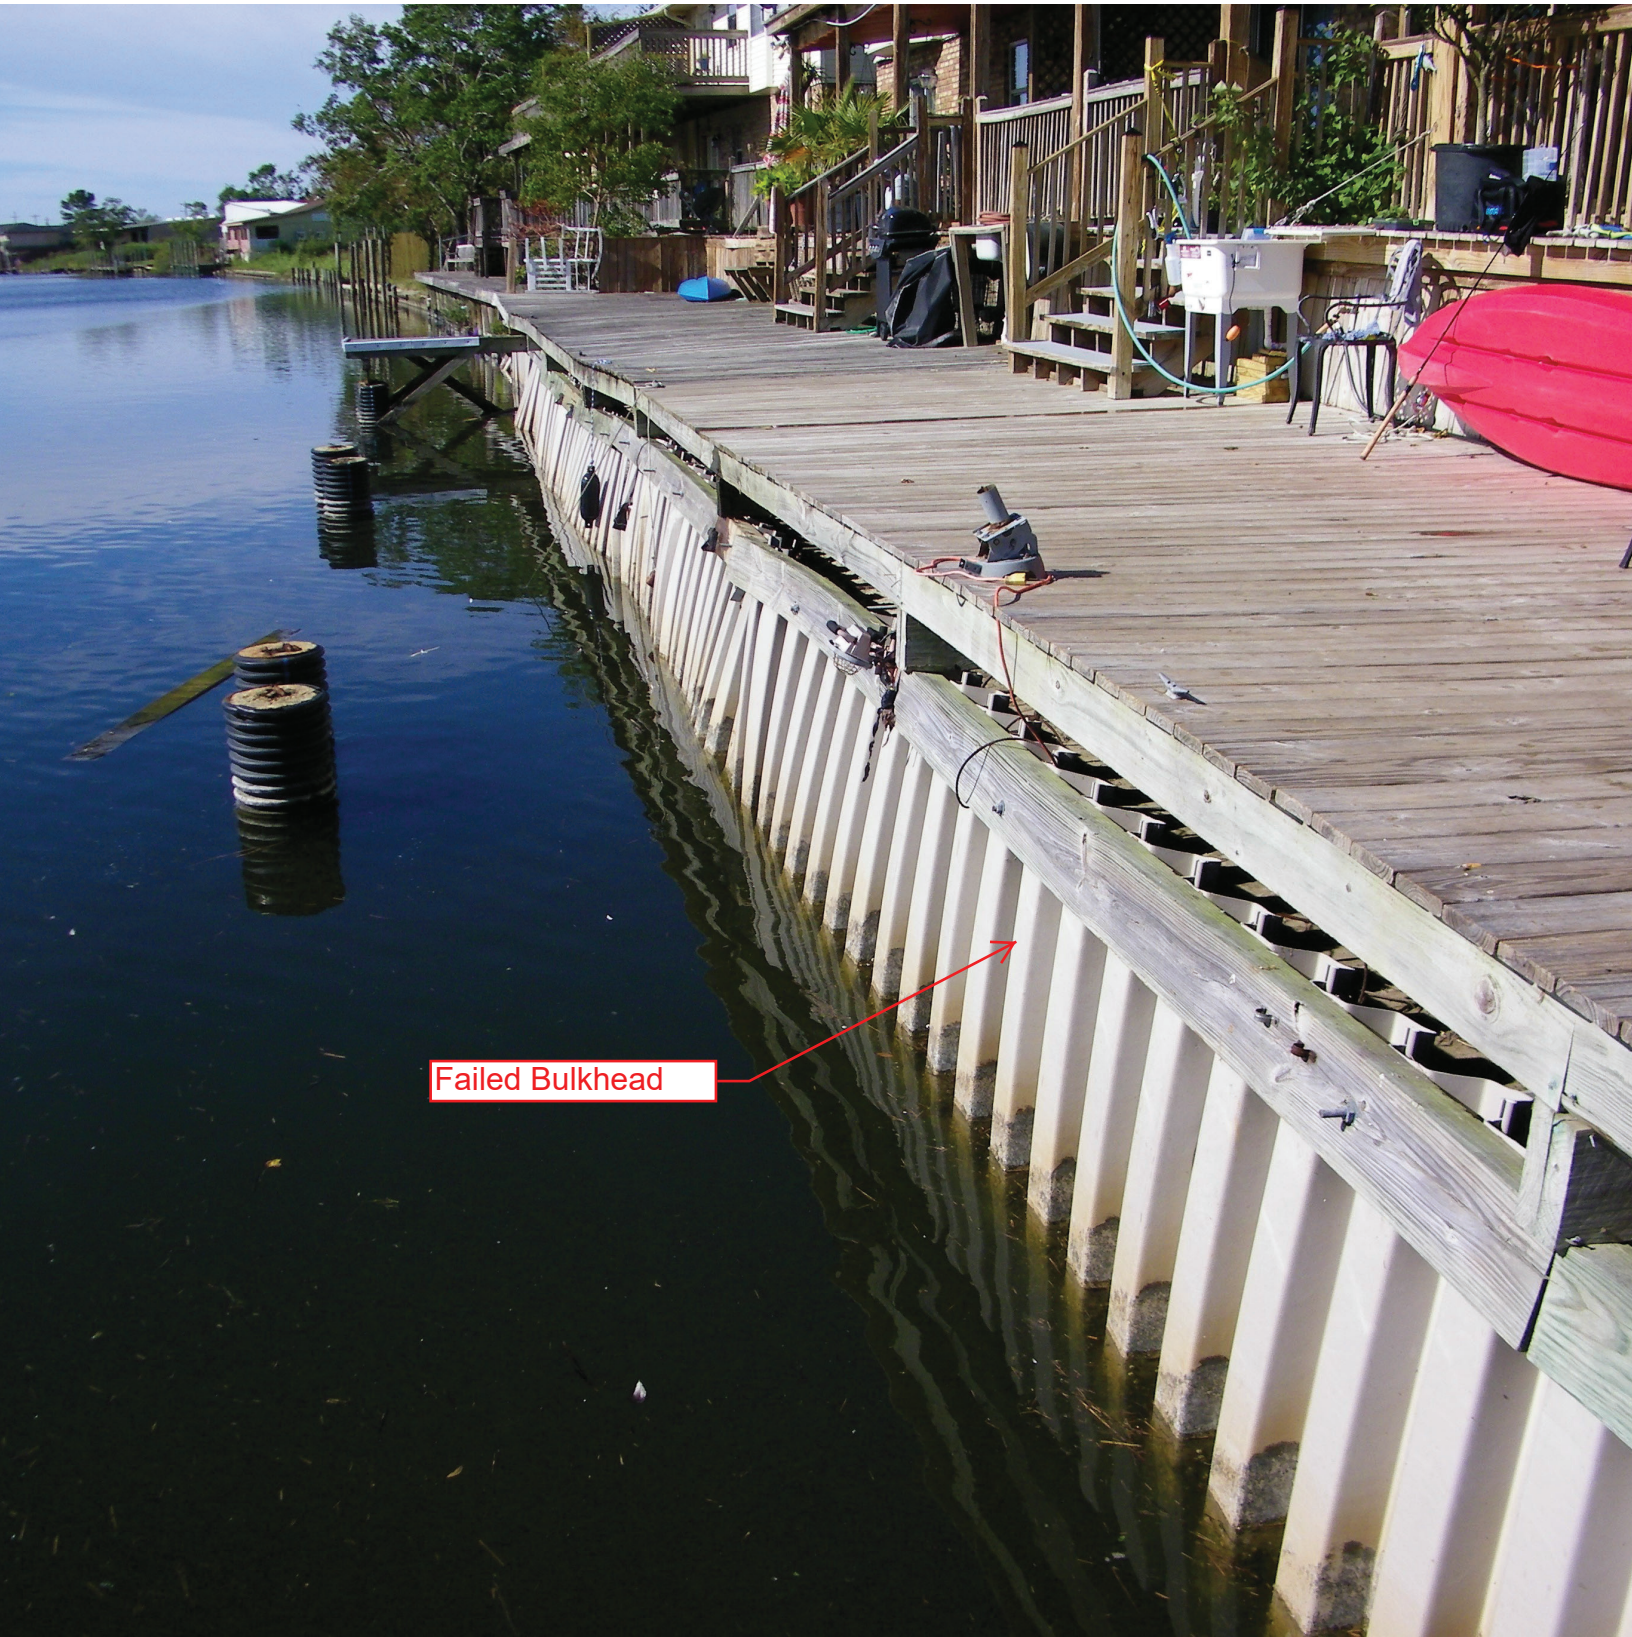
Upon inspection of the bulkhead, it was noted that the original concrete bulkhead is in place with an added PVC bulkhead on the outside of it, both bulkheads have failed. The PVC bulkhead appears to only have one horizontal batter board attached to it and no fill was brought in between the two bulkheads. It also appears that the original concrete bulkhead is still falling outward onto the PVC bulkhead causing damage.

Failed Bulkhead
