Structural Inspection

September 27, 2022

Ref: Bayou Mason
4800 Pontchartrain Drive
Slidell. La. 70458

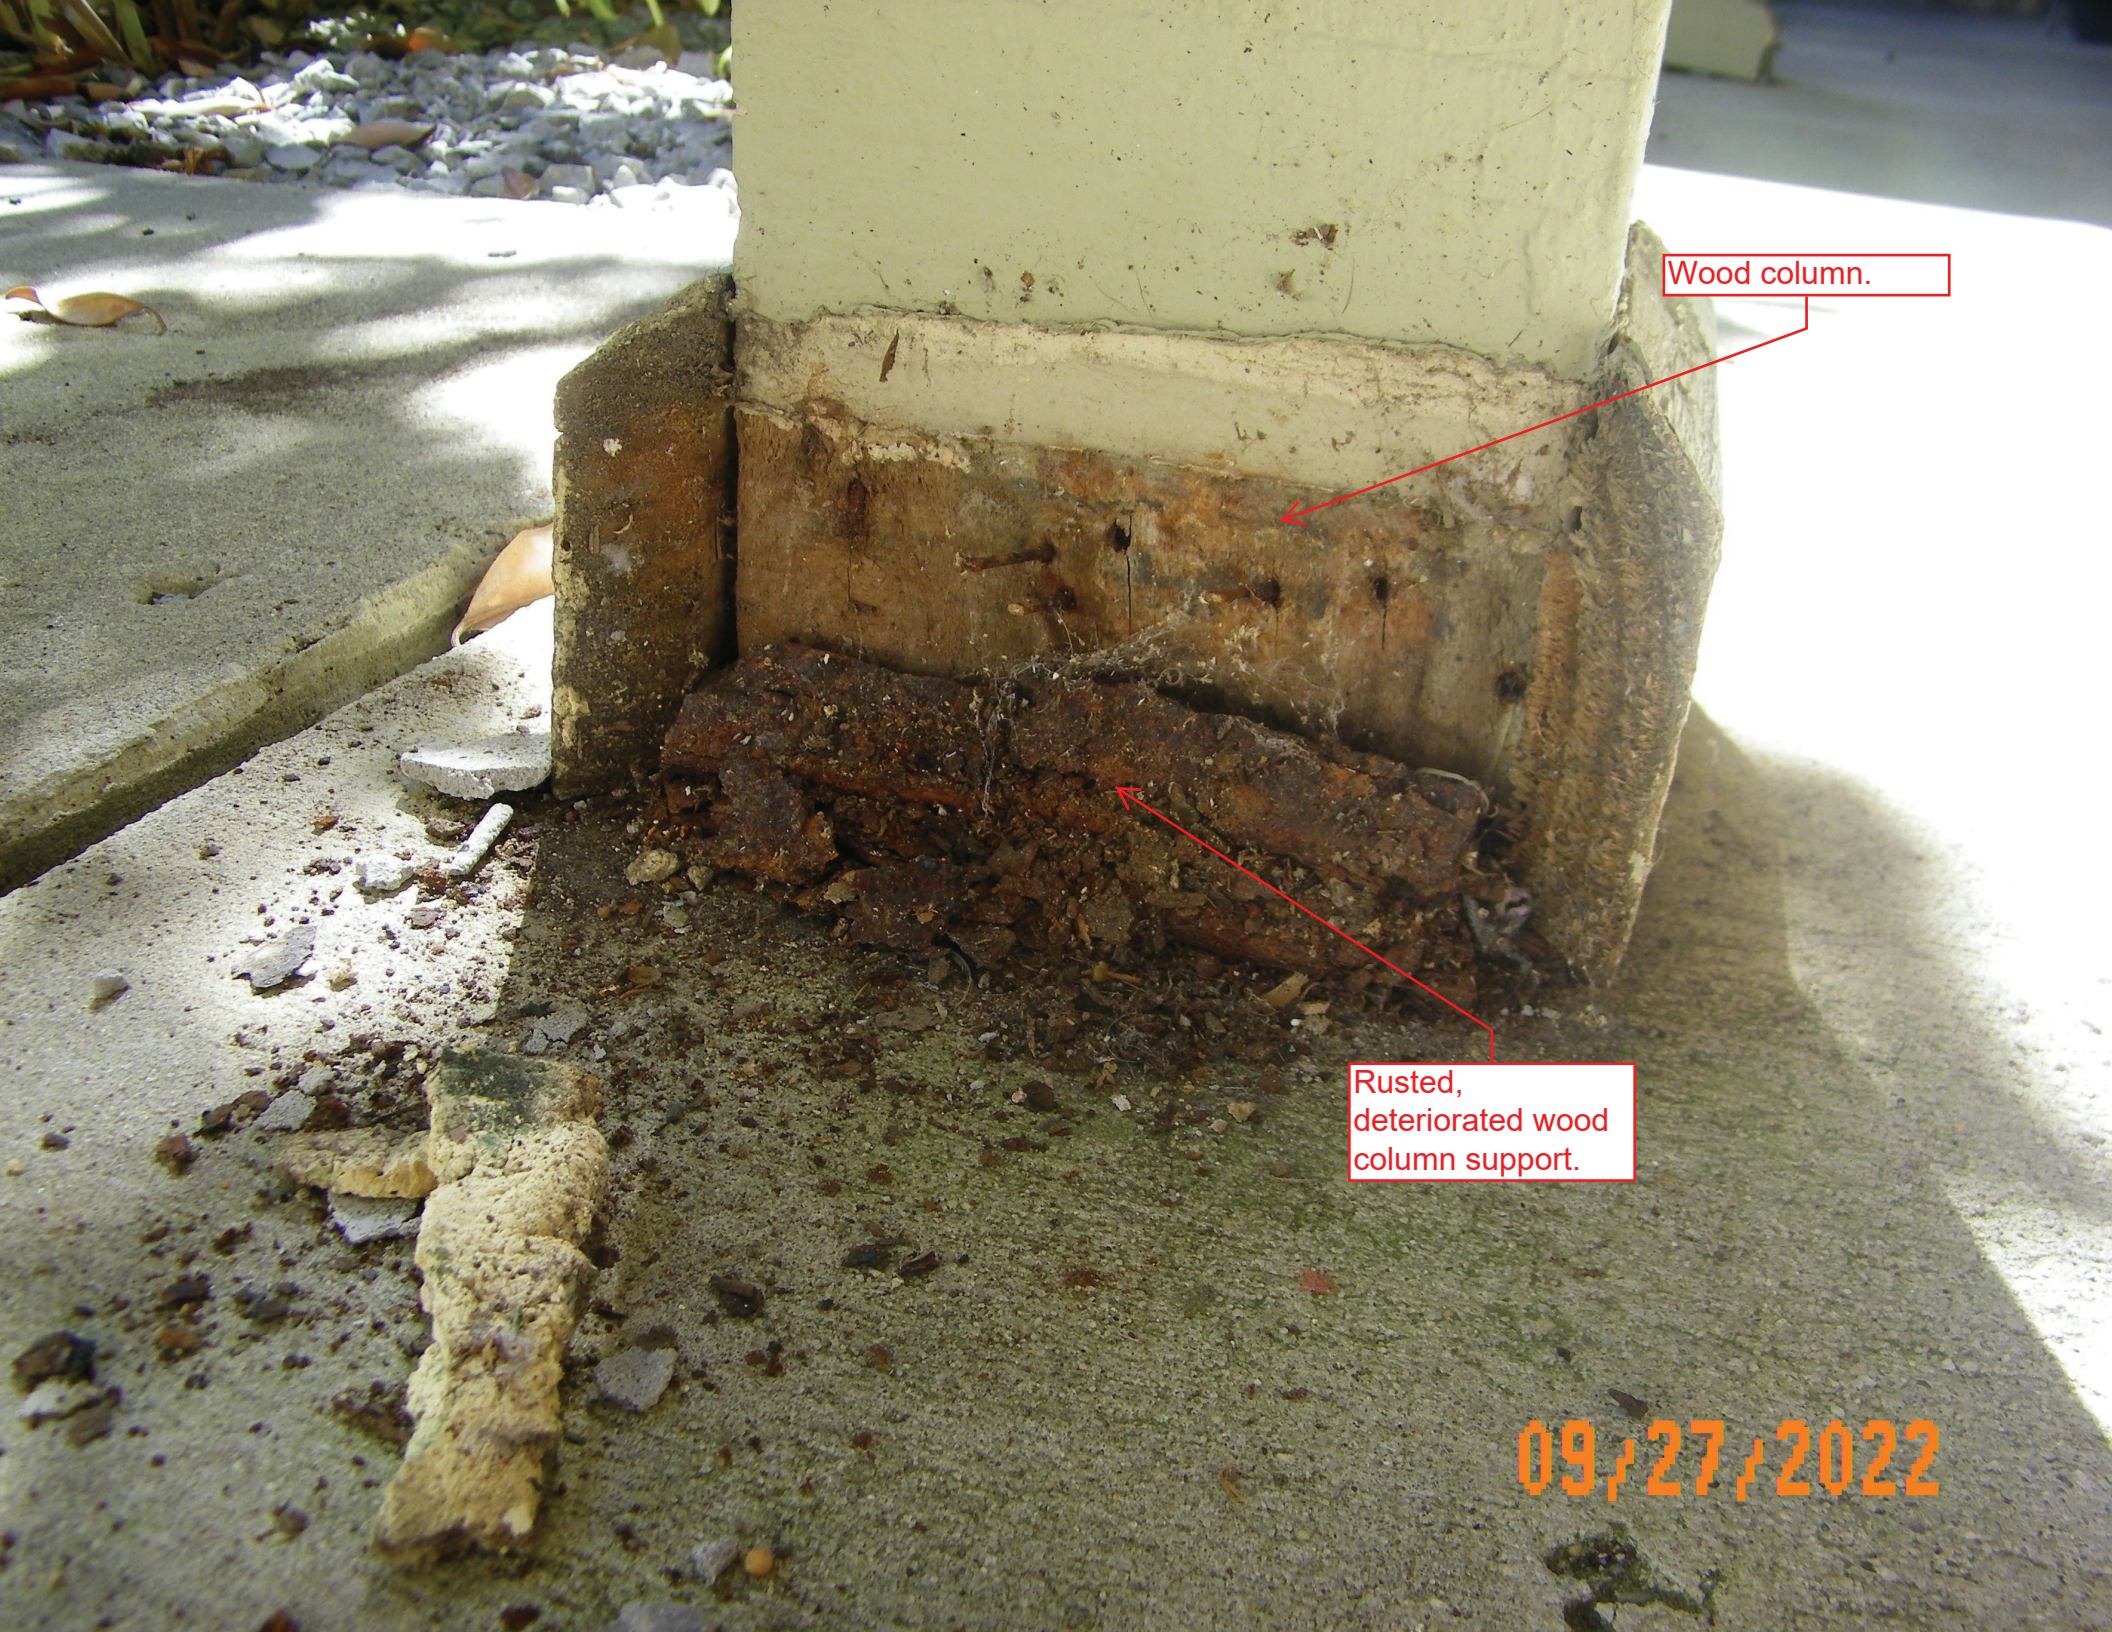
Upon inspection of the right staircase, some of the vinyl has been removed to expose the horizontal wood support that appears not be rotten. The wood columns in that area have rusted/deteriorated supports that have failed and allowed the collapse of the concrete walkways.

Wood column.

Rusted,
deteriorated wood
column support.

- 1) Remove the entire vinyl fascia covering the horizontal wood supports on all the upper walkways to detect rotten wood.
- 2) Remove the entire vinyl and wood soffit from under the walkways to detect rotten wood.
- 3) Remove and replace all connectors for the wood columns (ground floor and second floor).
- 4) Remove and replace all horizontal walkway supports that are rotten.
- 5) Remove and replace all floor joists that are rotten.
- 6) Remove and replace all rotten plywood that is supporting the concrete walkways. Install new plywood with lightweight concrete.
- 7) Remove and replace all cracked concrete walkways that have more than 1" separation or jack up back in place.
- 8) Seal all concrete walkways.
- 9) Reinstall all vinyl.
