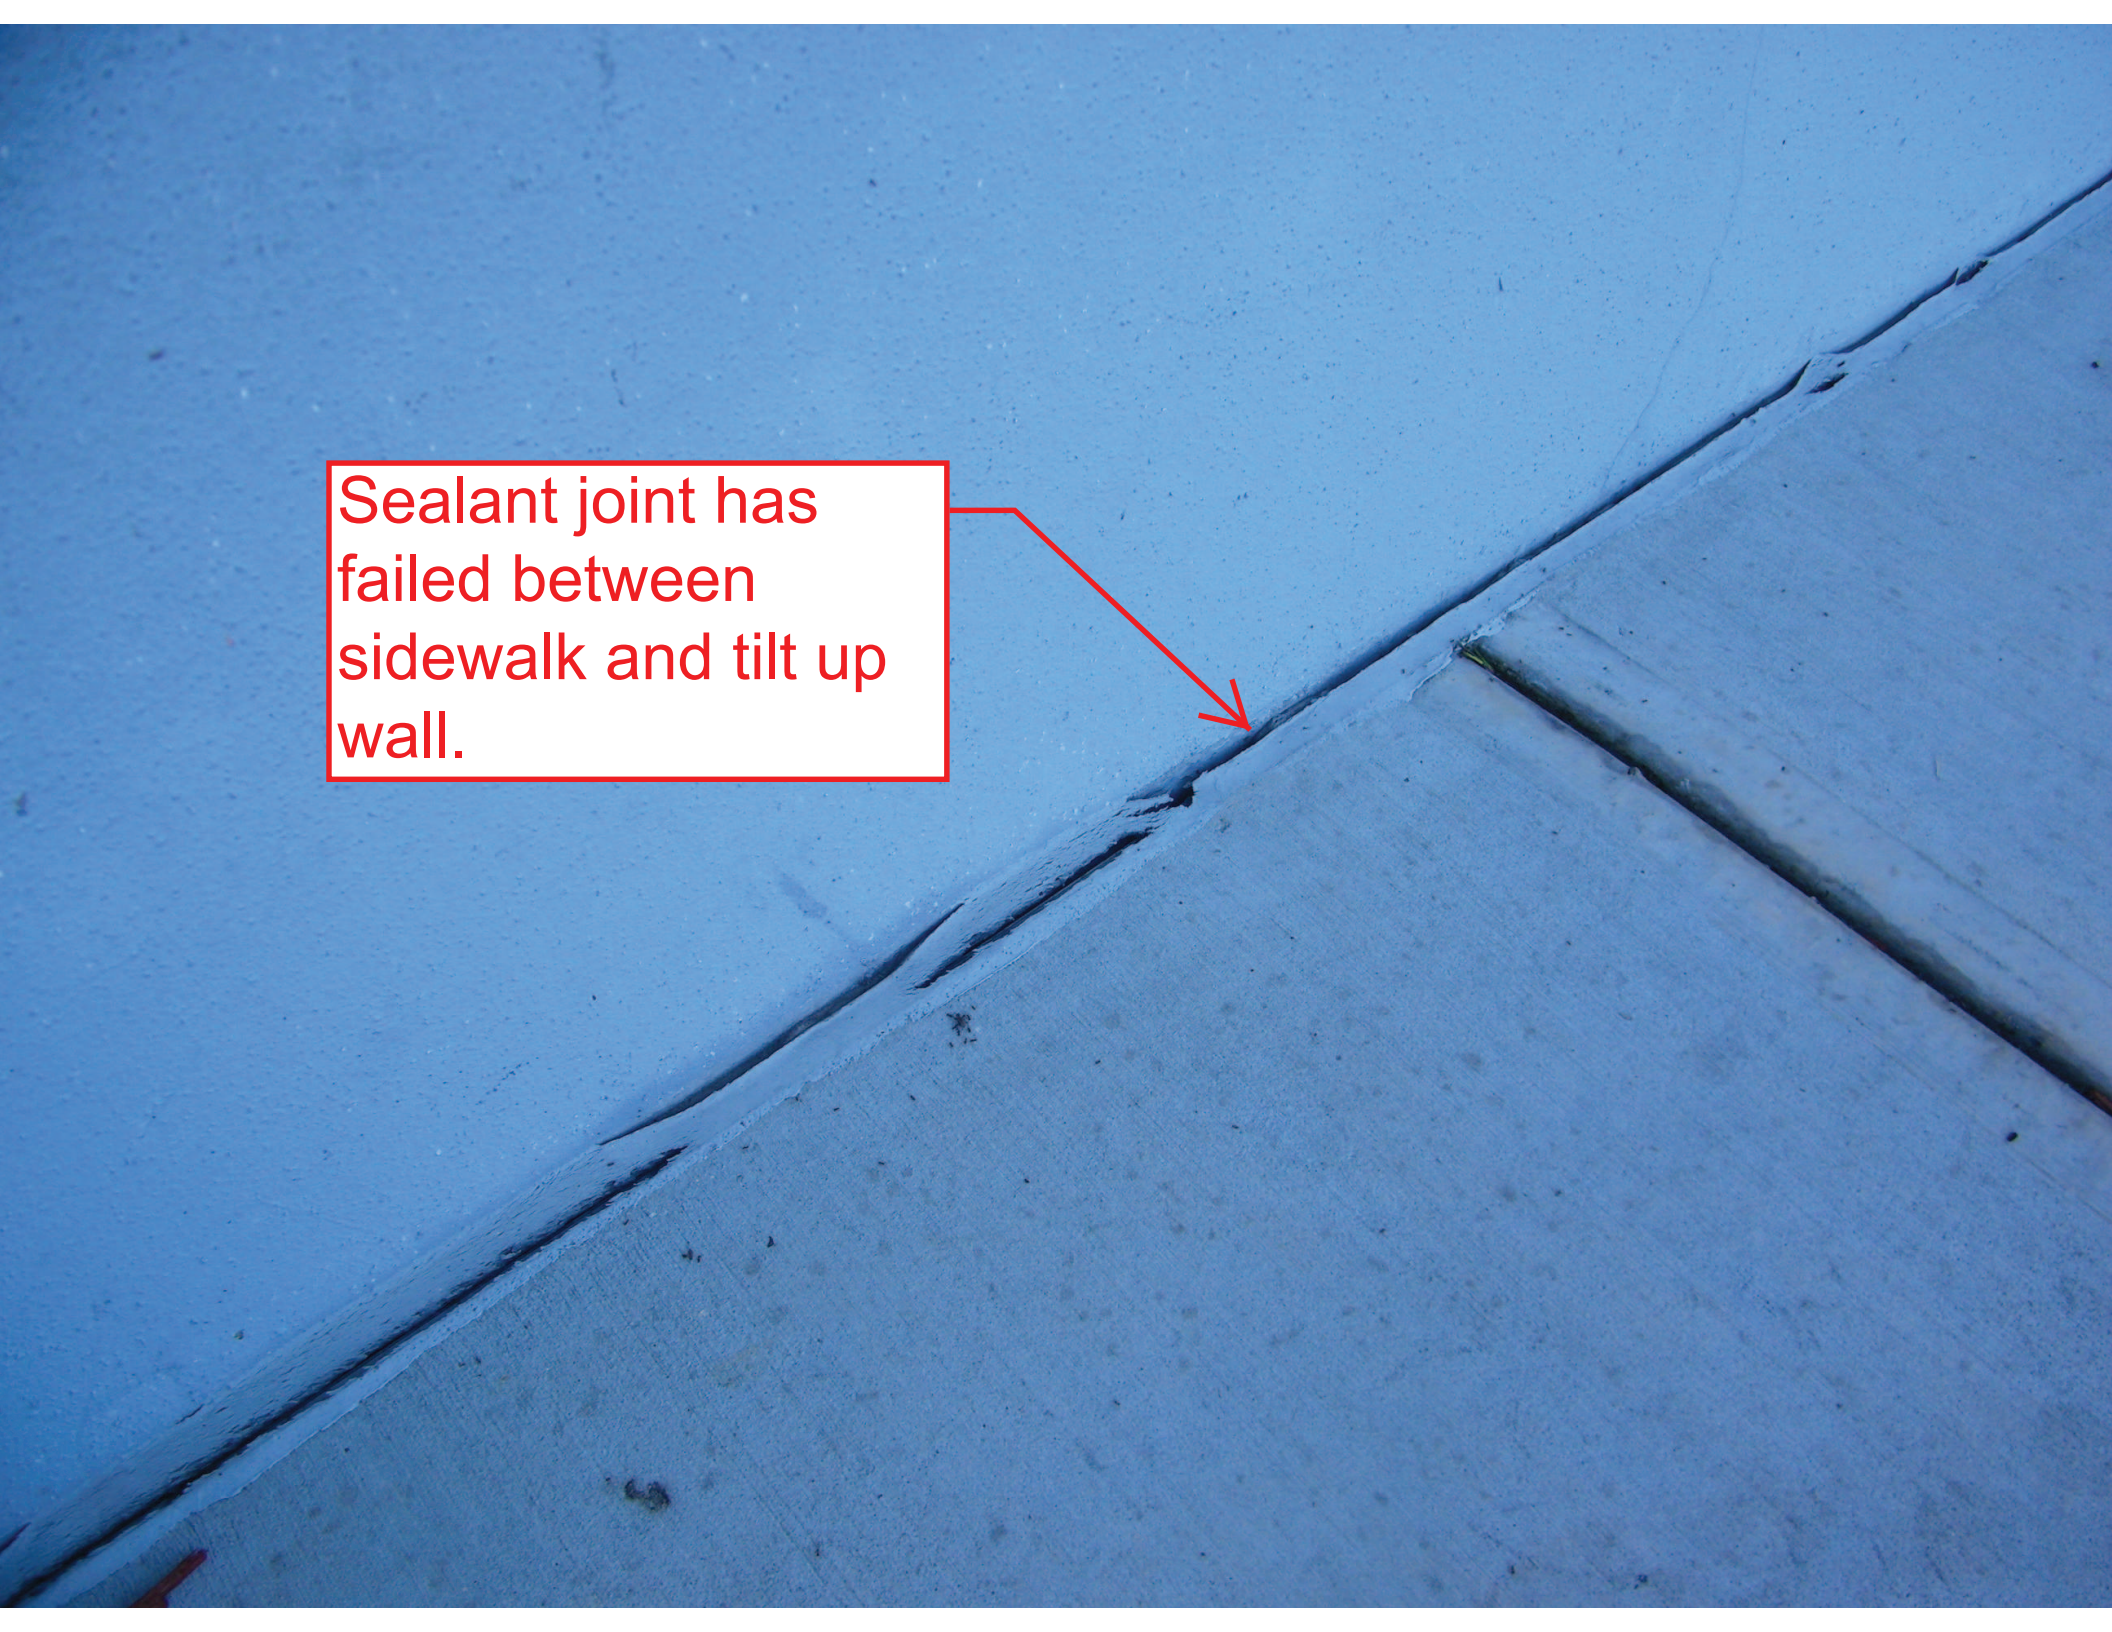
Sealant joint has failed between sidewalk and tilt up wall.

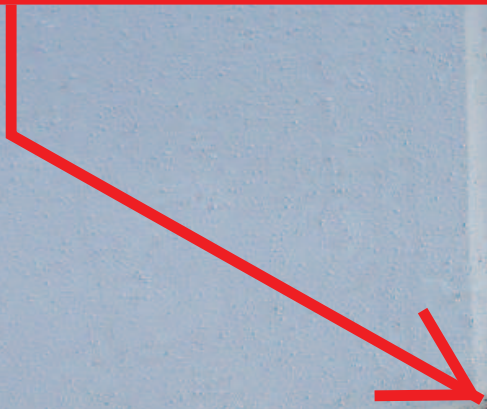
Joint sealant has failed.

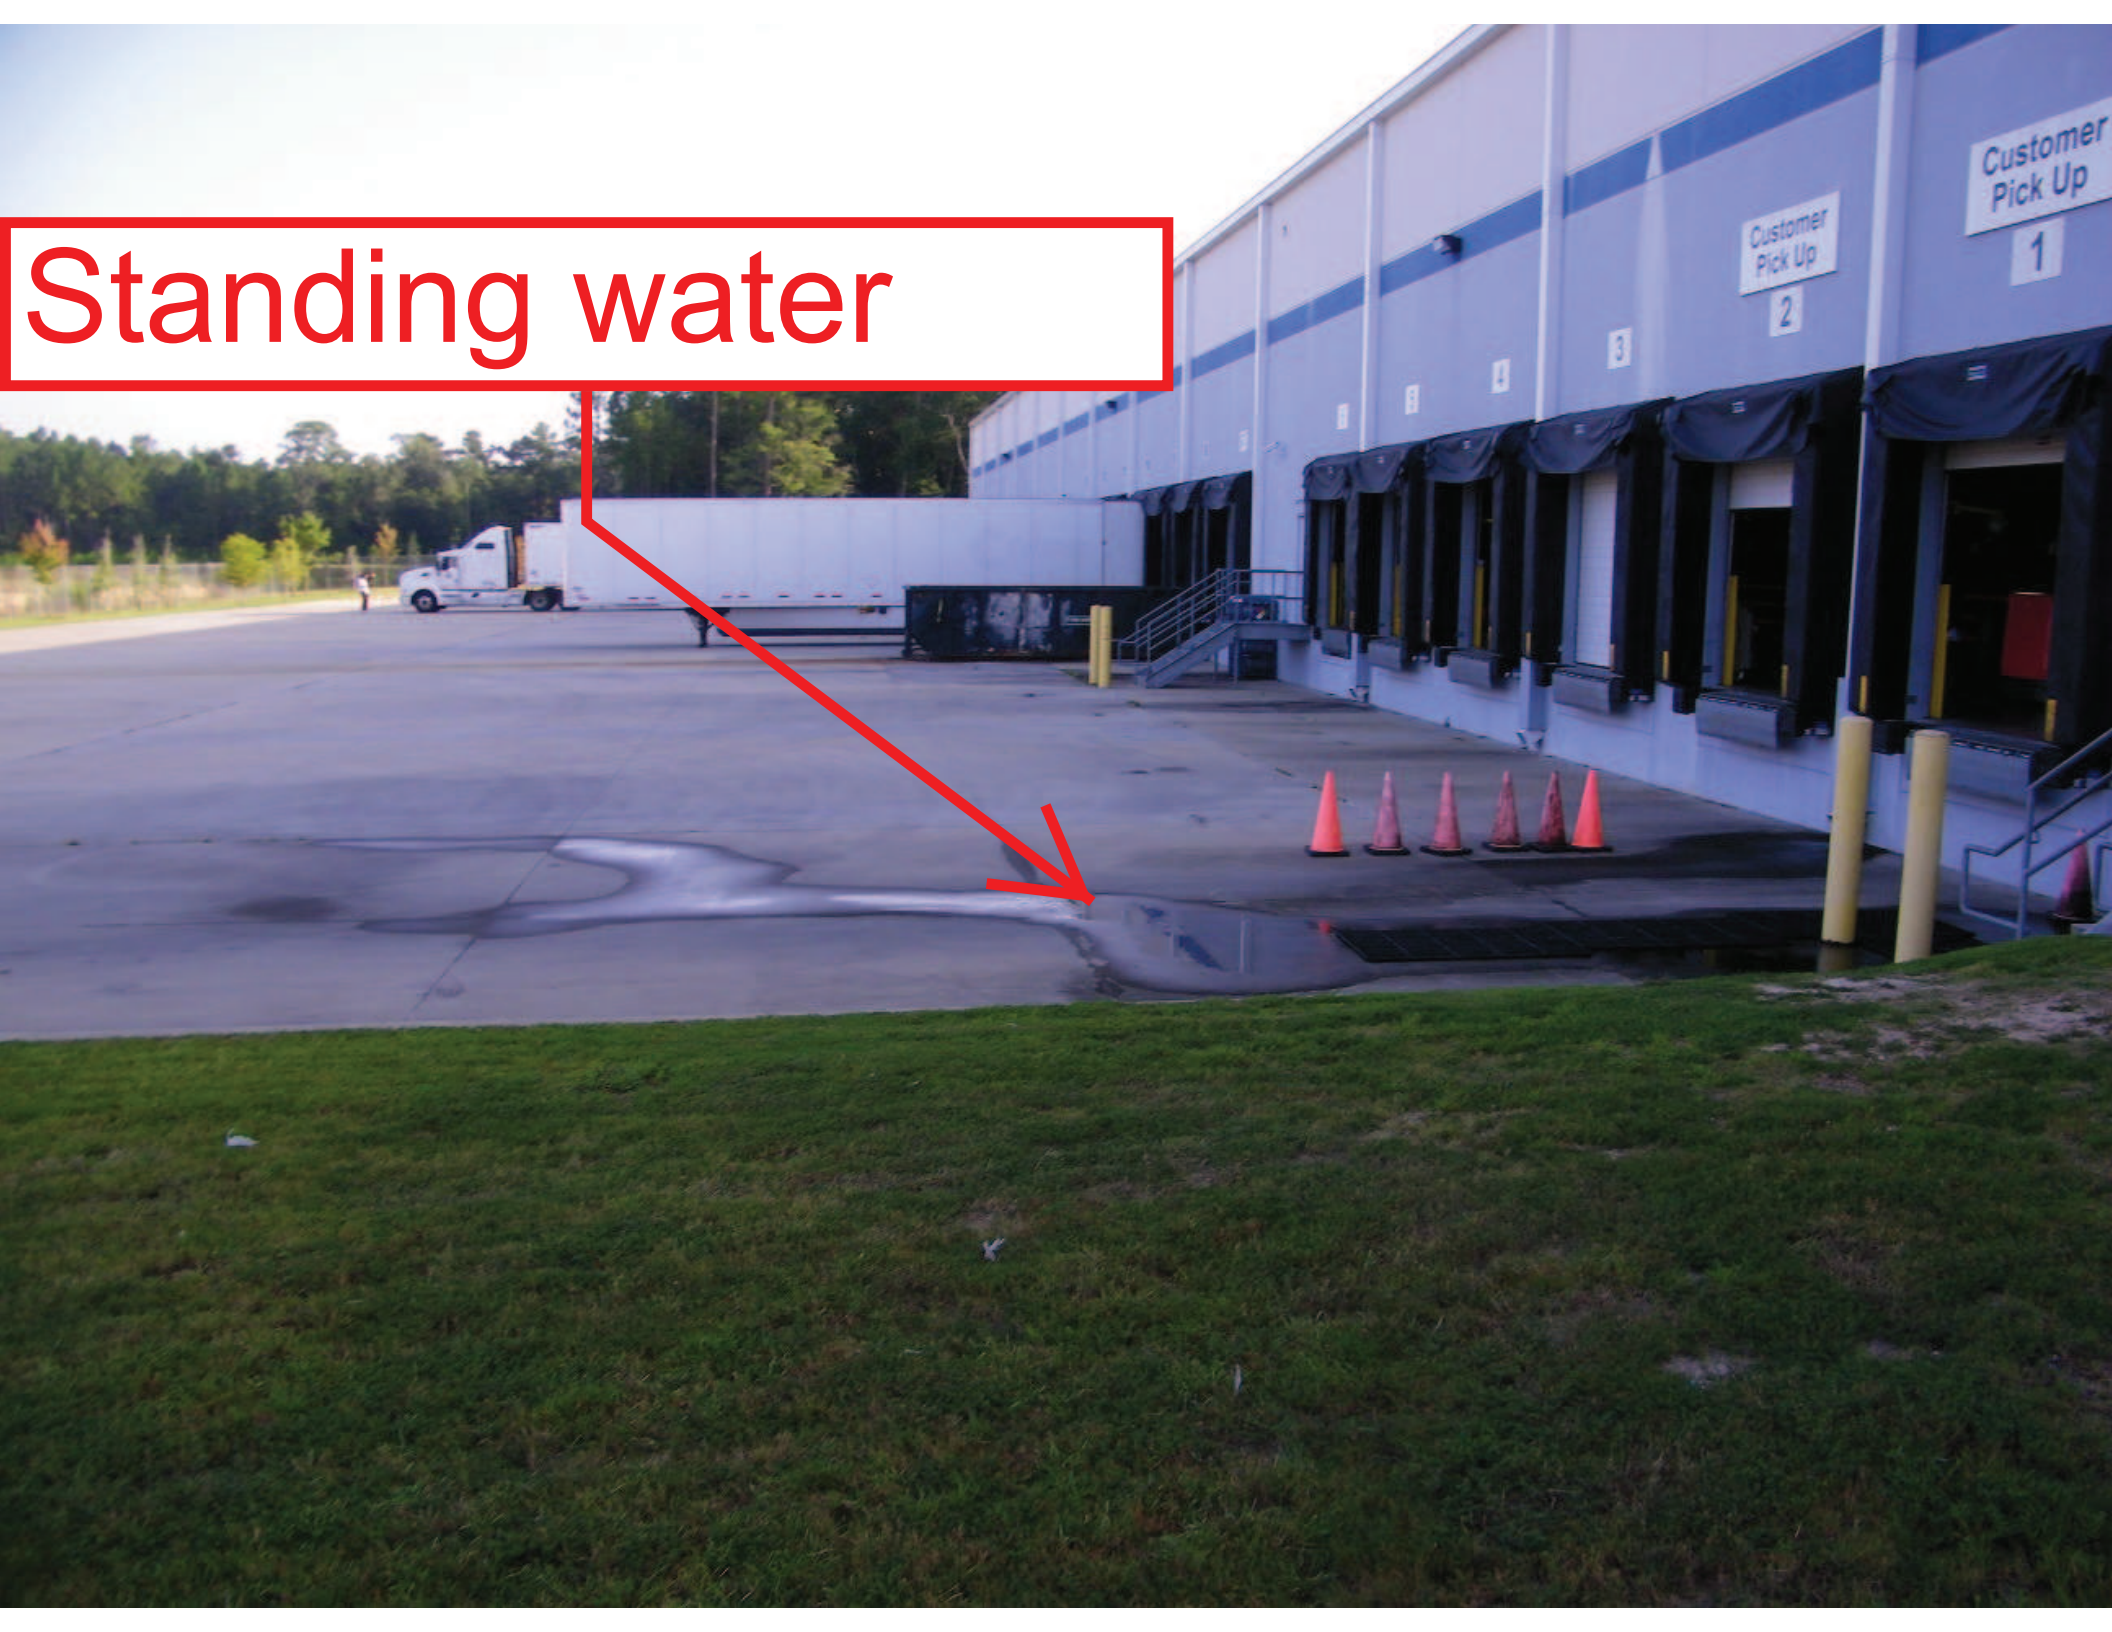
Standing water

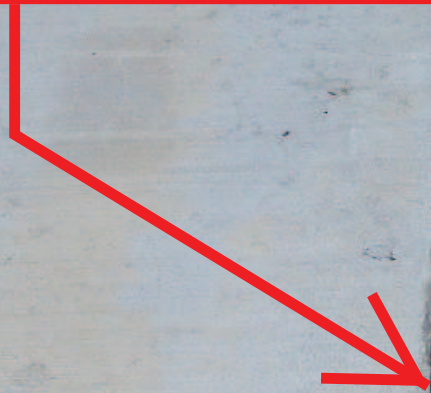
Failed sealant in
truck loading zone.

**Failed sealant in
loading zone.**

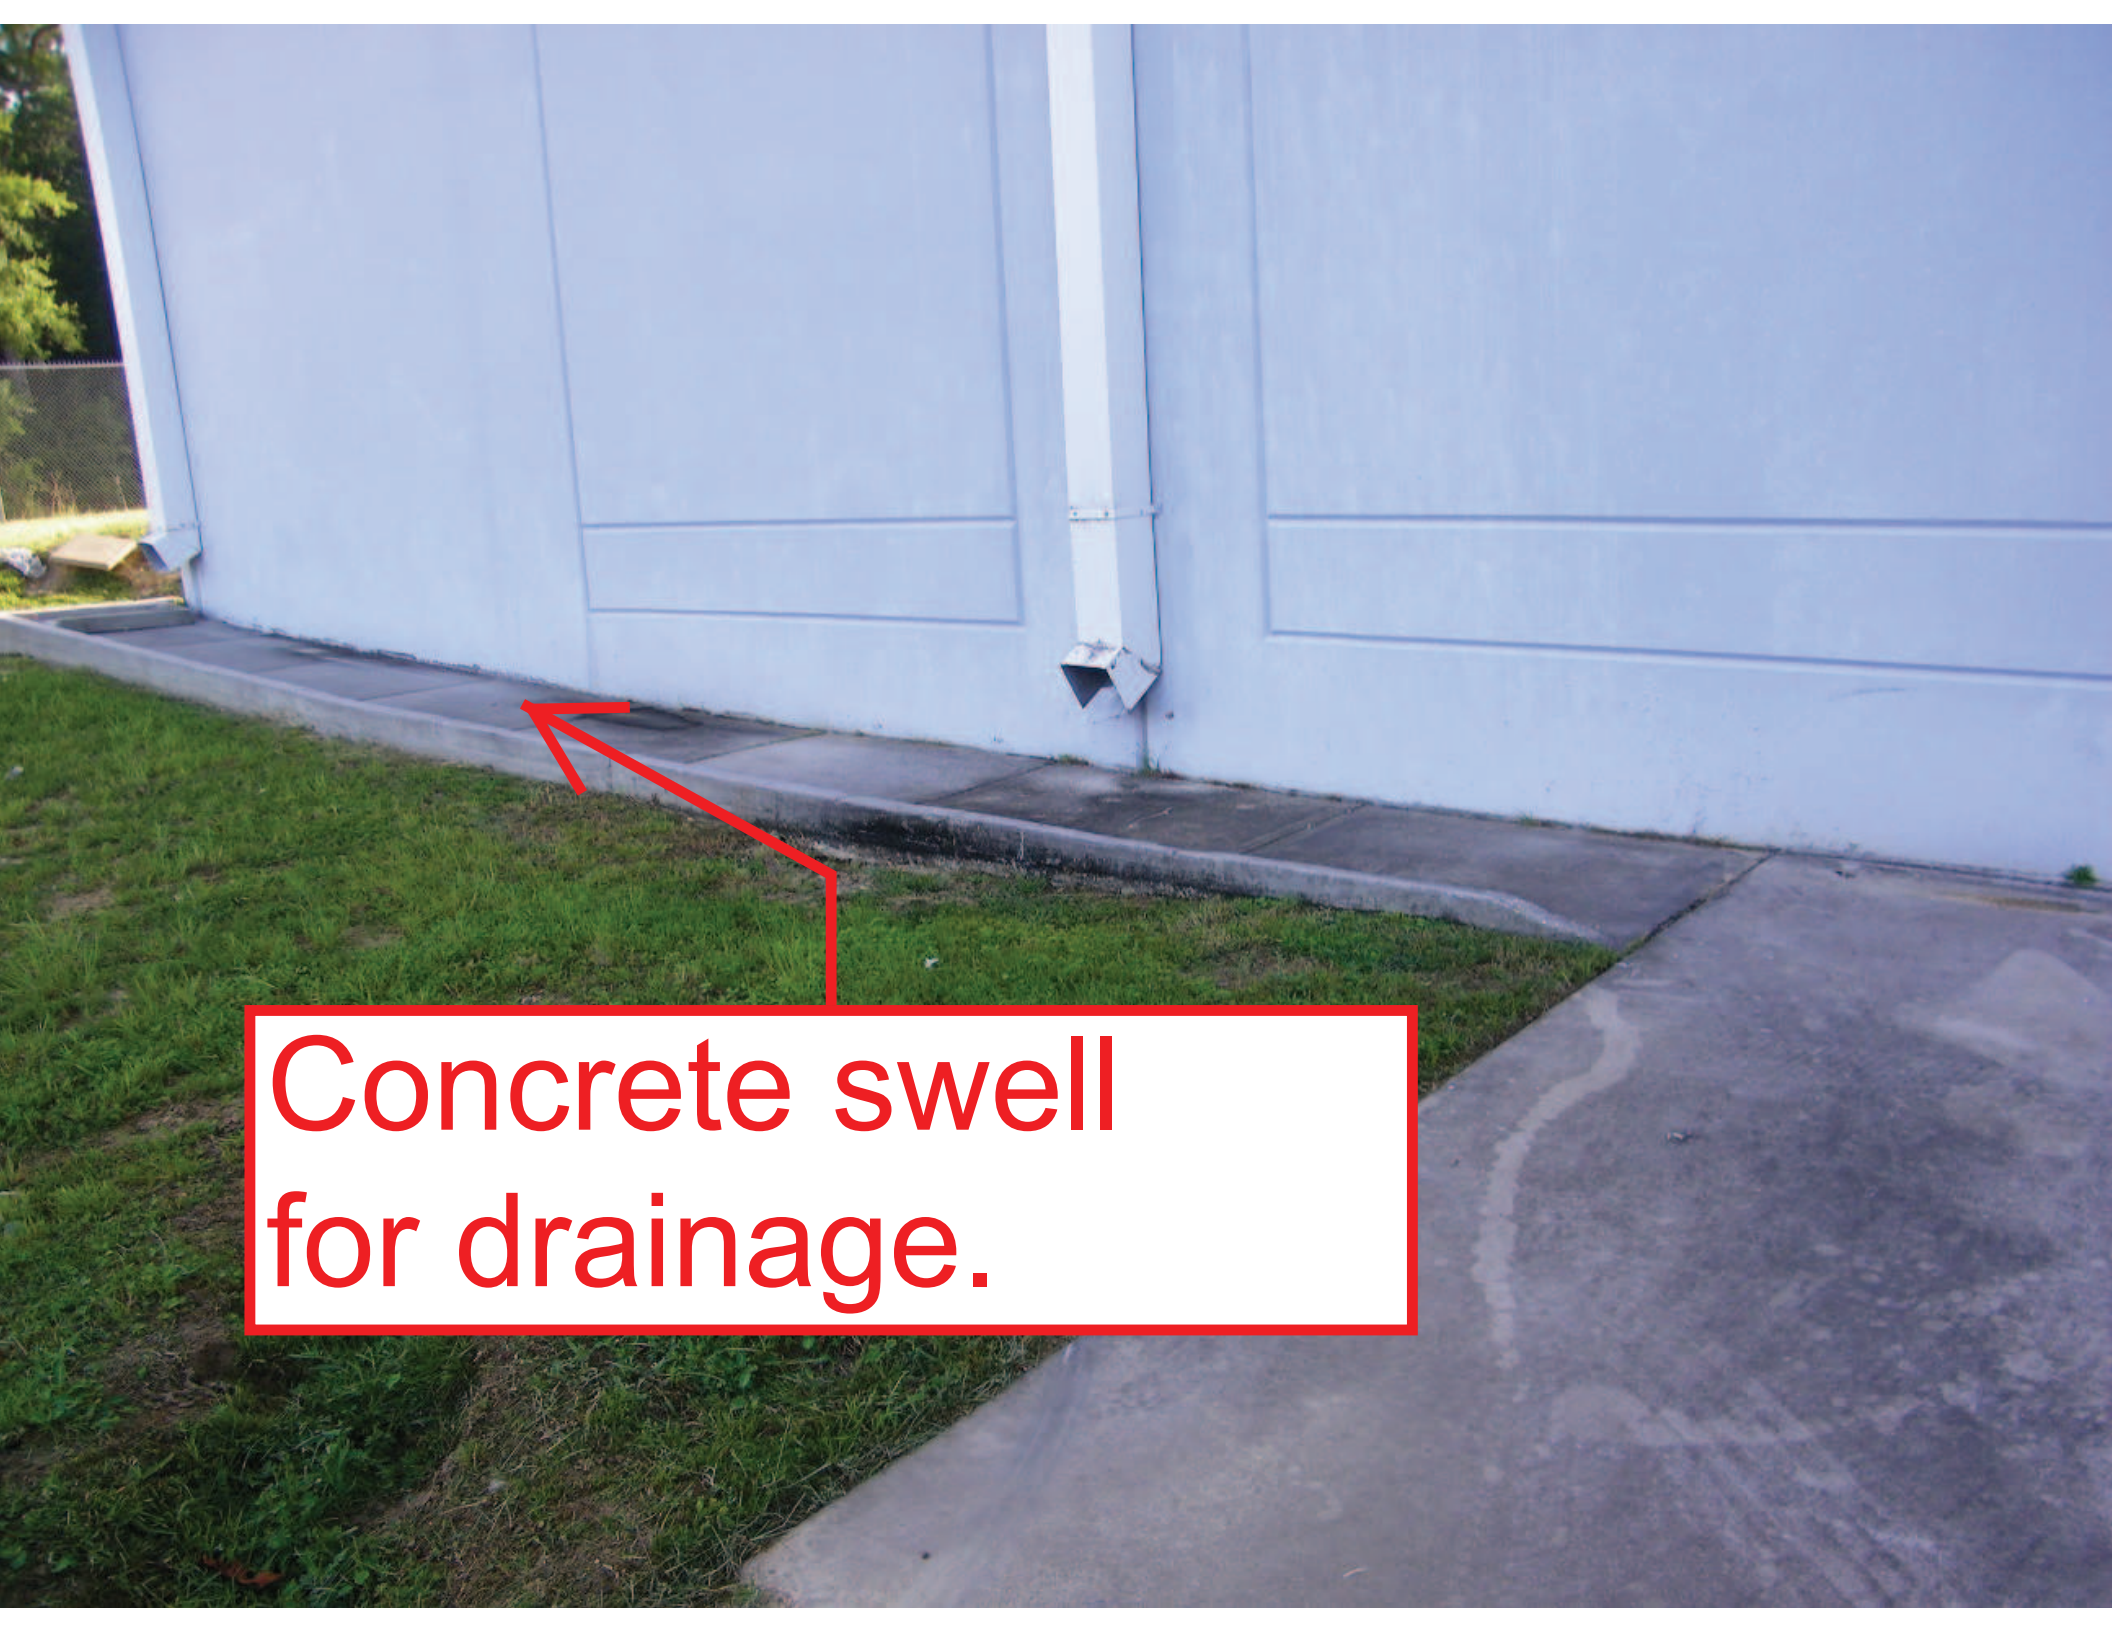
Concrete swell
for drainage.

Concrete swell
slopes to bldg with
failed sealant.

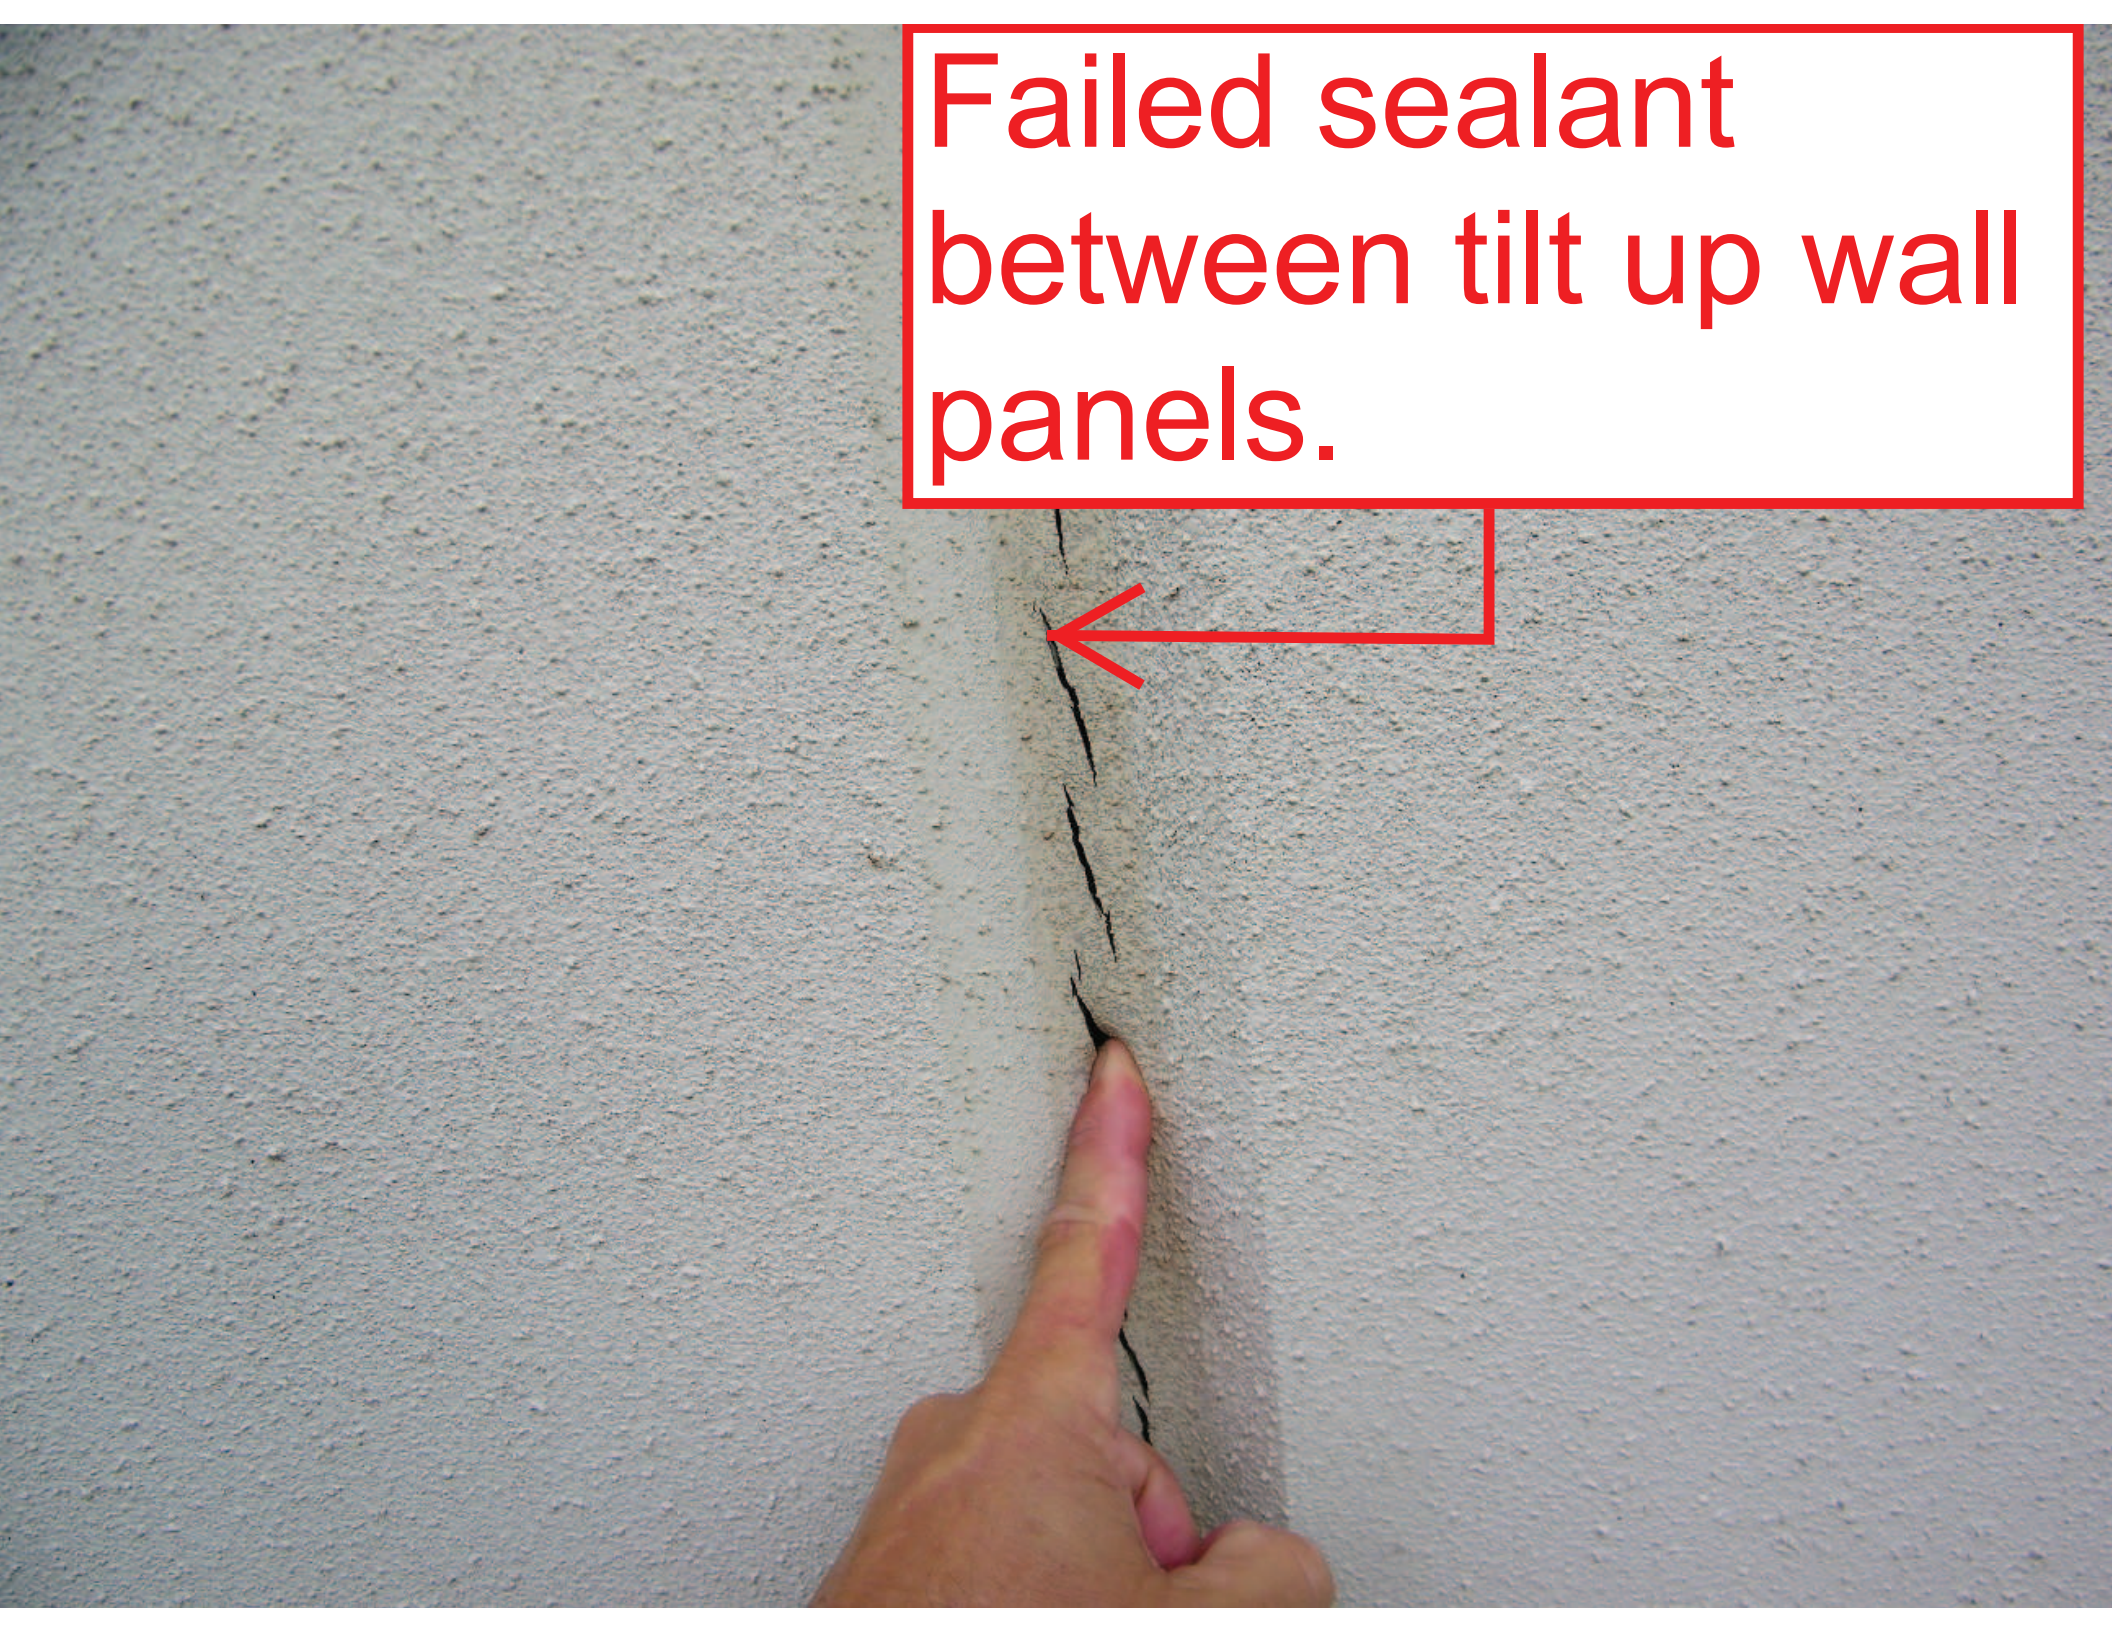
Failed sealant
between tilt up wall
panels.
