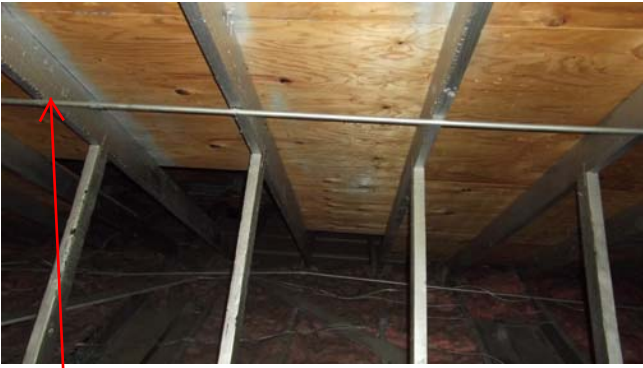
Roof framing members that have been painted.

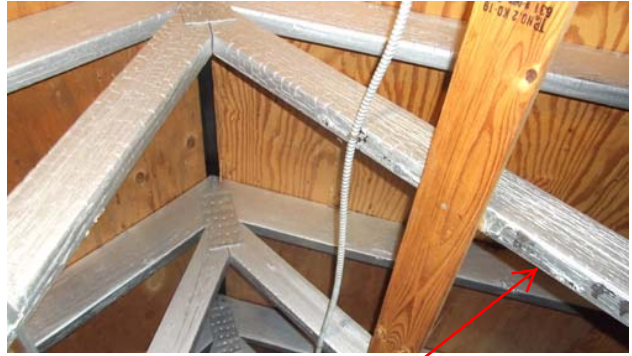
Roof framing members that have been painted.

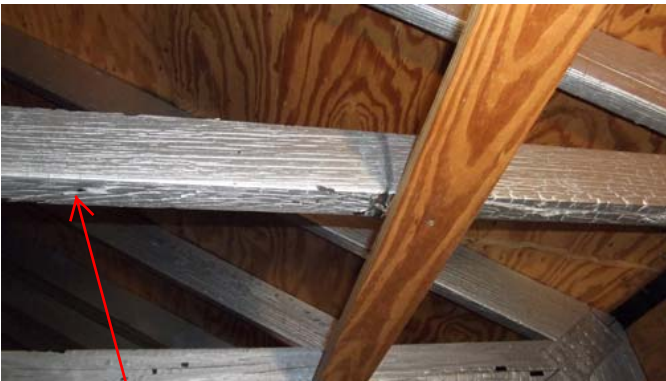
Roof framing member that has been painted.

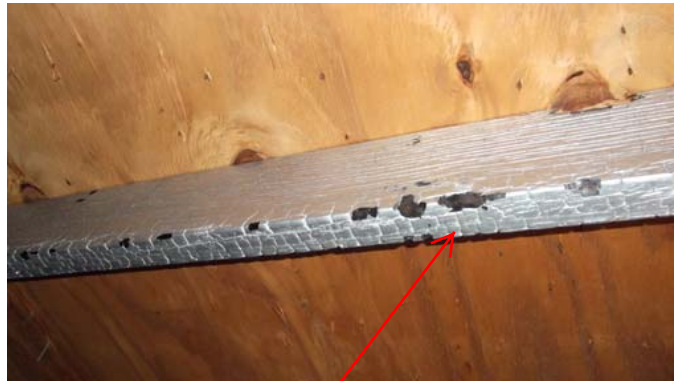
Roof framing member that has been painted.

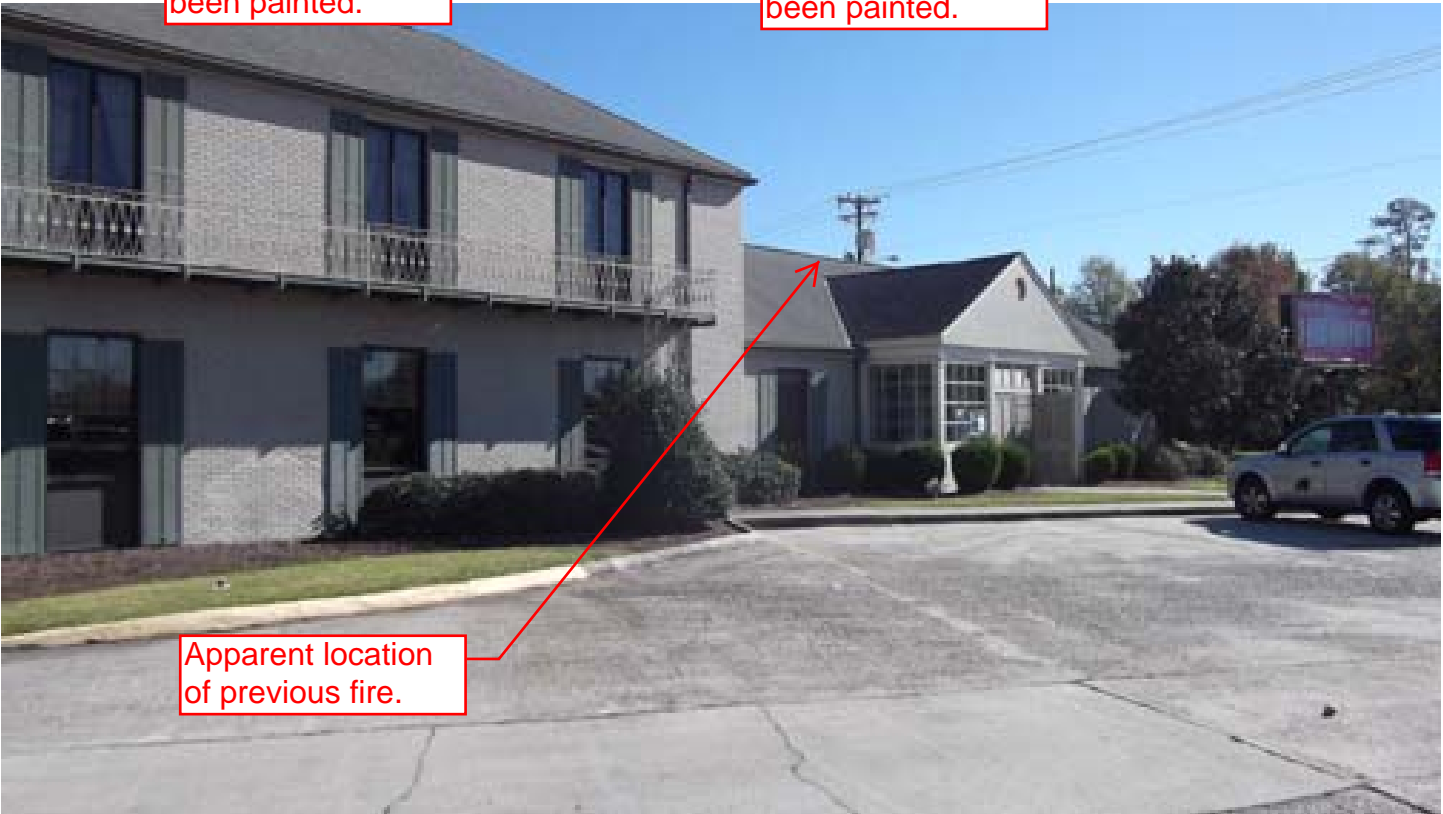
Apparent location of previous fire.

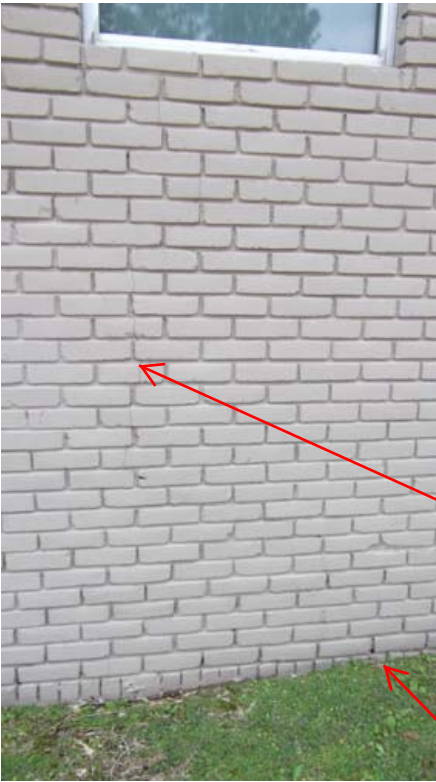
Crack in brick veneer.

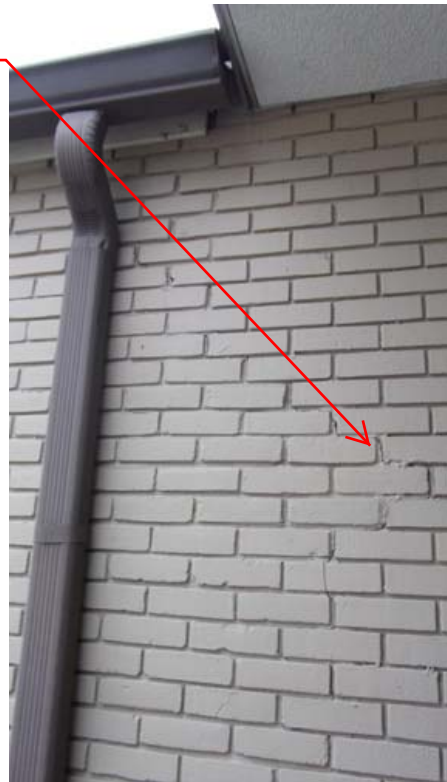
Crack in brick veneer.

Weep holes covered by landscaping.

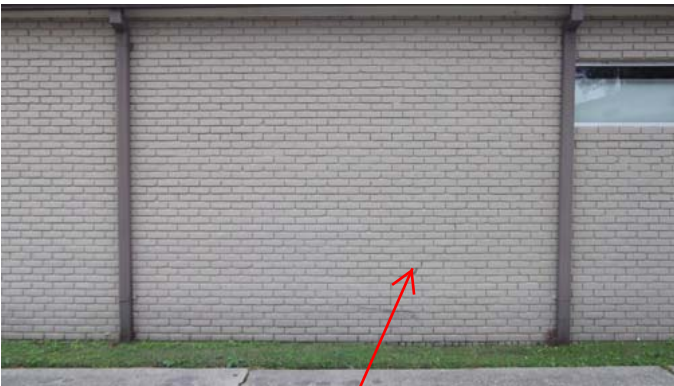
Crack in brick veneer.

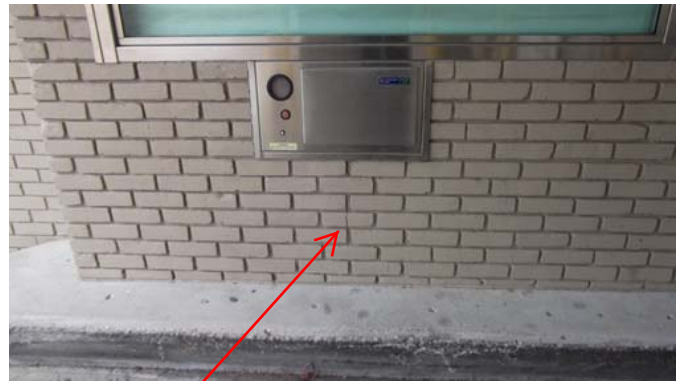
Crack in brick veneer.
