Structural Inspection

September 22, 2021

For: Mr. & Mrs. Sinclair
59386 N. Harrison Rd
Slidell, La. 70460

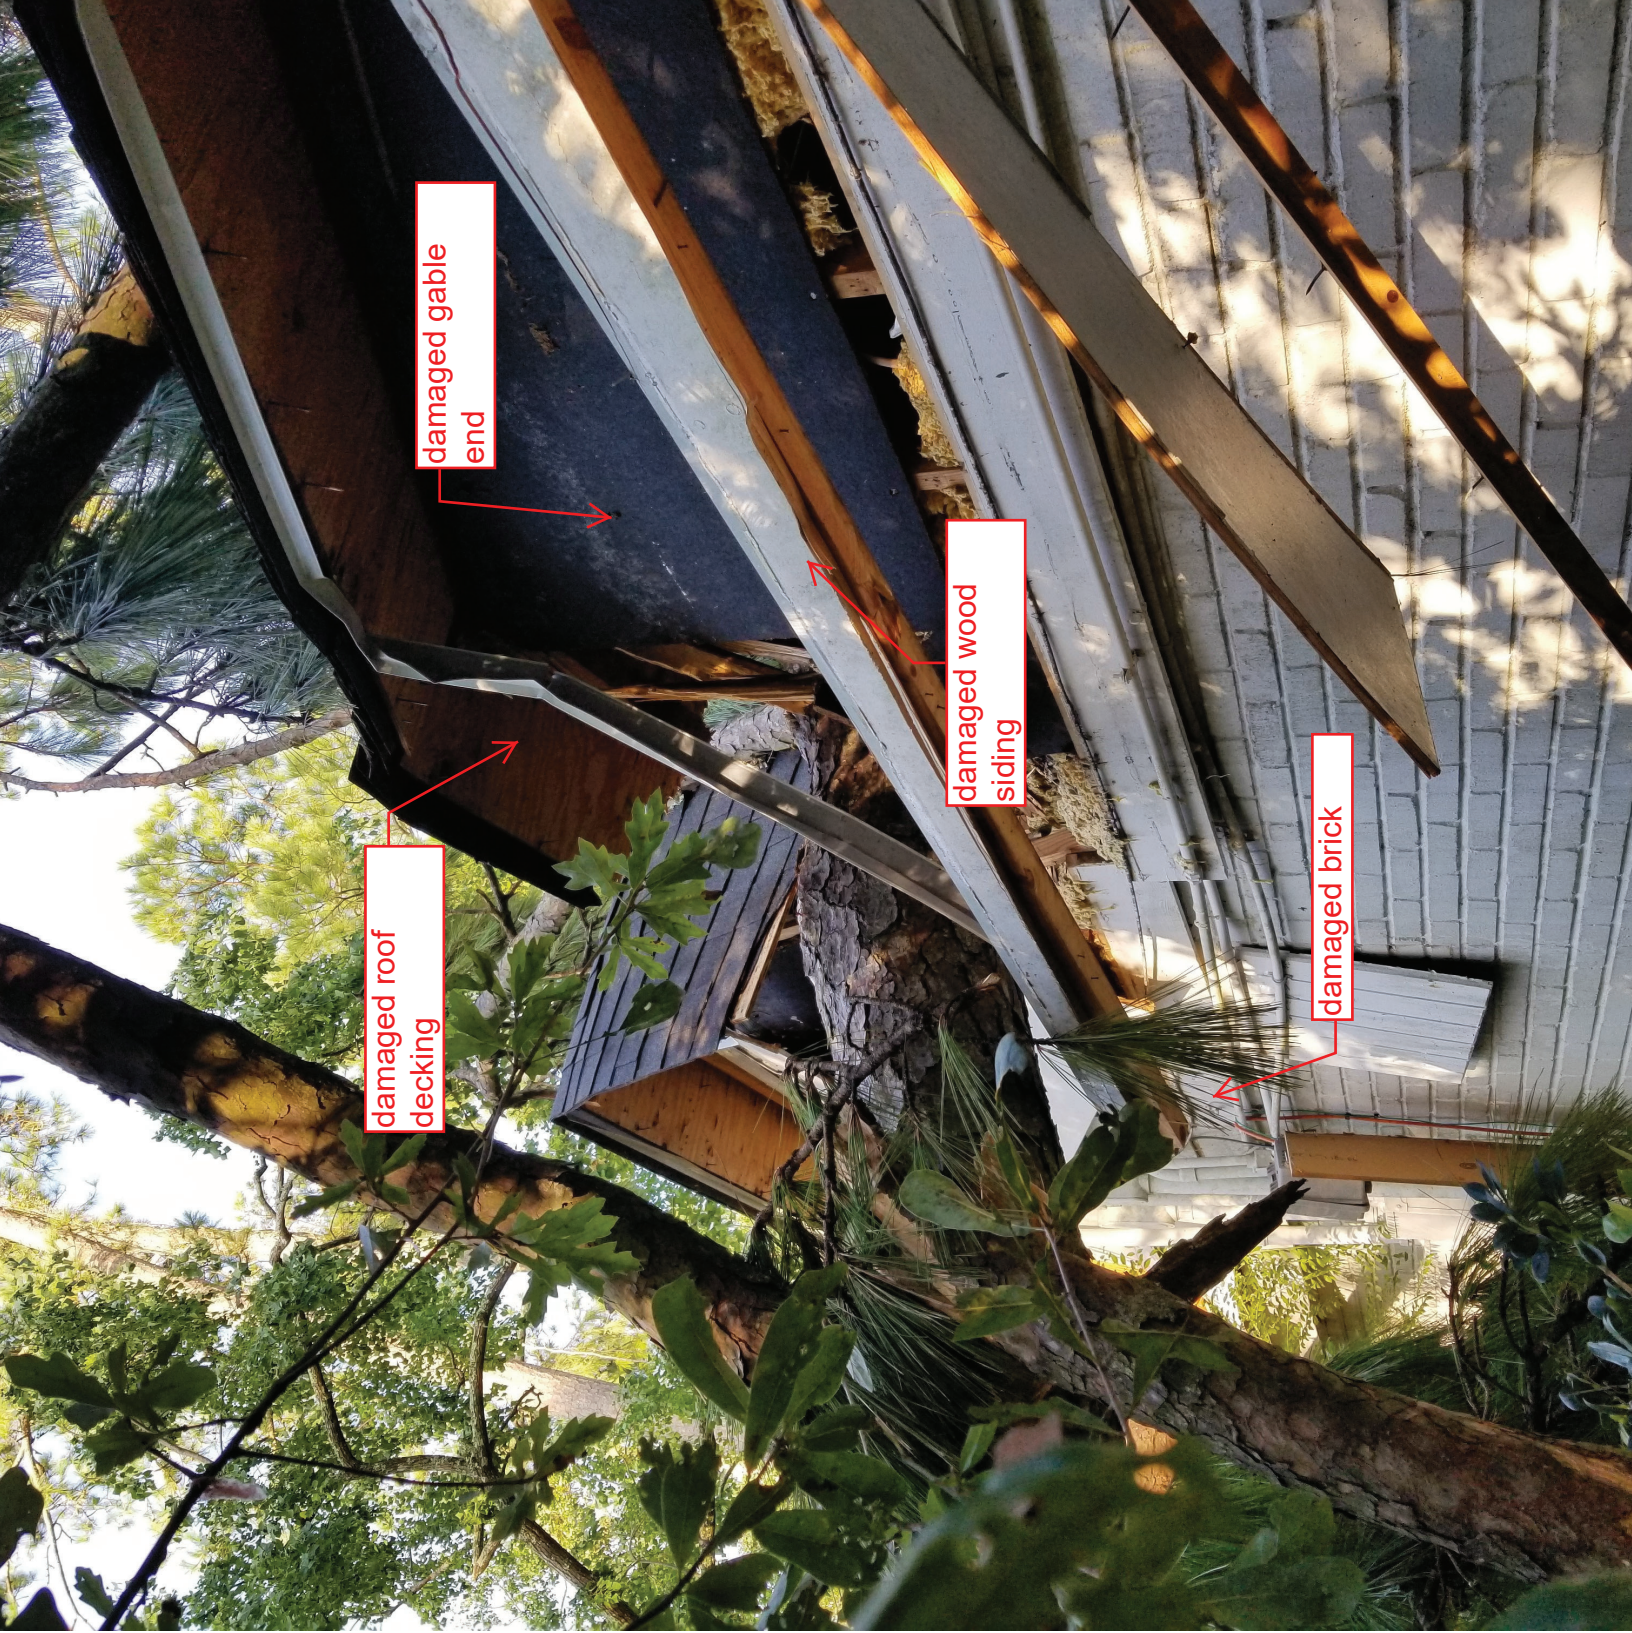
damaged roof decking

damaged gable end

damaged wood siding

damaged brick

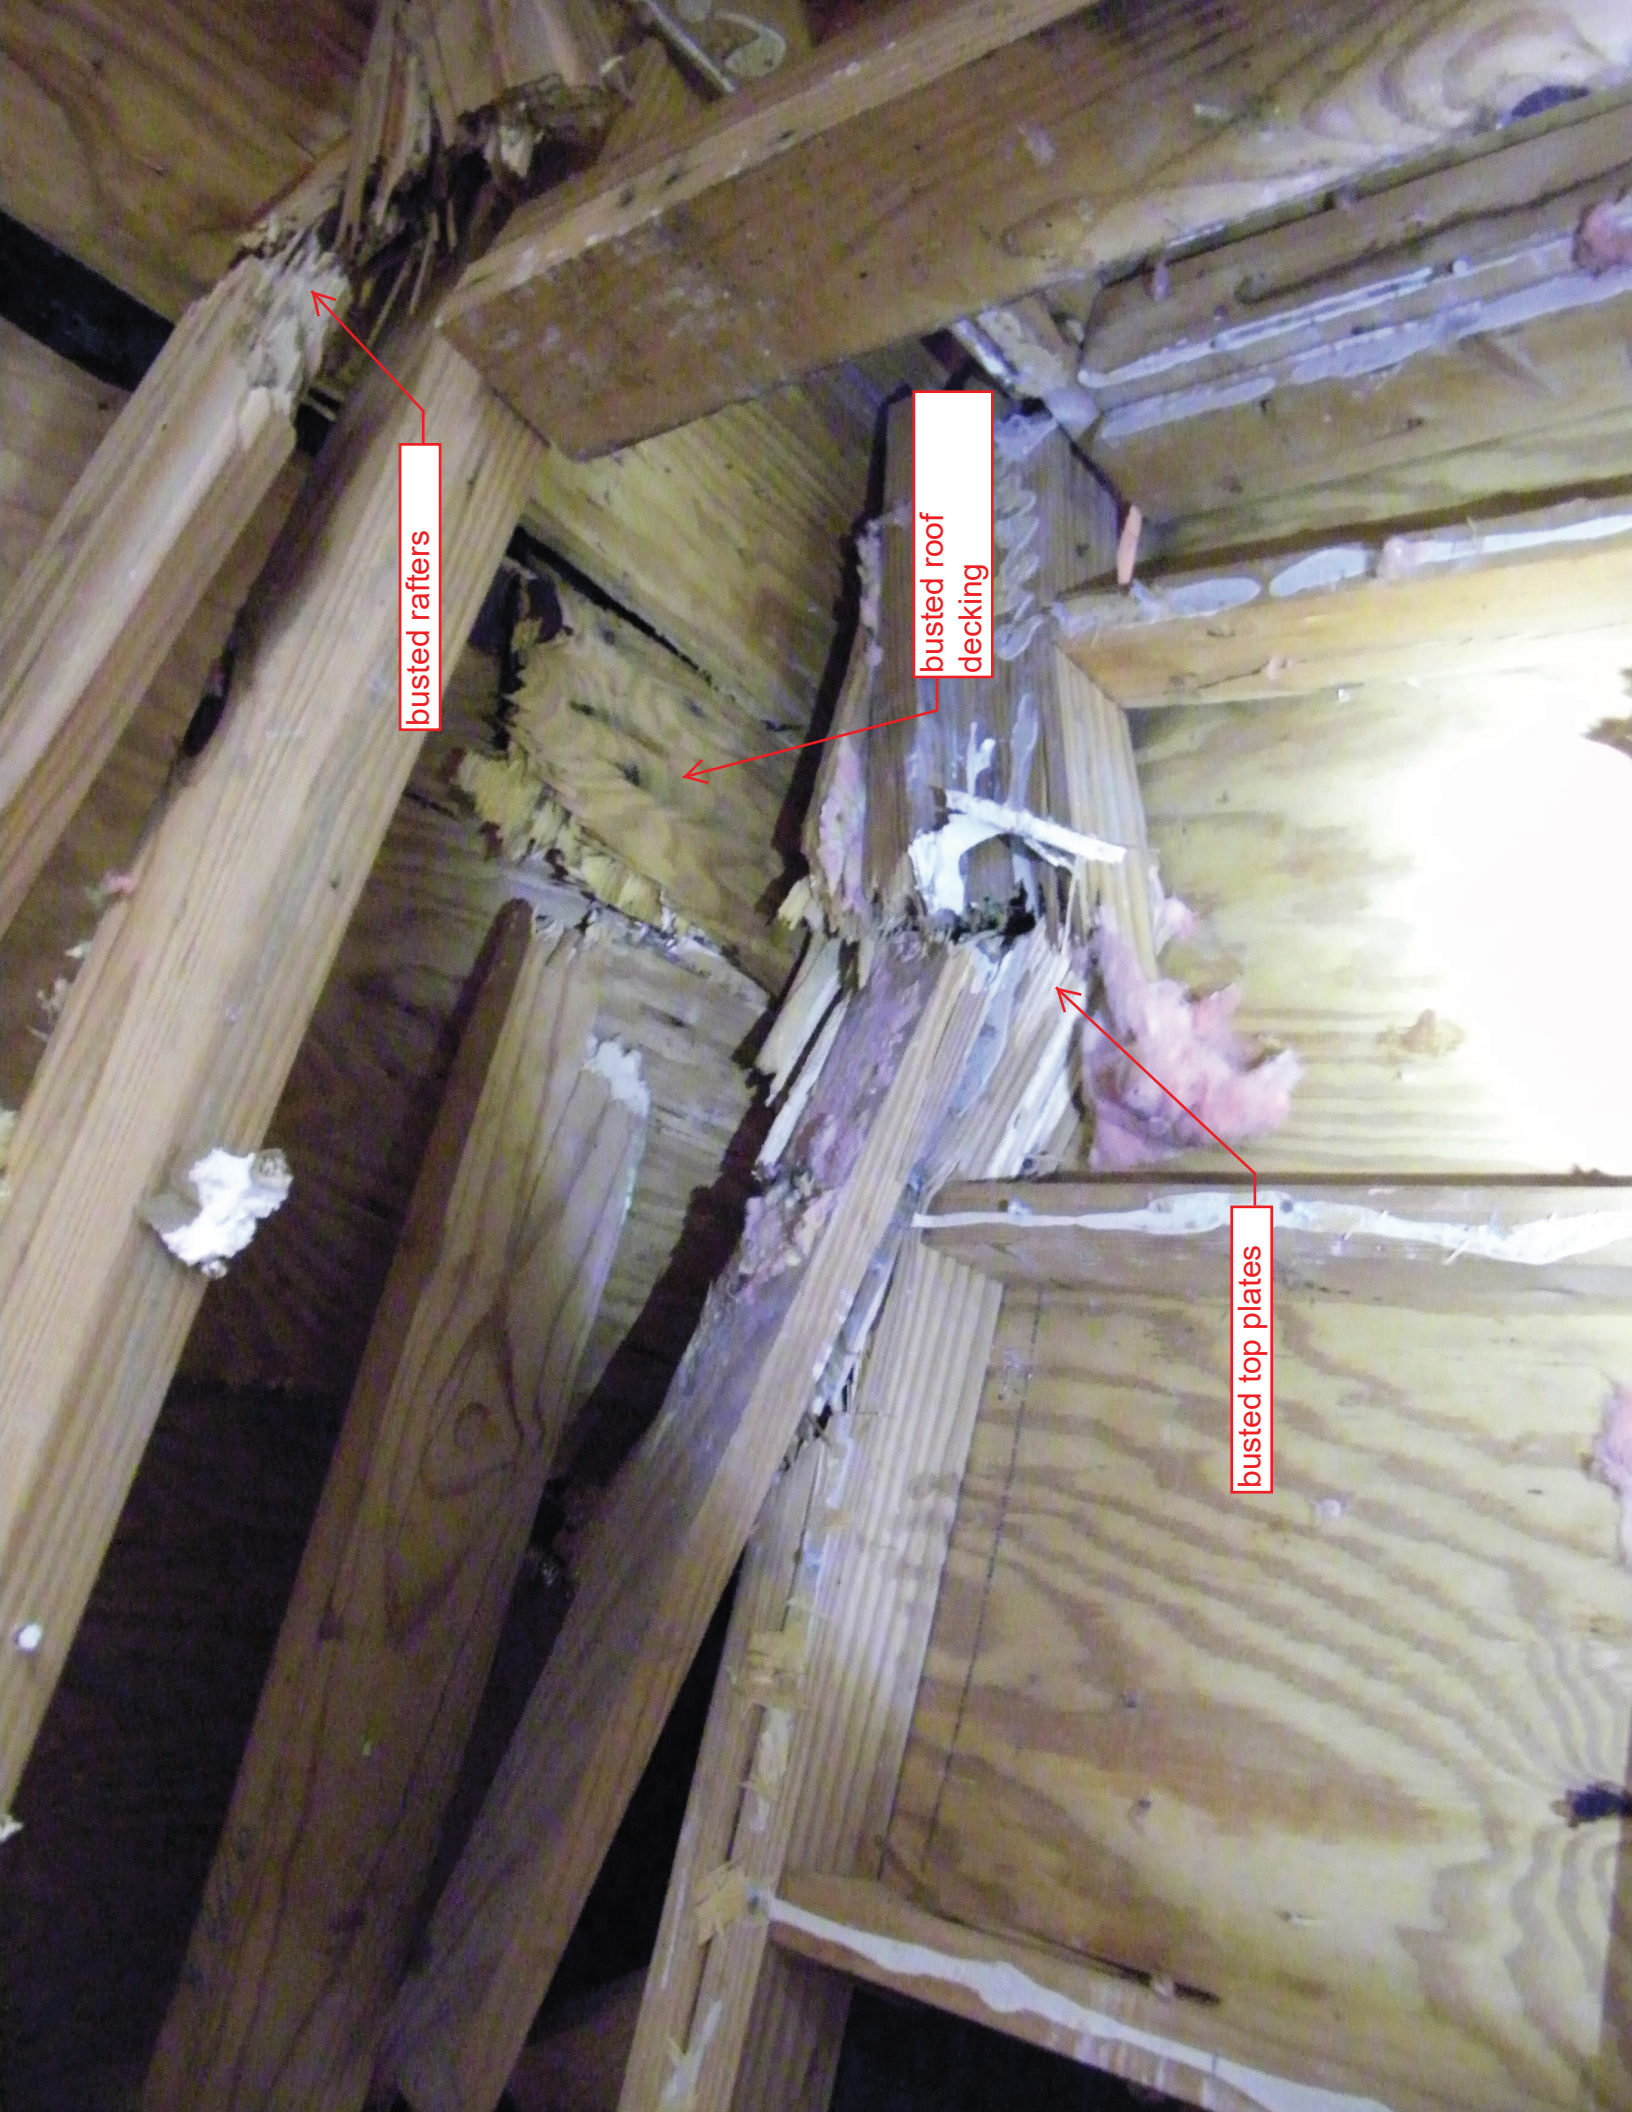
busted rafters

busted roof decking

busted top plates

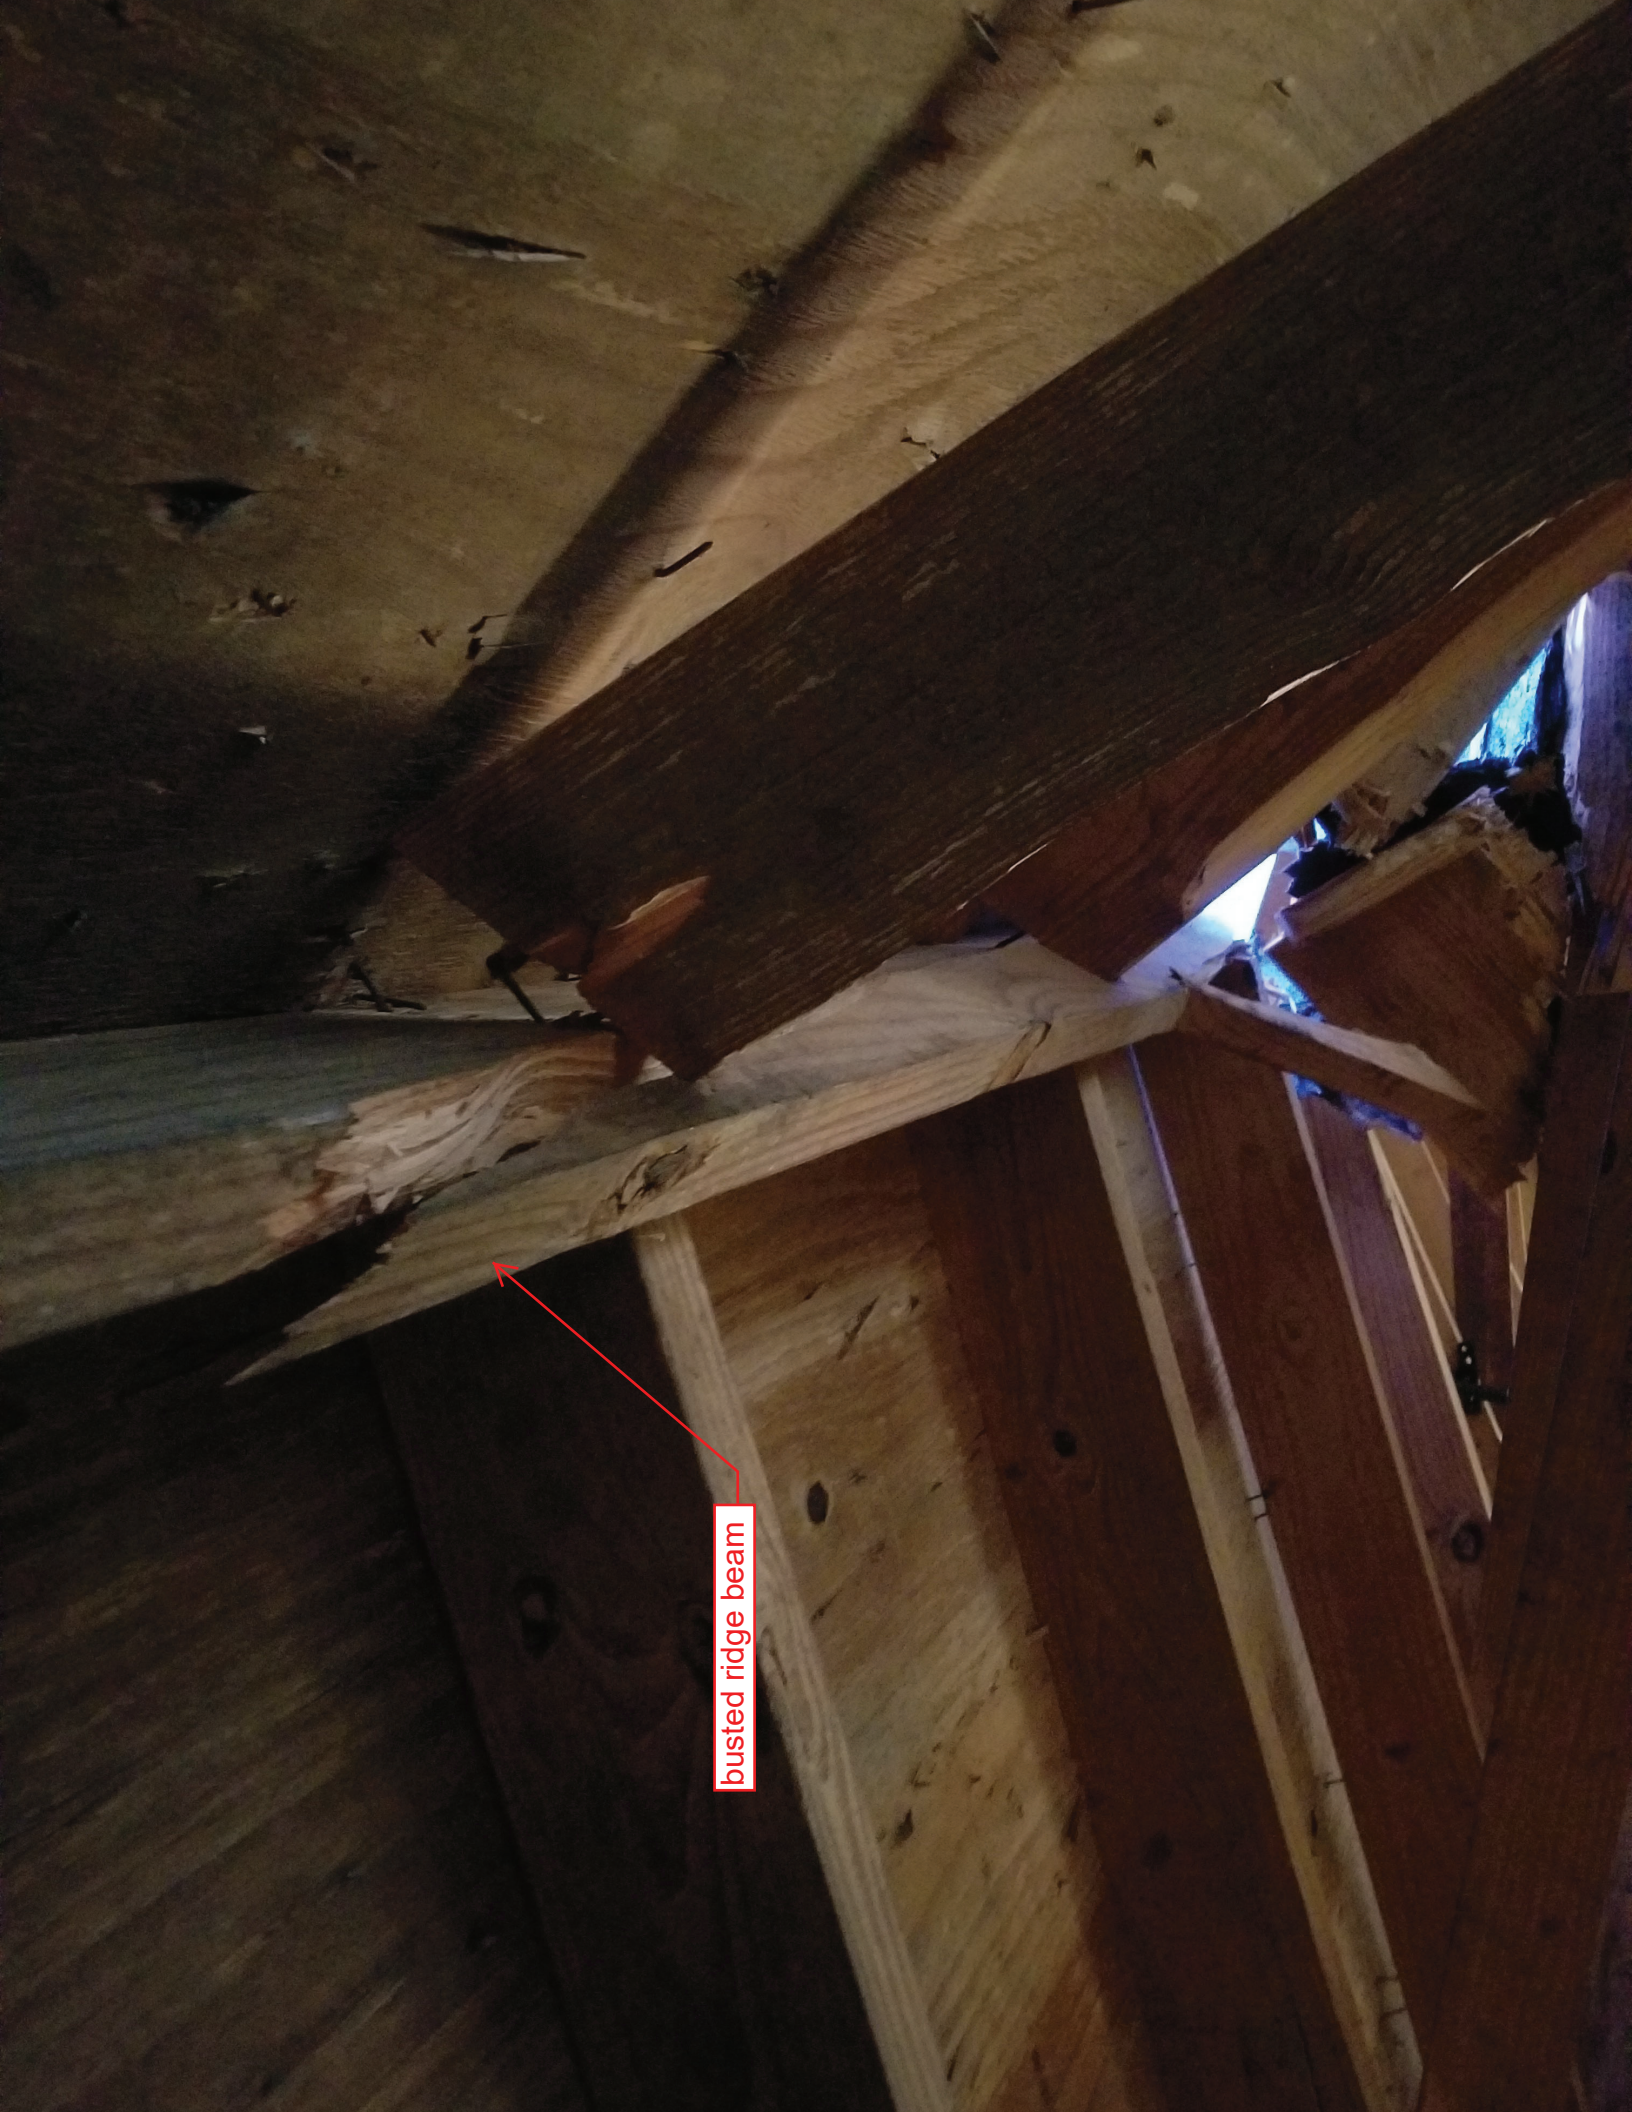
busted ridge beam

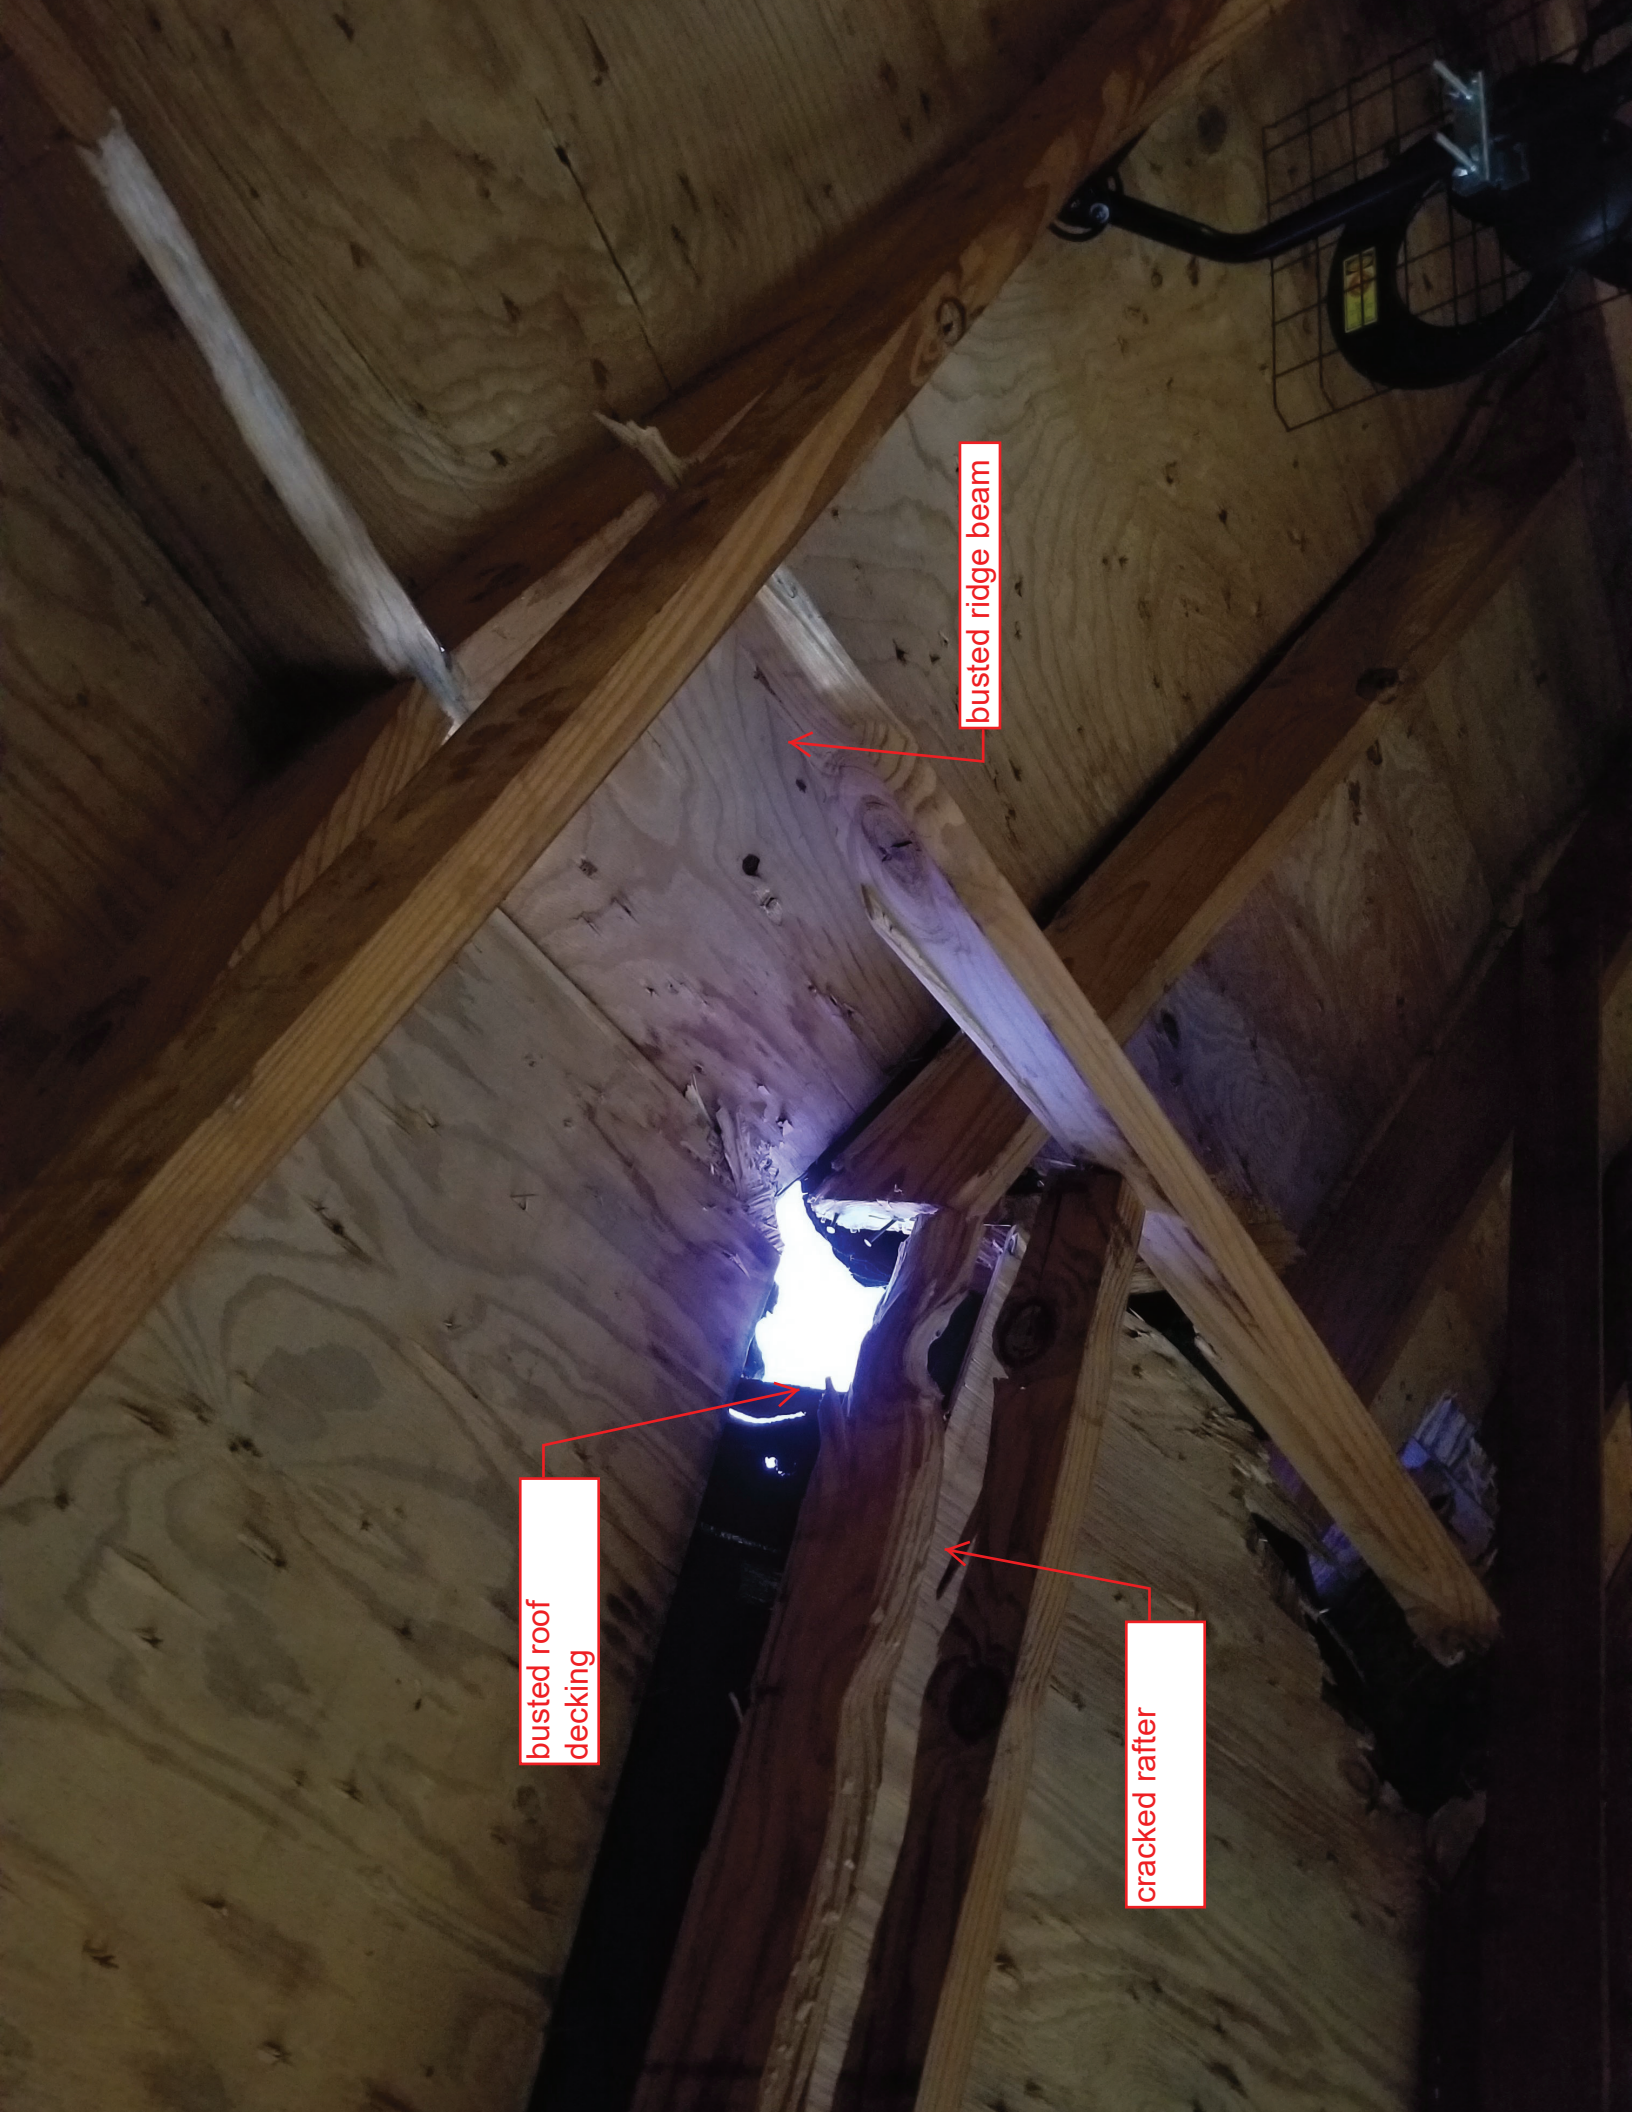
busted ridge beam

busted roof decking

cracked rafter

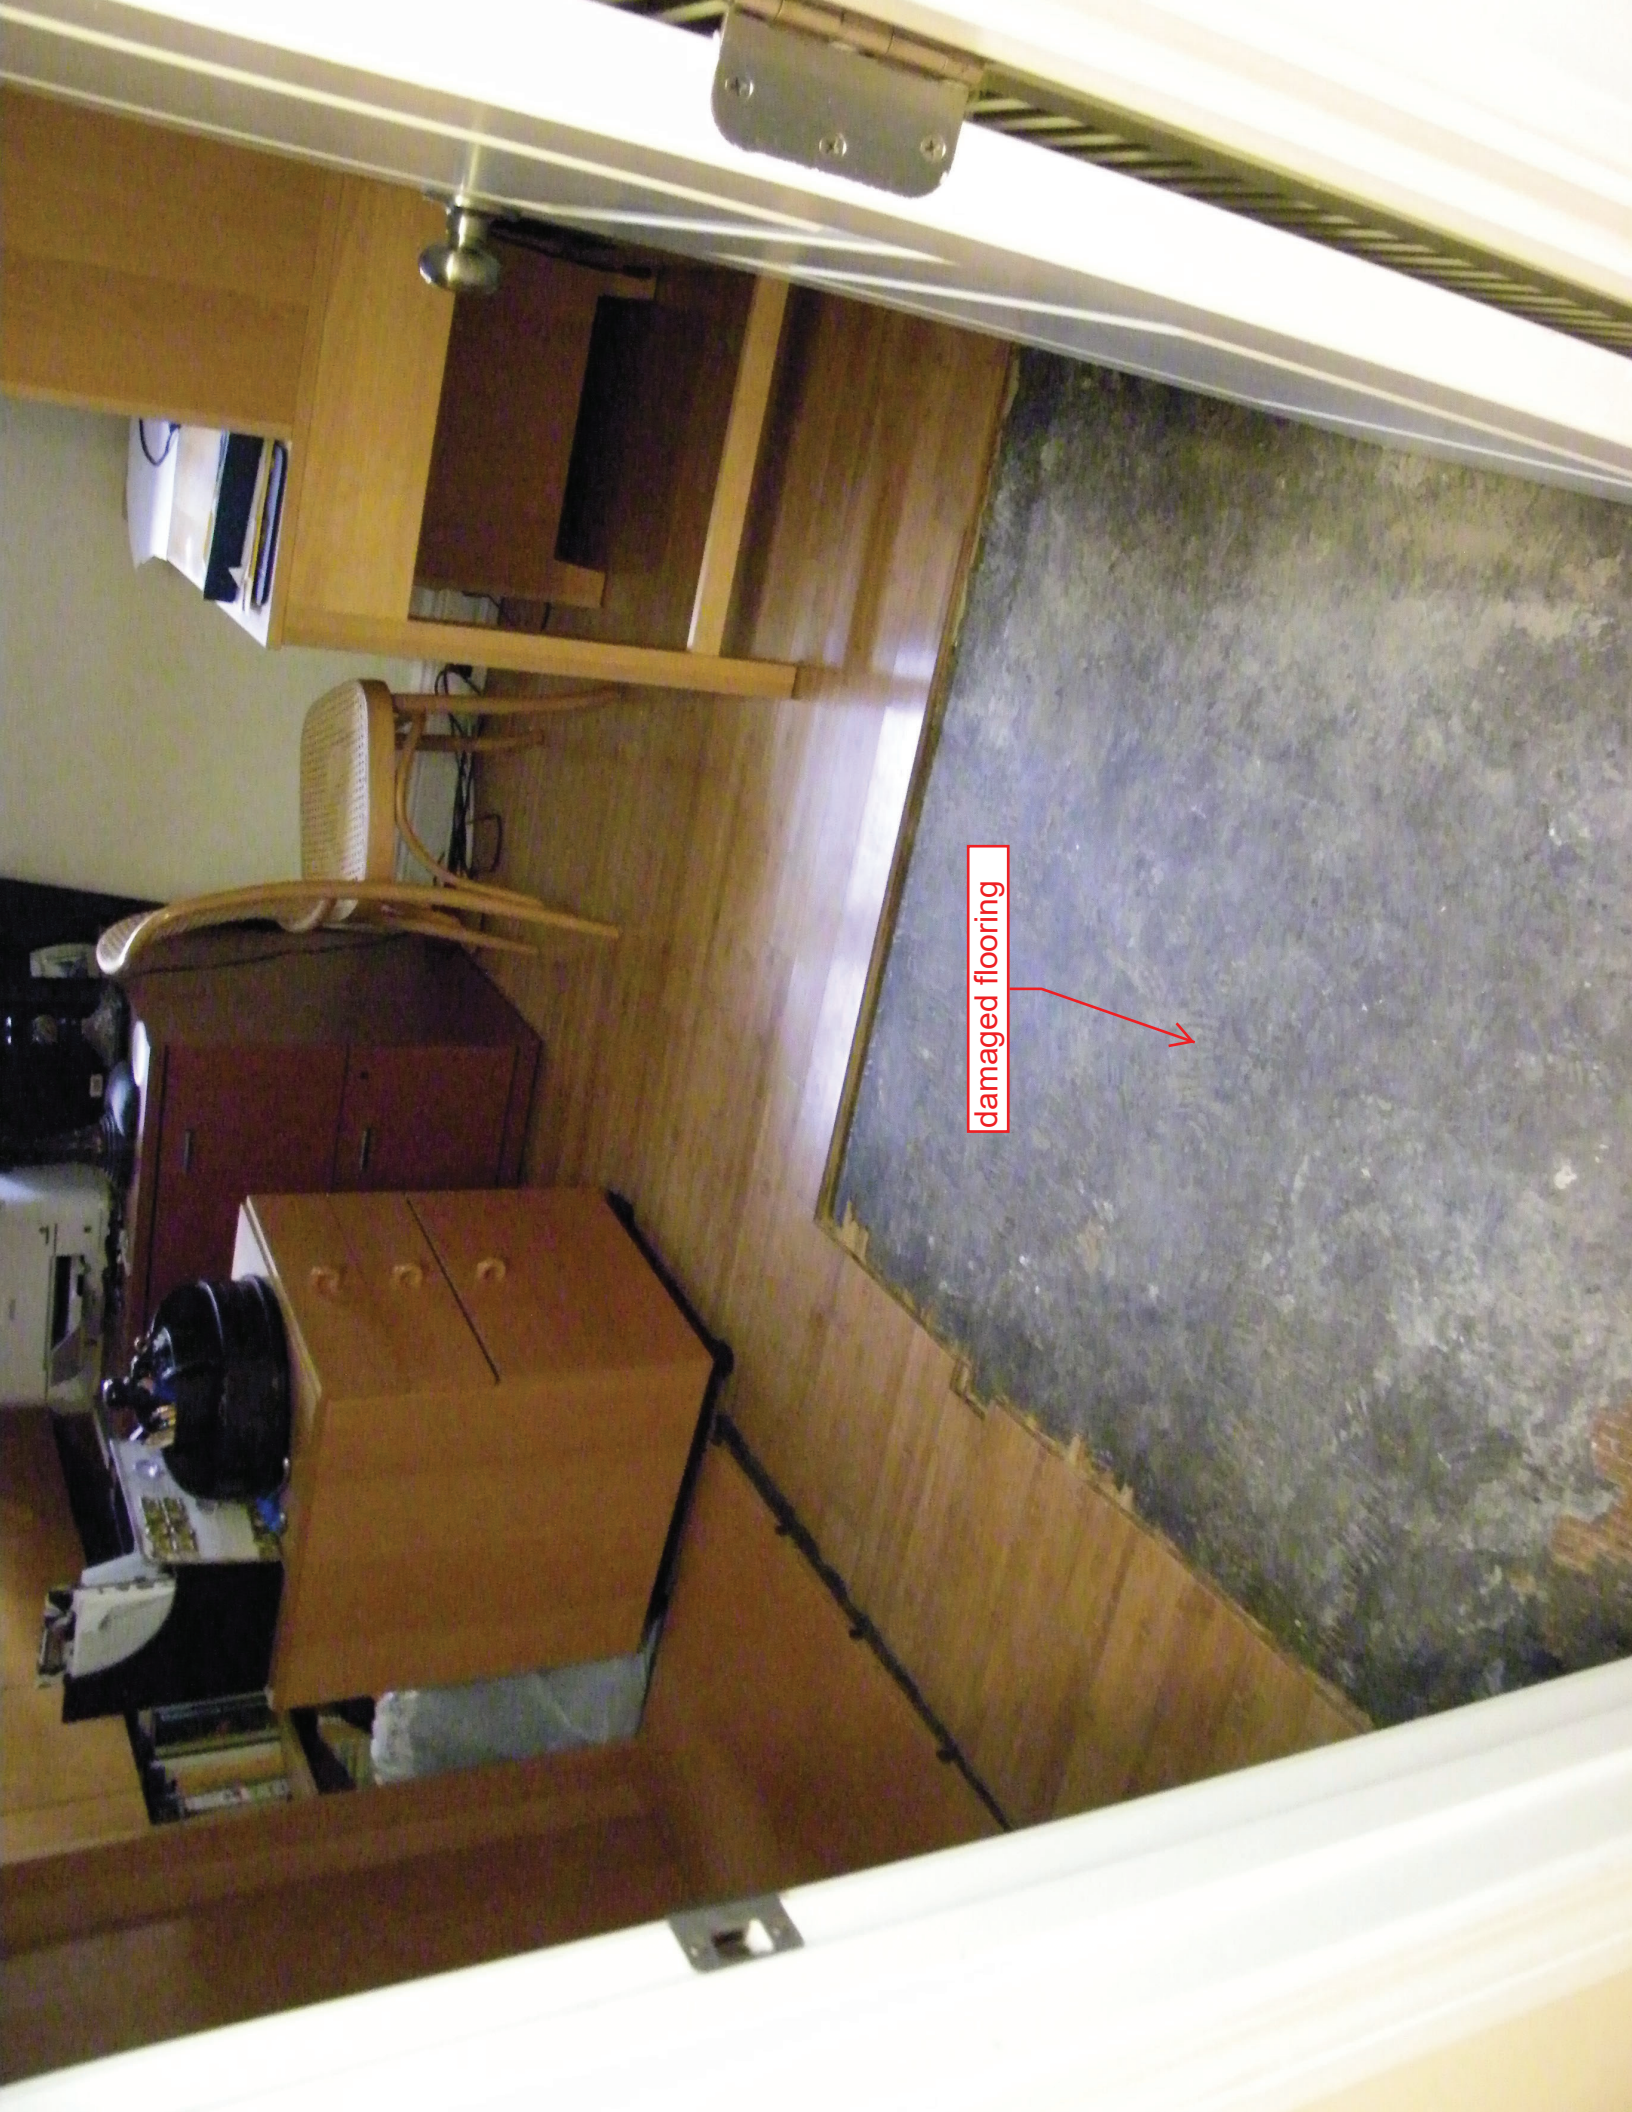
damaged flooring

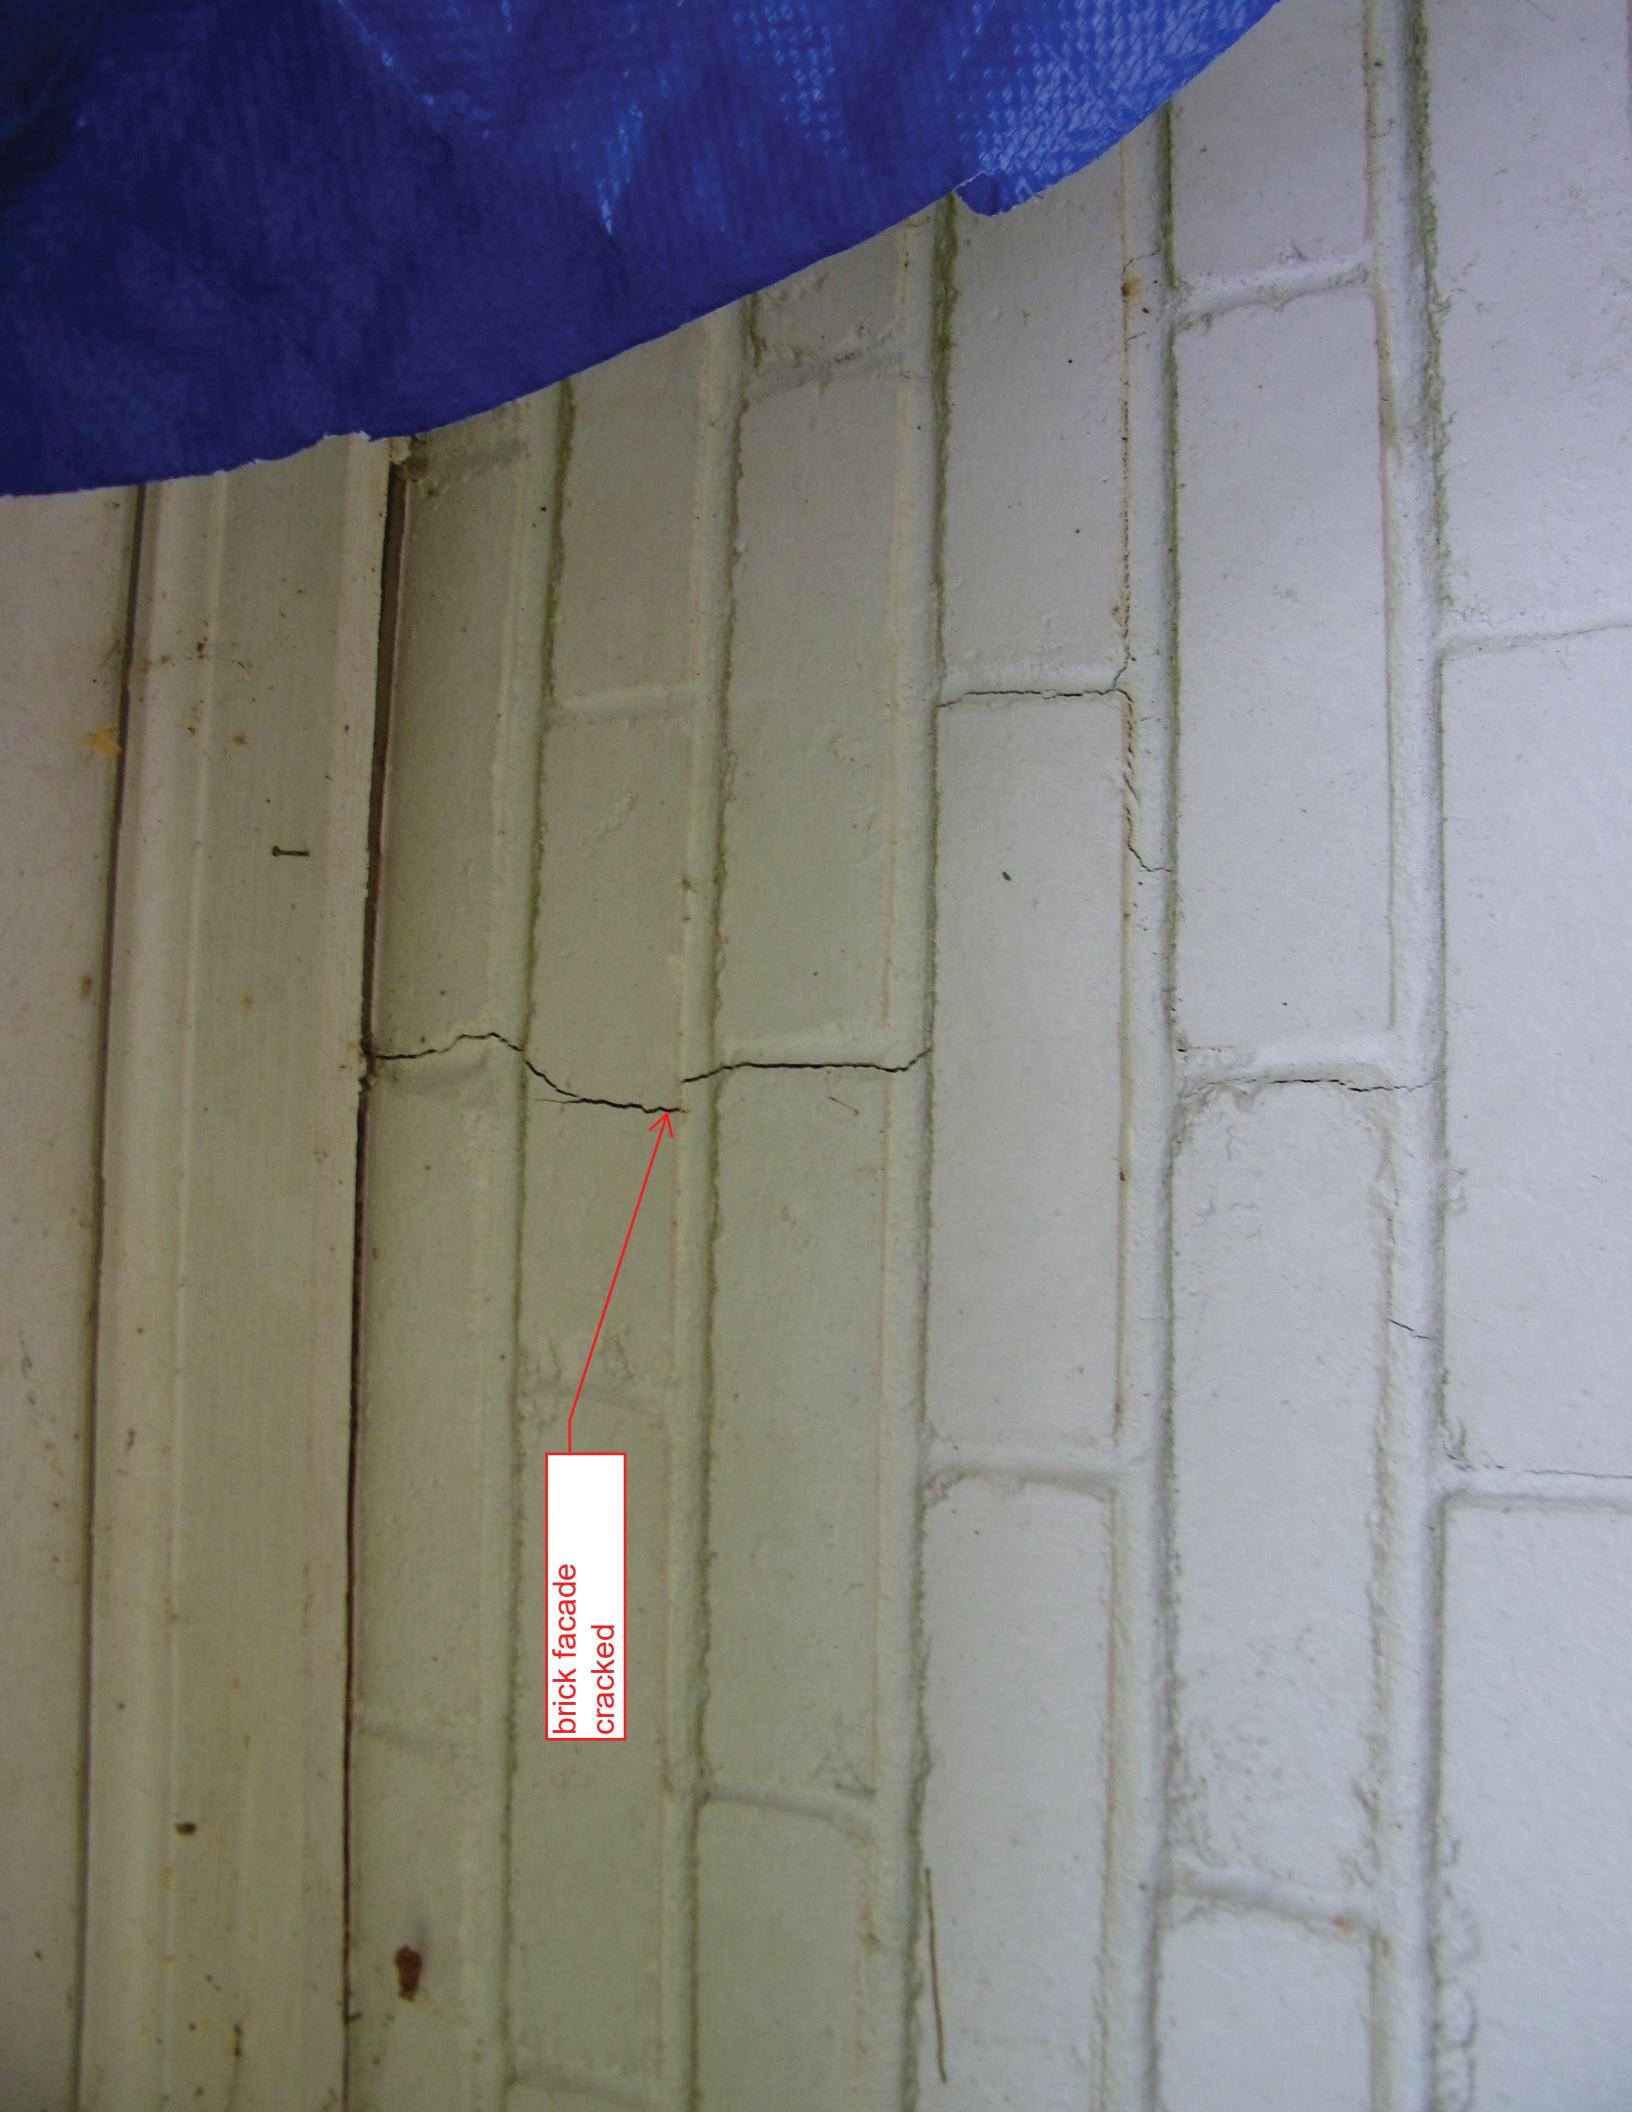
brick facade
cracked

horizontal and vertical cracks in Sheetrock

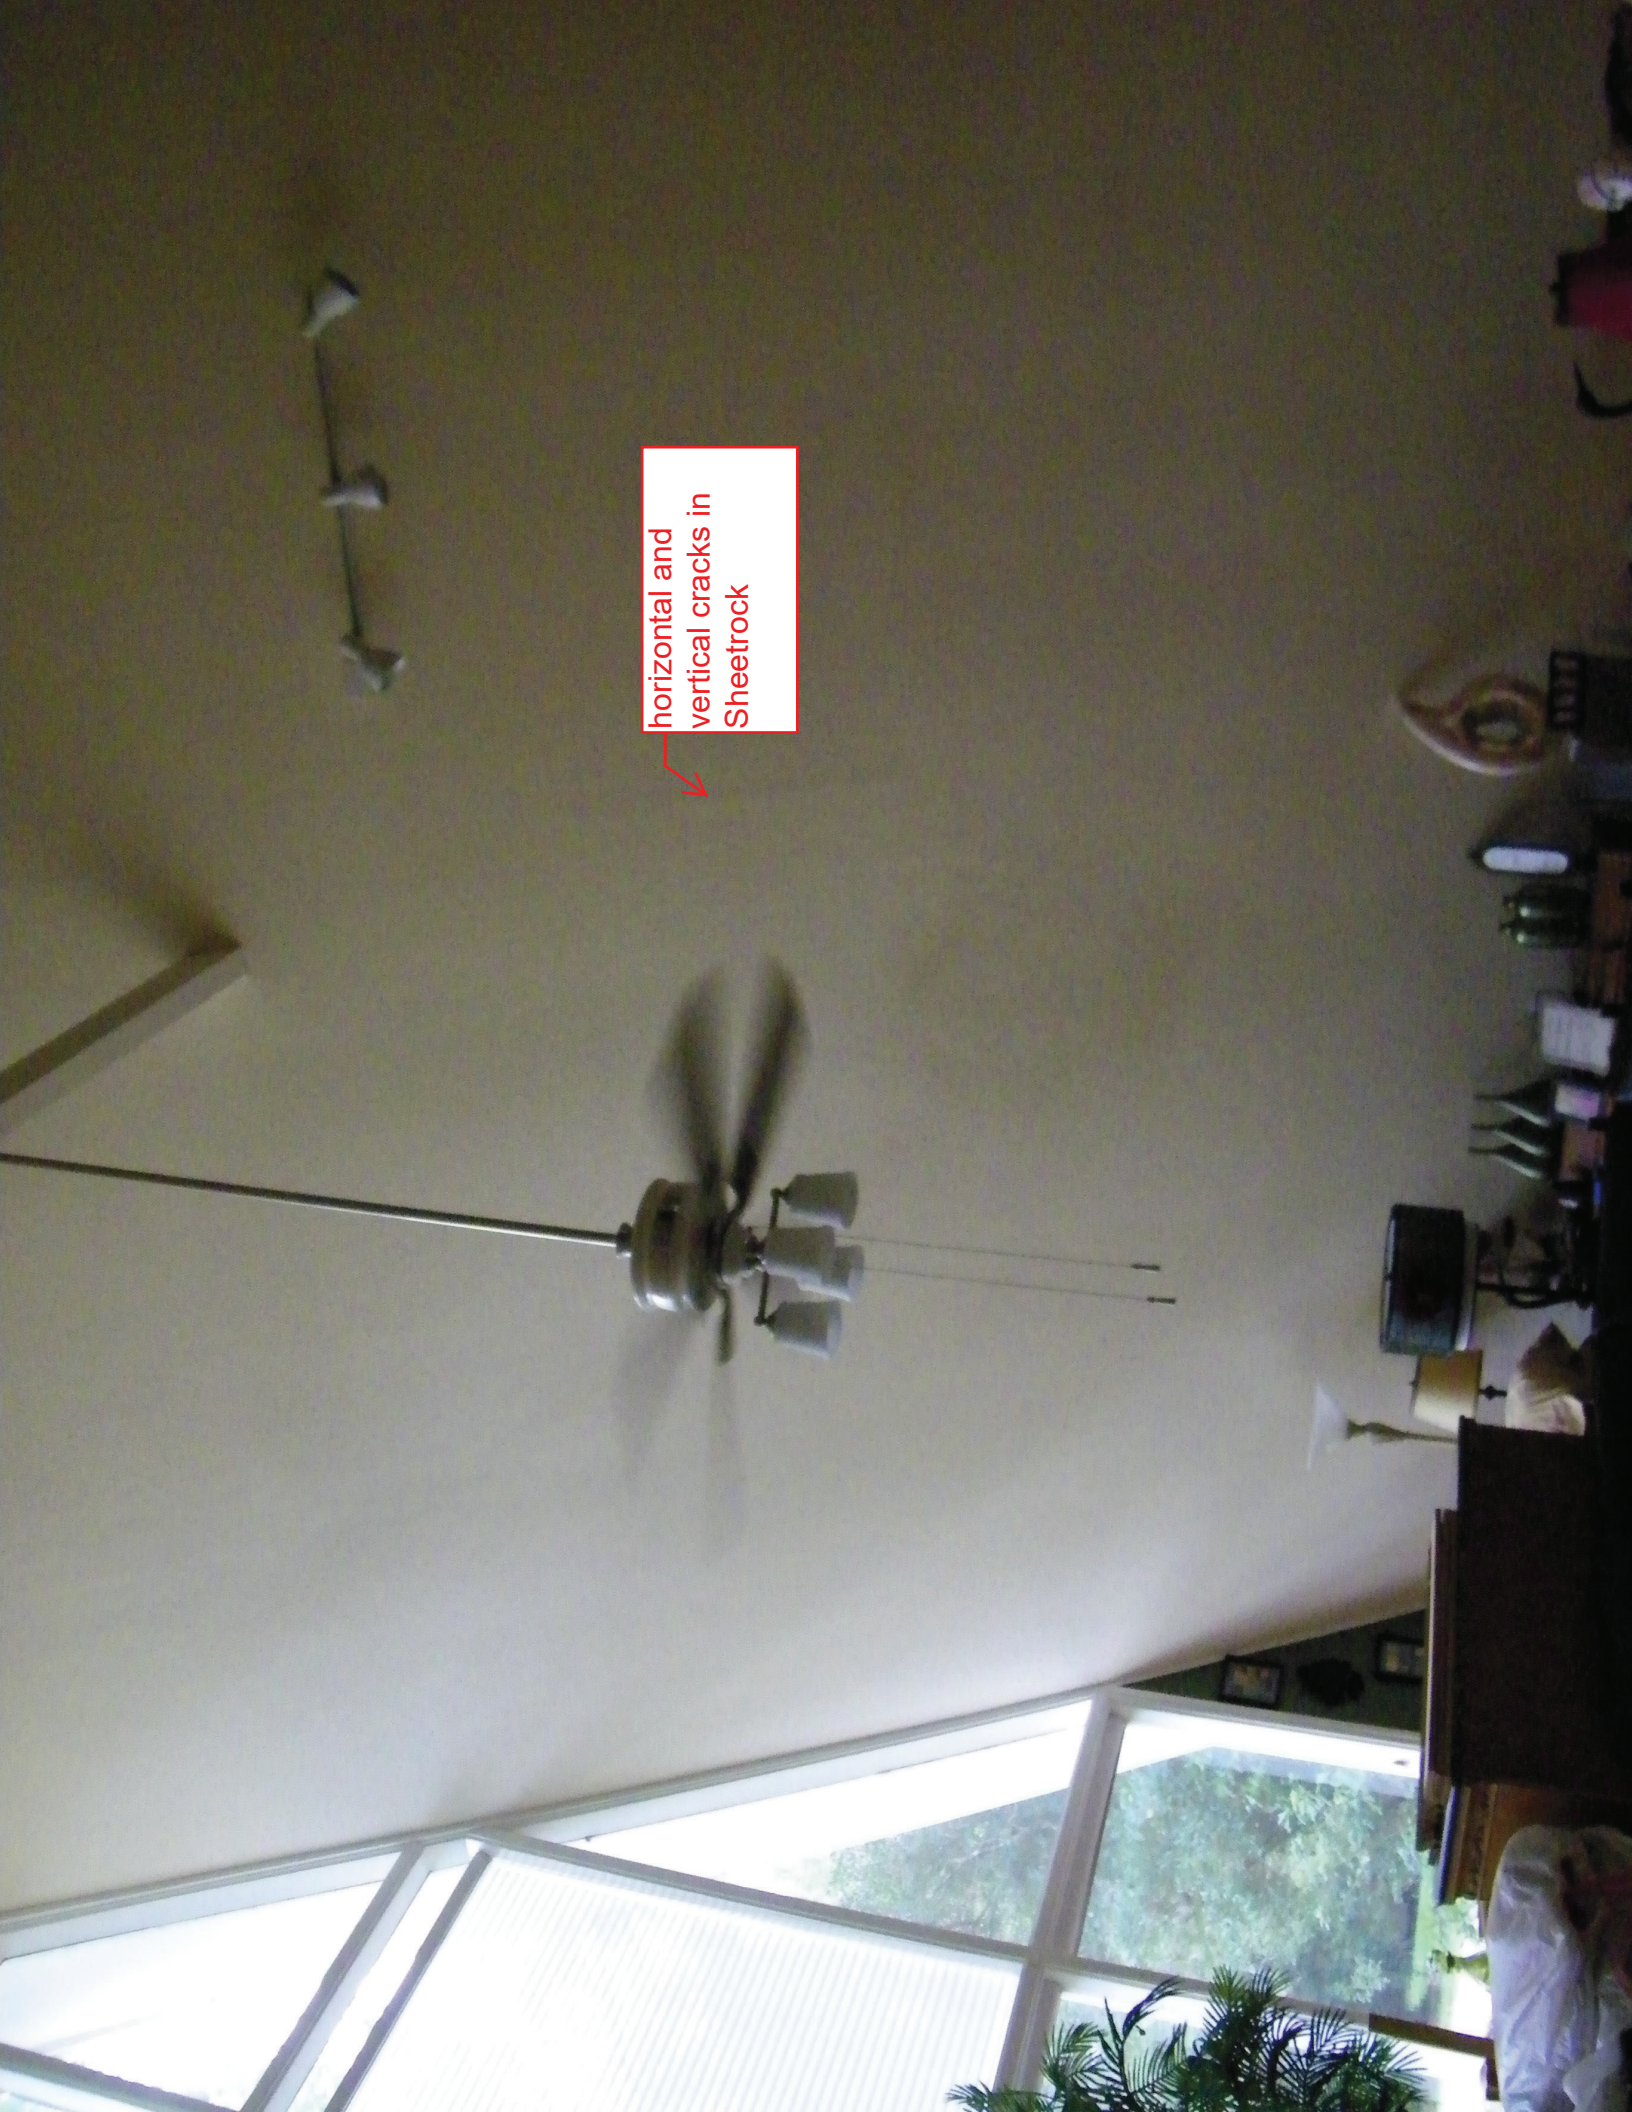
horizontal cracks in
sheetrock
