Structural Inspection

November 23, 2020

Ref: 6627 W Laverne St.
New Orleans, La. 70126

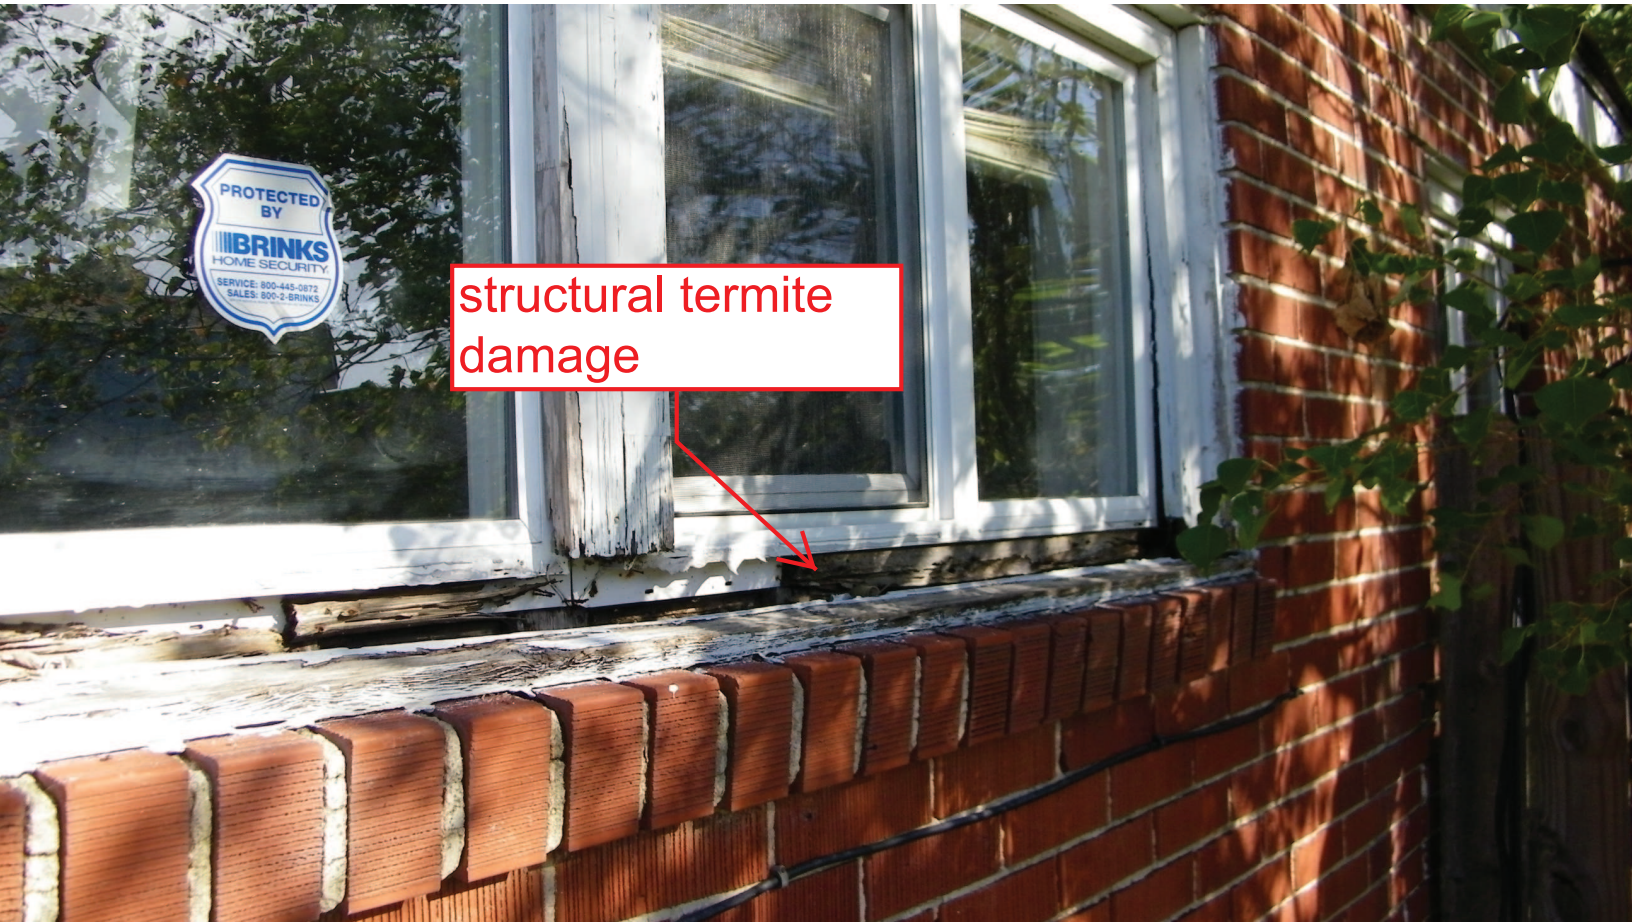
structural termite
damage

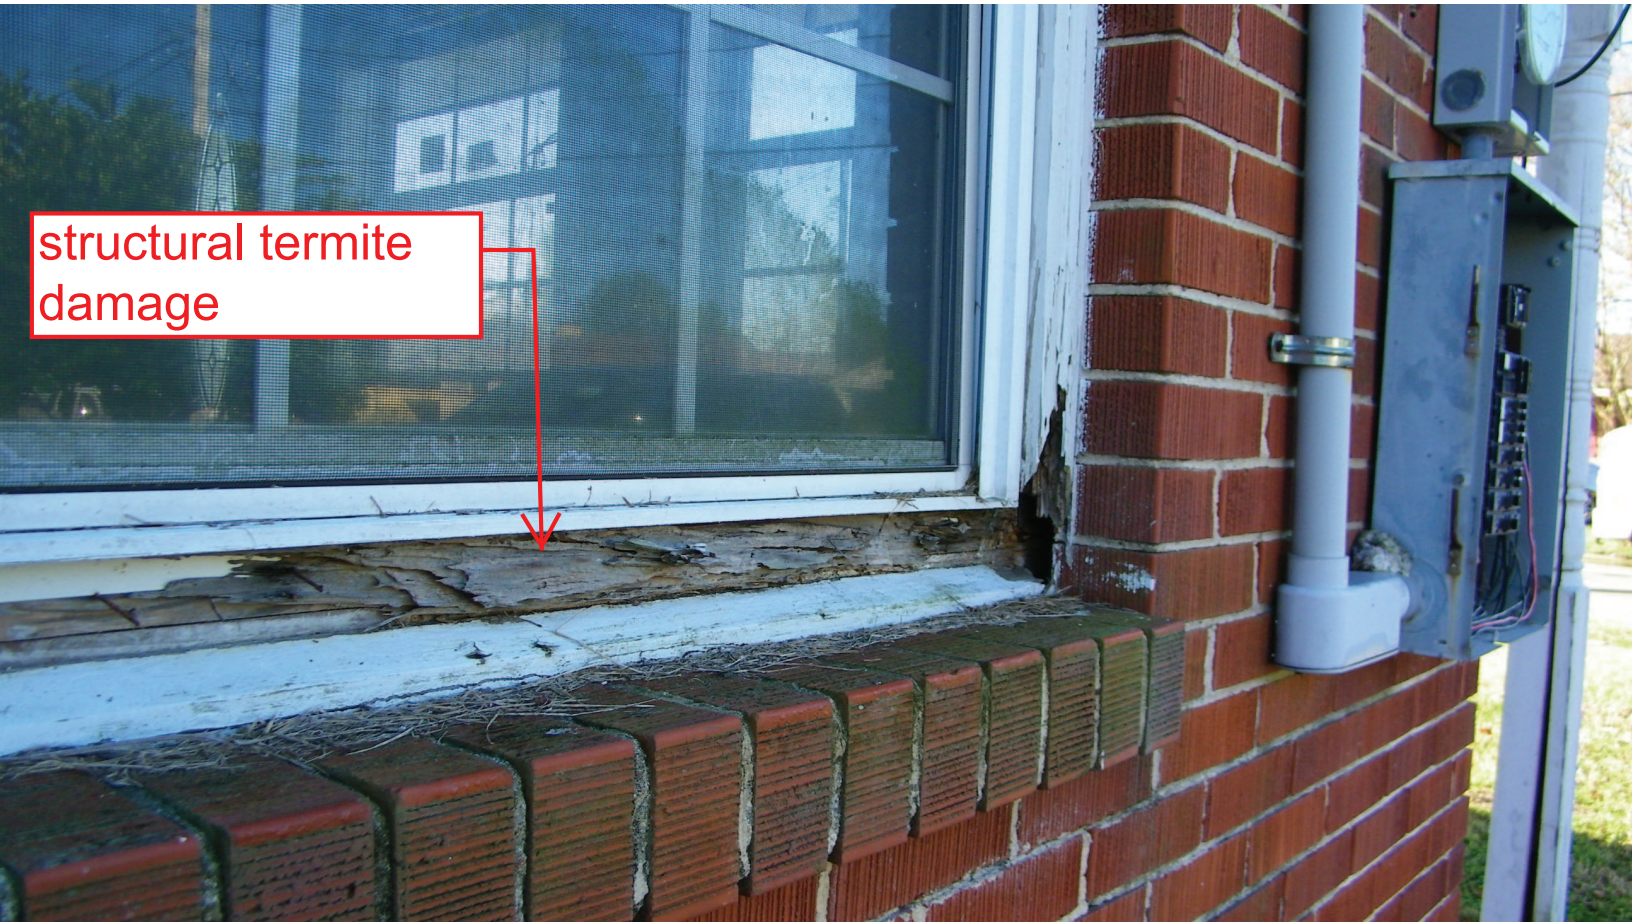
structural termite damage

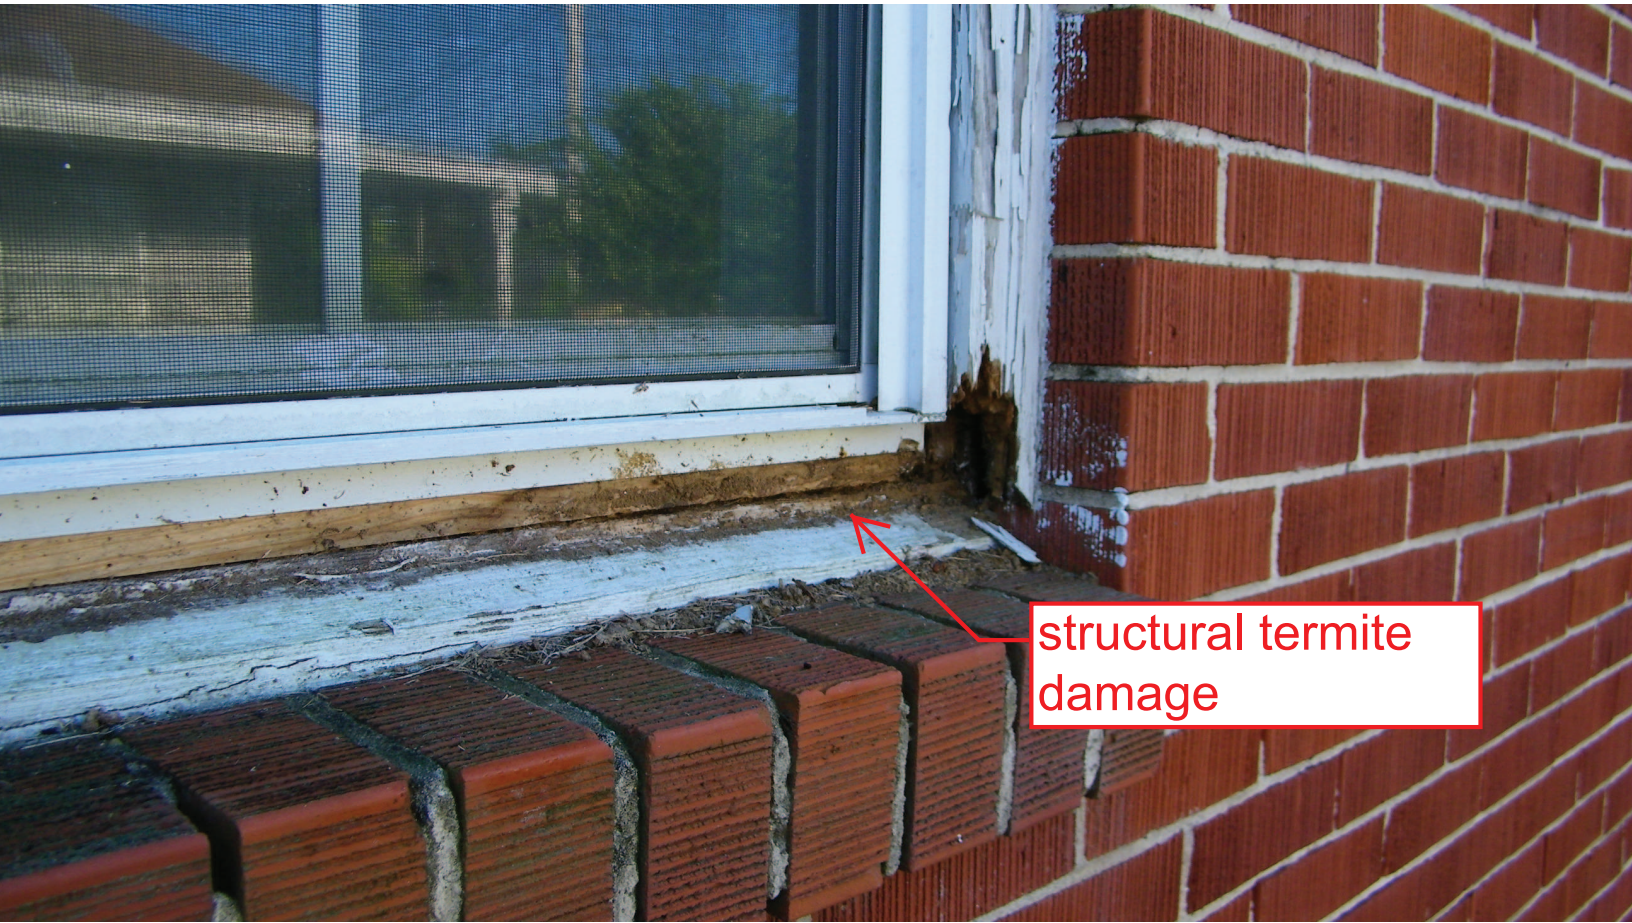
structural termite damage

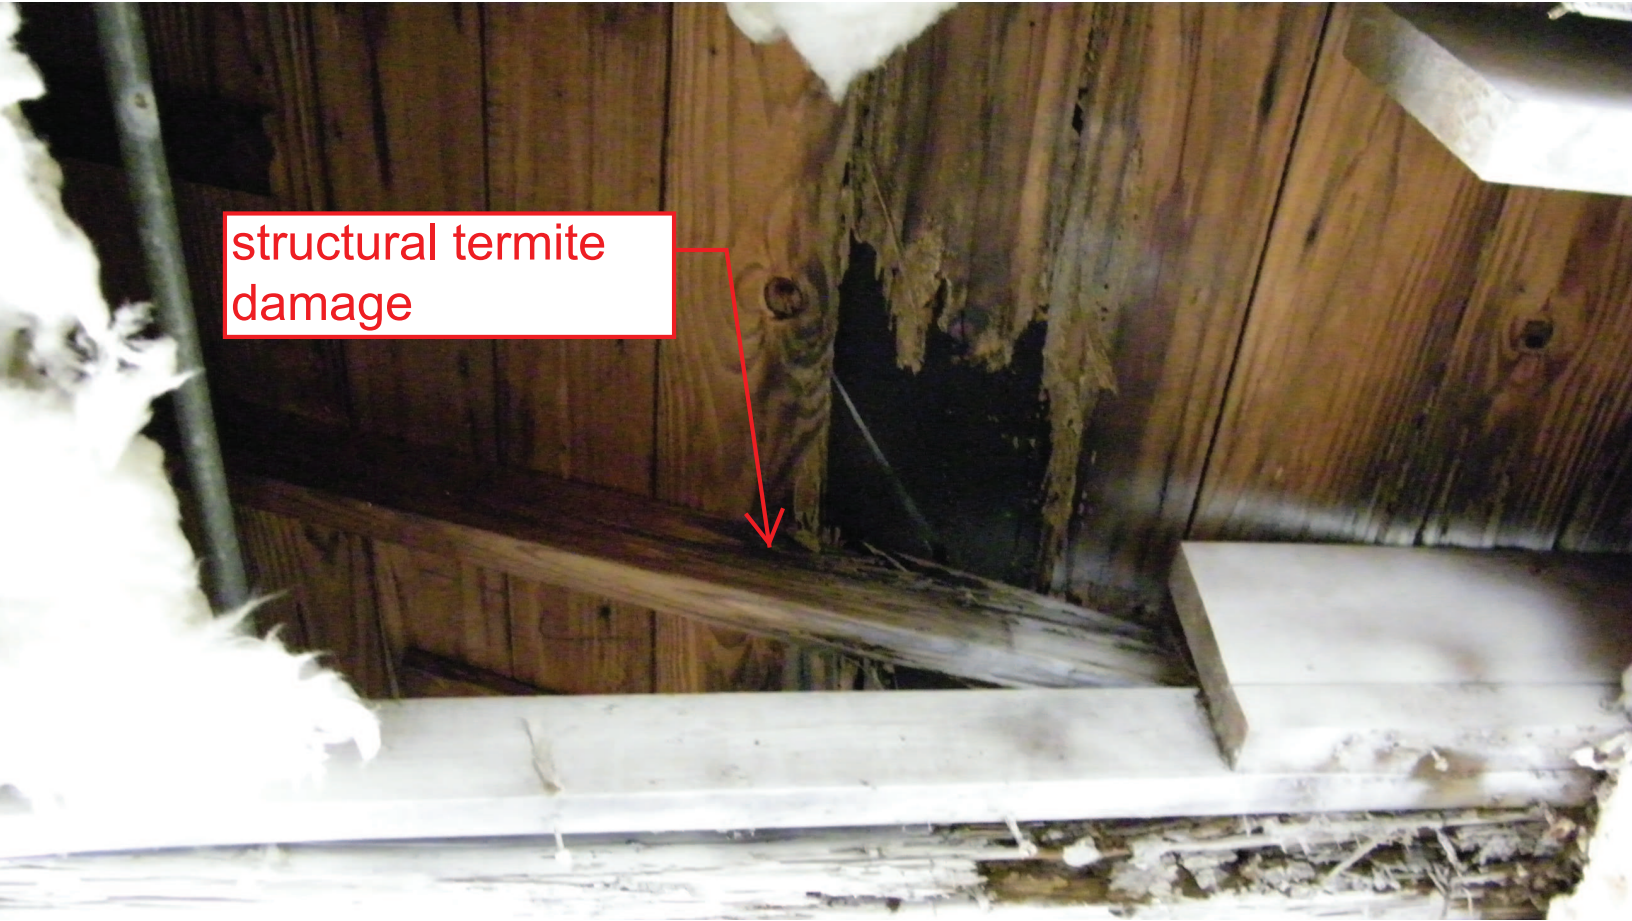
structural termite damage

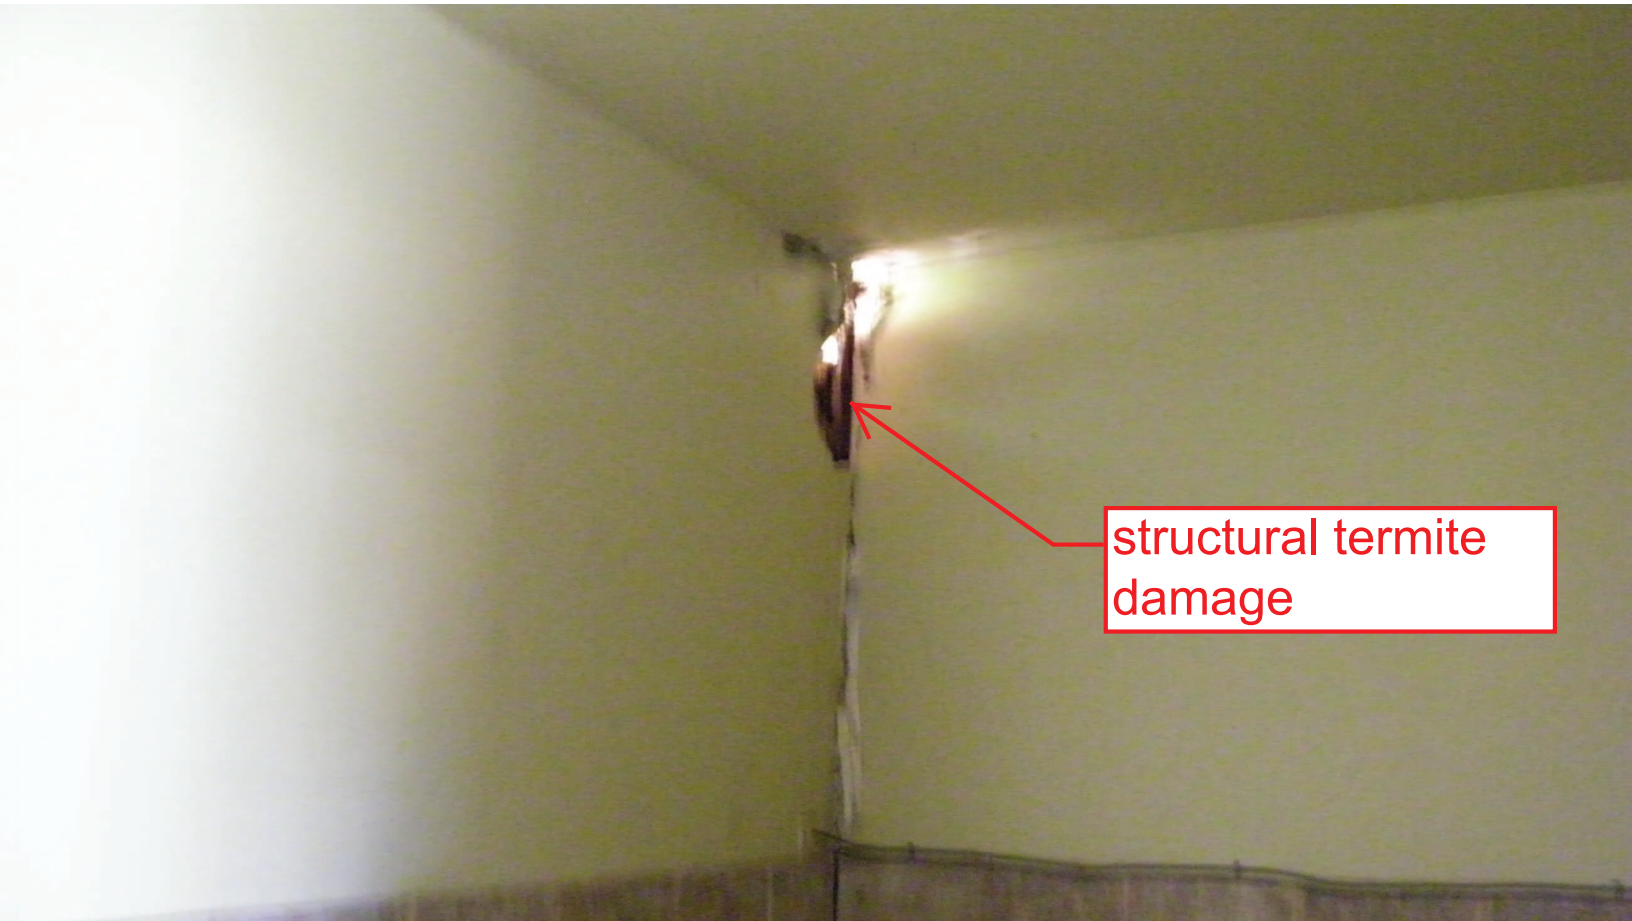
structural termite
damage

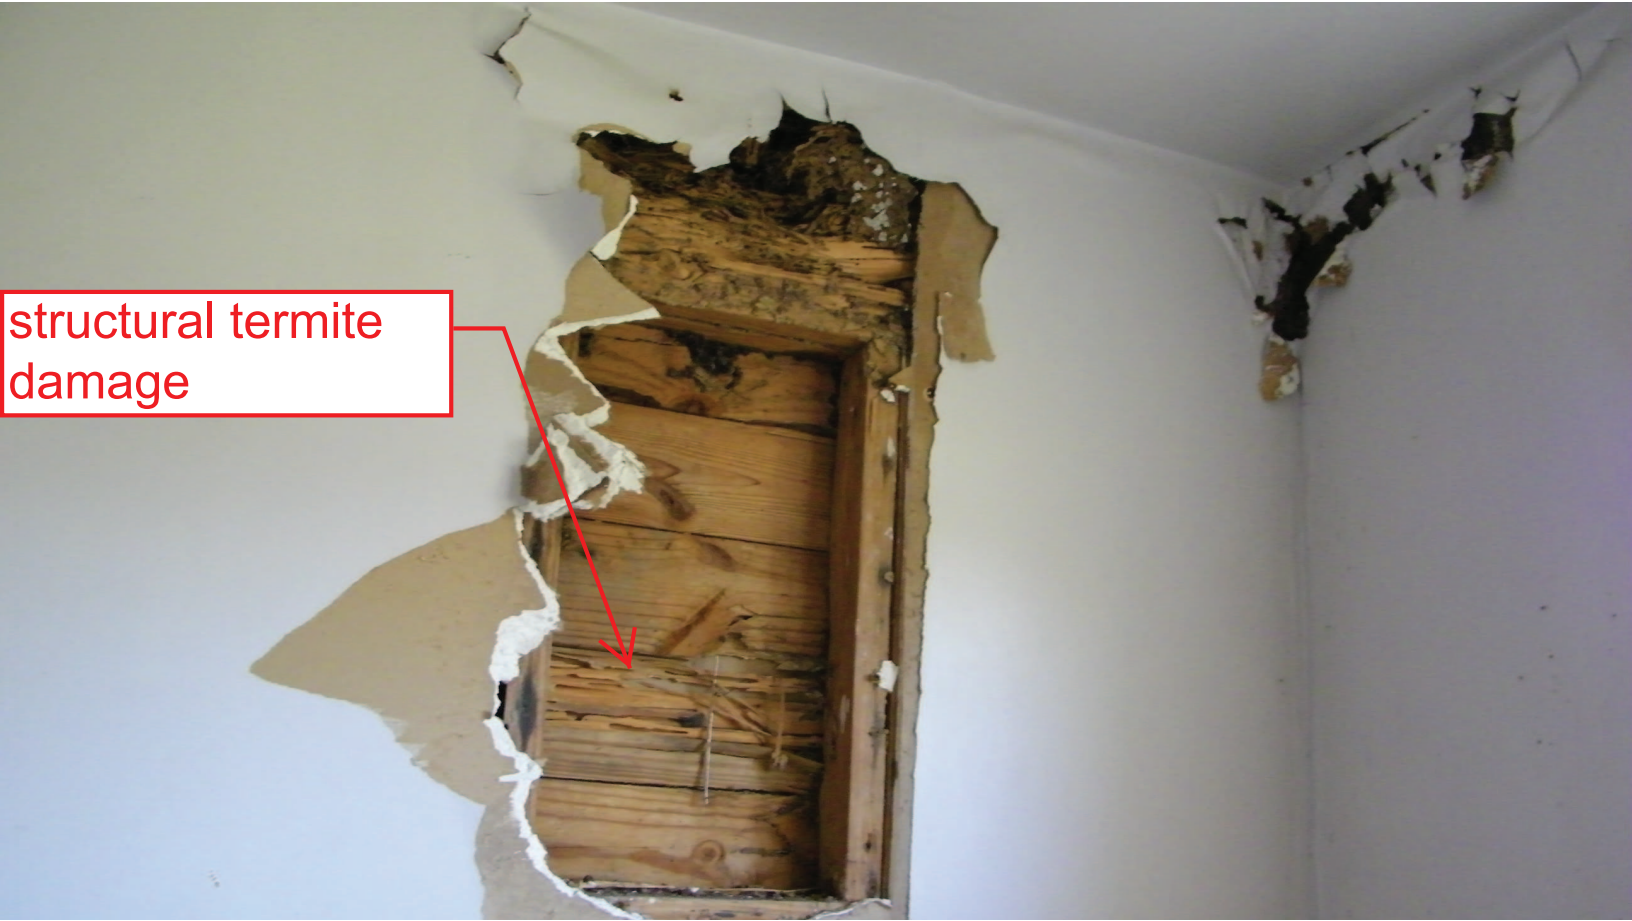
structural termite damage

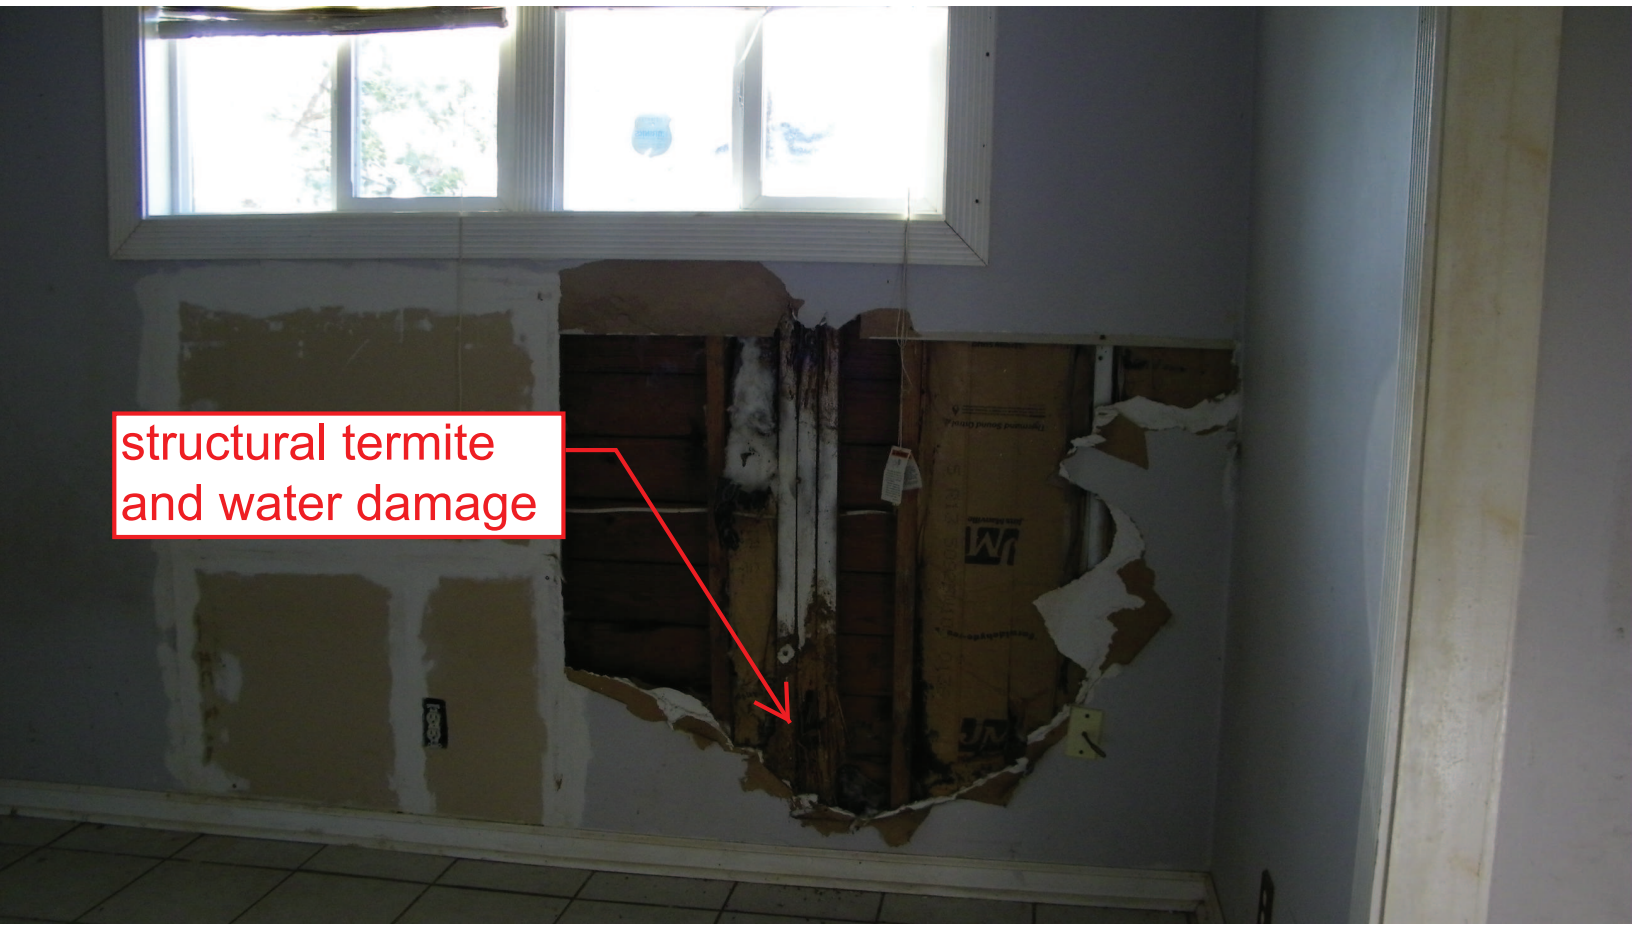
structural termite
and water damage

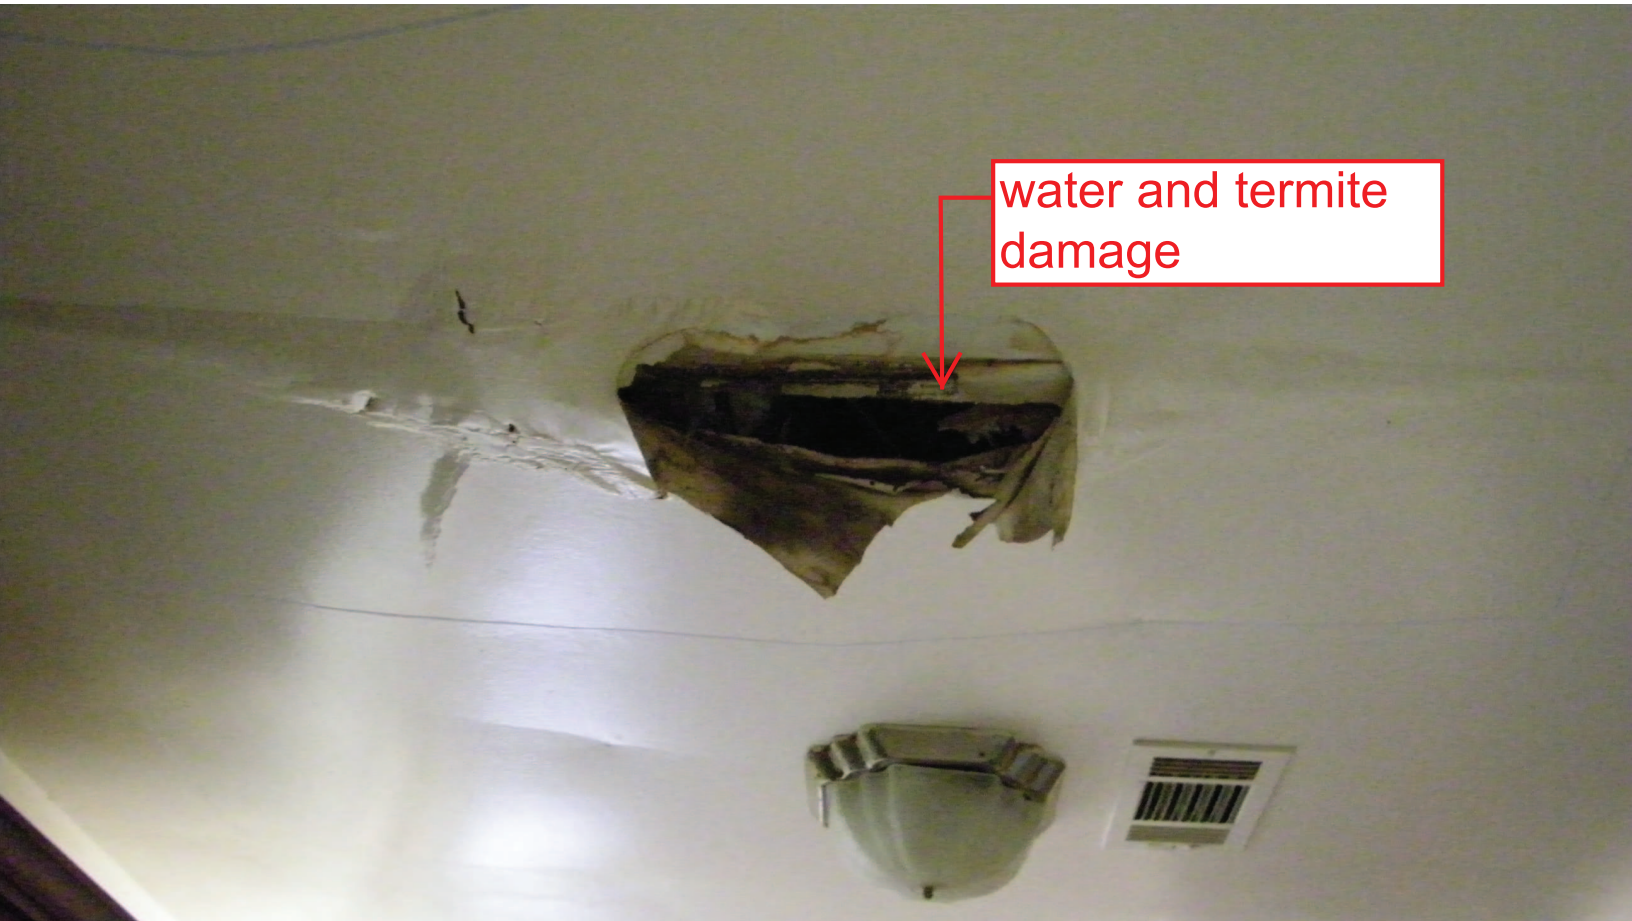
water and termite
damage

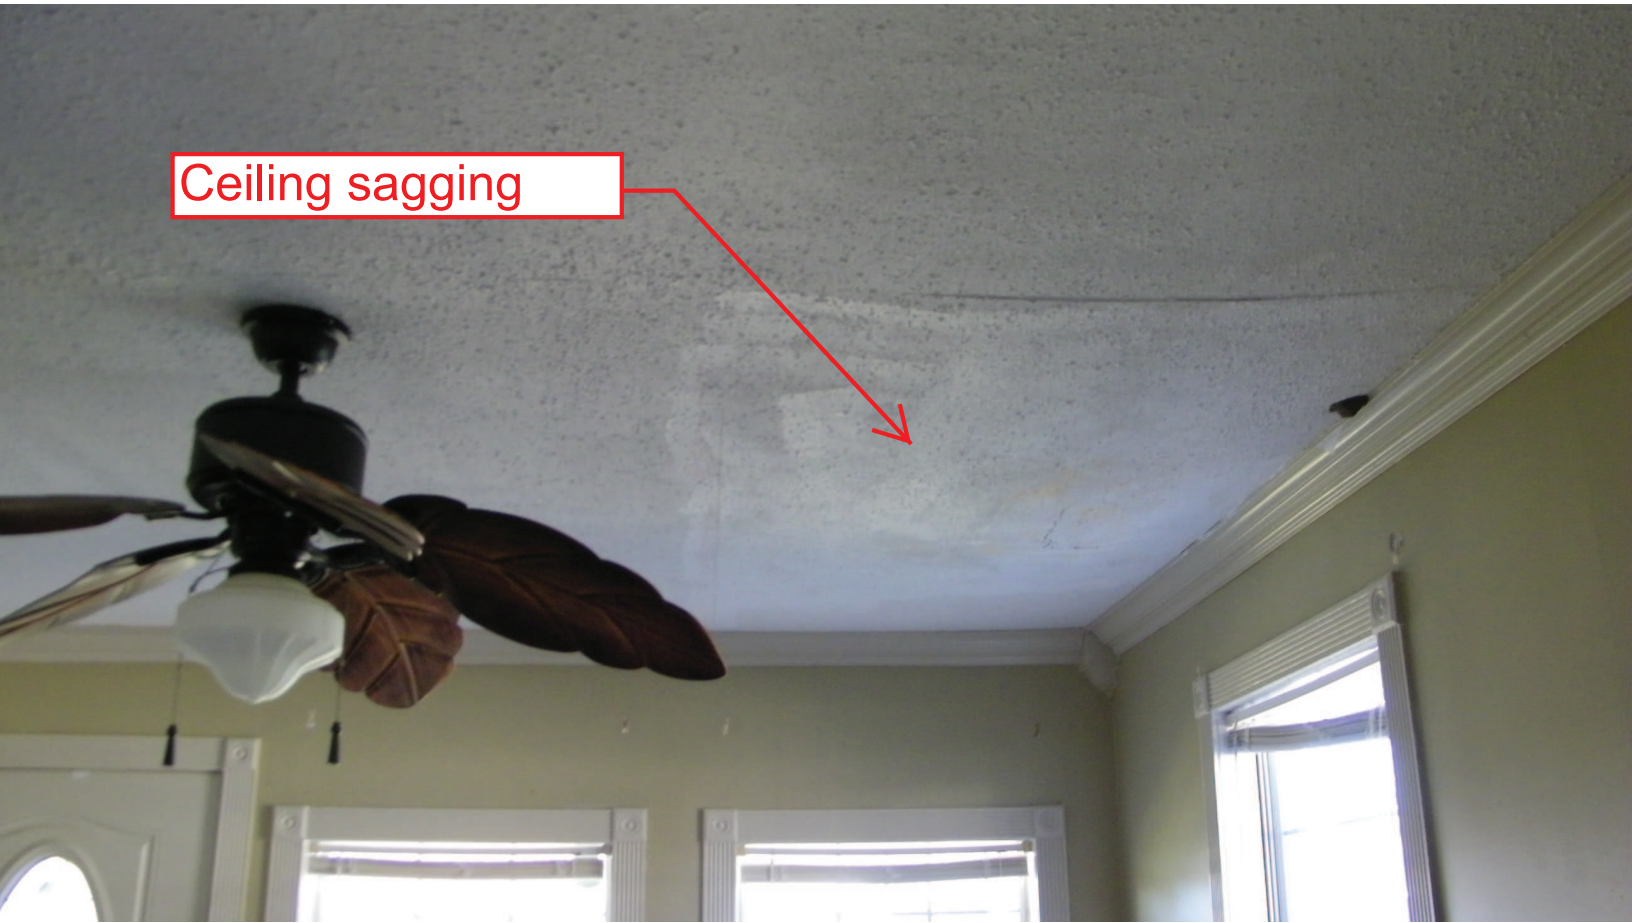
Ceiling sagging

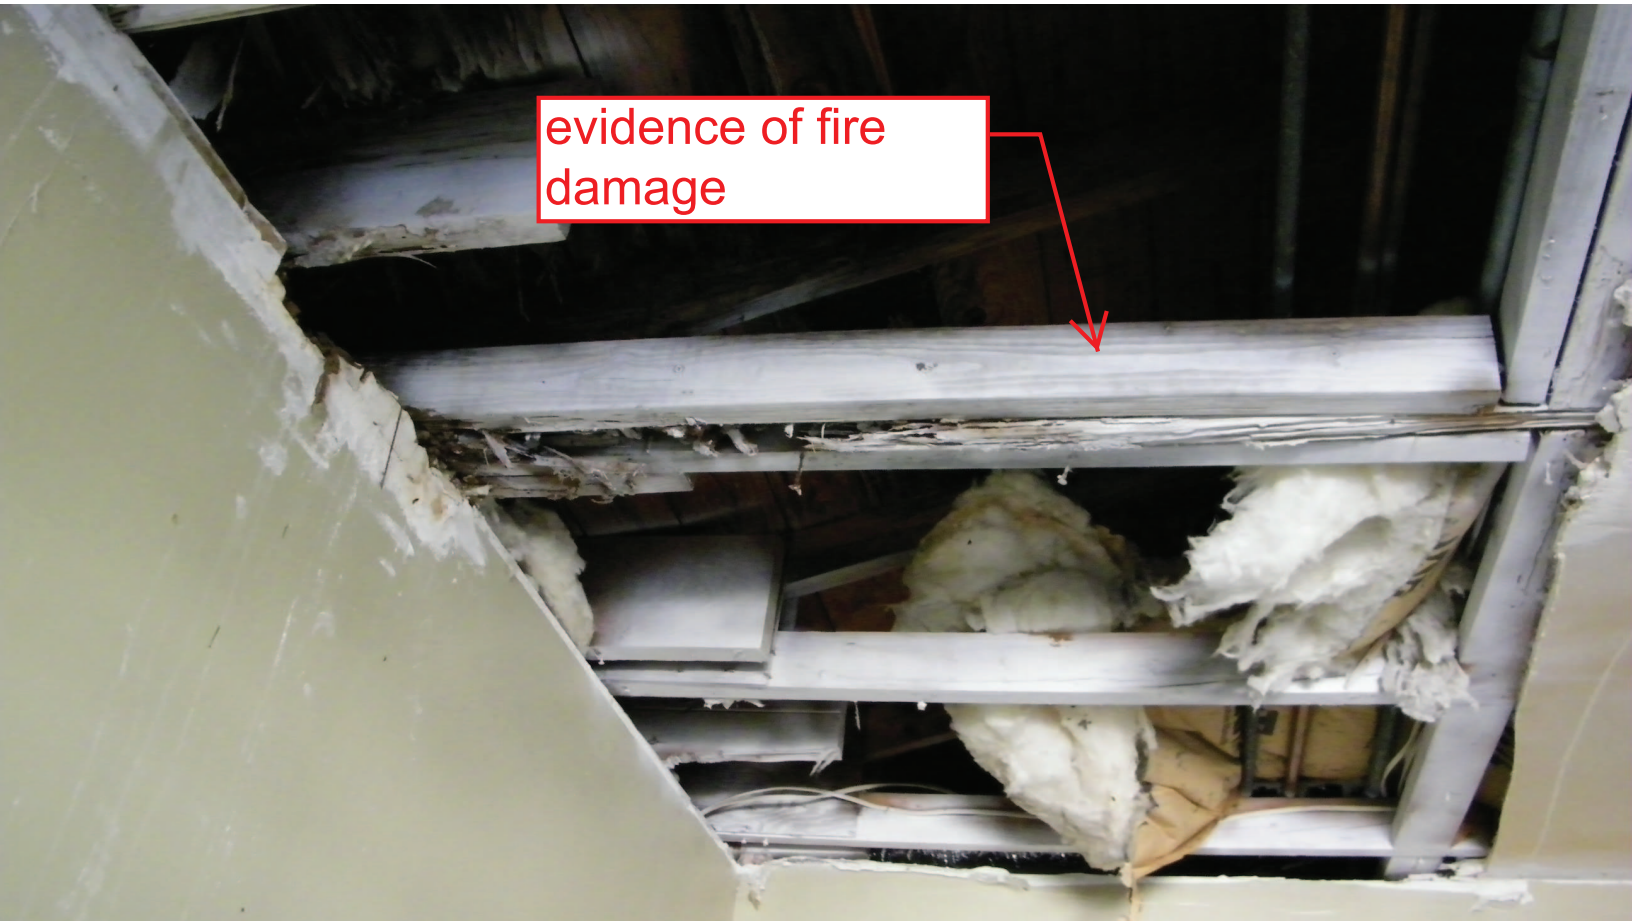
The interior of the home was noted to have severally damaged walls and ceilings in many of the rooms. Where these damages occur it is noted to have major termite infestation. Evidentially this home was in a fire at one time due the roof rafters being painted white. Some of the interior walls that fall on the exterior of the home have termite damage all the way to the exterior sheathing.

evidence of fire damage

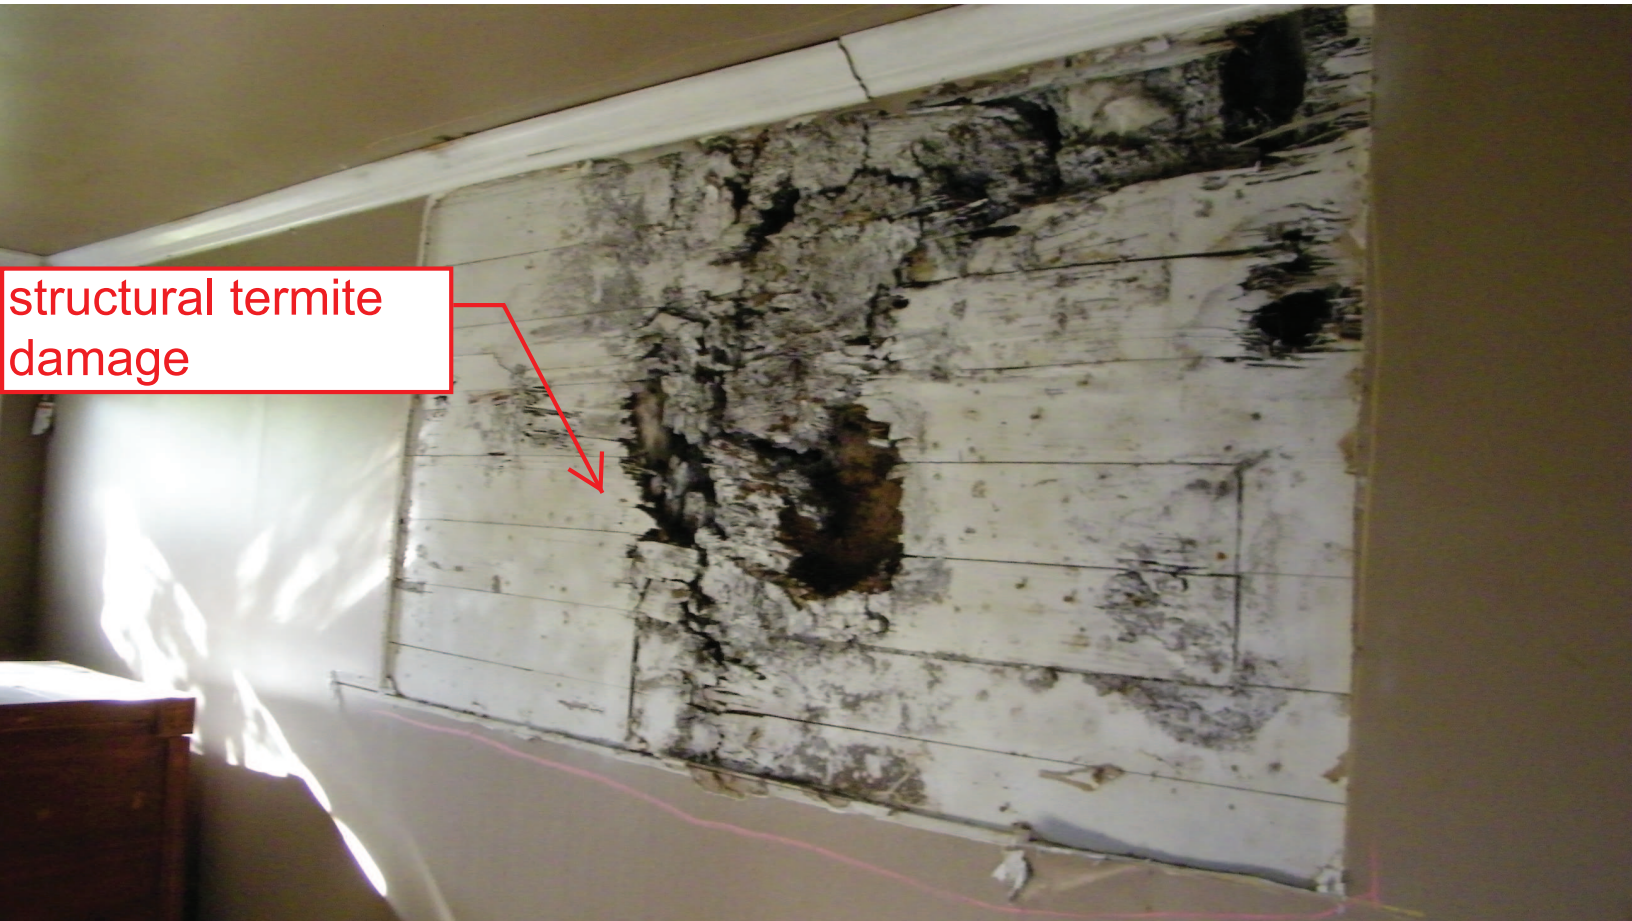
structural termite
damage

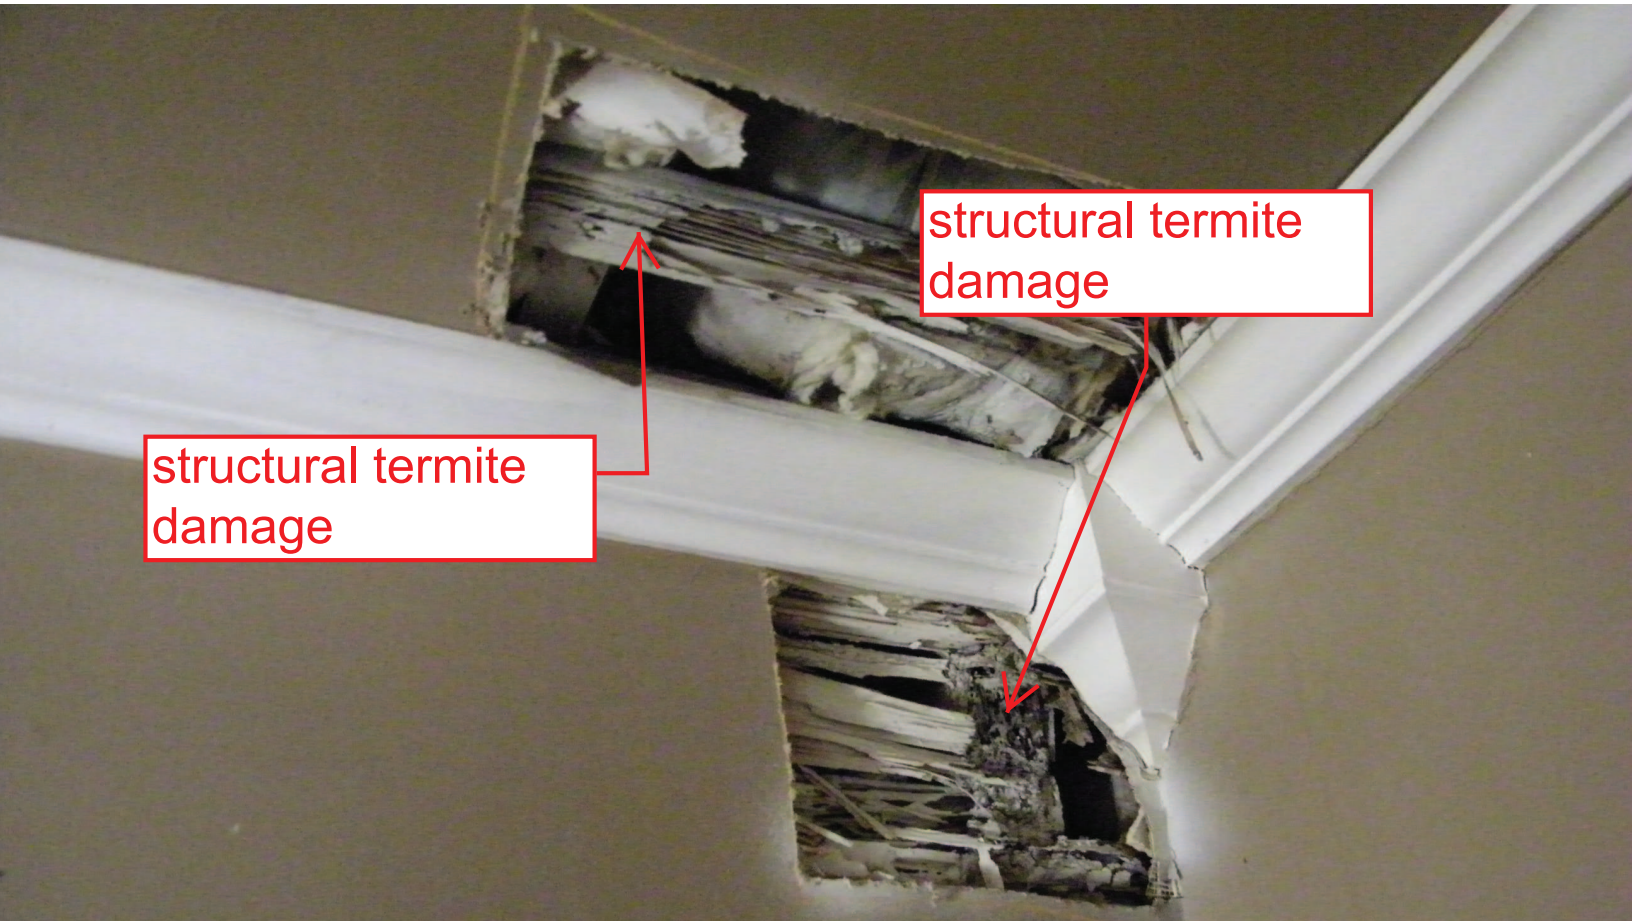
structural termite damage

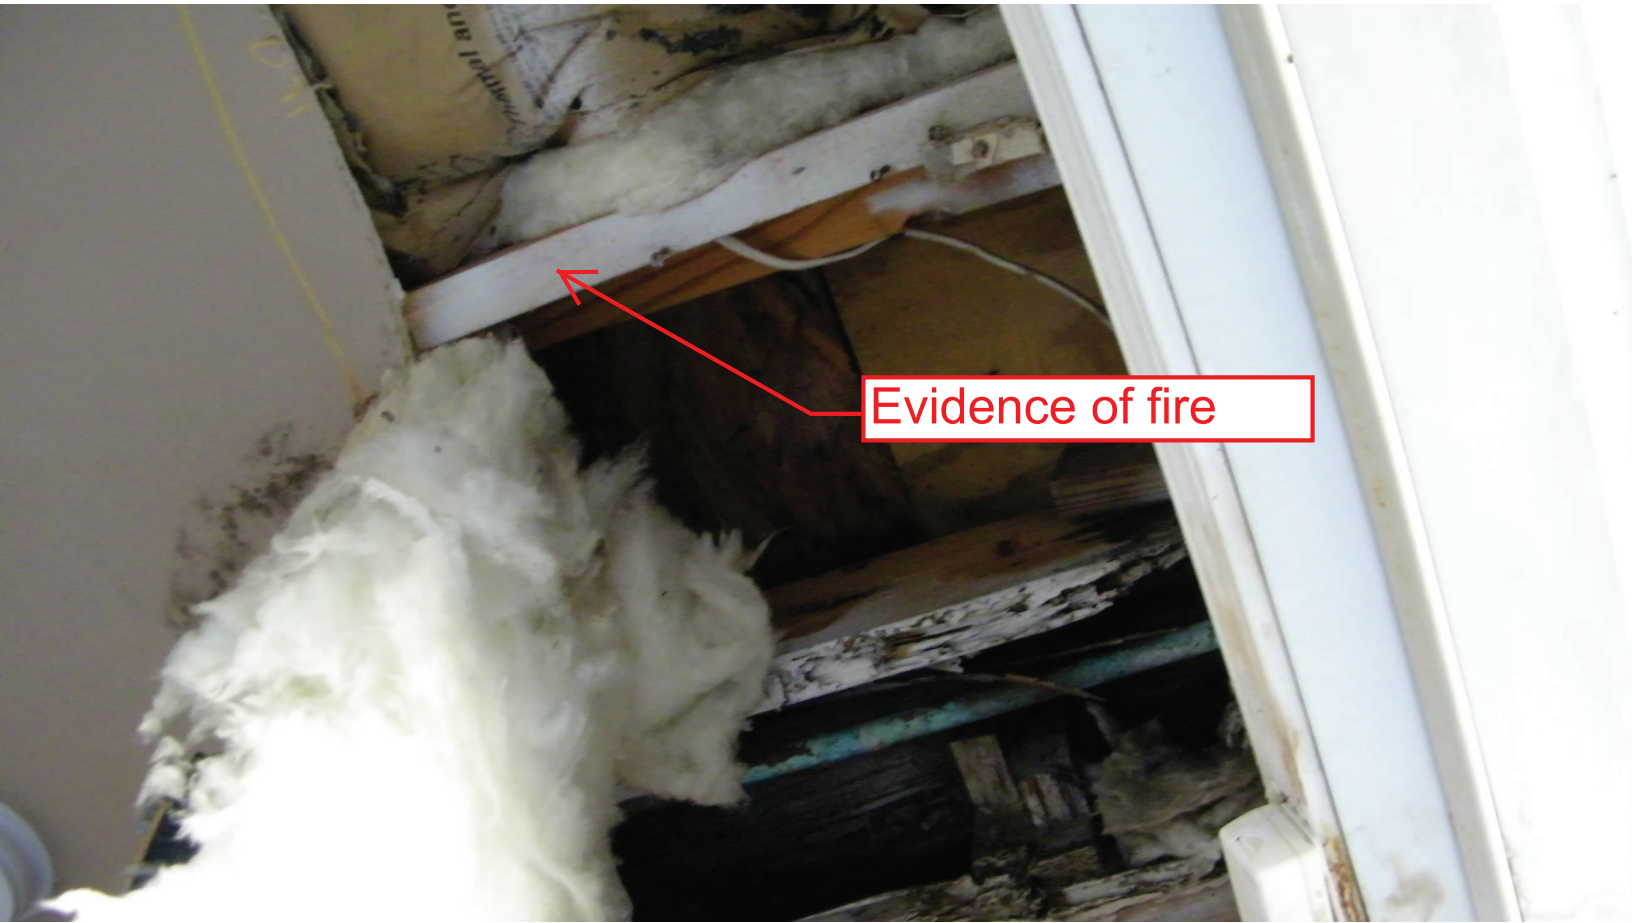
structural termite damage
