Structural Inspection

November 25, 2013

Subject: Structural Inspection of Residential Slab
200 Legendre Dr.
Slidell, LA 70458

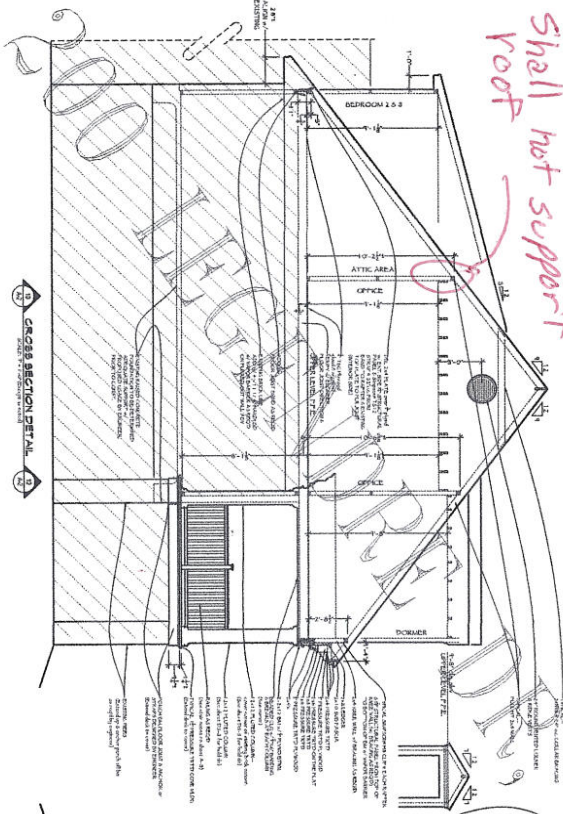
CROSS SECTION DETAIL

The reference drawings also show that some of the new 2nd floor walls do not sit directly over the 1st floor load-bearing walls.

The roof shall be supported only on the exterior walls, therefore transferring the roof load to the exterior concrete beams. The roof trusses shall be pre-engineered trusses and not stick built to ensure that no interior walls support the roof system or wind loads from the roof.

Additional support should be added to support the 2nd floor walls by doubling up on the 2x8 floor joist and ensuring that these double joists are directly under the 2nd floor wall(s) when running parallel.
