STRUCTURAL CERTIFICATION

For: Sonny Drouilhet
Location: 135 N Roadway
New Orleans, La 70460

Building Description: Two story boat house with living space/wood frame on pilings/metal roof

PILENG PLAN
 135 N. Roadway
 New Orleans, LA 70124

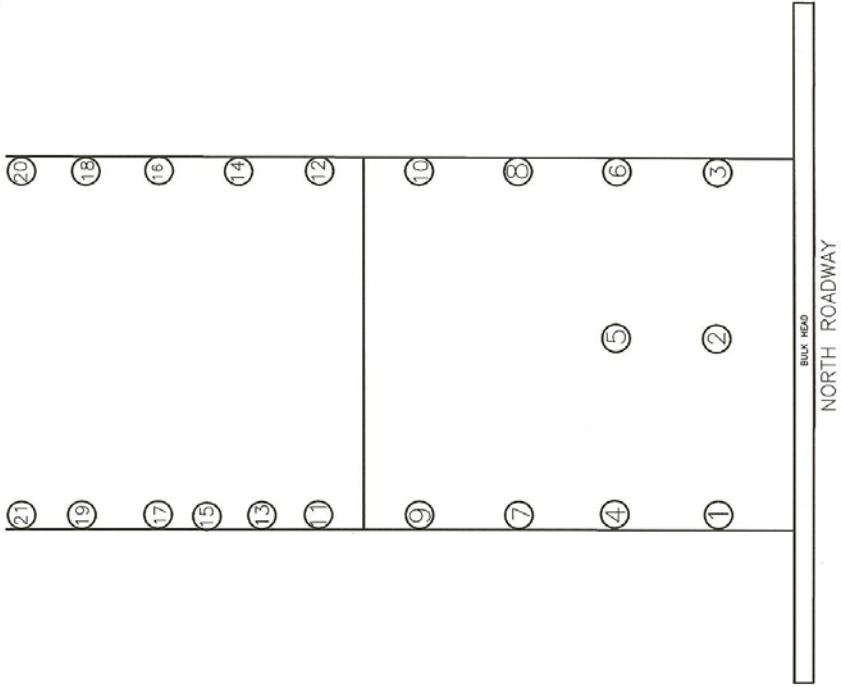
1. Piling #1 has deteriorated to fifty percent. Recommend repairing by concrete encasement with steel reinforcing.
2. Piling # 16 has a split running vertically above and below the water line approximately 1/2" deep. Recommend repairing by concrete encasement with steel reinforcement
3. The remaining pilings have deteriorated approximately twenty percent or less. No action need be taken at this time, but to guarantee longevity all piles should be treated with concrete and steel reinforcement.
4. The cross braces have rotted and are falling off of the piles. Replacement of the cross braces is recommended.

PILE#	ORIGINAL CIRCUM	ORIGINAL DIAM	CURRENT CIRCUM	CURRENT DIAM	CONDITION
PILE1	39"	12.4"	24"	7.64"	POOR
PILE2	40"	12.75"	31"	9.87"	FAIR
PILE3	40"	12.75"	33"	10.50"	GOOD
PILE4	39"	12.40"	33"	10.50"	GOOD
PILE5	39"	12.40"	32"	10.82"	GOOD
PILE6	38"	12.10"	32"	10.18"	GOOD
PILE7	36"	11.46"	32"	10.50"	GOOD
PILE8	40"	12.75"	34"	10.82"	GOOD
PILE9	CONC	CONC			GOOD
PILE10	39"	12.40"	38"	12.10"	GOOD
PILE11	37"	11.78"	31"	9.87"	GOOD
PILE12	40"	12.75"	36"	11.46"	GOOD
PILE13	39"	12.40"	35"	11.14"	GOOD
PILE14	37"	11.78"	35"	11.14"	GOOD
PILE15	40"	12.75"	36"	11.46"	GOOD
PILE16	36"	11.46"	35"	11.14"	FAIR
PILE17	36"	11.46"	31"	9.87"	GOOD
PILE18	36"	11.46"	36"	11.46"	GOOD
PILE19	42"	13.37"	39"	12.42"	GOOD
PILE20	39"	12.40"	34"	10.82"	GOOD
PILE21	39"	12.40"	32"	10.19"	GOOD

- NOTES
1. THE PILES WERE TESTED FOR EROSION AND DECAY.
 2. MEASUREMENTS WERE TAKEN AT LOW TIDE.
 3. THE ORIGINAL CIRCUMFERENCE WAS MEASURED AT THE TOP OF THE PILE.
 4. THE CURRENT CIRCUMFERENCE WAS MEASURED AT THE SMALLEST DIAMETER ABOVE THE WATER LEVEL.
 5. ONE INCH SHOULD BE SUBTRACTED FROM THE CURRENT MEASUREMENTS ALLOWING FOR WATER SOAKED AND DECAYED WOOD.
 6. THE CROSS BRACING IS ROTTED AND NOT ATTACHED TO PILING.
