## Structural Inspection

December 22, 2015

For: Dan and Diane Berkshire  
108 Yorkshire Dr  
Slidell, LA 70458

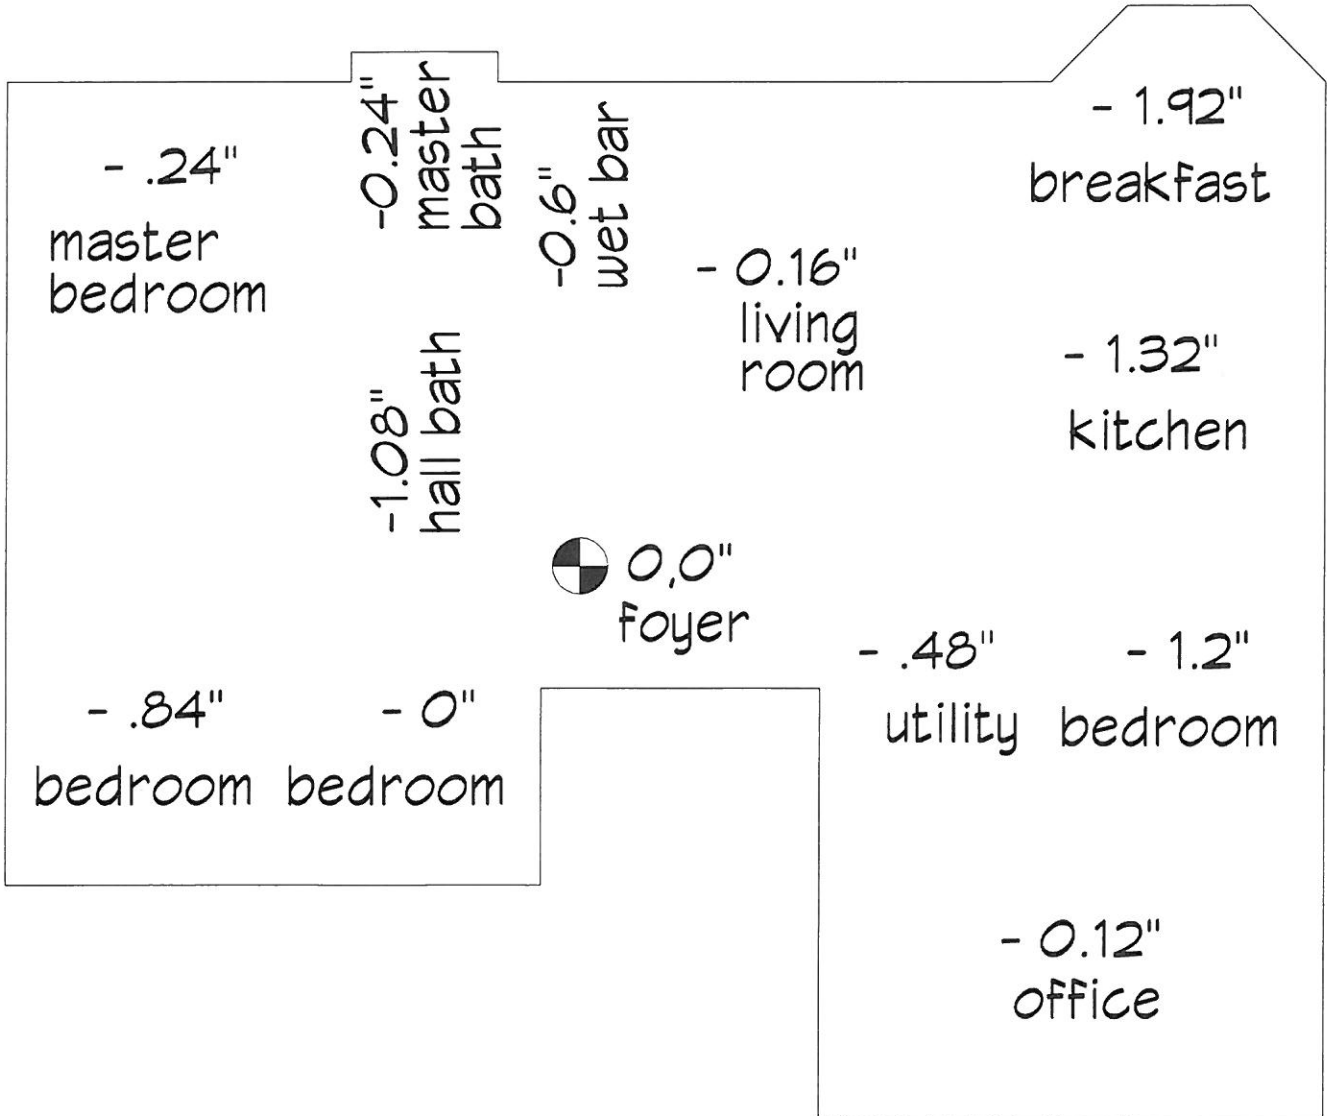
Attachment: Floor Plan Noting Elevation Differences

A zip level was used to verify the floor height conditions. It's evident from these readings that the home has experienced some settlement over the years. It is important to note that all floor height conditions are within acceptable tolerances. Most of the numbers are from the differences noted with different types of flooring material (carpet, ceramic tile and wood flooring).
