Structural Inspection

07-20-2022

Kevin & Andrea Schneider
21 Briar Hollow Drive
Covington, La. 70433

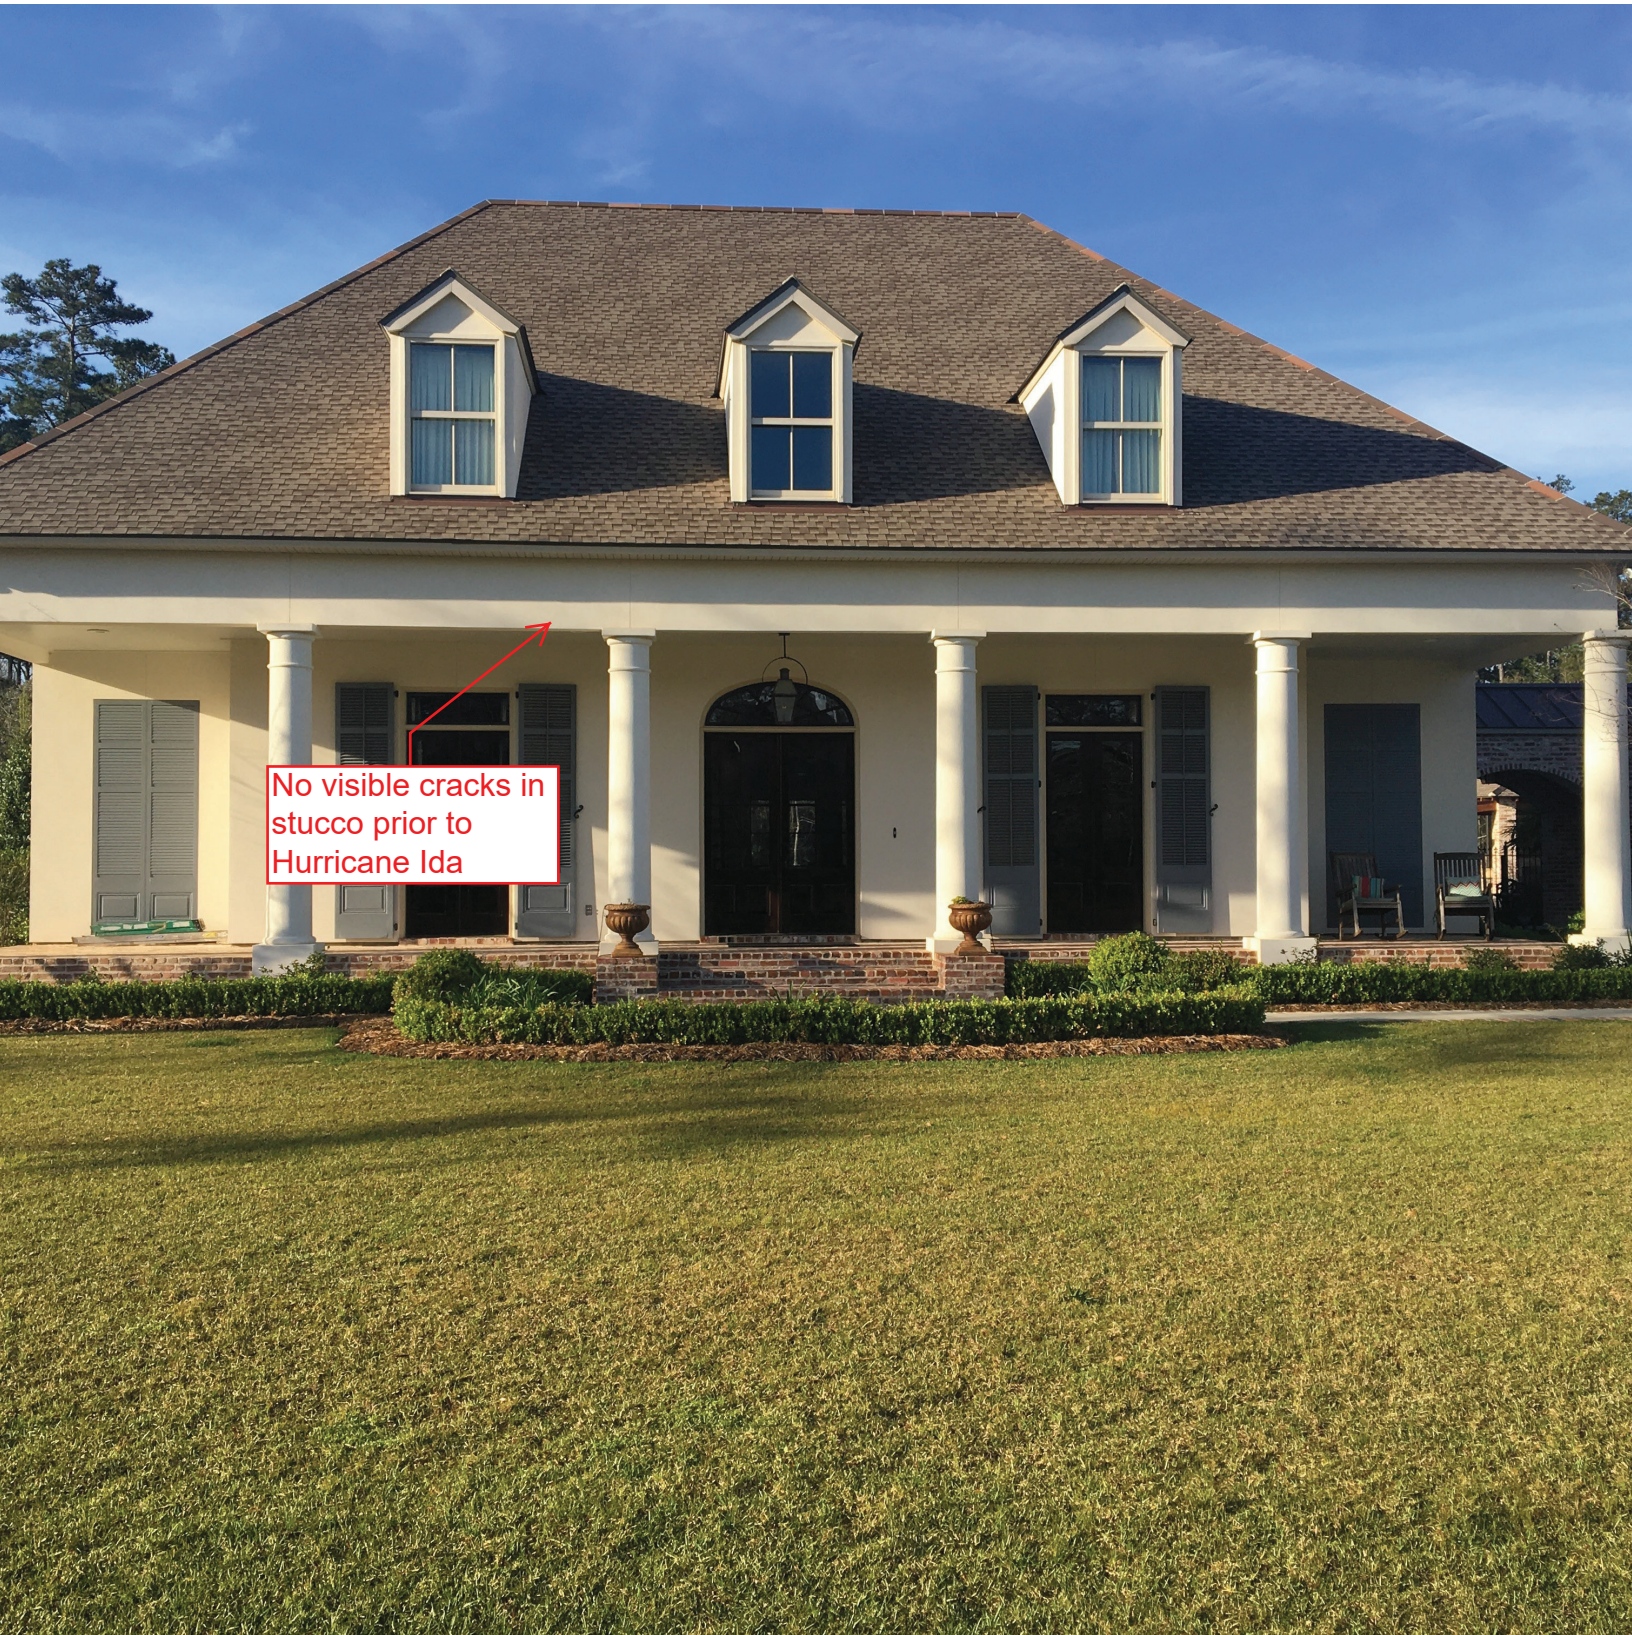
No visible cracks in stucco prior to Hurricane Ida

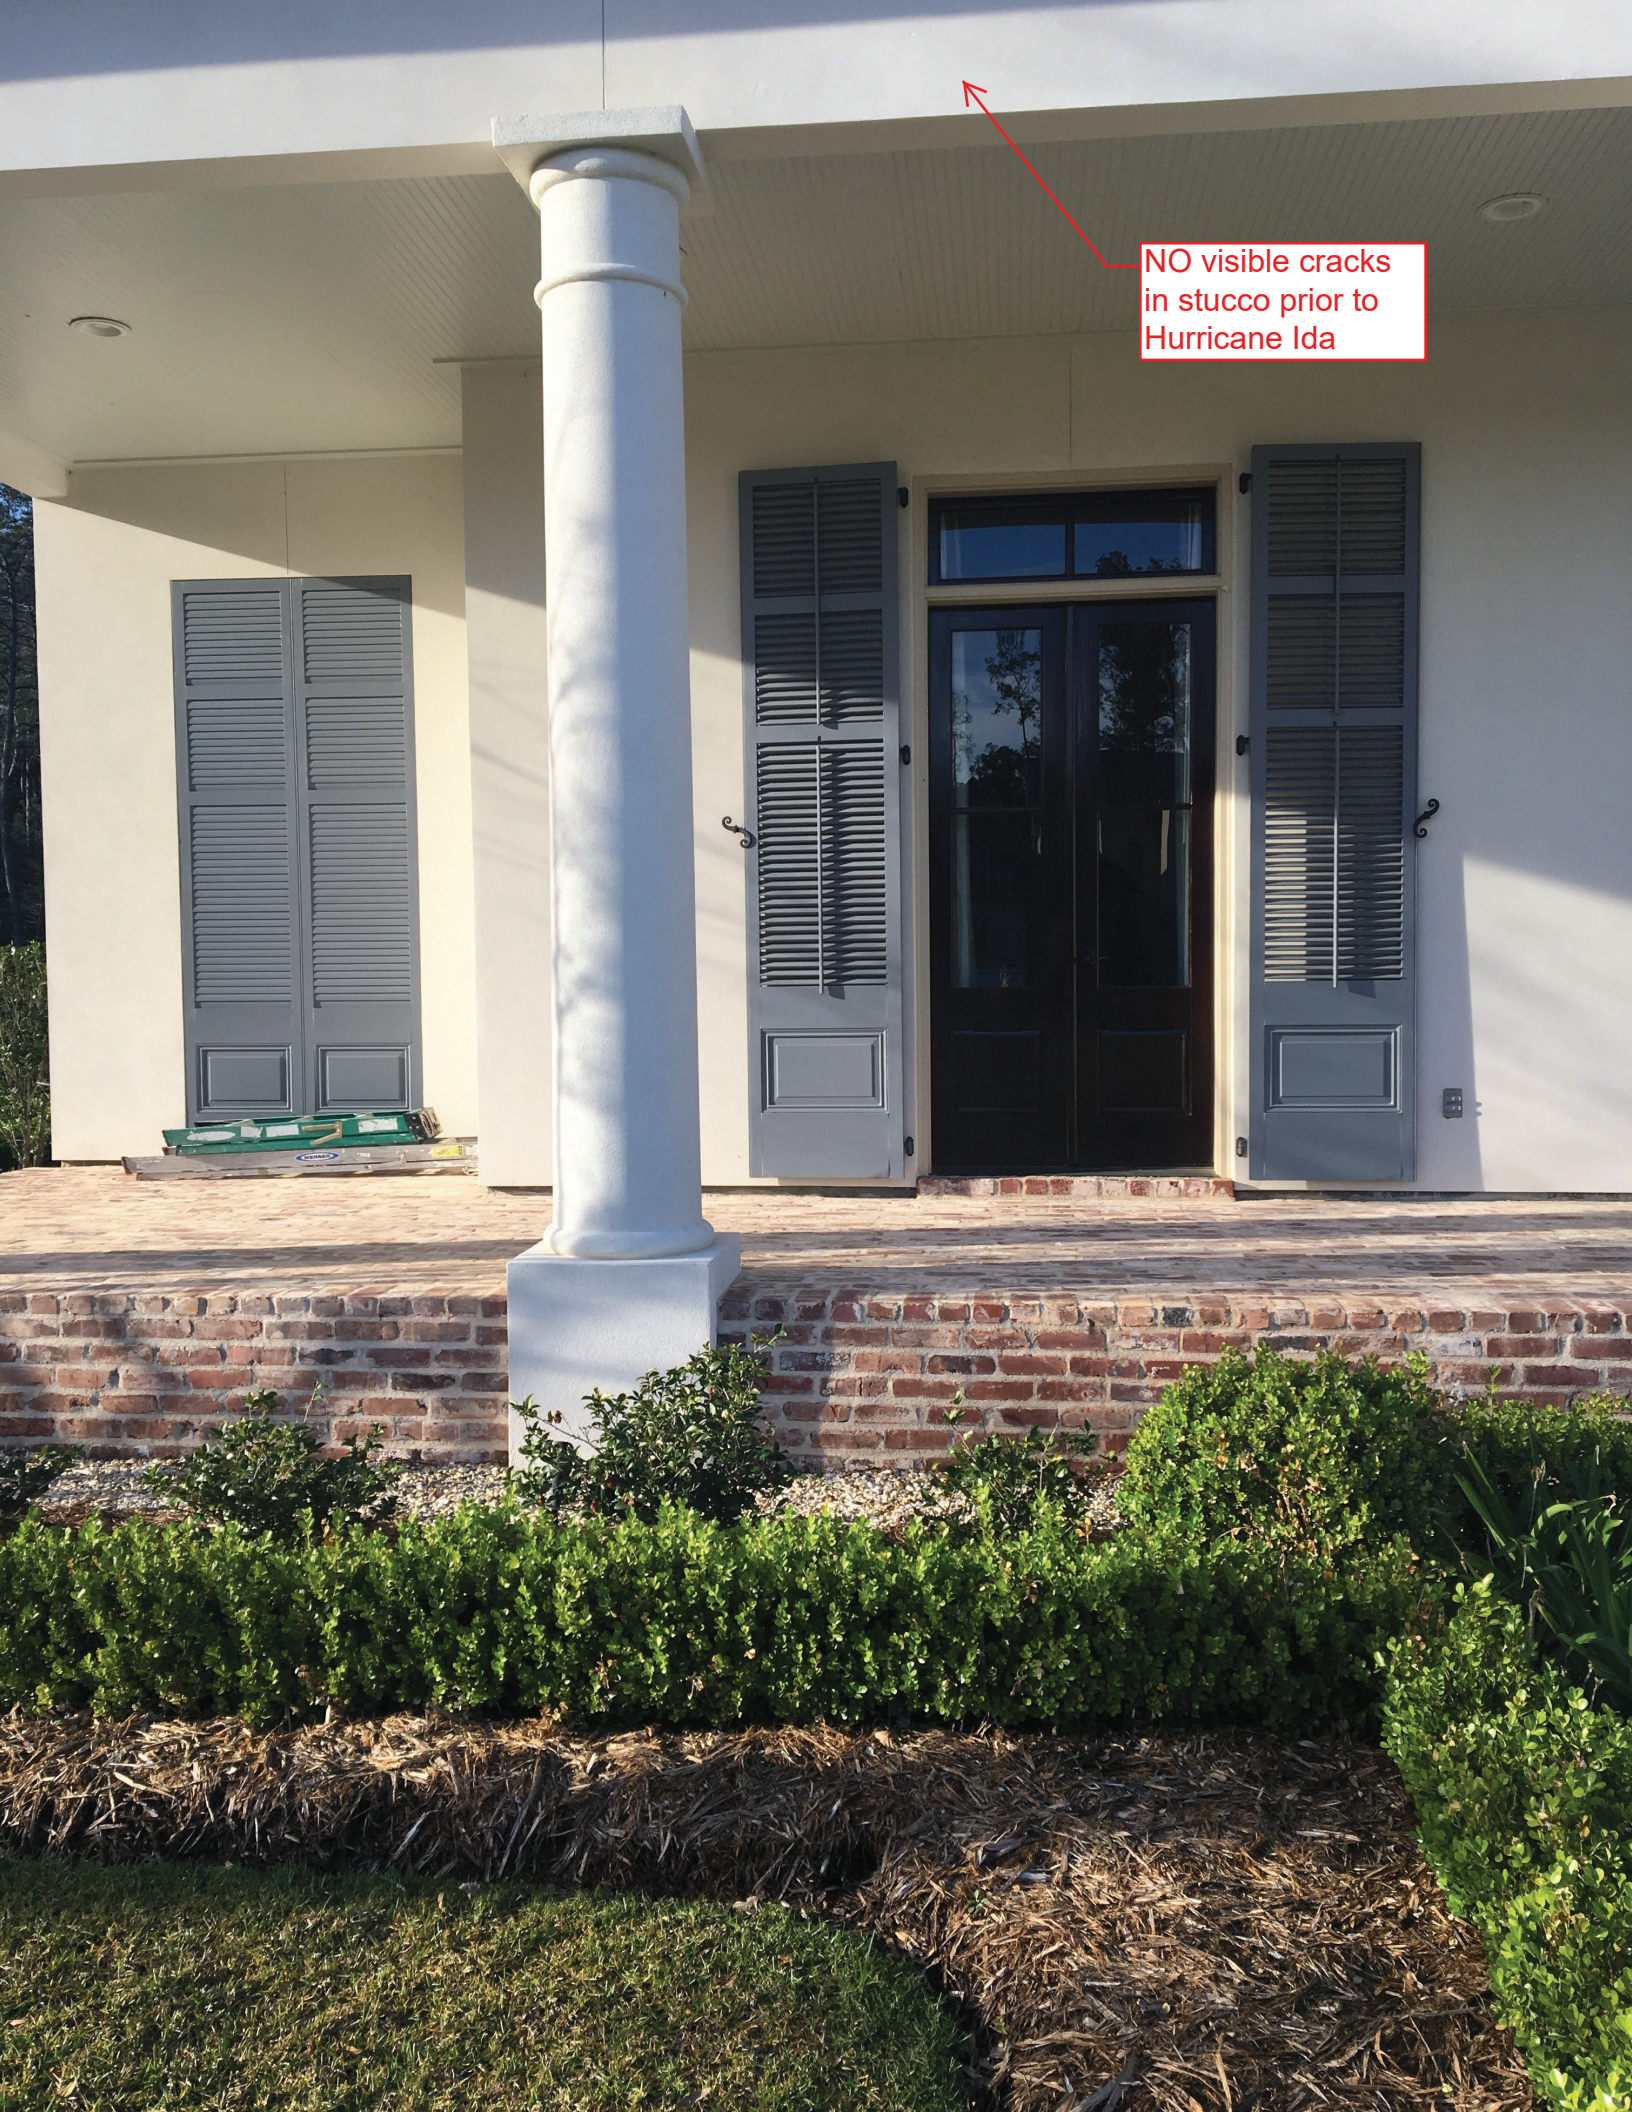
NO visible cracks
in stucco prior to
Hurricane Ida

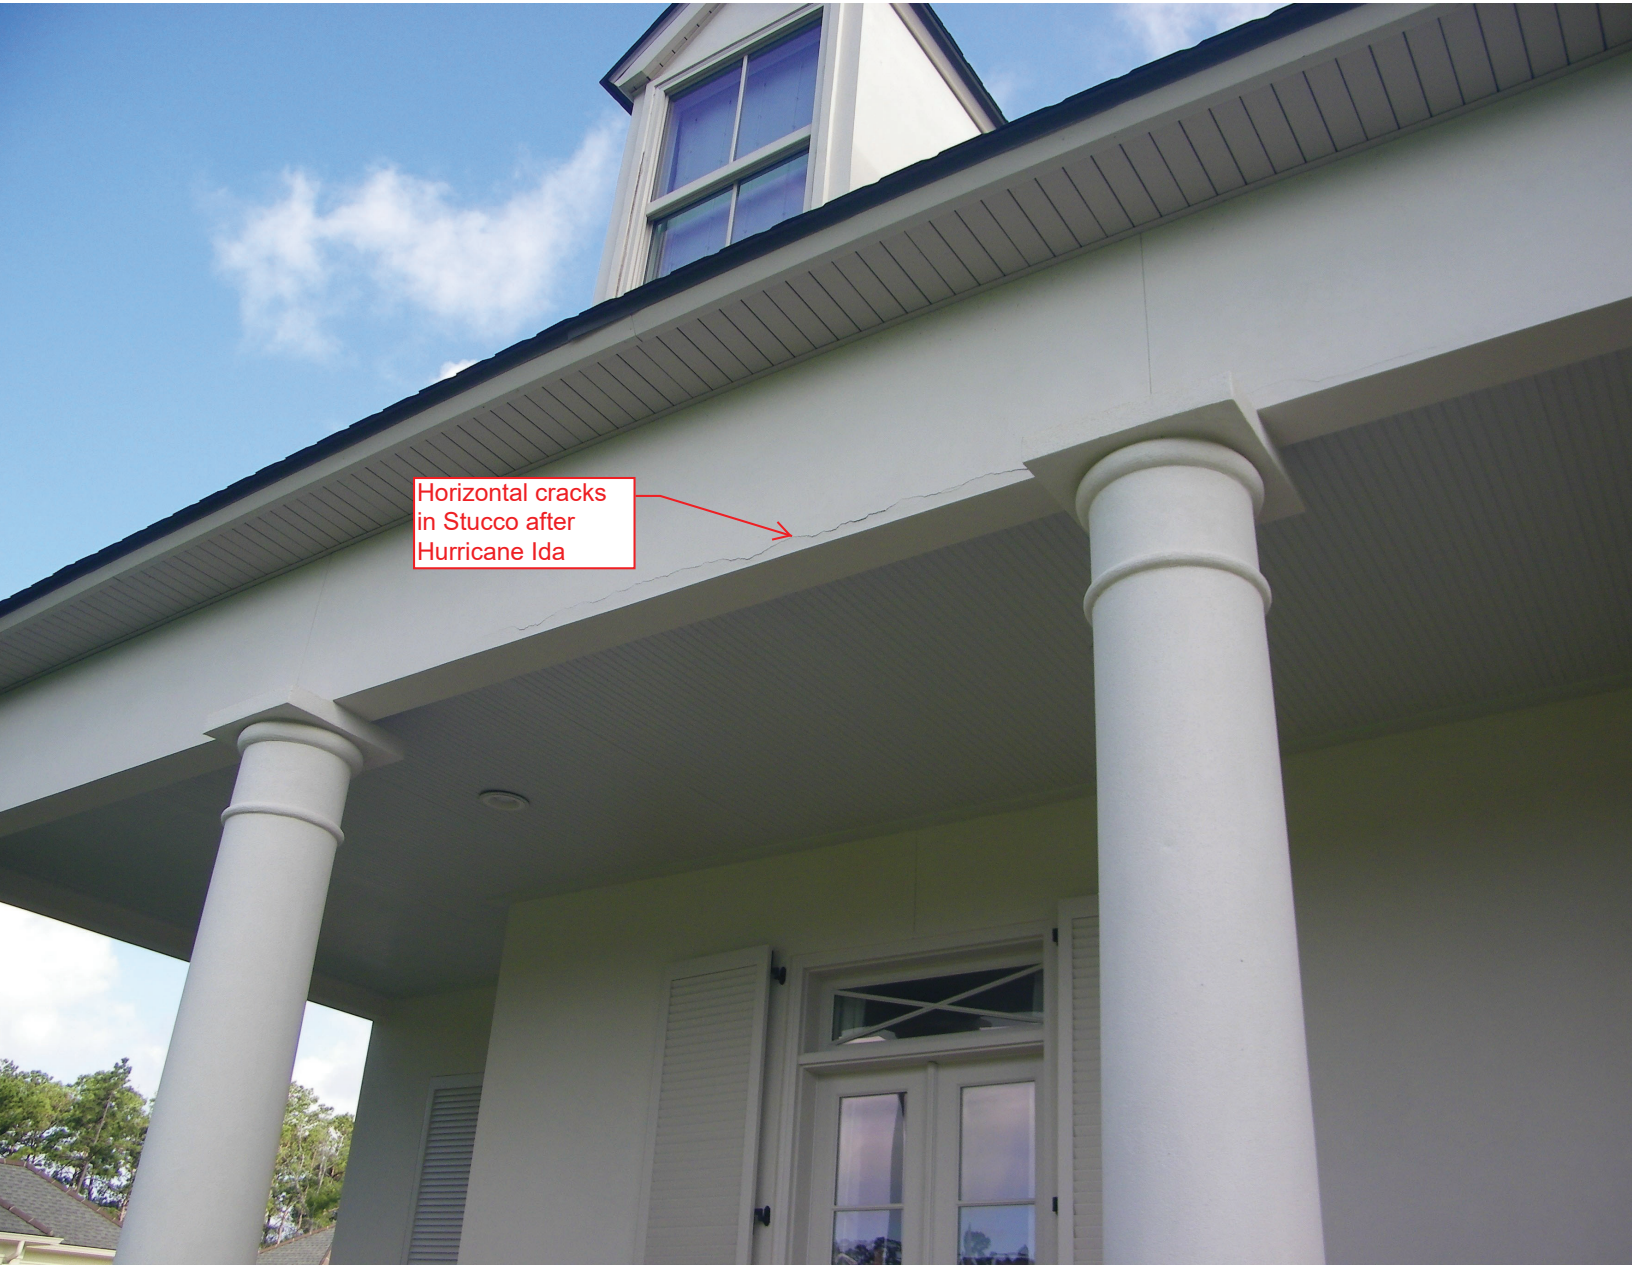
This home faces the south. Upon a visual inspection of the exterior of the home, it was noted on the front of the home to have several horizontal cracks in the stucco above the front porch walkway and the front porch house walls to have vertical cracks on the corners.

Due to the force of the high winds it has racked the home slightly causing stucco damage as noted above and can be repaired.

Horizontal cracks
in Stucco after
Hurricane Ida

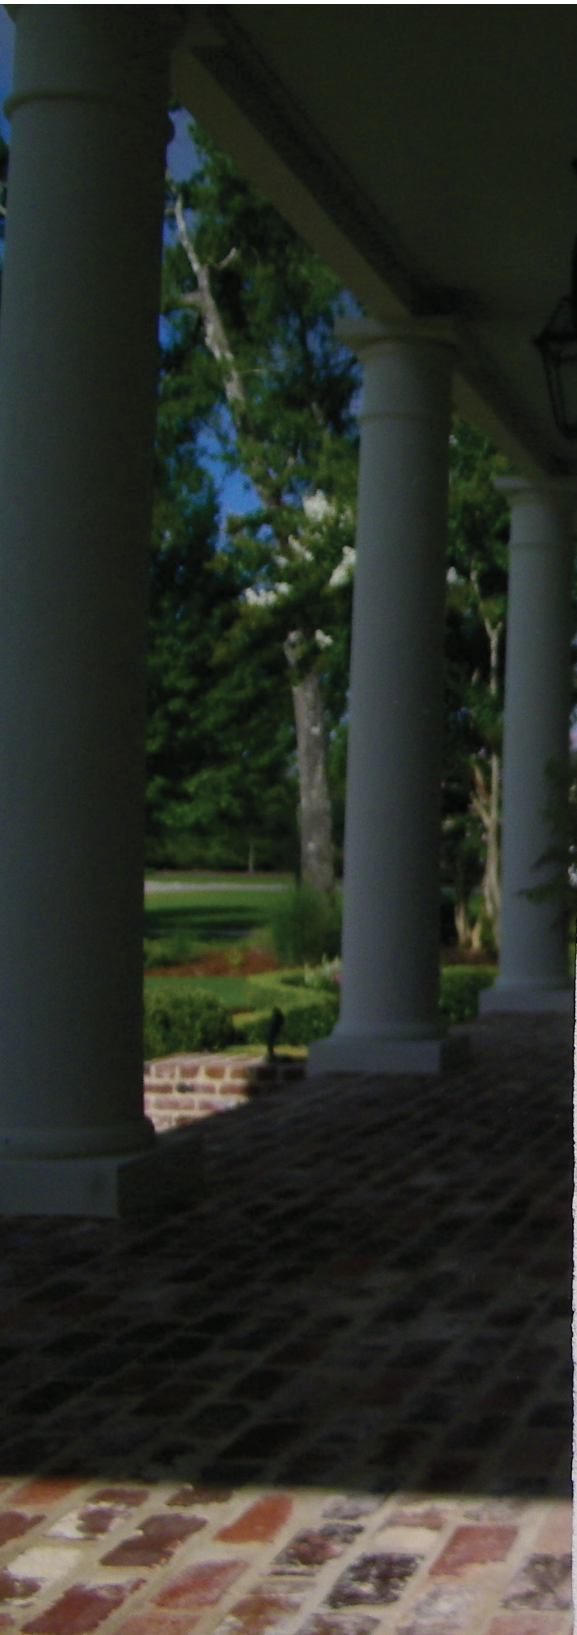
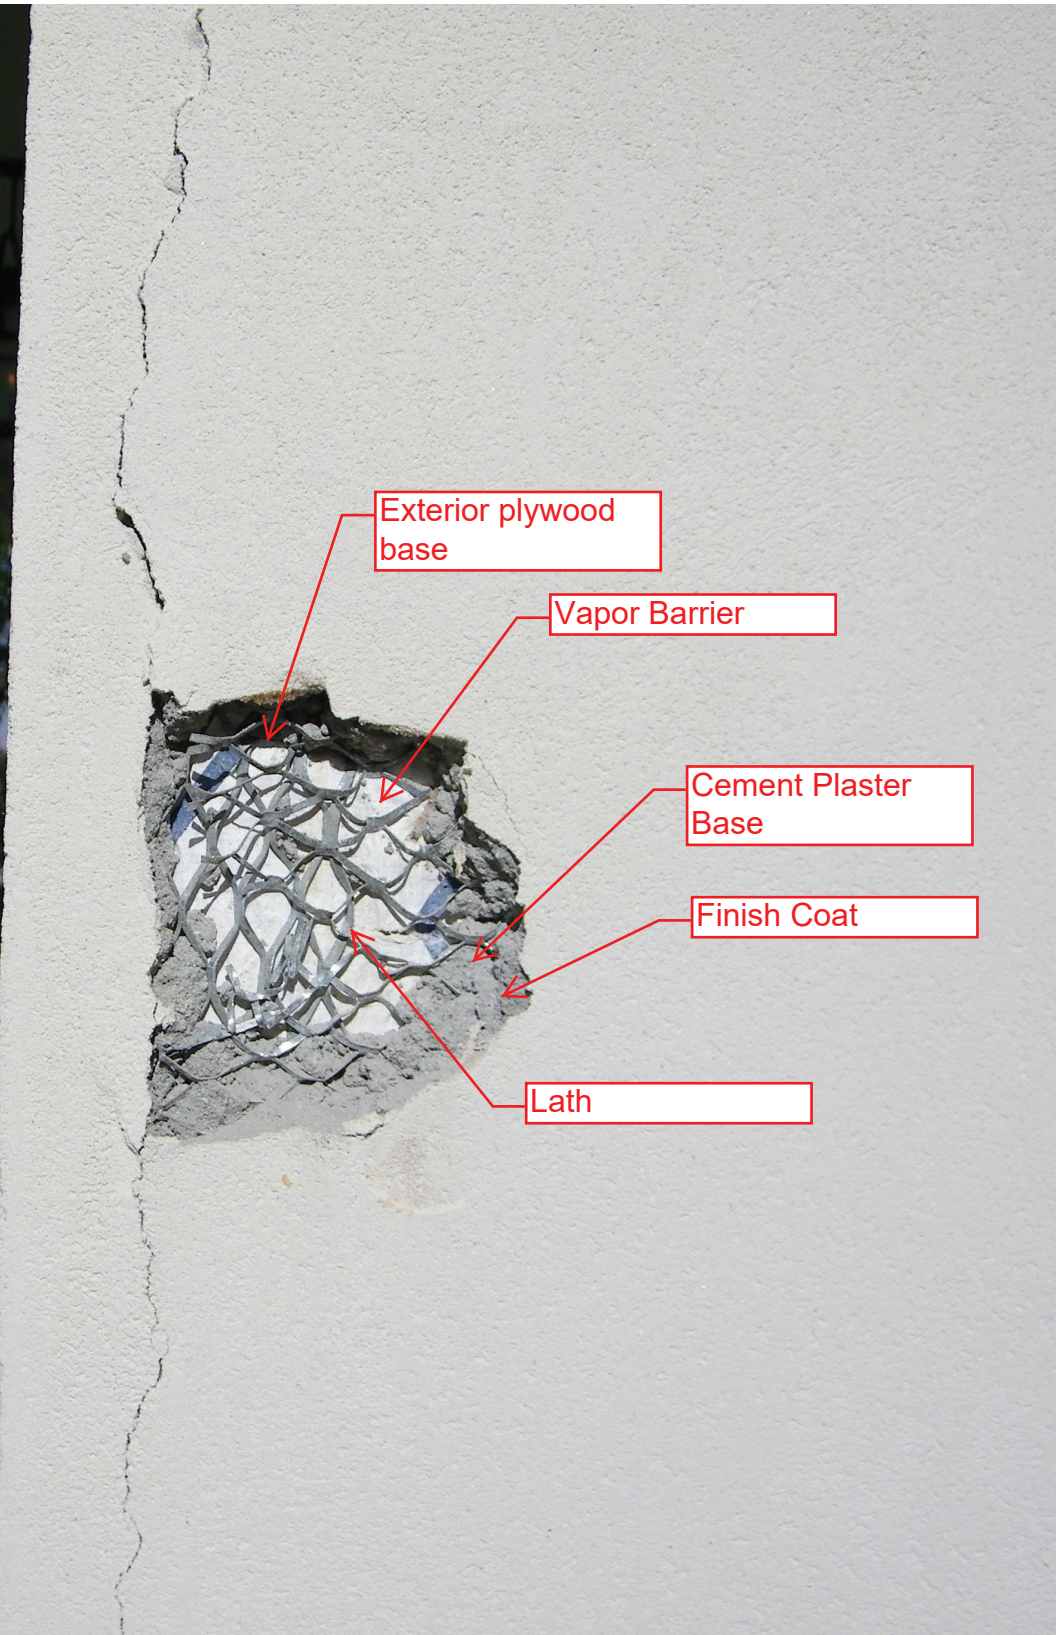
An inspection hole was created in stucco of the front porch wall near one the existing vertical cracks to verify the construction method of installation. It was noted to have an exterior plywood base with a vapor barrier and metal lath, cement plaster base coat and a finish coat.

Exterior plywood base

Vapor Barrier

Cement Plaster Base

Finish Coat

Lath
