Structural Inspection

October 24, 2017

Ref: 212 Melody Lane
Slidell, La. 70458

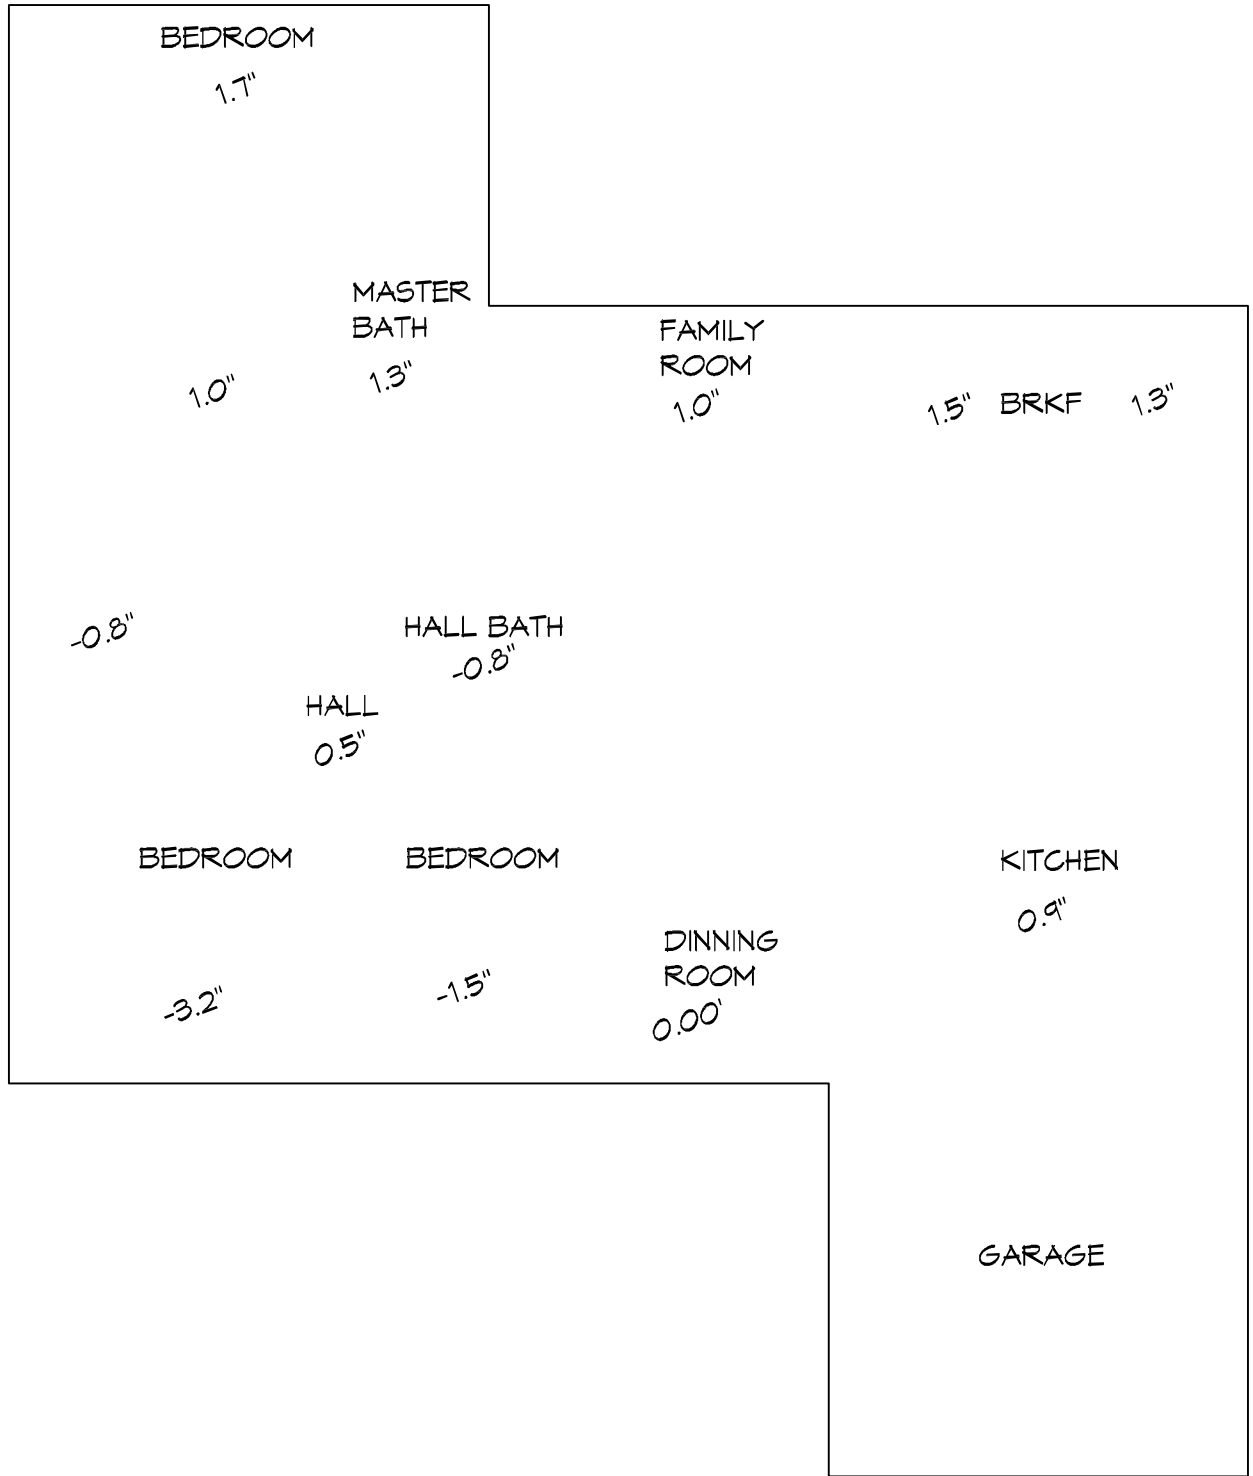
Upon inspection, a zip level was used to verify the floor height conditions. The level was set up at the front of the home near the dining room. The slopes range in the house from 0.0" to -2.3" in the main areas. The area in question (bedrooms), from the back of the master bedroom to the front bedroom has a combined slope of -4".

4" SLOPE TO FRONT
↓

It is recommended when there is more than a 3” elevation difference (tripping hazard) to have the home stabilized with screw pilings.
