Structural Inspection

January 10-2022

For: Jennifer Bondio
215 North Blvd
Slidell, La. 70458

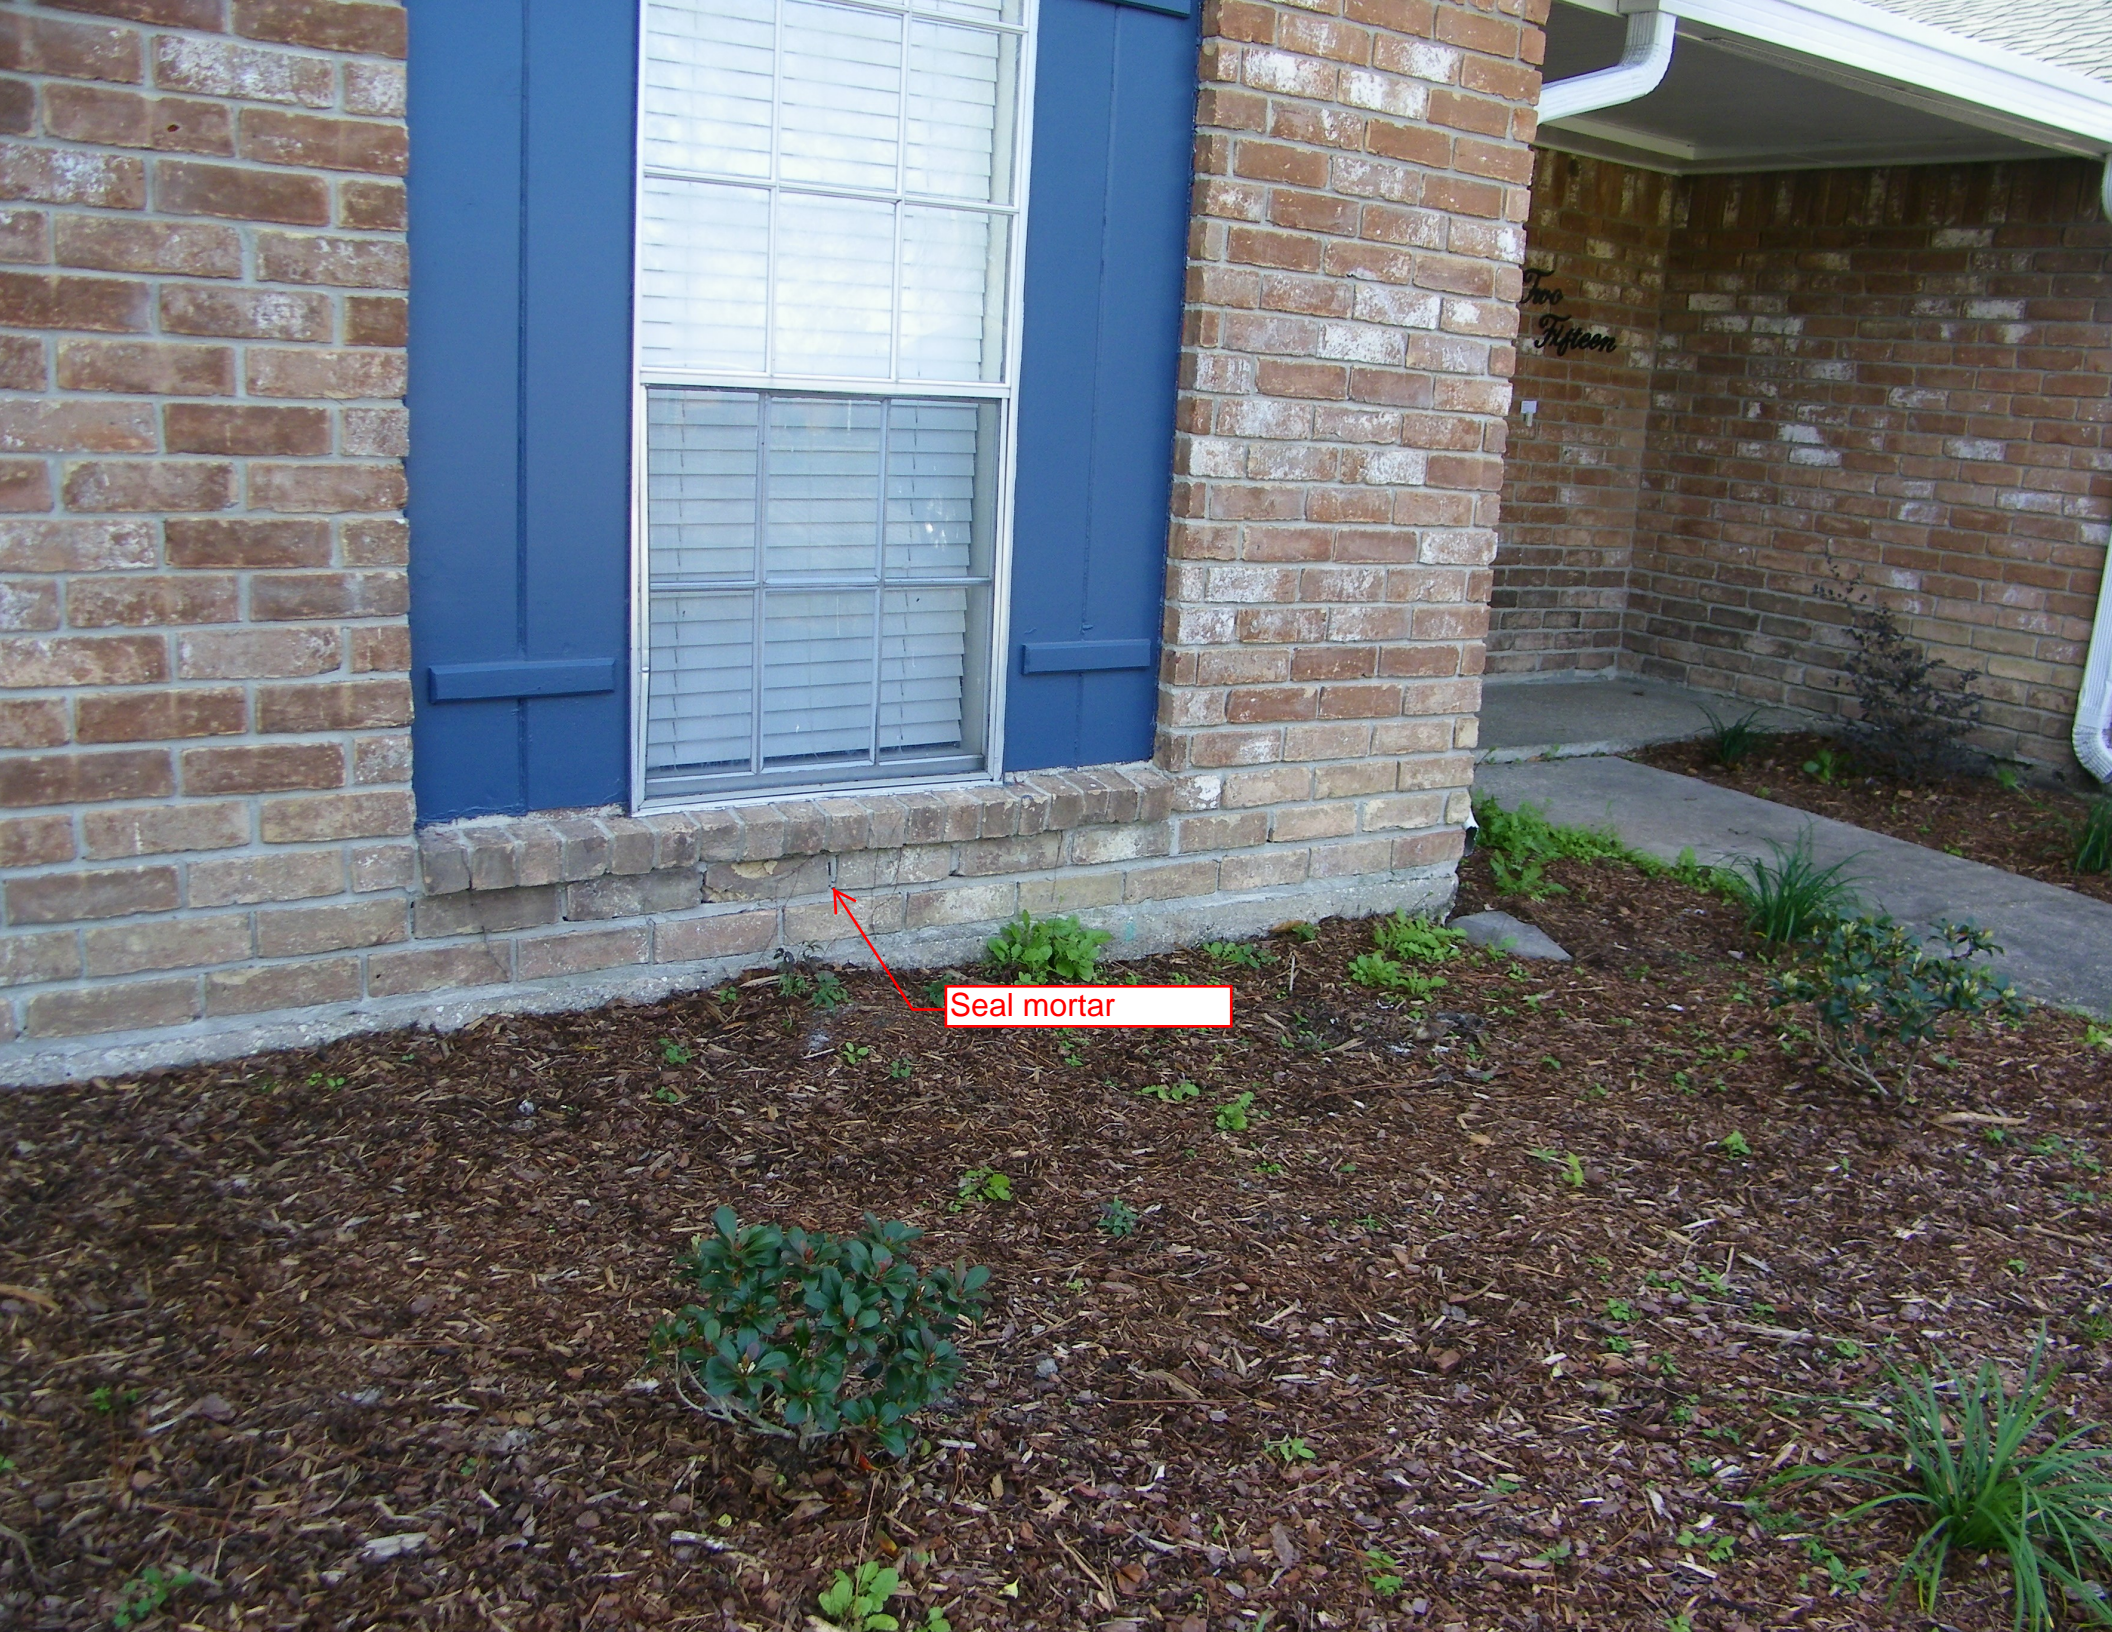
There are some bricks that have lost mortar around them; the cracks in the brick veneer do not show up in the foundation.

- 1) Seal the cracks in the brick veneer with a non-shrinking grout, to prevent insects from entering the home.
- 2) Remove stump.

Seal mortar

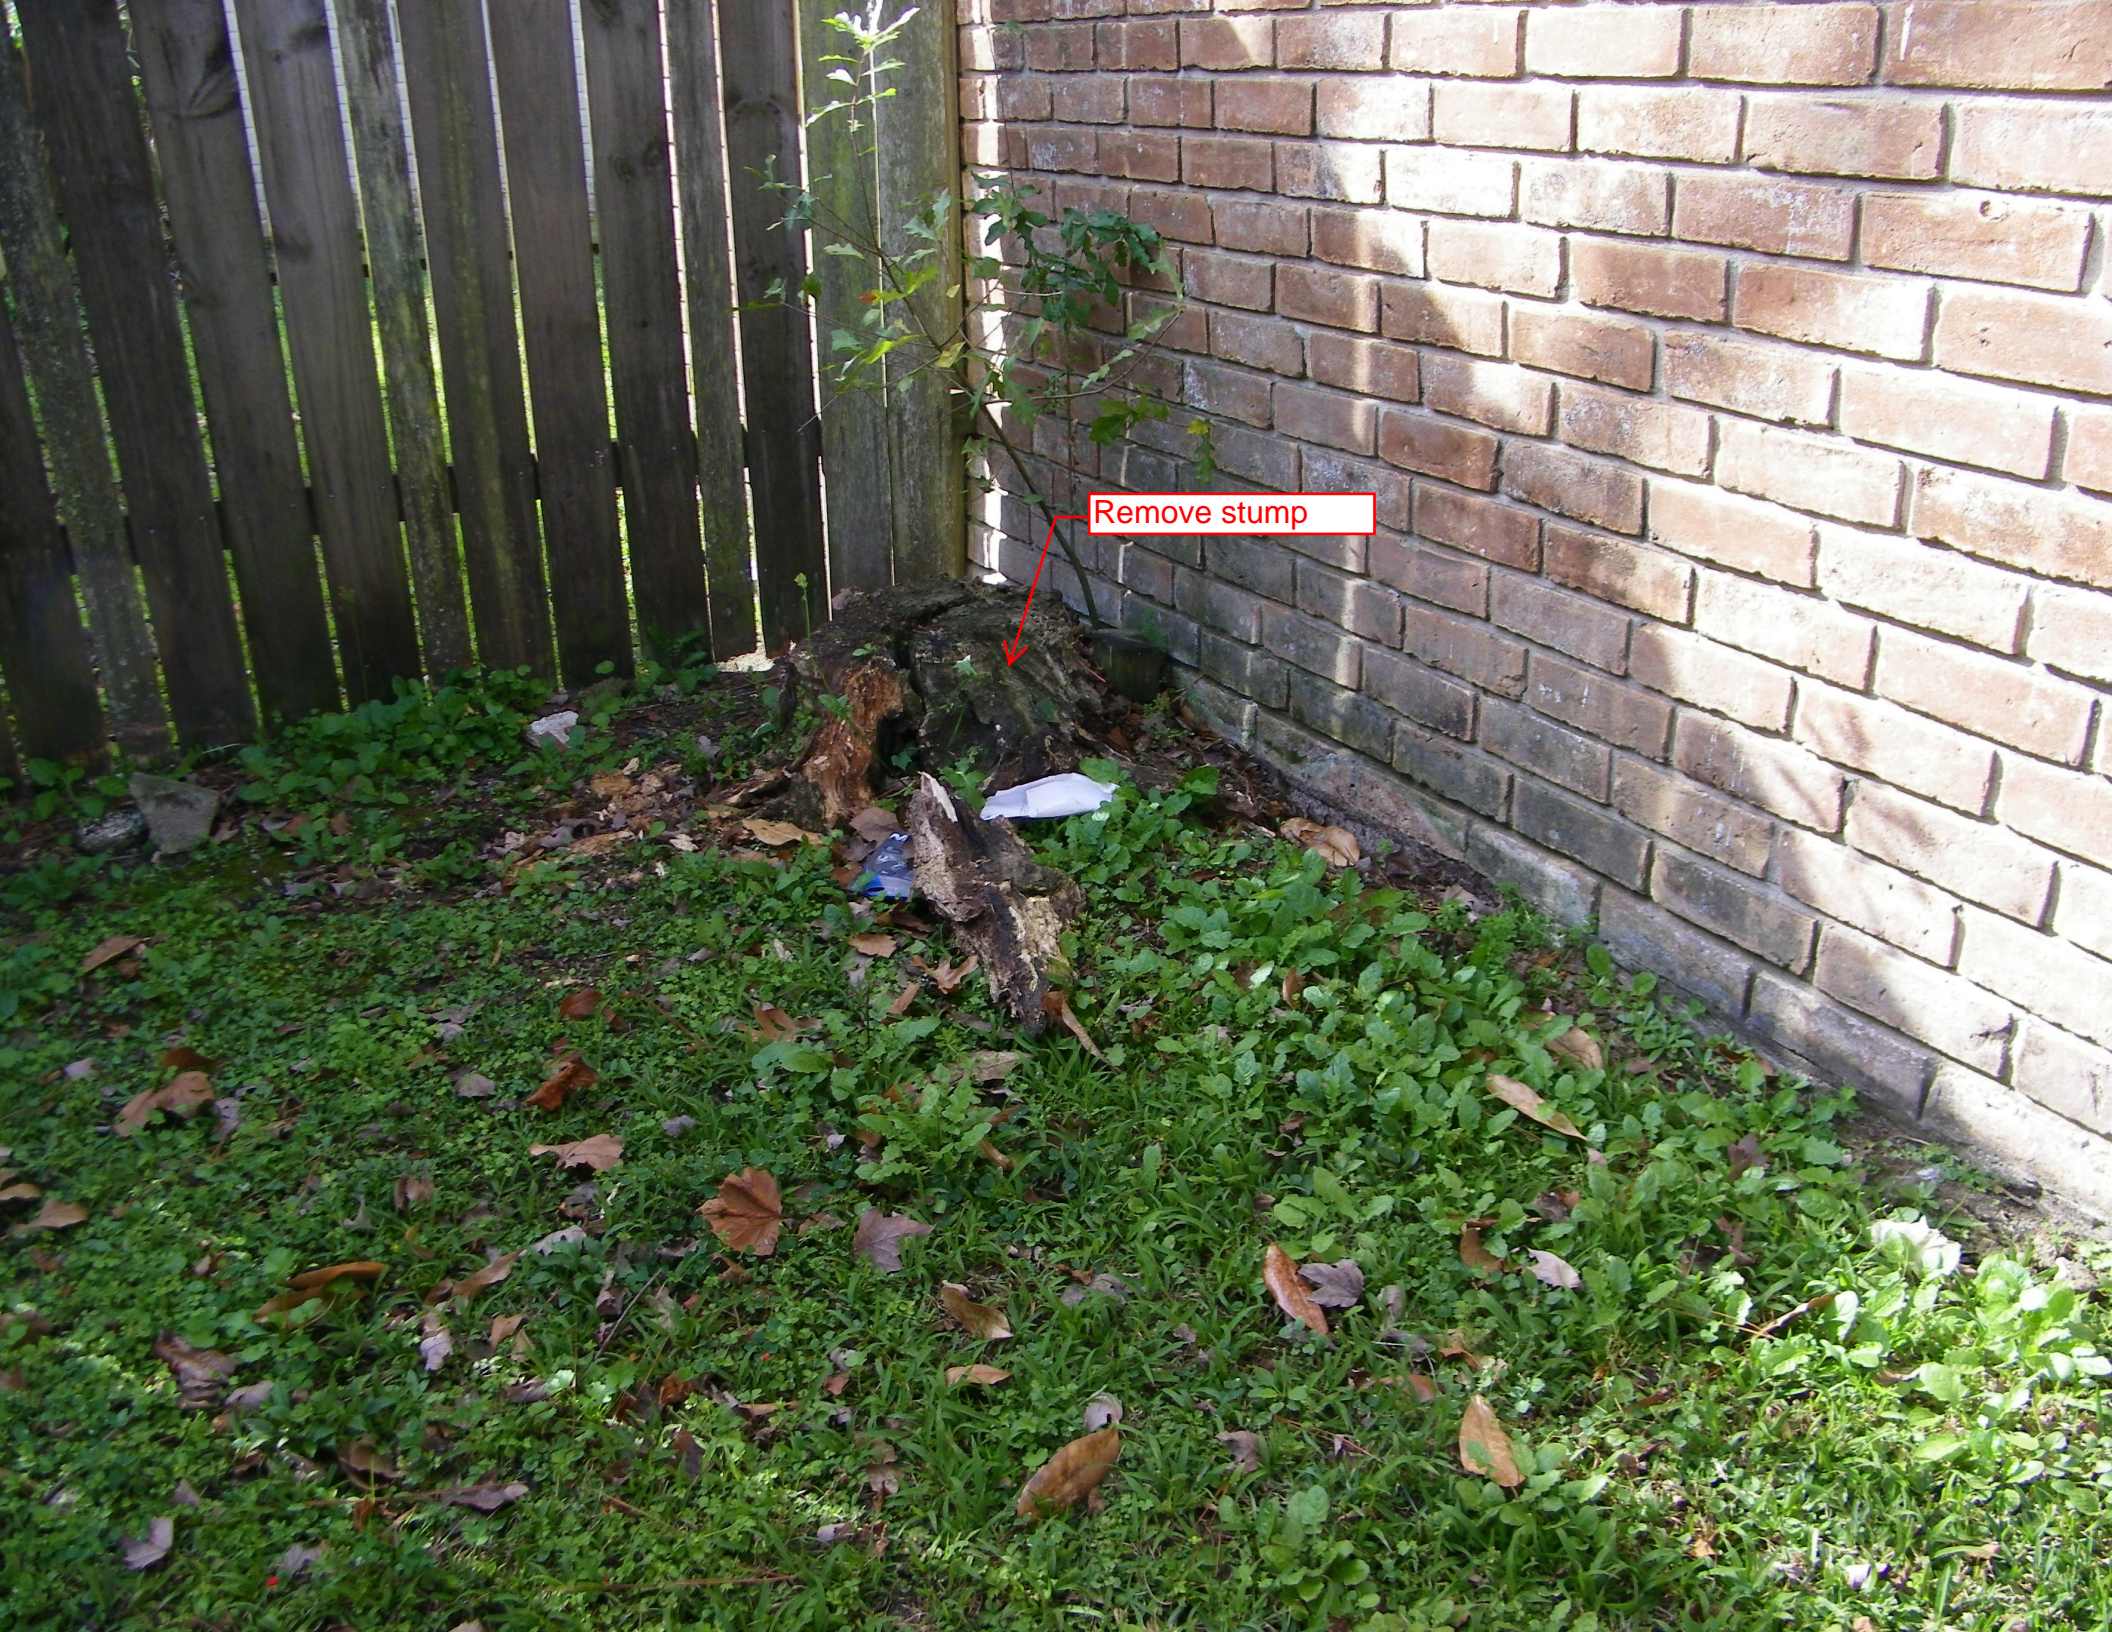
There is a stump on the left side of the home near the foundation that is deteriorating.

Remove stump

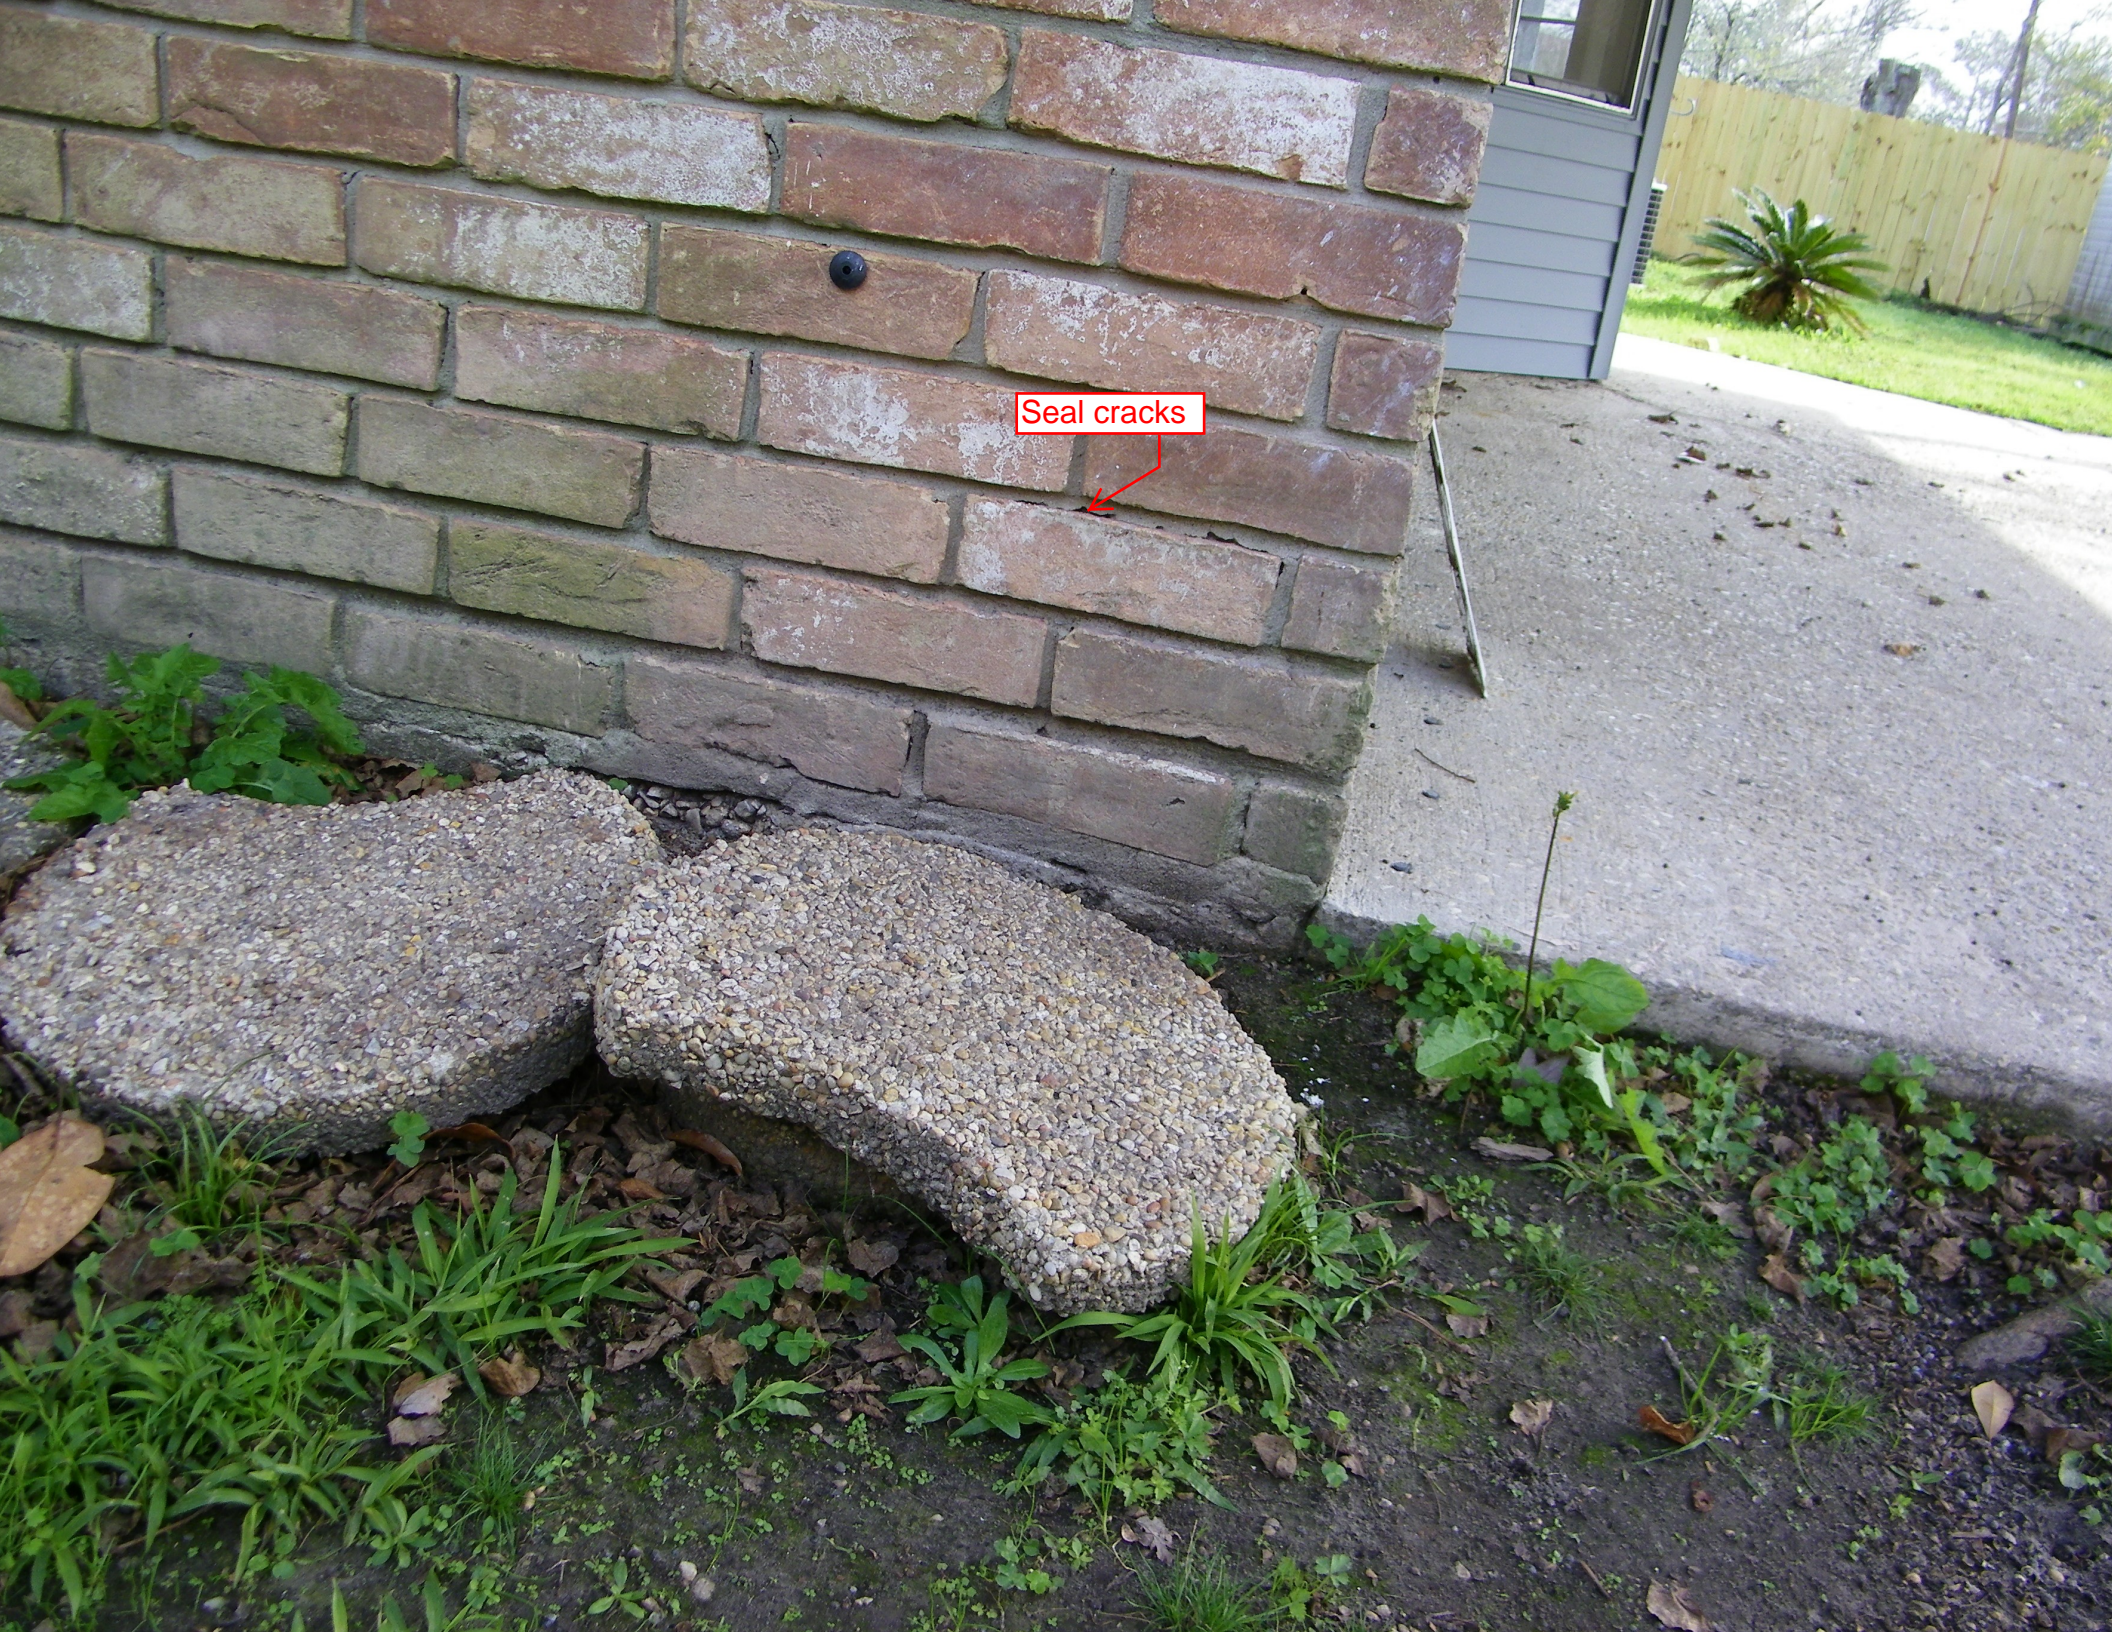
The cracks in the brick veneer do not appear to have compromised the structural integrity of the home. It is my opinion that the structural integrity of this home is currently sound, but the foundation will expand and contract with the ground movement and any standing water. It is recommended when there is more than a 3" elevation difference (tripping hazard) to have the home stabilized with screw pilings.

Seal cracks

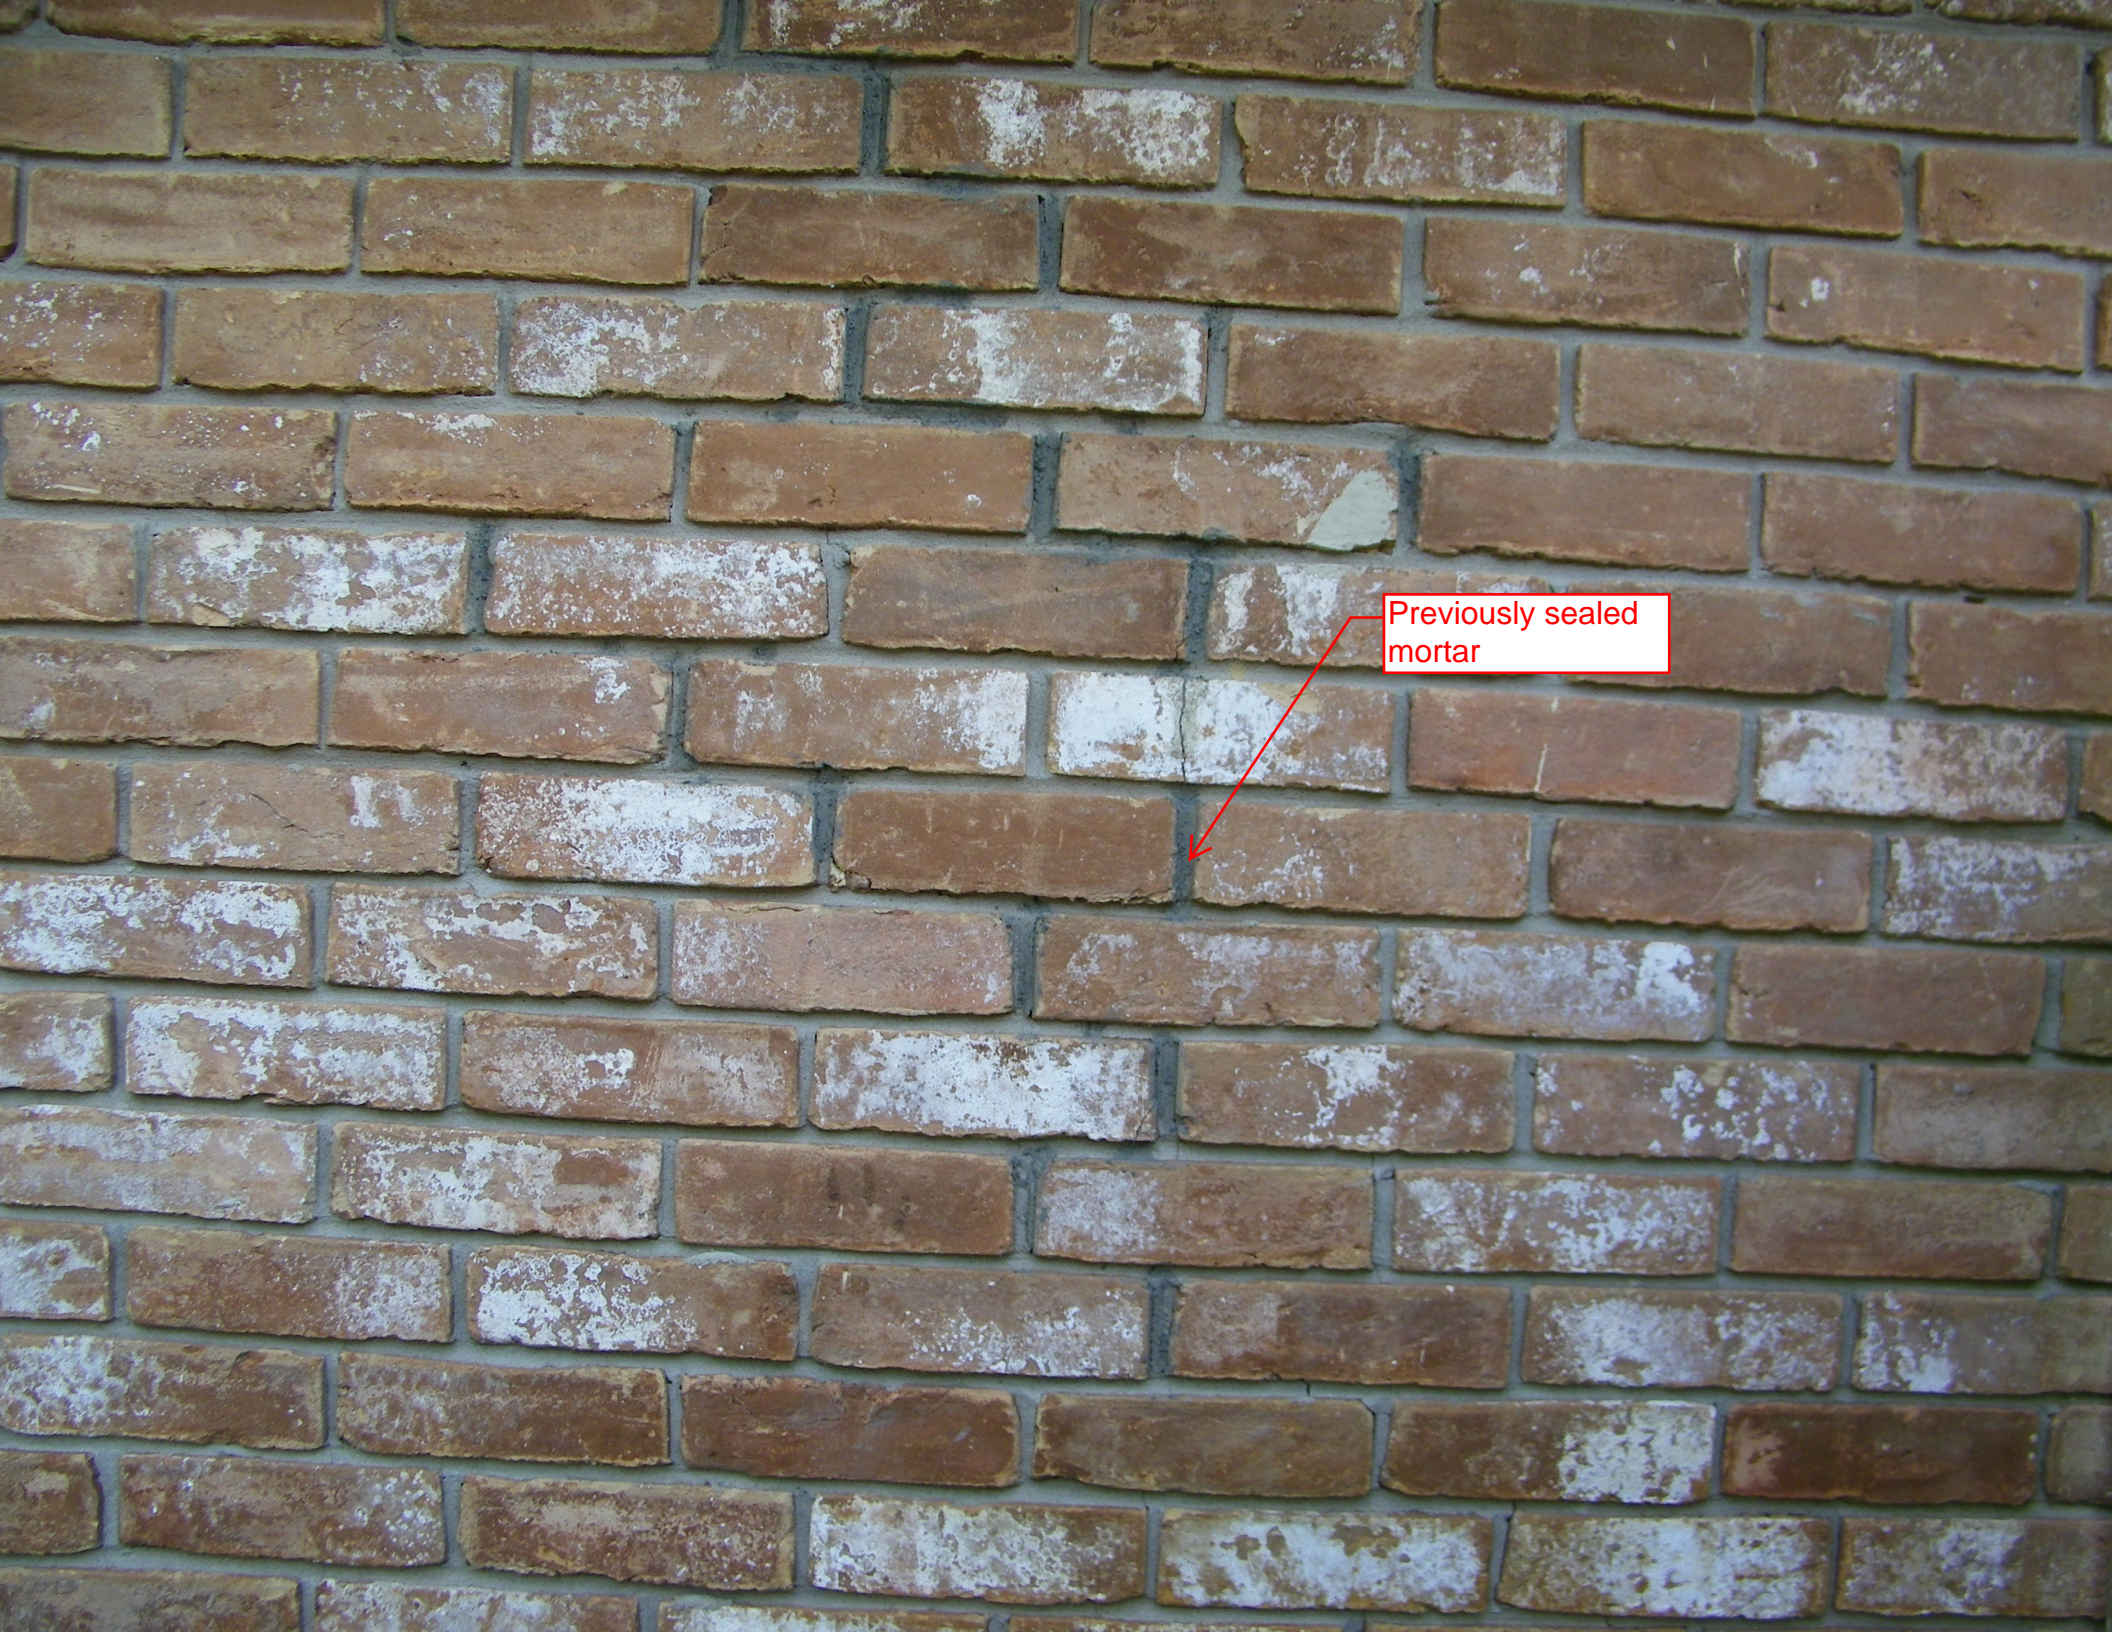
Previously sealed mortar
