HOME INSPECTION REPORT

**301 River Landing Dr
Slidell, LA 70461**

Inspection Date:
Wednesday, February 15, 2017

Email:
Vic@a-pro.net
Report Number:
0220170162

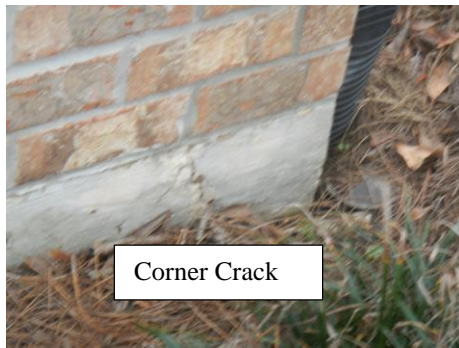
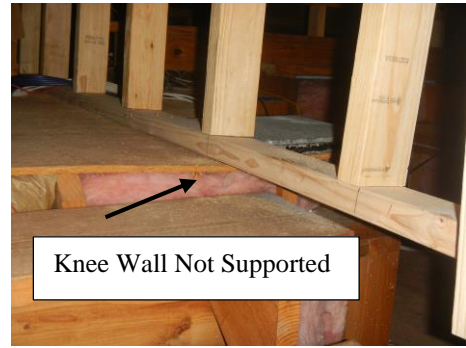
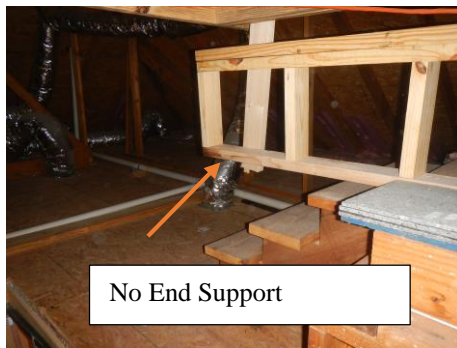
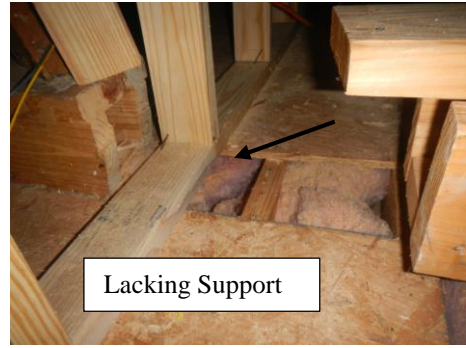
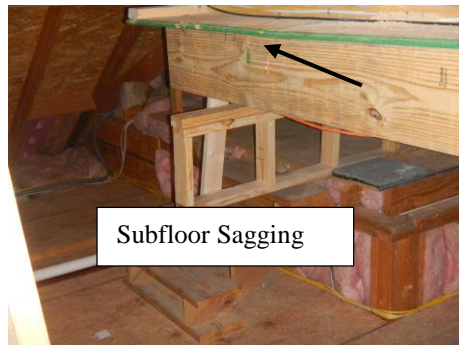
- **Major Concern:** The floor structure has experienced some sagging on the northeast corner of the media room. The knee wall and subfloor do not appear to be properly supported. The attic decking and media room subfloor are sagging. This is usually the result of the framing design of the building. A structural engineer/contractor should be consulted to determine the type and cost of repairs.

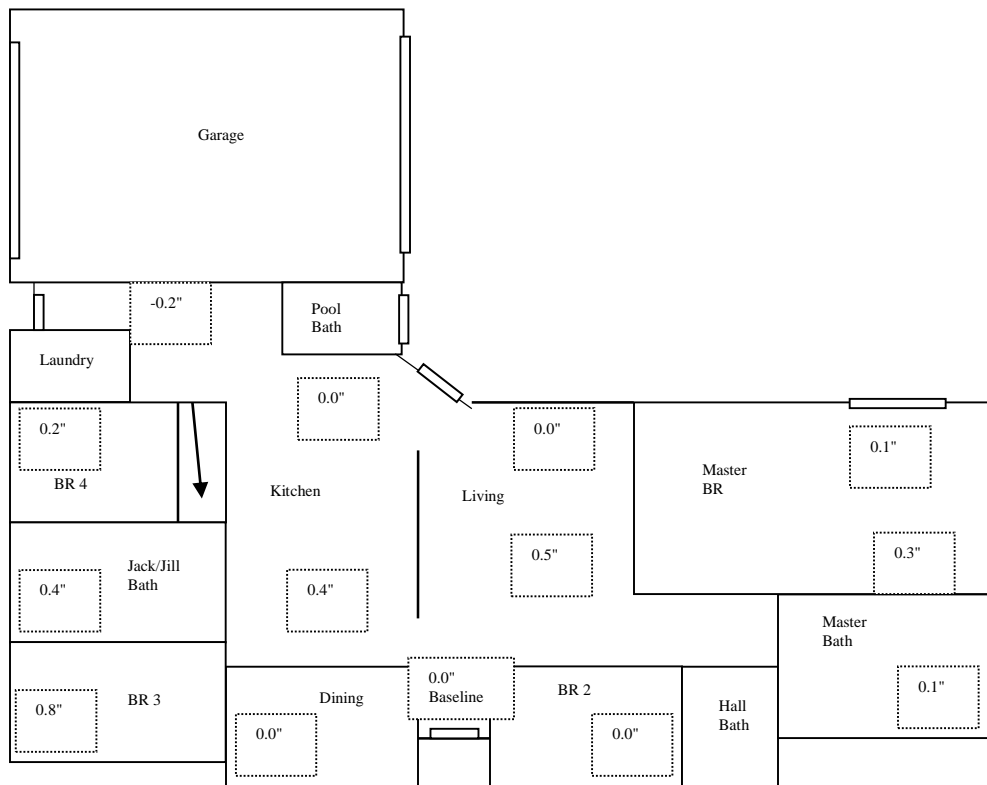
FLOORING ELEVATION SURVEY

There was a flooring elevation differential of 1.0 inches at the time of the inspection. This is within acceptable limits for a home of this age and construction. Floor covering thicknesses were not deducted.

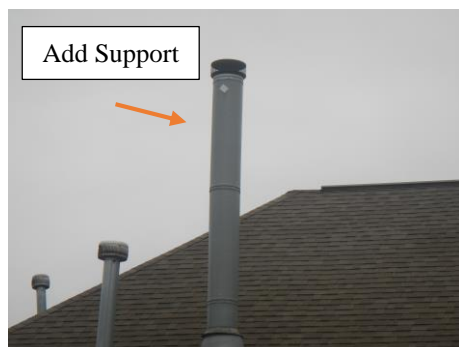
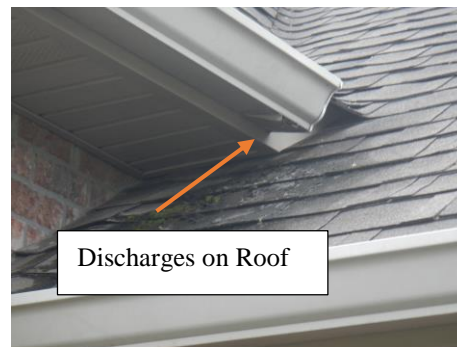
- **Improve:** Downspout(s) that discharge onto the roof should be extended to discharge directly into the gutters below. This condition, if left unattended, can result in premature deterioration of the roofing adjacent to a downspout.

- **Improve:** The metal chimney should be braced in order to ensure its stability in heavy winds.

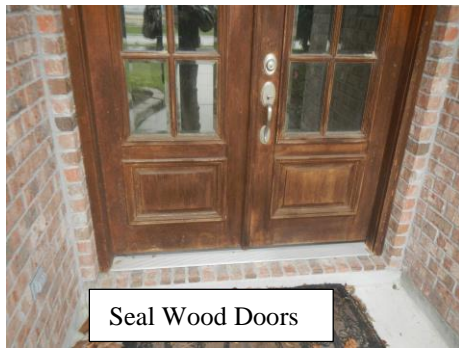
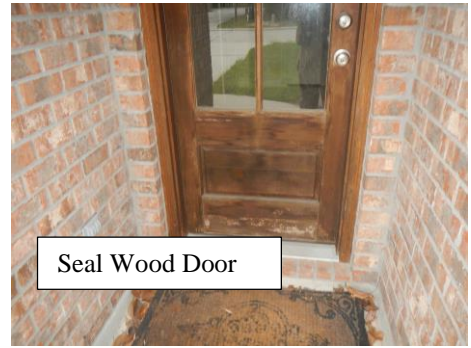
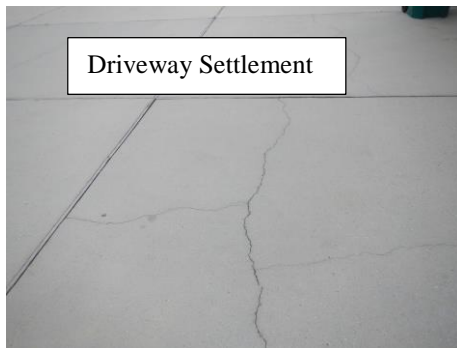
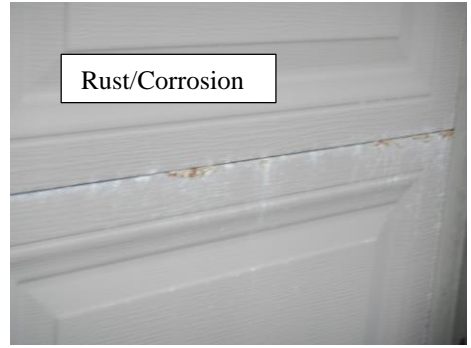
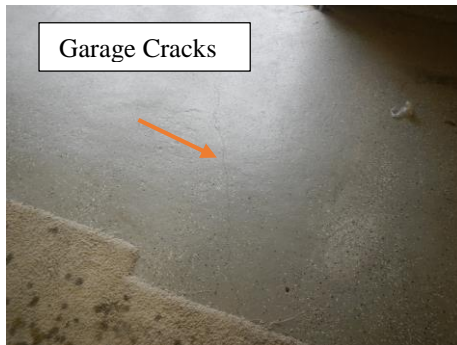
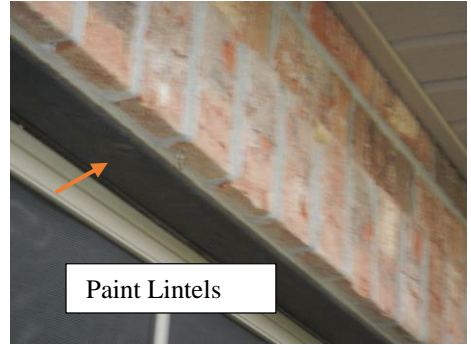
- **Improve:** The wood exterior door(s) should be resealed to protect the door from damage.

- **Improve:** The lentils (in effect, the metal beams supporting the brickwork above openings in a wall) should be painted in various locations.

- **Monitor:** The soil below the driveway has settled and/or heaved in various locations. Persisting movement may result in the need for resurfacing.

- **Monitor:** The garage floor slab has typical cracks. This is usually the result of shrinkage and/or settling of the slab.
- **Improve:** The metal overhead garage door should be prepped and painted as necessary. Surface rust and minor damage was noted on the north door.

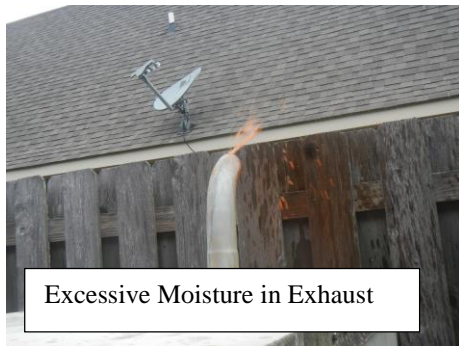
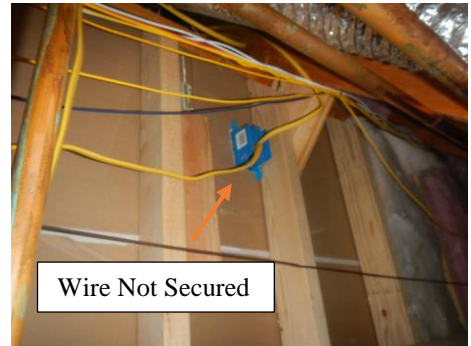
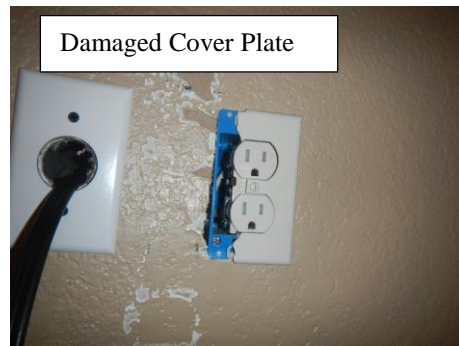
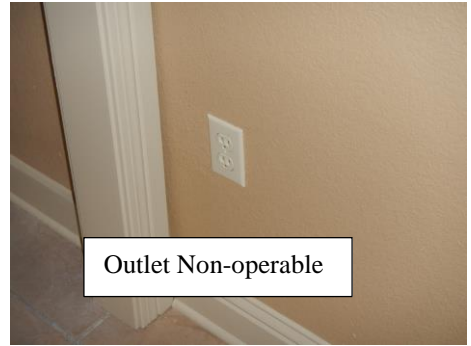
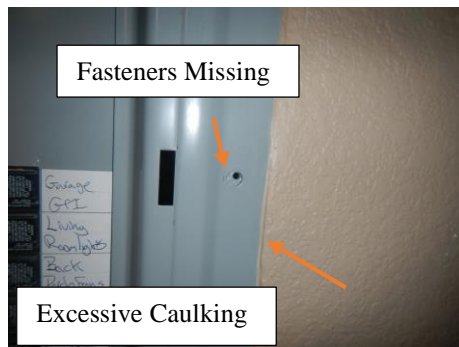
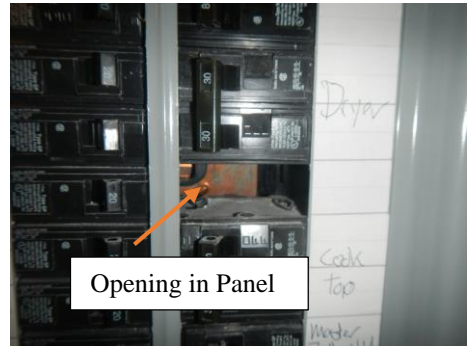
- **Improve:** The generator requires servicing. Heavy condensation was noted from the exhaust when testing.

- **Improve:** An outlet in the fourth bedroom is inoperative. This outlet and circuit should be investigated.
- **Improve:** The damaged outlet cover plate in the media room should be replaced.

- **Improve:** Loose wiring behind the second floor bathroom should be secured. The wiring exiting the junction box should be secured.

- **Improve:** The damaged light switch in the living room should be repaired/replaced. The recessed lights would blink when operating. The lights would not turn off.
- **Monitor:** The inoperative light switches in the foyer, third bedroom, rear entry door and kitchen may need to be repaired. These switches may be connected to an outlet or light fixture not currently in use. If this is not the case these circuits should be investigated.

- **Improve:** Any openings in the auxiliary panel should be covered.
- **Improve:** Missing fasteners on the distribution panel should be replaced.

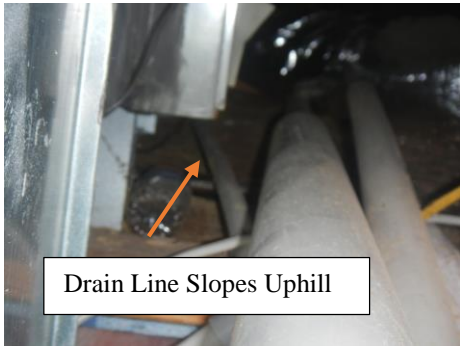
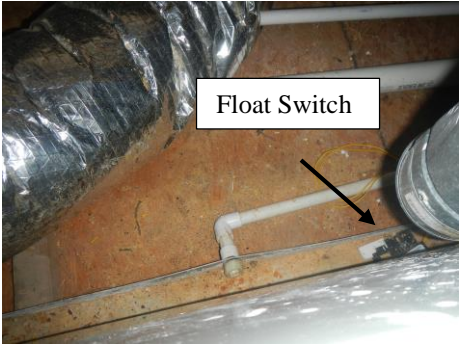
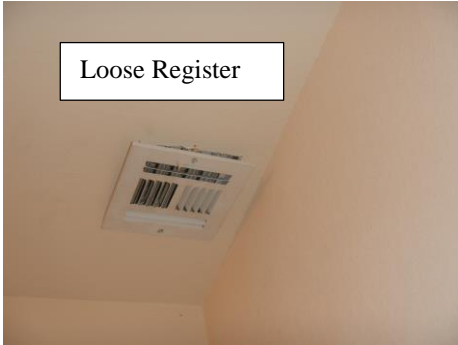
- **Improve:** In order to reduce the potential for water damage, it is recommended that the condensate drain line be improved on the auxiliary drain pan to act as a primary drain and maintain the float switch as a secondary shutoff device. The drain line flows uphill and the float switch is laying in the bottom of the pan.
- **Monitor:** The air conditioning system(s) should be tested once the outside temperature permits. The outside temperature should be above 60 degrees F before the unit can tested.

- **Improve:** The loose supply register in the Jack and Jill bathroom closet should be better secured.

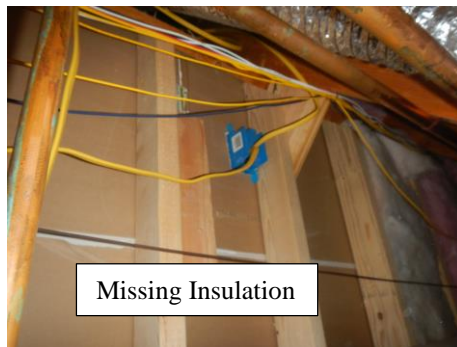
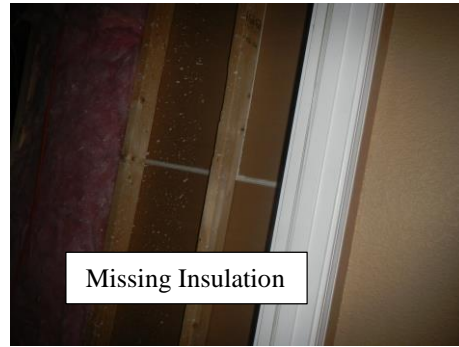
- **Improve:** Missing insulation on the walls in the main attic should be replaced.

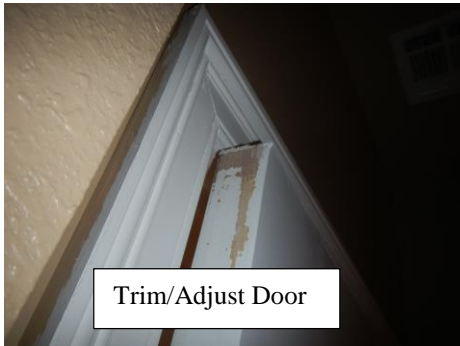
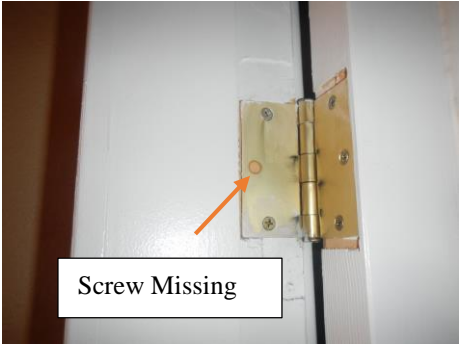
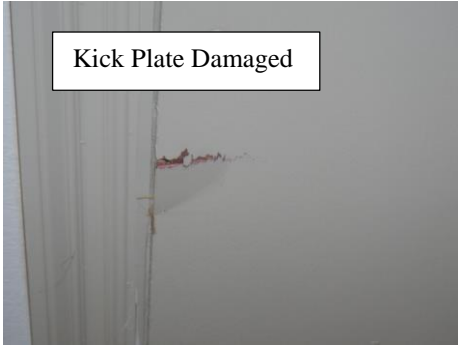
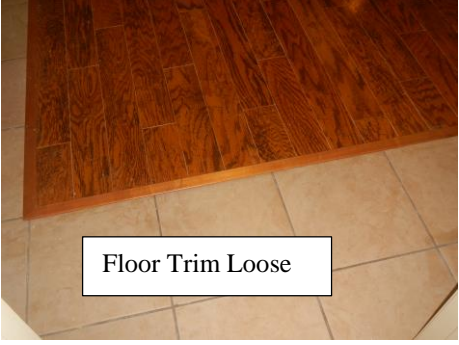
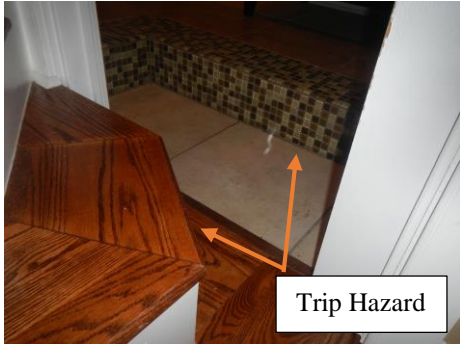
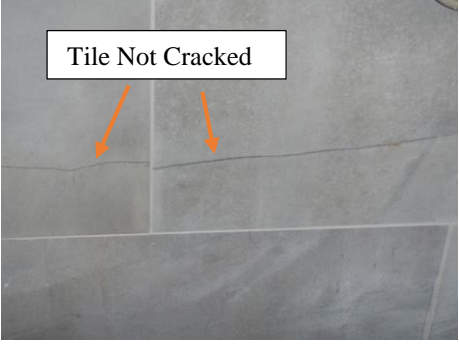
- **Monitor:** Typical drywall flaws were observed in the media room.

- **Improve:** Damaged or non-functional door hardware on the secondary entry door in the master bedroom should be improved. The bottom latch is stuck.
- **Improve:** One or more hinge screws are missing on the door in the media room.
- **Improve:** The door in the media room should be trimmed or adjusted as necessary to work properly.
- **Improve:** The door in the fifth bedroom closet should be trimmed or adjusted as necessary to work properly.

- **Safety Issue:** The transition from the stairs to the second floor bathroom is a trip hazard. Improvements should be made to reduce this condition. In the meantime, care should be taken when entering or exiting this bathroom.

- **Improve:** The attic pull-down stairs should be repaired for improved. The kick plate is damaged.

- **Improve:** The floor trim is loose in the fourth bedroom.
