## Structural Inspection

September 29, 2022

Ref: 436 Nighthawk Dr.  
Slidell, La. 70461

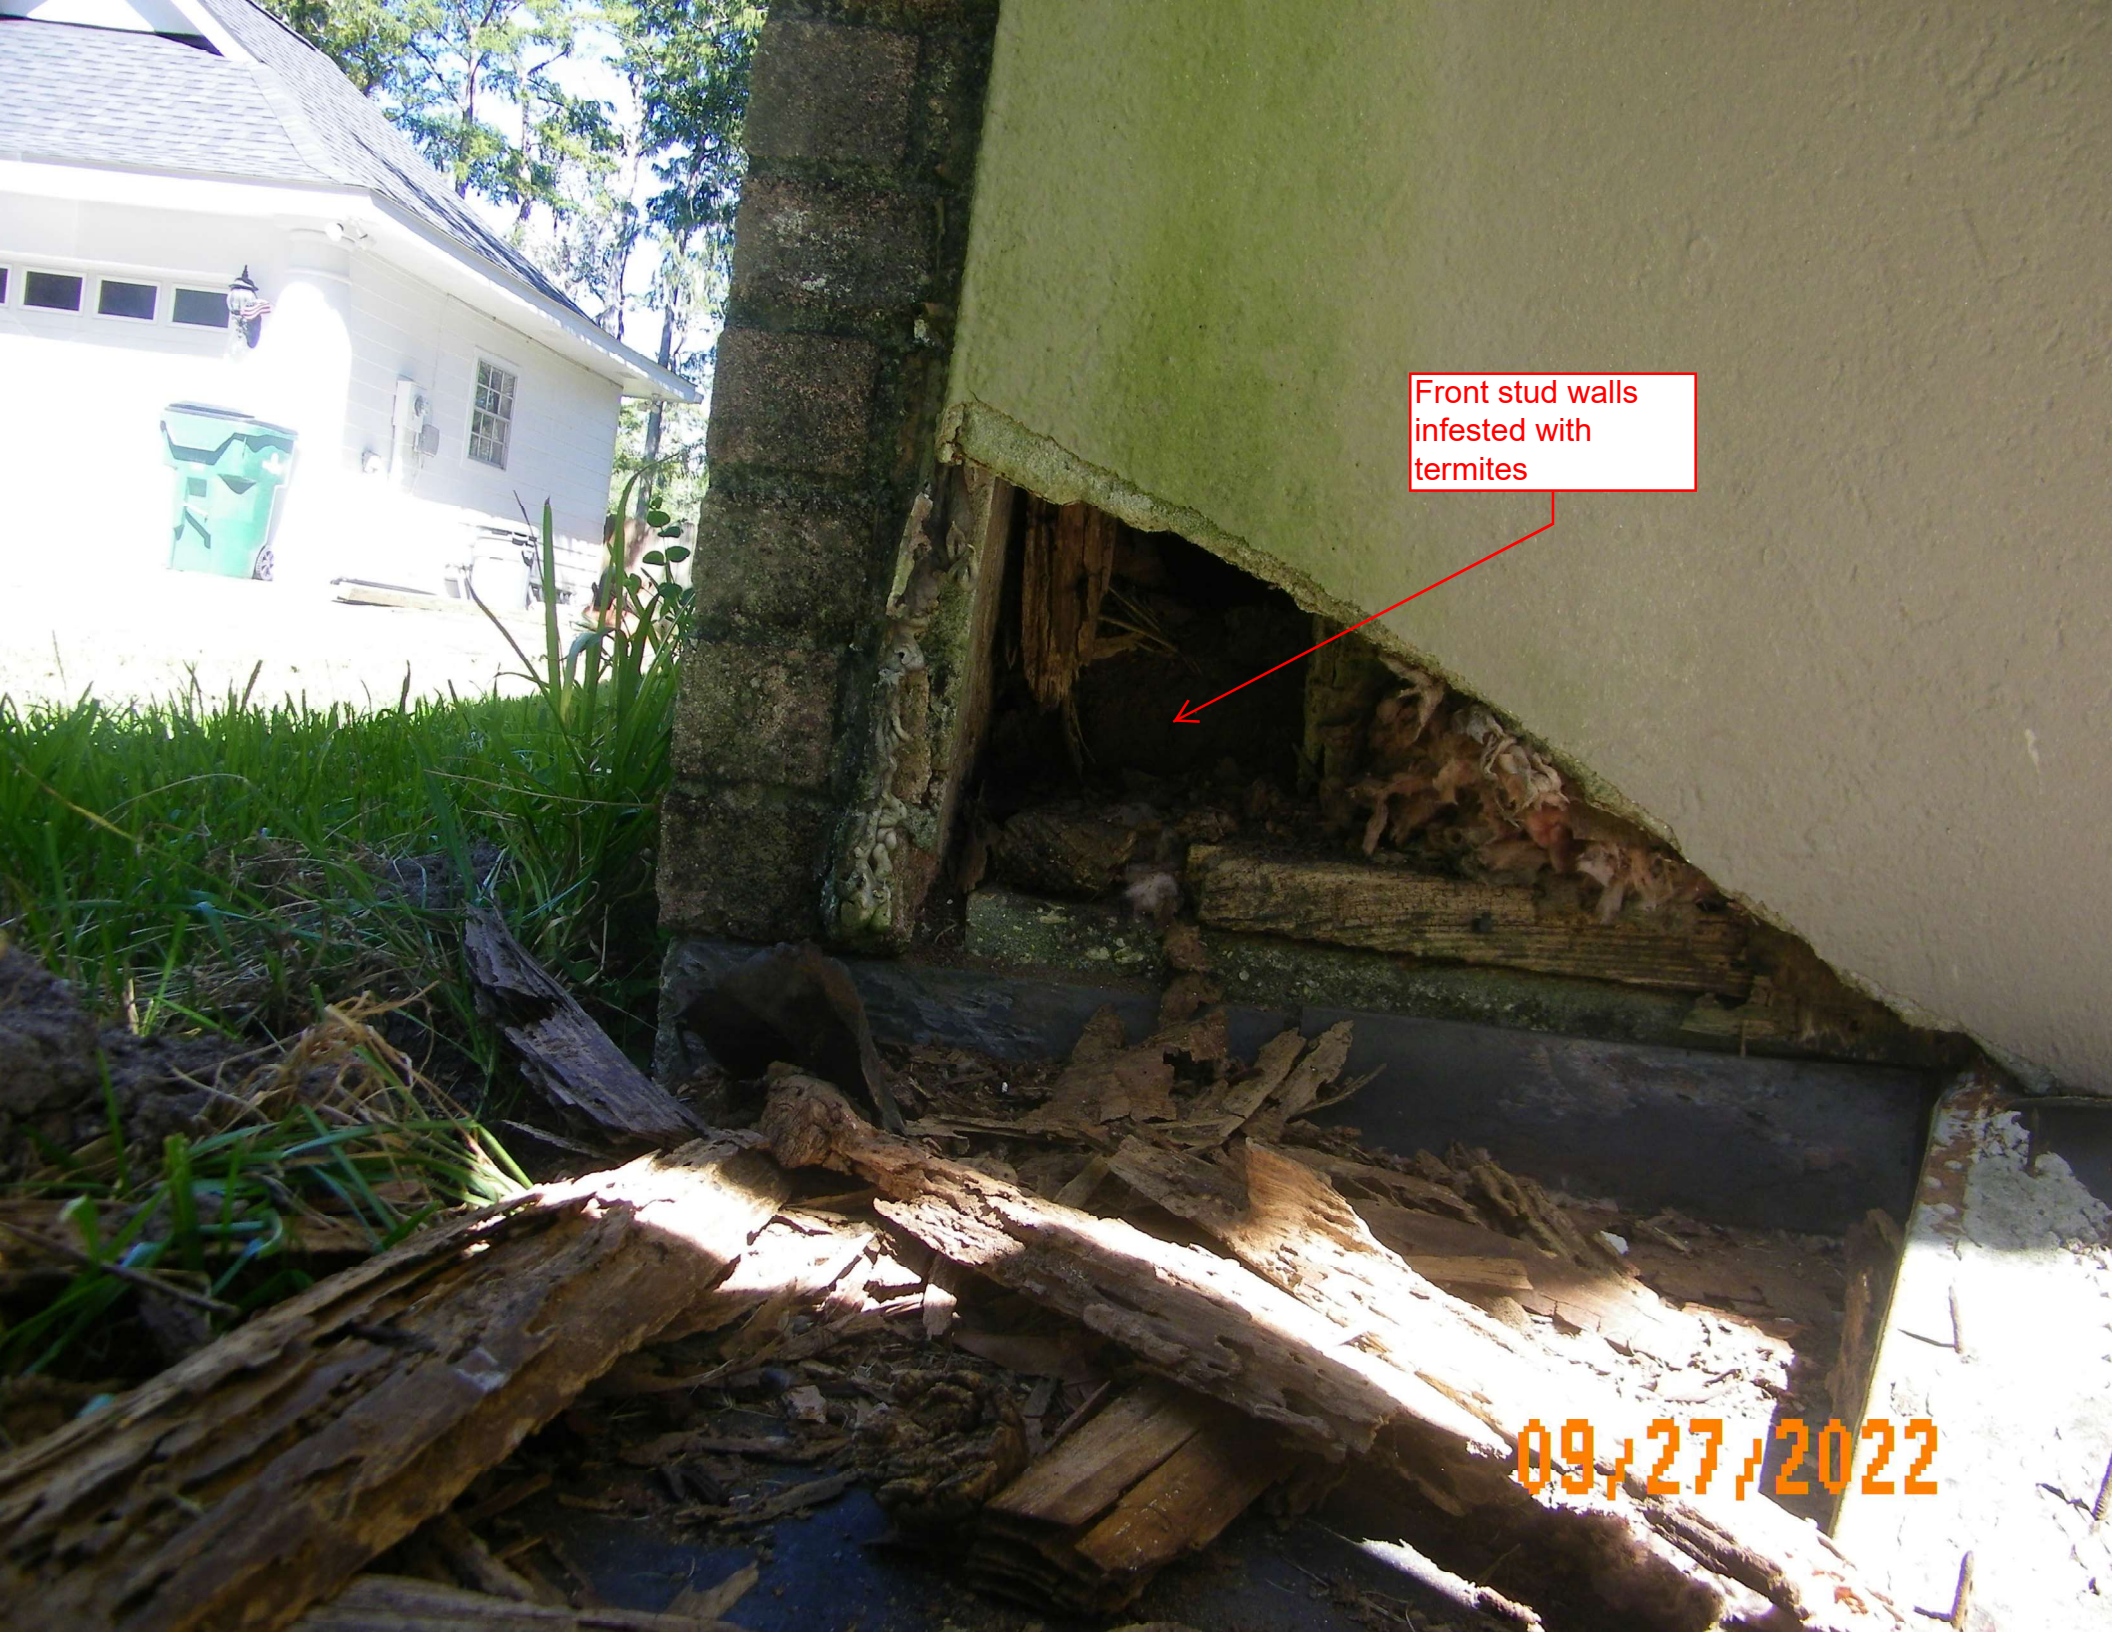
Front porch  
structural beam  
termite infested.

The home should be gutted to expose all the wood lumber that has been infested with termites and replaced with new lumber.

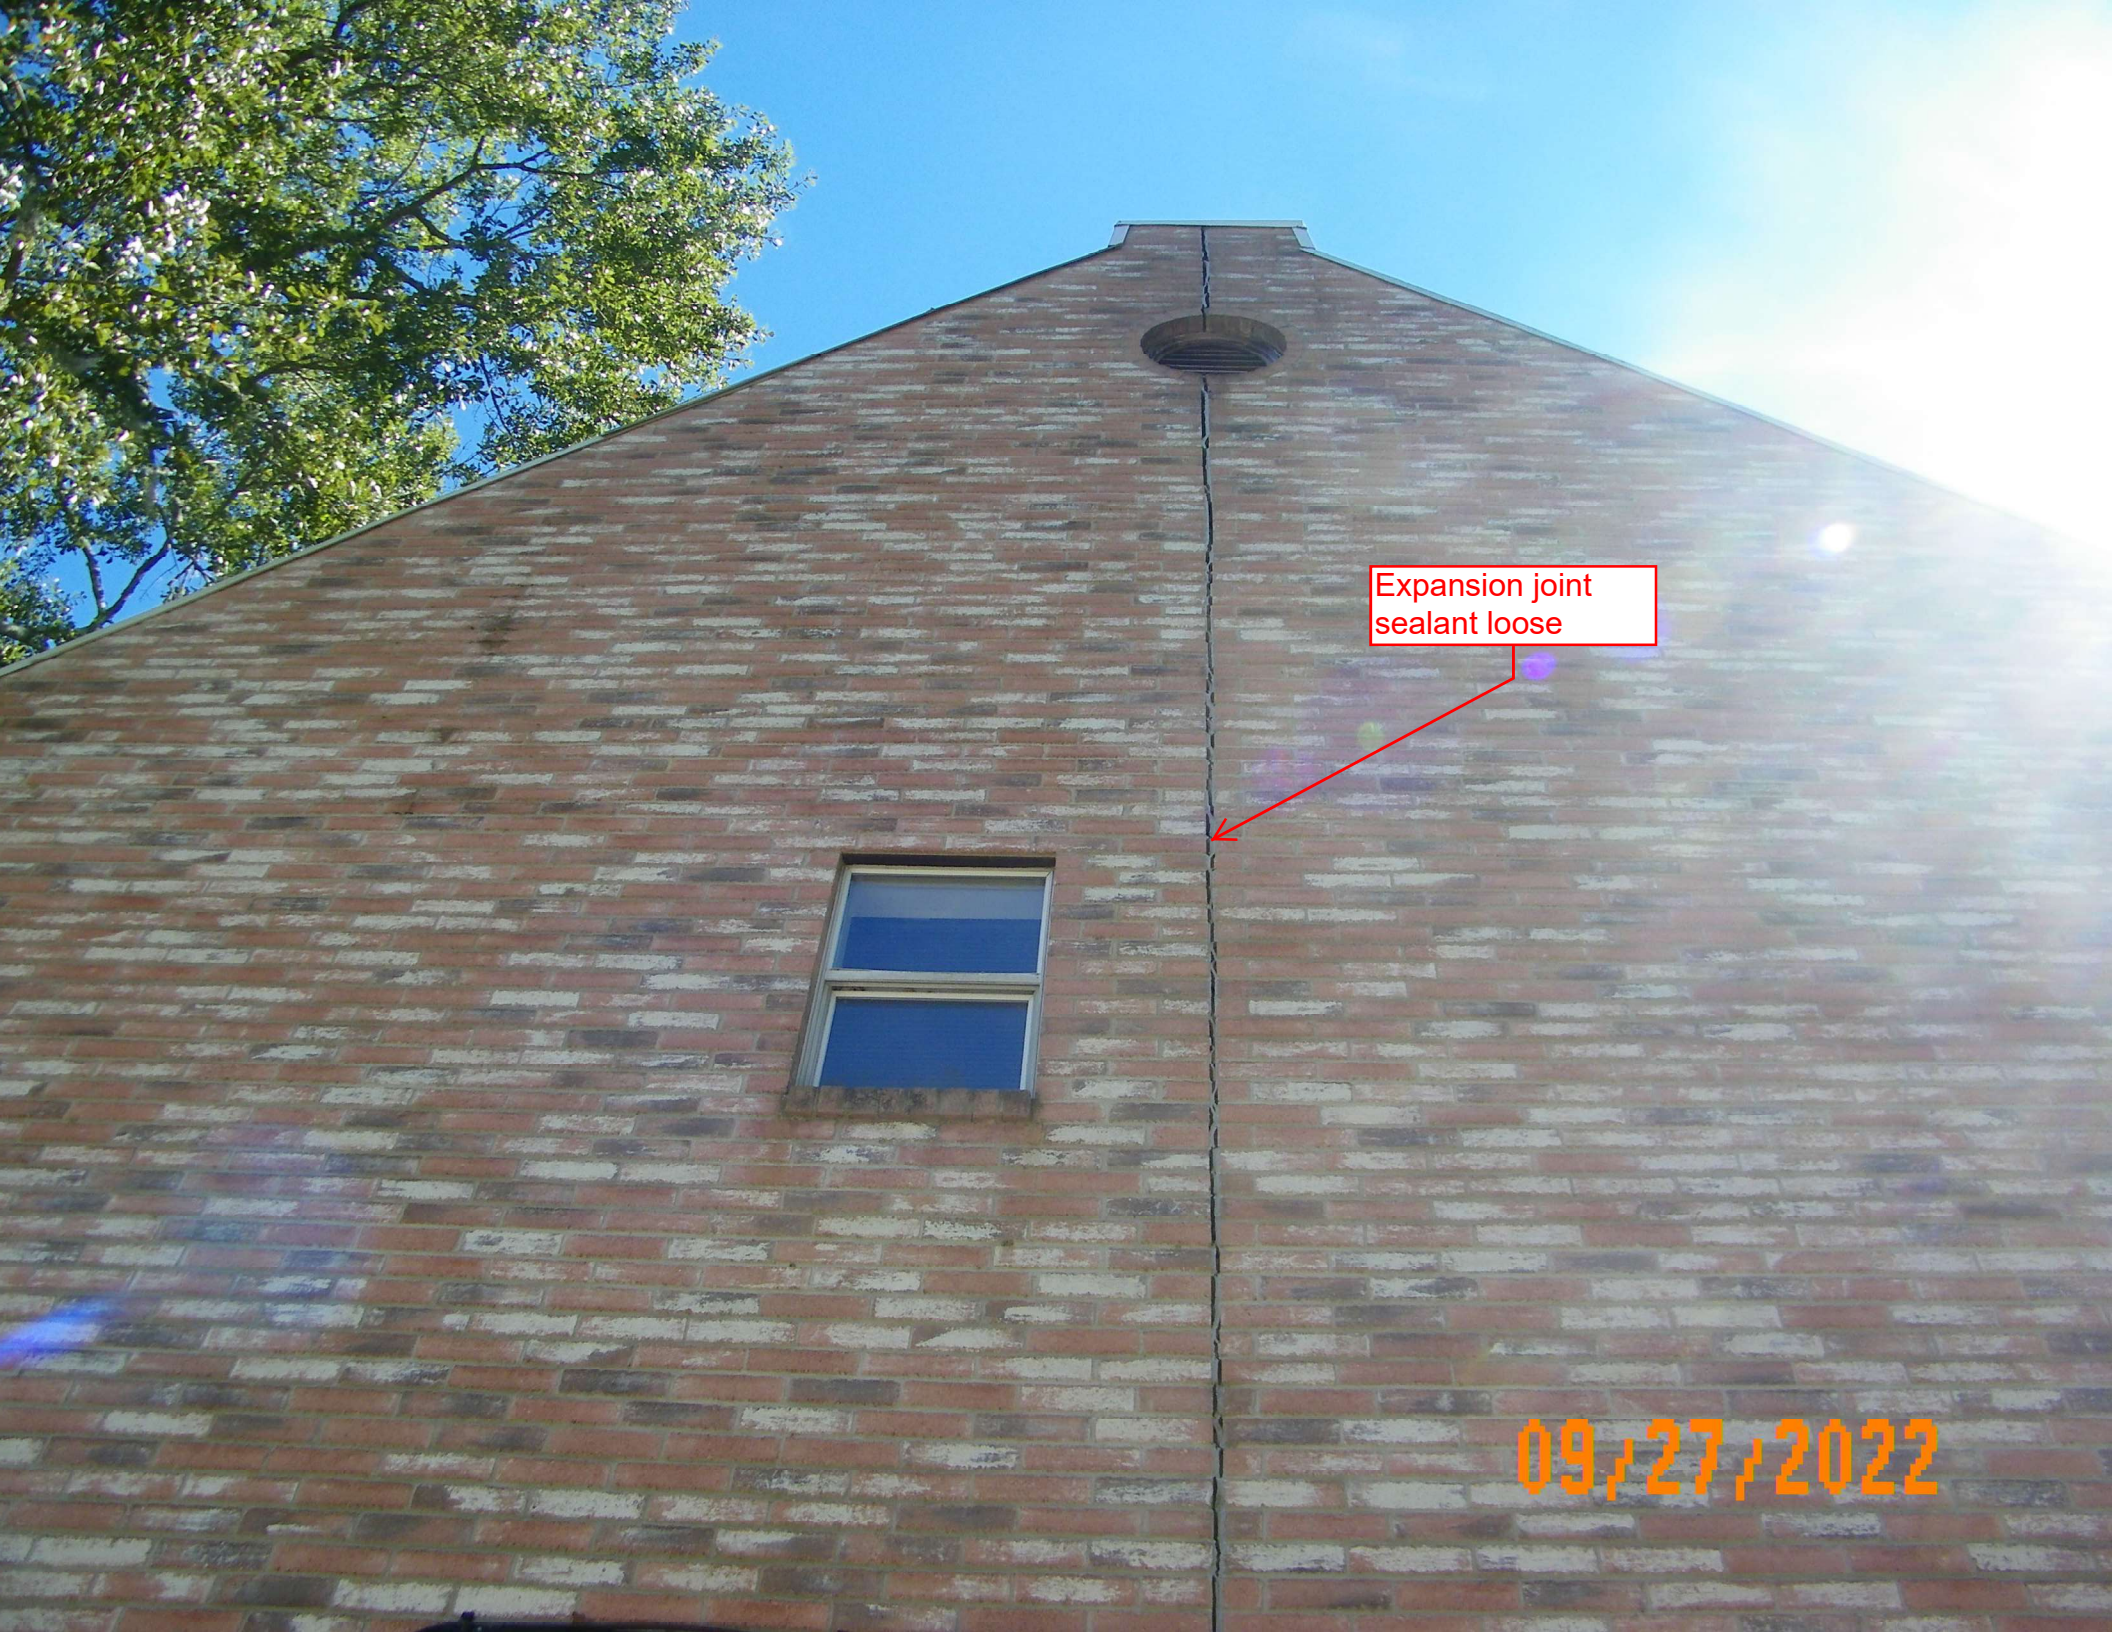
Front stud walls  
infested with  
termites

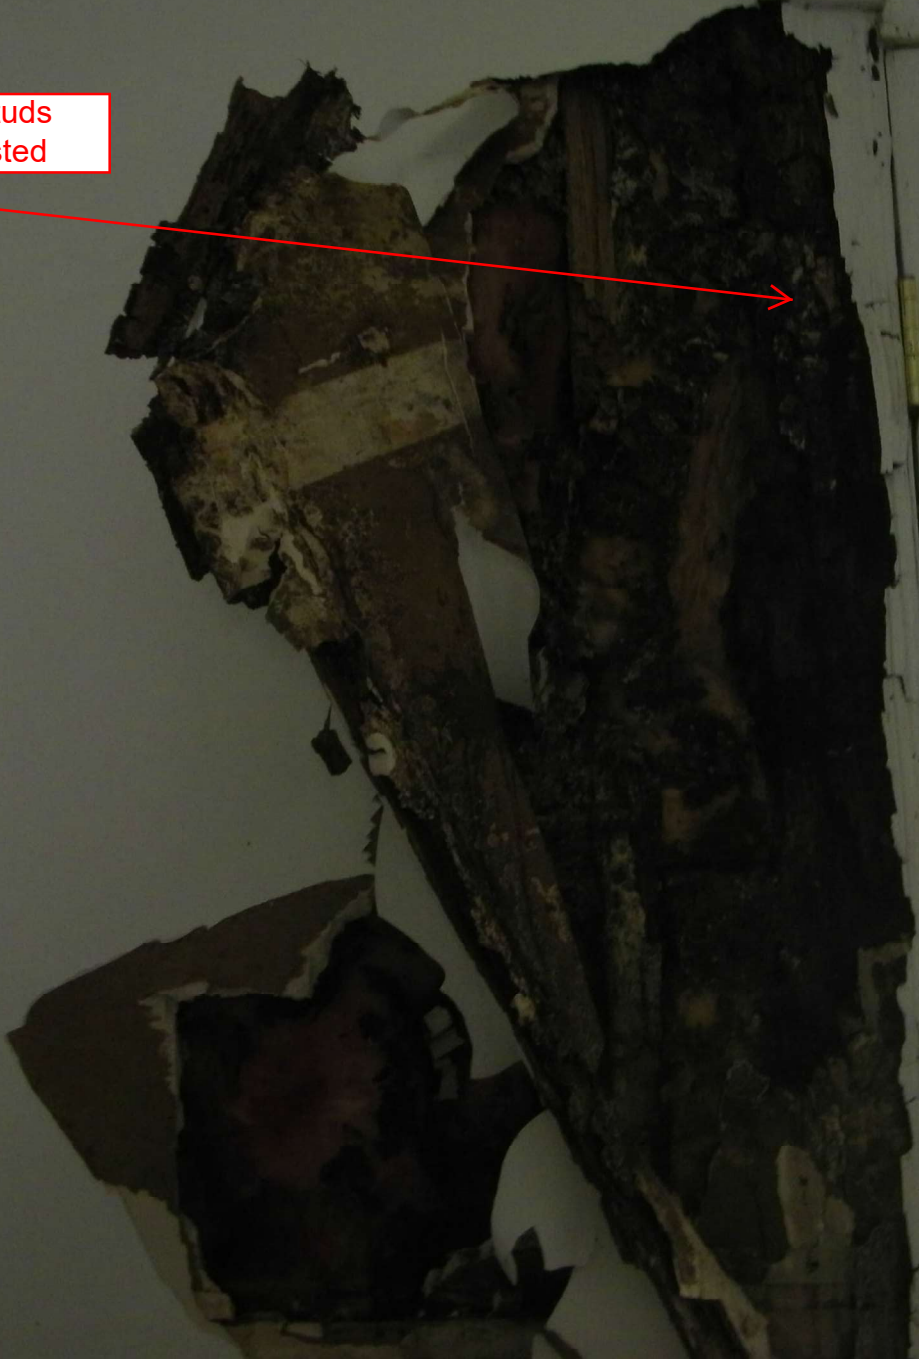
Front wall studs  
termite infested

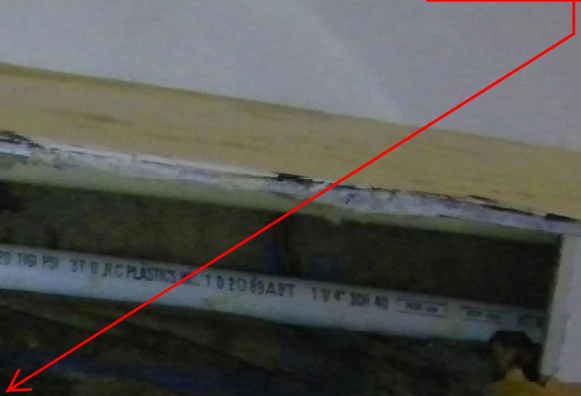
Termite infested  
2nd floor wood joist

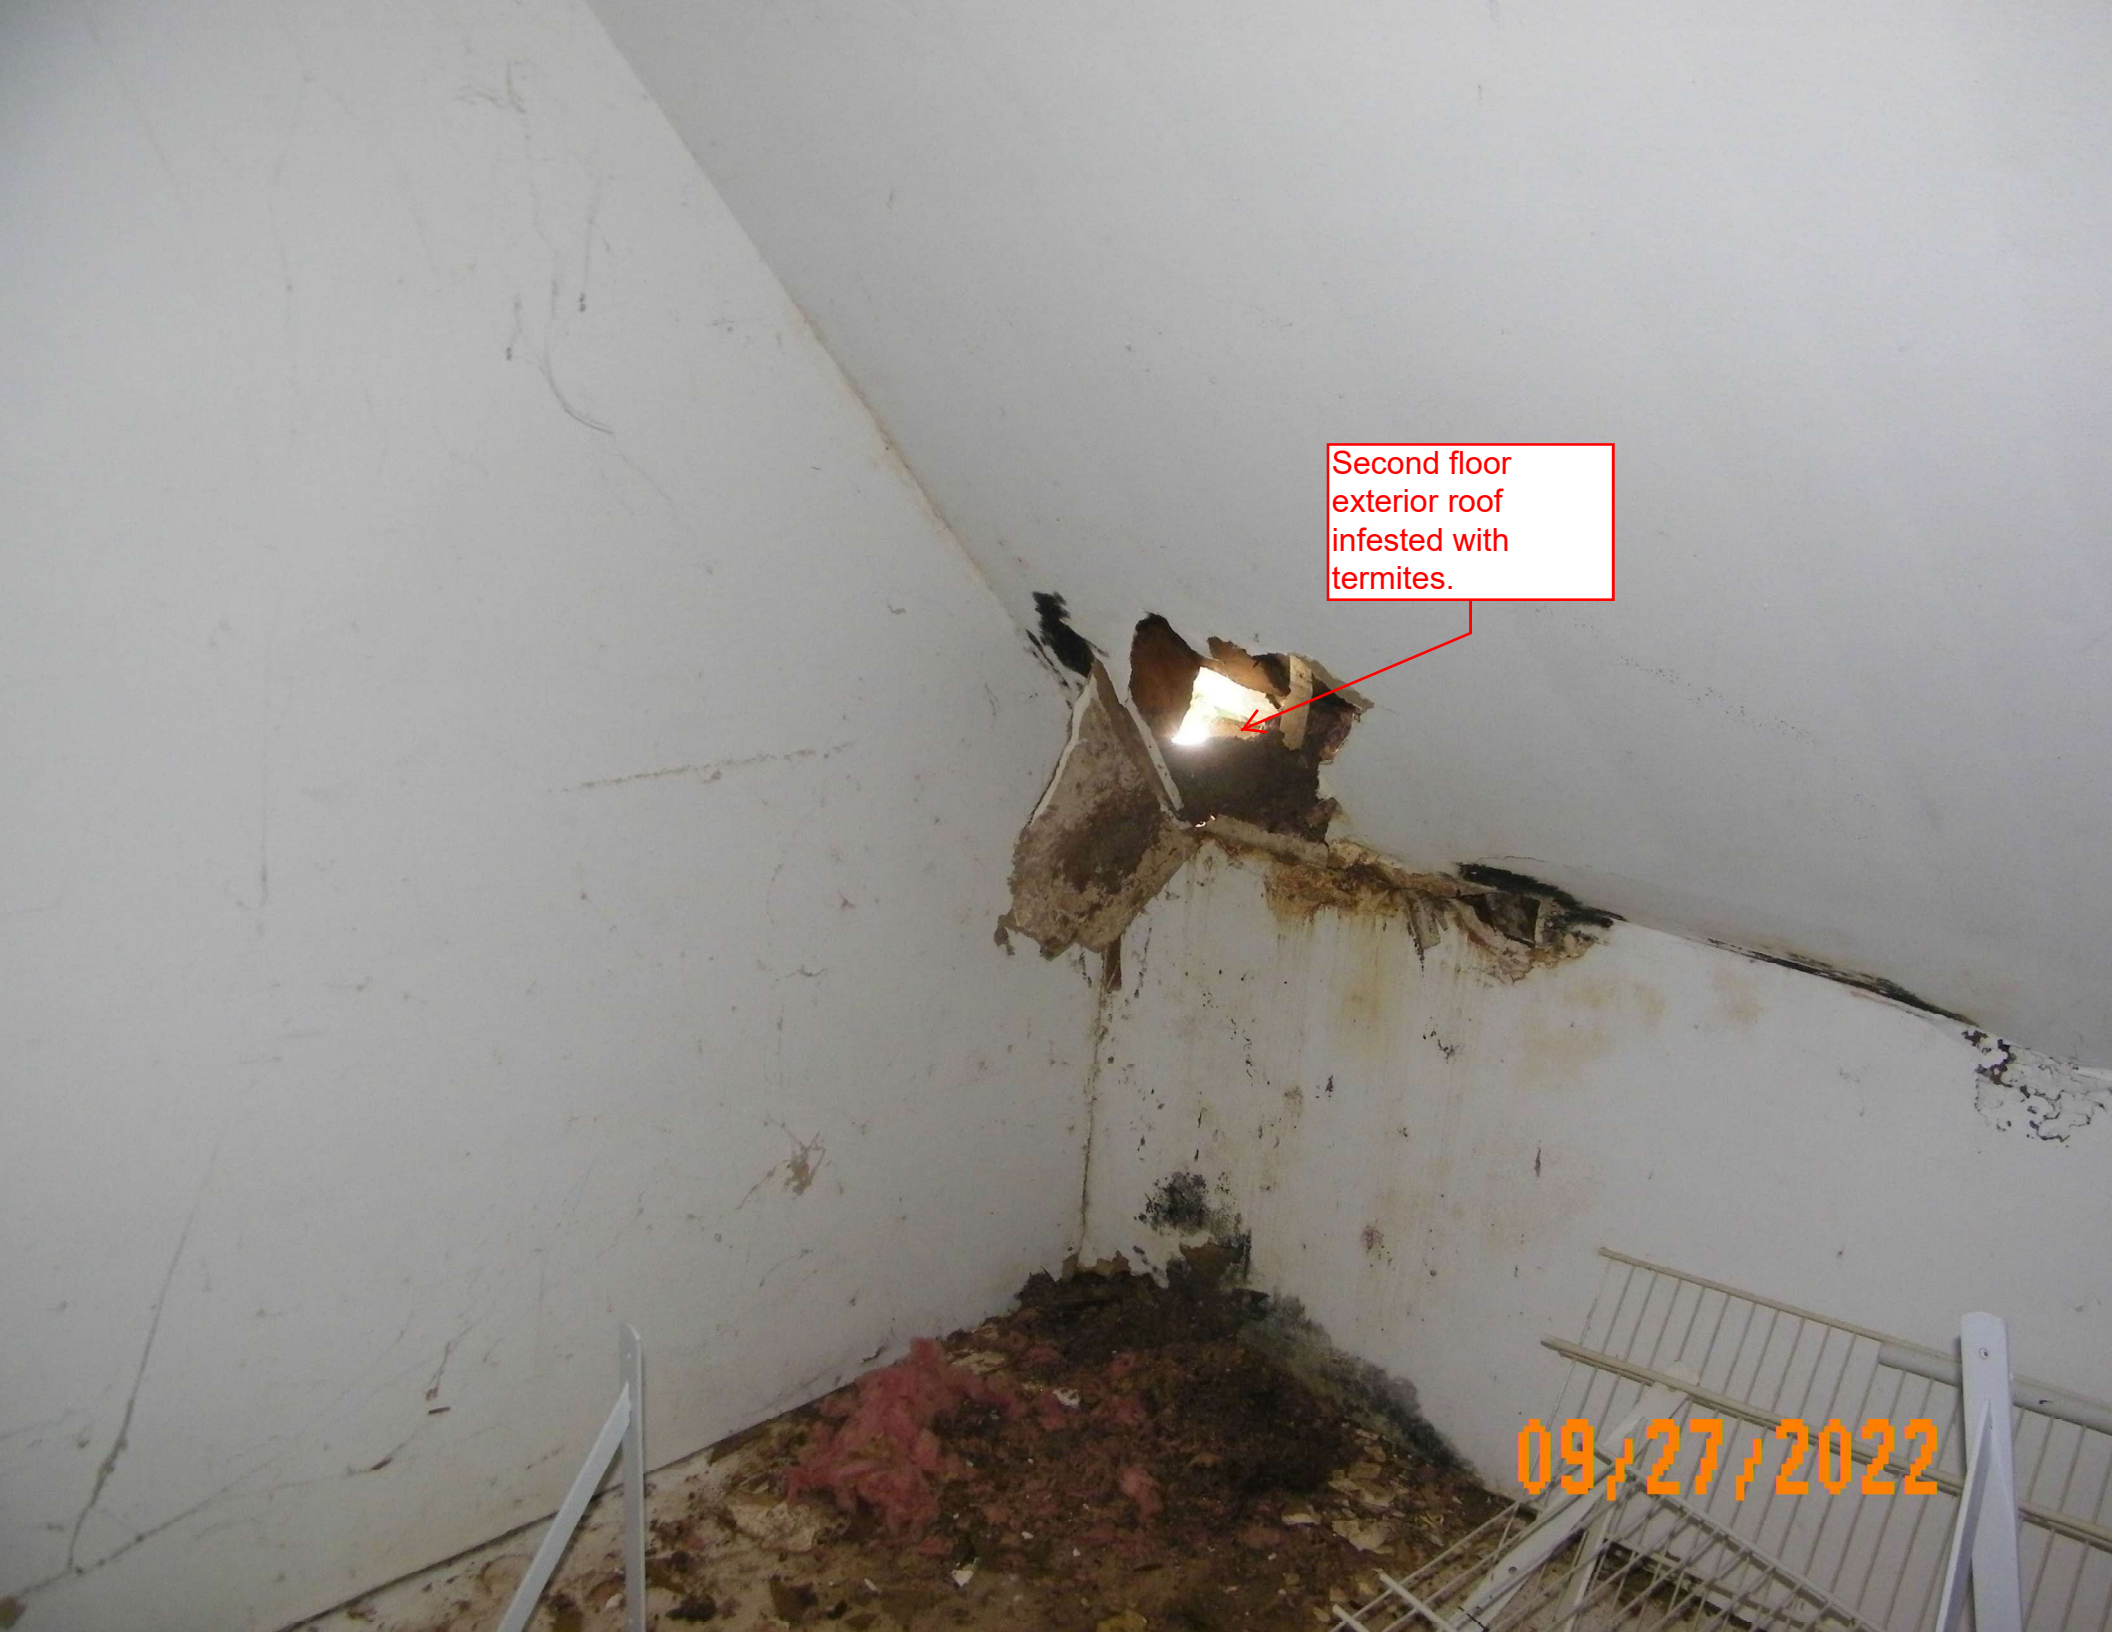
Second floor exterior roof infested with termites.
