550 Pontchartrain Drive, Slidell, LA

Inspection Date:
12/02/2016

Prepared For:
St Tammany Federal Credit Union

Report Number:
B-120216

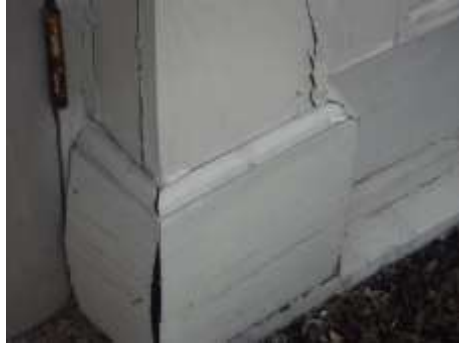
Figure 1 Trim materials need repairs.

Repair: Fascia and soffit materials need repair. Recommend a licensed contractor evaluate and give cost of repair. Brick walls are cracked in various locations and should be sealed. Consult with a licensed contractor for repairs.

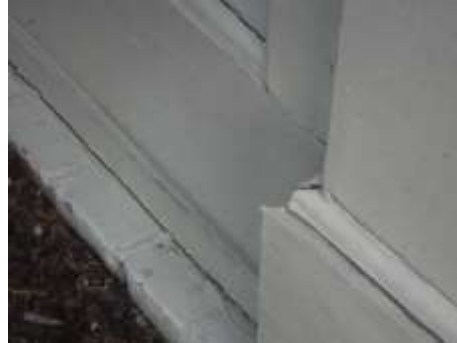
Figure 2 Trim materials need repairs.

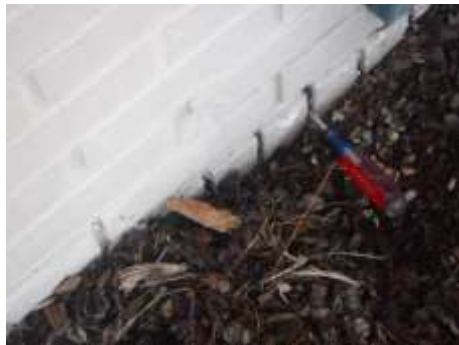
Figure 3 Weep holes need to be exposed and beds should drain in a positive direction away from the building.

Improve: Garden beds are too high and are covering the weep holes. This can cause damage to the walls. Recommend water drain at a positive fall away from the foundation.

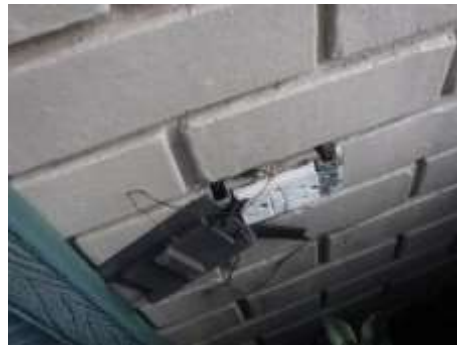
Figure 4 The GFCI outlet does not operate and the outlet needs a proper weather proof cover.

Repair: The front outlet to the left does not operate and is loose; it needs a proper weather proof cover.

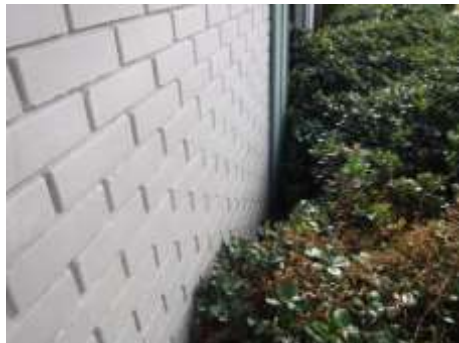
Figure 5 Trim bushes 18" back from the walls.

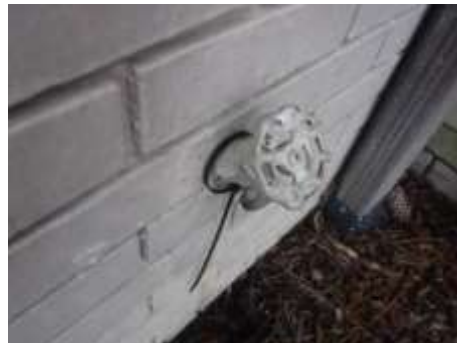
Figure 6 Recommend anti-siphon valves on the hose bibs to protect the water supply.

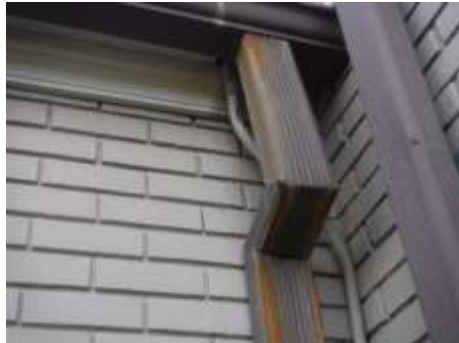
Figure 7 Gutters leak.

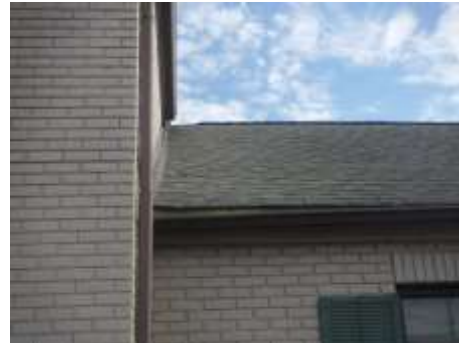
Figure 8 Gutters need proper slope and attachments are loose.

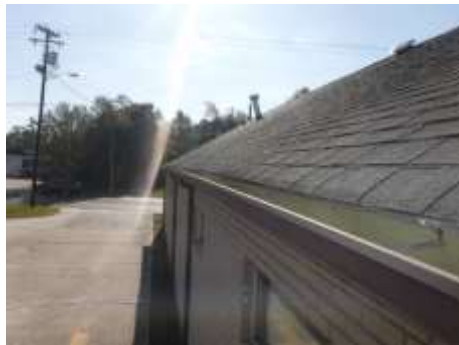
Figure 9 Improper slope and dented.

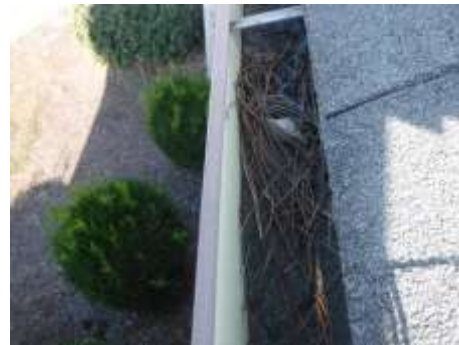
Figure 10 Gutters need cleaning.

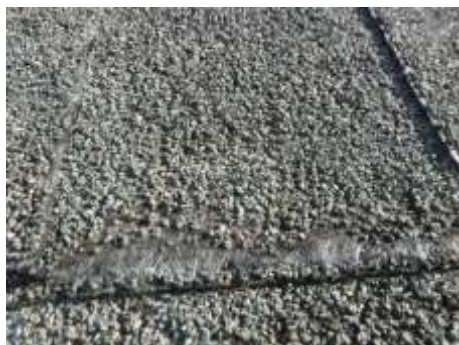
Figure 11 Roof has exposed fiberglass fibers and are brittle.

Repair: Roof is showing signs of wear. Shingles are broken, brittle, granules are missing and the flat roof at the rear appears to be leaking. Recommend a licensed roofer evaluate both roofs and make repairs. There is evidence of moisture damage decking in the attic to the left. Recommend additional ventilation, recommend operating fans and if possible, vents installed in the soffits to control moisture at the eaves.

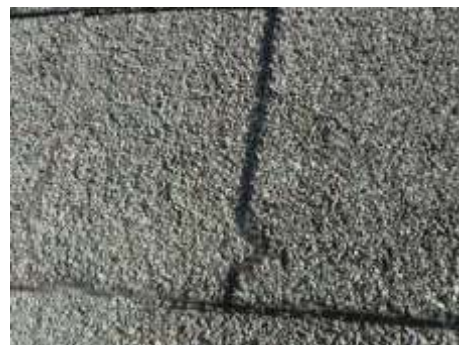
Figure 12 Shingles are damaged in various locations.

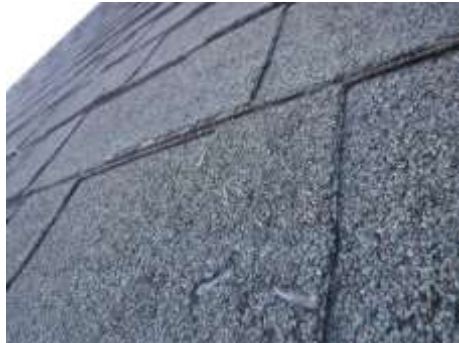
Figure 13 Same as 12; possible hail damage.

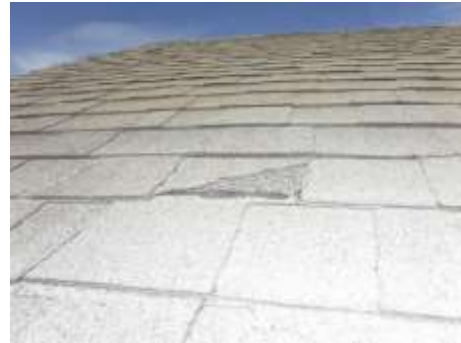
Figure 14 Broken shingles.

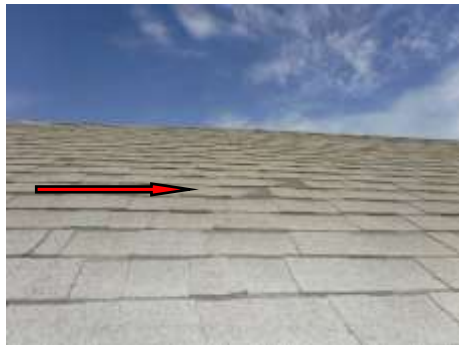
Figure 15 Broken shingle, recommend a roofer evaluate both roofs.

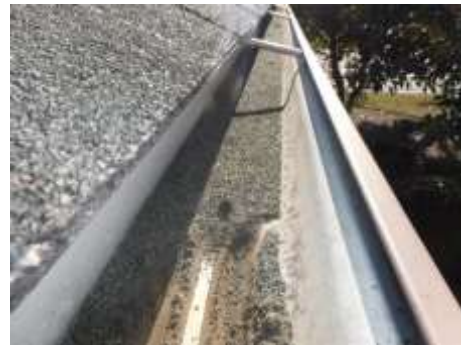
Figure 16 Shingles losing granules.

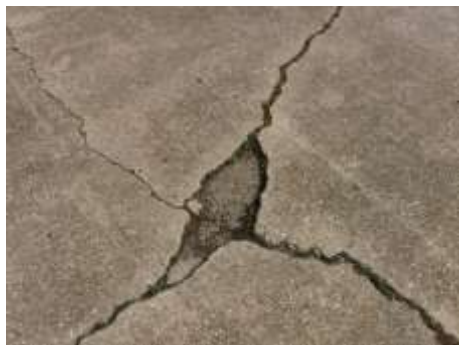
Figure 17 Driveway needs repairs in various locations. Possible trip hazard.

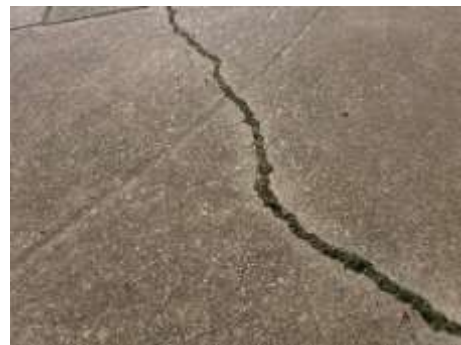
Figure 18 Seal the cracks to prevent a trip hazard.

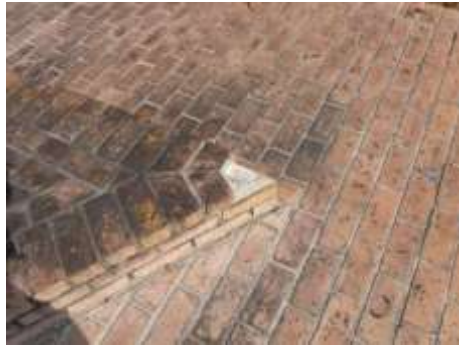
Figure 19 Missing bricks.

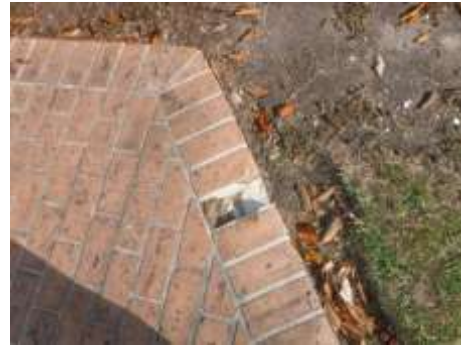
Figure 20 Missing bricks.

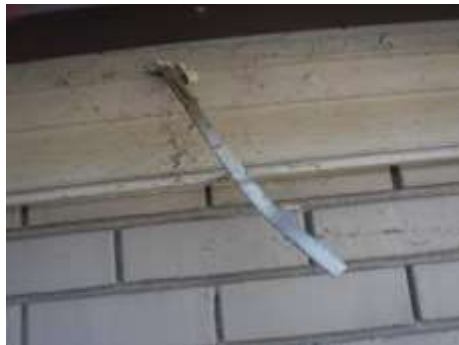
Figure 21 Wires should terminate in a box and cover or be removed.

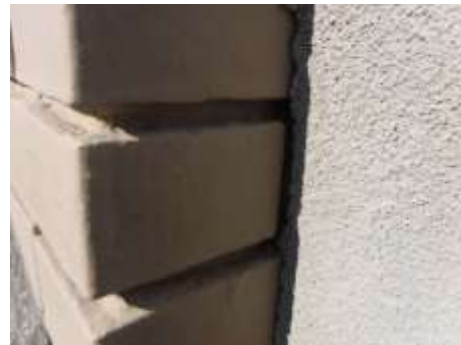
Figure 22 Caulk all vertical cracks where 2 different wall claddings meet, also caulk the windows and doors where the caulk has failed. Recommend a licensed contractor make all repairs.

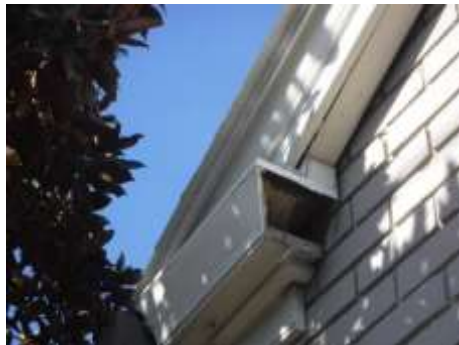
Figure 23 Soffits and fascia needs repairs, caulk and painting.

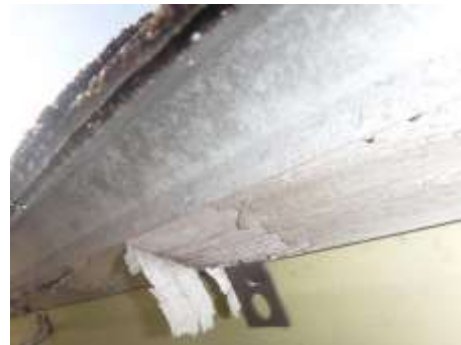
Figure 24 Fascia needs painting behind the gutters.

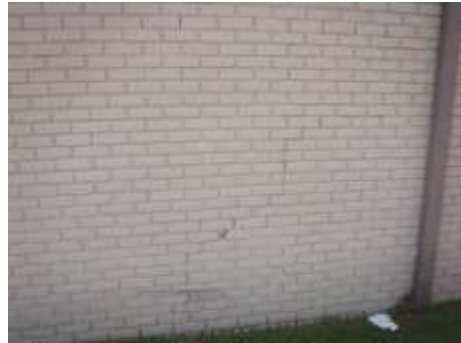
Figure 25 Typical brick cracks, recommend caulking.

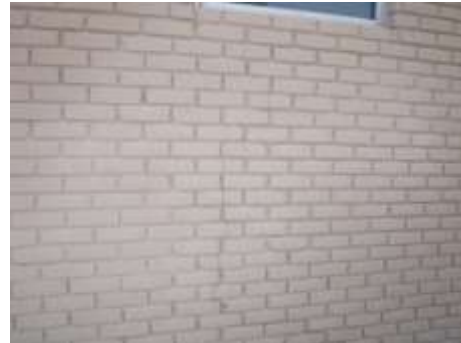
Figure 26 Same as 25 and cracks are in various locations.

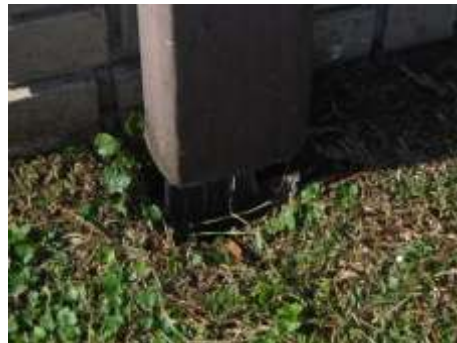
Figure 27 Recommend gutters terminate in a proper connector.

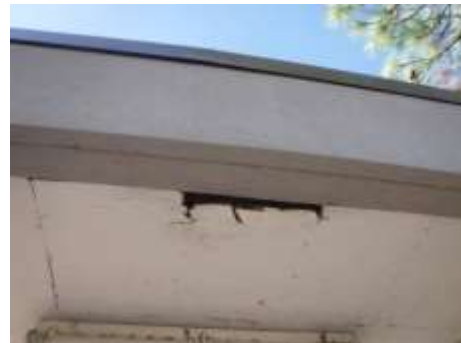
Figure 28 Soffit materials are rotten at the rear canopy, possible hidden damage; recommend a licensed contractor evaluate.

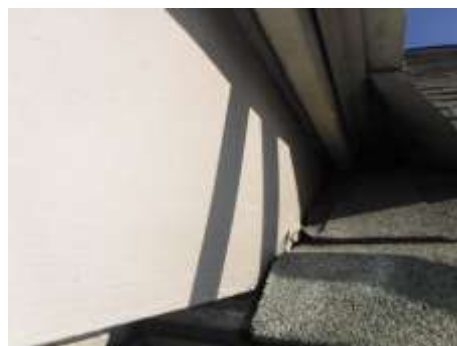
Figure 29 Should be a flashing at the fascia.

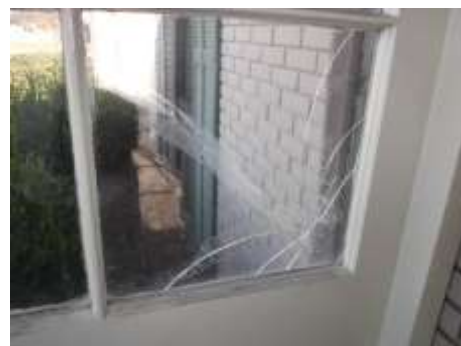
Figure 30 Cracked glass needs repairs.

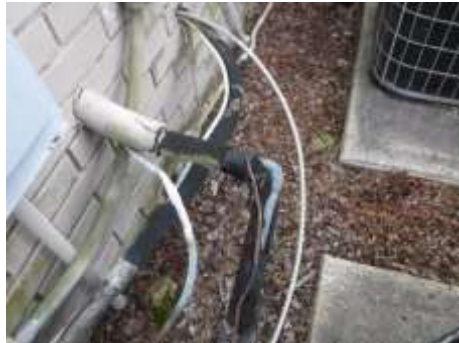
Figure 31 Lines need proper insulation.

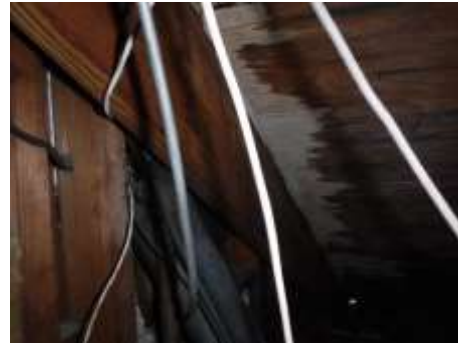
Figure 32 Moisture damage to the decking, recommend a roofer evaluate.

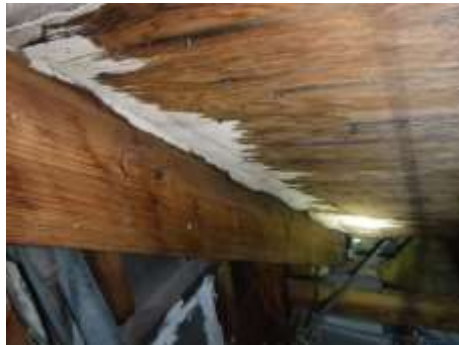
Figure 33 Same as 25.

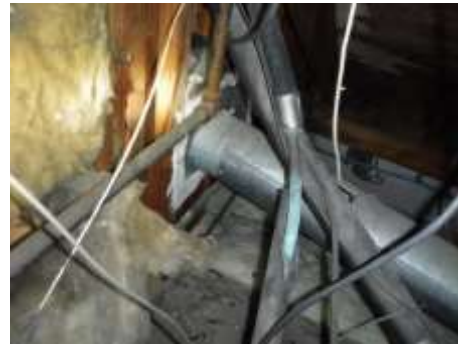
Figure 34 Refrigerant lines need insulation.

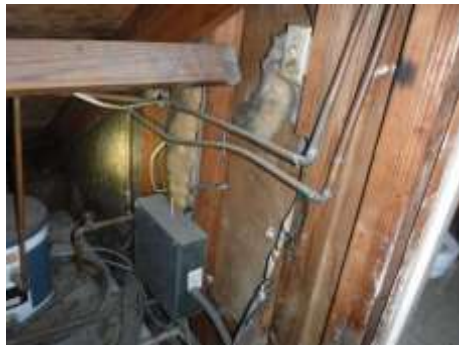
Figure 35 Replace all missing insulation.

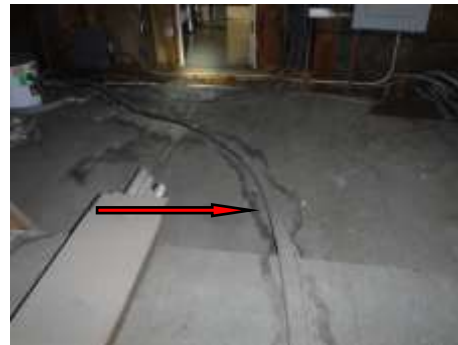
Figure 36 Refrigerant lines dripping.

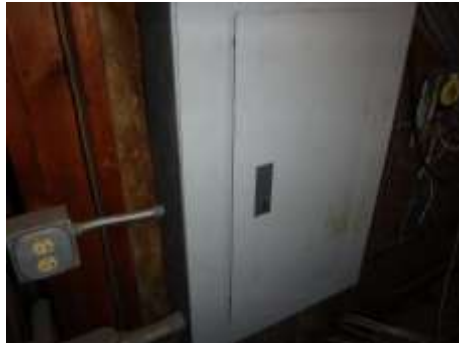
Figure 37 The lock does not operate.

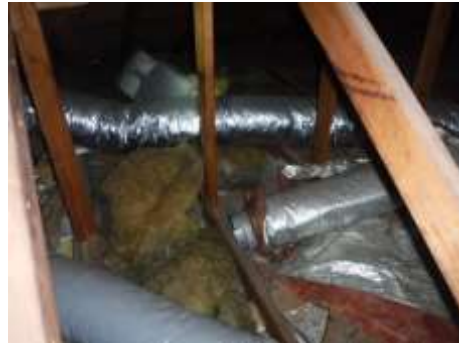
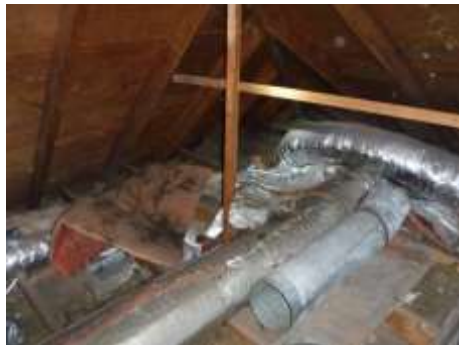
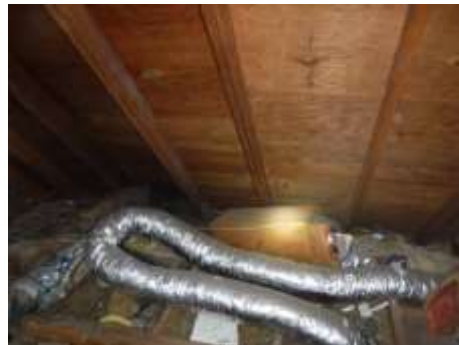
Figure 38 recommend all the debris be removed from the attic.

Figure 39 Same as 38.

Figure 40 Same as 38.

Improve: The attic is full of debris, which should be removed for safe access. There is an obsolete AC and heat unit with an active gas line I recommend be removed. Once the attic is cleaned, the fire barrier walls need to be properly sealed and replace any missing insulation. Also, remove the old electrical wires that are cut so that they may not be energized in the future. Fresh air intakes that have been dismantled need to be installed in their proper positions and vent all bath fans out of the attic. Install safe decking to access the attic where needed. Consult with a licensed contractor for repairs. See the photos.
Major Concern: The building has evidence of a fire; the trusses are charred and have been sprayed with a silver paint. I recommend a Structural Engineer evaluate. See the photos.

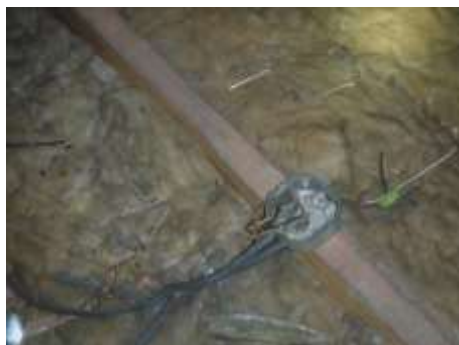
Figure 41 Remove all useless wiring.

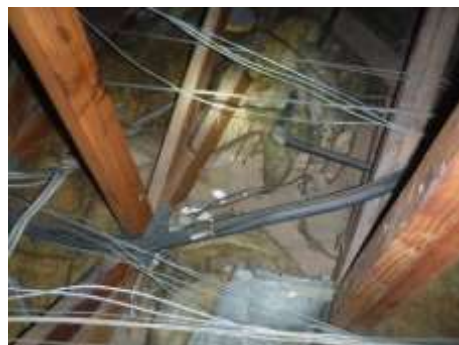
Figure 42 Replace missing insulation.

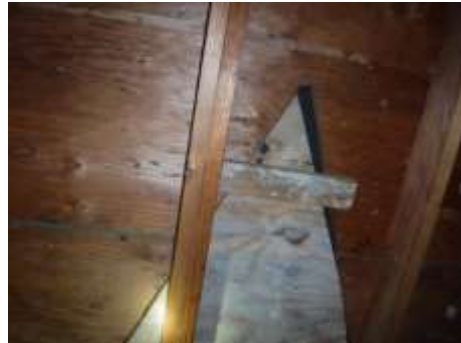
Figure 43 The attic needs additional ventilation.

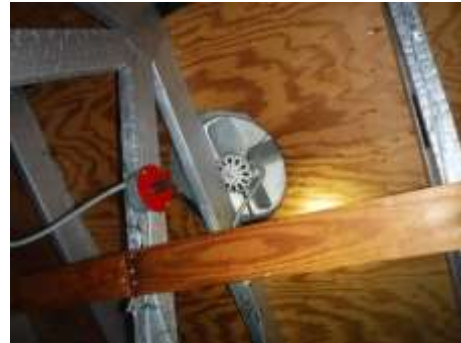
Figure 44 Power fan does not operate.

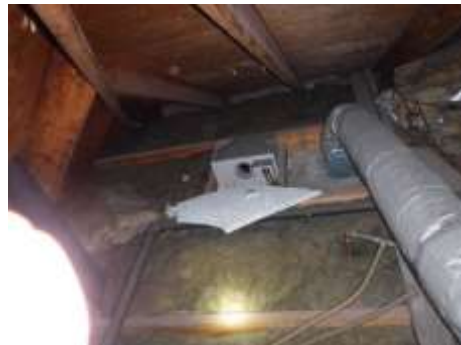
Figure 45 Vent the bath fans to the exterior of the attic.

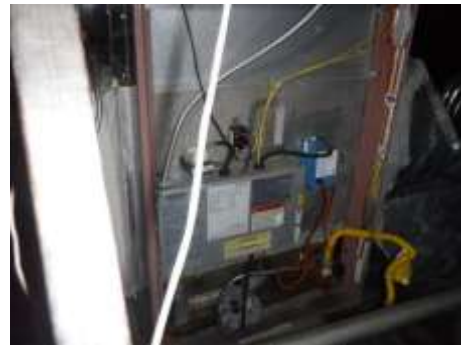
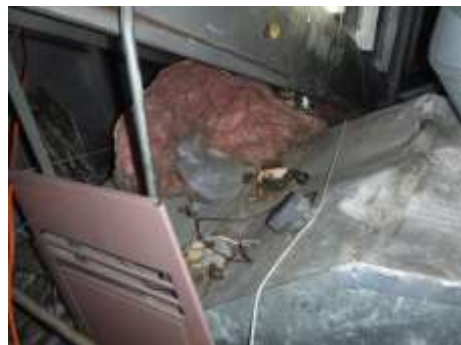
Figure 46 Recommend old AC and heater be removed and the gas line capped.

Figure 47 Same as 46.

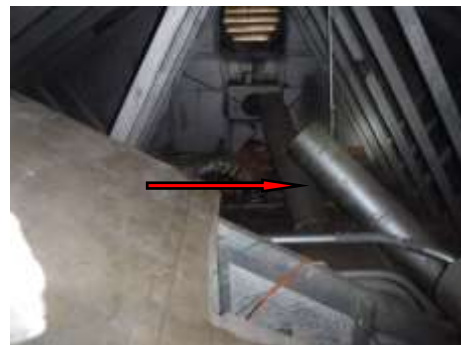
Figure 48 Recommend fresh air intake be connected.

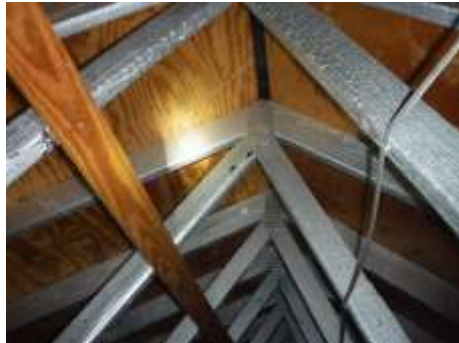
Figure 49 The trusses have been burnt, recommend an engineer evaluate.

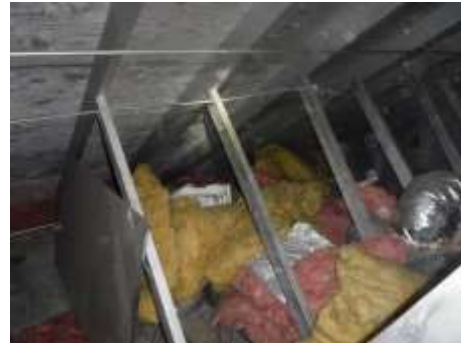
Figure 50 Insulation is displaced.

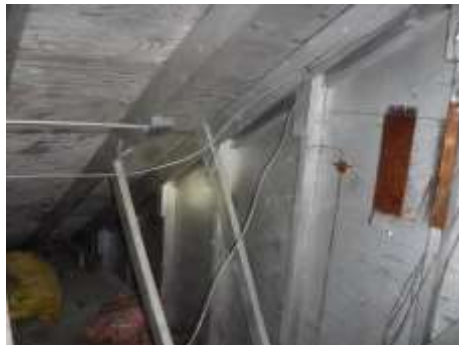
Figure 51 Wall is missing the insulation.

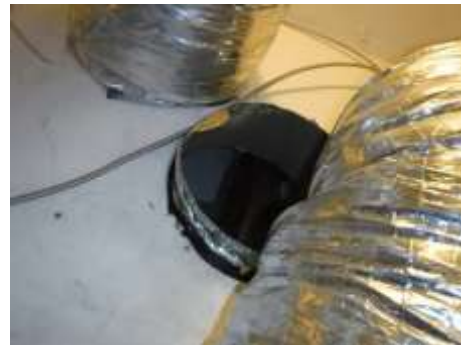
Figure 52 Connect the return air duct.

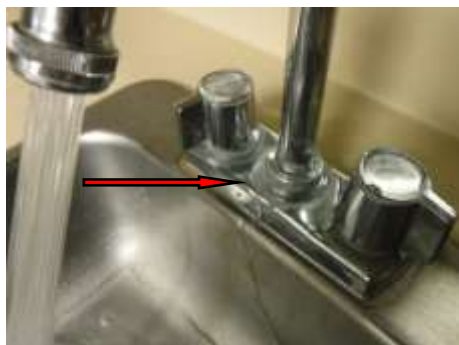
Repair: Safety Issue: Bar sink on the second floor leaks badly at the spout and the GFCI outlet on the left does not trip when tested.

Figure 53 Bar sink leaks at the nut.

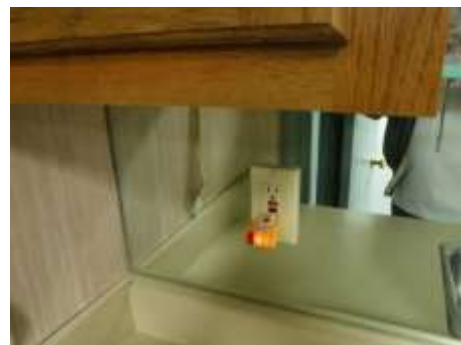
Figure 54 The GFCI by the bar sink to the left does not operate.

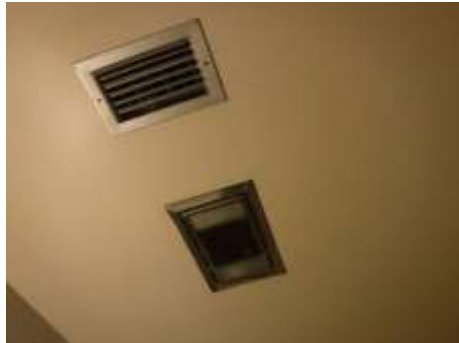
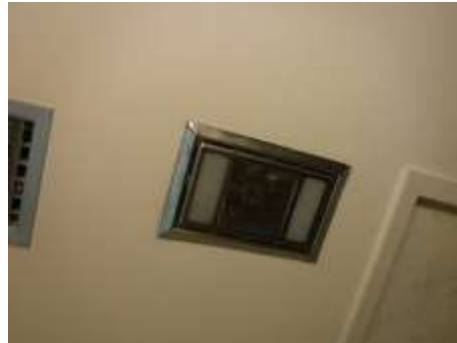
Repair: Both bath fans on the second floor took a long time to come on and are noisy; will possibly need replacing and the heater in the men's bath did not come on.

Figure 55 Bath fans run poorly; second floor.

Figure 56 Same as 55; other bath.

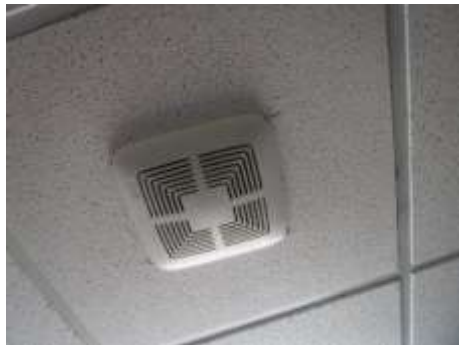
Figure 57 Bath fan is loud first floor rear bath.

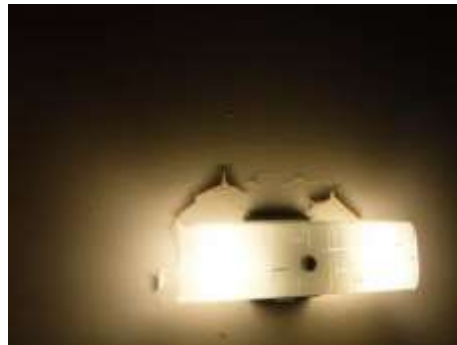
Figure 58 Both second floor baths have peeling paint.

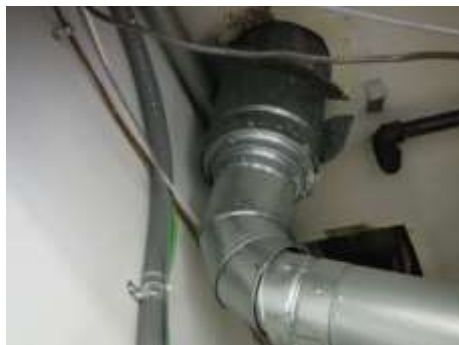
Figure 59 Vent needs repairs and seal all fire barrier wall ceiling where needed.

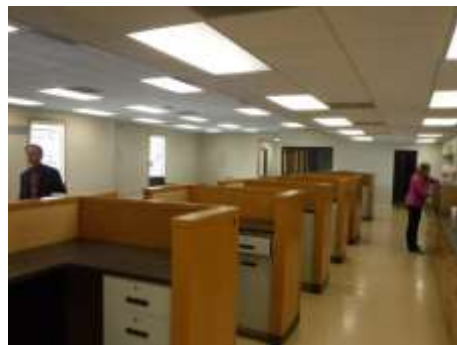
Repair: The teller station for the entire length has no grounding.

Figure 60 No grounding to the outlets at the teller bays.

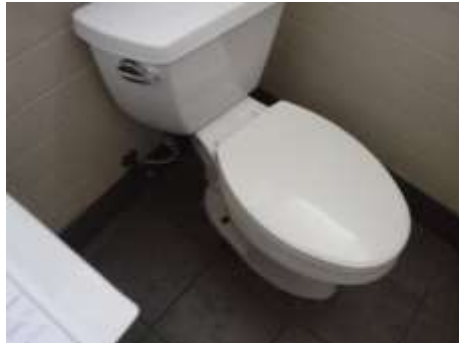
Repair: The toilet is set at an angle, caulk needs replacing and add closet caps where needed to prevent bolts from decomposing. Bath fan is noisy and may need replacing. First floor rear bath.

Figure 61 The toilet needs to be properly set.

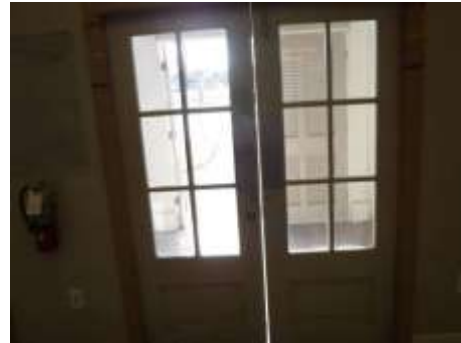
Figure 62 These are interior doors.

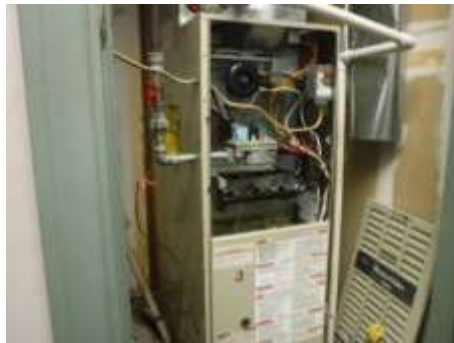
Repair: This unit did not operate at all.

Figure 63 the 3 unit did not operate at all.

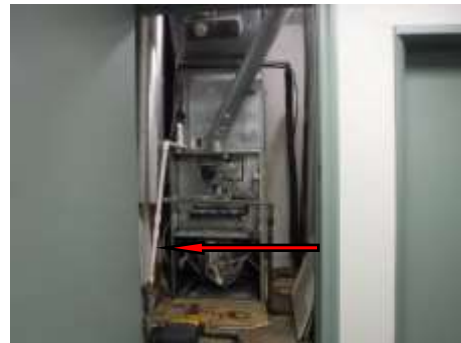
Figure 64 The on and off switch needs replacing.
