HOME INSPECTION REPORT

607 Florida St
Mandeville, LA 70448

Inspection Date:
8/5/2021 3:00 PM

Report Number:
0820210696

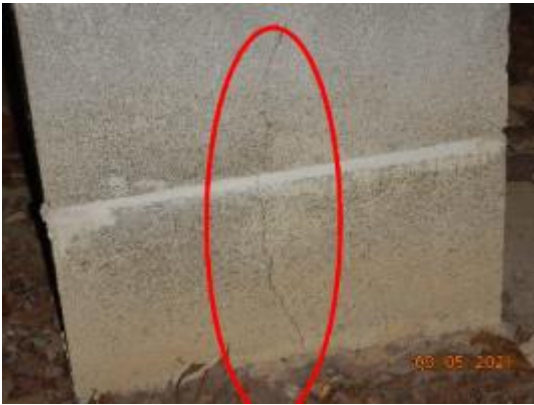
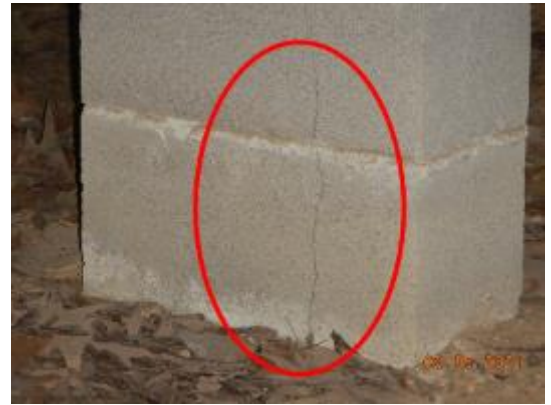
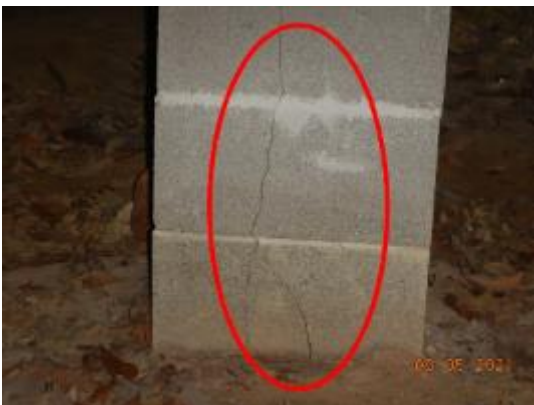
- **Improve:** A deteriorated pier in the crawl space should be repaired or rebuilt as needed. **See Photos 1-3**

Photo 1: Rebuild Piers.

Photo 2: Rebuild Piers.

Photo 3: Rebuild Piers.

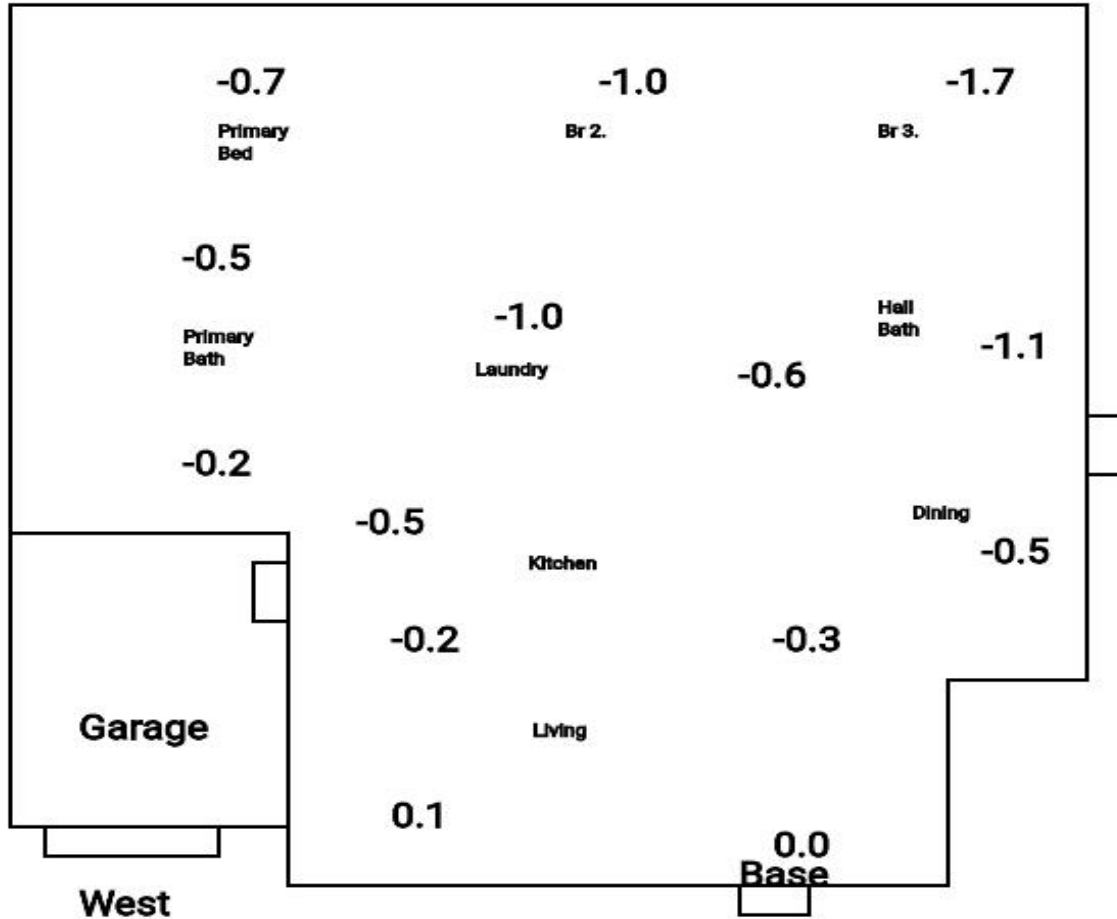
The span of all visible joists appears to be within acceptable limits. A foundation elevation differential of 1.8 inches was recorded on the main structure (refer to Elevation Survey). This is within normally acceptable tolerances for a home of this age and location.

**607 Florida St
Mandeville, LA 70448
1.8" Differential**

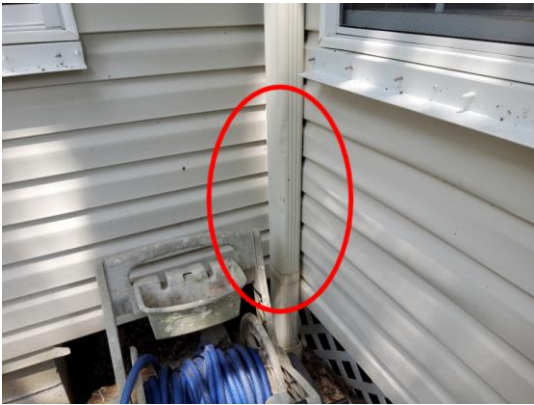
Photo 4: Downspout Damaged.

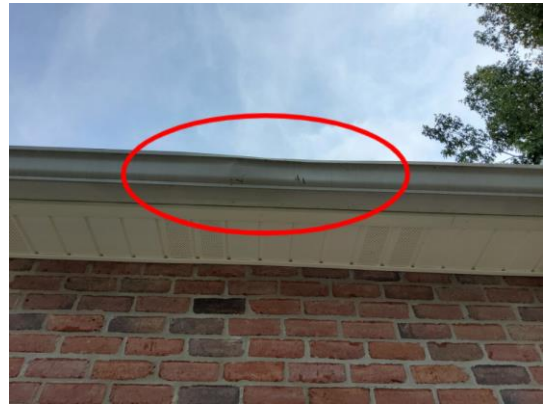
Photo 5: Minor Damage on Gutters .

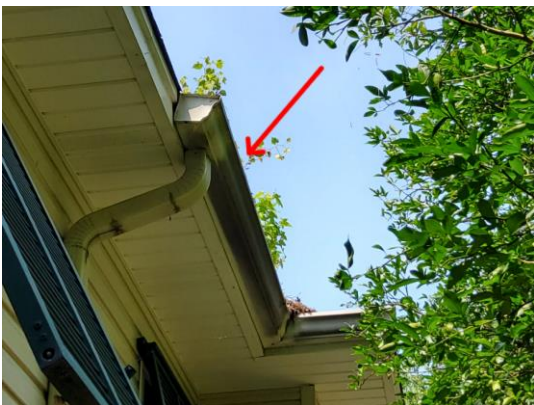
Photo 6: Gutter Cleaning Needed.

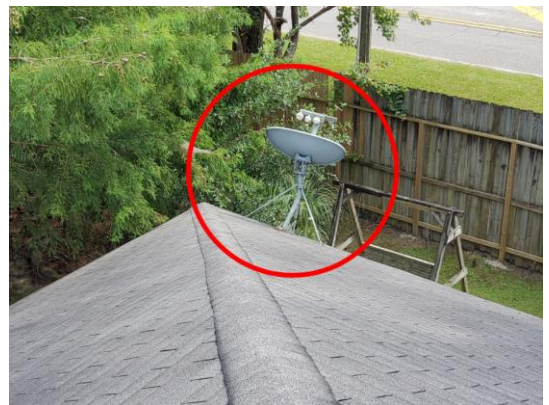
Photo 7: Dish Installed on Roof.

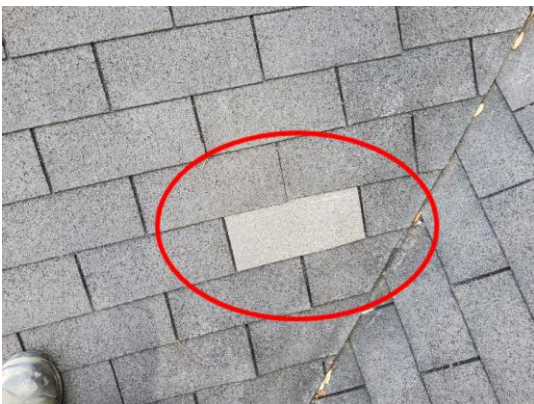
Photo 8: Prior Repairs Noted.

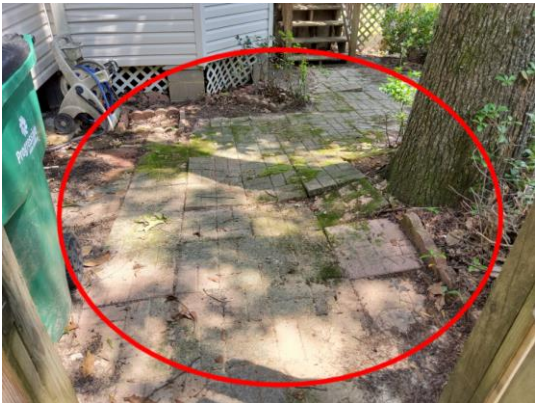
Photo 9: Walkway Trip Hazard.

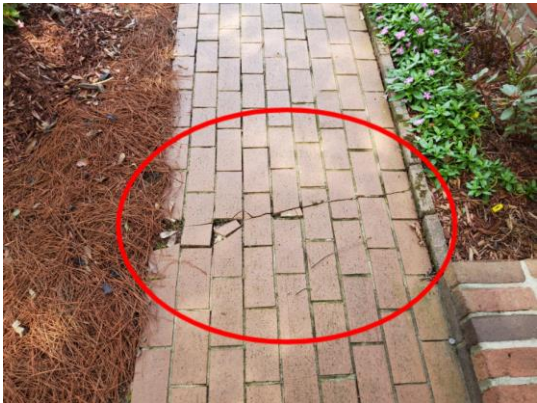
Photo 10: Walkway Settlement .

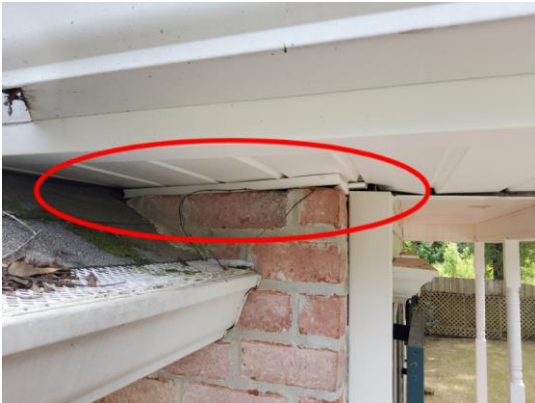
Photo 11: Seal Openings.

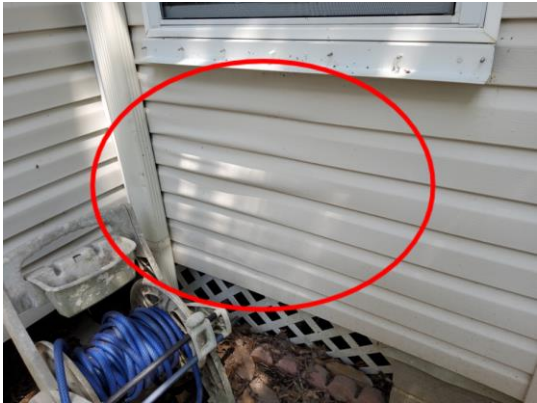
Photo 12: Vinyl Siding Damaged.

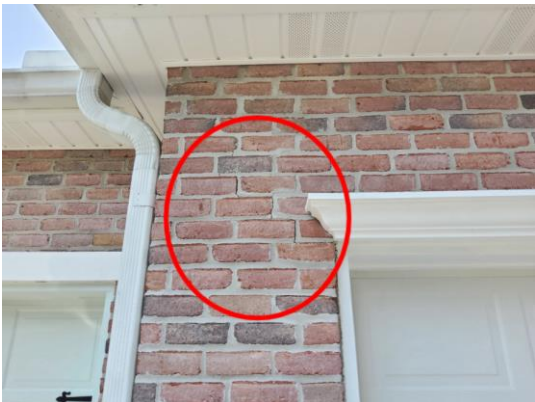
Photo 13: Cracks Typical.

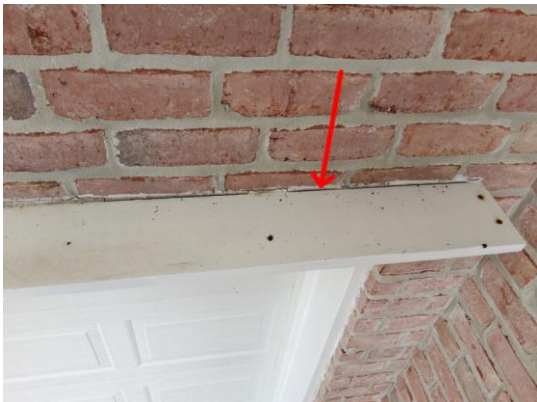
Photo 14: Trim Caulking.

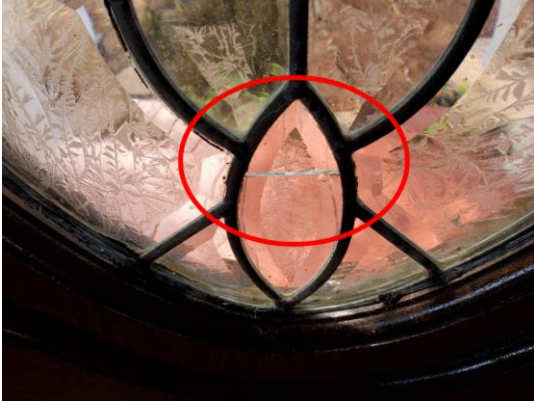
- **Improve:** The entry door is damaged and should be repaired or replaced as necessary. The glass is cracked. **See Photo 15**

Photo 15: Entry Door Damaged.

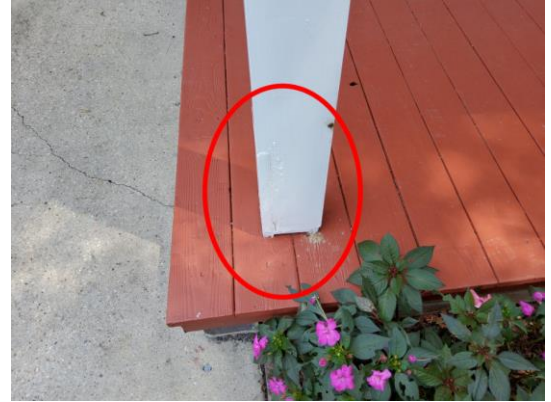
- **Improve:** The base of the wood column shows evidence of moisture damage/rot at the west side of the house. Repair or replacement should be undertaken as necessary. **See Photo 16**

Photo 16: Wood Column Base Rot.

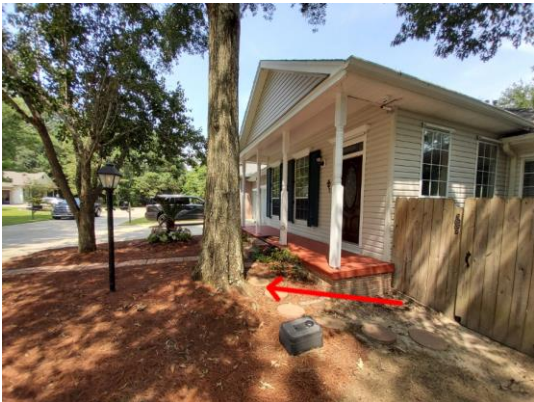
- **Improve:** The proximity of a tree relative to the foundation at the west side of the house may influence the integrity of the foundation. It is recommended that this tree be removed. **See Photo 17**

Photo 17: Tree Proximity.

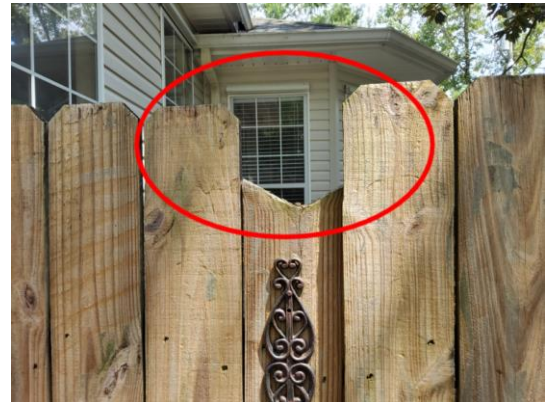
- **Improve:** The fencing at the west side of the house is in fair condition. Minor repairs are needed. **See Photo 18**

Photo 18: Fair Condition, Minor Repairs.

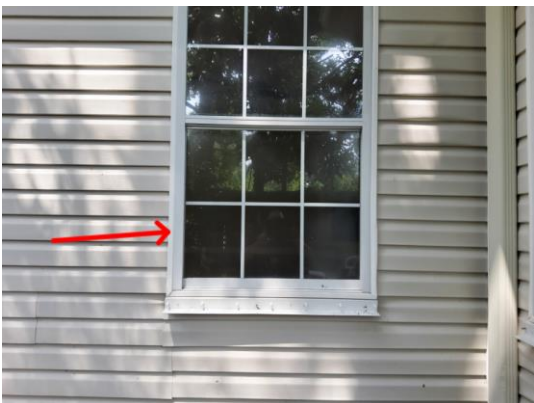
- **Monitor:** It may be desirable to replace window screens where missing at the south side of the house. The owner should be consulted regarding any screens that may be in storage. **See Photo 19**

Photo 19: Window Screen Missing.

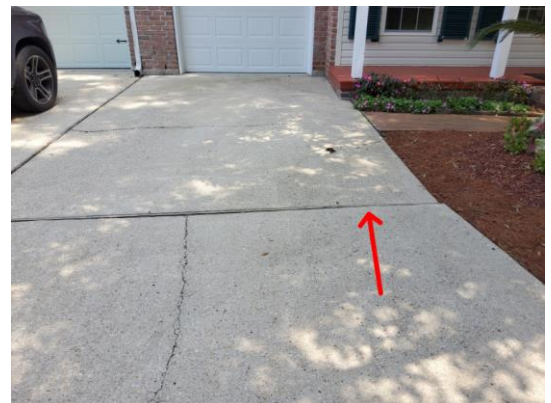
Photo 20: Driveway Settlement / Heaving.

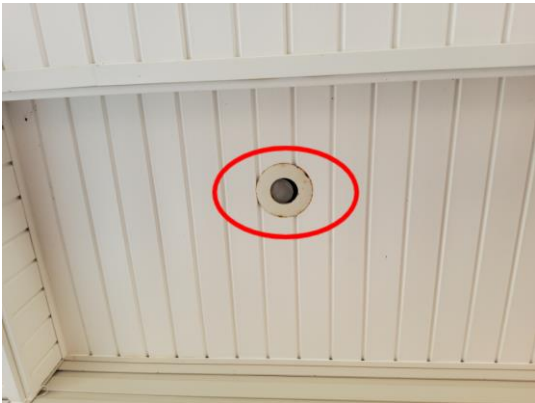
Photo 21: Trim Rings Rusting on Soffit Lights.

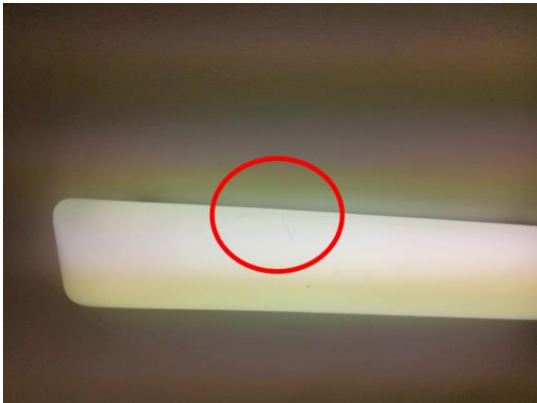
Photo 22: Damaged Globe.

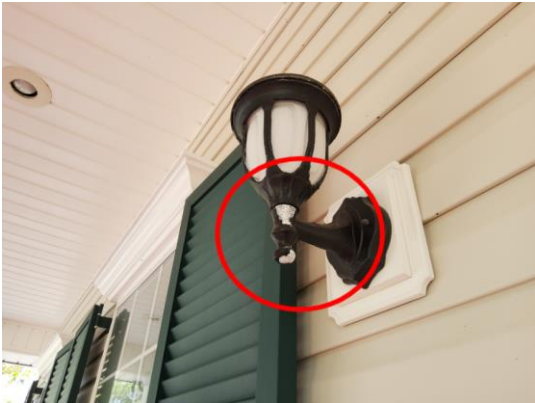
Photo 23: Light Fixture Paint Peeling.

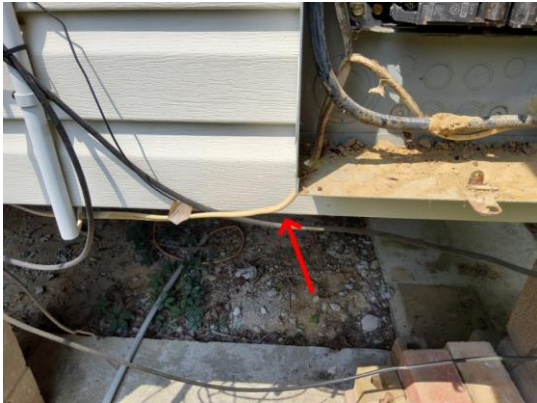
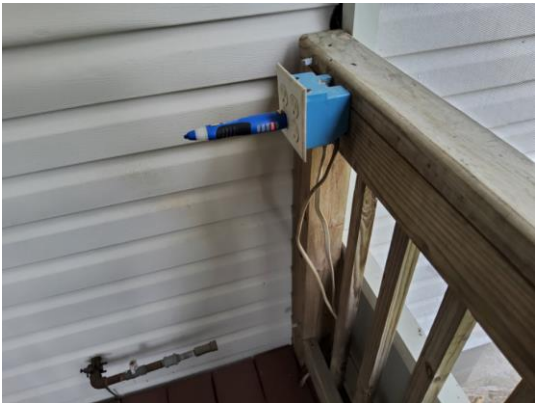
Photo 24: Wiring Exposed on Exterior .

Photo 25: Wiring Exposed on Exterior .

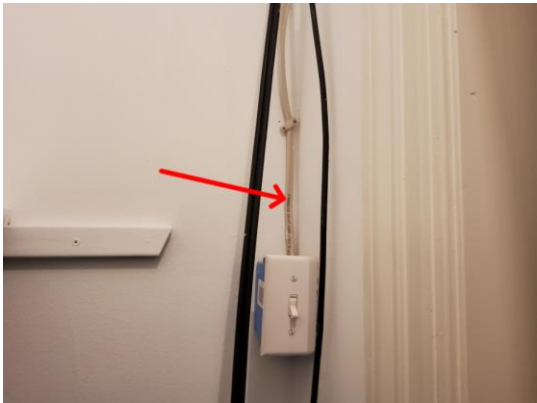
Photo 26: Wiring Exposed on Walls.

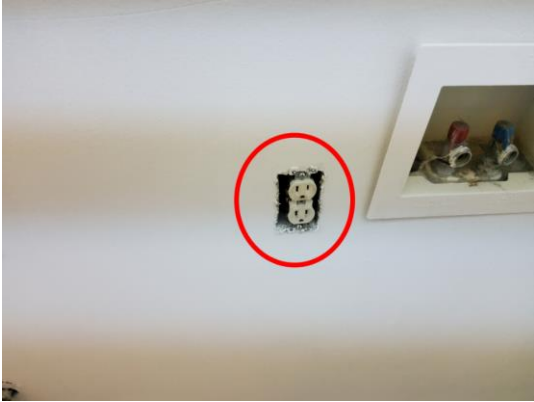
Photo 27: Cover Plate Missing.

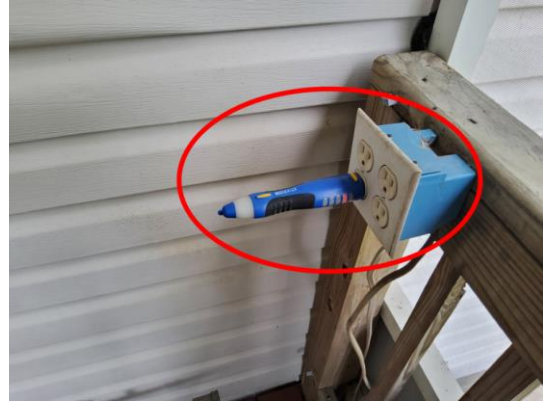
Photo 28: Ungrounded 3-prong Outlet.

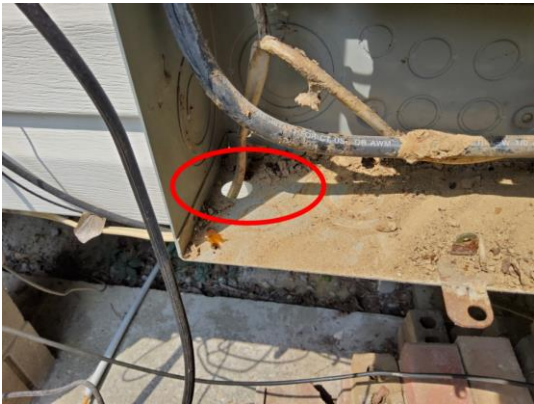
Photo 29: Cable Clamps Needed.

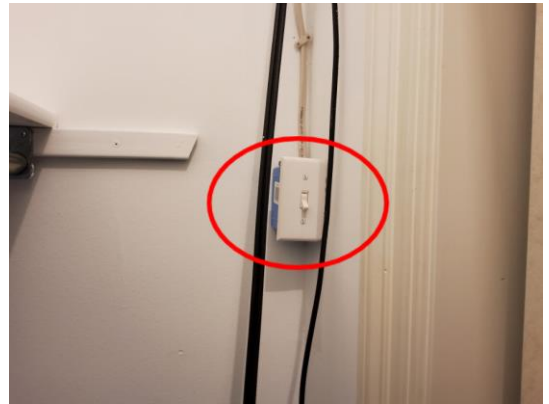
- **Monitor:** The inoperative light switch may need to be repaired in the third bedroom closet. This switch may be connected to an outlet or light fixture not currently in use. If this is not the case these circuits should be investigated. **See Photo 30**

Photo 30: Light Switch Non-operable.

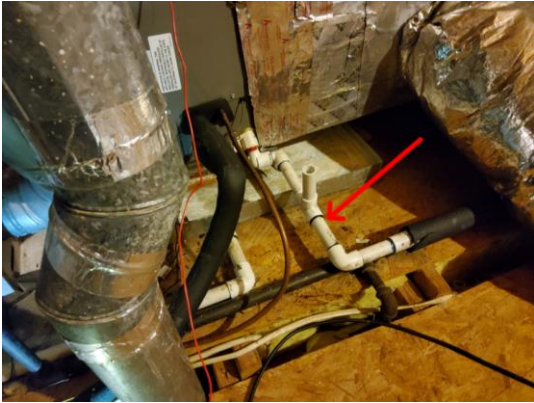
- **Improve:** The air conditioning condensate drain line should be better insulated in the attic. Ideally, the drain line should be insulated a minimum of six feet from the evaporator. Insulating the piping will help prevent condensation from forming on the piping and dripping onto the insulation and eventually the ceiling. **See Photo 31**

Photo 31: Insulate Condensate Drain Line.

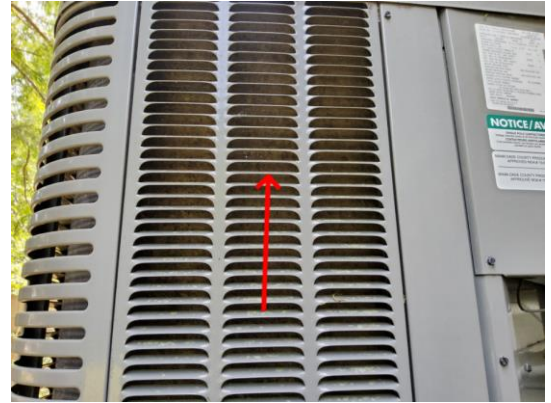
- **Improve:** The outdoor unit of the air conditioning system at the east side of the house requires cleaning. Dirty coils will decrease the cooling efficiency of the system. **See Photo 32**

Photo 32: Outdoor Unit Dirty.

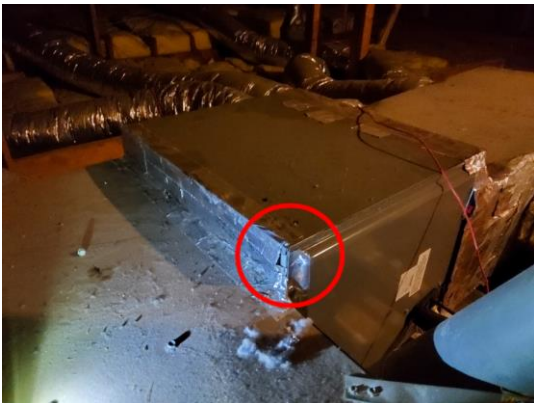
- **Improve:** Loose fitting joints and/or openings in the ductwork in the attic should be improved. **See Photo 33**

Photo 33: Seal Duct Openings.

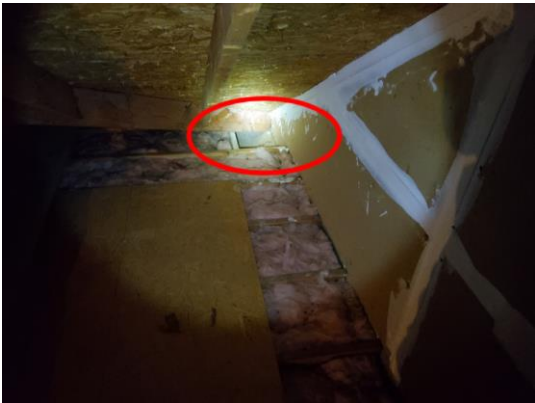
- **Improve:** Missing insulation on the ceiling should be replaced in the attic. **See Photo 34**

Photo 34: Missing Ceiling Insulation .

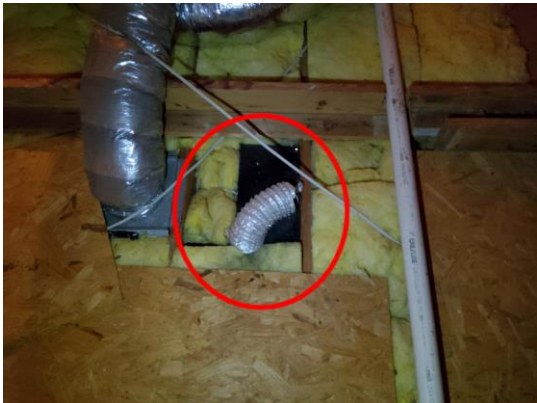
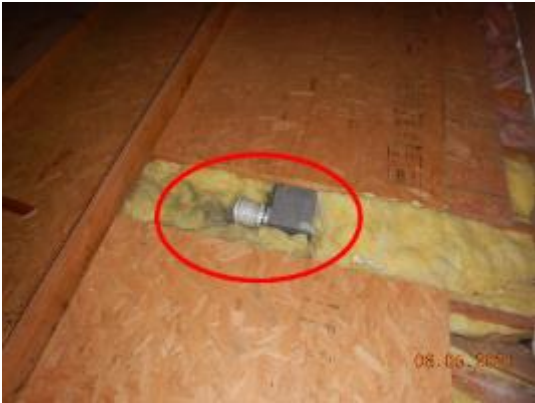
Photo 35: Vent Exhaust Vents to Exterior.

Photo 36: Vent Exhaust Vents to Exterior.

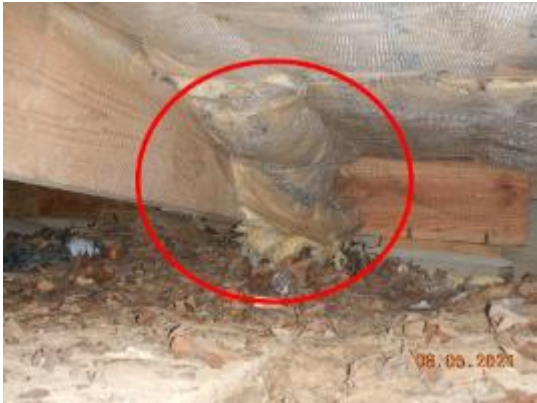
- **Improve:** Loose or damaged insulation in the floor above the crawl space in the crawl space should be improved. The existing floor insulation has either fallen down or has been forced down by vermin. An insulation contractor needs to go through the crawl space and repair or replace the floor insulation. **See Photo 37**

Photo 37: Loose/Damaged Insulation.

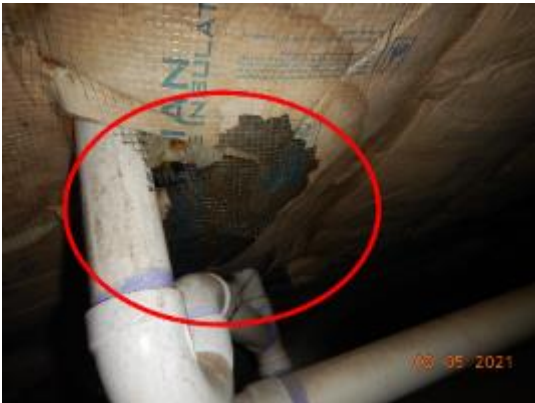
Photo 38: Shower Pan Leaks.

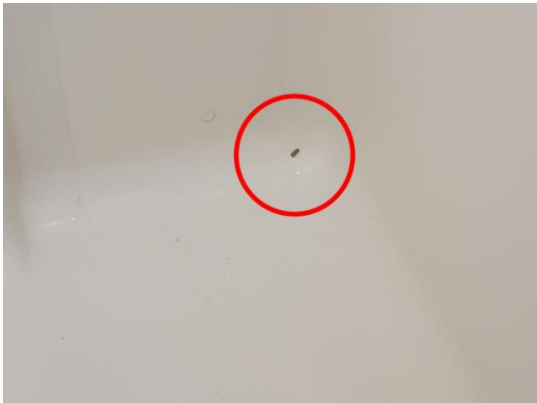
Photo 39: Shower Finish Damaged.

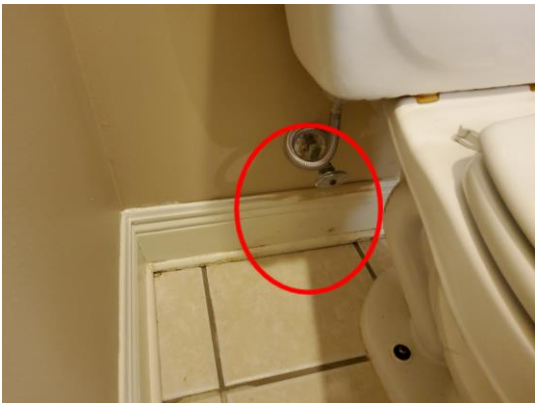
Photo 40: Valve Stem Leak.

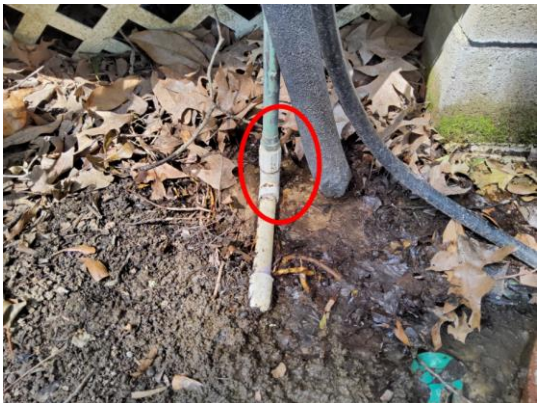
Photo 41: Pipe Leak.

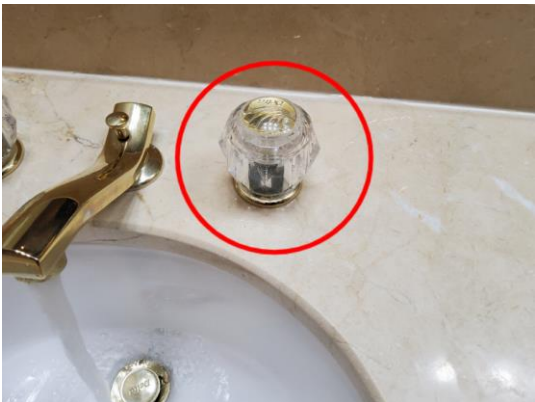
Photo 42: Sink Faucet Leaky.

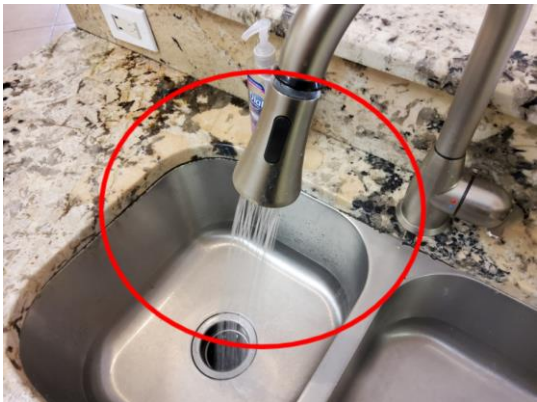
Photo 43: Sprayer Inoperative.

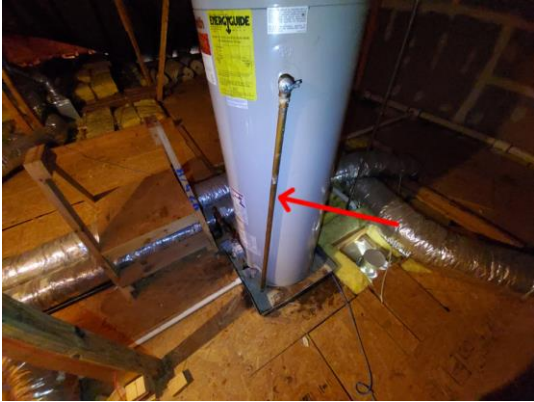
Photo 44: Add Discharge Piping for TPR.

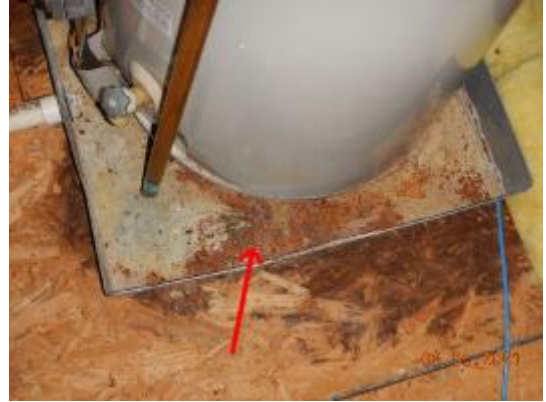
- **Improve:** In order to reduce the potential for water damage, it is recommended that the corroded drain pan below the water heater be replaced due to corrosion in the attic. **See Photo 45**

Photo 45: Corroded Drain Pan.

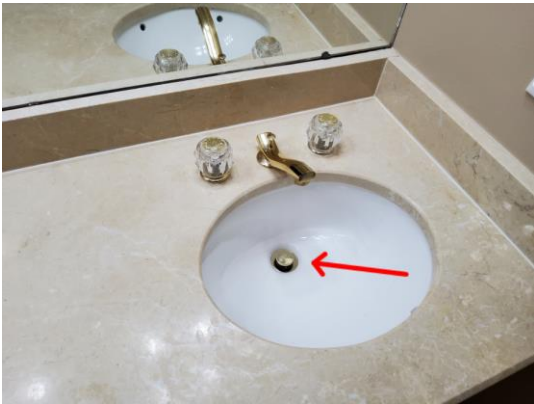
Photo 46: Drain Stopper Adjust.

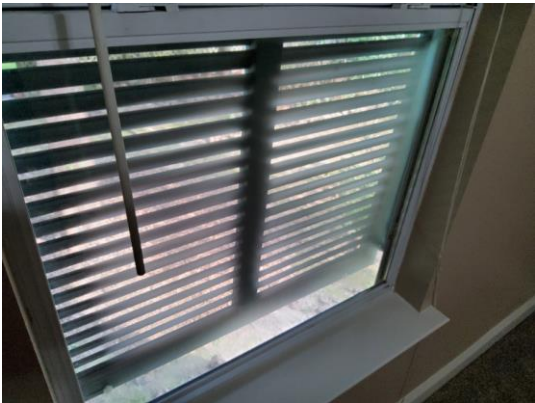
- **Improve:** The windows have lost their seal in the third bedroom, in the dining room, and in the living room. This has resulted in condensation developing between the panes of glass. Due to weather conditions or environmental factors, other windows that have lost their seal may exist in the home. A qualified window repair contractor should be engaged to repair all windows as required. **See Photo 47**

Photo 47: Lost Seal.

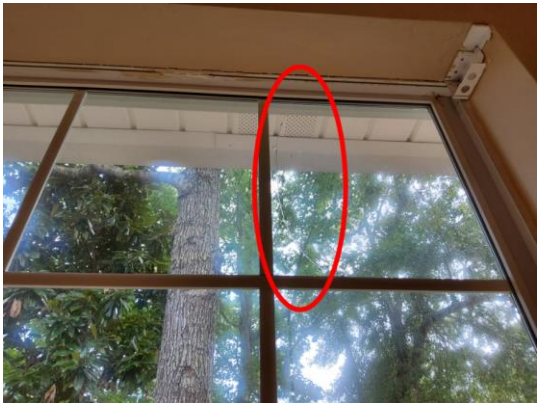
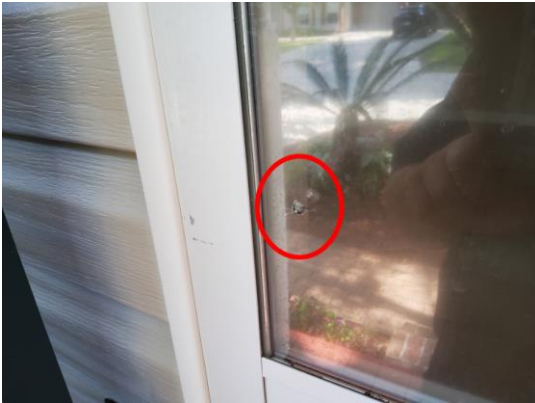
Photo 48: Window Broken.

Photo 49: Window Broken.

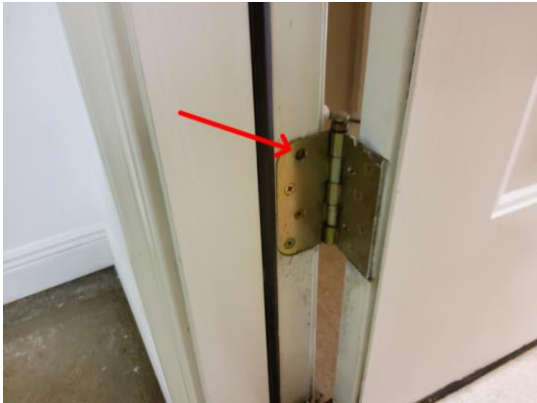
Photo 50: Door Hinge Screws Missing.

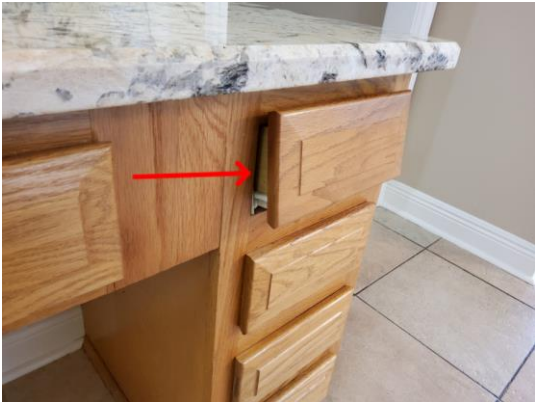
Photo 51: Drawer Damage/Inoperative.

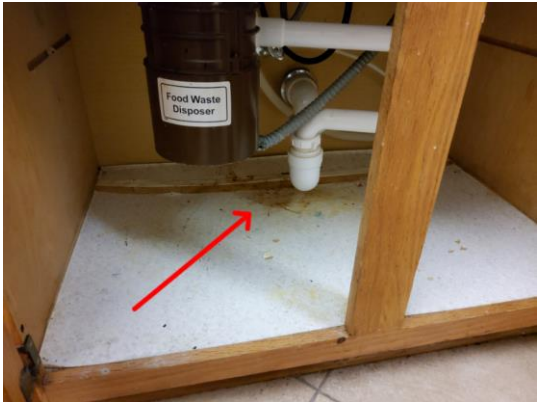
Photo 52: Cabinet Prior Water Damage-
Improve.

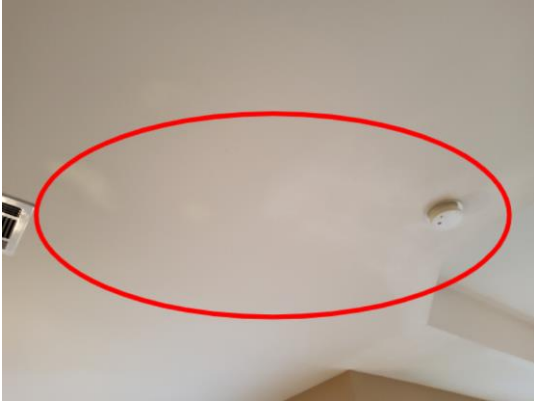
Photo 53: Patching - Ceiling.

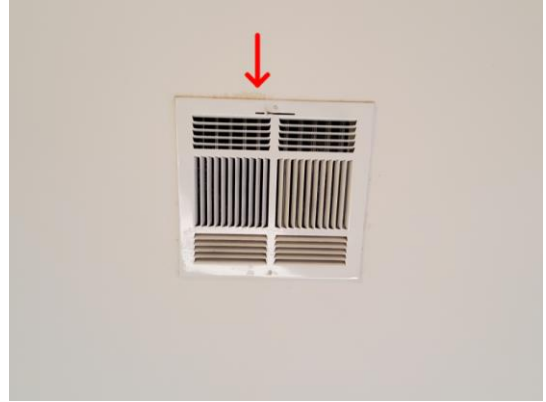
Photo 54: Water Staining - Ceiling.

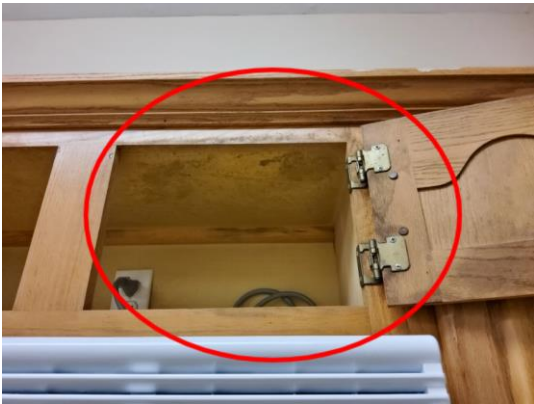
Photo 55: MOLD - Monitor.

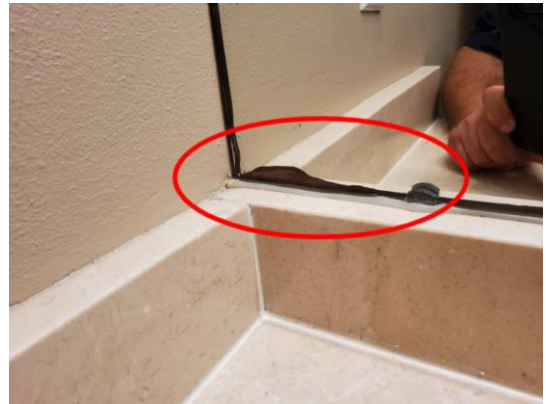
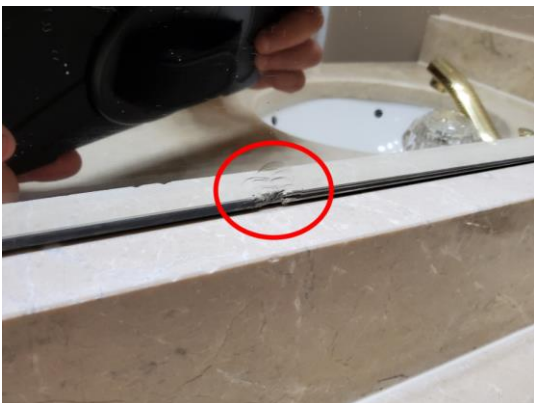
Photo 56: Bathroom Mirror Damage.

Photo 57: Bathroom Mirror Damage.

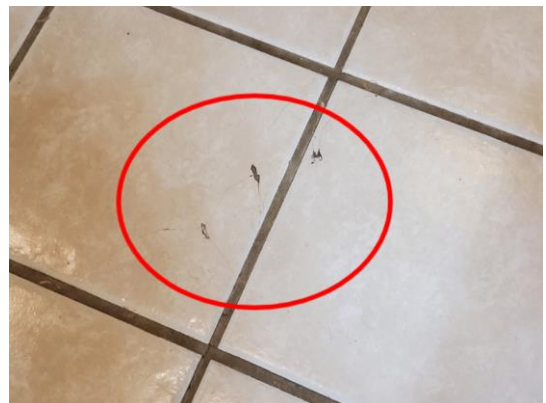
- **Monitor:** The tile floor is cracked in the primary bathroom and in various locations. Repairs are discretionary. **See Photo 58**

Photo 58: Tile Cracked.

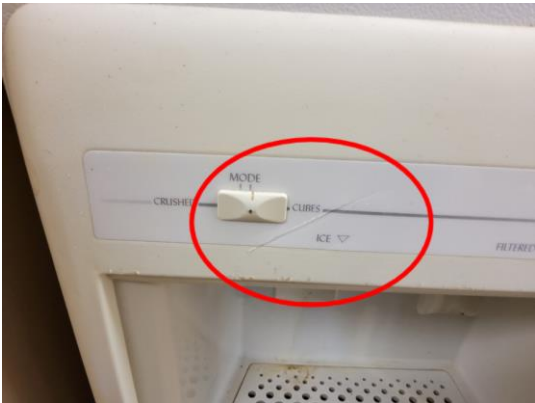
Photo 59: Refrigerator Control Panel Damaged.

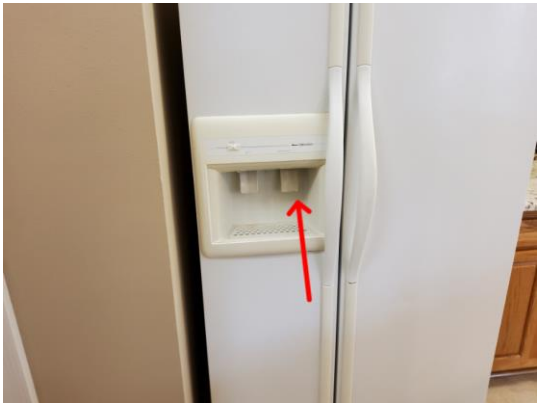
Photo 60: Water Dispenser Not working.

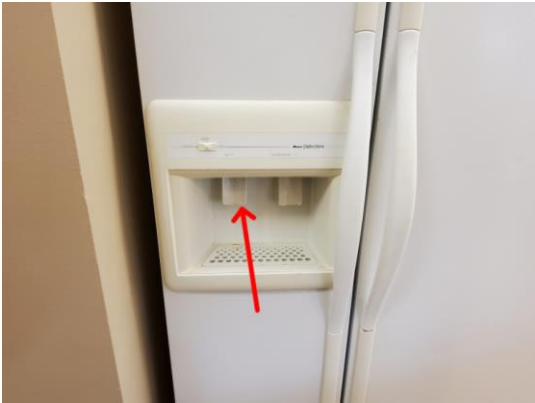
Photo 61: Icemaker Non-operable.

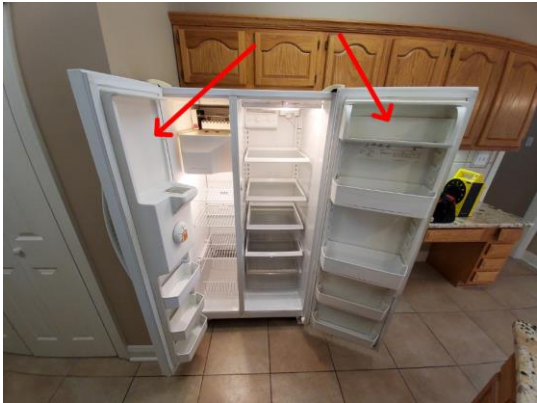
Photo 62: Drawer Damaged.

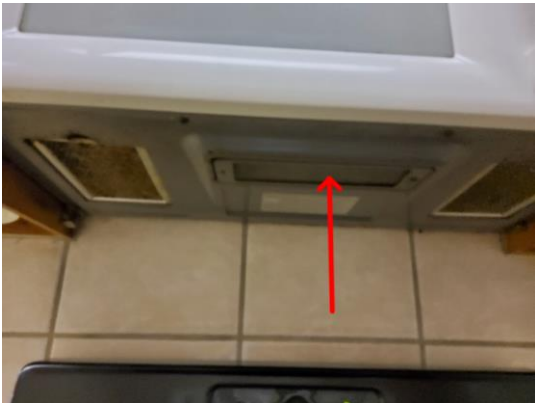
Photo 63: Light Non-operable Under Microwave.

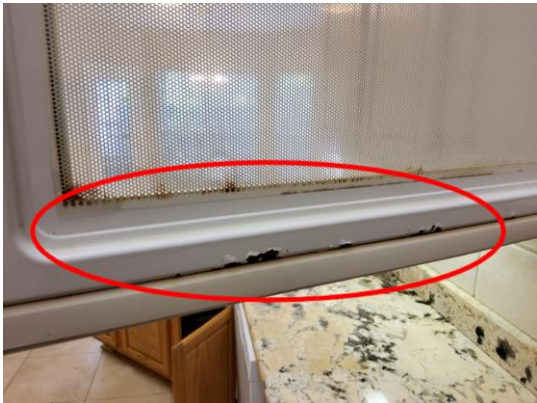
Photo 64: Rust in Microwave.
