Acutec Home Inspectors
Acutec Home Inspectors
Slidell, La 70459

628 Poupee Lane
Slidell, La 70460

Inspector Name Shawn Gregg
Company Name Acutec Home Inspectors
Address Acutec Home Inspectors
City Slidell **State** La **Zip** 70459
Phone 985-290-8993
E-Mail Shawn@AcutecLLC.com
Report Name Hawk042215
Payment Amount: 365.00
Payment Method: Check

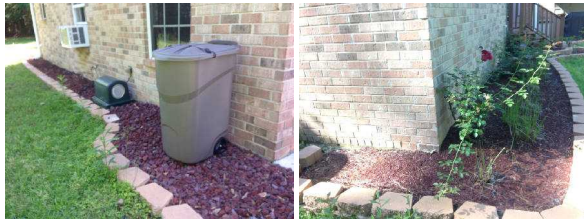
1. **Driveway: Concrete:**
2. **Walkways: Pavestones / Brick:**
3. Marginal **High soil:** High soil to foundation. The soil should be pulled away from the structure to prevent insect and moisture damage.

Some areas of foundation were not visible and could not be evaluated.

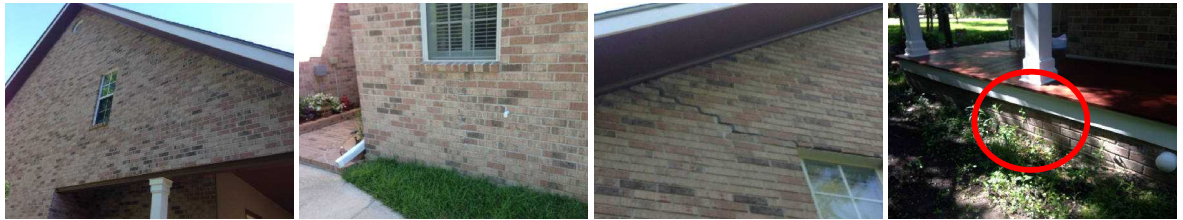
5. Marginal **Brick Veneer:** Alterations or repairs noted in brick siding. Appears functional.

Repairs on brickwork may indicate past or present problems with the structure or foundation. It is recommended that the buyer ask about any past or present problems and details of the repairs. Some repairs may have a warranty or the need for ongoing evaluation.

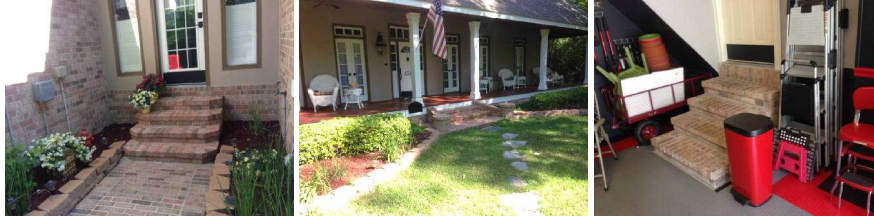
8. Marginal **Steps:** Missing handrails. Any steps with more than two risers should have handrails for safety purposes.

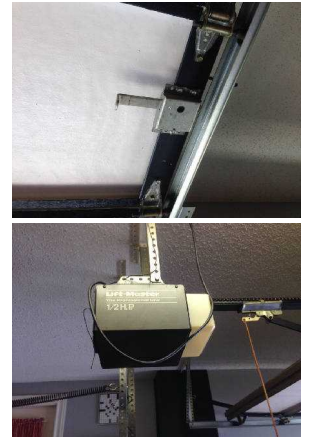
1. **Type of Structure:** Attached **Car Spaces:** 2
2. Acceptable **Garage Doors:** Metal
3. Acceptable **Door Operation:** Motorized, Manual-- Manuel locks should be removed from garage doors that have automatic openers. Damage or injury can occurred if the remote is used to open the door while locked.
4. Acceptable **Door Opener:** Lift Master-- Modern garage door openers are equipped with a pressure safety reverse sensor that stops the door if it is closing and comes down on top of someone or something. Pressure safety reverse switches are not tested during a home inspection as damage or injury could result, but should be tested by client to ensure they work properly. If the sensor does not reverse the door or if not equipped, the opener should be replaced with a new unit. See manufacture information to determine the best means of testing the model installed.

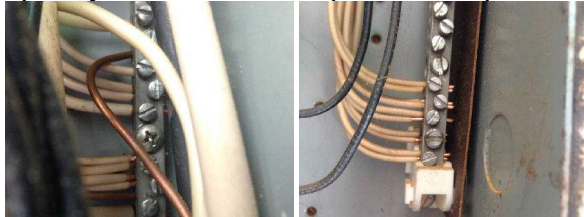
3. **120 VAC Branch Circuits:** Copper-- The neutral wires are bundled, each wire should be terminated under its own screw. Current standards for new construction specify the wires be separated to prevent fire and electrocution hazards.

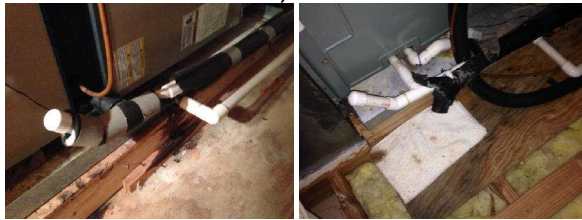
- 1. Acceptable **A/C System Operation:** Appears Functional-- It is typically recommended that the HVAC be serviced by a licensed professional to ensure proper installation and operation when purchasing a home. The units may need routine servicing, undetected repairs or installation corrections.
- 2. Defective **Condensate Removal:** Missing or torn insulation. Should be installed on first 6-8" to prevent water from dripping from pipe. (over garage room with small opening and on third level attic unit.)

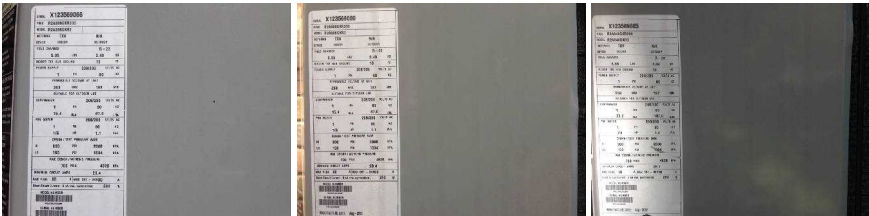
4. Manufacturer: International

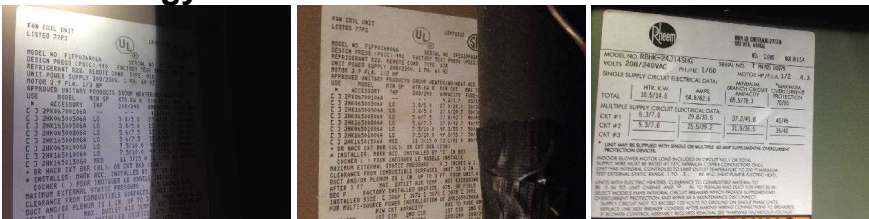
- 5. **Model Number:** r2a336gkr2, r2a336gkr2, r2a348gkr2 **Serial Number:** x123569066, x123569080, x123569665
- 6. **Area Served:** Undetermined, Multiple units **Approximate Age:** 3, 3, 3
- 7. **A/C Fuel Type:** Electric **Temperature Differential:** Not measured
- 8. **Heat energy source:** Electric
