Structural Inspection

July 15, 2020

Ref: Village at Northshore – JoAnn – Building Damage

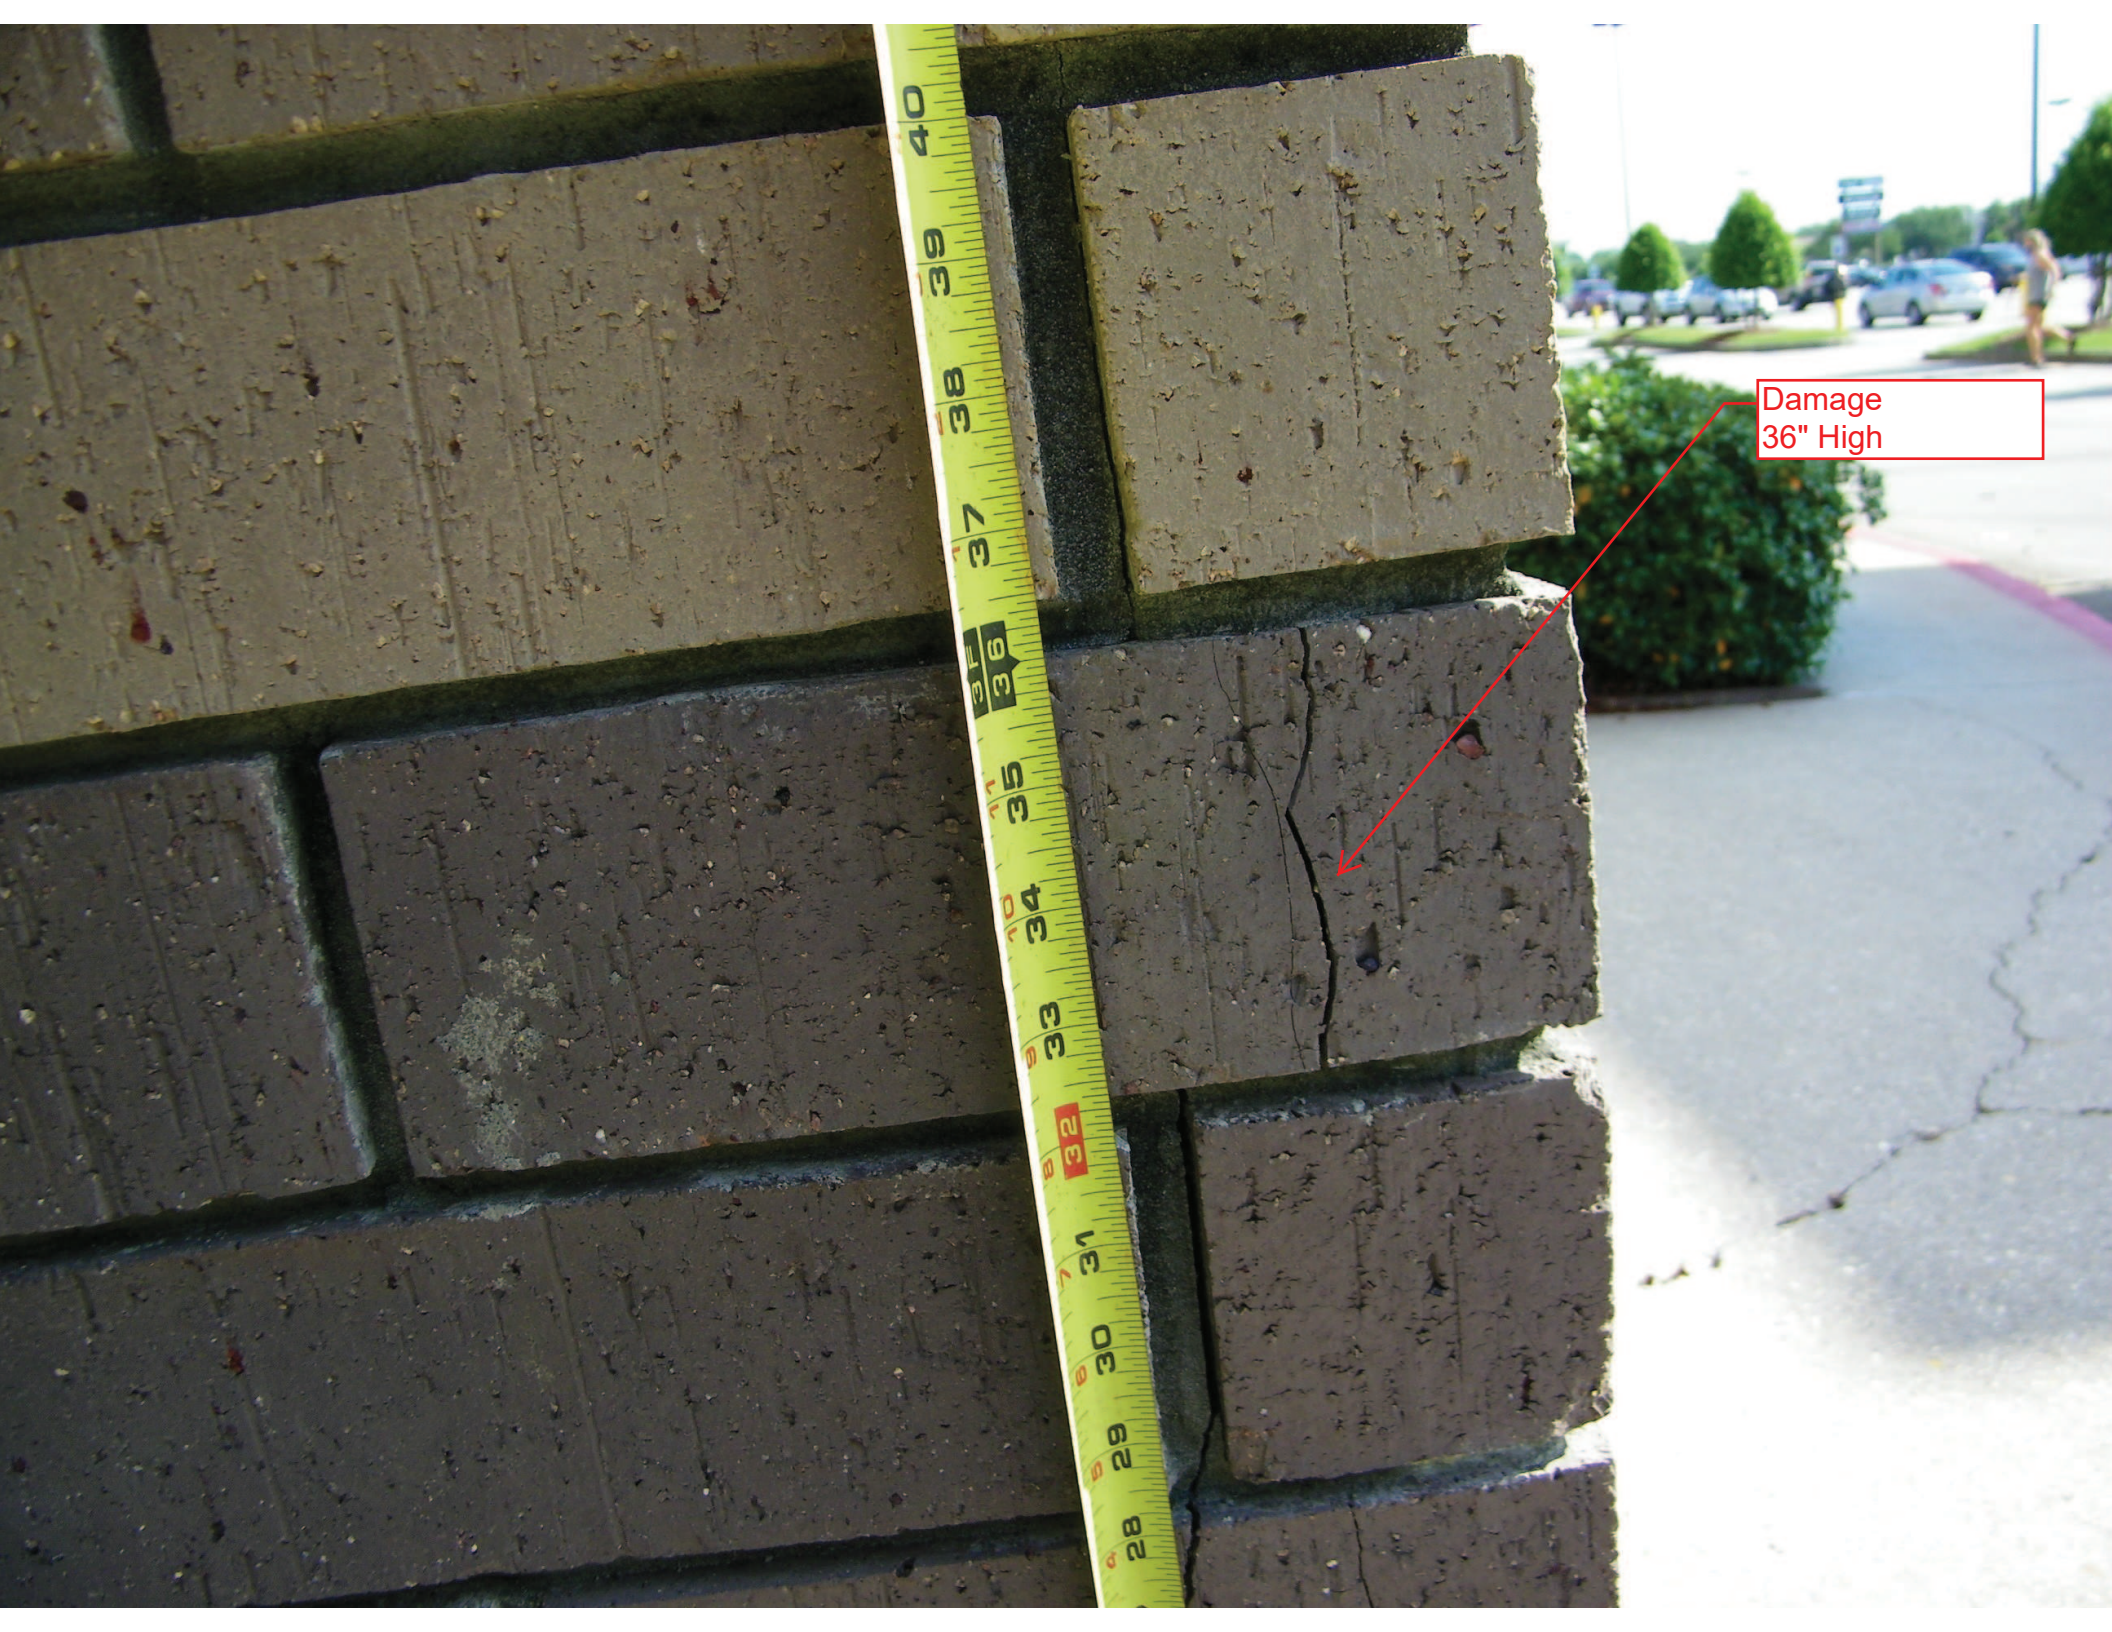
Damage

- 1) Remove all damaged bricks in that area on both the southeast and eastern side of the building and replace with new to match existing.

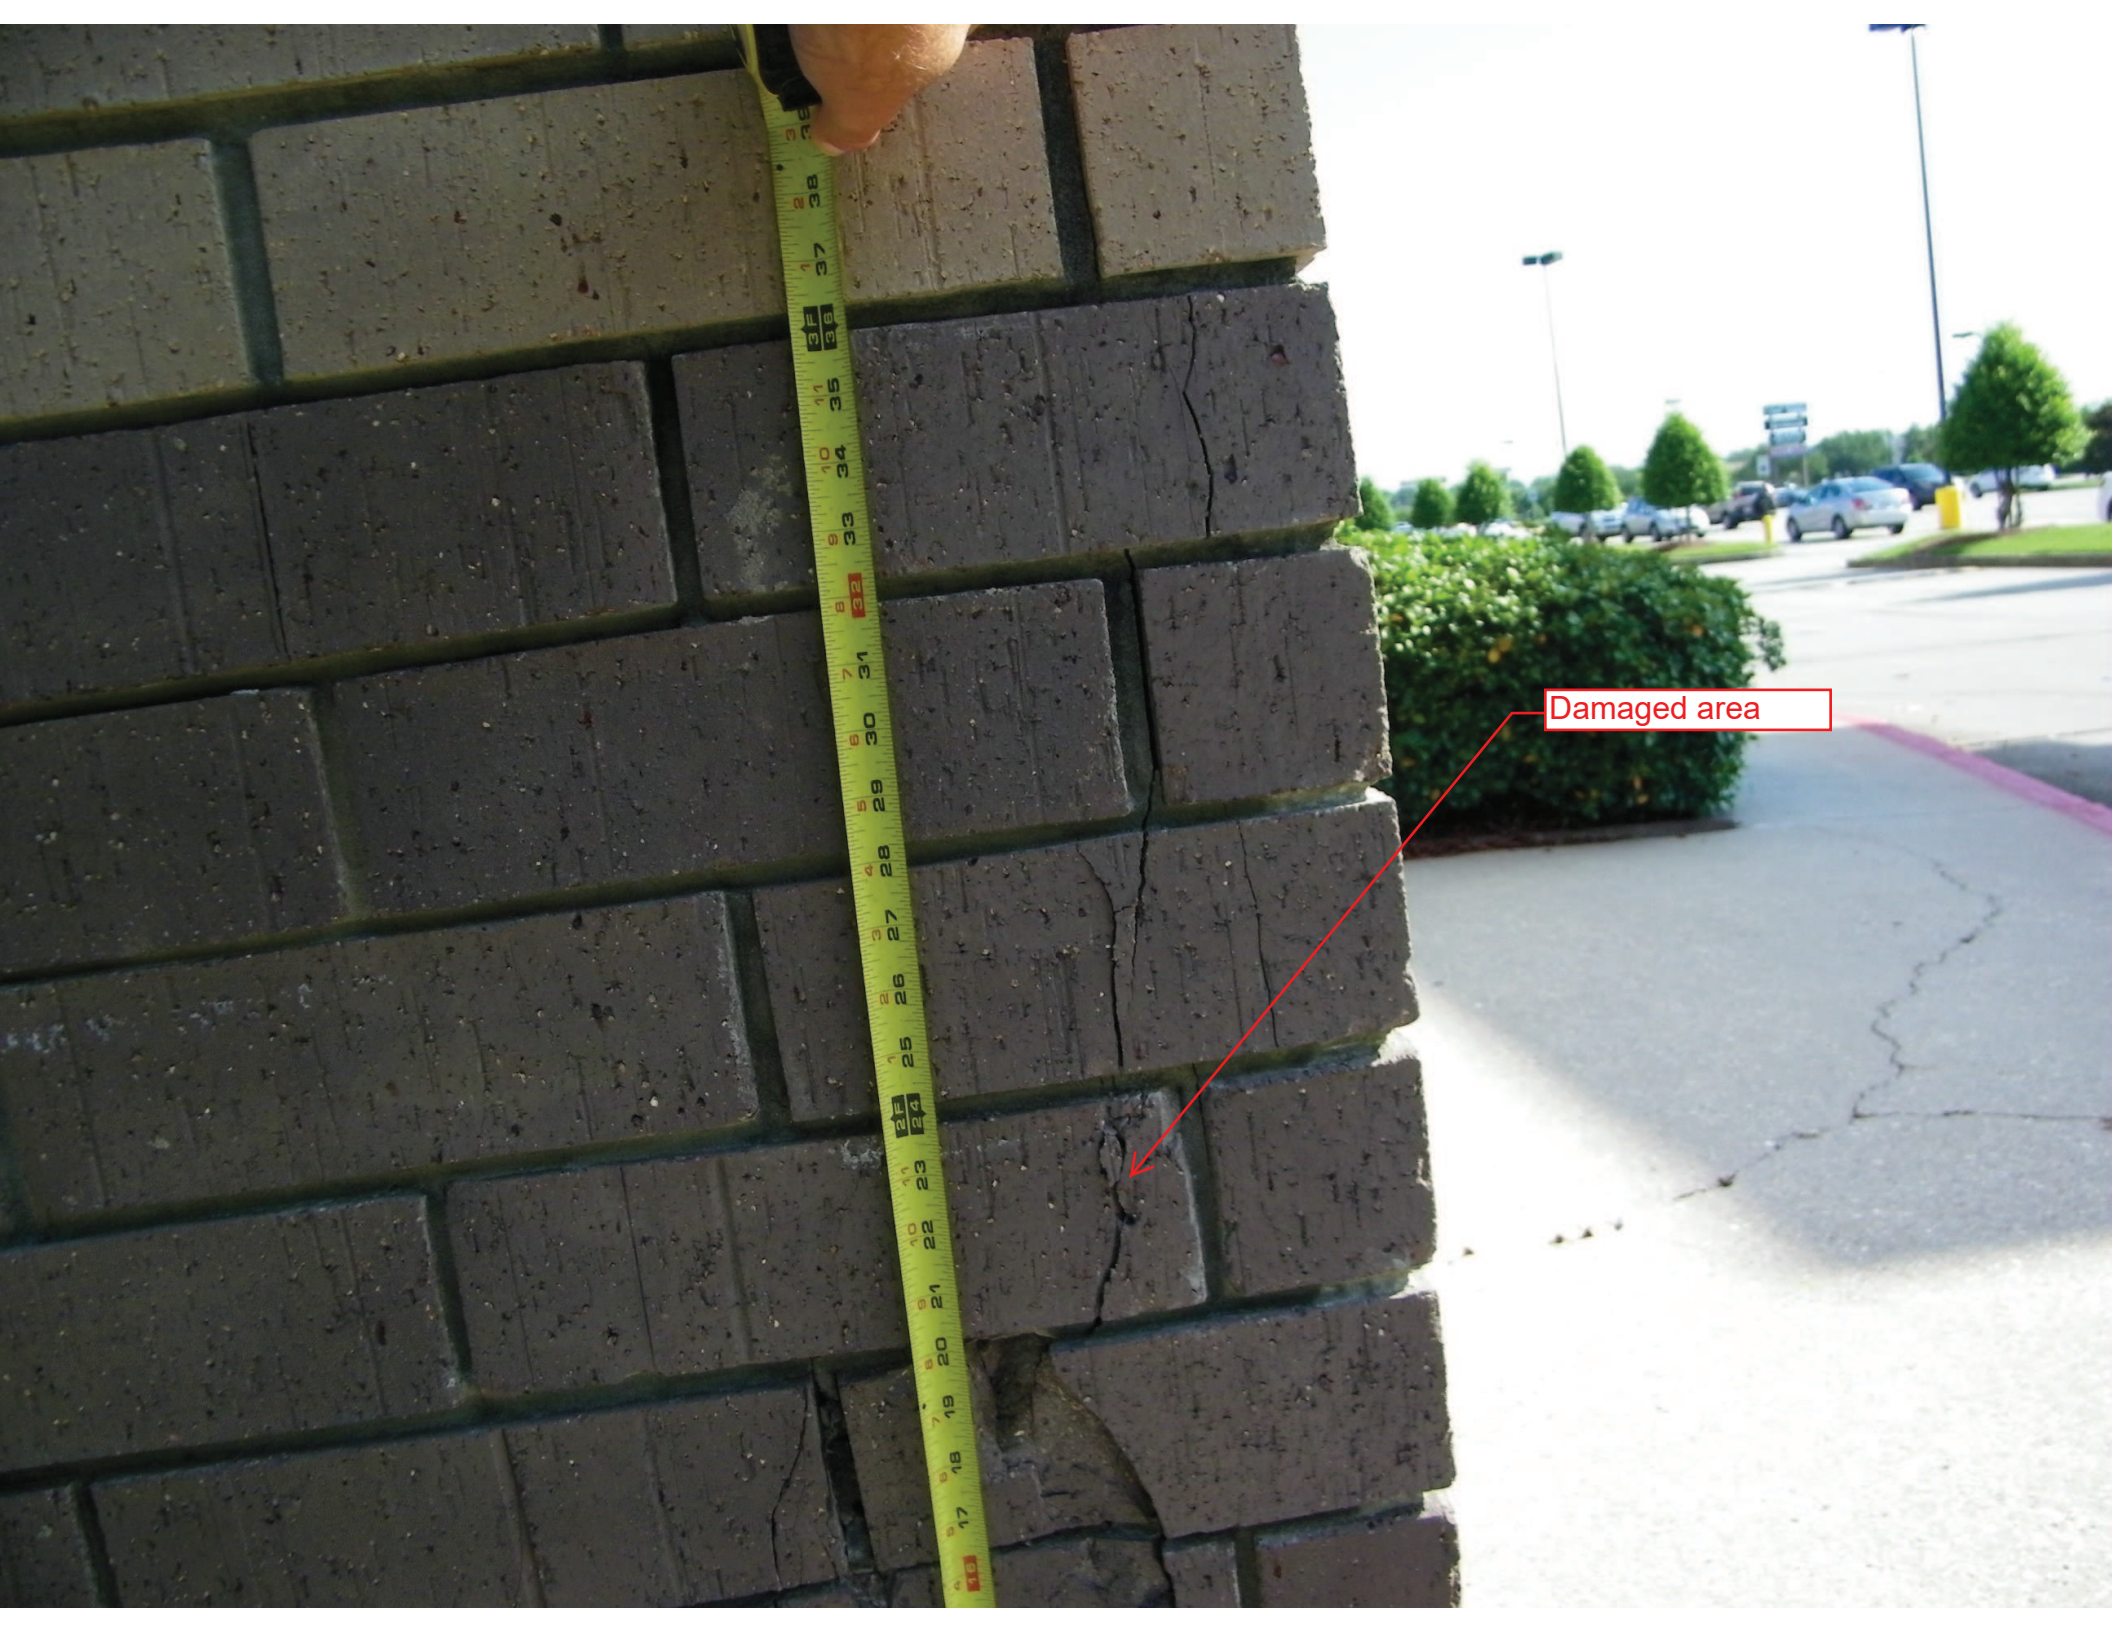
Damage
36" High

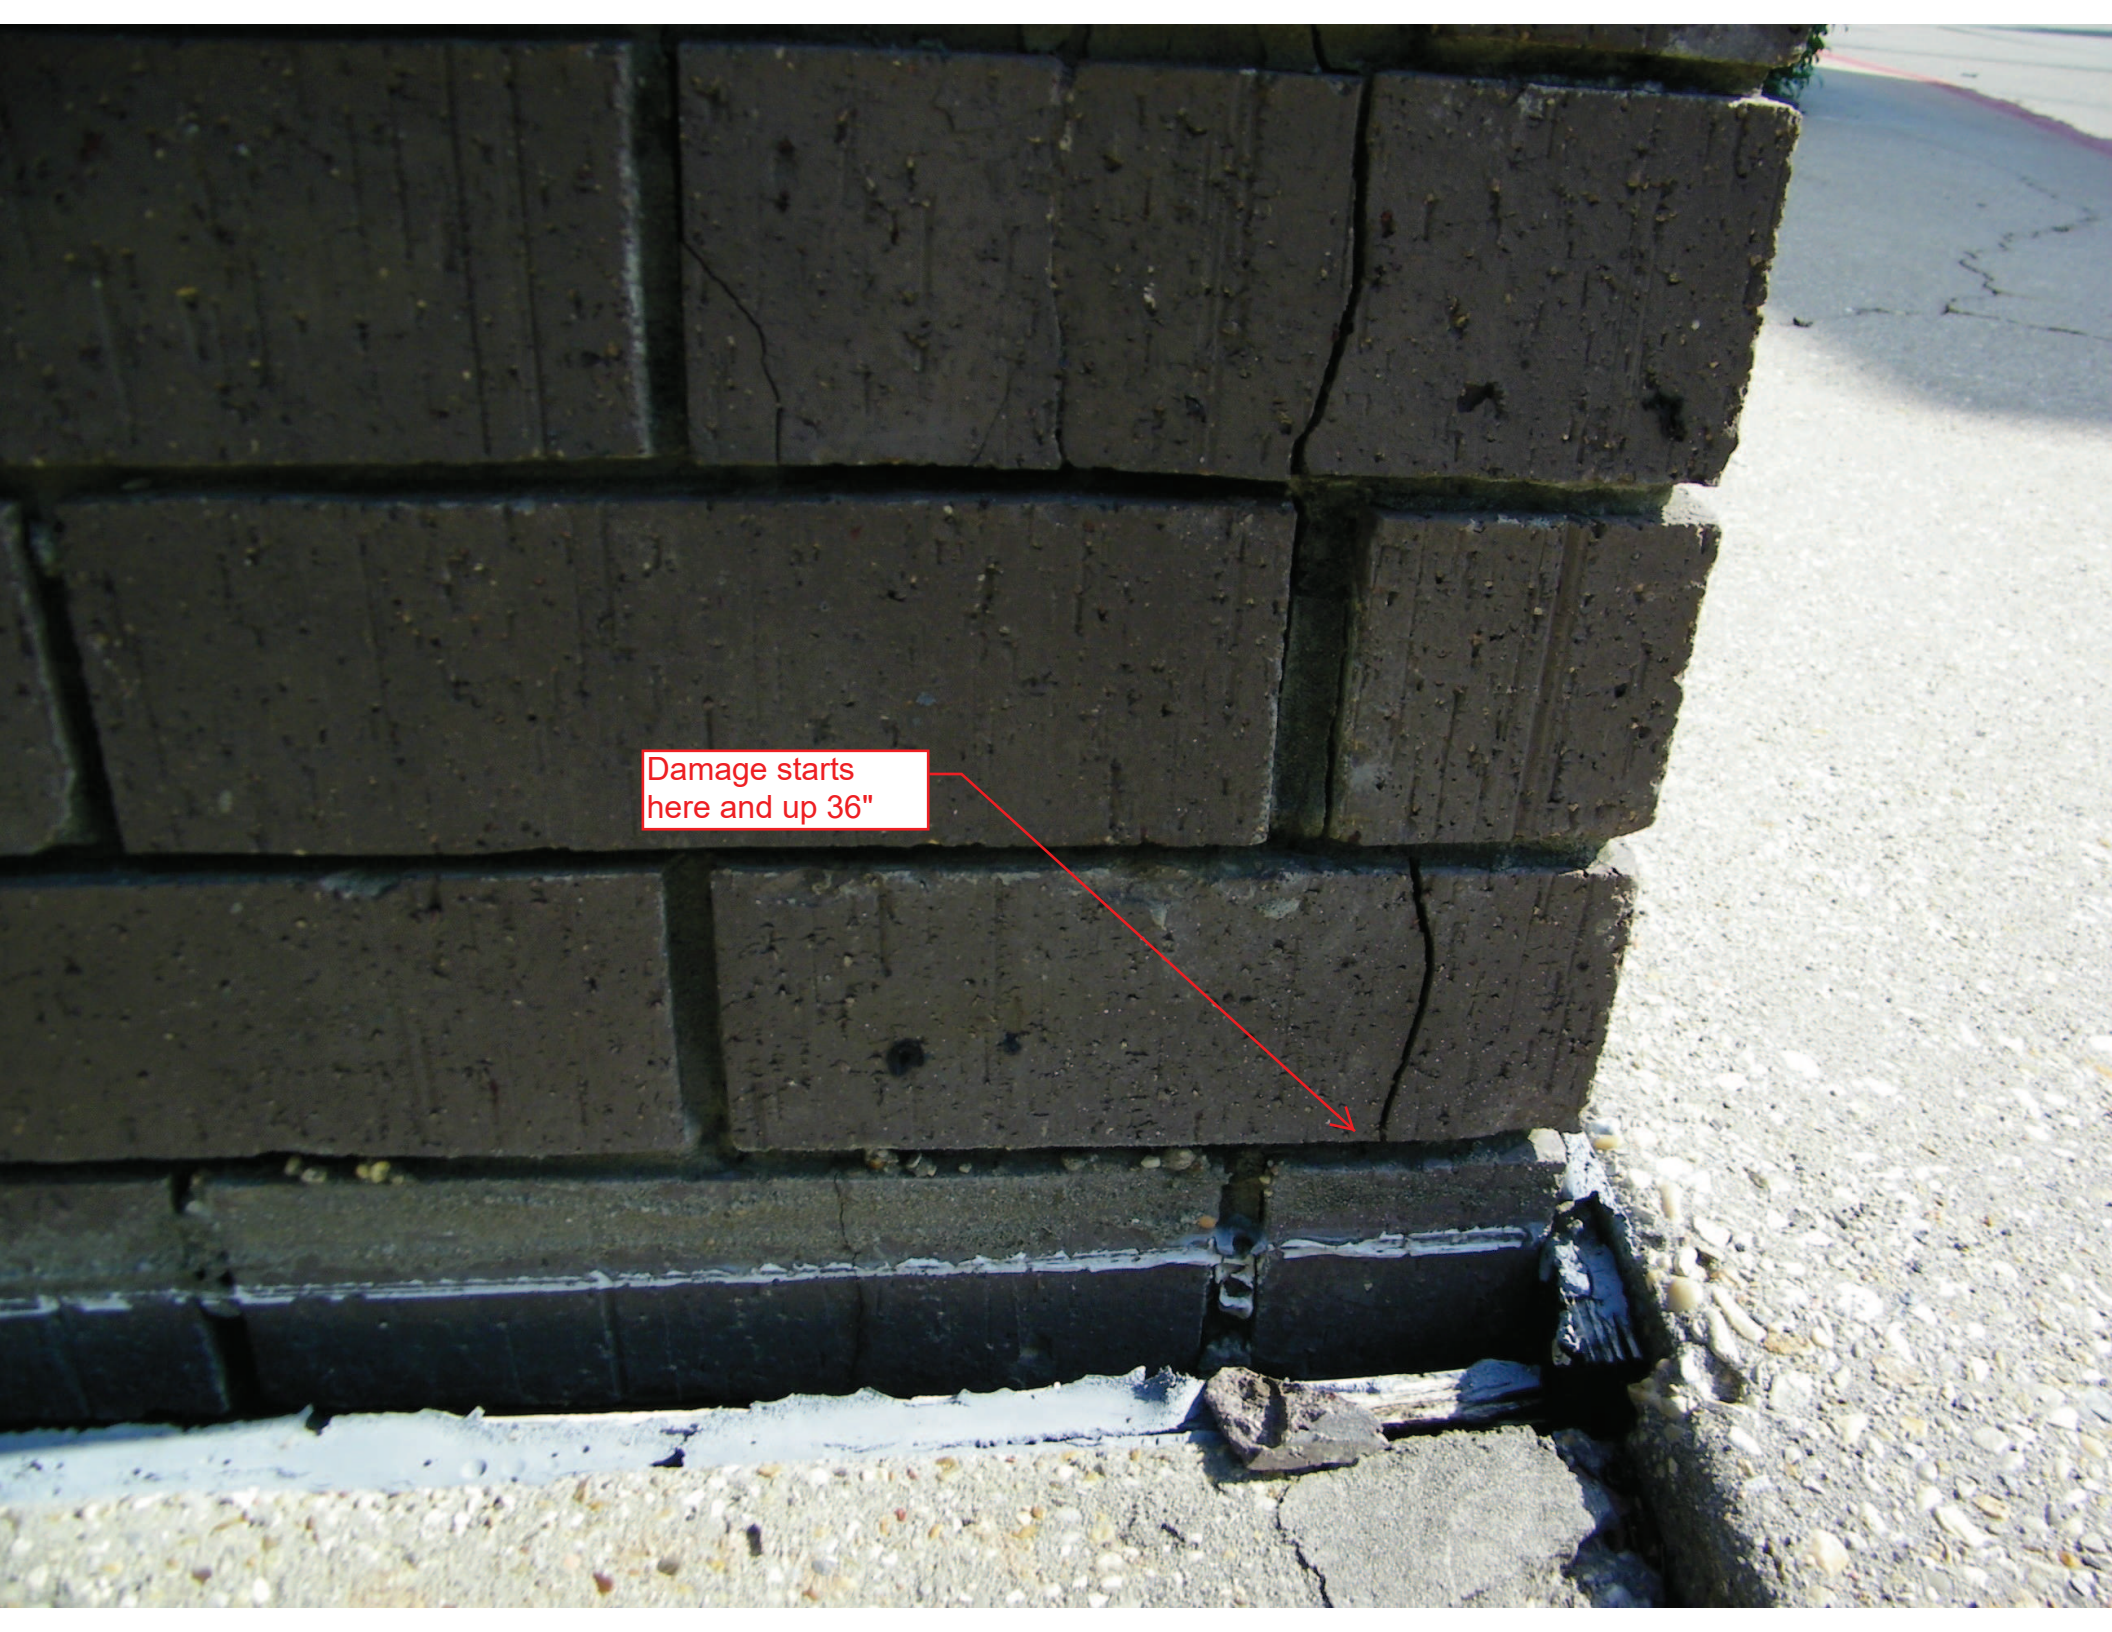
Damaged area

Damage starts here and up 36"

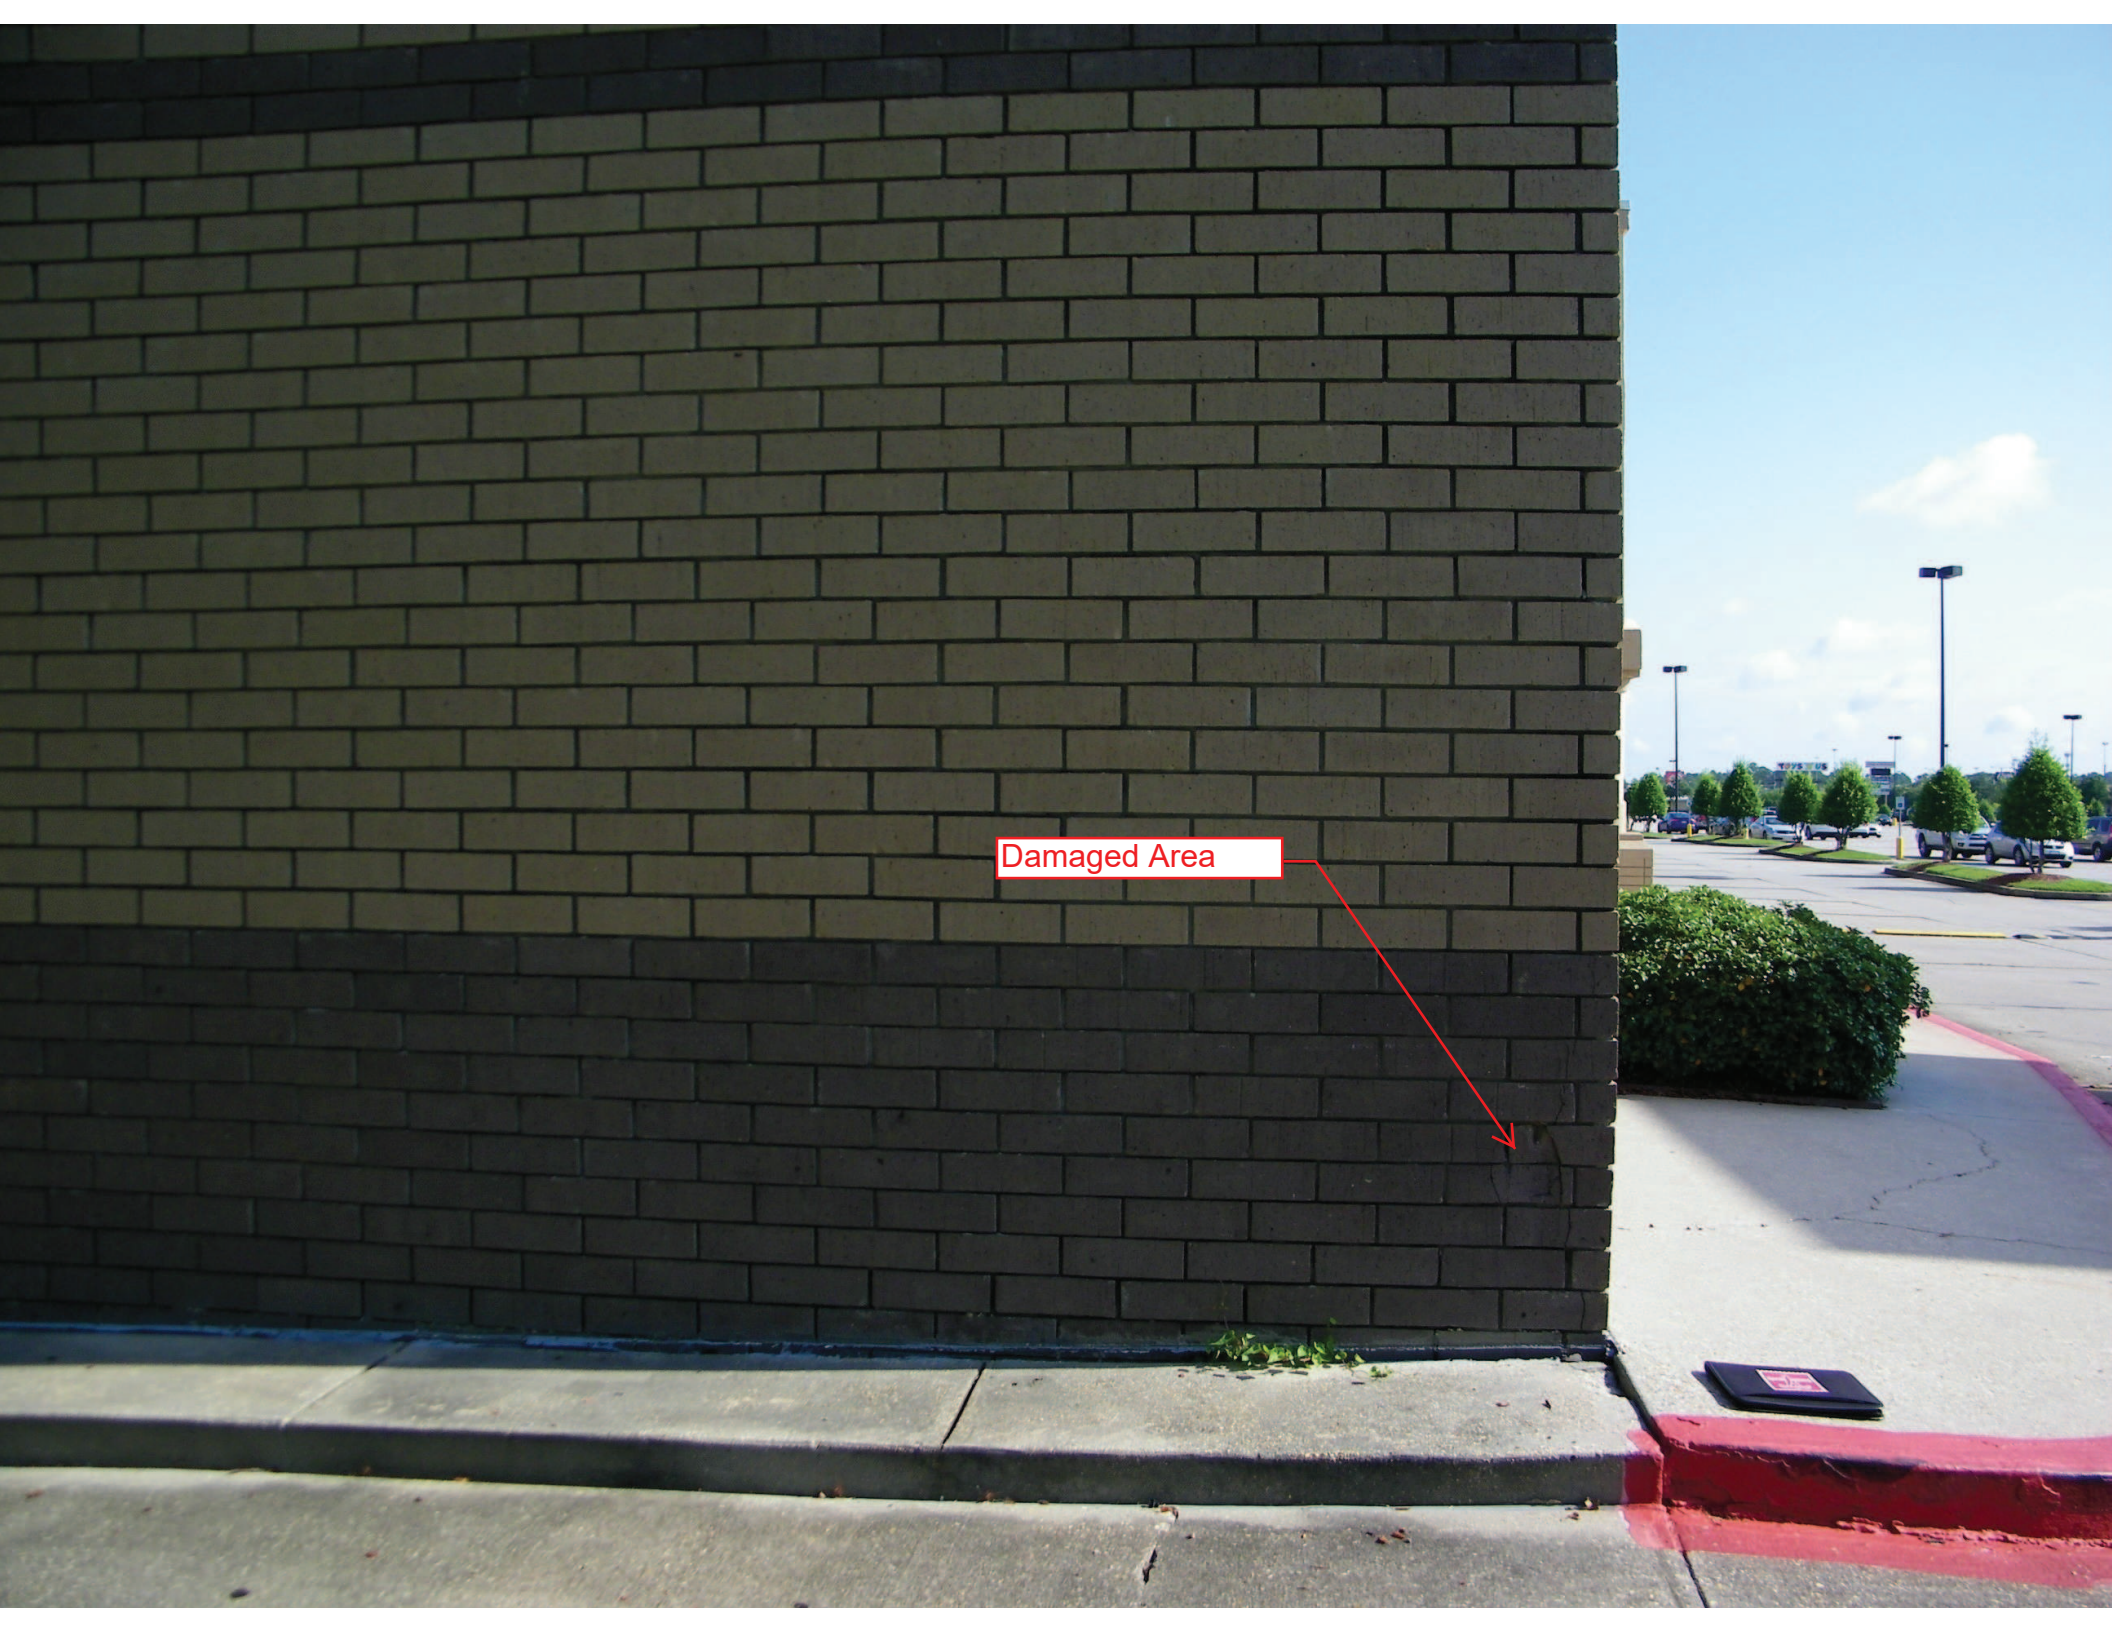
Damaged Area

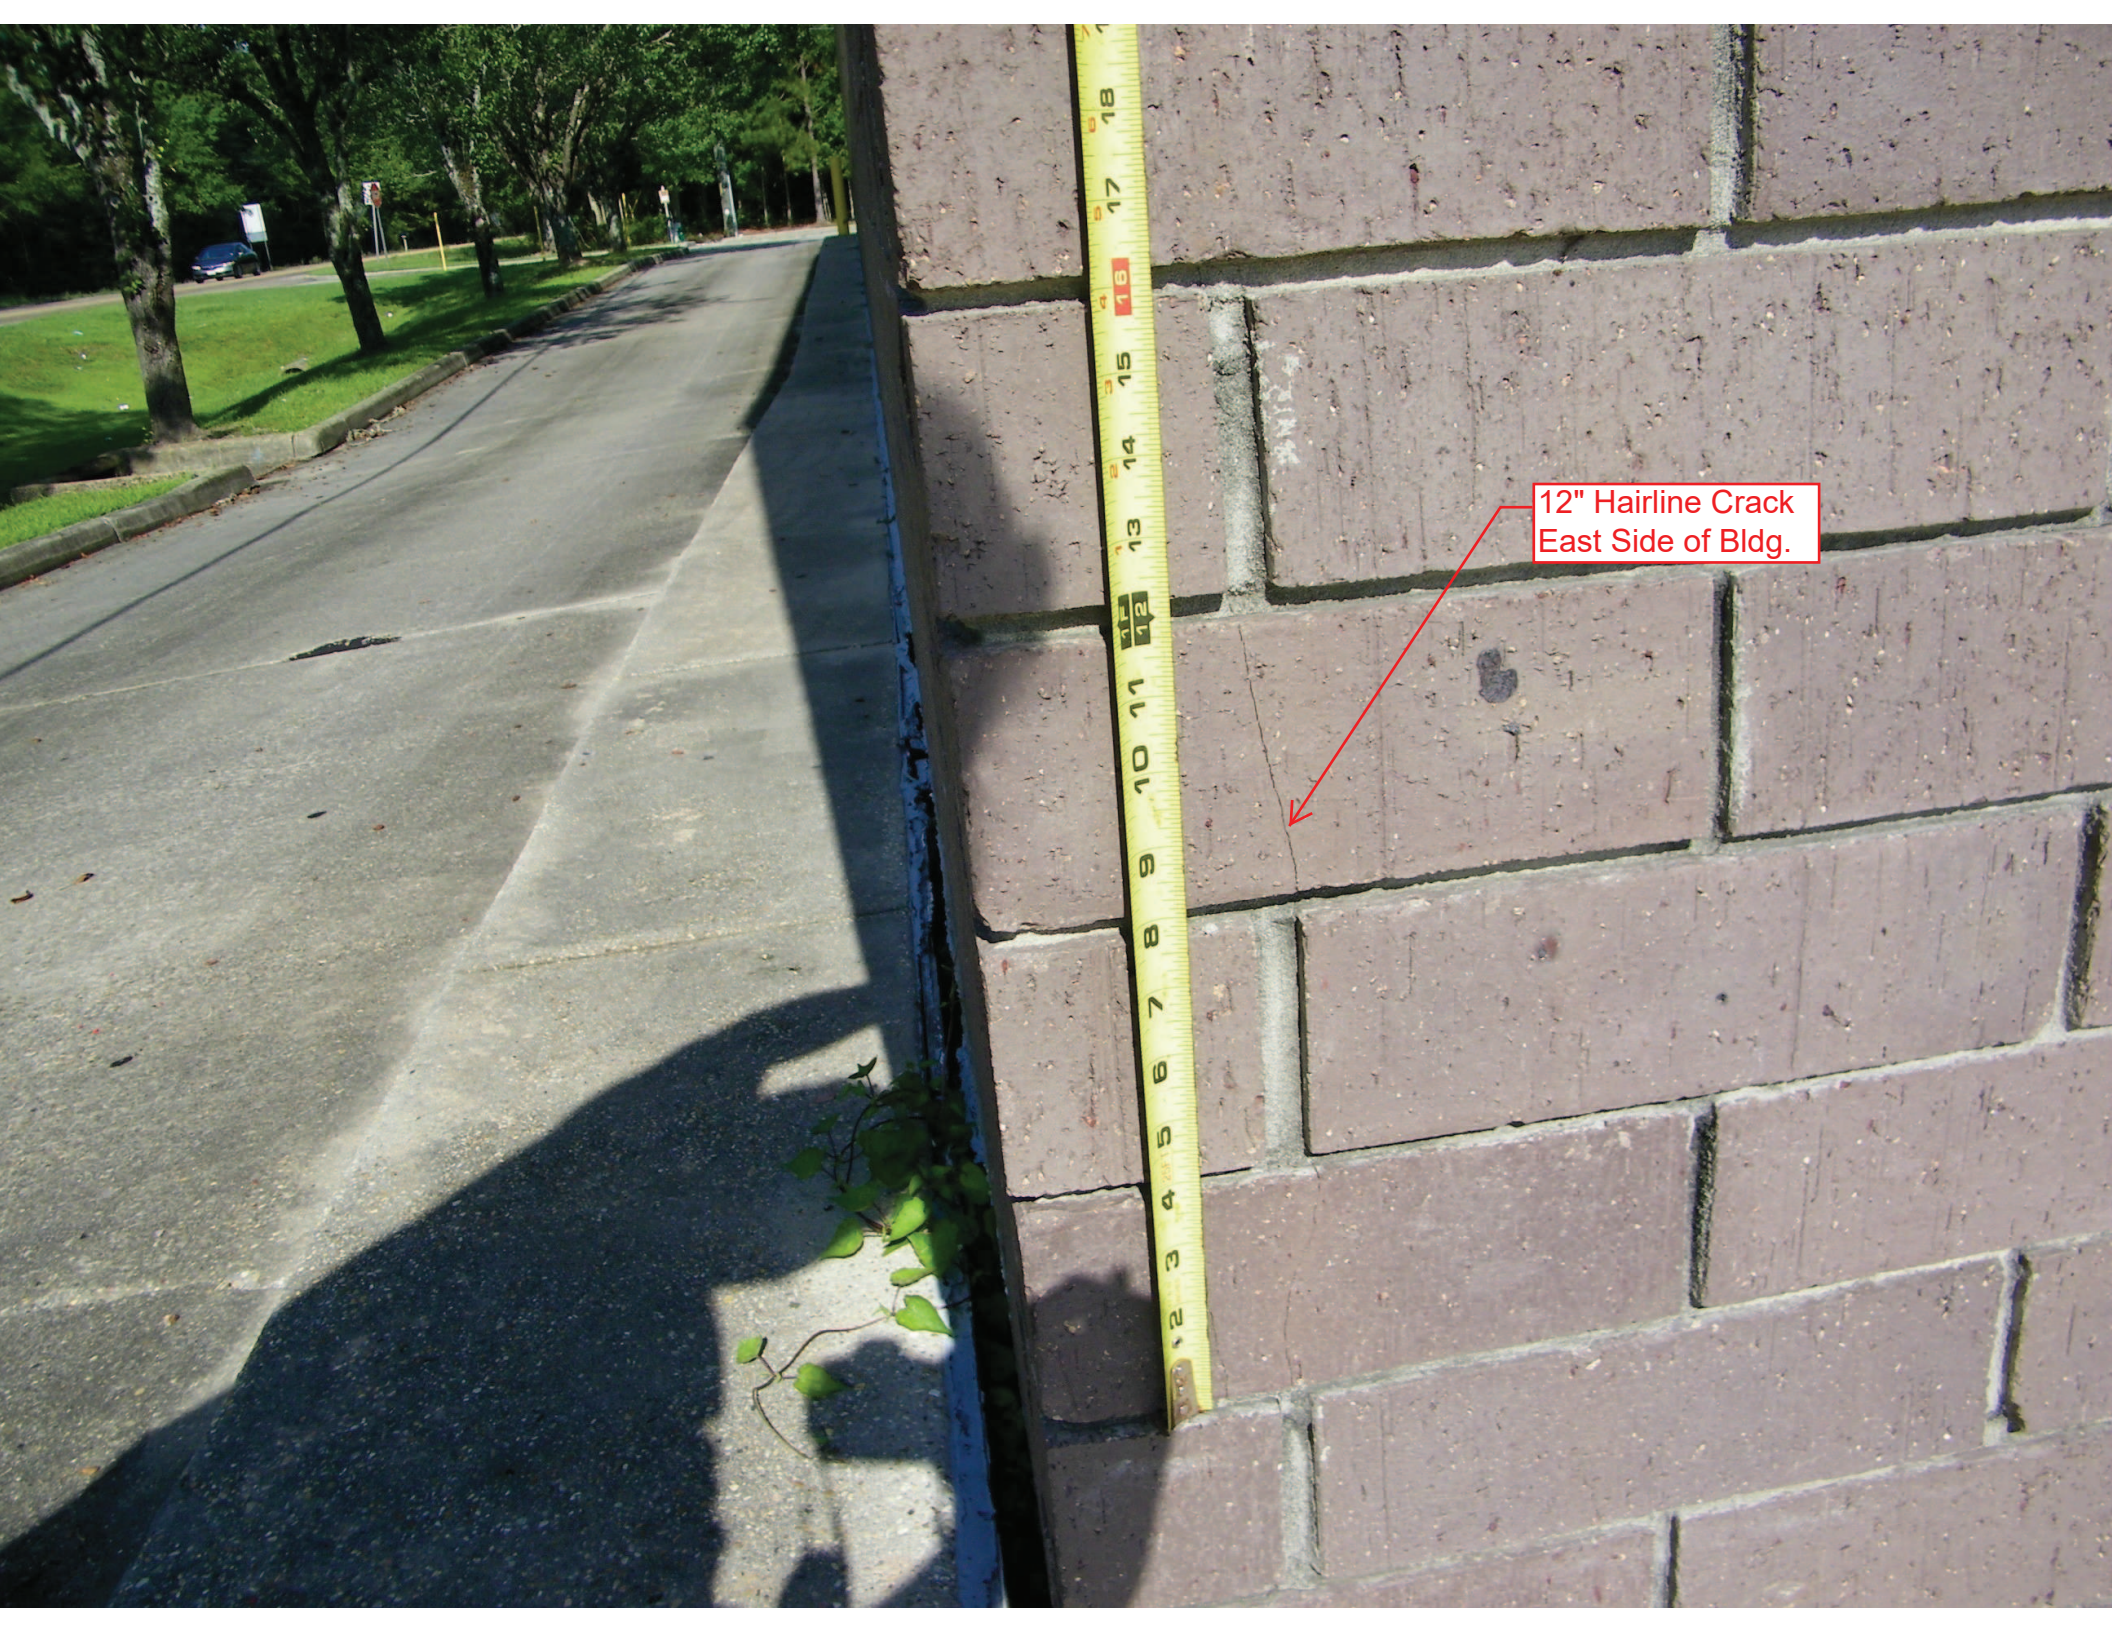
12" Hairline Crack
East Side of Bldg.
