HOME INSPECTION REPORT

**1480 Fremaux Ave,
Slidell, La.**

Inspection Date:
9/10/2014

Report Number:
39092014

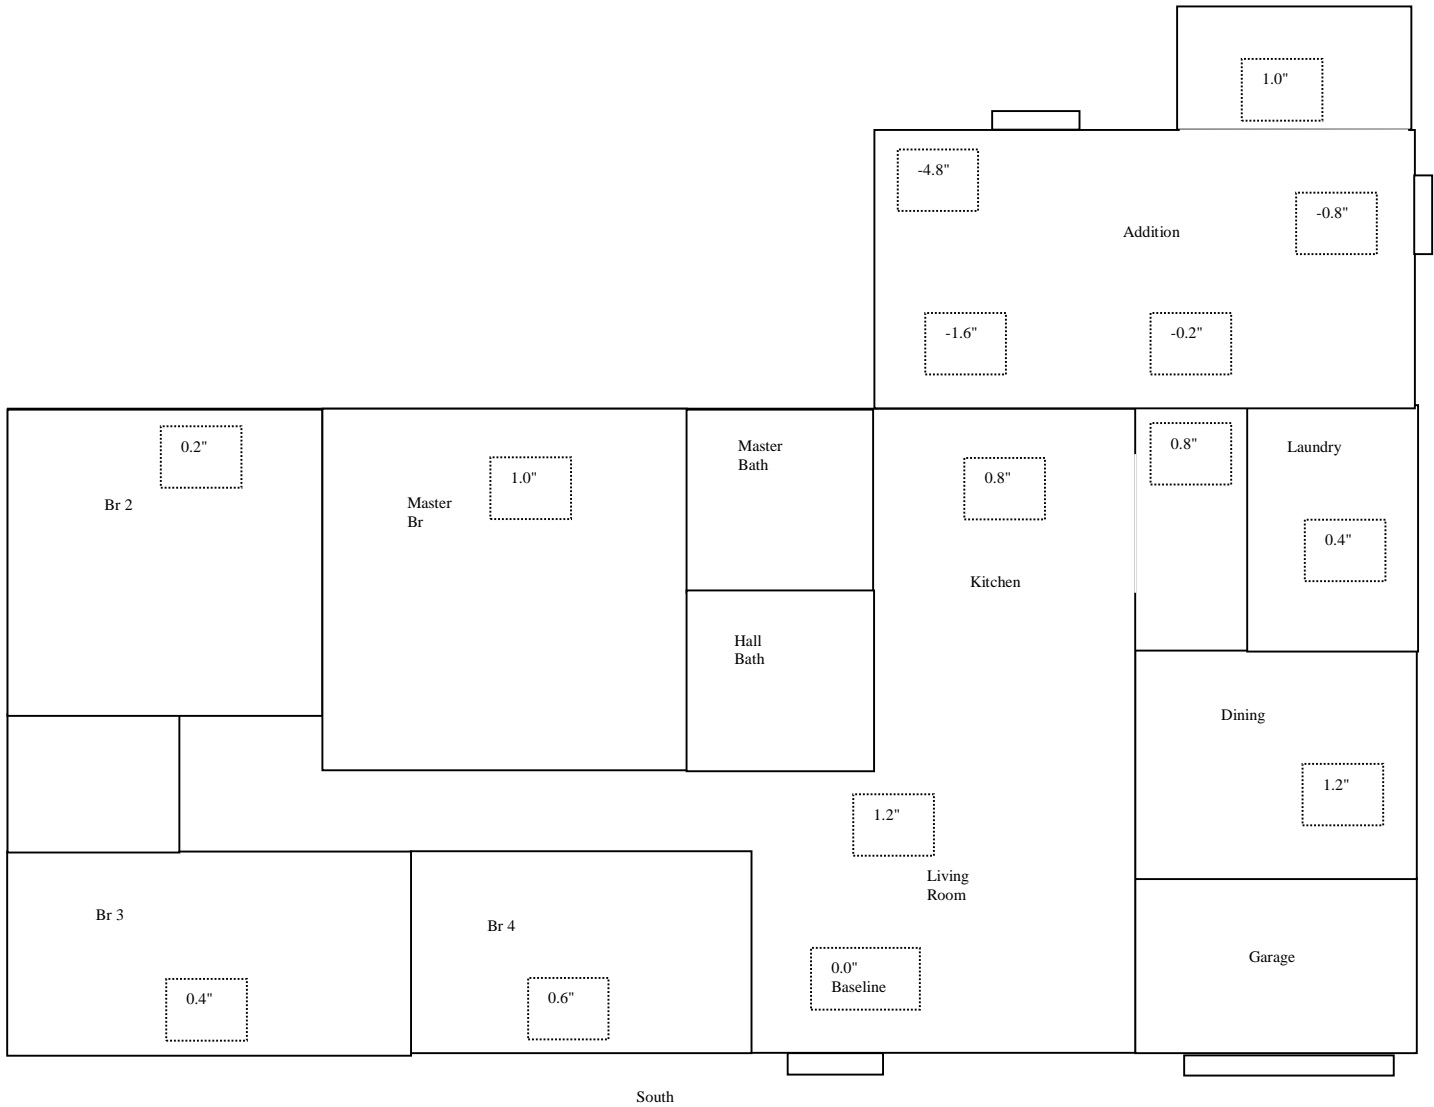
FLOORING ELEVATION SURVEY

- There was a flooring elevation differential of 4.6 inches in the addition at the time of the inspection. This is greater than typical for a home of this age and location. Structural repairs *may* be necessary or desirable. Since evaluating the structural integrity of the home is beyond the scope of this inspection, it is recommended that a professional structural engineer be engaged to evaluate the building.

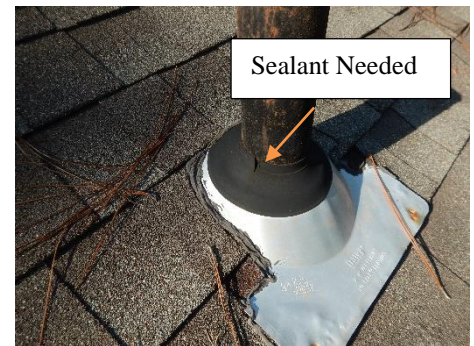
- **Improve:** Debris should be removed from the roofing.
- **Improve:** The plumbing vent and service mast flashing is damaged and should be repaired.
- **Improve:** The valley flashing on the south slope is loose and should be secured.
- **Monitor:** Prior repairs to the roofing are evident at the south slope. This would suggest that problems have been experienced in the past. This area should be monitored.

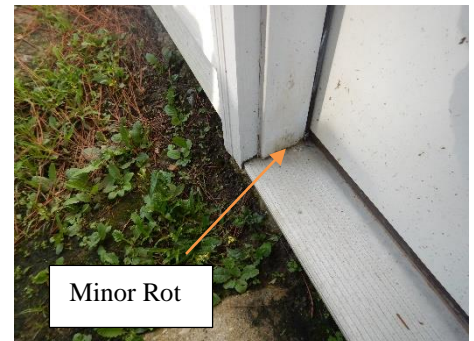
- **Improve:** Wood/soil contact with the fencing should be eliminated. Rotted or damaged fencing that is uncovered should be repaired.
- **Improve:** The gate and/or latch mechanism needs adjustment to function properly.

- **Improve:** Tree branches at the north side of the home should be trimmed away from the house.
- **Improve:** Damaged siding at the north and east side of the home should be repaired or replaced as needed.

- **Improve:** While the fencing sections are in reasonably good condition, the support posts are in poor condition. Replacement of the deteriorated posts is recommended.

- **Improve:** The loose siding at the east side of the home should be re-secured.
- **Improve:** Localized evidence of minor rot was visible at the door frame at the east side of the home. Repairs should be undertaken in conjunction with painting.

- **Improve:** The windows require caulking.
- **Improve:** The threshold for the door on the north side of the home is lacking support, this should be improved to prevent damage.

- **Improve:** A drainage swale (if effect, a wide and shallow ditch) should be created at the west side of the home. Drainage swales are intended to divert storm water away from the house and ultimately off the lot.

- **Monitor:** The soil below the driveway has settled and/or heaved. Persisting movement may result in the need for resurfacing.
- **Monitor:** Minor damage was noted to the window frame on the north side of the home.

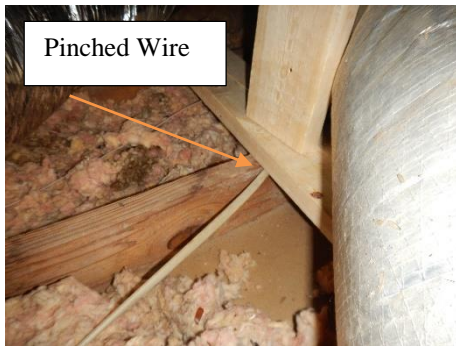
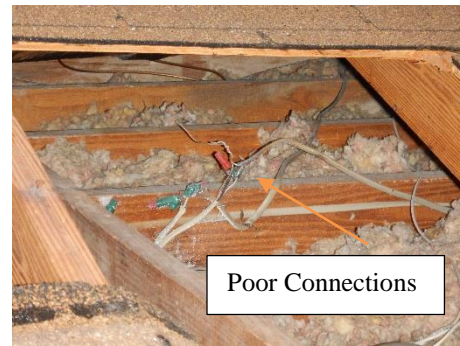
- **Improve:** A ground fault circuit interrupter (GFCI) outlet on the north side of the home did not respond correctly to testing during the inspection. This receptacle should be replaced.

- **Improve:** Abandoned wiring on the north side of the home in the soffit and in the attic should be replaced or appropriately terminated.
- **Improve:** Missing light covers should be replaced on the exterior of the home.

- **Improve:** Missing outlet cover plates in the garage should be replaced.
- **Improve:** The outlet(s) that have been painted over in the garage should be improved.

- **Improve:** Ungrounded 3-prong outlets should be improved in the addition. Alternatively, a grounded cable could be strung to this outlet, or a separate ground wire could be connected. Some electrical codes allow the installation of a ground fault circuit interrupter (GFCI) type outlet where grounding is not provided.

- **Improve:** Missing light covers should be replaced in the addition.
- **Improve:** Linking (sometimes referred to as bridging) should be provided wherever two fuses or breakers serve the same circuit, the circuit marked for the A/C. This ensures that the entire circuit is shut off whenever a fuse is pulled, or a breaker is tripped. Linking is required, for example, on circuits serving kitchen split receptacles, baseboard heaters and any 240 volt appliance.

- **Improve:** Any openings in the main panel should be covered.
- **Improve:** Cable clamps (sometimes referred to as bushings or grommets) are required where wiring passes into the main distribution panel. Cable clamps serve to protect the wiring from the metal edges of the panel openings.

- **Improve:** Abandoned wiring in the attic should be replaced or appropriately terminated.
- **Improve:** Improper electrical connections in the attic should be improved. All electrical connections should be made inside junction boxes fitted with cover plates.

- **Improve:** All junction boxes in the attic and under the sink should be fitted with cover plates, in order to protect the wire connections.
- **Improve:** Wiring exposed under the sink should be relocated or protected by a rigid conduit.

- **Improve:** A section of wiring in the attic is pinched between two framing members, this should be corrected to prevent the wire from being damaged.

- **Monitor:** Aluminum solid core wiring was noted in the main panel. The aluminum wiring should be fitted with special connectors and outlets to ensure safe operation of these circuits. During installation of this special hardware, all connections should be checked for signs of damage or overheating. ***It should be pointed out that the aluminum wiring itself is a perfectly acceptable electrical conductor.*** The connection points can experience overheating or become loose due to the properties of aluminum wiring. Upon fitting the wiring with the special connectors and outlets, the wiring is considered to be safe.

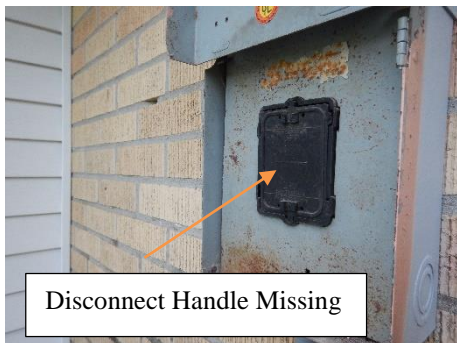
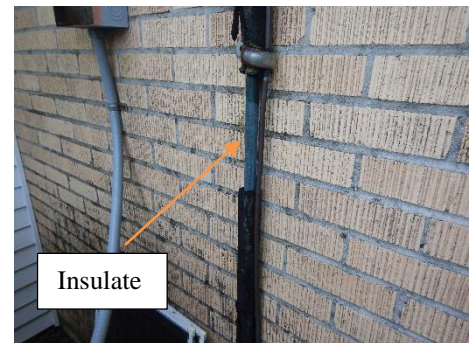
- **Improve:** The service disconnect handle for the A/C unit is broken, and should be repaired.
- **Improve:** It is recommended that the return air be cleaned.
- **Improve:** Damaged A/C line insulation in the attic and on the exterior should be repaired/replaced as needed, this seems to be the cause for the water damage on the master bedroom ceiling.
- **Monitor:** The capacity of the air conditioning system may prove to be marginal during the warmer days of the summer. Without performing detailed heat gain calculations, or living in the home during warm summer days, actual conditions are difficult to predict. No improvements are recommended at this time.

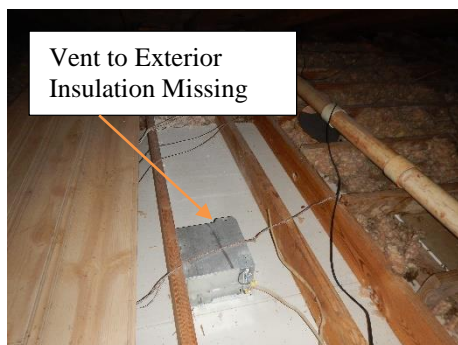
- **Improve:** Compressed insulation should be rearranged.
- **Improve:** Missing insulation should be replaced in the attic.
- **Improve:** Exhaust vent pipes for the bathrooms should be vented to the building exterior to keep moisture out of the attic space.

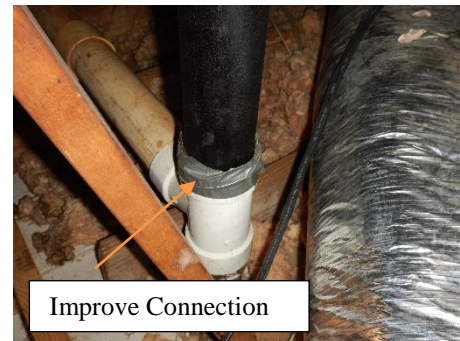
- **Improve:** The gas water heater was non-operable at the time of the inspection. The gas was off to the home.
- **Improve:** The sink in the hall bathroom is leaking at the waste pipe connection, and should be repaired as necessary.
- **Improve:** The toilet in the master bathroom is loose.
- **Improve:** Cracked, deteriorated and/or missing bathtub enclosure grout and caulk should be replaced in the master bathroom.
- **Improve:** The discharge piping serving the Temperature and Pressure Relief (TPR) Valve for the water heater is not installed. Copper, CPVC or PEX piping should be used.
- **Improve:** It is recommended a drain pan be installed under the water heater.
- **Improve:** Waste vent connections in the attic should be improved. Currently the cast piping and PVC are taped together.

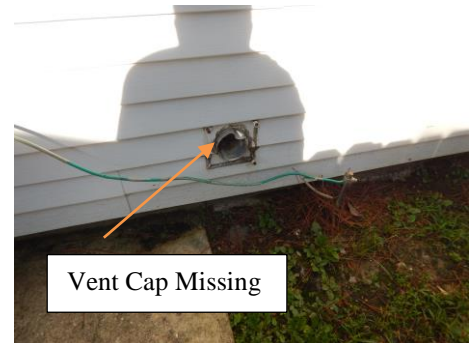
- **Safety Issue:** The smoke detector(s) did not respond to testing.
- **Improve:** The gas range was not tested due to the gas being off at the time of the inspection.
- **Improve:** The dryer vent is missing. It should be replaced and protected against vermin entry.

Vent Cap Missing
