Structural Inspection

July 31, 2018

Ref: 1015 Gloria Ct.
Mandeville, La. 70471

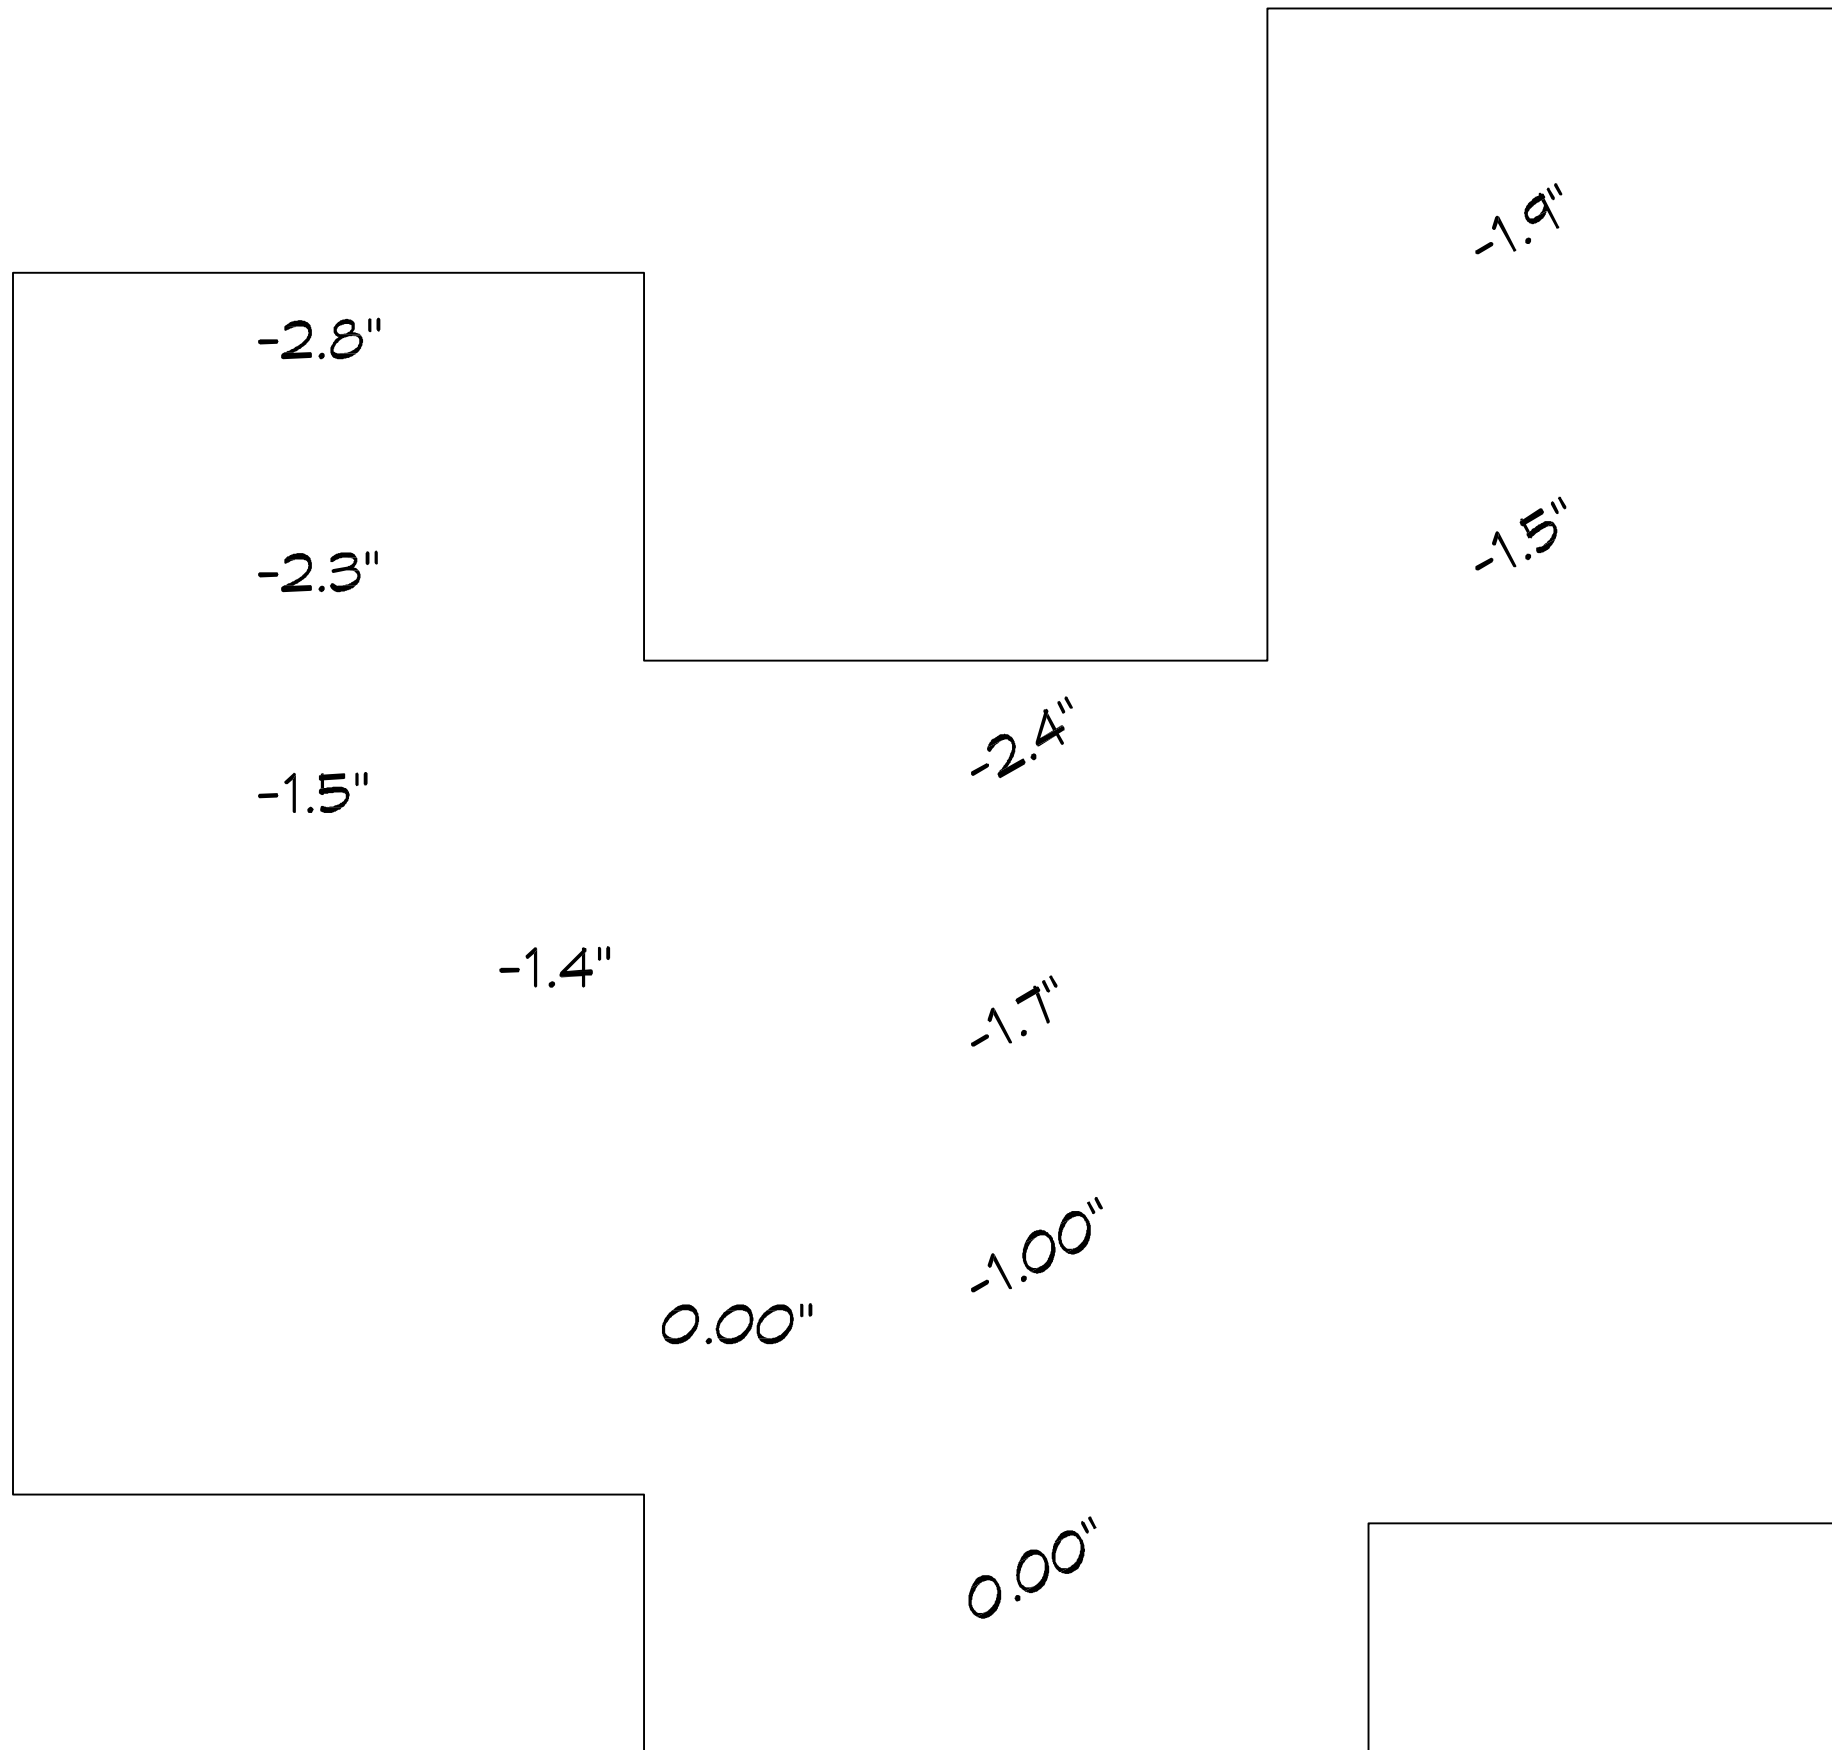
Upon inspection, a zip level was used to verify the floor height conditions. The level was set up at two different areas due to flooring materials used in the home. First area (near front door with wood flooring) at zero inches and measured -2.4" to the rear family room of the home. Second area (kitchen with ceramic flooring) at zero inches and measured -2.8" to the rear bedroom. The left rear bedroom floor appears to have the most notable slope with an overall slope from the front to the rear of the home.

0.00" #S ON CERAMIC TILE

0.00" #S ON WOODEN FLOOR
