Structural Inspection

May 11, 2016

Ref; 1352 7th Street
Slidell, La. 70458

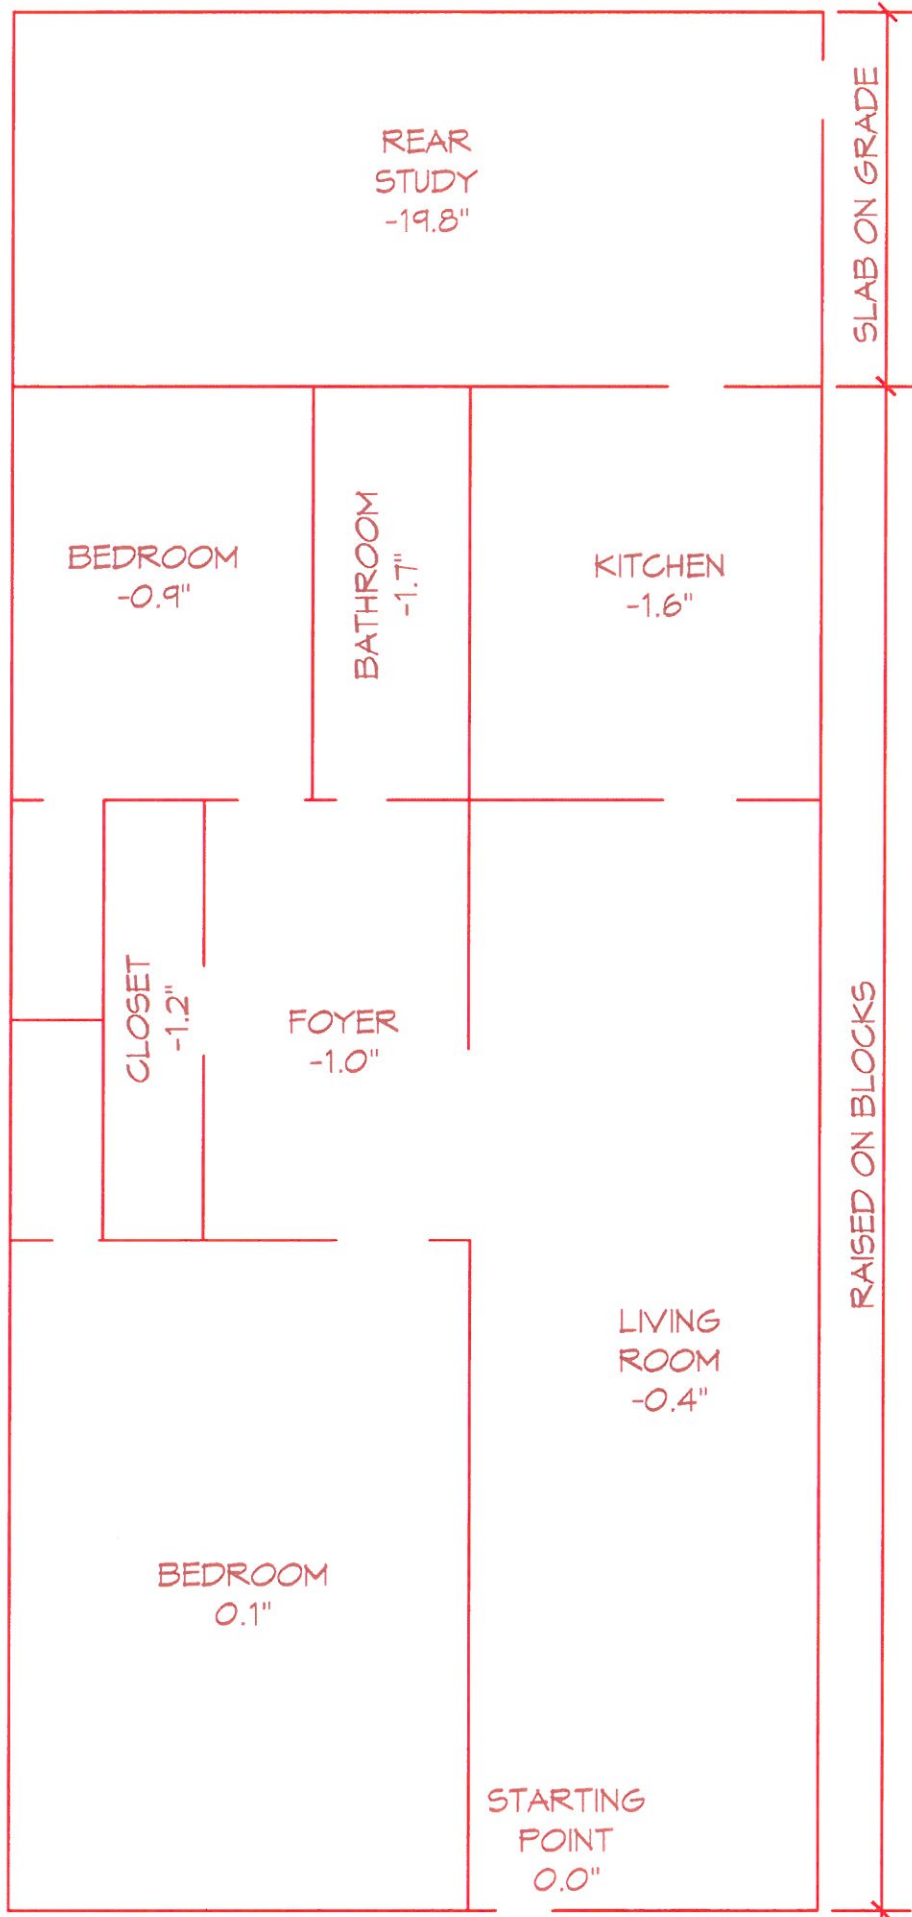
Attachment: Floor Plan Noting Elevation Differences

Upon inspection, a zip level was used to verify the floor height conditions. It's evident from these readings that the home has experienced some settlement over the years. It is important to note that all floor height conditions are within acceptable tolerances. Most of the numbers are from differences noted near the rear of the home. (See attached sketch and pictures)
