# Inspection Report

**Property Address:**  
139 Everest Drive  
Slidell La. 70458

**DTM Building Inspection Serv.,LLC**

<b>Date:</b> 5/12/2017	<b>Time:</b> 02:30 PM	<b>Report ID:</b> 03649
<b>Property:</b> 139 Everest Drive Slidell La. 70458	<b>Customer:</b> Mr. Ryan Dey Ms. Briana Davis	<b>Real Estate Professional:</b> Lloyd Clark III

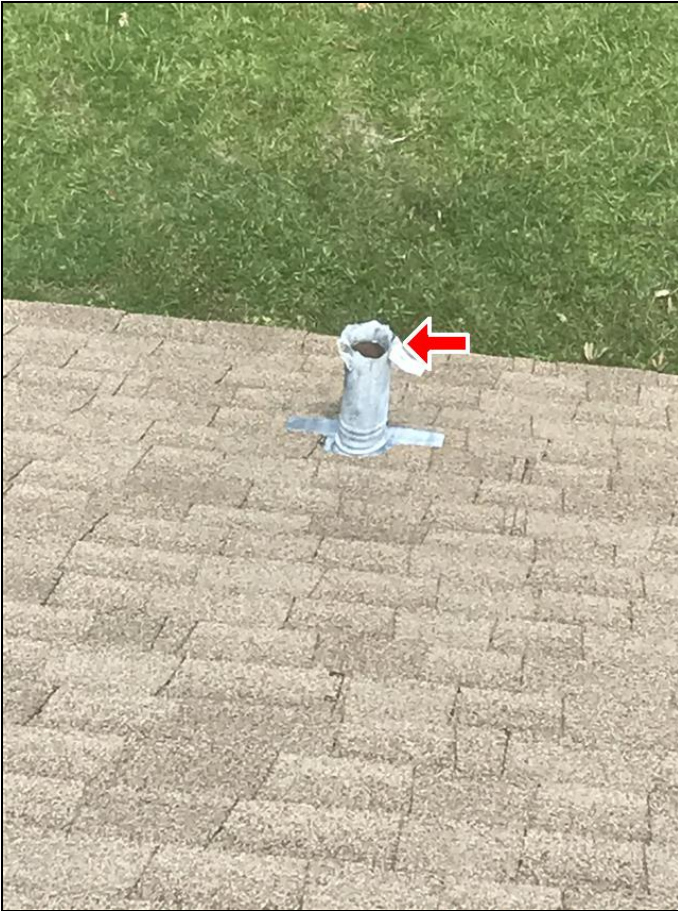
**1.1 One of the lead vent stacks/covers and skirts have been damaged by rodents. (over laundry room) I would recommend replacing any damage stack covering so there is no chance of water entrances into the attic space.** Repair or replace as needed.

1.1 Item 1(Picture) rodent damage on cover

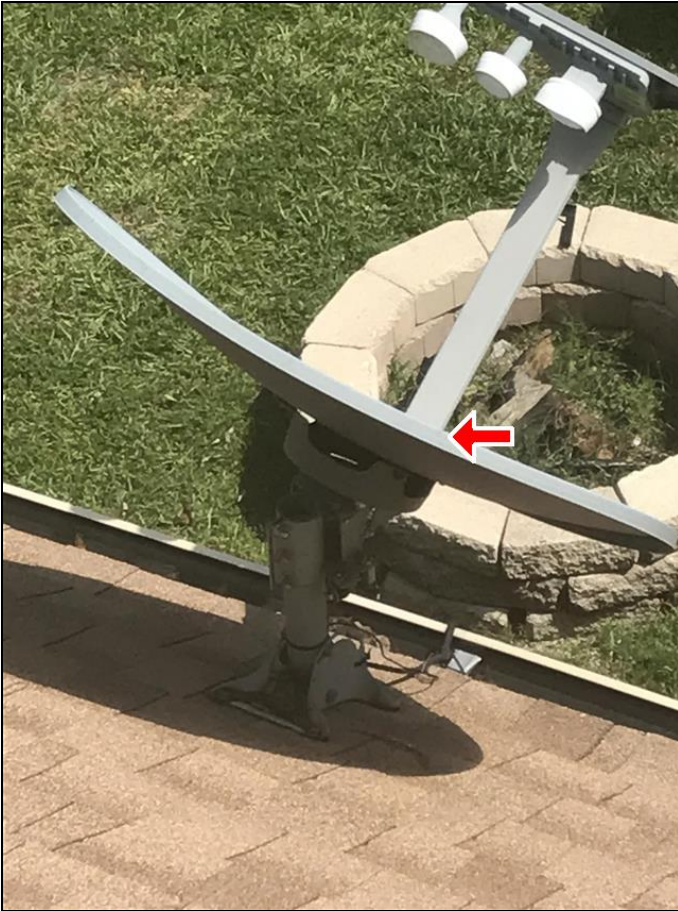
**1.2 There is a Television dish that is installed on top of the roof shingles of the home.** It is not a good idea to installed these dishes on the roof like this as you can create roof leaks around the fastening hardware, and this dish could be ripped off the roof in high winds. This could cause major damage if this were to occur. The recommended install would be to fasten the dish to the eave of the home. This is for your information and repair as needed by a qualified licensed roofer.

1.2 Item 1(Picture) TV dish on roof

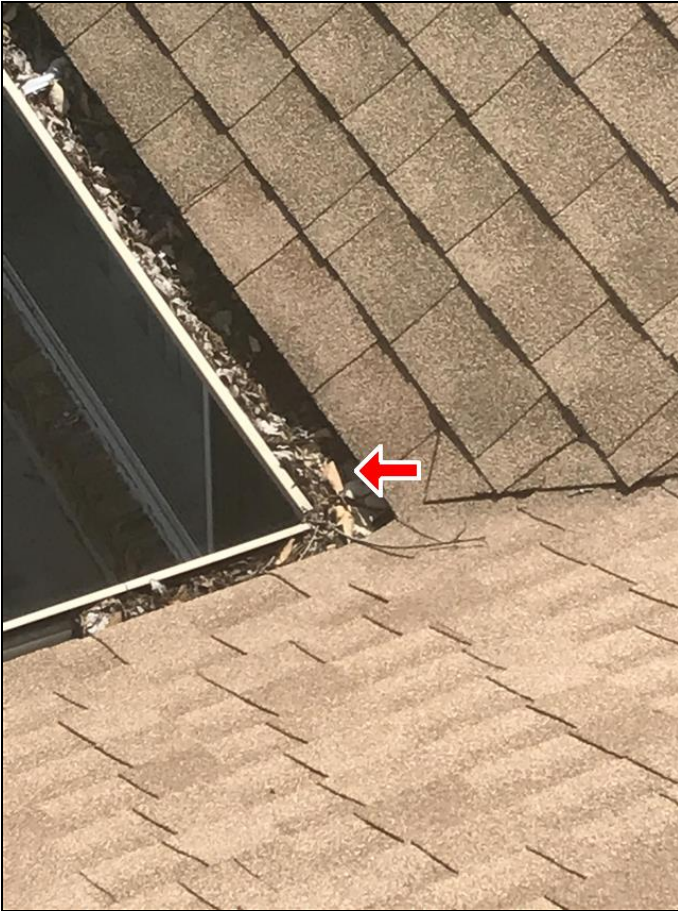
**🏠 (2) The gutters are full of debris in areas and needs to be cleaned.** The debris in gutters can also conceal rust, deterioration or leaks that are not visible until cleaned, and I am unable to determine if such conditions exist. Gutter debris can lead to moisture damage to the eaves and promote wood destroying insect activity. Clean the gutter cans as needed on a regular basis by a qualified person.

1.3 Item 1(Picture) gutter debris

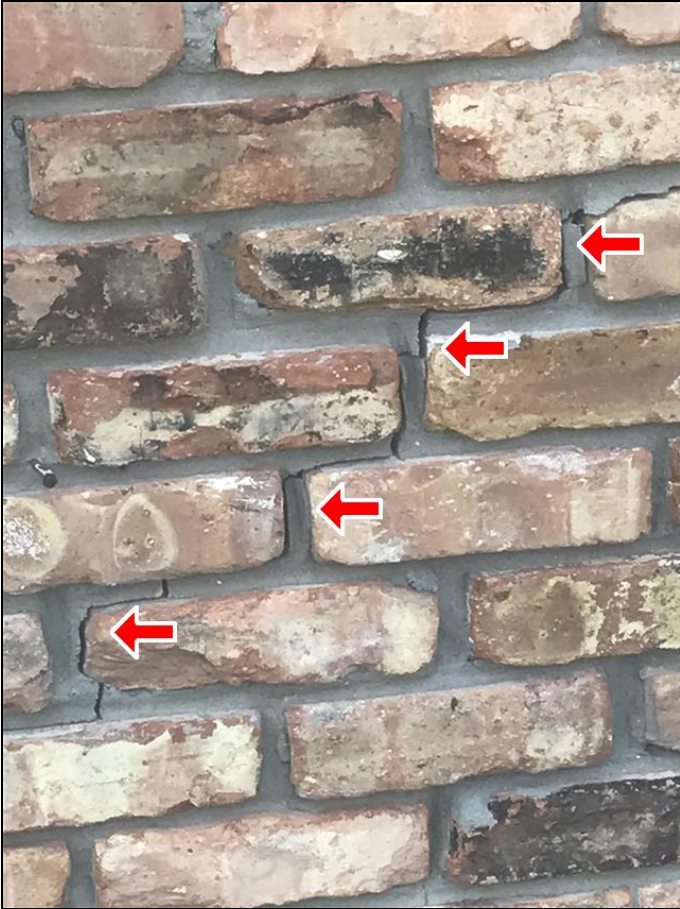
**2.0 (1) There is some brick/mortar cracking on the brick veneer siding of the home. (front porch, left side, right side, and rear) The heaviest cracking was on the rear outside the master.** It appears this cracking is typically in brick veneer walls and most do not represent a structural problem but can show some movement in the foundation of the home. If there is serious movements in the brick wall or bricks that have shifted away from the wall, then this typically would require further evaluation, however that was not visible on this inspection. This cracking should be monitored over time to ensure no further movement is occurring. Any major movements should be address with a specialist. Repair as needed.

2.0 Item 1(Picture) mortar cracking

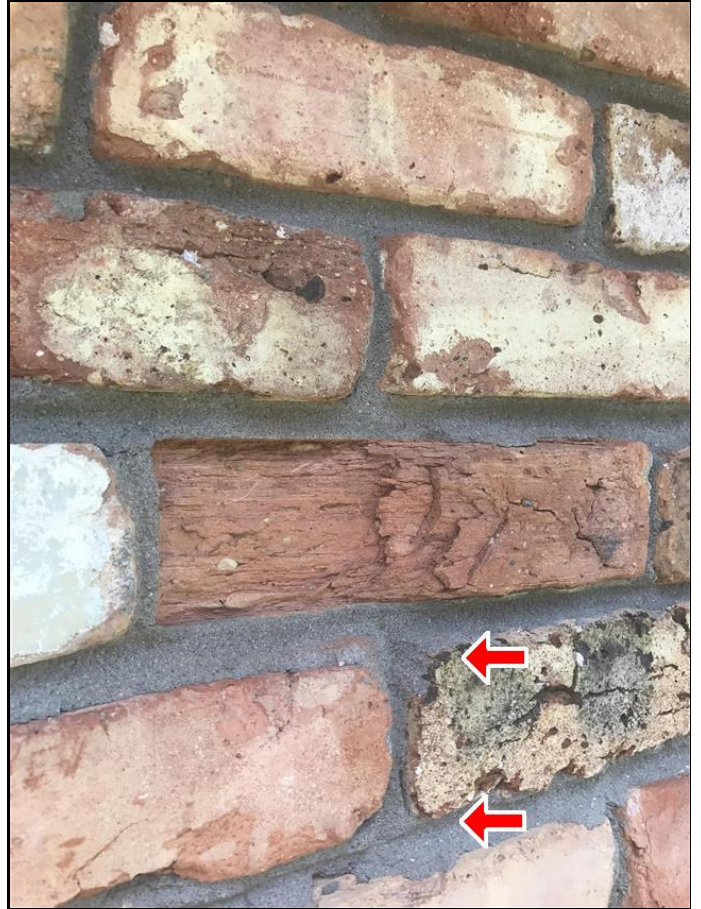
**It appears the mortar joints on the rear left and rear of the home appears to have been coated with a weather coating or water proof sealant.** Apparently this home has had some flooding issues or concerns in the past as the foundation also has been coated with a black weather proof coating as well. This coating as covered the weep holes on the brick wall and now will not allow any moisture to drain that could get behind the wall. This can be a concern as this water would sit inside the wall cavity and caused moisture concerns. The coating on the mortar joints is not much of a concern. This is just for your information.

2.0 Item 2(Picture) mortar has weather proofing on mortar

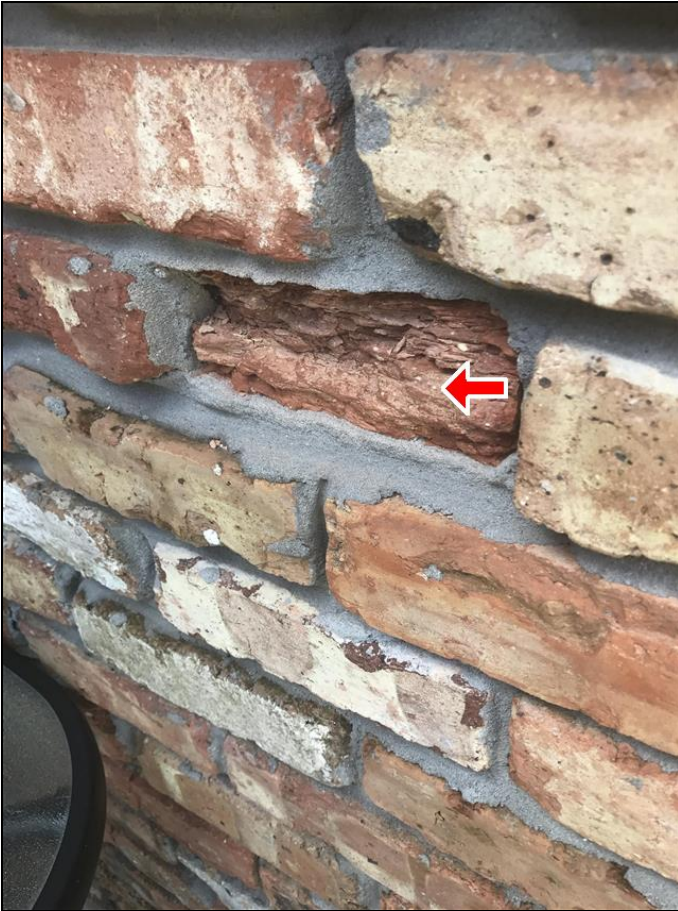
**There is signs of crumbling bricks around the home. This appears to be a bad batch of bricks when installed. The mixture of the bricks may not have correct when the bricks were made. The bricks that are**

crumbling appear to be very dry. Some of the bricks may require repairs if further deterioration occurs. Recommend a qualified licensed contractor to inspect and repair as needed.

2.0 Item 3(Picture) crumbling brick in wall

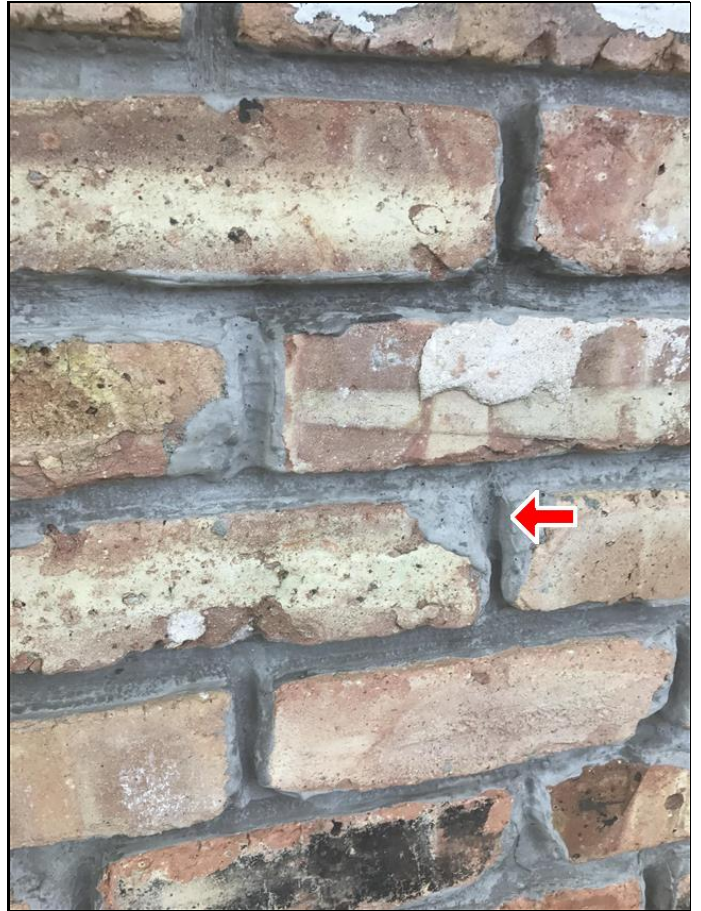
2.0 Item 4(Picture) weather coating over mortar

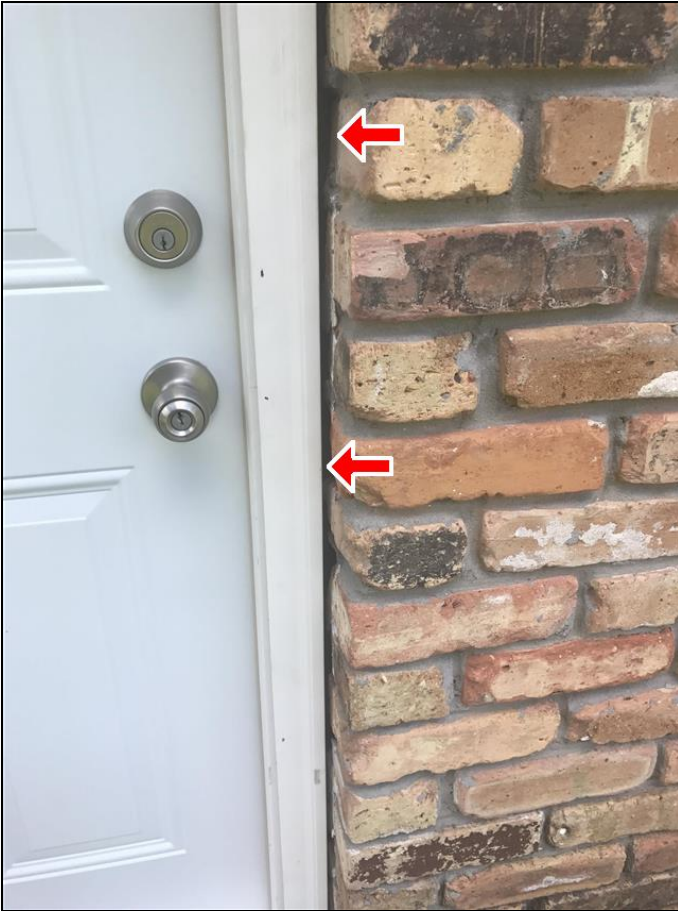
2.1 (1) Recommend sealing the door frames on the (front , garage door frame, garage man door) of the home. Sealing between the frame and the siding material will help prevent any moisture damage behind the walls. Repair as needed by a qualified person.

2.1 Item 1(Picture) door frame needs sealing

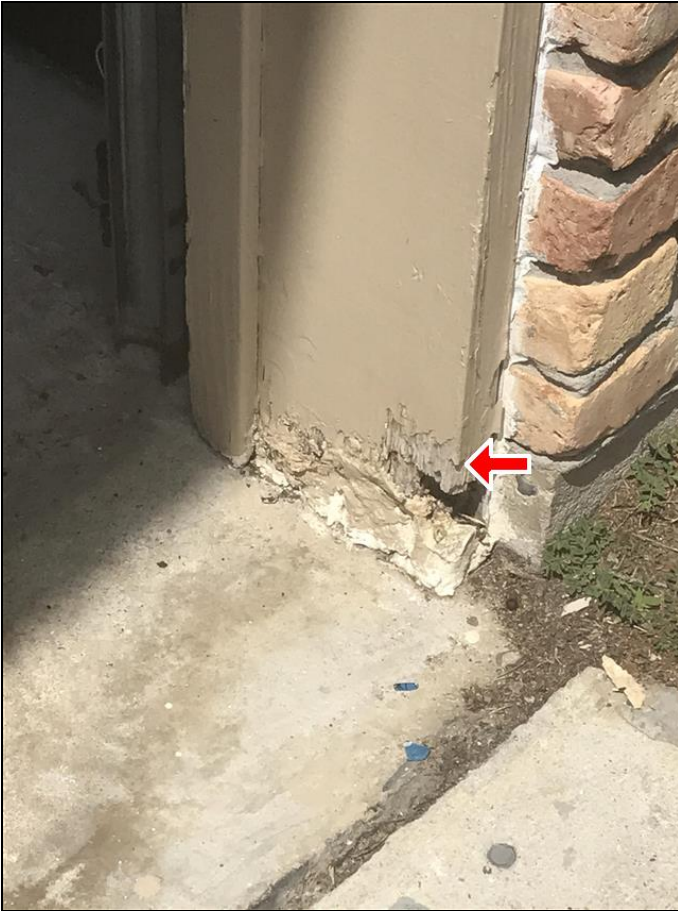
(2) **There is moisture damage visible to the (garage) door frame at the bottom of the door jam.** This damaged wood should be replaced to prevent further deterioration of the the framing. Repair as needed by a qualified person.

2.1 Item 2(Picture) damage to garage door frame

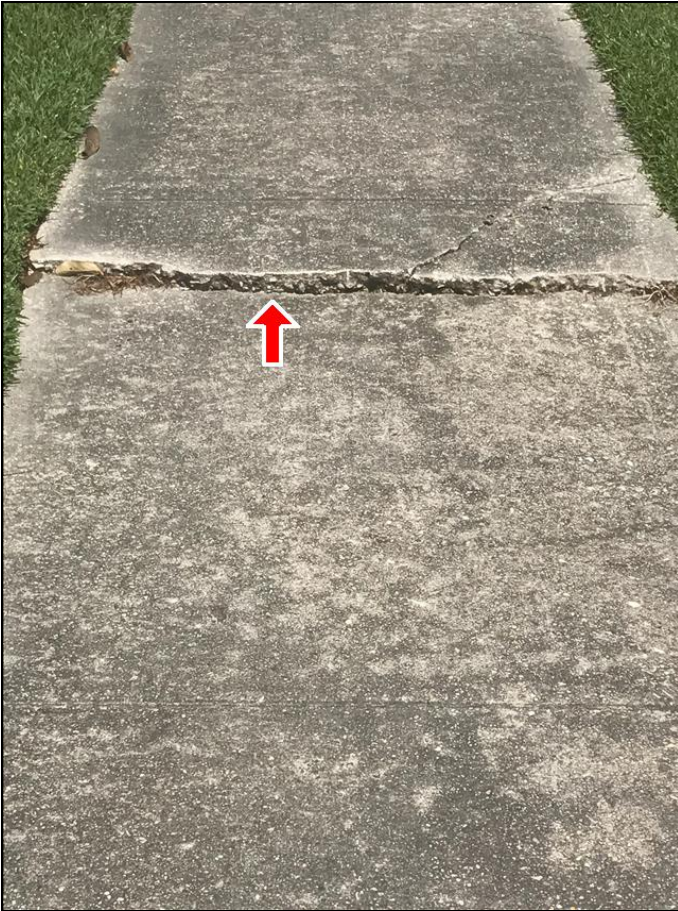
**(2) The (front walkway) of the home is not level and has separations in the concrete which could be considered a tripping hazard. This could result in a fall or injury due to this hazard. Recommend repairing the concrete in order to prevent any injuries. Repair as needed by a qualified licensed contractor.**

2.4 Item 1(Picture) possible trip hazard

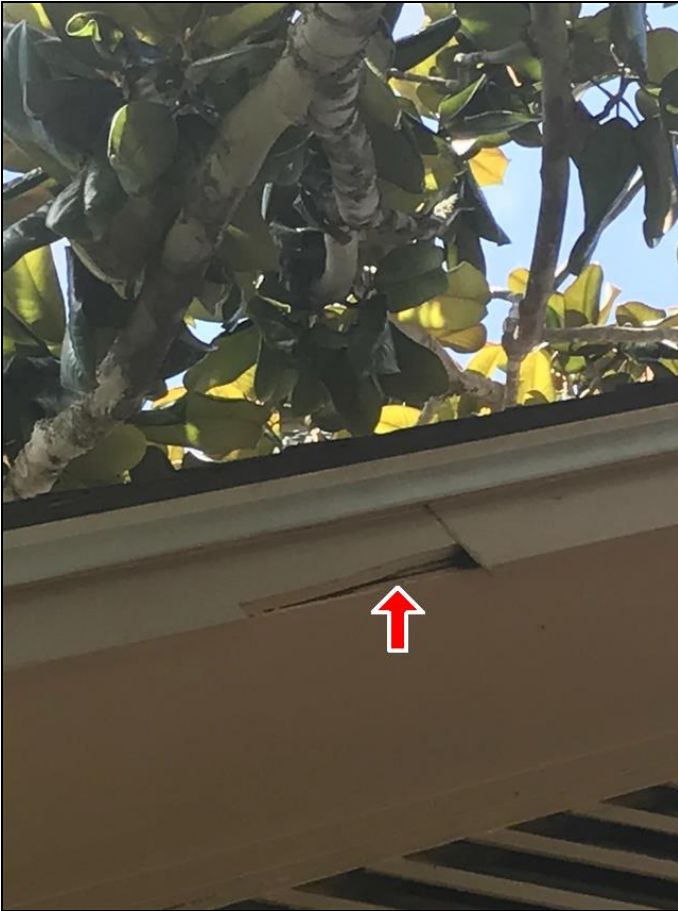
**2.5** There is a damaged piece of fascia board on the right side of the home. Recommend replacing the damaged board to ensure the fascia is well sealed. Repair as needed.

2.5 Item 1(Picture) broken/damaged fascia board

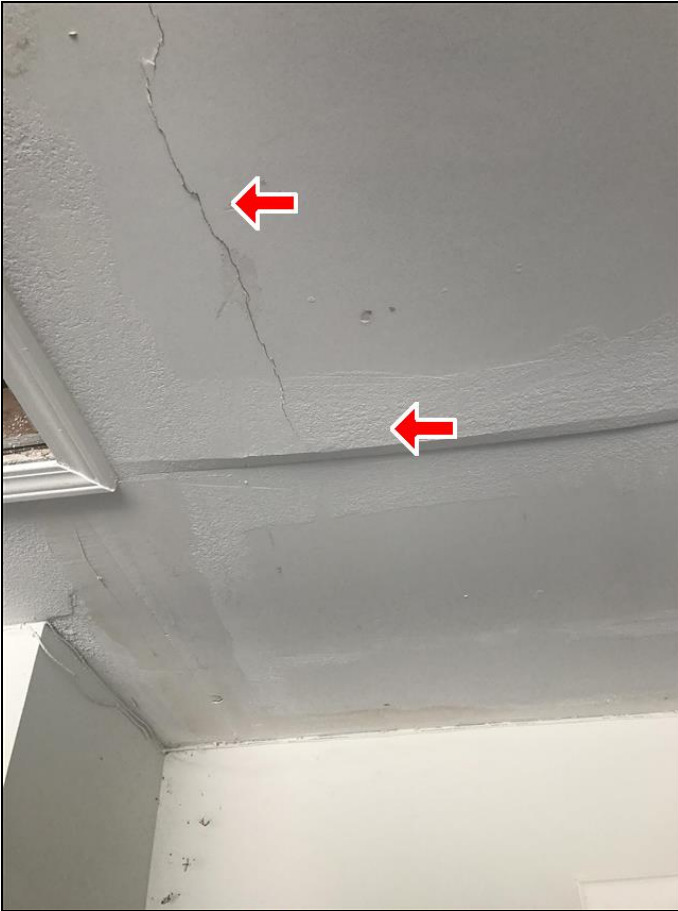
**3.0** (1) There was signs of a ceiling crack(s) in the garage ceiling. The cracking should be monitored in the future to ensure no further cracking or movement. Any concerns should be brought to a specialist. The cracks appear to be a cosmetic concern at this point in time. Repair as needed.

The ceiling appears to be pushed down or loose by the attic staircase. The drywall should be secured as needed by a qualified person or contractor.

3.0 Item 1(Picture) ceiling cracks, drywall loose in garage

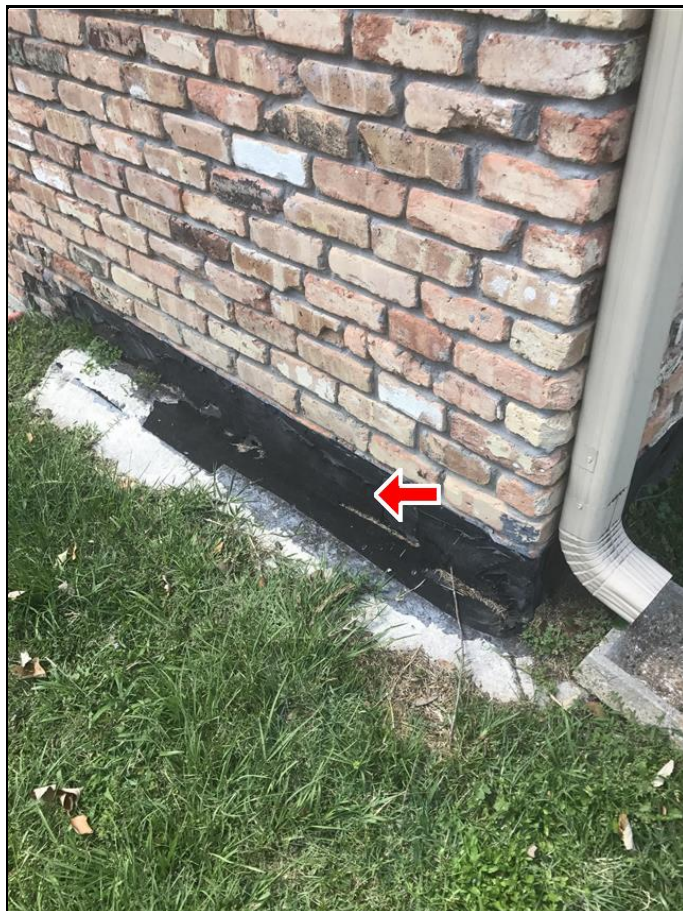
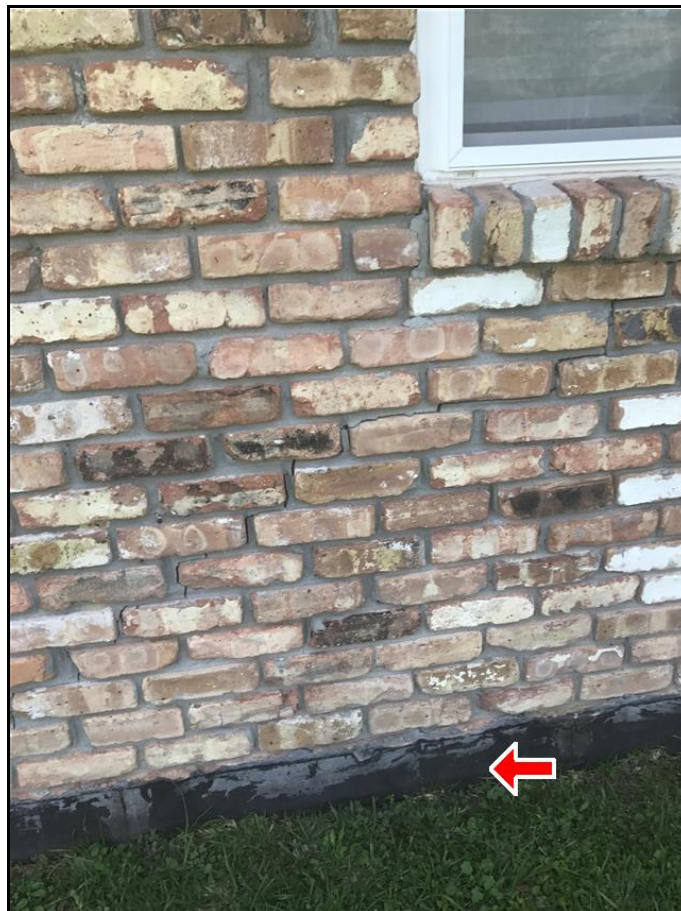
As mentioned earlier in this report, the foundation wall on the left exterior and rear is covered with a weather proof sealant over the foundation wall. This sealant appears to have been applied as this area of the yard was taking on heavy amounts of water, mainly due to the lack of a gutter can and poor grading in the rear yard. This black coating on the foundation wall however is a concern from a wood destroying insect perspective. The insects can get up under the black coating and you will not even know they are there. This coating really should be removed, and better drainage installed to help with the water removal in this area of the home. Recommend repair as needed by a qualified licensed contractor.

5.0 Item 1(Picture) black coating on foundation and 1st row of bricks

5.0 Item 2(Picture) black weather proof sealant over foundation

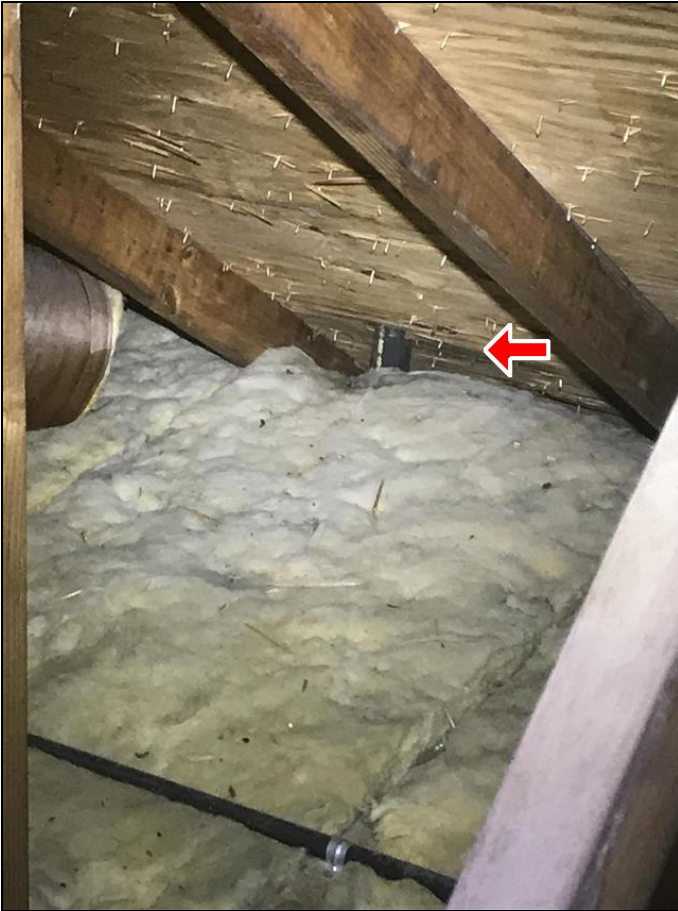
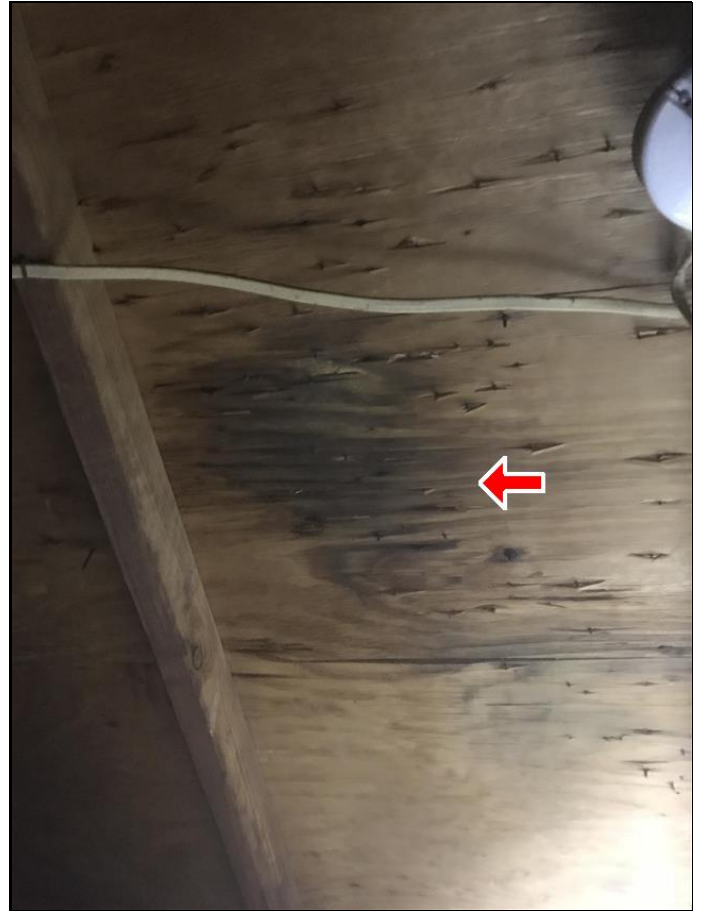
**5.5** There is evidence of roof leak in the attic space. (vent over laundry room, left attic space) The stain appears to be old and from a previous leak, however I do recommend that you monitor these areas to ensure there is no current leak. Repair as needed.

5.5 Item 1(Picture) moisture stains by plumbing vent

5.5 Item 2(Picture) moisture stains

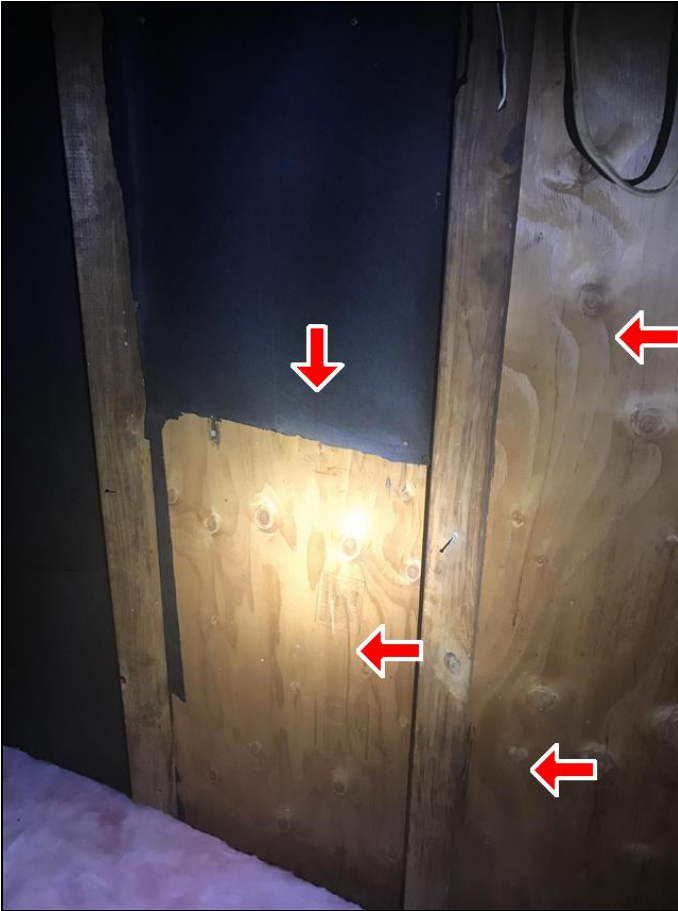
The black wall wrap or moisture barrier is missing under the left attic gable vent. This is installed during construction and appears to have been torn off, possibly due to moisture damage. Recommend repair as needed.

5.5 Item 3(Picture) black barrier missing in areas

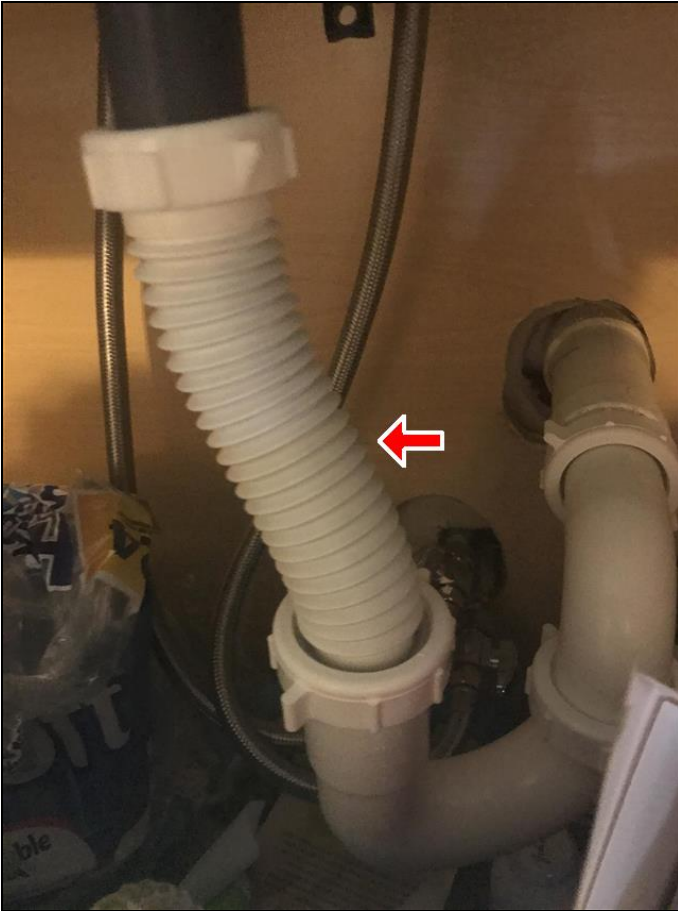
**6.0 (1) The (master sink) drain lines have plastic flex piping material installed. Using flex pipe under the kitchen sink is generally not allowed in today's plumbing as grease and debris can get caught in the grooves of the flex line and cause the drain to back up. More importantly though is this drain pipe is a very thin wall material which typically cracks in the grooves of the flex and begins to leak. Recommend installed solid plastic pipe in this area as needed by a qualified licensed plumber.**

6.0 Item 1(Picture) flex pipe on master sinks

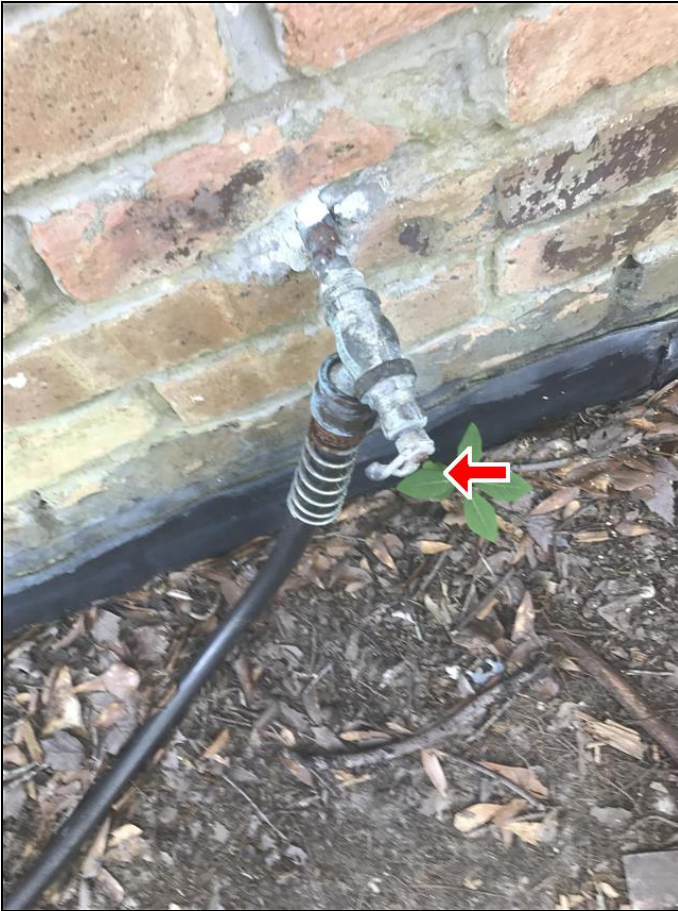
The hose bib handle on the left rear of the home is broken and mostly missing. Recommend replacing the handle as needed by a qualified licensed plumber.

6.1 Item 1(Picture) hose handle broken

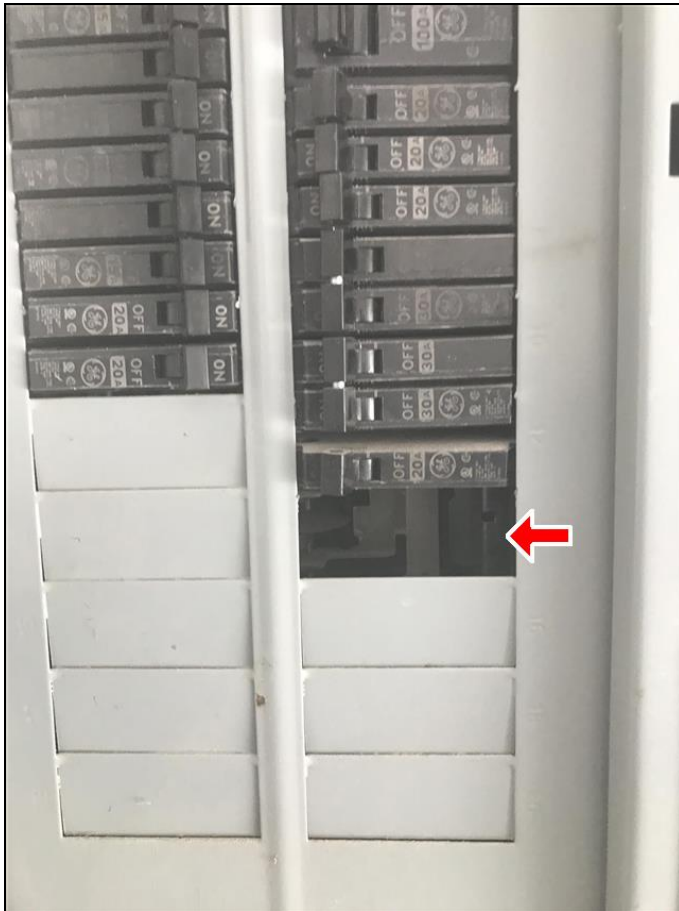
(2) The main panel is missing a knock out on the interior panel cover. This knock out is designed to prevent anyone from touching any live electricity without unscrewing the interior panel cover. You can buy these knock out clips at a electrical supply house. Repair as needed.

7.1 Item 1(Picture) missing knock out

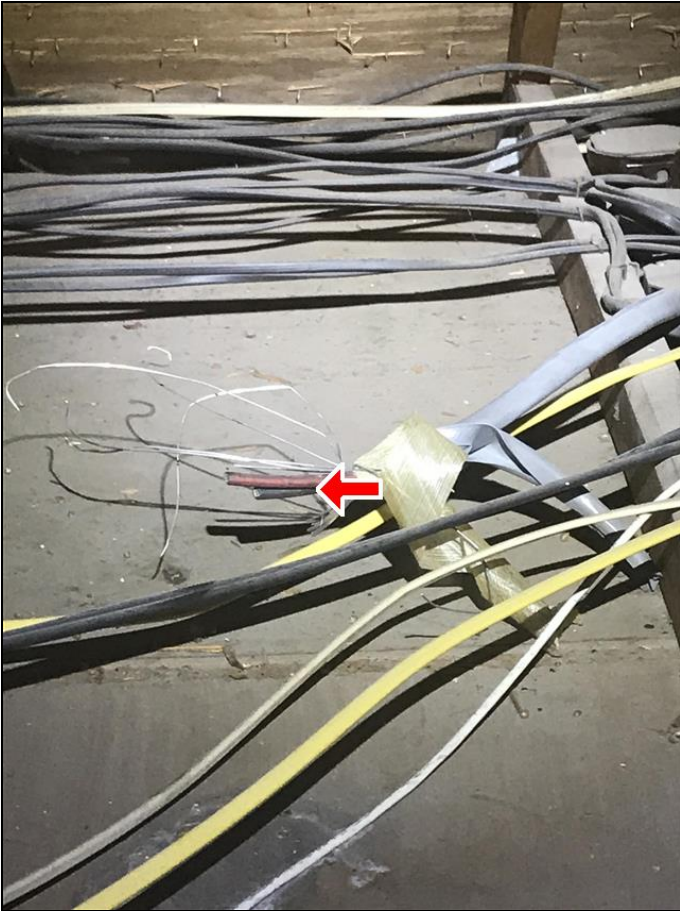
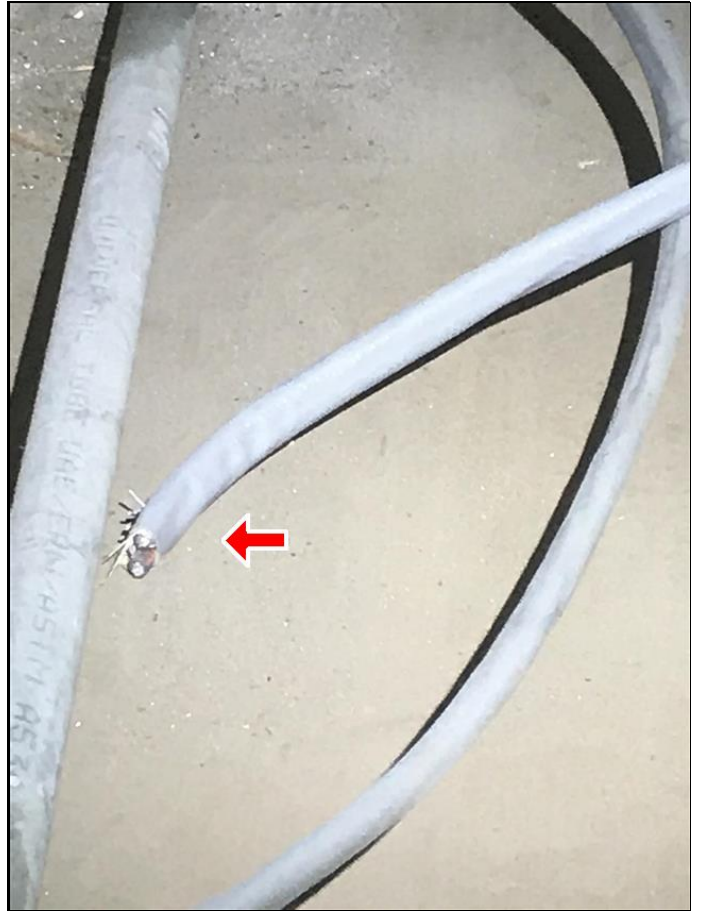
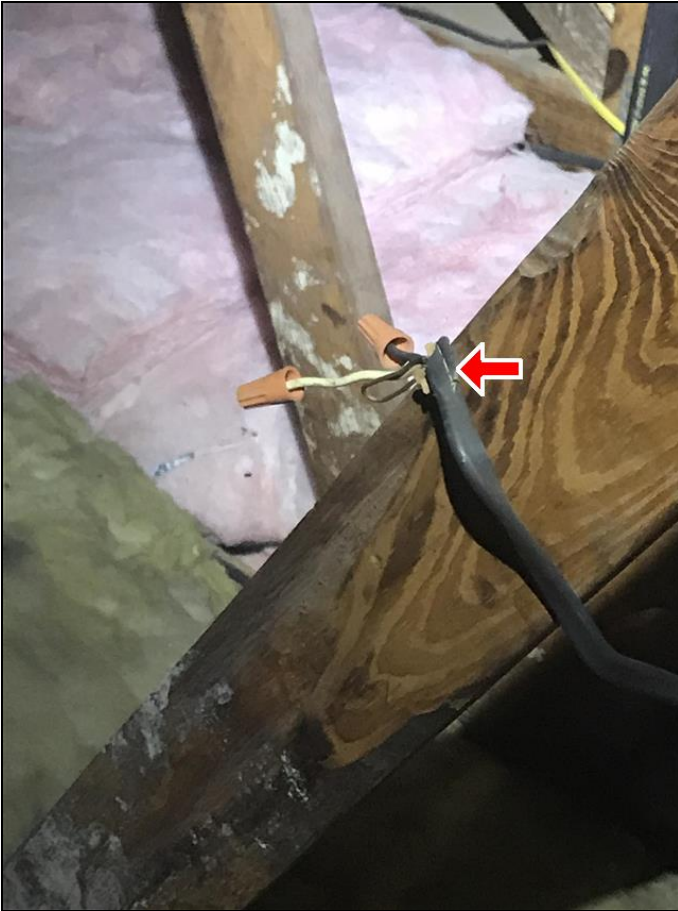
(5) **There is some open wiring in the (garage attic space) of the home.** Any wires that are spliced and are not in a closed junction box are considered open wiring and a electrical hazard. I recommend a qualified licensed electrician inspect all open wiring and repair as needed.

7.3 Item 1(Picture) open wiring

7.3 Item 2(Picture) open wiring in attic

7.3 Item 3(Picture) open wiring in attic

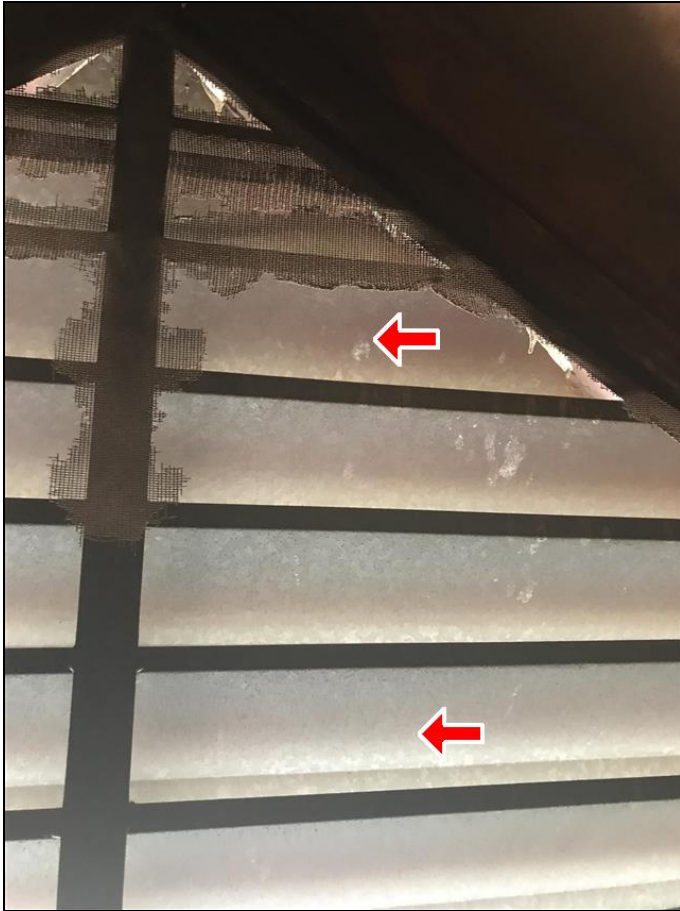
**9.3 The gable vent on the (garage and left attic) of the home needs to be re-screened from the interior of the attic space. This is needed to prevent any pest entrance into the home. Repair as needed by a qualified licensed contractor.**

9.3 Item 1(Picture) re-screen gable vents

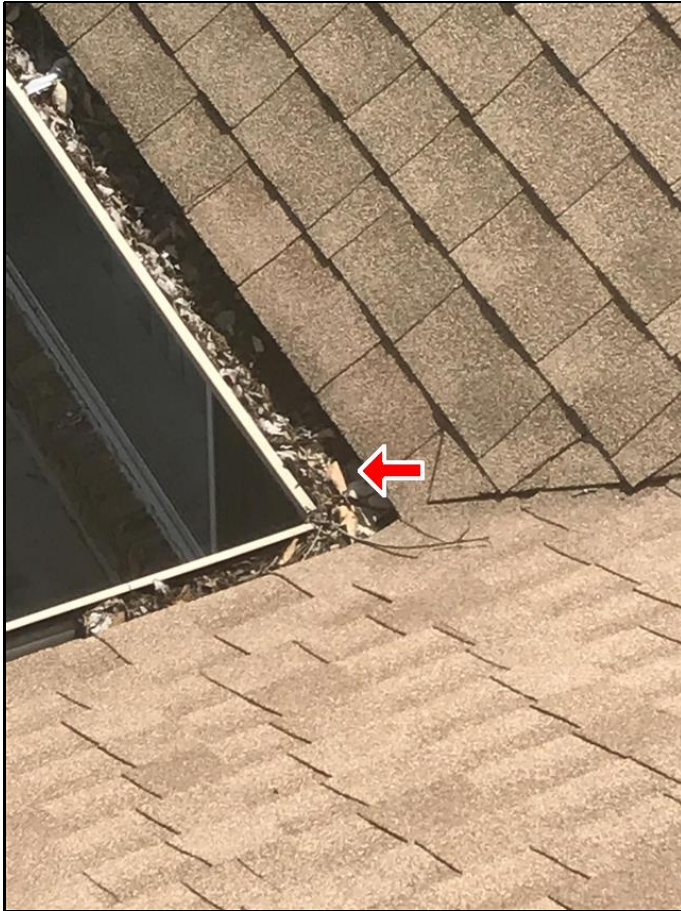
(2) **The gutters are full of debris in areas and needs to be cleaned.** The debris in gutters can also conceal rust, deterioration or leaks that are not visible until cleaned, and I am unable to determine if such conditions exist. Gutter debris can lead to moisture damage to the eaves and promote wood destroying insect activity. Clean the gutter cans as needed on a regular basis by a qualified person.

1.3 Item 1(Picture) gutter debris
