Structural Inspection

07-20-2022

Kevin & Andrea Schneider
21 Briar Hollow Drive
Covington, La. 70433

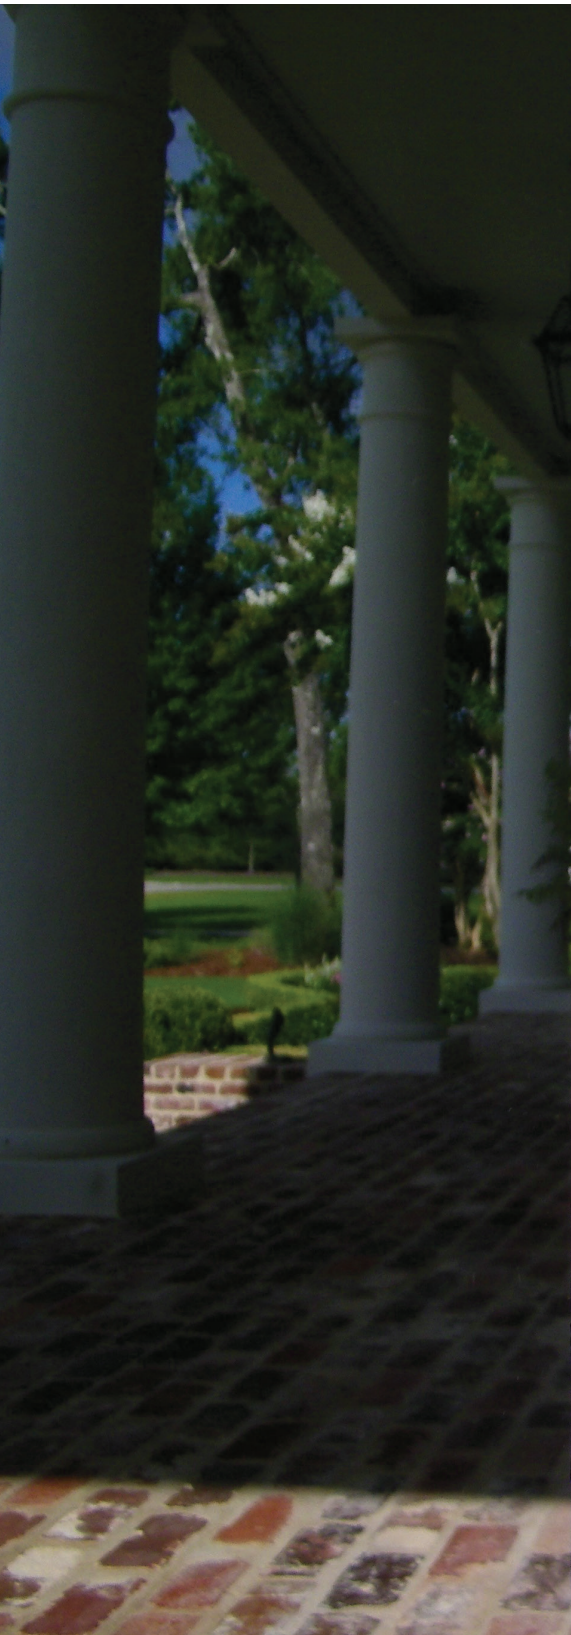
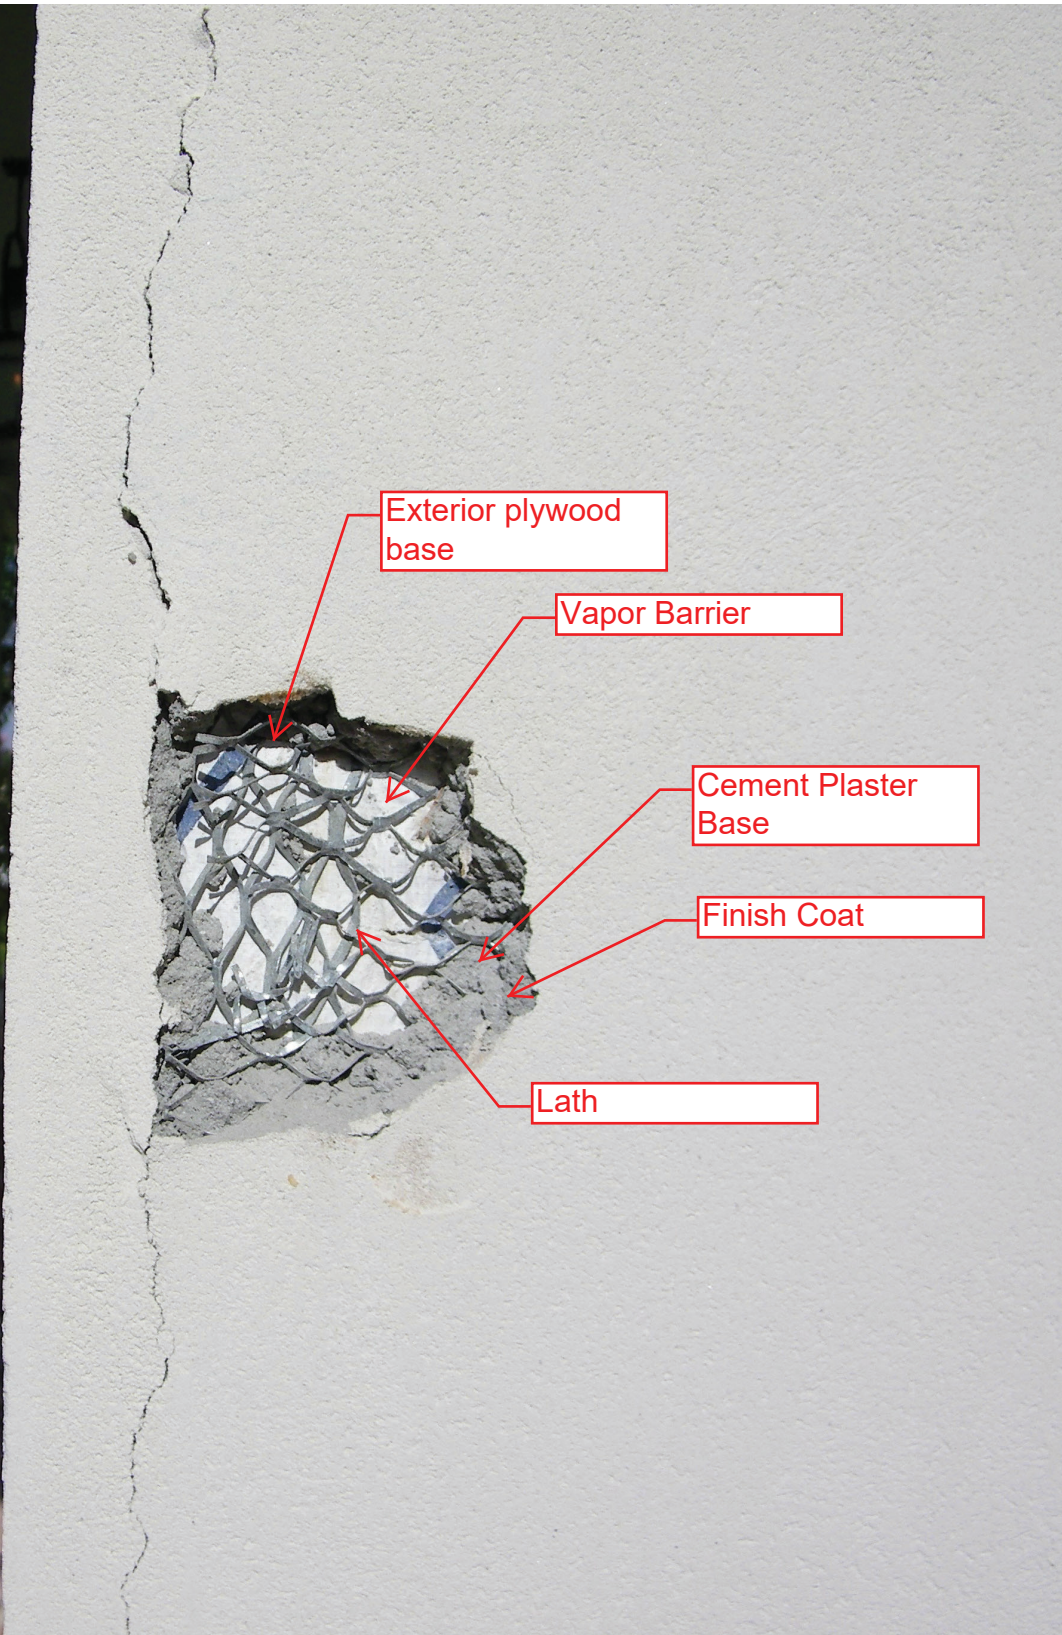
A hole was created in stucco of the front porch wall near one the existing vertical cracks to verify the construction method of installation. It was noted to have an exterior

plywood base with a vapor barrier and metal lath, cement plaster base coat and a finish coat.

Exterior plywood base

Vapor Barrier

Cement Plaster Base

Finish Coat

Lath
