Acutec Home Inspectors  
PO Box 93  
Slidell, La 70459

336 Cape Breton  
Slidell La 70458

**Inspector Name** Shawn Gregg  
**Company Name** Acutec Home Inspectors  
**Address** PO Box 93  
**City** Slidell **State** La **Zip** 70459  
**Phone** Acutec Home Inspectors  
**E-Mail** Shawn@AcutecLLC.com  
**Report Name** Masker081016  
**Payment Amount:** 600.00  
**Payment Method:** Check

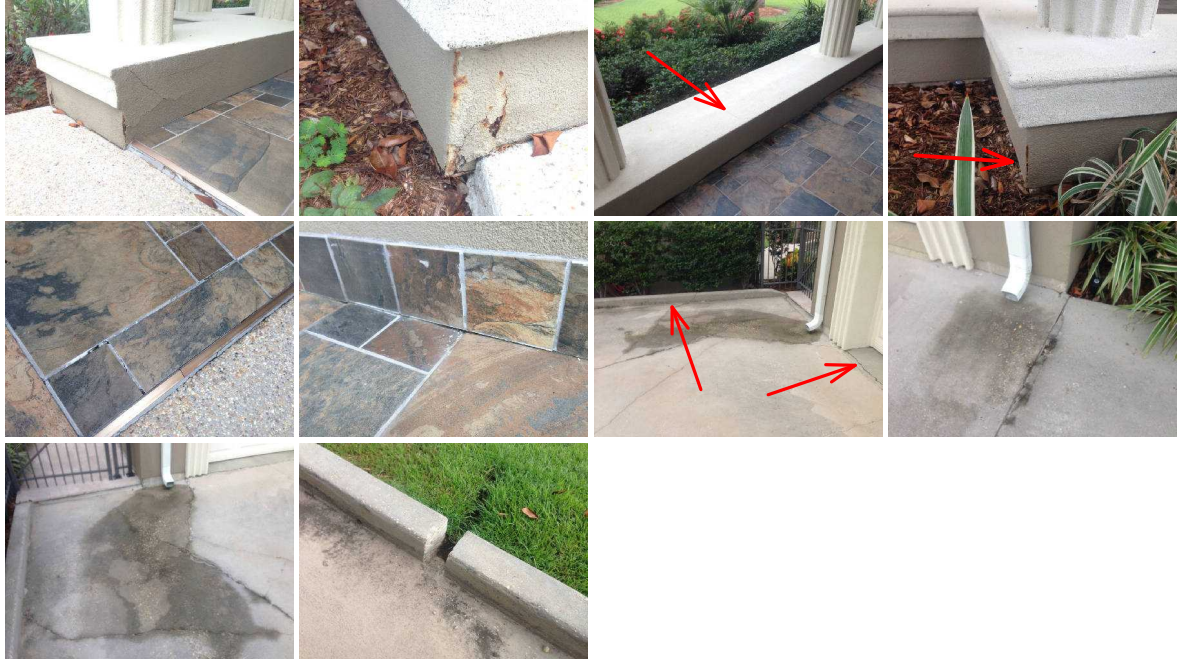
**Driveway: Concrete:** Stucco structure at driveway entrance is damaged. There are cracks and gaps with rust and water damage visible. Further evaluation and repair by a qualified contractor is recommended.

Gaps and cracks with missing grout noted with tiled drive. Repairs should be made to prevent further damage.

Driveway has cracks with sections separating. Repairs may not be necessary, but monitor for further movement and the need for repairs in the future. Sealing cracks may help reduce movement.

Cement curb was cut. Appears to be a water relief. This may indicate excessive water in this areas.

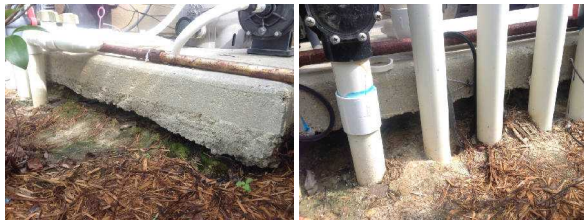
**Grading:** Ground under the pool equipment support pad has dropped/settled. If concrete is left unsupported, movement or damage can occur. The pool plumbing may be in a bind and may require repair. This should be evaluated by a qualified contractor.

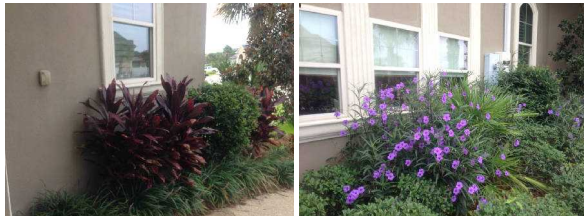
**Vegetation:** Vegetation near exterior sidings. This is a conducive condition for insects and moisture damage. Recommend keeping all plants 1 foot from structure.

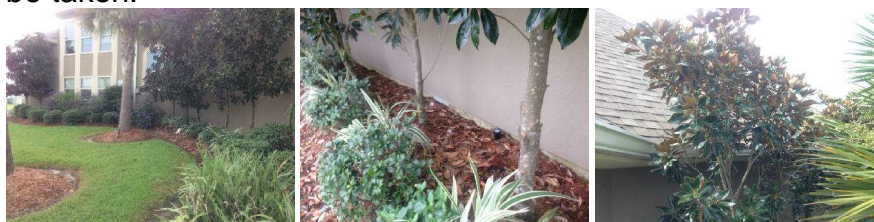
**Trees:** Trees growing close to structure can cause damage to roof, siding and other components. Regular pruning required. A licensed arborist should evaluate trees close to the structure, trees that appear to be damaged and remaining trees for potential concerns.

Tree roots are close to the structure. This can be a concern if roots grow under the foundation. There are many large trees planted within 2-3 feet of the foundation. This should be evaluated by a licensed arborist to determine if proactive measures should be taken.

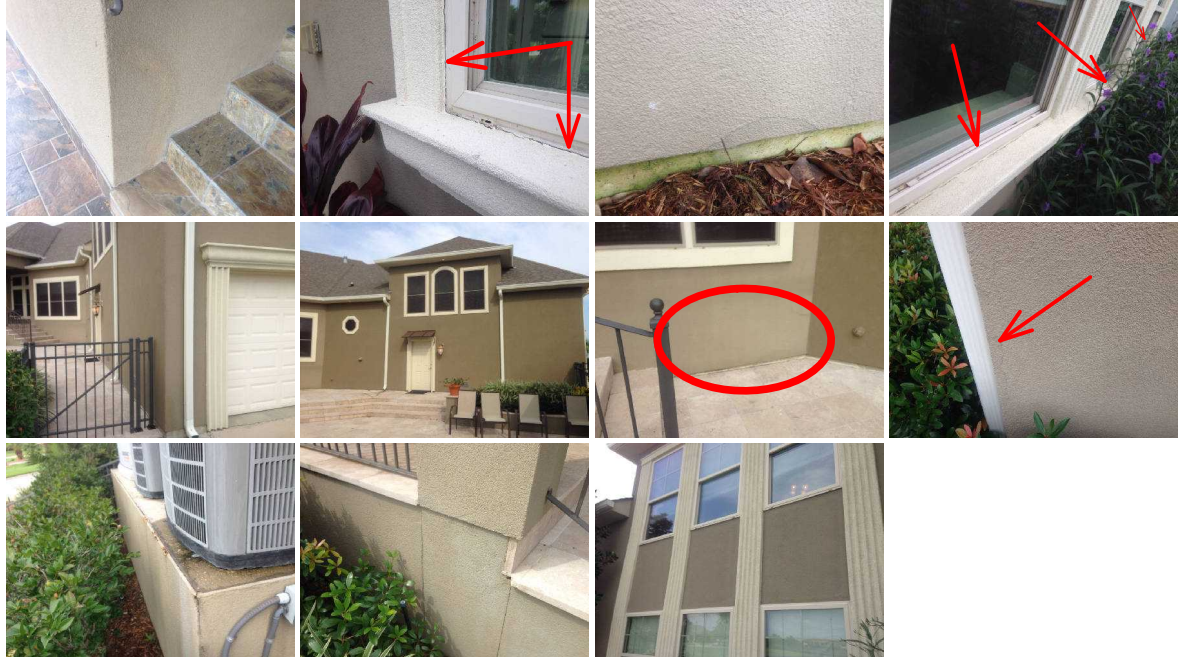
**Siding:** Cracks noted in stucco siding. Cracks are typical with this type of material as shrinkage/ settlement can form cracks over time. There are also areas of damage around the exterior.

There are noted repairs and a few areas that appear to need repair or at least evaluation by a stucco expert. It is recommended that the structure is evaluated to determine if any immediate action is needed or could reduce further damage. Gaps between materials allows water entrance, which promotes damage to concealed material behind or below.

Structures with stucco siding are difficult to fully evaluate during a standard Home Inspection, especially when painted, as this house has been. A qualified stucco expert/inspector should be consulted for a full evaluation of condition of components.

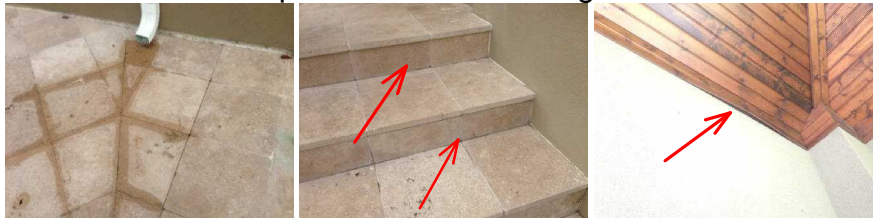
**Porch / Patio:** Tiles have gaps at joints between components. These should be secure and sealed to prevent movement and damage.

There is loose wood trim on ceiling of pool house living area (near fireplace). Repairs should be made to prevent further damage.

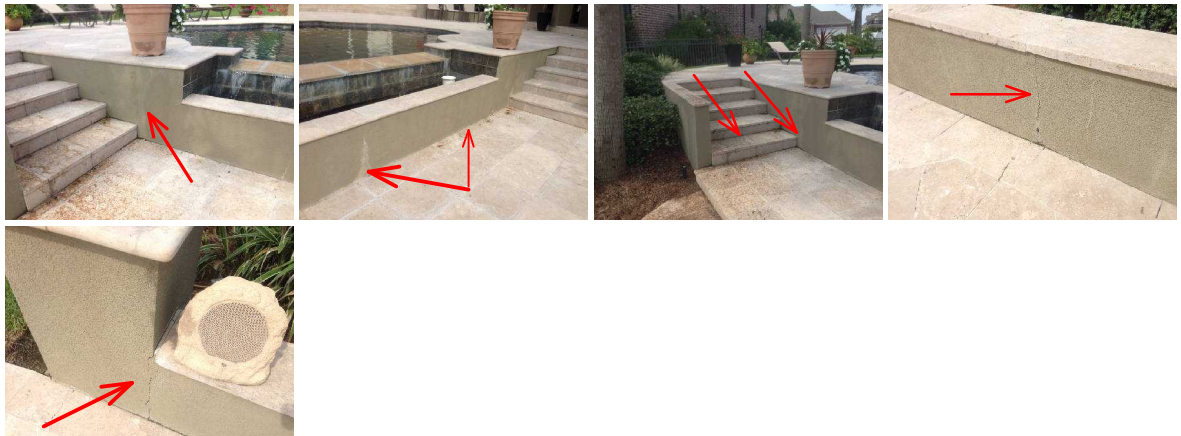
**Deck:** The pool deck and surrounding structure has signs of cracks and repairs. There are heavy water stains visible near water feature. This area should be evaluated to determine the extent of damage and necessary repairs.

Handrails missing. Recommend having safety rails installed according to current standards.

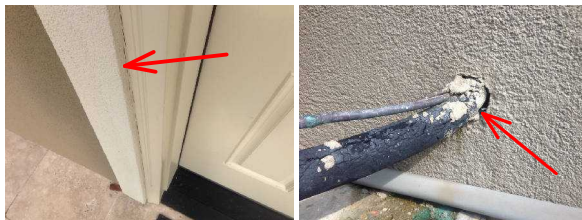
**Other concern:** Open gaps or seams noted, adding silicone/ caulk to open seams around the exterior can prevent moisture and insect entrance. It can also help reduce damage from high winds and rain getting behind materials. Areas typically included are when two different materials meet or change direction. These should be sealed to prevent insect and moisture from entering or damaging the structure.

Gaps exist at one or more openings around the exterior, such as those where outside faucets, refrigerant lines, and/or gas supply pipes penetrate the exterior. Gaps should be sealed as necessary.

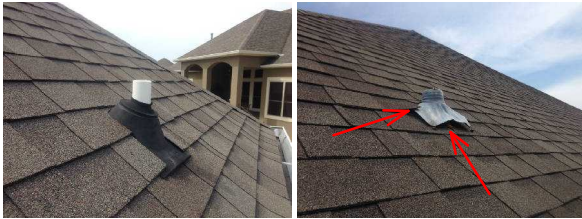
7. Defective **Plumbing Vents:** PVC, Rubber boots, Lead boots-- Flashing does not rest tight to roof below. This area is prone to leak as water may travel up and under flashing. This metal should not be raised. There is daylight visible from underside in attic. Repairs should be made.

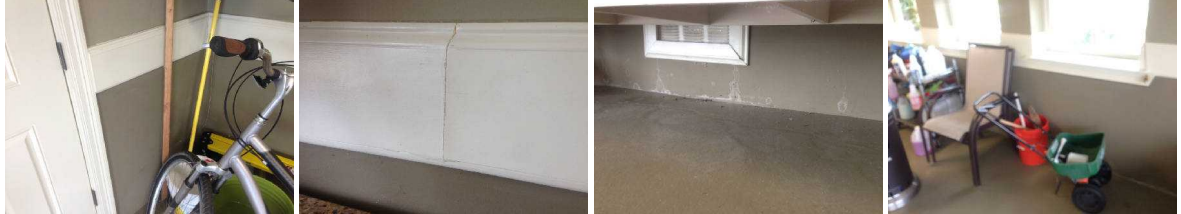
6. Marginal **Walls:** Signs of past or present water leakage. Further evaluation recommended.

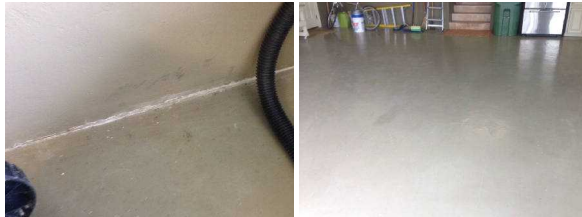
7. Marginal **Floor/Foundation:** Evidence of water entrance on garage flooring. Further evaluation and actions recommended to prevent water from entering structure.

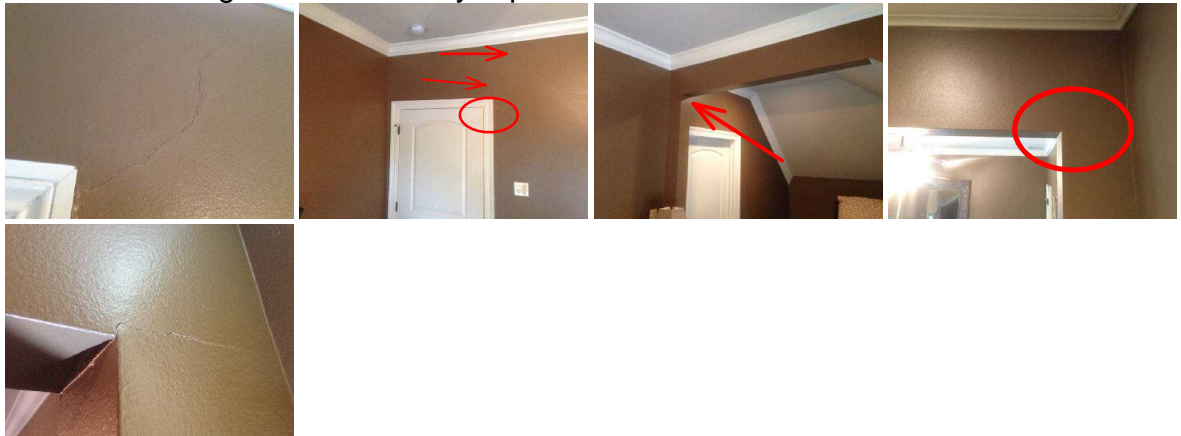
1. **Structure Type:** Wood frame  
2. **Foundation:** Poured concrete  
3. Defective **Bearing Walls:** Wood frame-- There are cracks in walls in more than one area. The door in this area is difficult to close and sticks in jamb. These may be an indication of structural movement or damage. A licensed contractor should evaluate for the cause, extent of damage and necessary repairs.

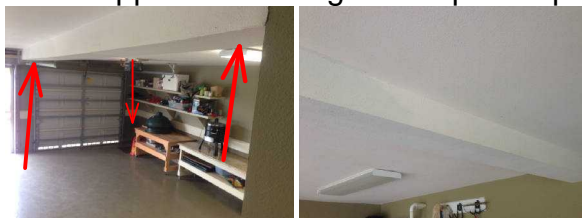
4. Marginal **Beams:** The visible beam in garage, below bedroom upstairs, appears to sag in the center. With the visible cracks in drywall and the door casing that is out of square above, this should be evaluated further by a licensed contractor.

There appears to be signs of repair or paint to components in this area.

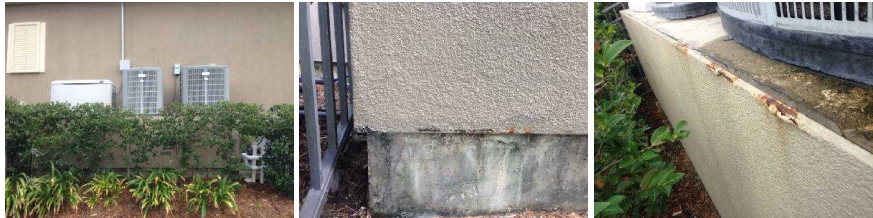
2. Defective **Exterior Unit:** Raised structure-- The structure has visible damage to stucco and metal components with heavy rust buildup in gaps. Further evaluation and repairs are recommended.

Units on raised platforms should be secured to platform to prevent movement of equipment. Some local standards as well as many insurance policies are now requiring raised units to be secured. It could not be verified that these were or were not secured to structure.

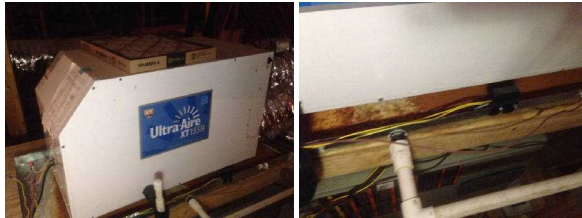
The overflow pan under the unit shows excessive rust and should be serviced and evaluated for pan repairs.

The condensate and pan drain lines are connected with AC condensate drain lines. Dedicated drains lines may prove beneficial in preventing drain problems. Further evaluation is recommended.

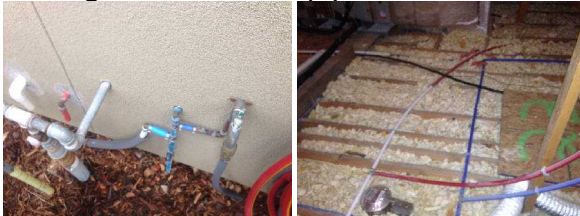
3. Marginal **Water Lines:** Plastic, Copper-- Exposed pipes are vulnerable to freezing and damage. All exterior pipes should be insulated.

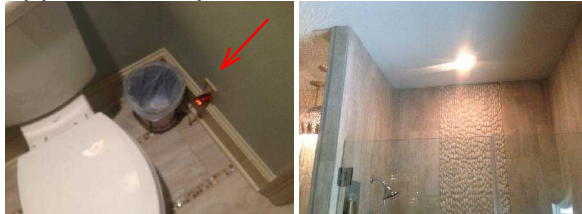
**Electrical:** Non-GFCI circuit within 6 foot of water. GFCI outlets should be installed as safety devices.

It is recommended that electrical fixtures over the shower or tub be GFCI protected for safety purposes. This is a current standard found in new construction homes in some areas and can be added for additional safety benefits in older homes. Fixtures did not appear to be protected. Further evaluation recommended.

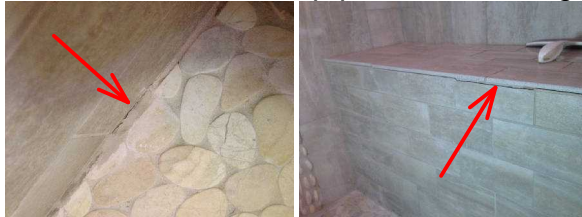
**Shower/Surround:** Loose or missing grout. The grout/ caulk at the seams has split open leaving a small gap. Moisture can enter and damage materials if not sealed tight. Any current leaks or damage was not visible during home inspection and would require a licensed contractor to evaluate. Re-grout all areas necessary. Silicone should be used in corners to help prevent cracking.

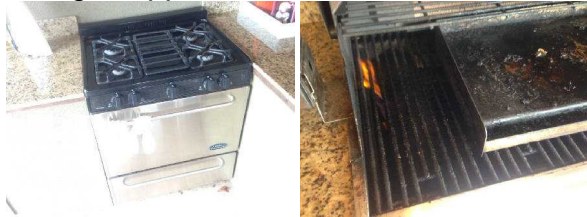
5. Defective **Cooking Appliances:** The oven/cooktop was nonfunctional at the time of inspection. There appeared to be gas present to the unit, but there was no spark at burners and the light did not function. Further evaluation recommended.

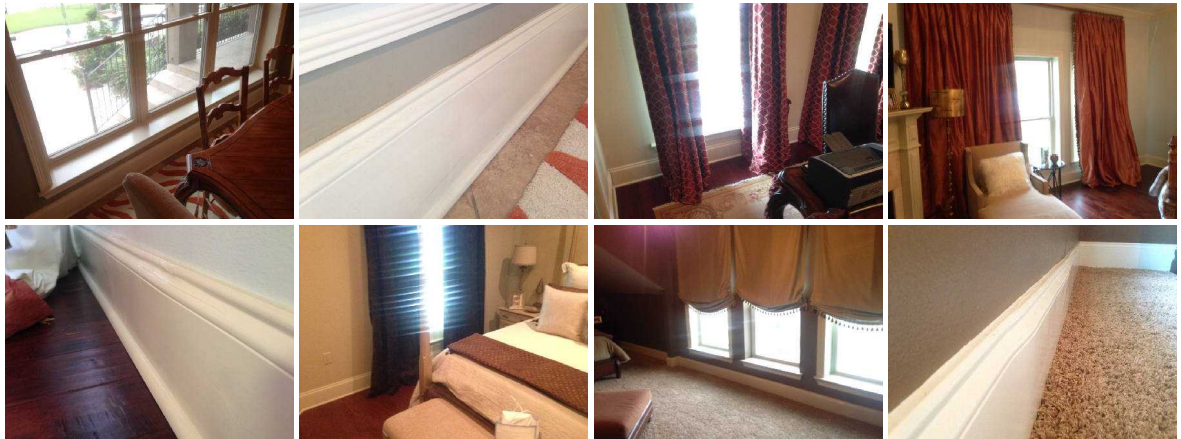
**Walls:** Evidence of past or present water leakage. Further evaluation by a licensed contractor to determine the cause, extent of damage and necessary repairs is recommended.

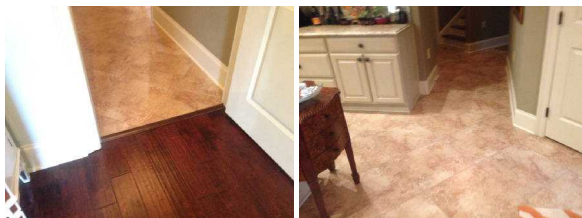
**Floor:** Transition trim is loose between different flooring materials in areas. Repairs should be made.

Floor tiles and wood planks have a hollow sound. This is indicative of improper installation or separation of the material for various reasons. Cracks may form over time from normal use and material movement. A professional installer should be consulted for additional information.

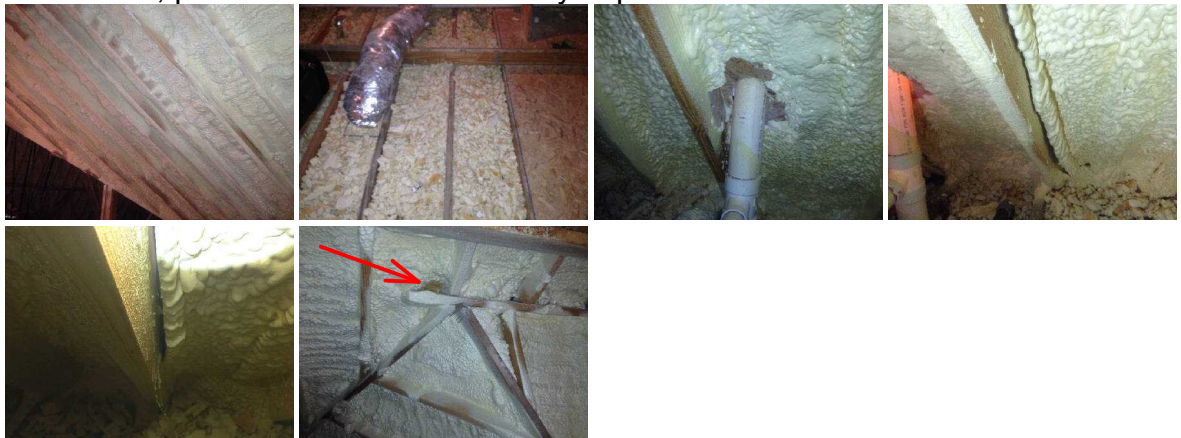
7. Defective **Insulation:** Spray Foam, Loose pieces on ceiling -- Spray Foam insulation is present. Evaluating the product, method installed or adverse conditions related are beyond the scope of this inspection. It is suggested that research and an evaluation be performed by a qualified professional for more information.

There are areas that appear to have been modified or improperly installed and some that appear to have loose or deteriorated foam. There are areas that are not sealed and may negate the affect of the spray foam and possibly even create unfavorable conditions. A qualified spray foam inspector should evaluate the system for proper installation, performance and necessary improvements.

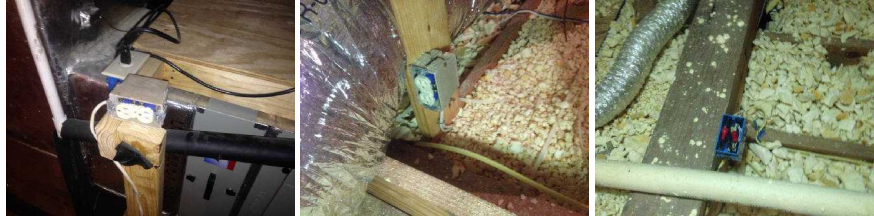
8. **Insulation Depth:** +/-6" varies
9. Defective **Wiring/Lighting:** Open junction boxes should have covers to prevent electrical and fire hazards.
