ENGINEERING EVALUATION

200 Legendre Drive
Slidell, LA 70458

February 27, 2011

Inspection No.: 2011-026
Date of Inspection: February 21, 2011
Engineer: Daniel T. Dormady, P.E.

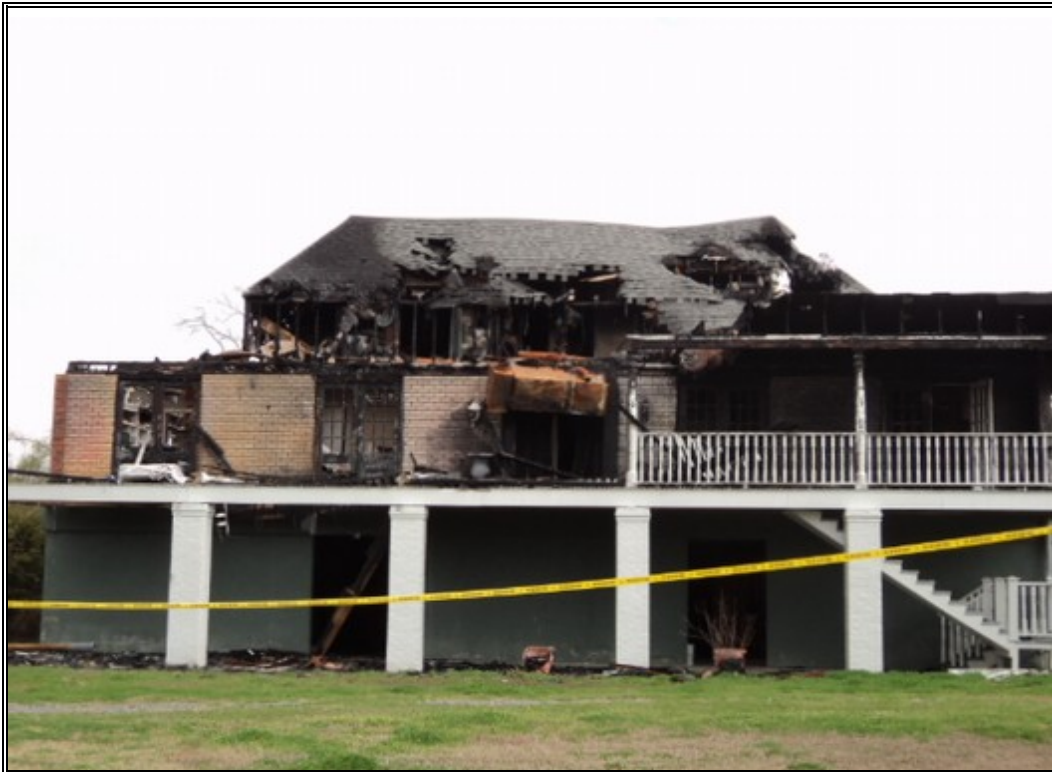
Photo Number
1

Description:
West elevation
view

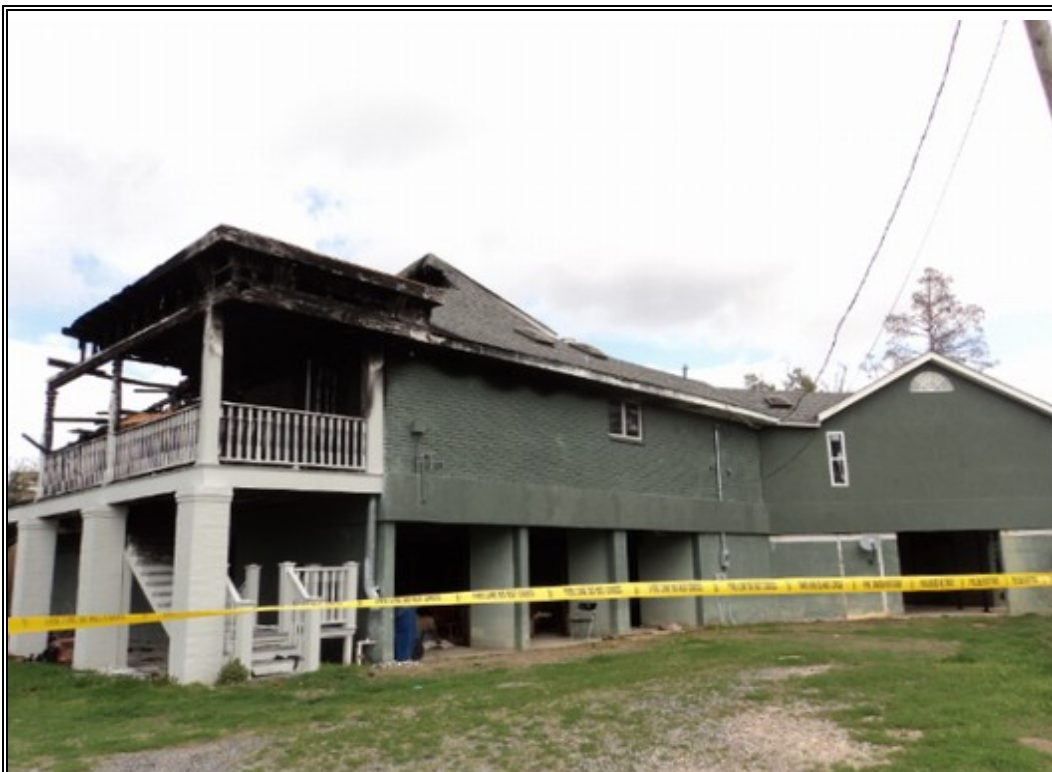
Photo Number
2

Description:
South elevation
view

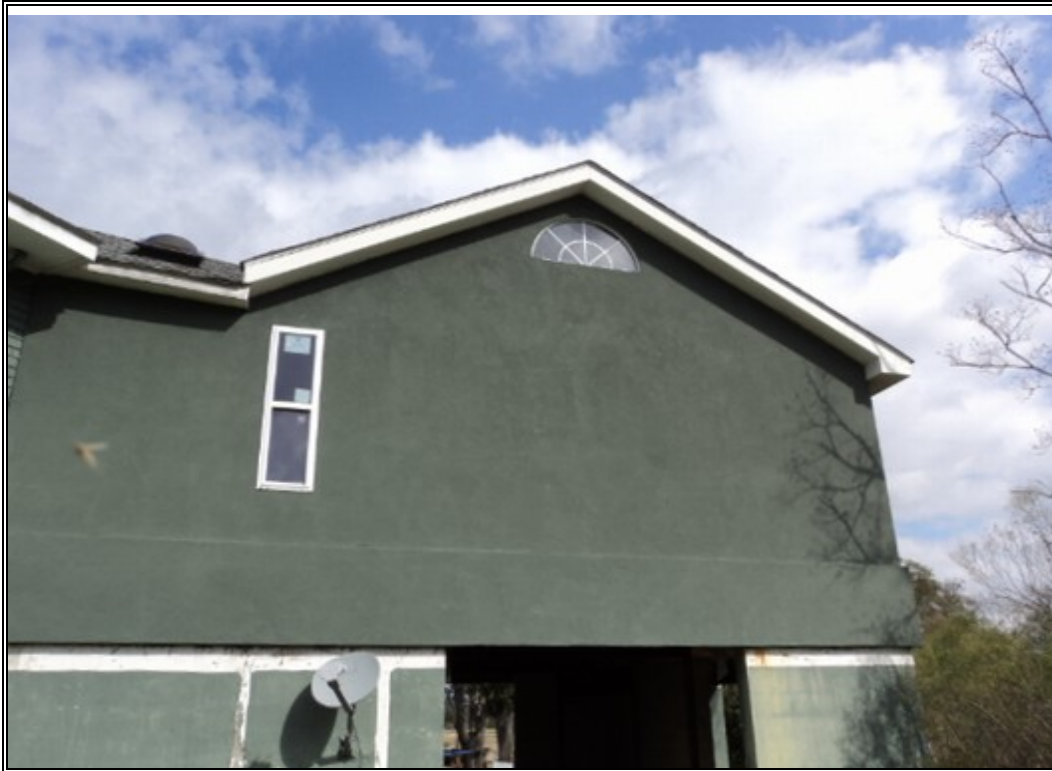
Photo Number
3

Description:
South elevation
view of the right
rear addition

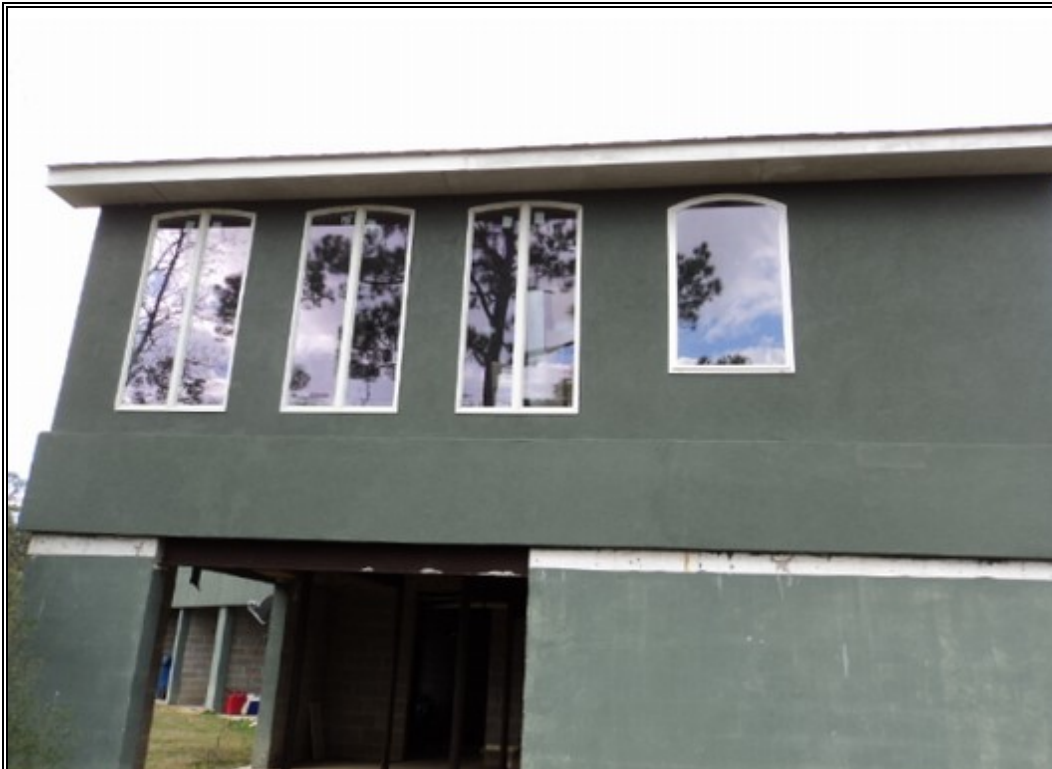
Photo Number
4

Description:
East elevation
view of the right
rear addition

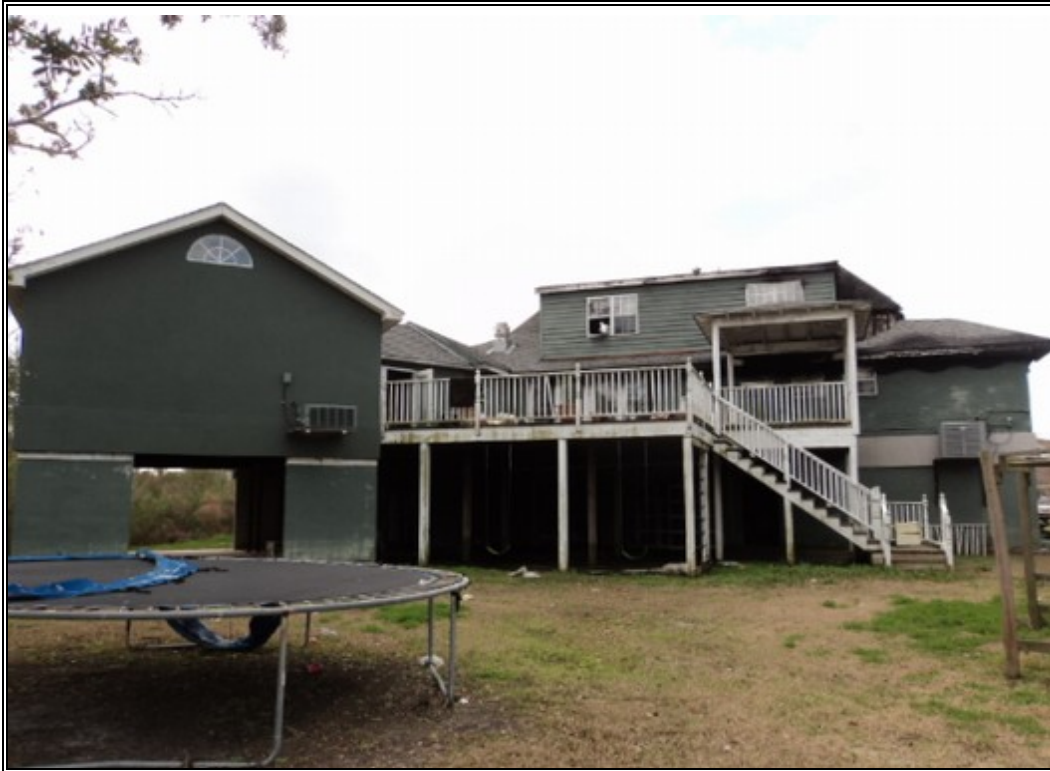
Photo Number
5

Description:
East elevation
view

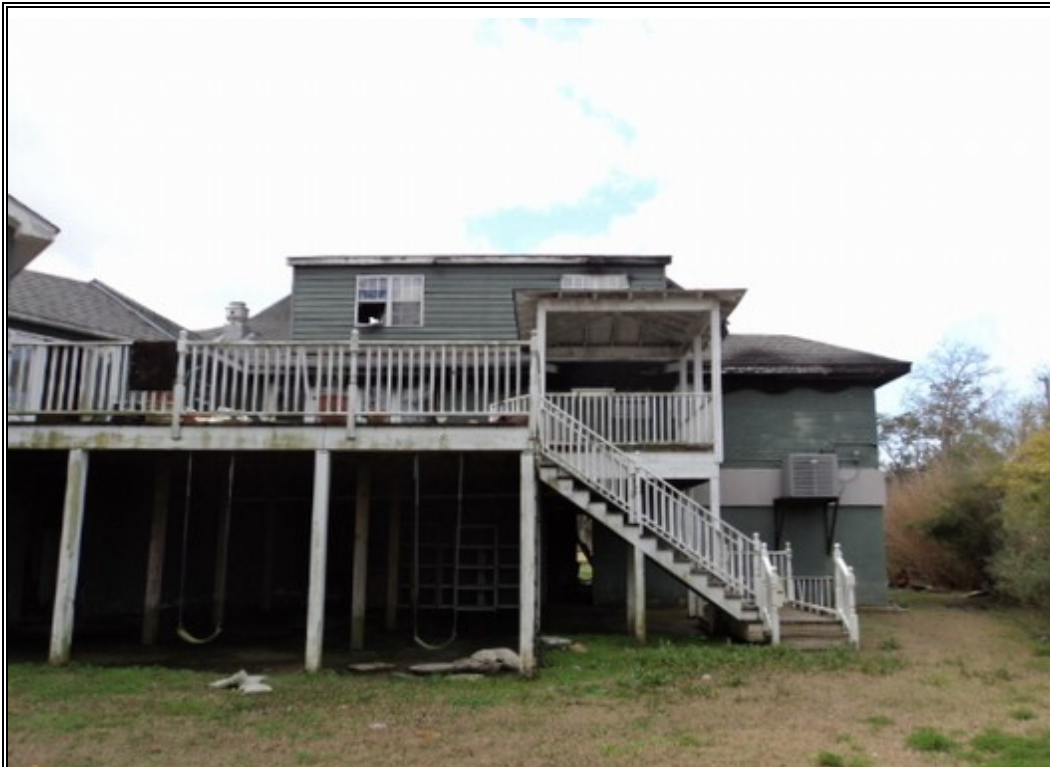
Photo Number
6

- There was no visible damage to the rear (east) deck structure and deck boards.

Description:
Rear deck

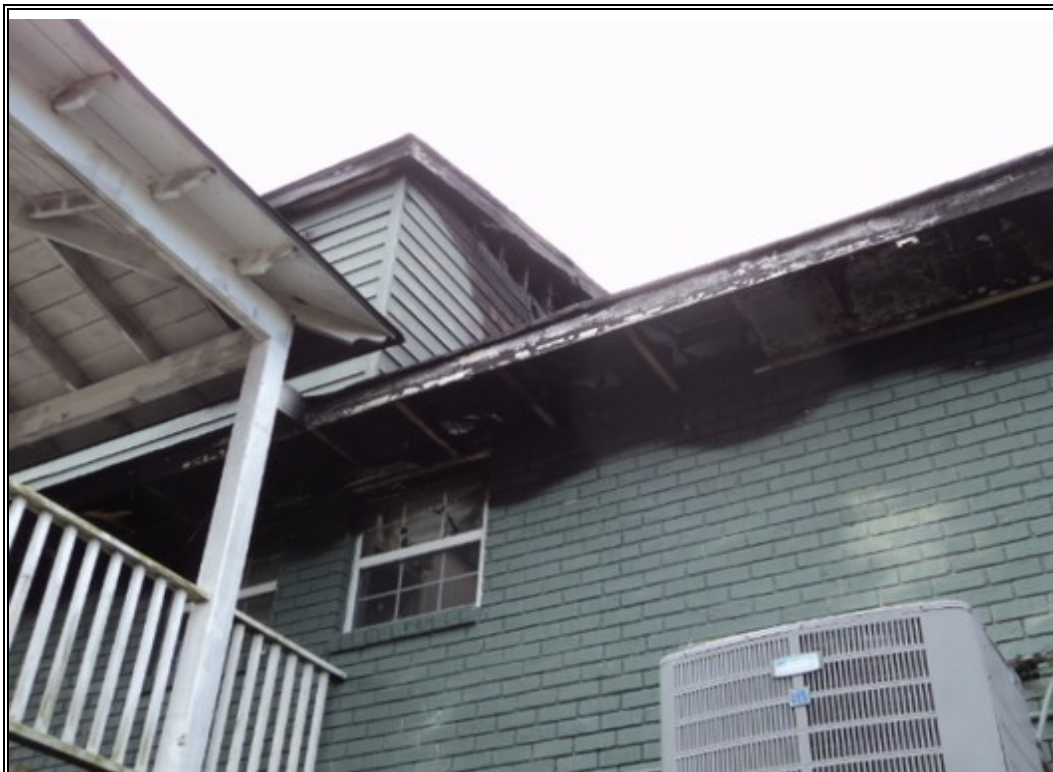
Photo Number
7

Description:
Damage visible to
rear soffit and
brick veneer

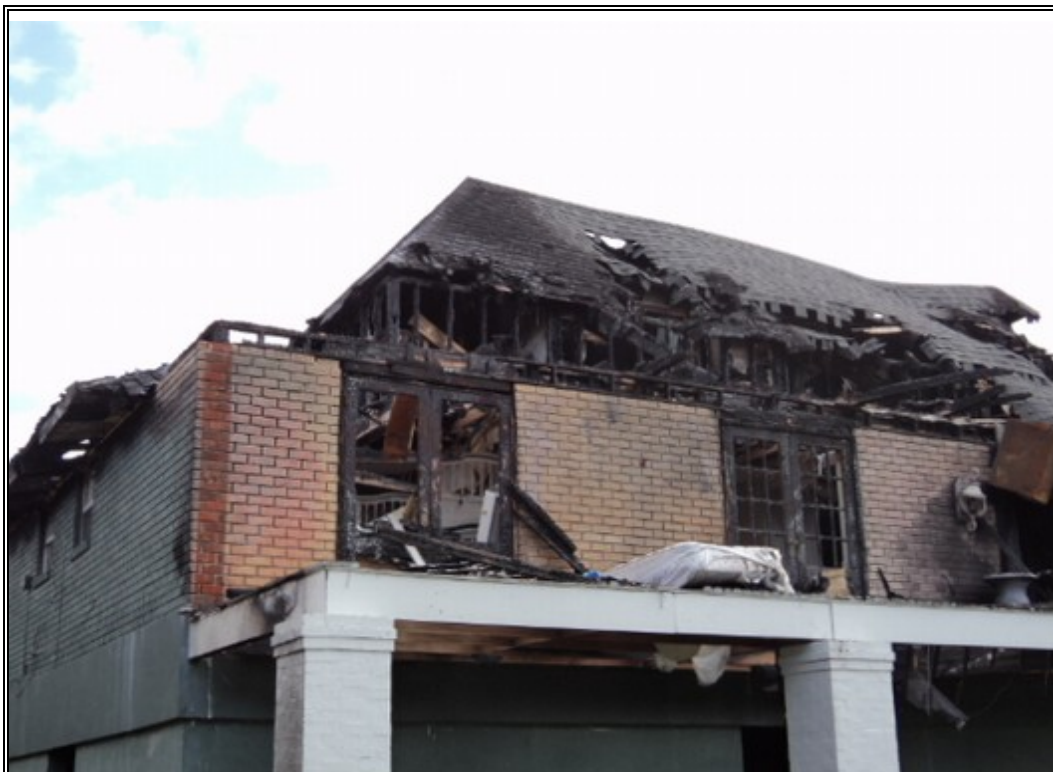
Photo Number
8

Description:
Left front corner of
the house; roof
collapsed, porch
damaged, and
structural damage
visible on the 1st
and 2nd floors

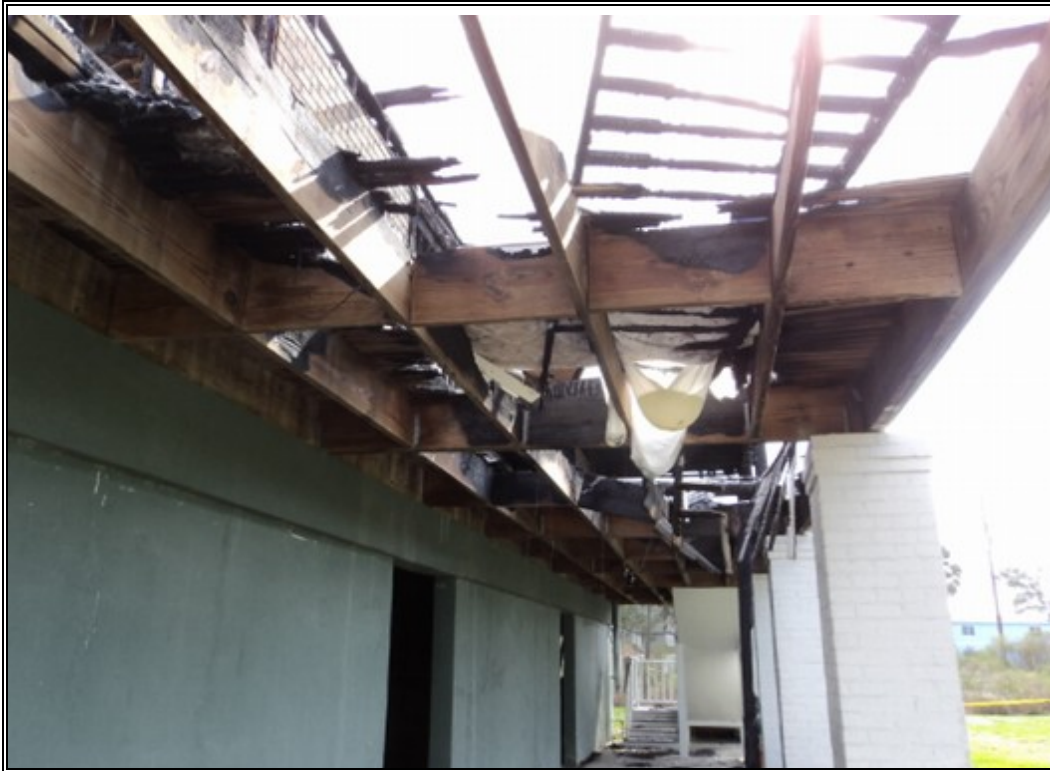
Photo Number
9

- The front deck framing was burnt and damaged, more heavily on the north end of the porch.
- The support columns and hand railing are missing at the north end of the front porch.

Description:
Underneath the
front porch; fire
damage visible

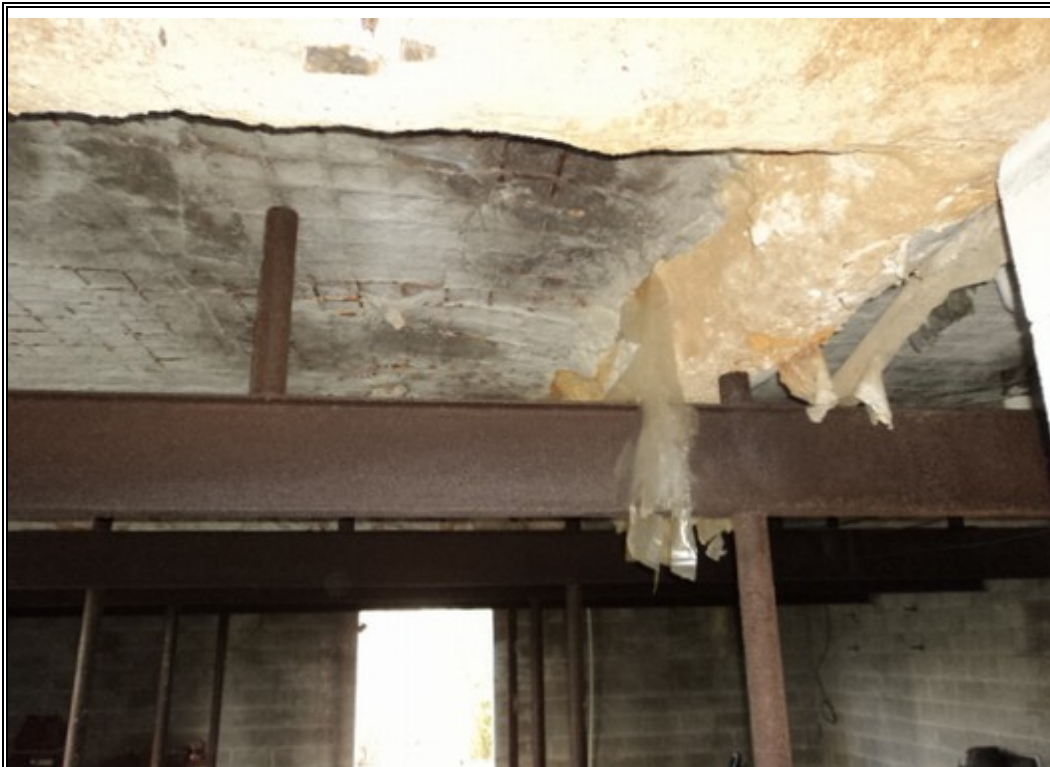
Photo Number
10

Description:
Bottom of the
concrete slab and
the steel support
structural
members; no signs
of fire damage

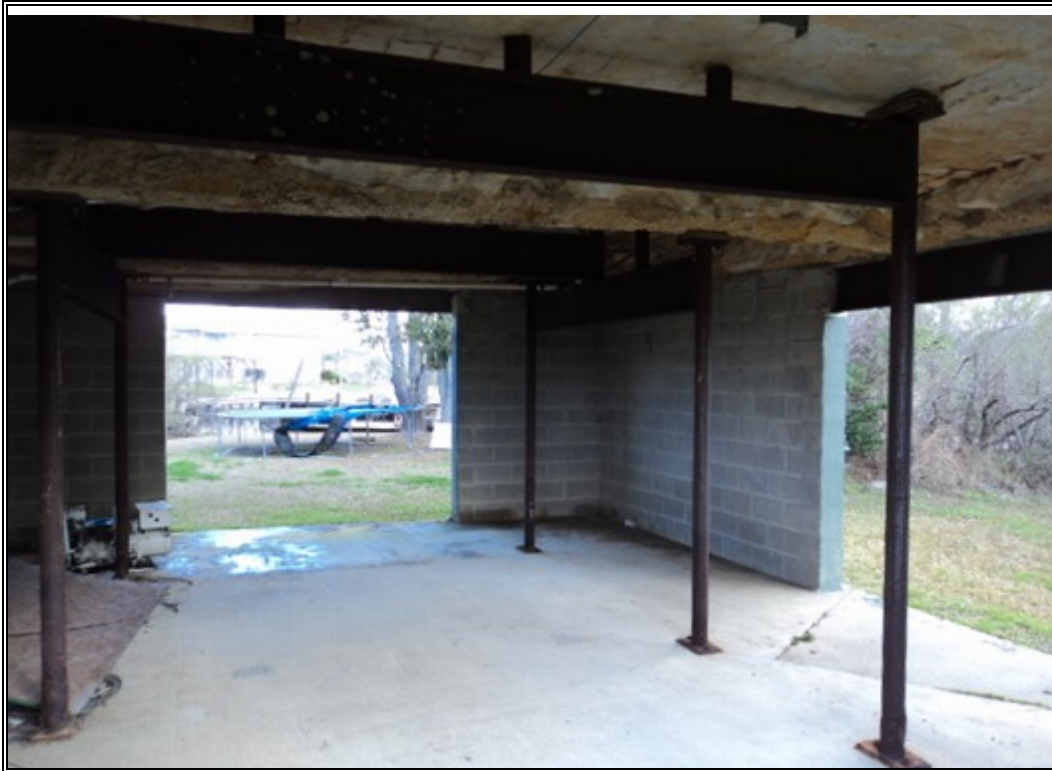
Photo Number
11

Description:
Bottom of the concrete slab and the steel support structural members; no signs of fire damage

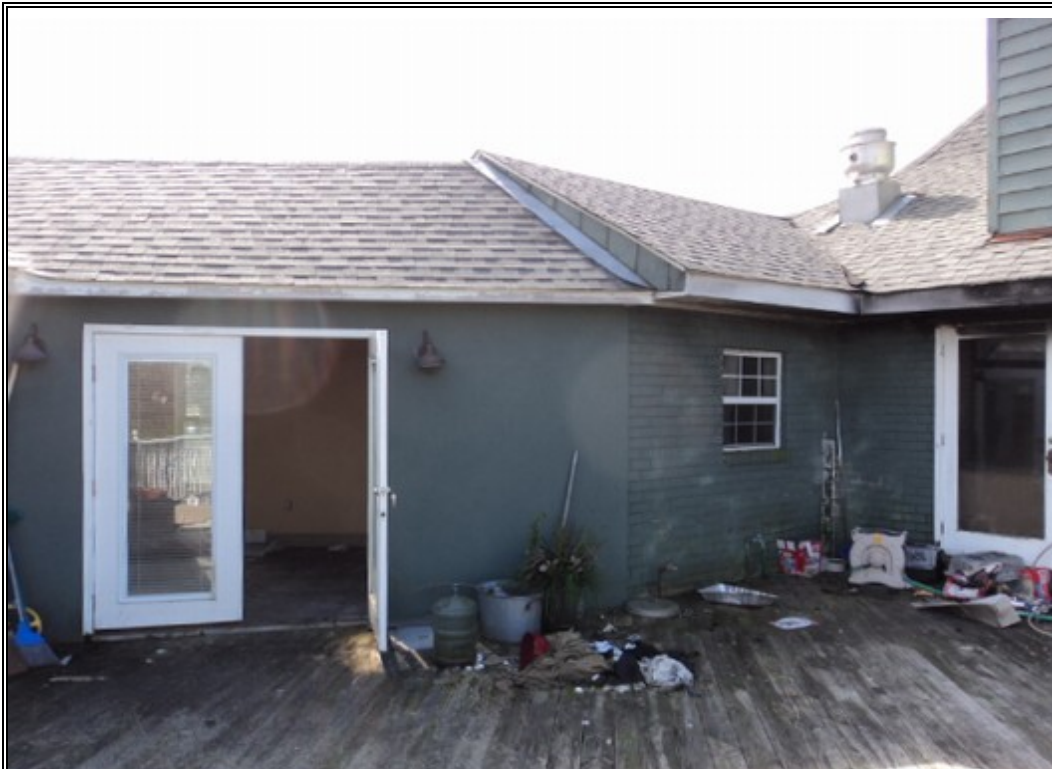
Photo Number
12

Description:
Rear deck and right rear addition; no fire damage visible

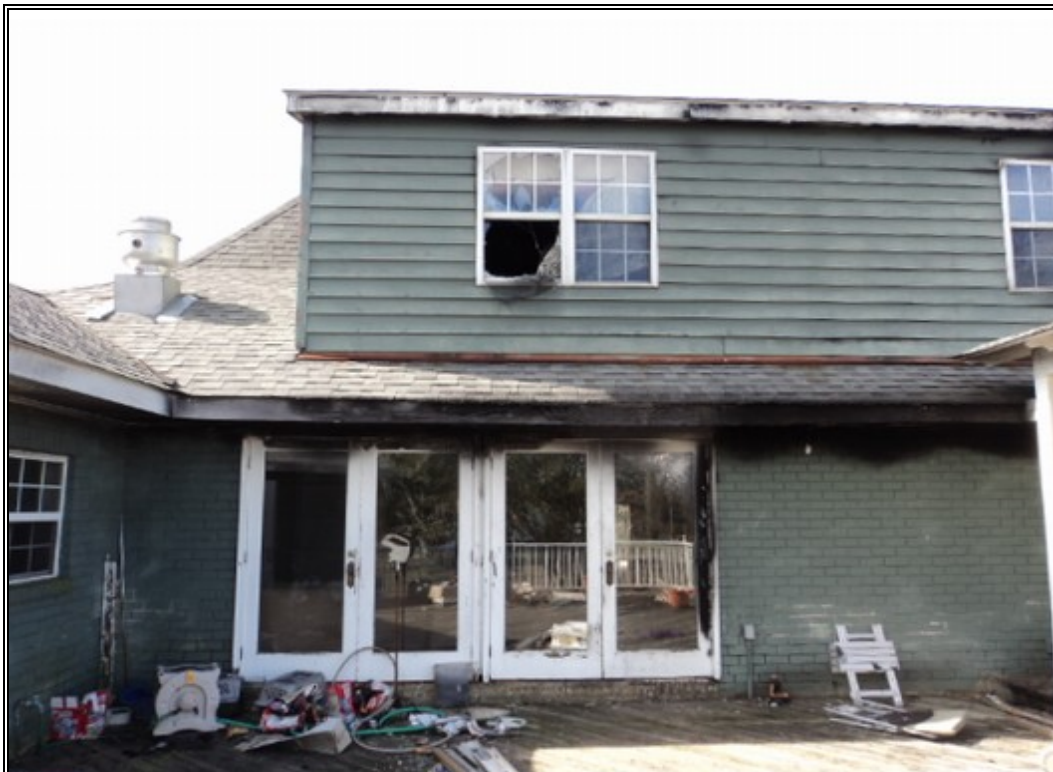
Photo Number
13

Description:
East elevation of
the house; fire
damage visible

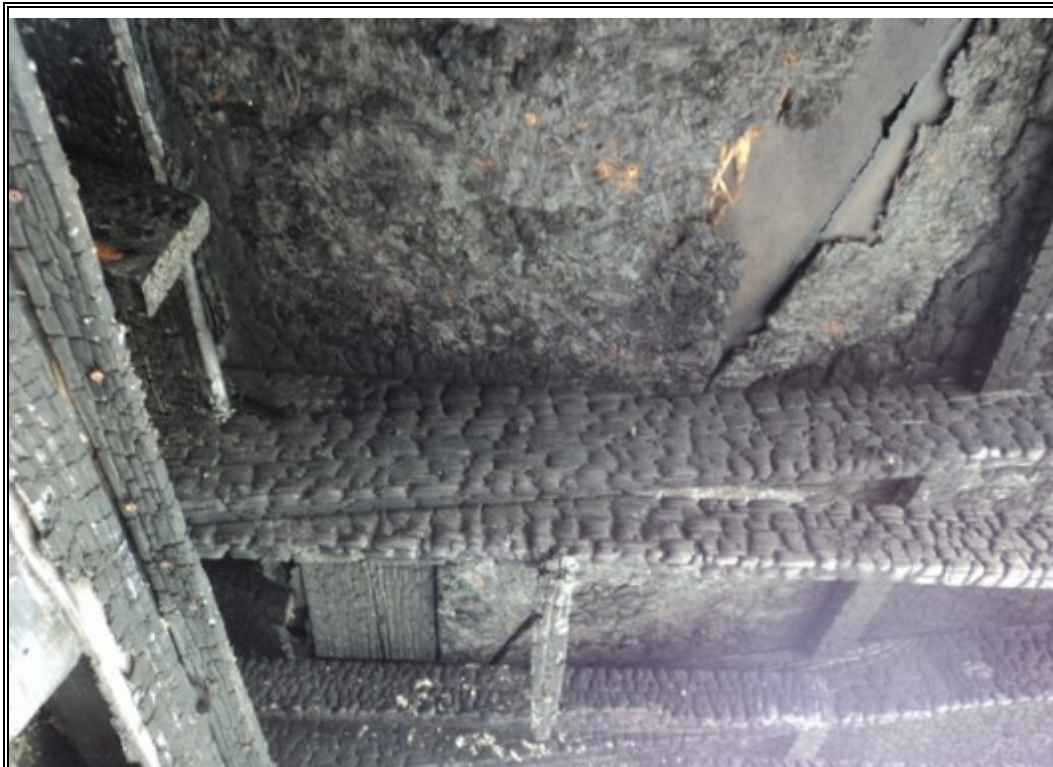
Photo Number
14

Description:
Severely fire
damaged roof
structure on front
porch

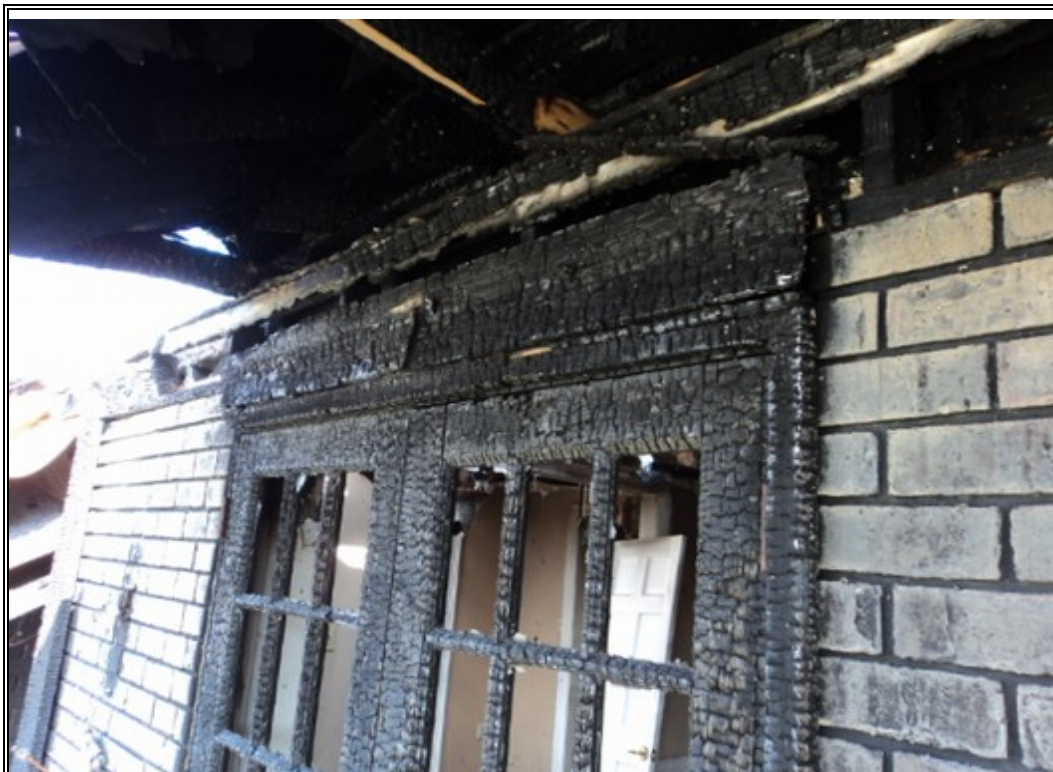
Photo Number
15

- The wood siding did not appear to be damaged on the east side of the original home.
- The French doors on the front (west) of the home were burnt and charred. The glass was missing in these doors.

Description:
Fire damaged
French doors on
the front porch

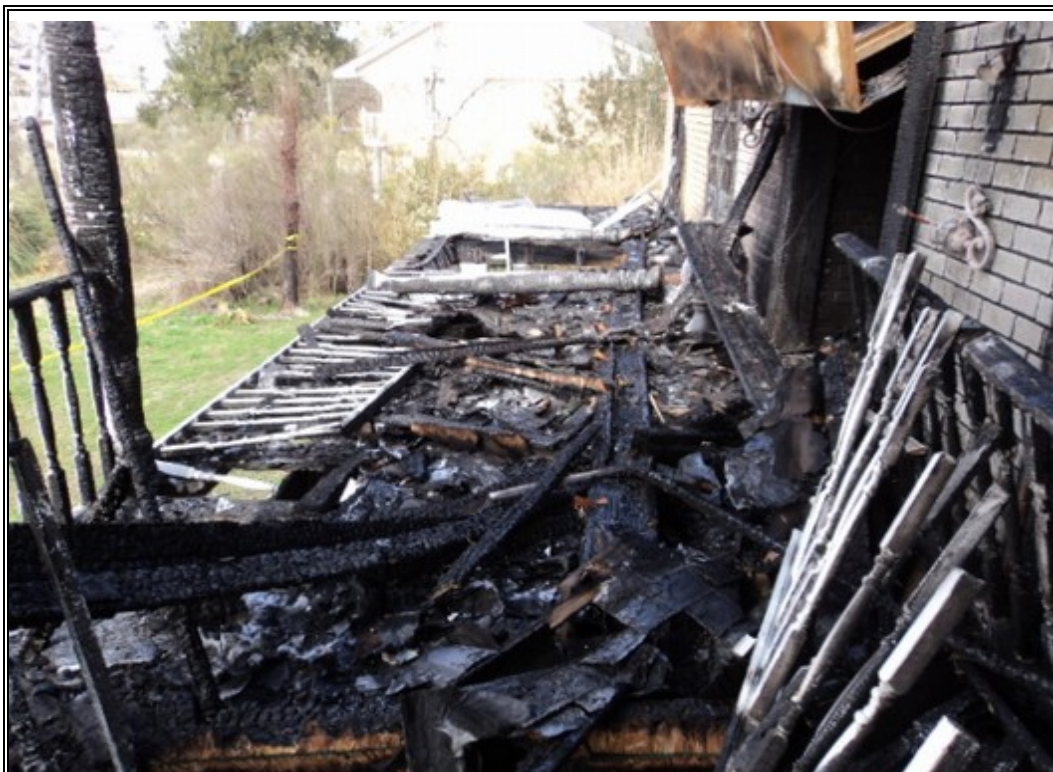
Photo Number
16

Description:
Fire damaged front
porch

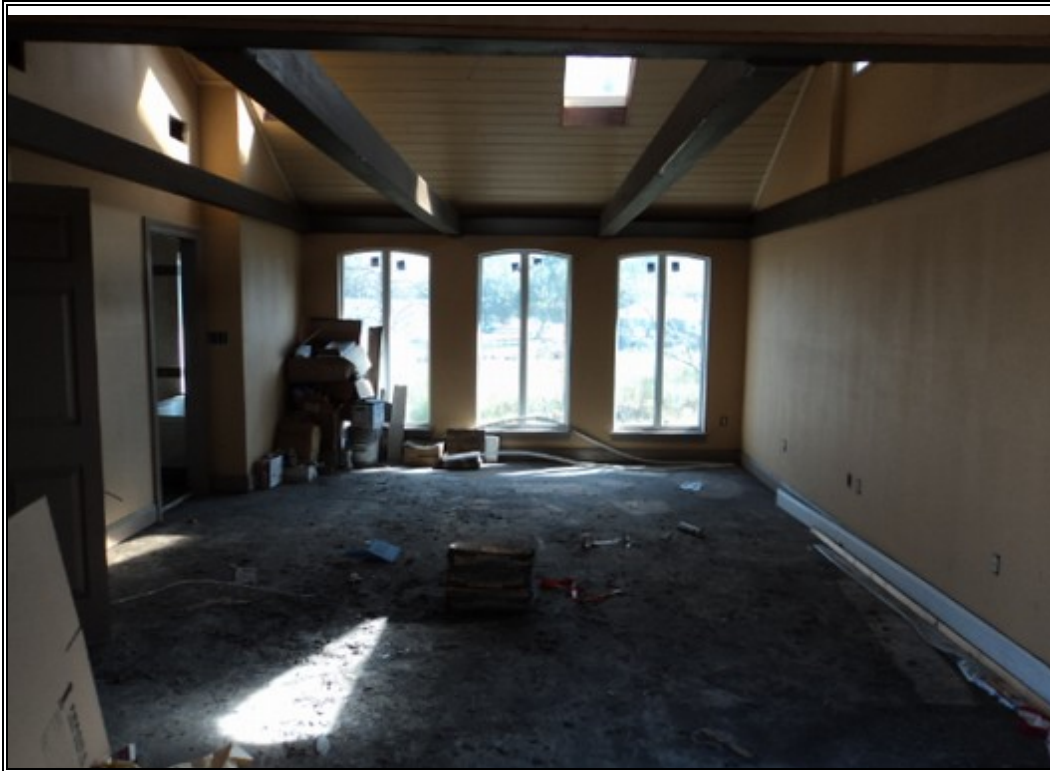
Photo Number
17

- The drywall on the ceiling and the walls in the addition were in tact. As a result, no inspection of the wall studs or the ceiling joists could be performed.
- The drywall on the walls and ceiling of the addition were soot stained. No evidence of charring was noted on the wood ceiling area or wood beams.
- The drywall on the walls and ceiling and the wood ceiling area of the addition were soot stained.
- The bathroom cabinets and fixtures are soot stained.
- A waterline mark was visible on the baseboard trim that was about 2 inches above the floor, most likely from the fire suppression activities.

Description:
Right rear addition
bedroom

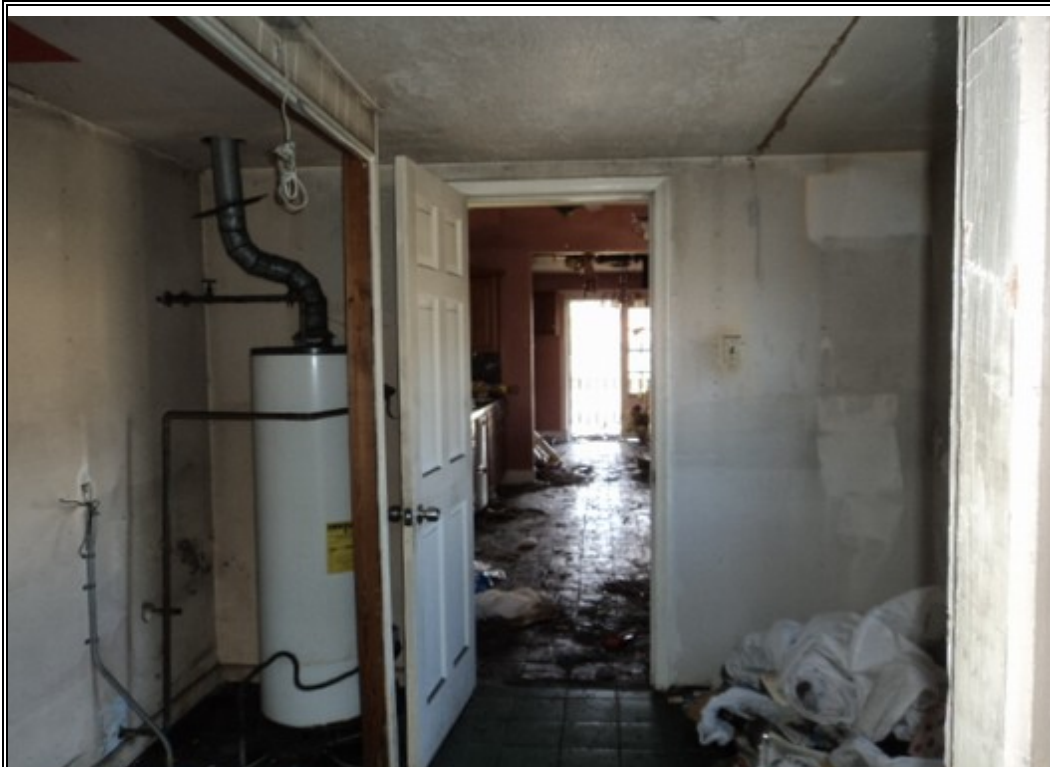
Photo Number
18

- The drywall on the walls and ceiling of the laundry room is still in tact. As a result, no inspection of the wall studs and ceiling joists could be performed.
- The drywall on the walls and ceiling of the laundry room were soot stained.

Description:
Laundry room

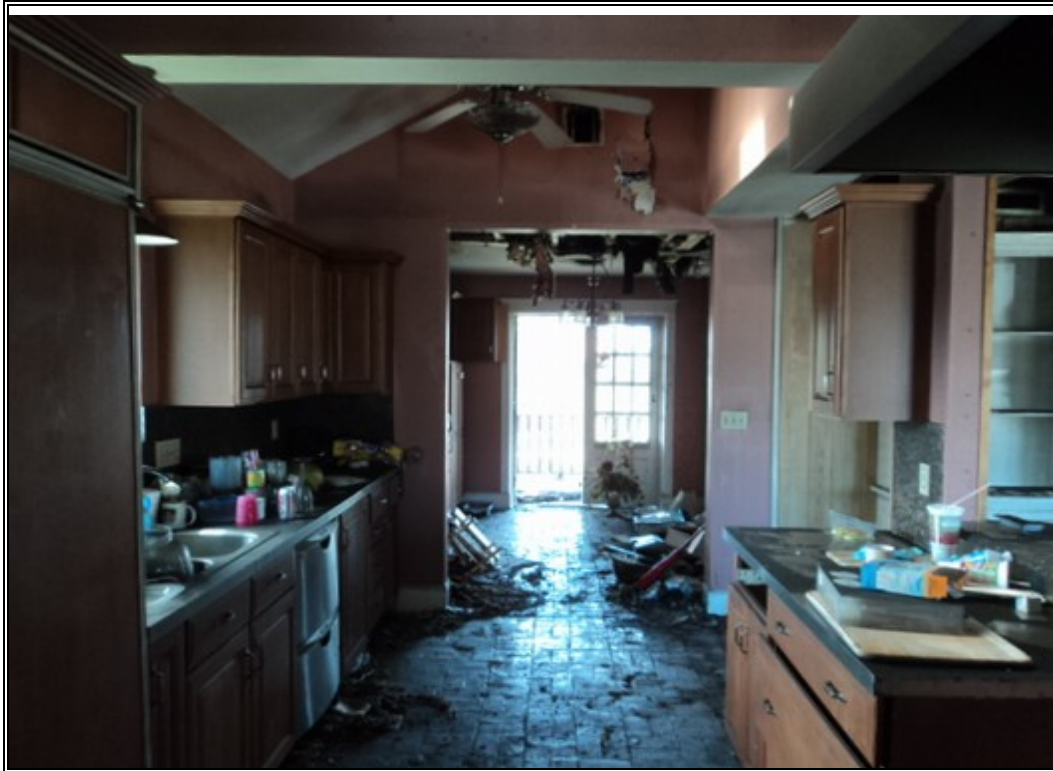
Photo Number
19

- The drywall on the ceiling and the wall in the kitchen were in tact. As a result, no inspection of the wall studs or the ceiling joists could be performed.
- The drywall on the walls and ceiling of the kitchen were soot stained.
- The kitchen cabinets and appliances are in tact; however, they are soot stained.

Description:
Kitchen

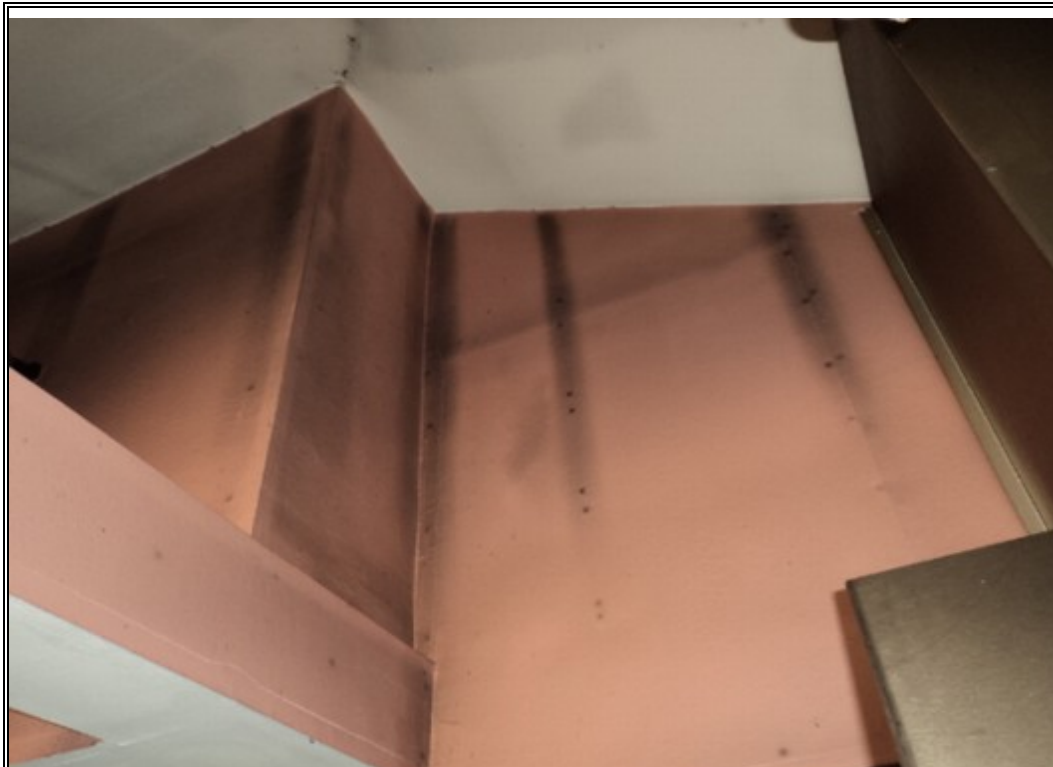
Photo Number
20

Description:
Example of soot
and water damage
to north kitchen
wall

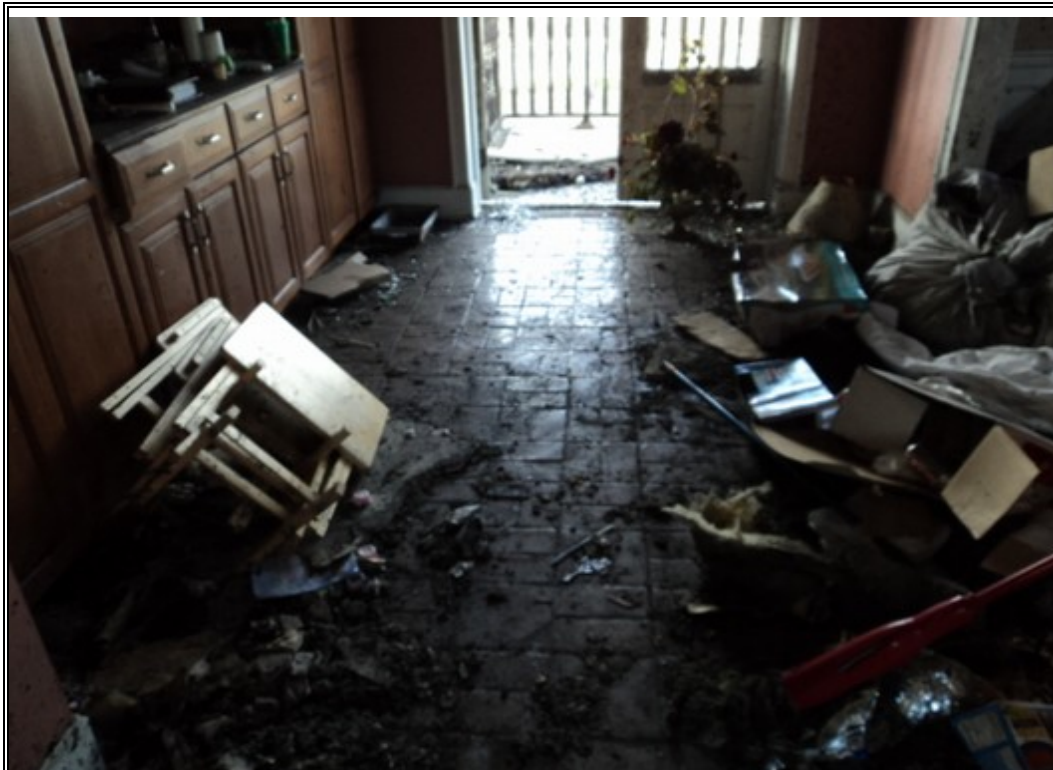
Photo Number
21

- Approximately 50% of the drywall is missing on the ceiling in the breakfast area exposing the ceiling joists.

- Some of the ceiling joists area burnt and damaged. The extent of the ceiling joist damage was deep into the wood.
- The drywall on the walls of the breakfast area is still in tact. As a result, no inspection of the wall studs could be performed.
- The roof rafters and roof decking that were visible through the ceiling joists in the breakfast area appeared to be badly burnt and damaged.
- The drywall on the walls and the remaining part of the ceiling in the breakfast area were soot stained.

Description:
Breakfast area

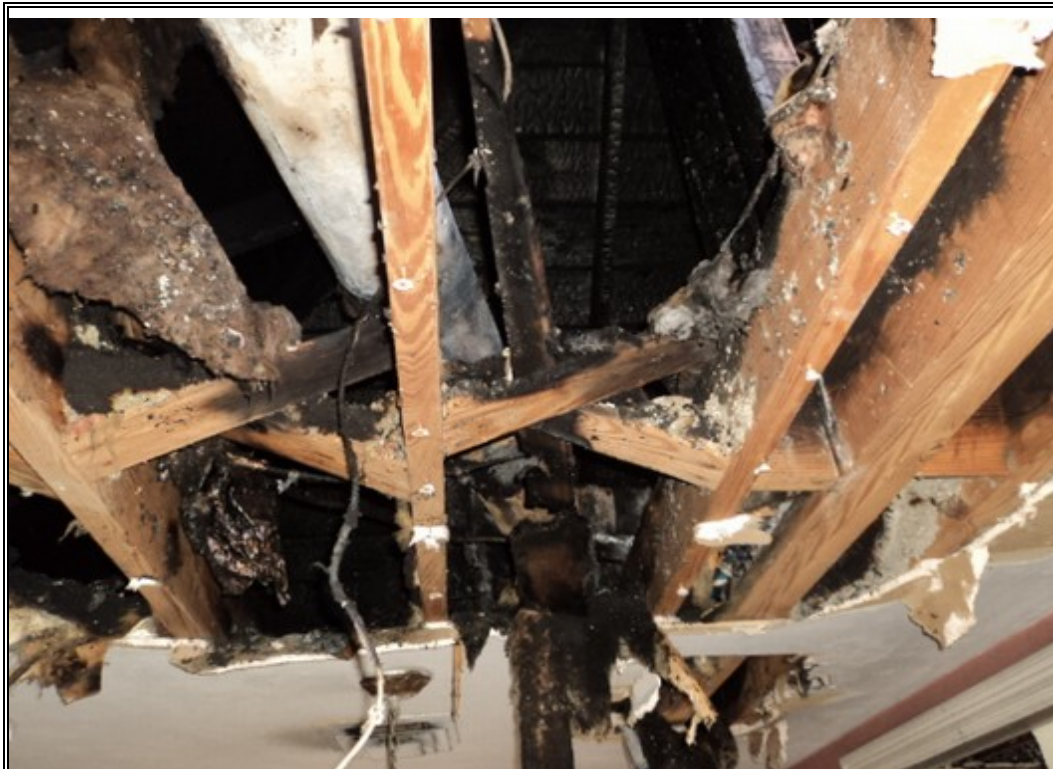
Photo Number
22

Description:
Breakfast area
ceiling; fire
damaged roof
structure visible
through the ceiling
joists

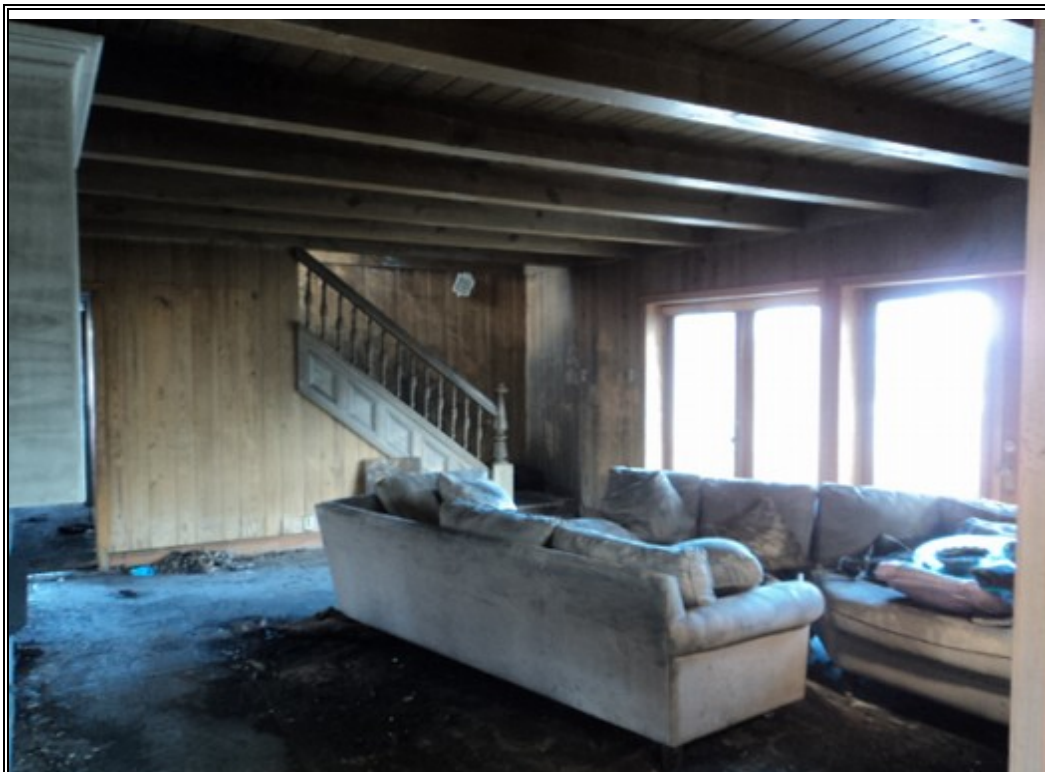
Photo Number
23

- The wood finishes on the walls and the ceiling of the den were not visibly burnt or charred. However, there are soot stains on the wood finishes on the walls and ceilings.
- There are water stains on the wood ceiling and on the wood ceiling beams.

Description:
Den

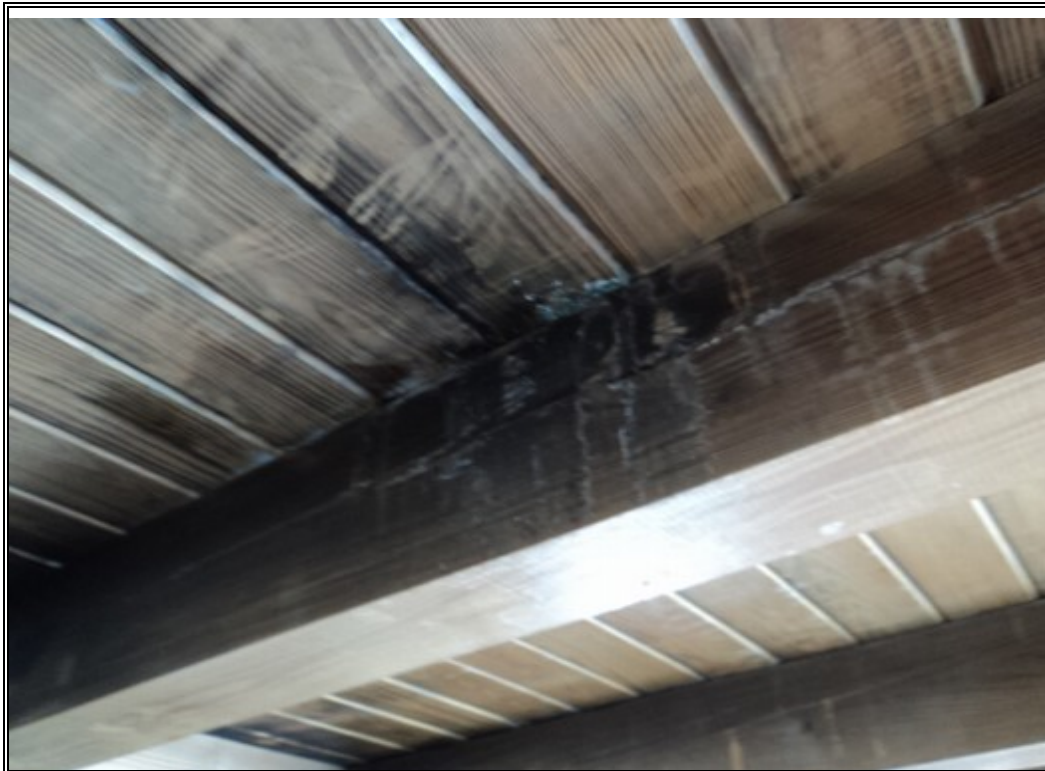
Photo Number
24

Description:
Water and soot
damage on den
ceiling wood finish
and beam

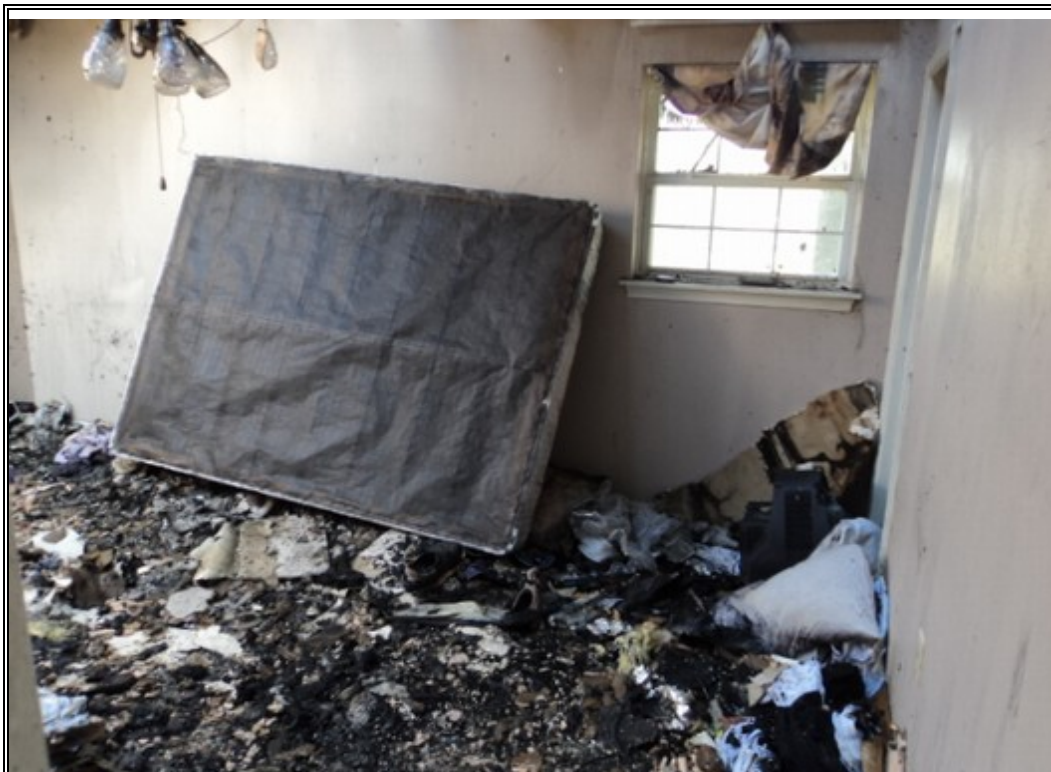
27

1st floor left rear
bedroom

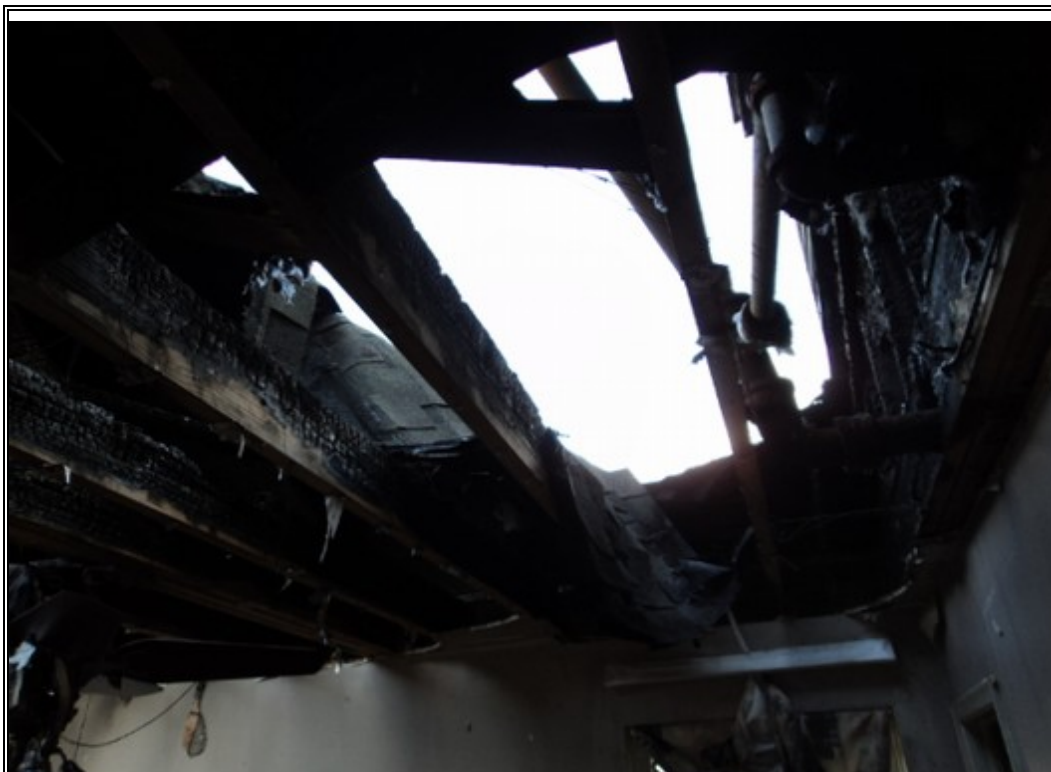
Ceiling in 1st floor
left rear bedroom

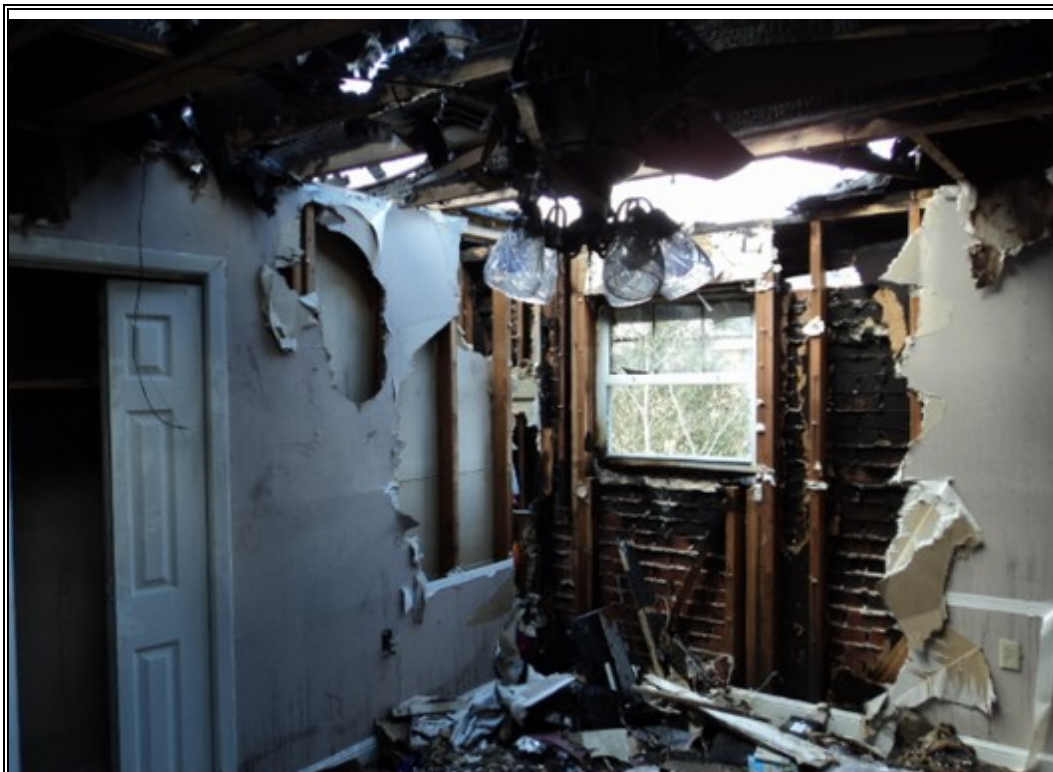
Photo Number
29

Description:
North wall and
ceiling in 1st floor
left rear bedroom
