ENGINEERING EVALUATION

200 Legendre Drive
Slidell, LA 70458

February 27, 2011

Inspection No.: 2011-026
Date of Inspection: February 21, 2011
Engineer: Daniel T. Dormady, P.E.

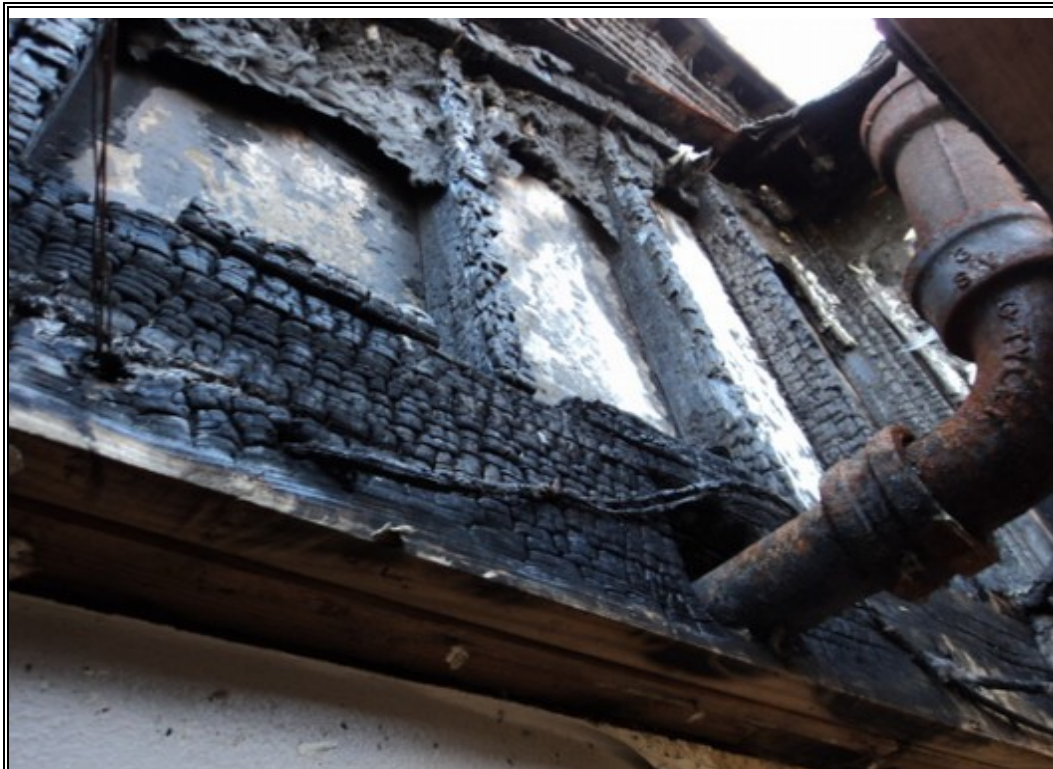
Photo Number
30

Description:
North 2nd floor
wall visible
through the 1st
floor left rear
bedroom ceiling

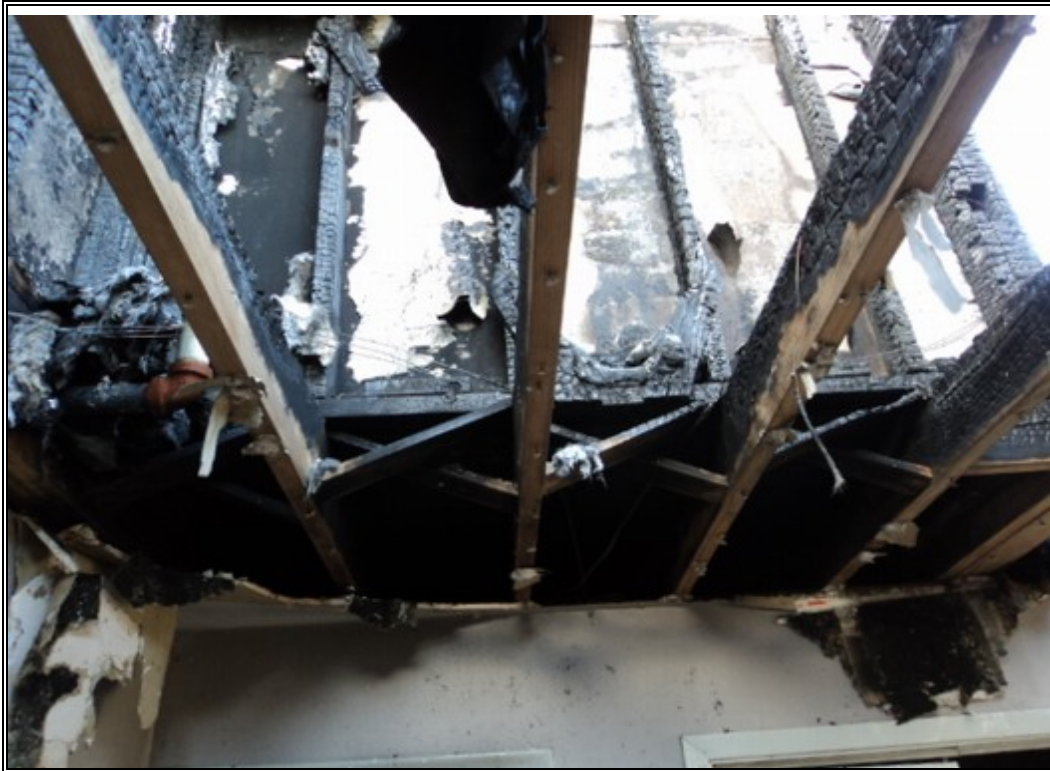
Photo Number
31

Description:
North 2nd floor
wall visible
through the 1st
floor left rear
bedroom ceiling

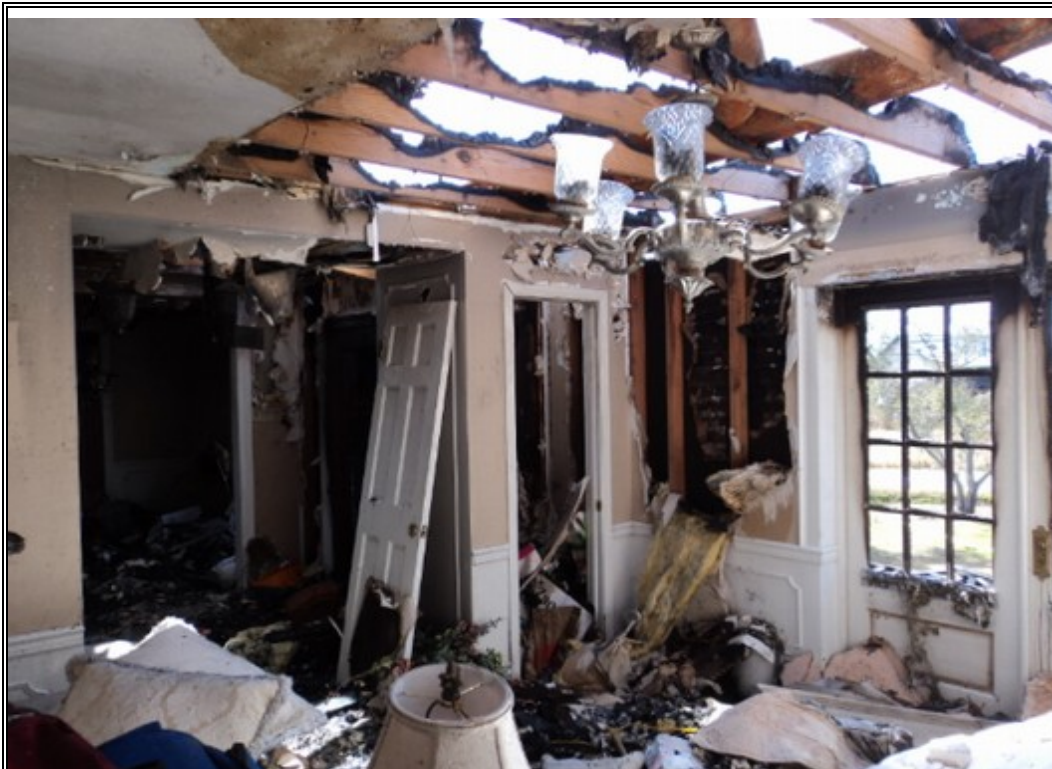
Photo Number
36

- The majority of the drywall on the ceiling of this room was missing, primarily across the front of the house and the exposed ceiling joists are burnt and badly damaged. The damage is deep into the ceiling joists that are visible such that portions of the ceiling joists are missing.
- There are sections of missing drywall on the west wall of this room exposing some of the wall studs. The studs that are visible are burnt and probing revealed that the damage goes deep into the wood of some of the studs.
- The French doors are charred at the top of the doors and the glass is broken in the doors.
- There are soot stains on the remaining drywall on the walls and ceiling in this room.

Description:
Living room on 1st
floor

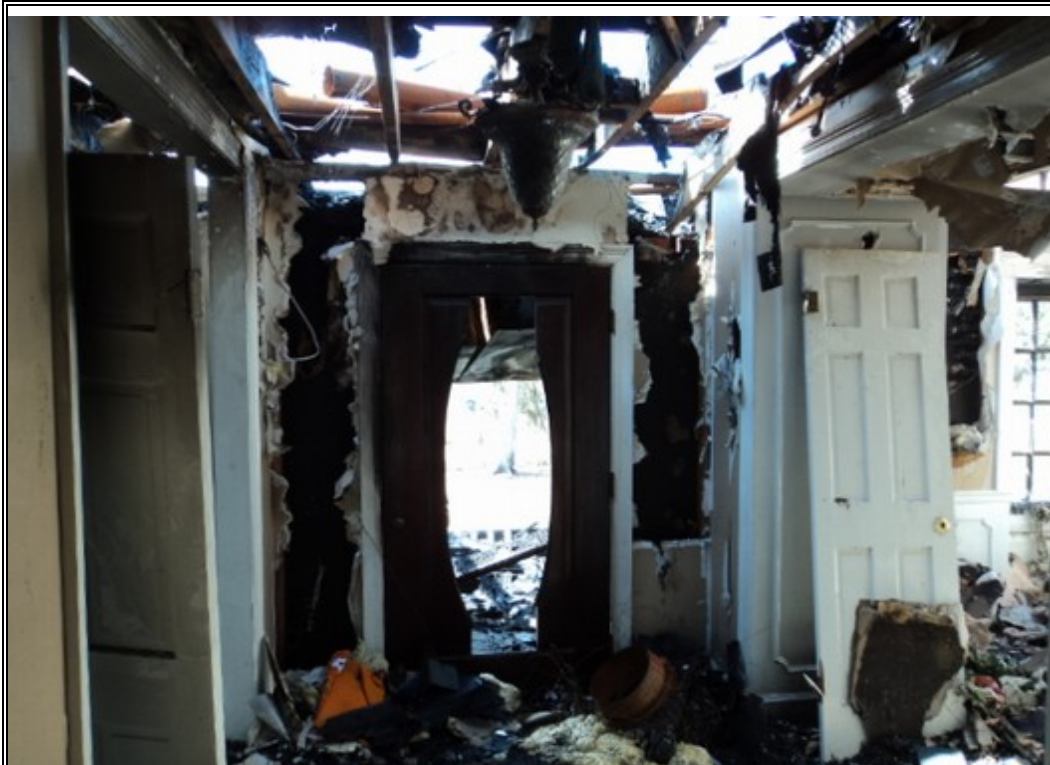
Photo Number
38

- The drywall on the ceiling of this area was missing and the ceiling joists are burnt and badly damaged. The extent of the ceiling joist damage was deep into the wood.
- The drywall is missing on the west wall of this area exposing the wall studs. The studs that are visible are burnt and probing revealed that the damage goes deep into the wood.
- The front door on the west wall in the foyer was charred at the top of the door and the doorframe. The glass was missing in the door.
- The remaining drywall on the walls of the foyer were soot stained.

Description:
Foyer at front door

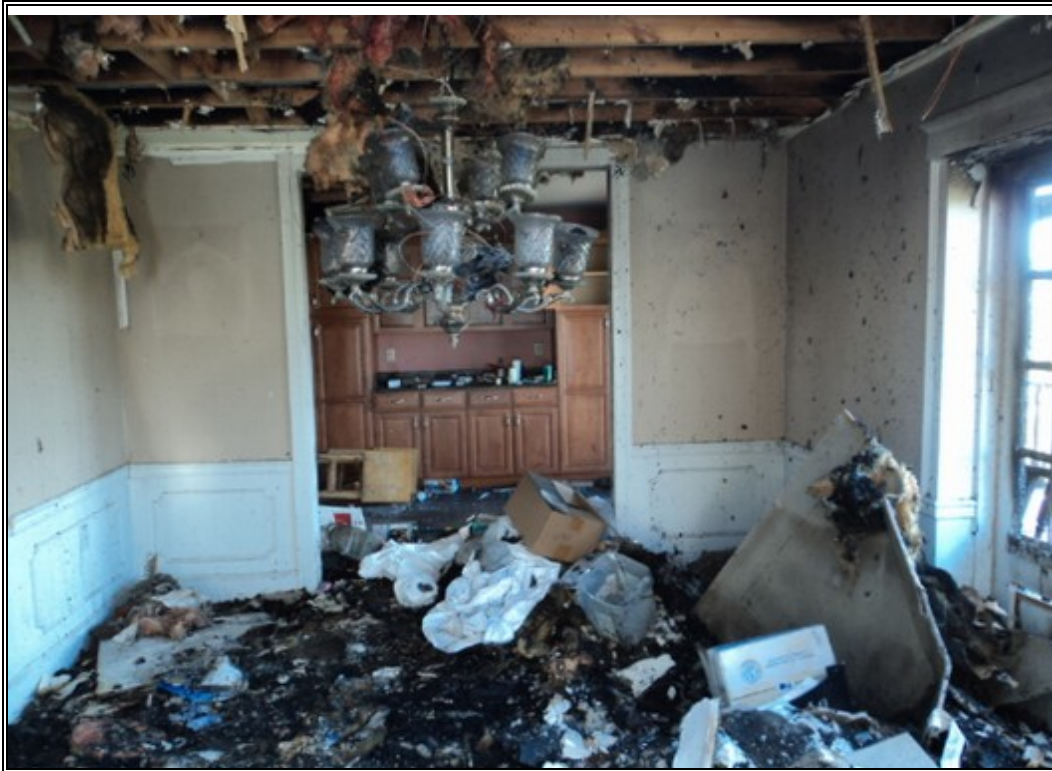
Photo Number
39

- The drywall on the ceiling of the dining room was missing and the ceiling joists are burnt and badly damaged. The extent of the ceiling joist damage was deep into the wood.
- Because the interior finishes were still in tact on the walls of the dining room, the wall studs were not visible for inspection.
- The drywall on the walls of the dining room were soot stained.
- The French doors on the west wall of the dining room are burnt and damaged. The glass was missing in the doors.

Description:
Dining room on 1st
floor

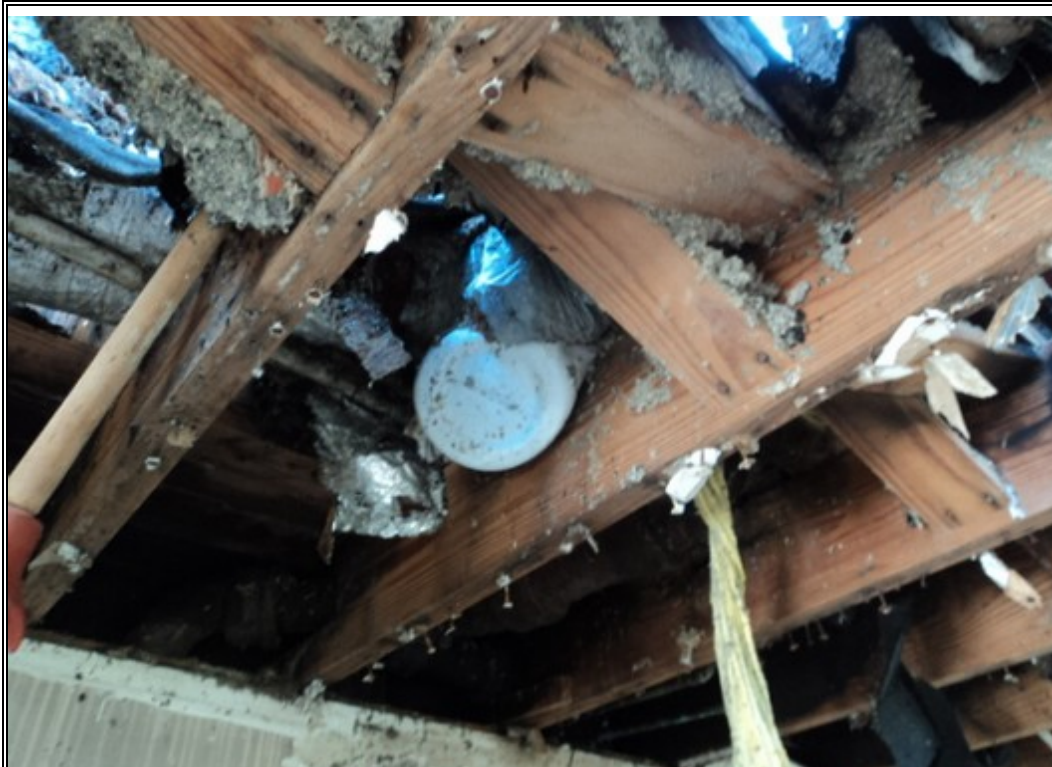
Photo Number
40

Description:
Dining room
ceiling

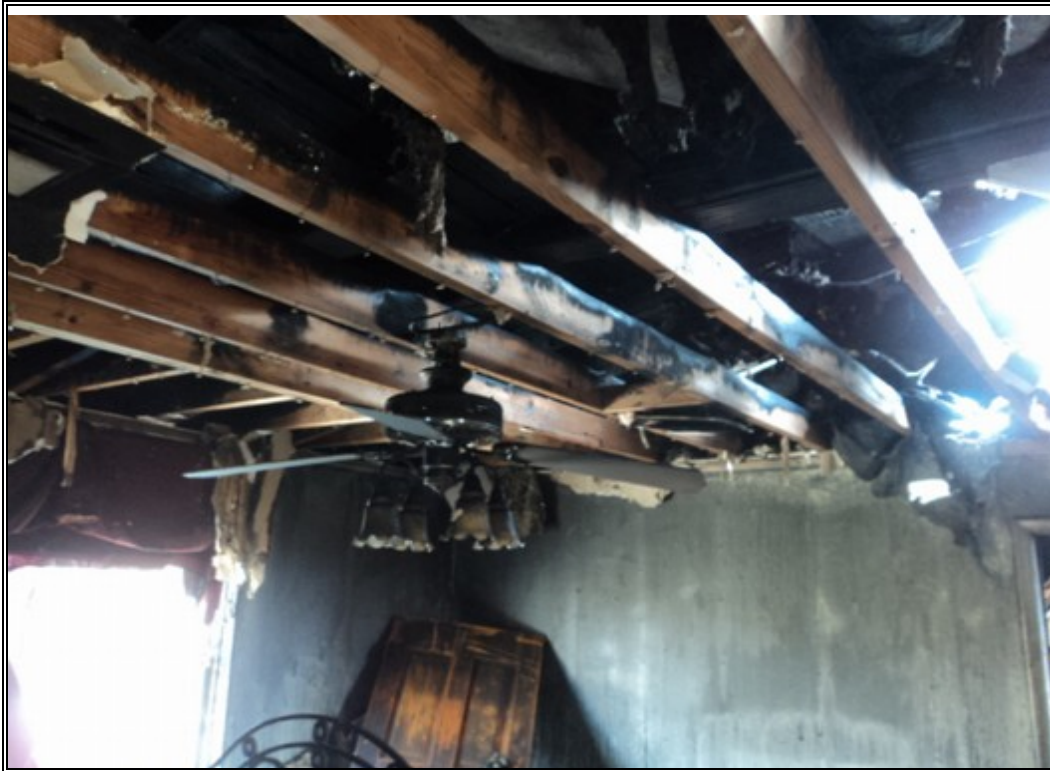
Photo Number
47

Description:
2nd floor south
bedroom ceiling

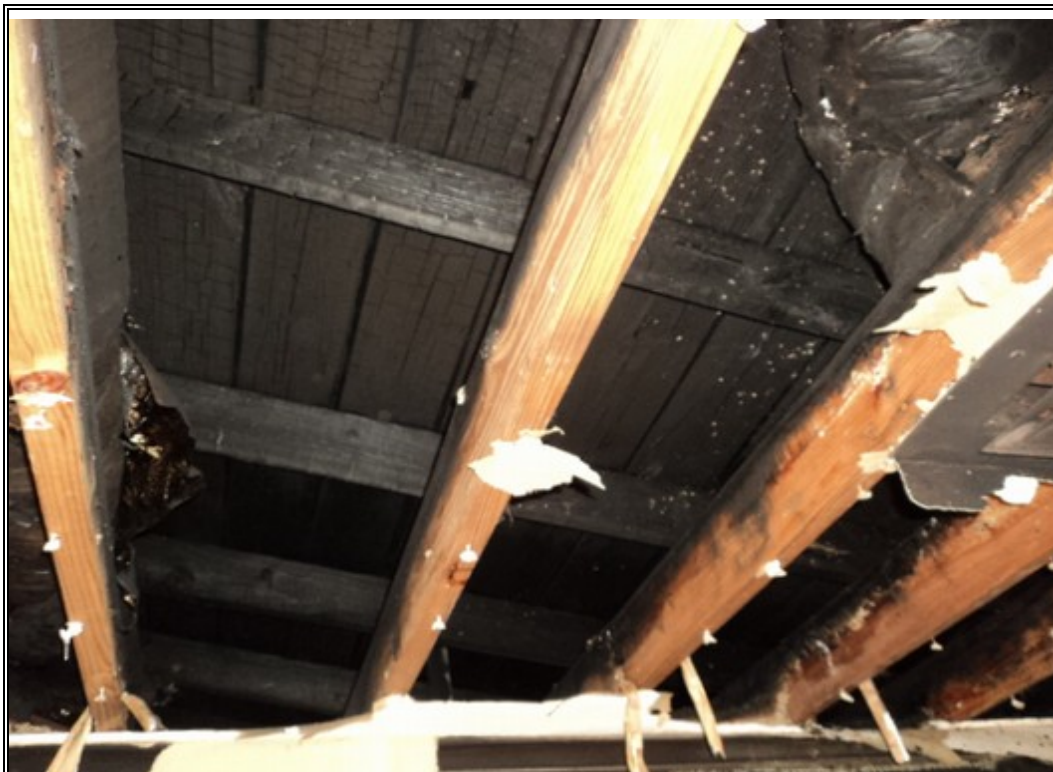
49

- The drywall on the ceiling of the 2nd floor hallway was missing, and the exposed ceiling joists are burnt and badly damaged. The damage is deep into the ceiling joists.
- The wall studs are also badly burnt and damaged.
- The roof rafters and roof decking visible through the ceiling joists are burnt and badly damaged. The roof has collapsed on top of the ceiling joists.
- The exterior door and doorframe is partially missing.

2nd floor hallway;
collapsed roof
structure visible
through the ceiling
joists

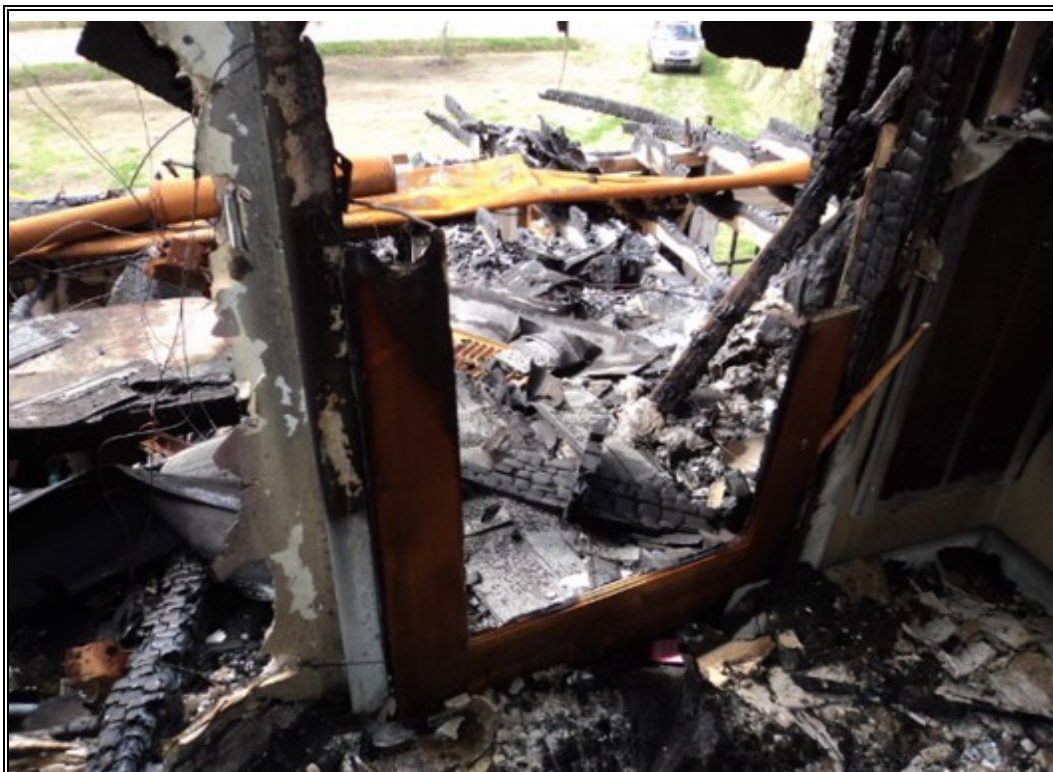
2nd floor hallway;
fire damaged wall
and door on the
west wall
