## Structural Inspection

05-04-2022

Mimi Mckee  
207 S Holly St.  
Hammond, La 70403

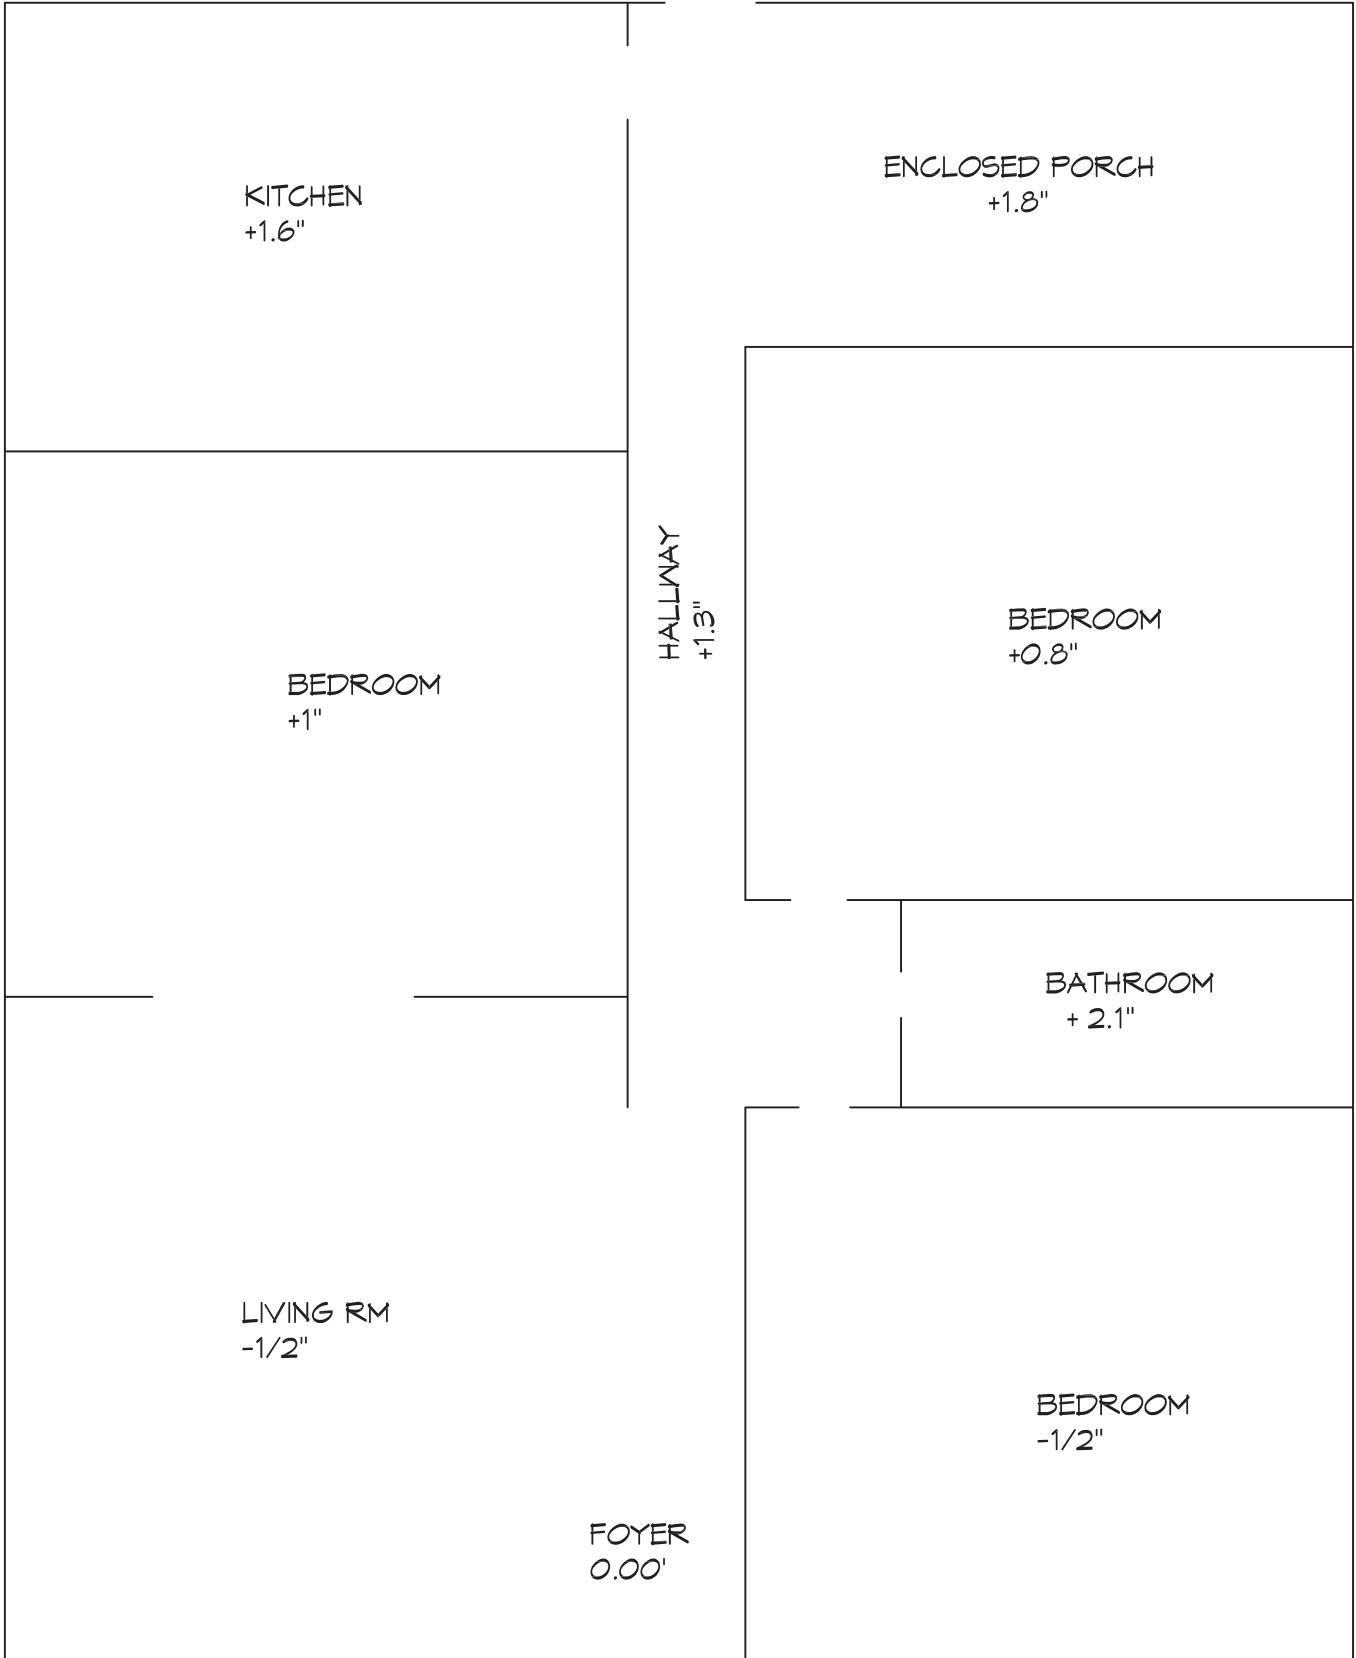
A zip level was used inside the home to verify the floor height conditions throughout. The level was set up at the front of home in the foyer. As per the attached sketch it shows that the home slopes from the rear of the home +1.8" to the front of the home of 0.0".

KITCHEN  
+1.6"

ENCLOSED PORCH  
+1.8"

HALLWAY  
+1.3"

BEDROOM  
+1"

BEDROOM  
+0.8"

BATHROOM  
+ 2.1"

LIVING RM  
-1/2"

BEDROOM  
-1/2"

FOYER  
0.00'

It is recommended to have the home leveled prior to any repairs.

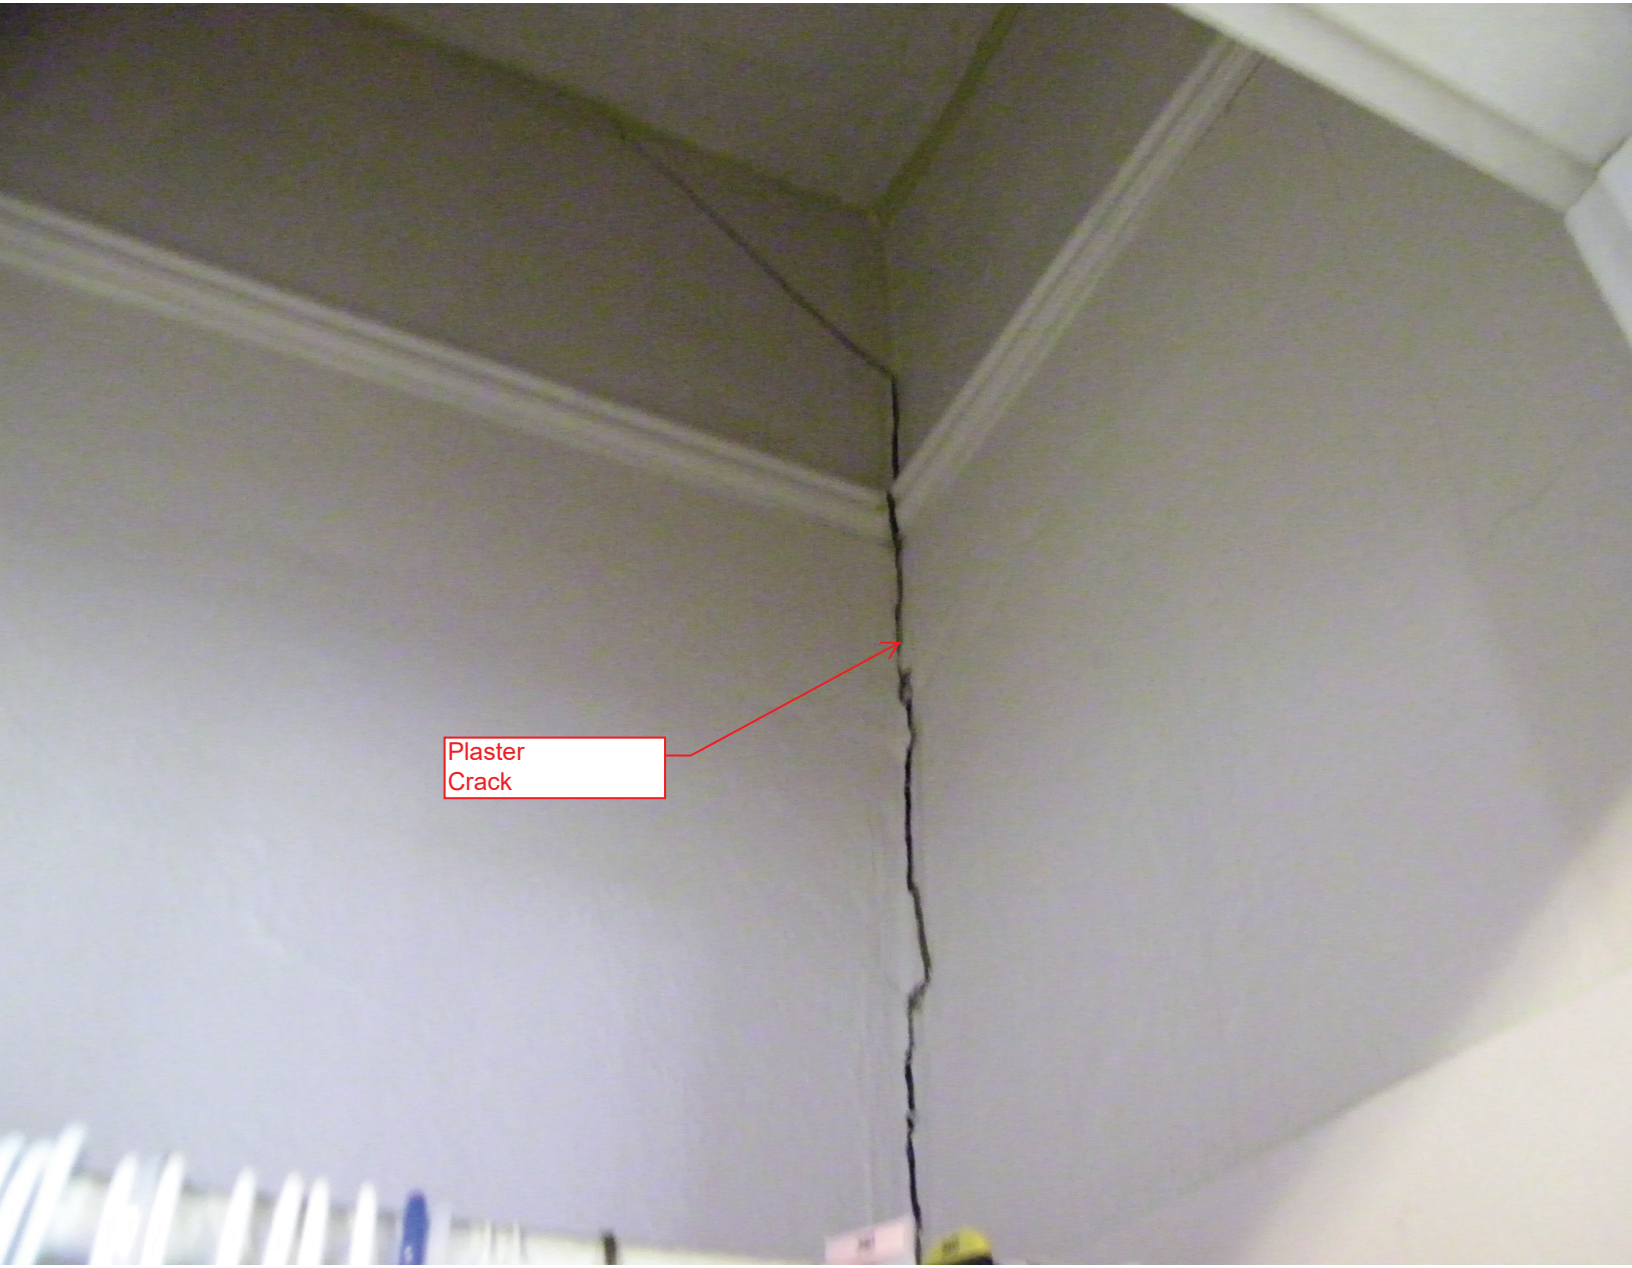
It appears that the front of the home settled from saturation of the earth. It also explains how the cypress trees are lying on their side from the earth being saturated in front of the home. With the wind and rain hitting the house it has caused it to wrack back and forth therefore causing plaster damage.

Plaster  
Crack

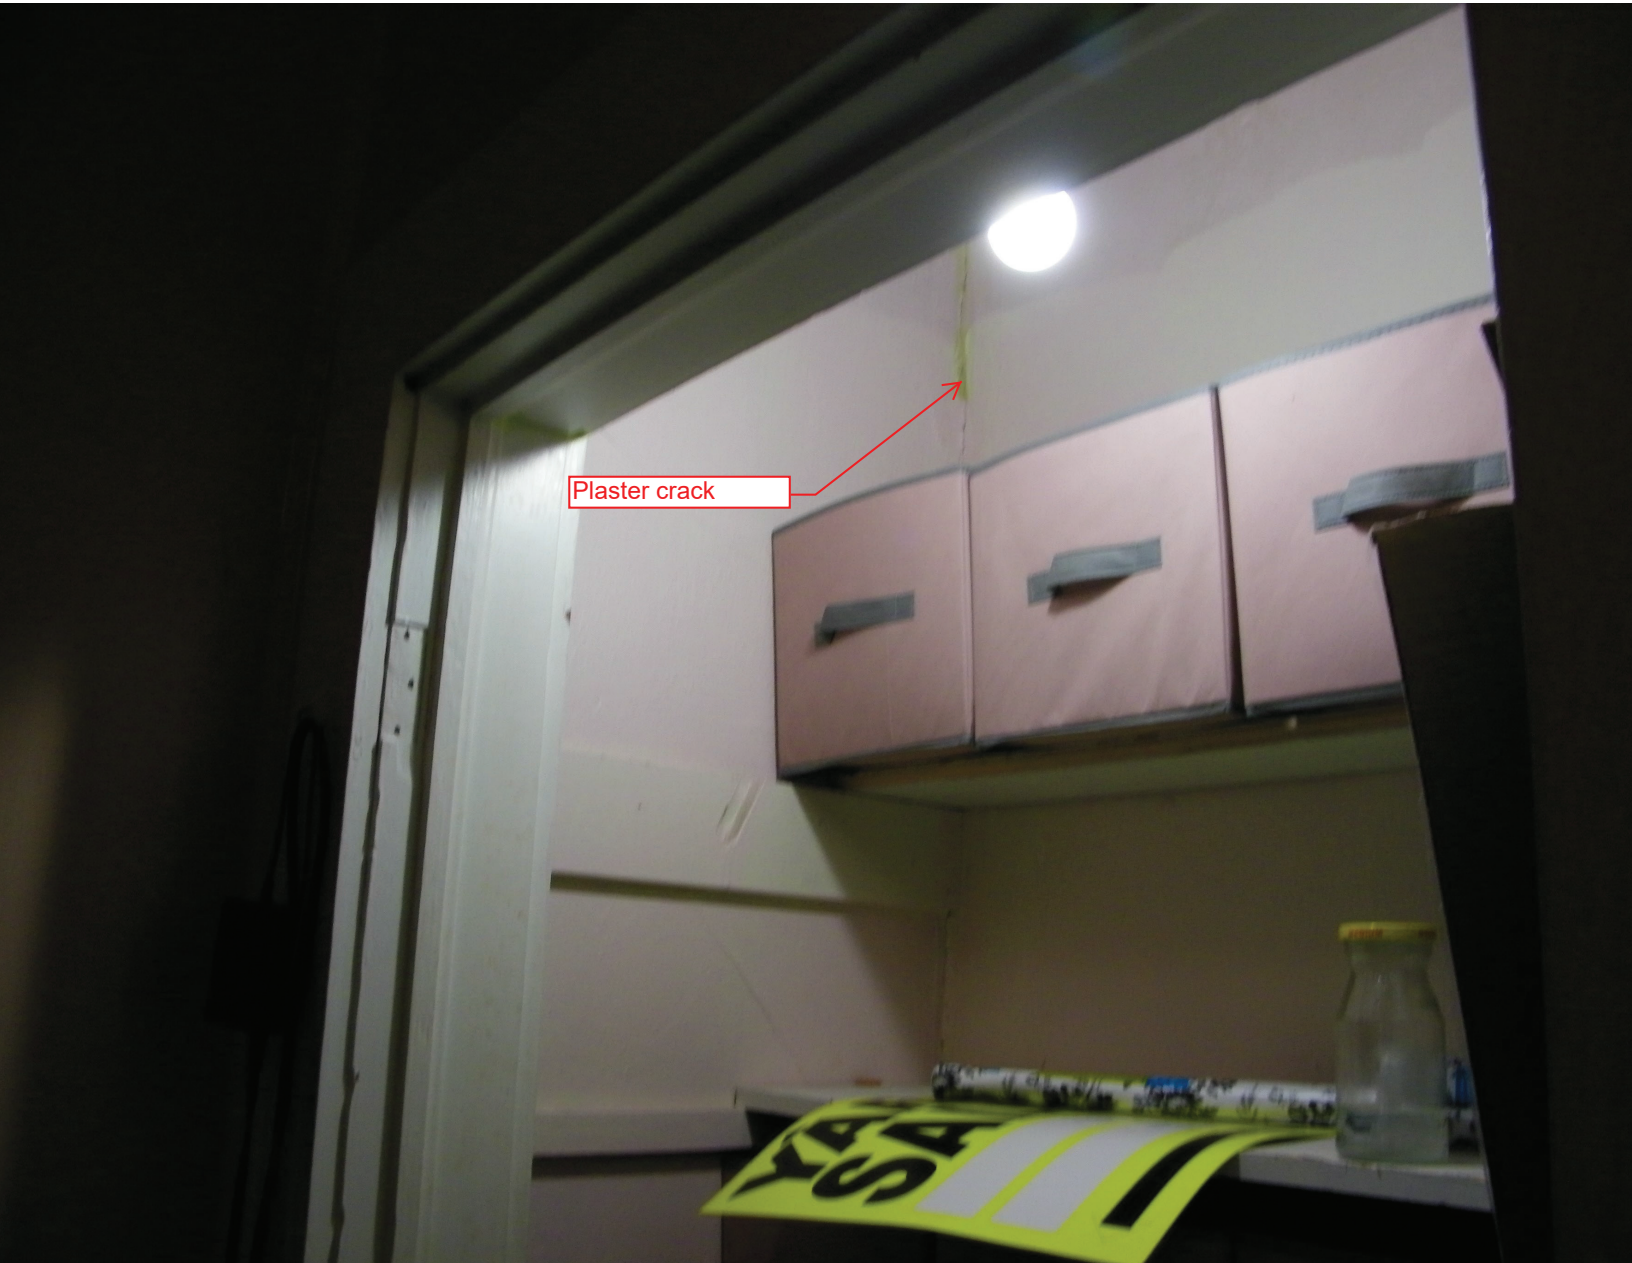
Plaster crack

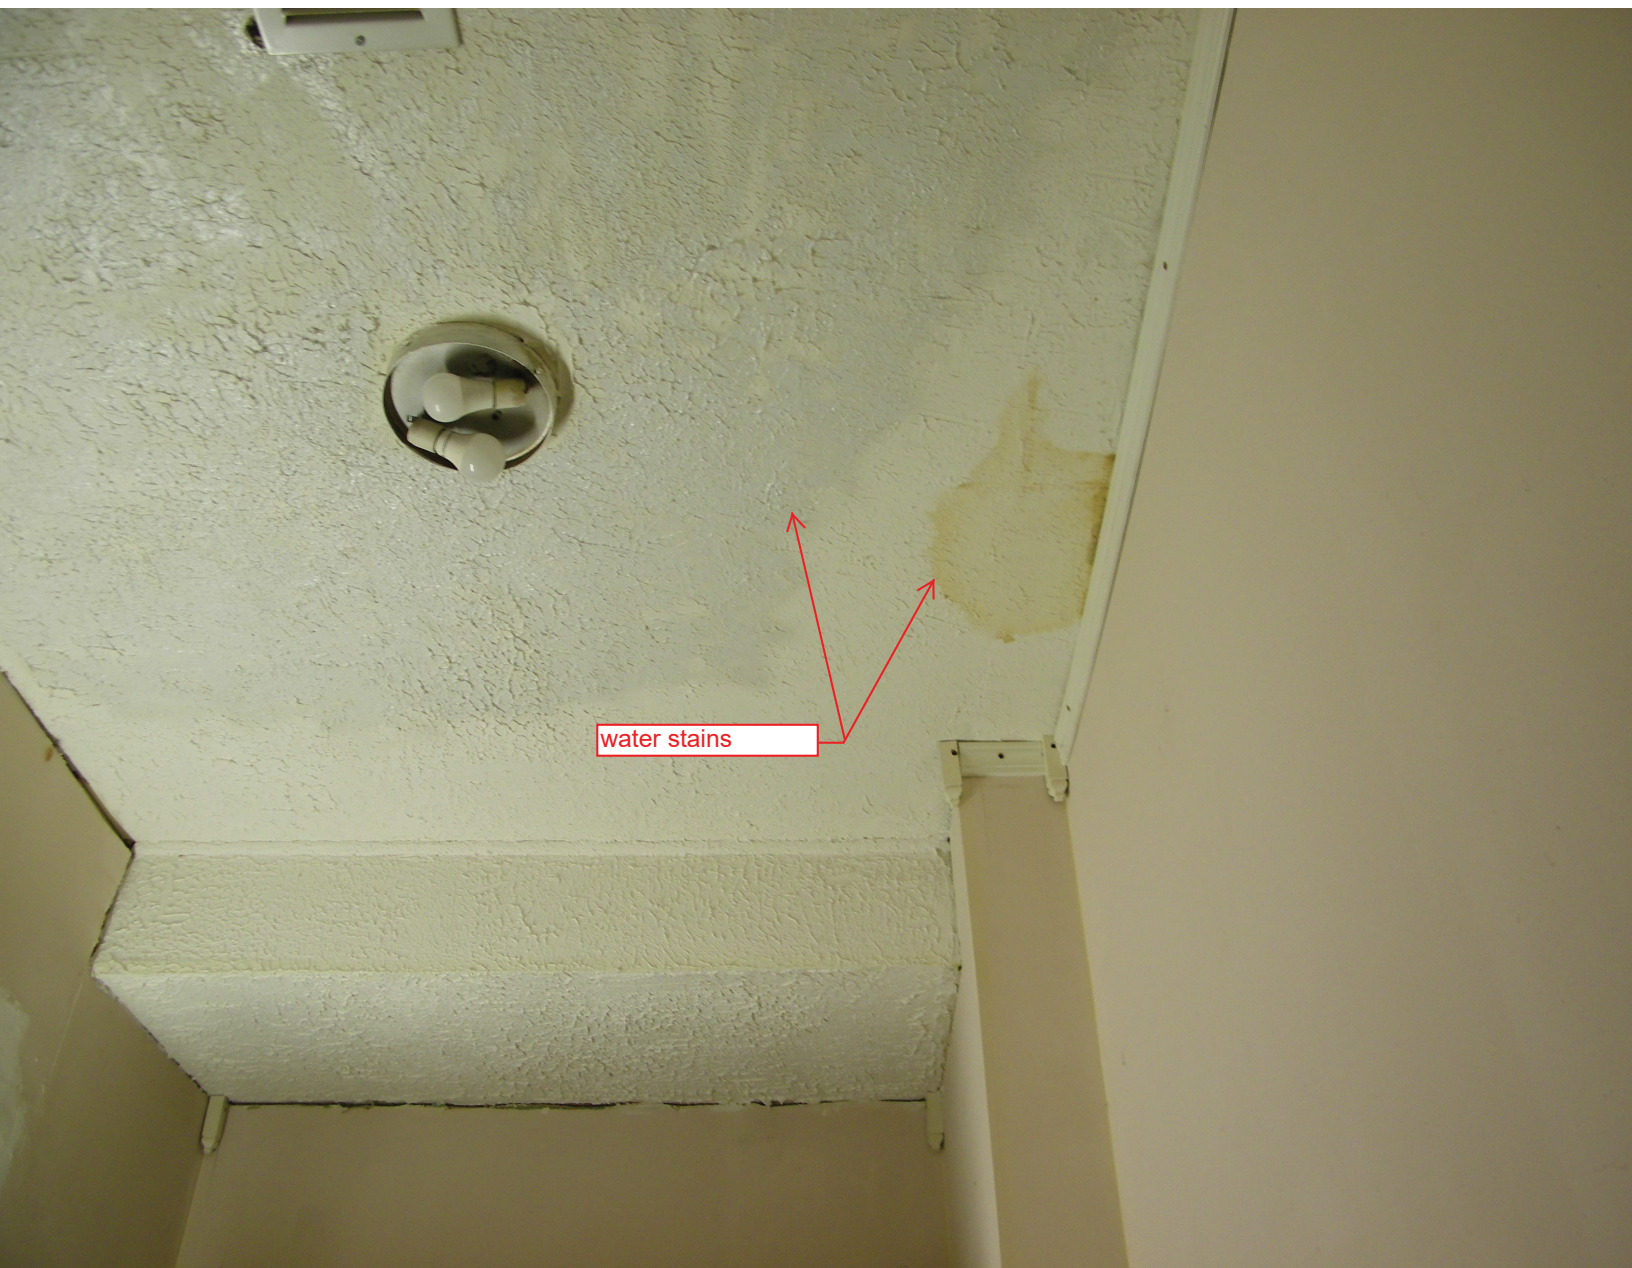
A visual inspection in the interior of the home noted plaster cracks in the front bedroom closets, living area, bathroom and kitchen walls and ceilings. It was also noted to have water stains in the ceilings in these areas as well.

water stains

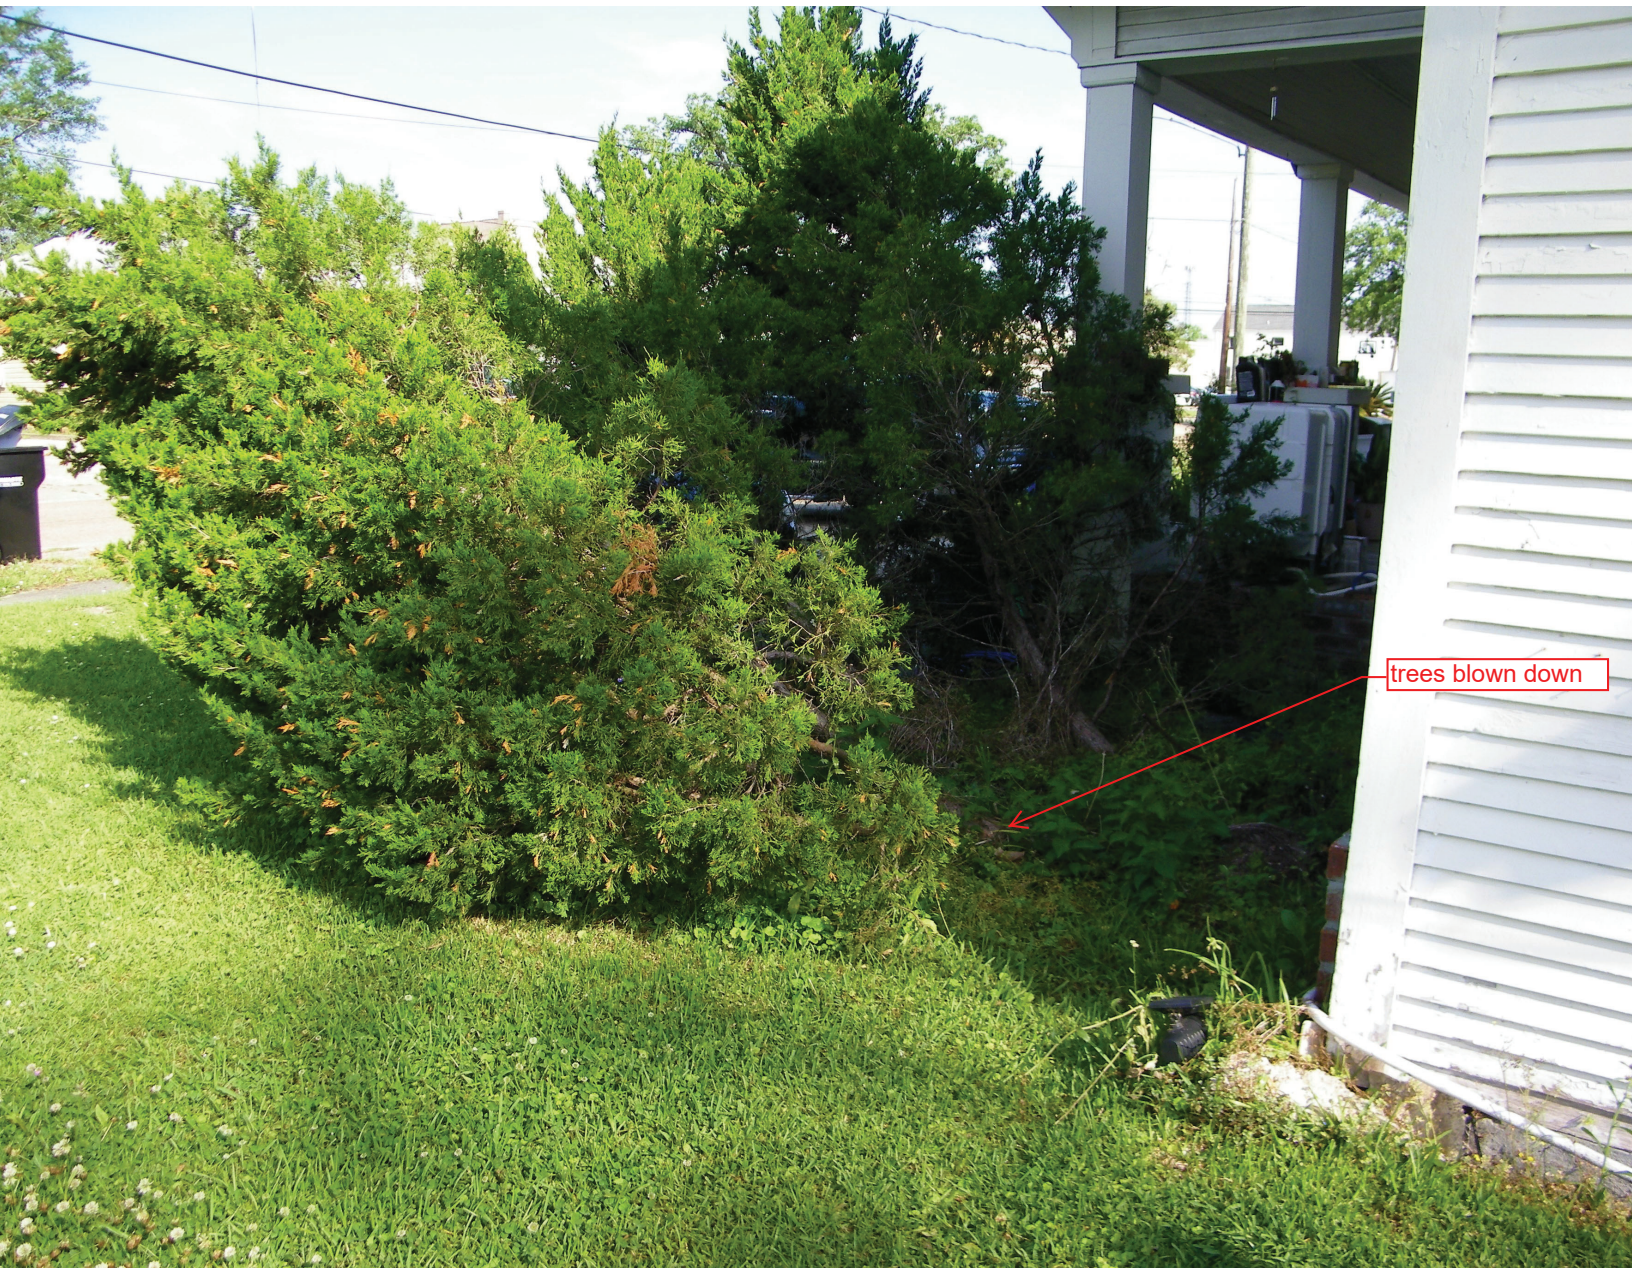
trees blown down

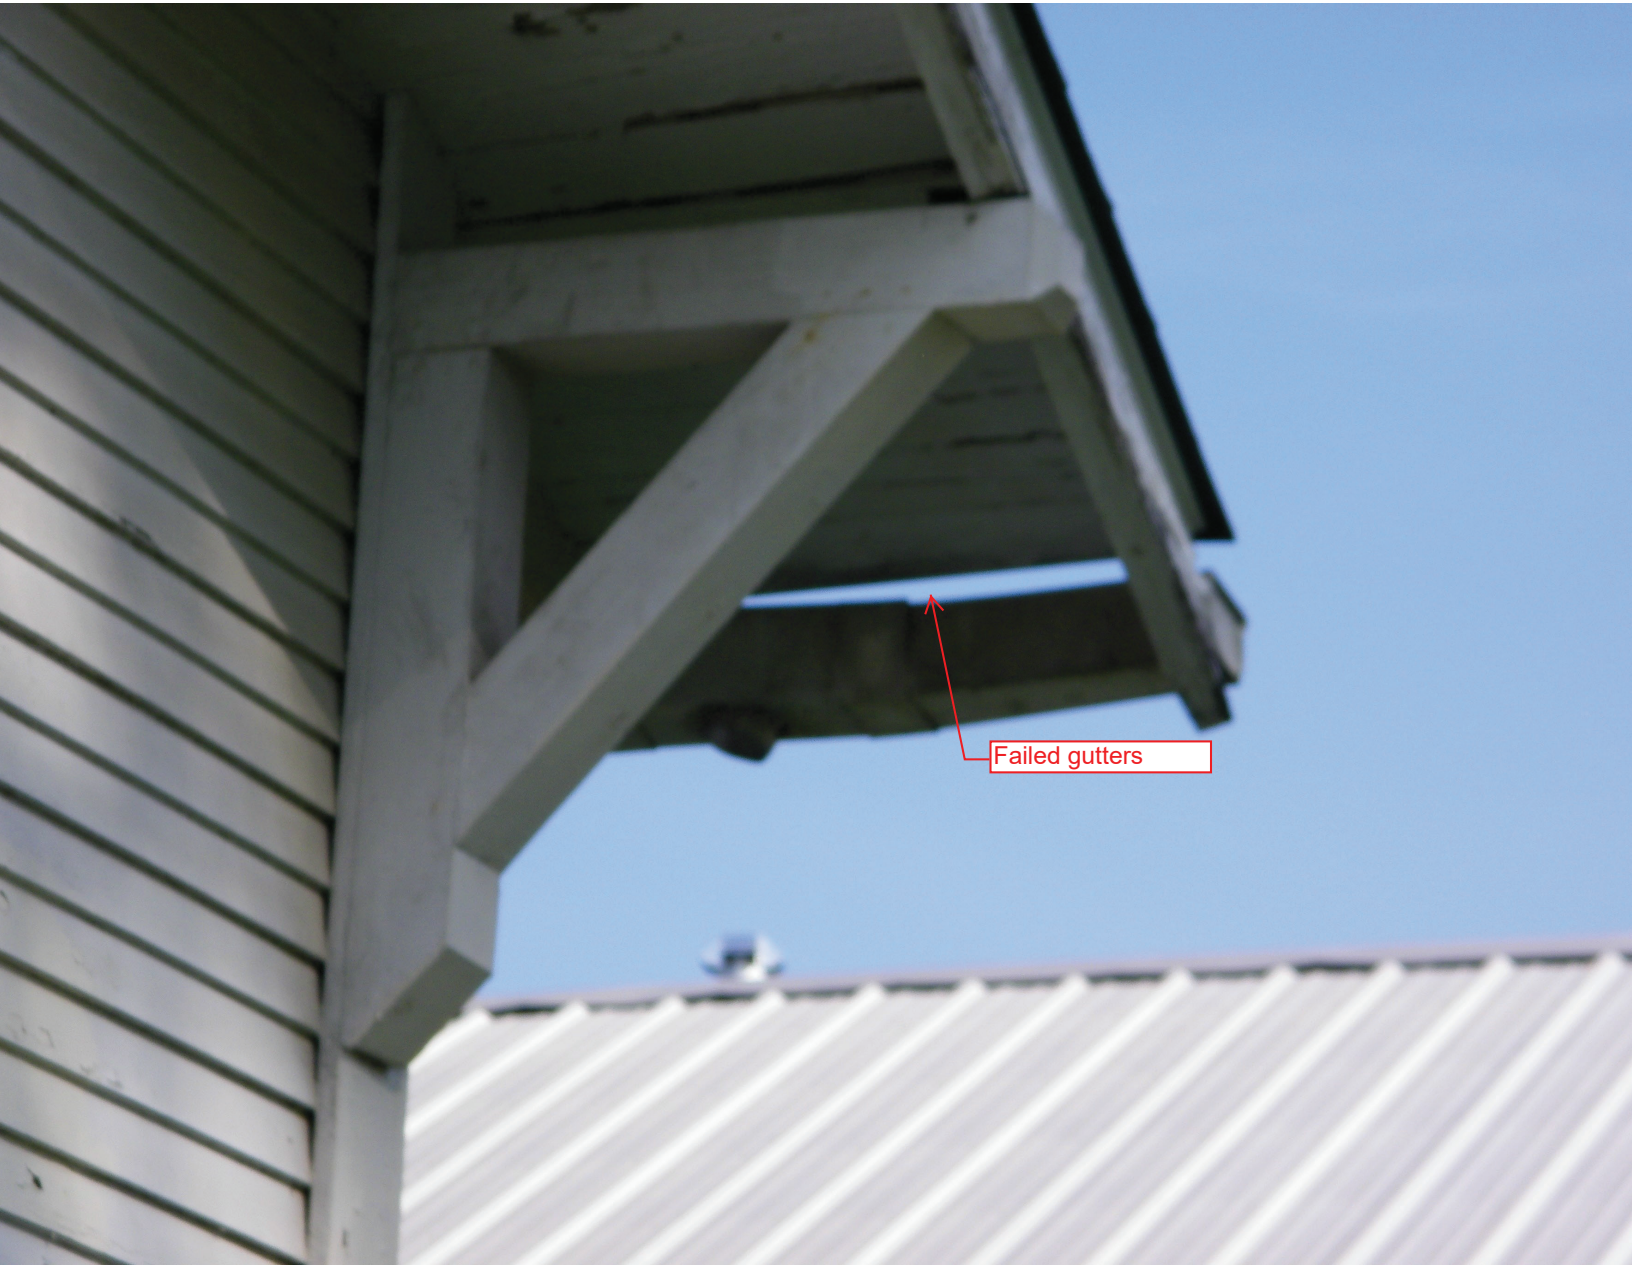
Failed gutters

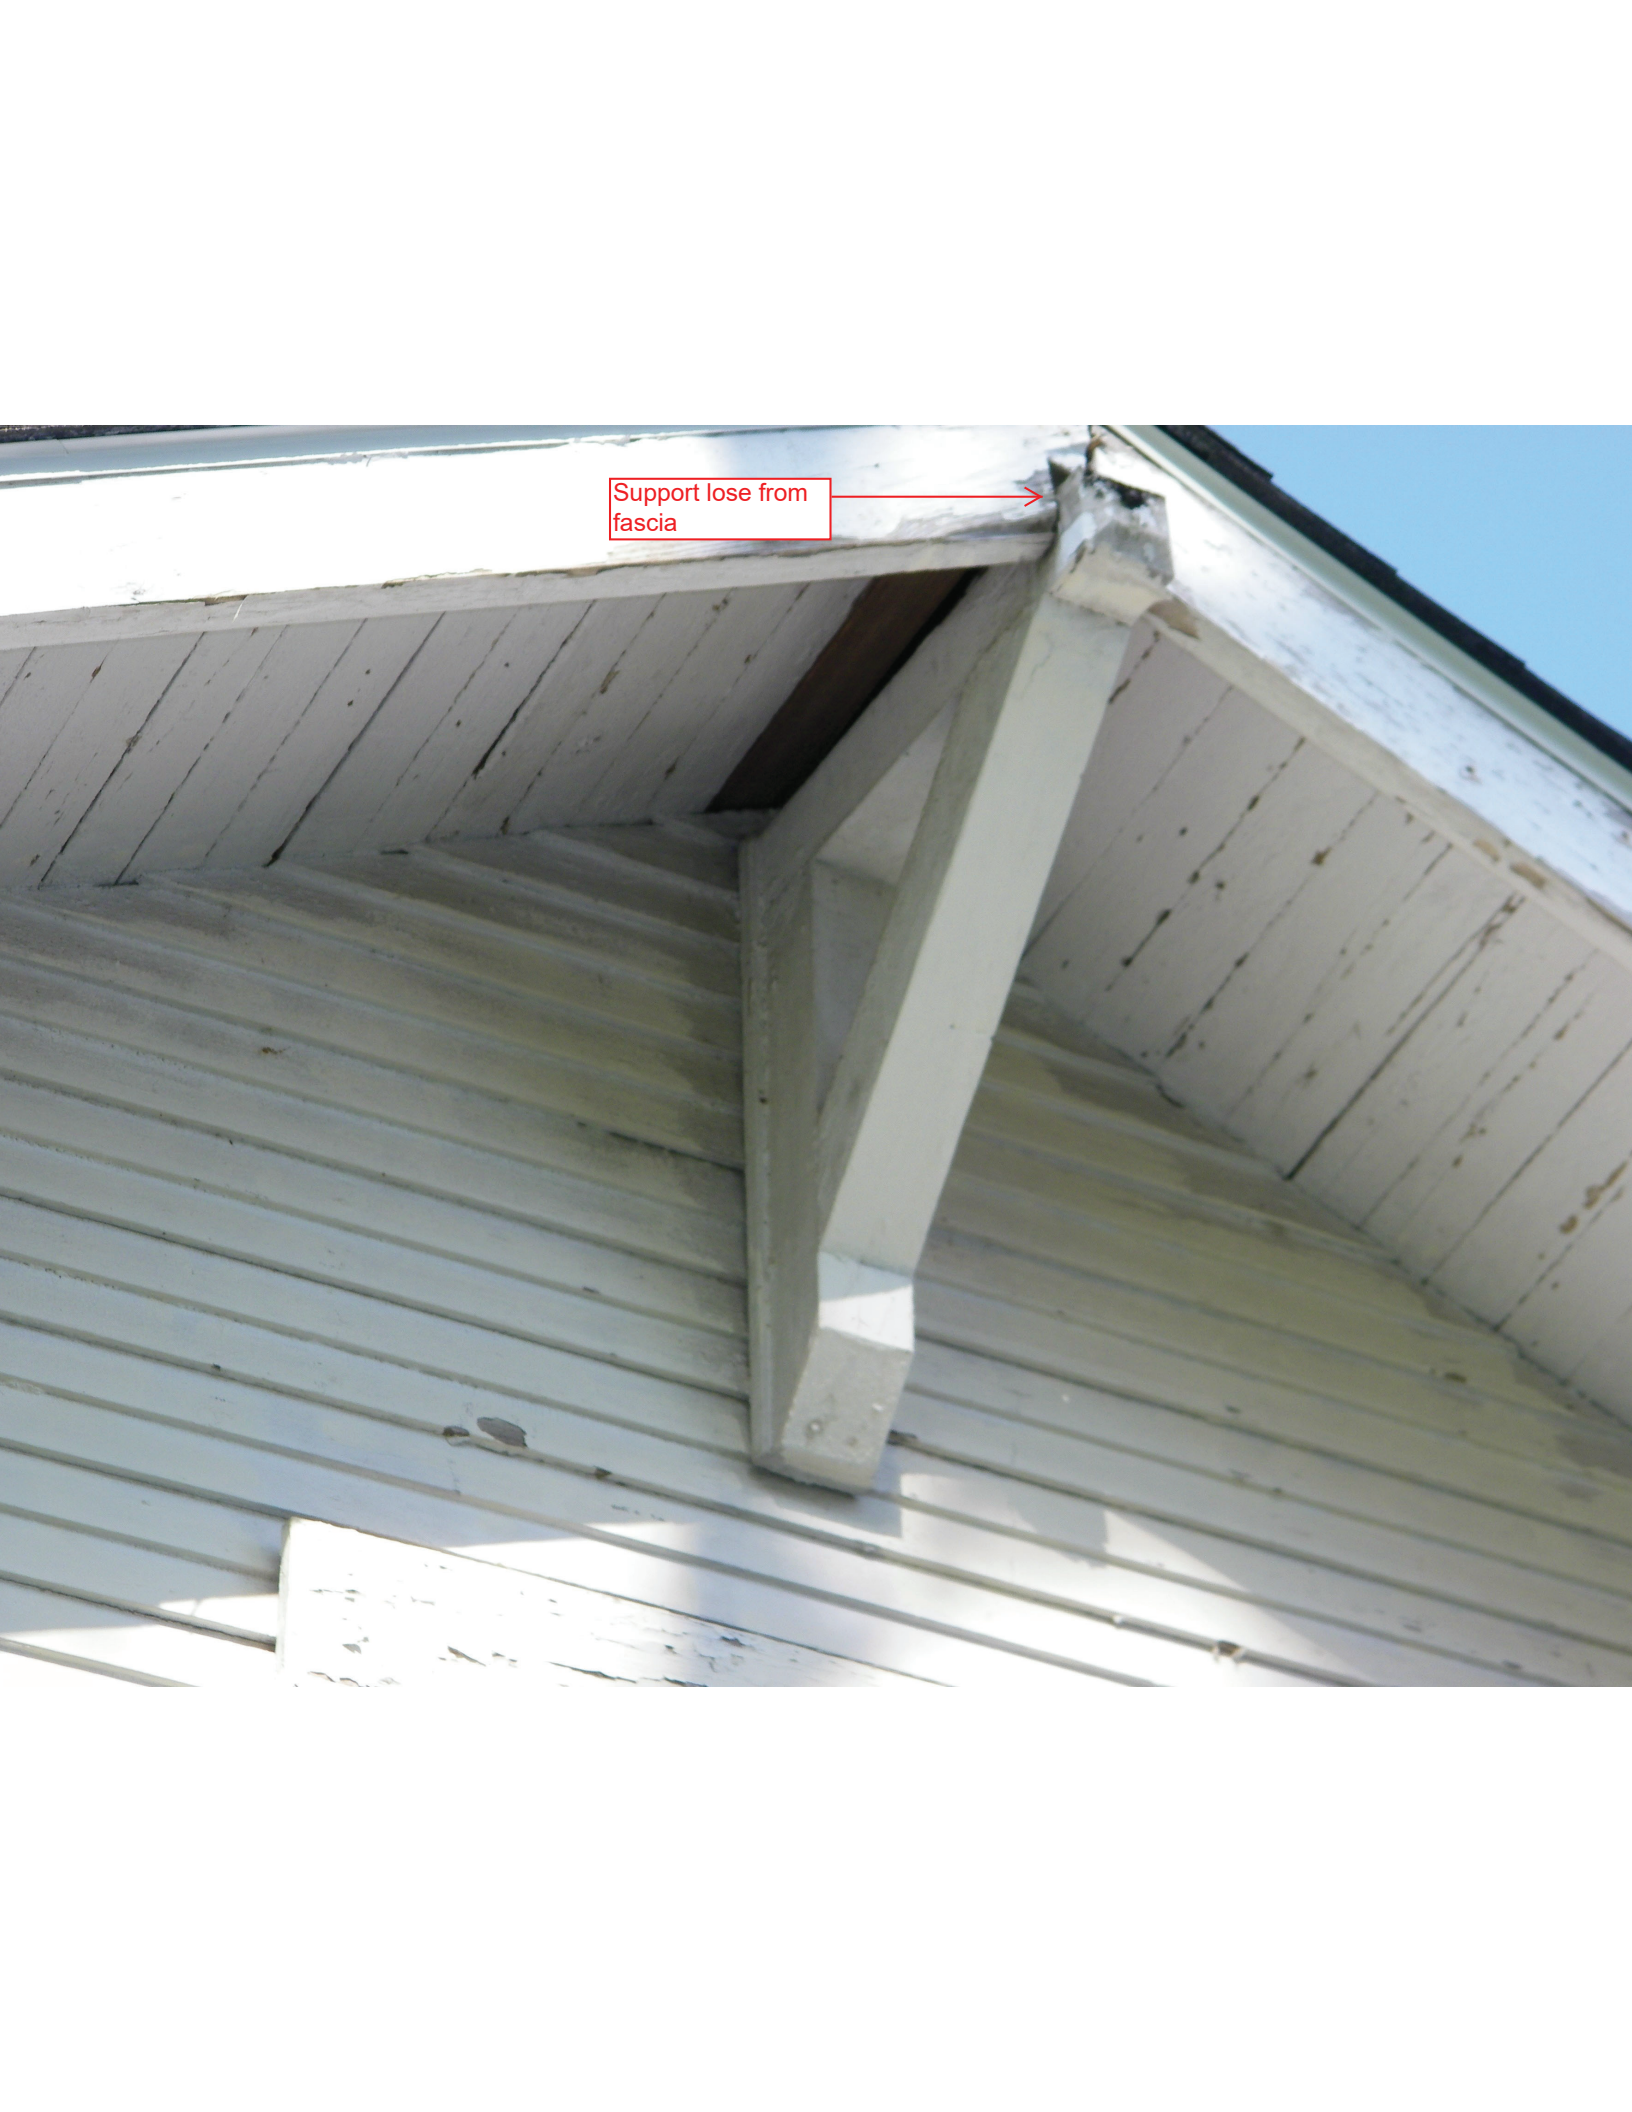
Support lose from  
fascia
