**BUILDING ROOF
RECOATING**

PEARL RIVER
HIGH SCHOOL
INDUSTRIAL ARTS
BUILDING
PEARL RIVER, LA

EXISTING
ROOF PICTURES

A-2

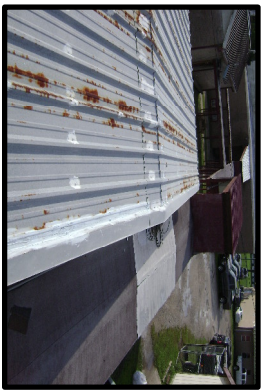
DAMAGED ROOF END RAKE
N.T.S.

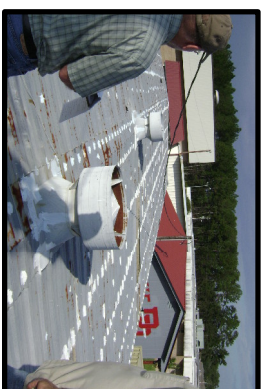
DAMAGED ROOF AND VENTILATORS
N.T.S.

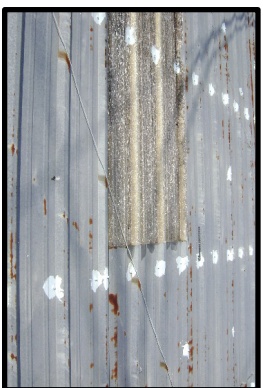
DAMAGED FIBERGLASS ROOF PANELS
N.T.S.

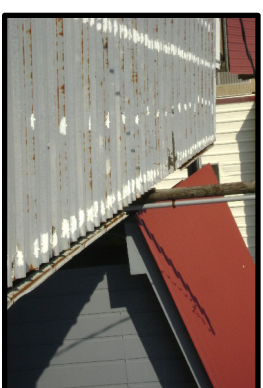
MISSING GUTTER
N.T.S.

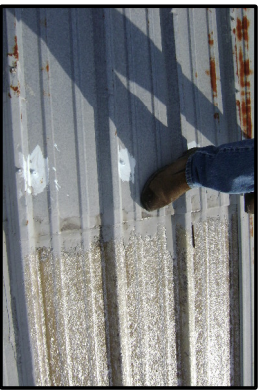
DAMAGED OVERLAPPING PANELS
N.T.S.

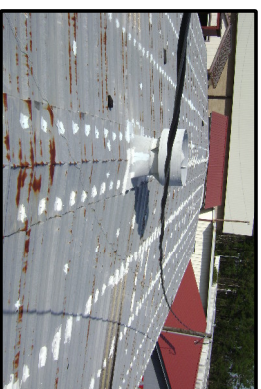
DAMAGED ROOF AND VENTILATORS
N.T.S.

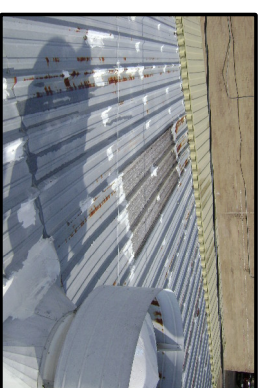
DAMAGED FIBERGLASS ROOF PANELS
N.T.S.

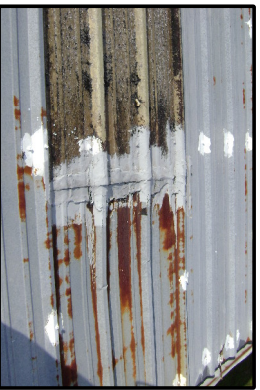
DAMAGED OVERLAPPING PANELS
N.T.S.

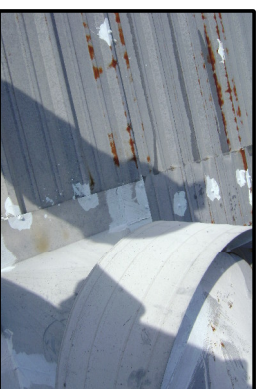
DAMAGED VENTILATOR BASE
N.T.S.

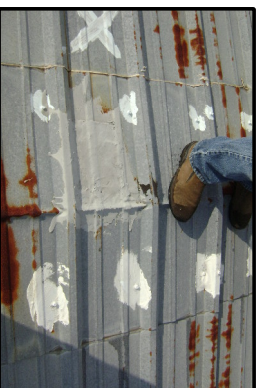
DAMAGED ROOF RIDGE
N.T.S.

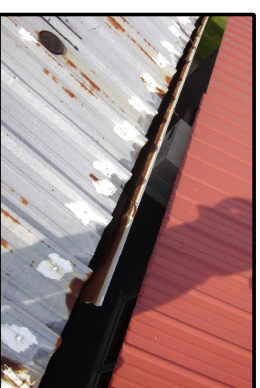
CORRODED GUTTERS
N.T.S.

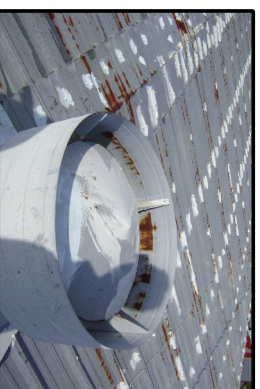
DAMAGED VENTILATOR
N.T.S.

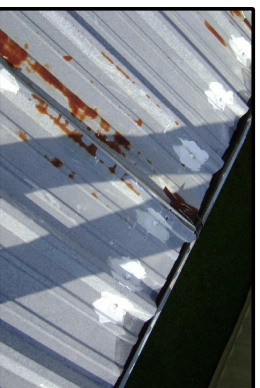
DAMAGED ROOF PANELS
N.T.S.

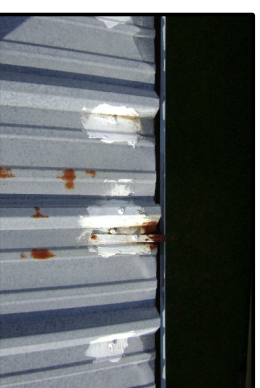
DAMAGED ROOF PANELS
N.T.S.
