BUILDING
REROOFING

PEARL RIVER
HIGH SCHOOL
INDUSTRIAL ARTS
BUILDING
PEARL RIVER, LA

EXISTING
"IN NEED
OF REPAIR"
PICTURES

A-2

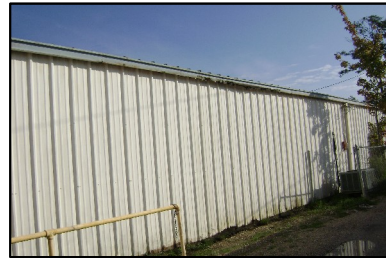
DAMAGED GUTTERS
N.T.S. A
A1|A2

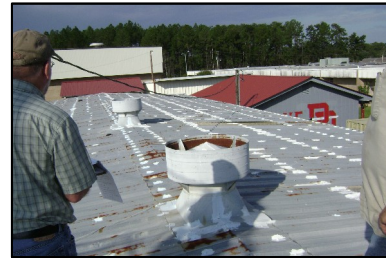
DAMAGED ROOF AND VENTILATORS
N.T.S. B
A1|A2

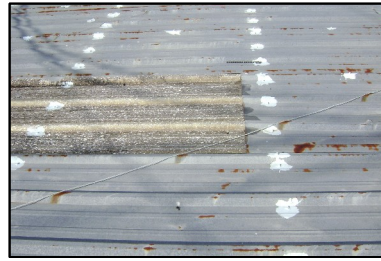
DAMAGED FIBERGLASS ROOF PANELS
N.T.S. C
A1|A2

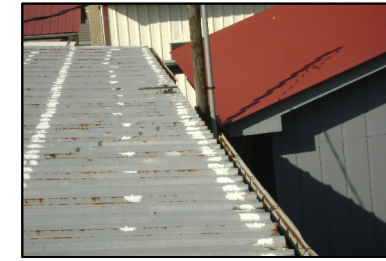
MISSING GUTTER
N.T.S. D
A1|A2

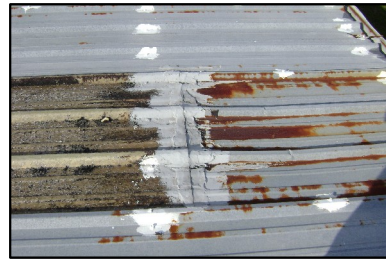
DAMAGED OVERLAPPING PANELS
N.T.S. E
A1|A2

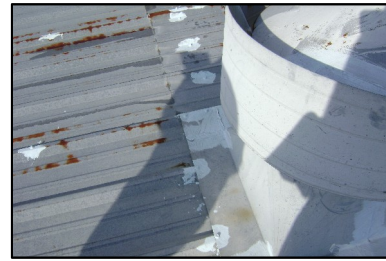
DAMAGED VENTILATOR BASE
N.T.S. F
A1|A2

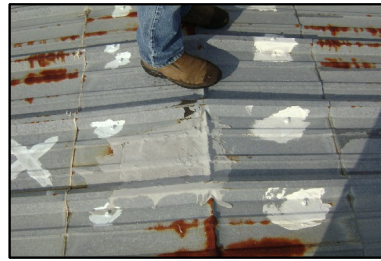
DAMAGED ROOF RIDGE
N.T.S. G
A1|A2

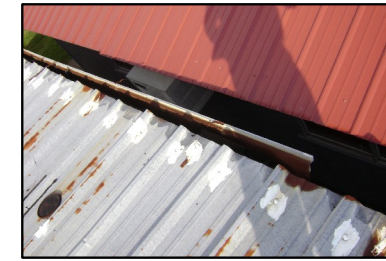
CORRODED GUTTERS
N.T.S. H
A1|A2

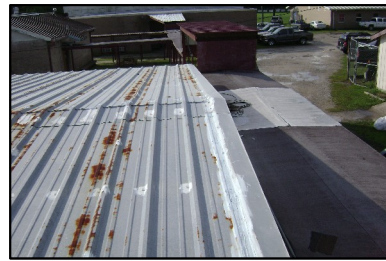
DAMAGED ROOF END RAKE
N.T.S. J
A1|A2

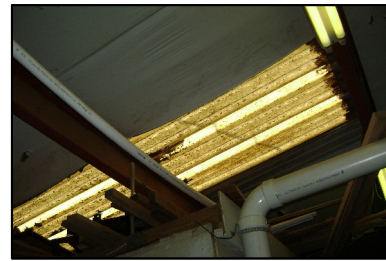
DAMAGED INTERIOR CEILING/ROOF
N.T.S. K
A1|A2

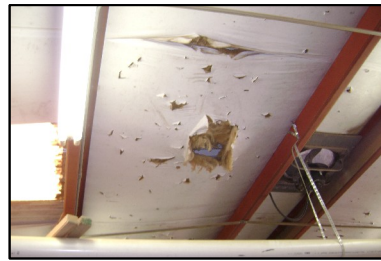
DAMAGED INTERIOR CEILING INSULATION
N.T.S. L
A1|A2

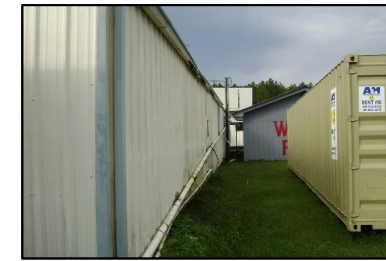
IMPROPER EXTERIOR DRAINAGE SYSTEM
N.T.S. M
A1|A2

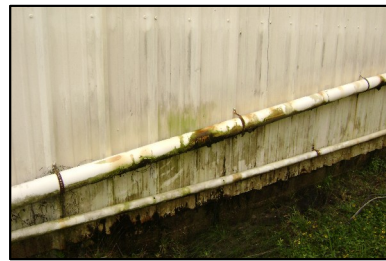
DAMAGED EXTERIOR WALL PANELS
N.T.S. N
A1|A2

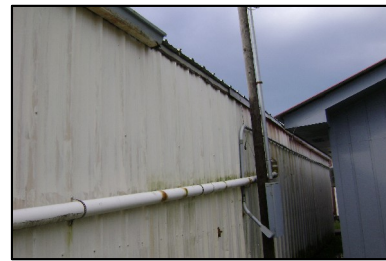
"CODE VIOLATION"
DRAINAGE OVER ELECTRICAL
N.T.S. P
A1|A2
