**BOARD OF COMMISSIONERS OF THE PORT OF NEW  
ORLEANS**

**ASBESTOS DAMAGE ASSESSMENT  
MECHANICAL EQUIPMENT CO. INC.  
(MECO)**

**3855 FRANCE ROAD  
NEW ORLEANS, LOUISIANA**

**APRIL 2008**

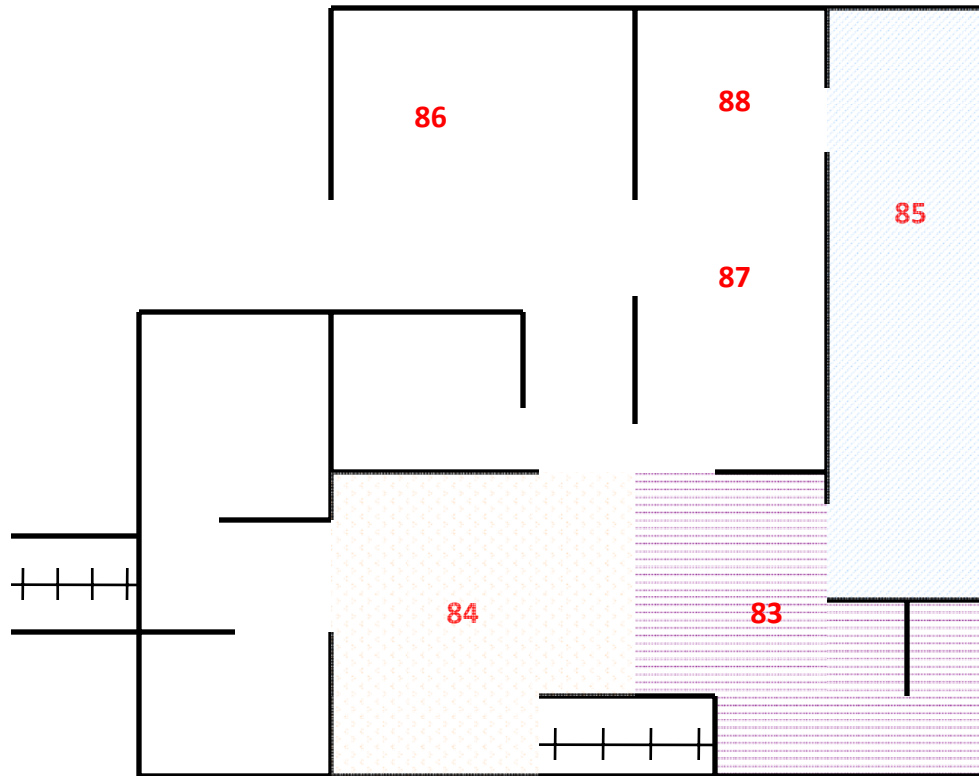
Mechanical Equipment Co.  
Building 1 First Floor  
Site Plan  
Orleans Parish, Louisiana

red numbers  
indicate sample  
locations

White Tile	Yellow Tile	Gray Tile
------------	-------------	-----------

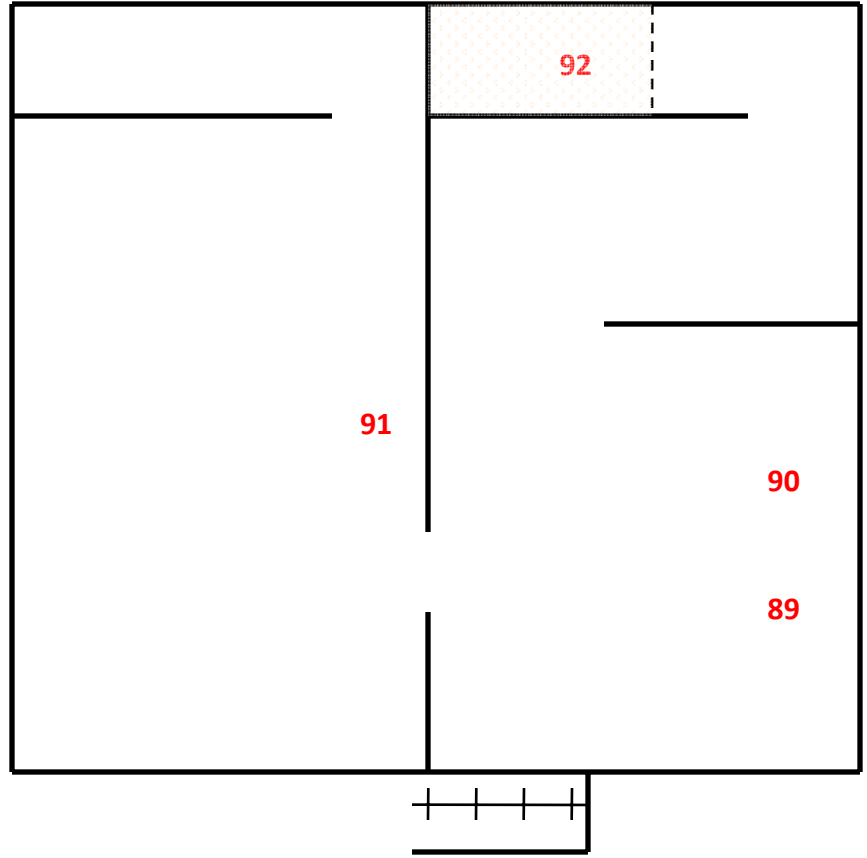
Mechanical Equipment Co.  
Building 1 Second Floor  
Site Plan  
Orleans Parish, Louisiana

red numbers  
indicate sample  
locations

Tan / Gray  
Tile
