**Attachment 2**

**UP-DATED  
PHOTOGRAPH  
DESCRIPTIONS  
2-15-08**

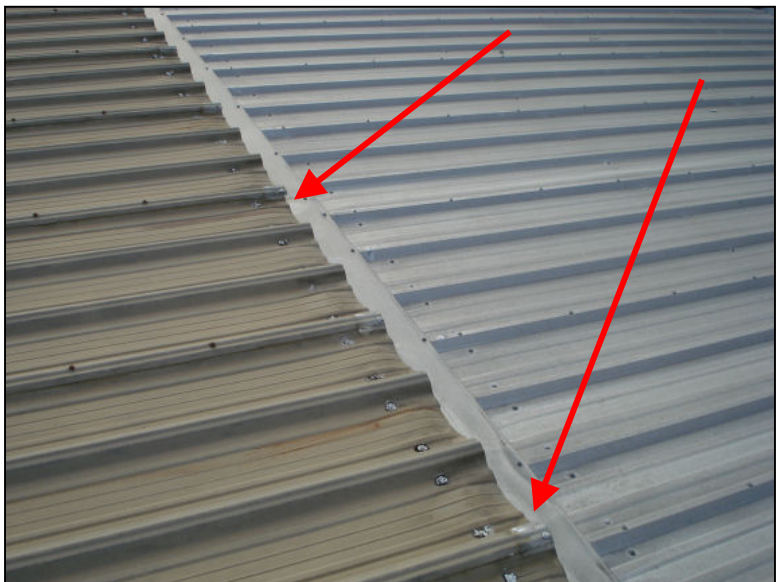
3. Damaged edge.

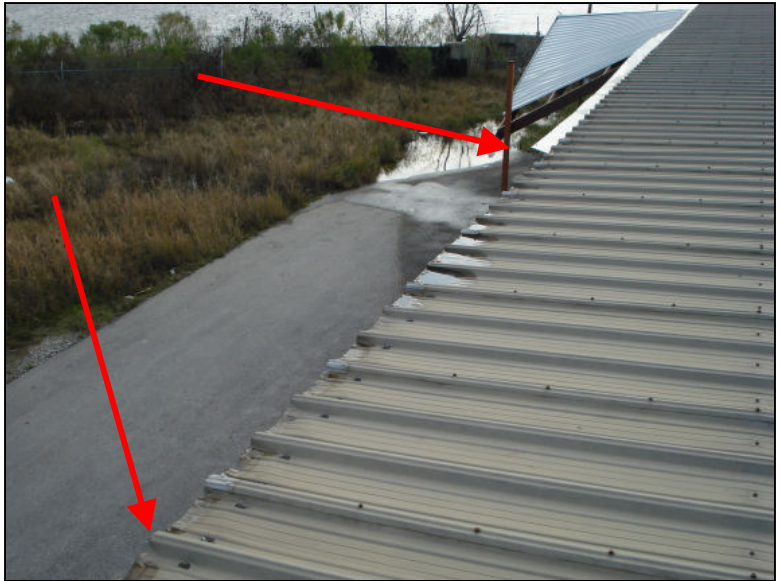
- 4. Missing gutter and eve trim.

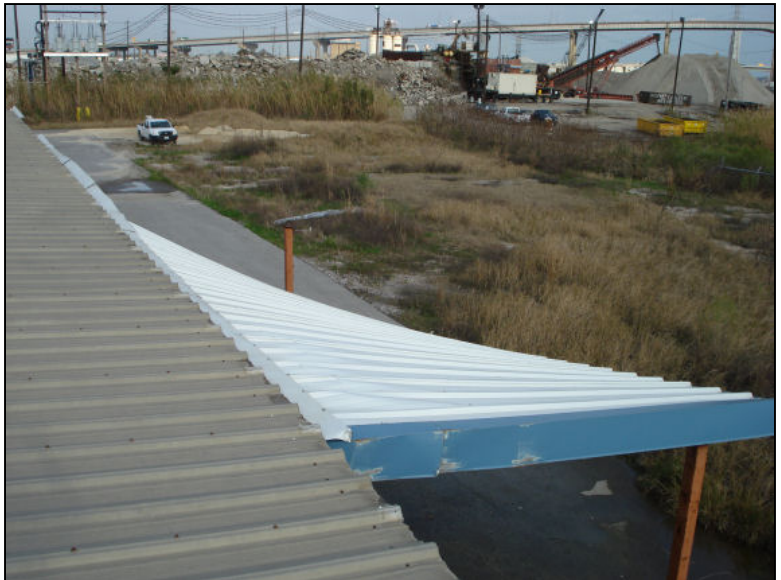
- 5. Damaged canopy collapsing.

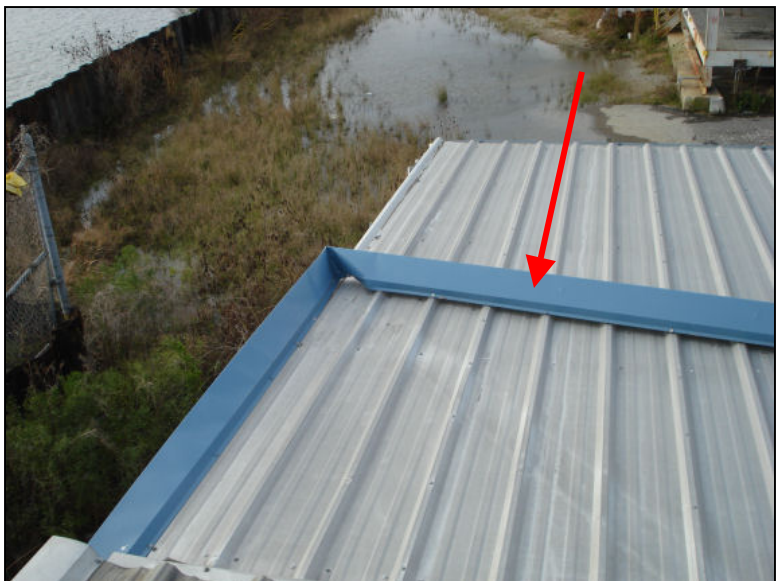
- 6. Detached eave trim.

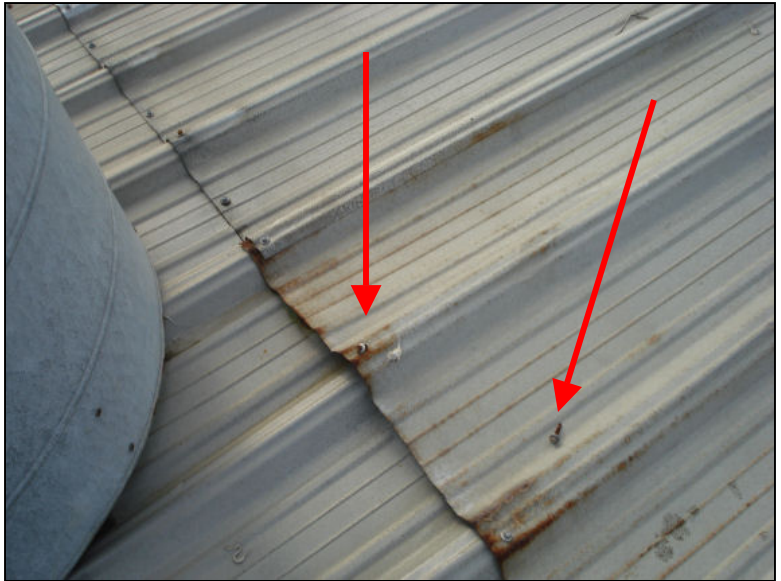
7. Lifted panel fasteners pulled out.
