**Attachment 2**

**UP-DATED  
PHOTOGRAPH  
DESCRIPTIONS  
2-15-08**

1. Meco building 2.

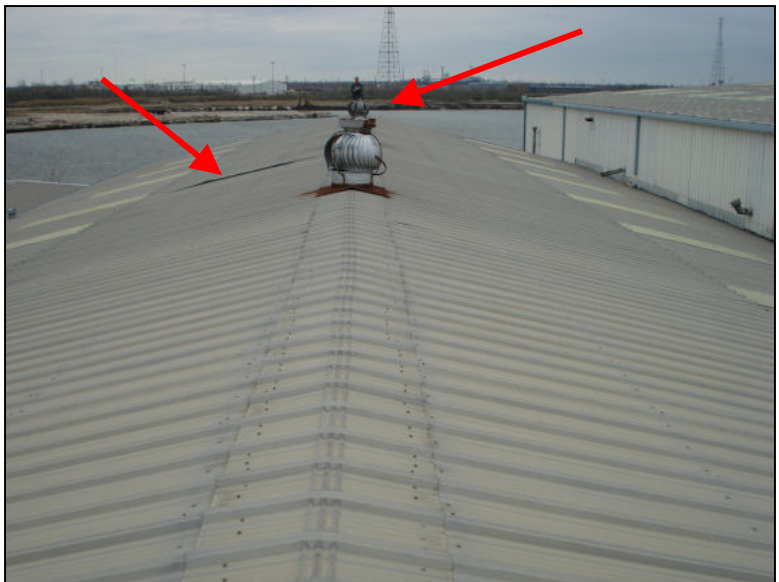
2. Lifted also damaged vent.

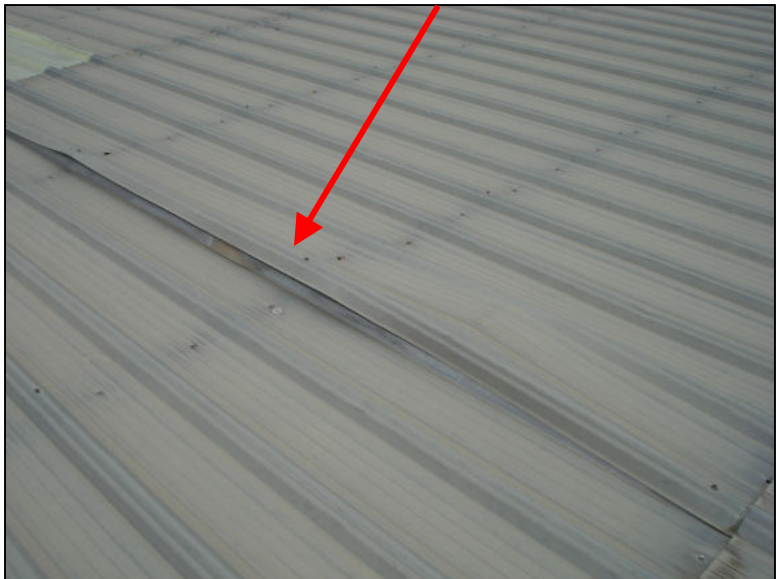
3. Buckled.

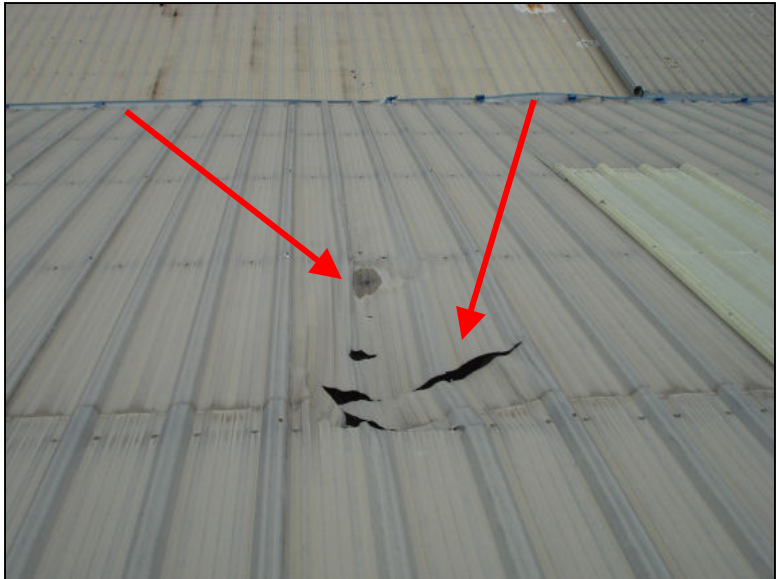
- 4. Buckled and torn by flying debris.

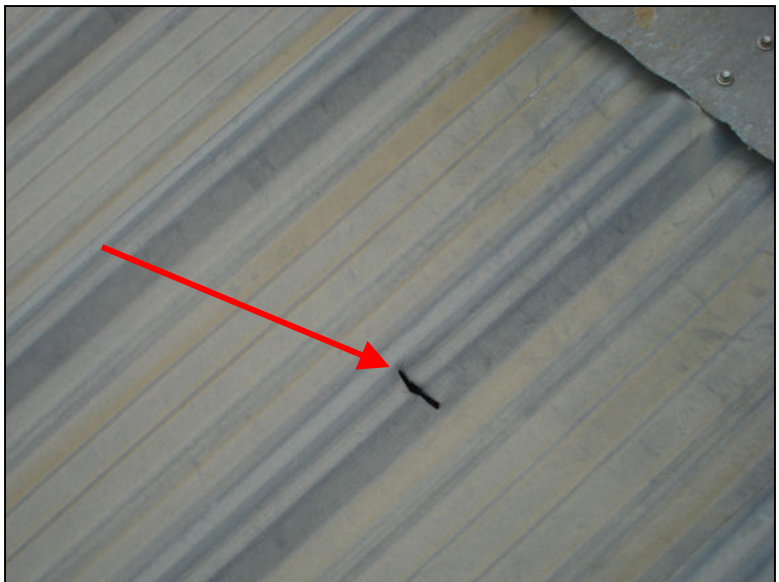
- 5. Hole from flying debris.

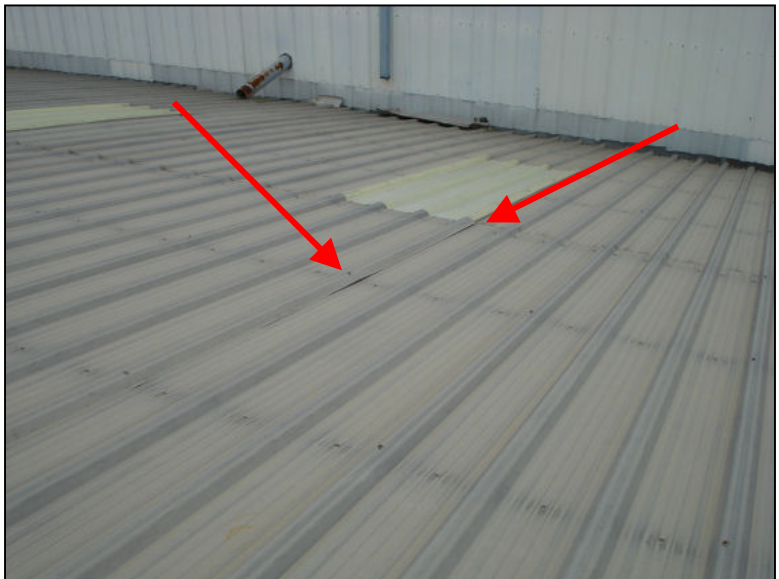
- 6. Buckled.

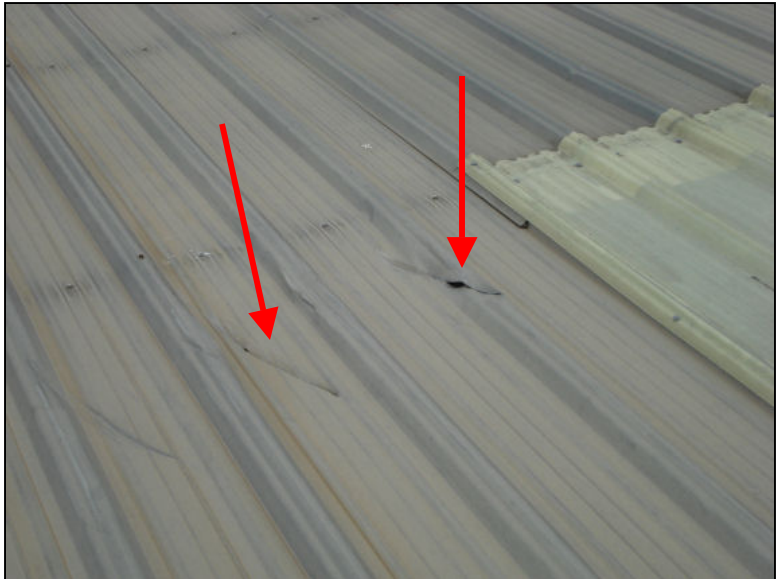
7. Dented and torn from flying debris.

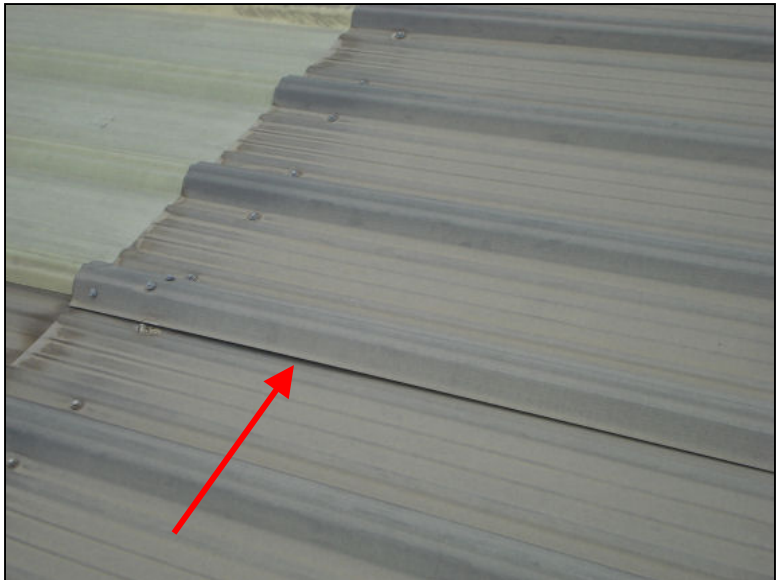
8. Lifted.

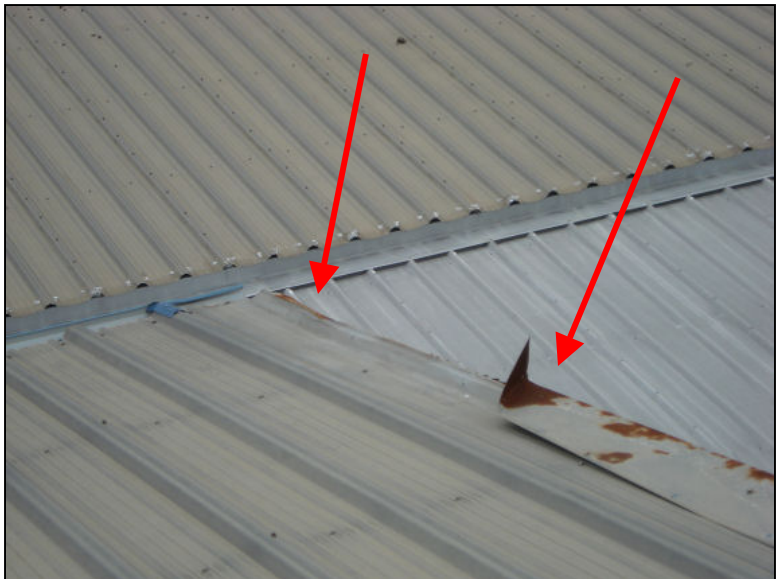
9. Buckled and missing rake trim.

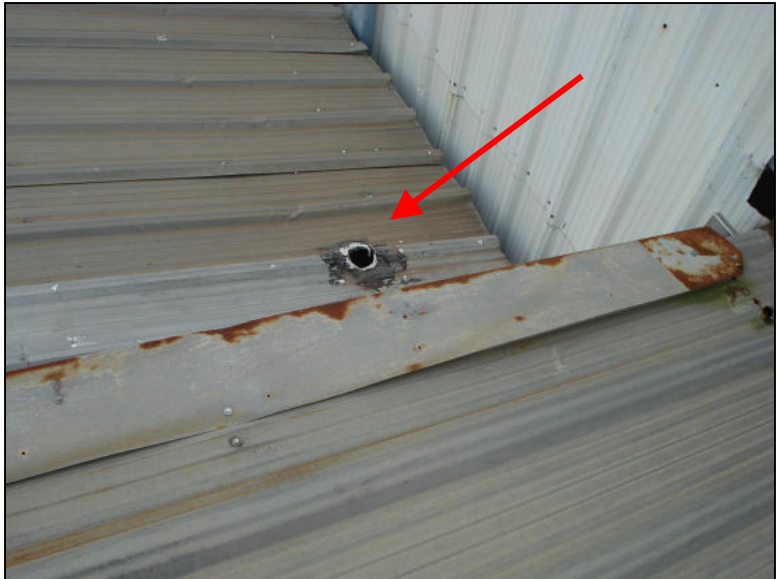
10. Vent pipe broken off flush with roof.

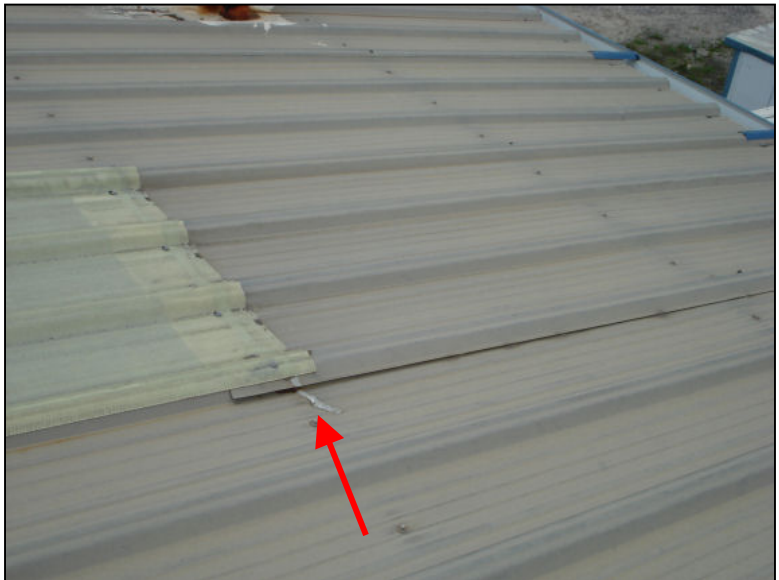
11. Lifted.

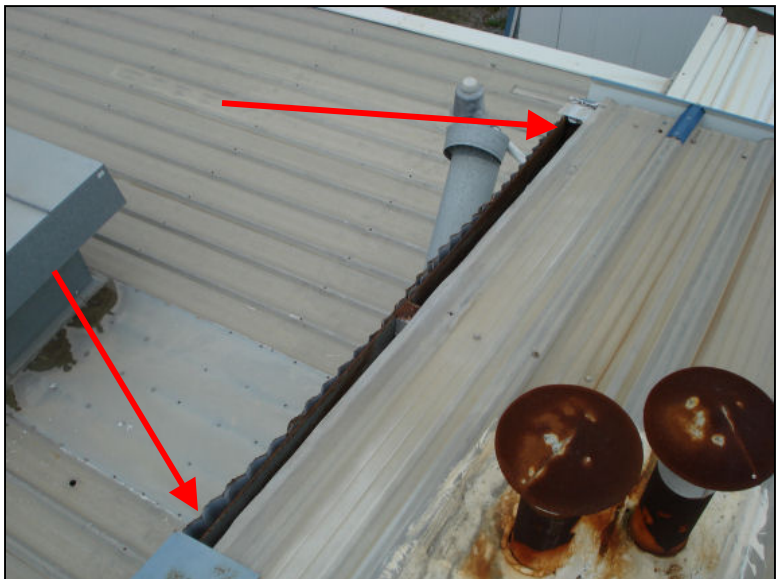
13. Rake trim missing.

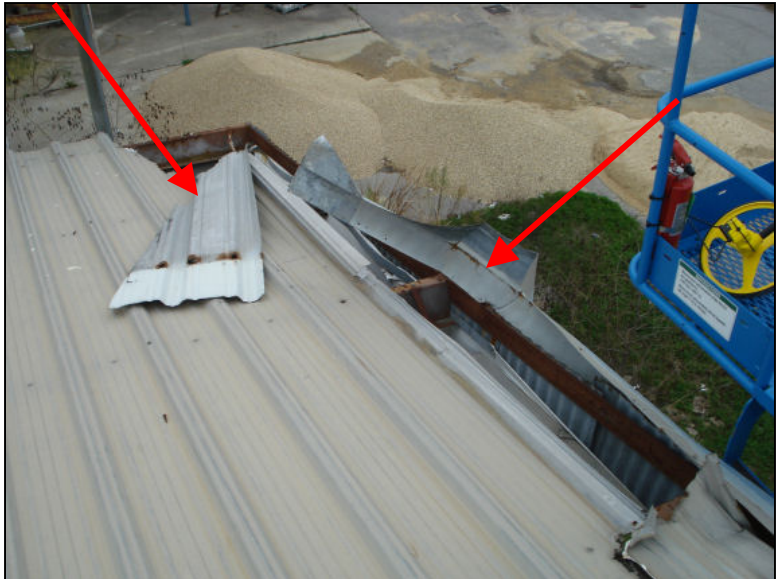
14. Lifted and buckled.

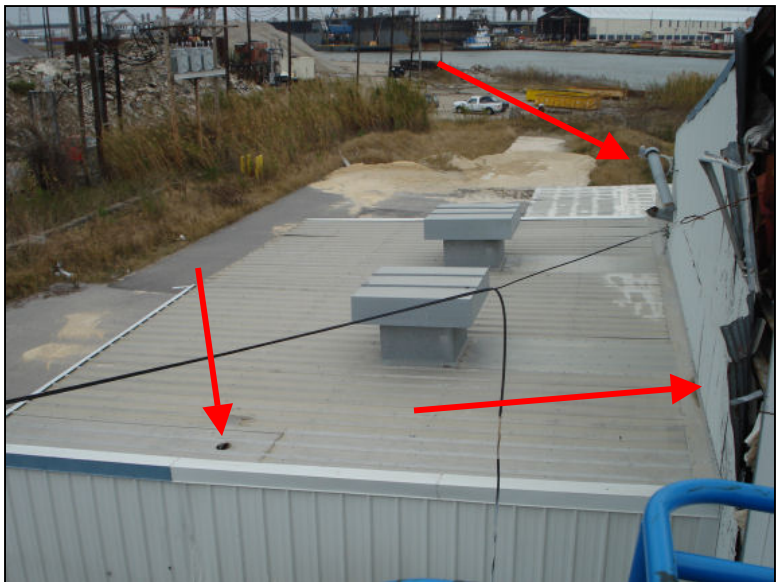
15. Missing and detached vents also damaged side panels.

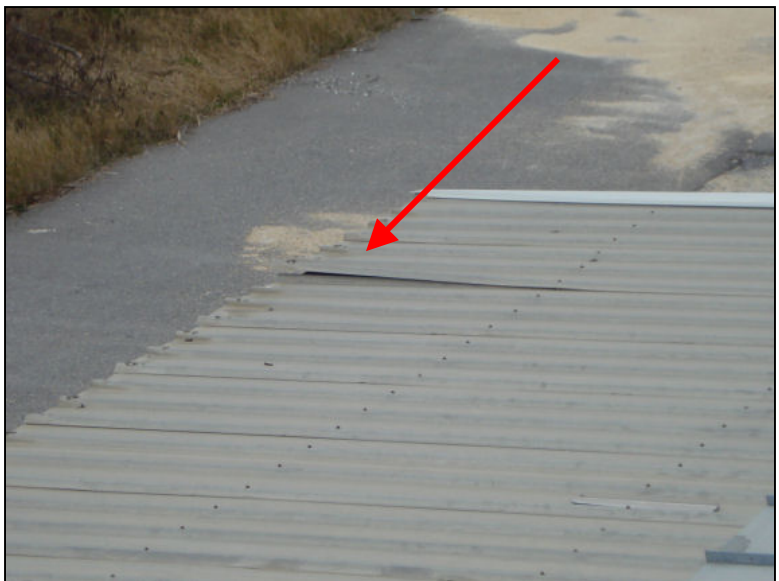
16. Lifted.

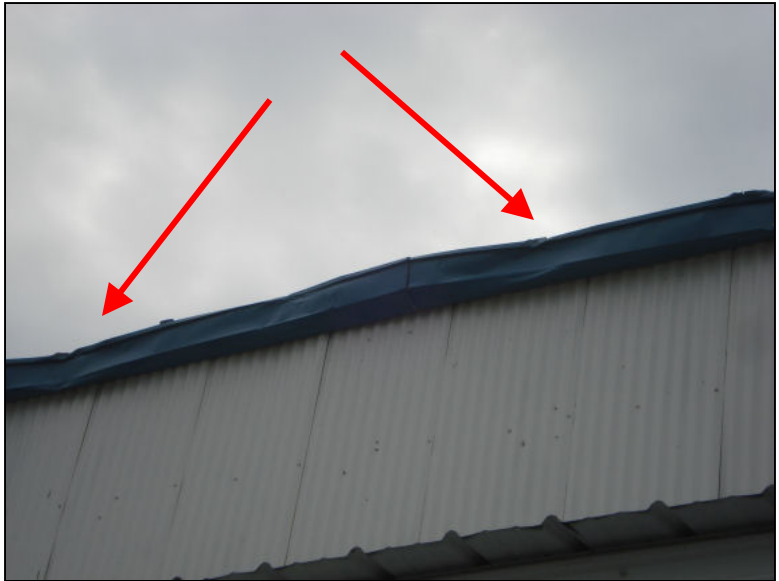
17. Damaged gutter.

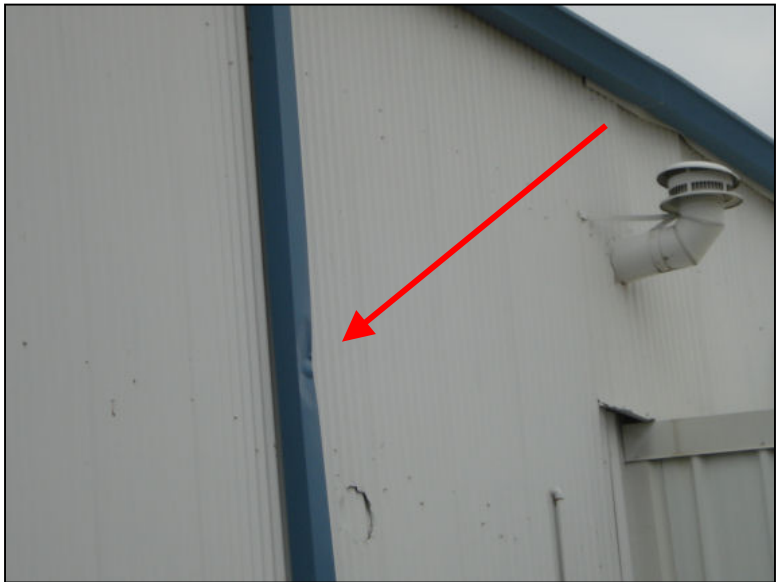
18. Damaged down spout.

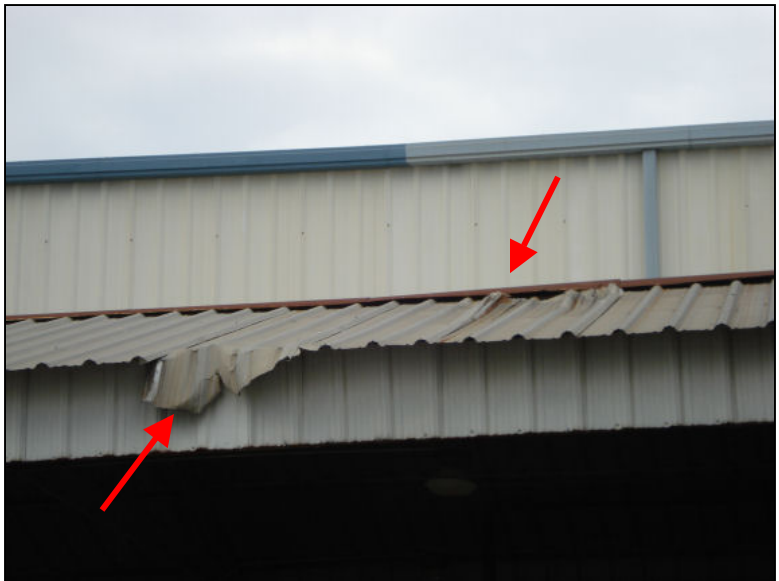
19. Buckled and torn.
