Attachment 2

**UP-DATED
PHOTOGRAPH
DESCRIPTIONS
2-15-08**

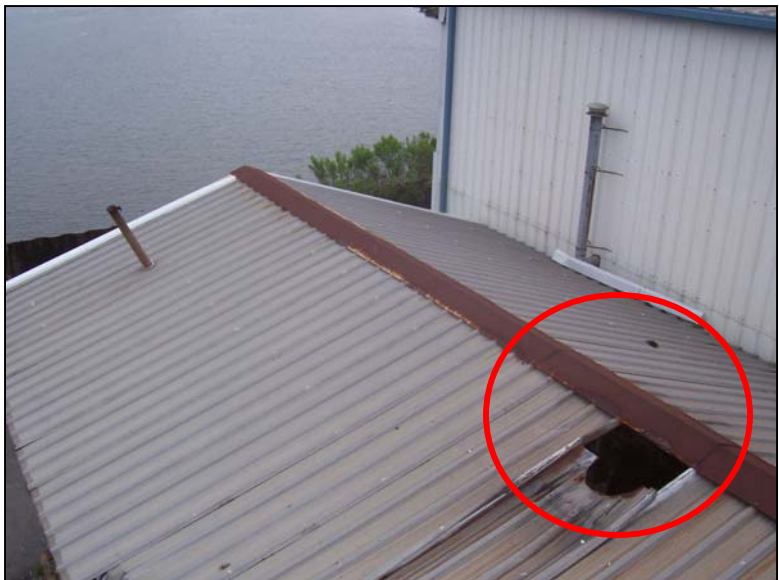
2. Overview damaged roof.

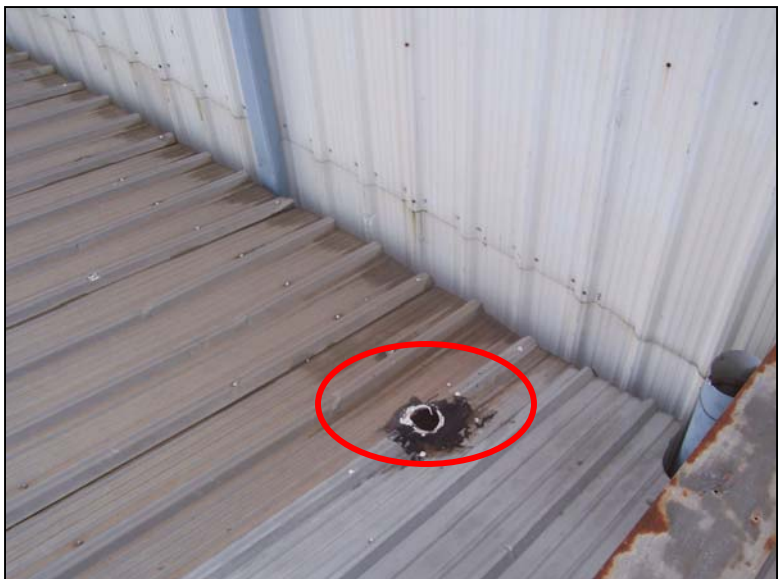
3. Damaged vent.

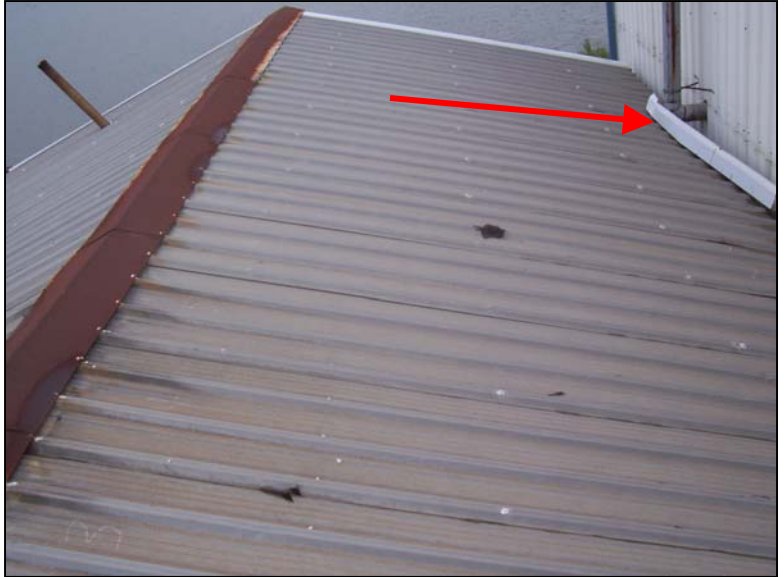
4. Overview of loose downspout lying on roof.
