CONDITION SURVEY  
OF  
**ST. TAMMANY PARISH GOVERNMENT  
BUILDING**

520 OLD SPANISH TRAIL  
SLIDELL, LA 70458

MARCH 12, 2012

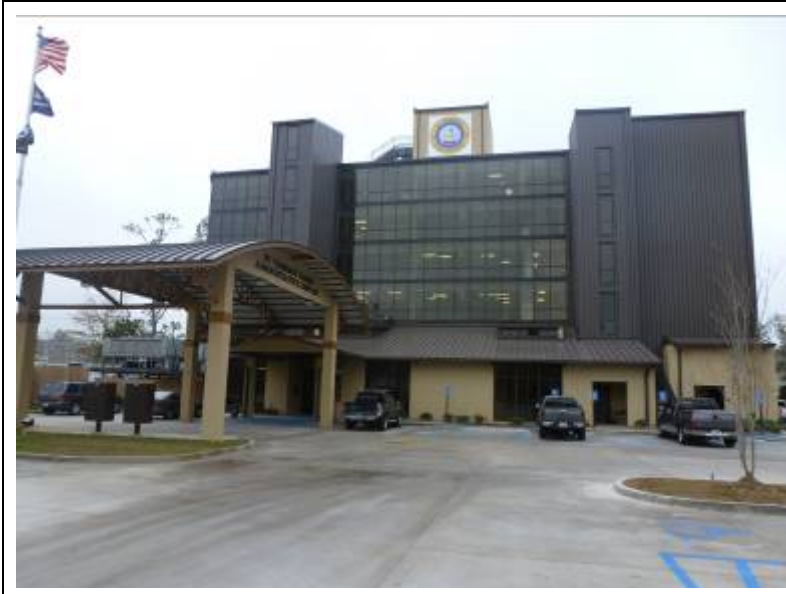
Office Tower

This photo shows the St. Tammany Parish Administration Office Tower.

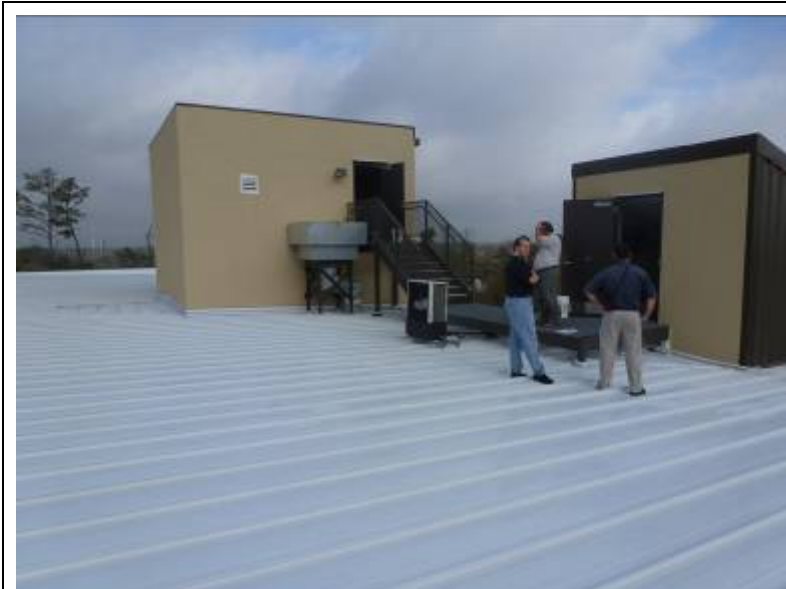
Office Tower Upper Main Roof Area.

This photo shows an overall view of the upper main roof area being surveyed.

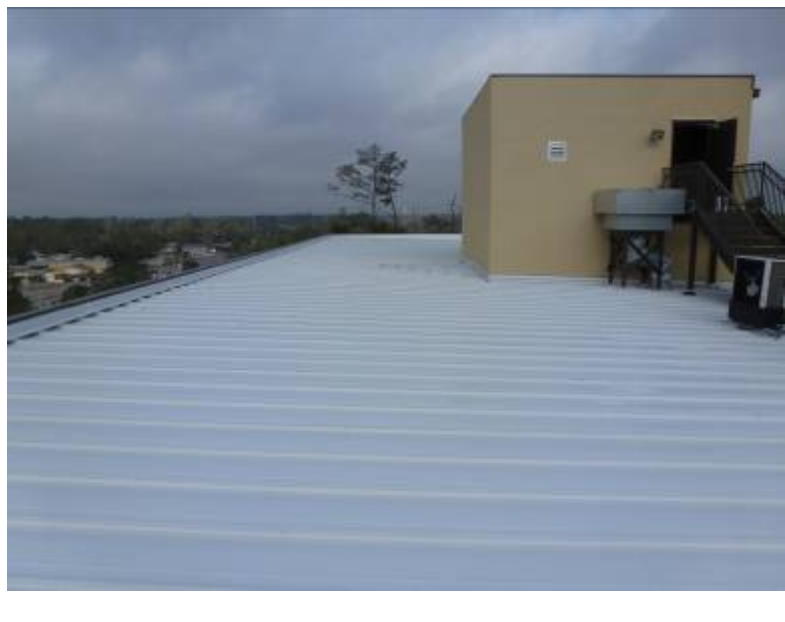
<p><b><u>Item No. 002:</u></b></p> <p><b><u>Comments:</u></b> Additional view of 6<sup>th</sup> floor area.</p>
---	---

**Additional Comments:** Roof panels are 24 ga. not 16 ga. as shown on drawings.

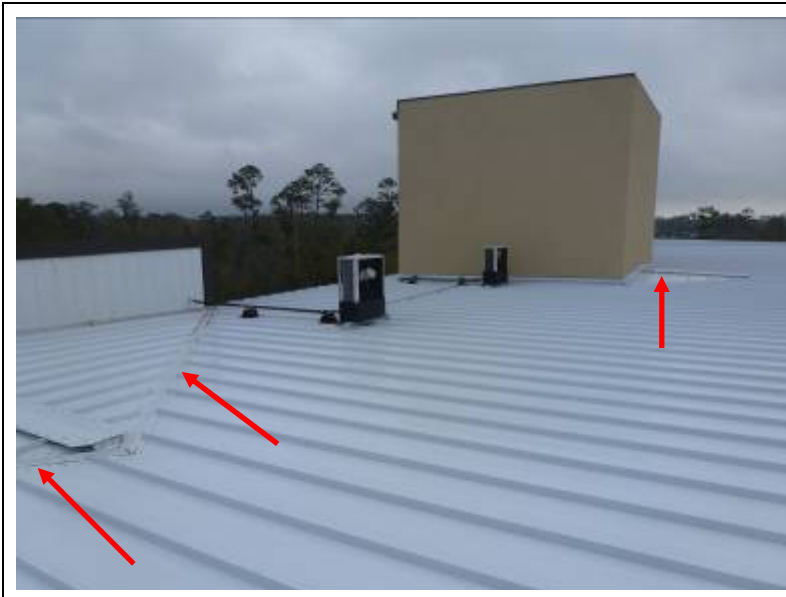
**Item No. 003:**

Additional view of 6<sup>th</sup> floor area. Leaks are occurring at valley lines indicated by arrows. The valleys were installed incorrectly.

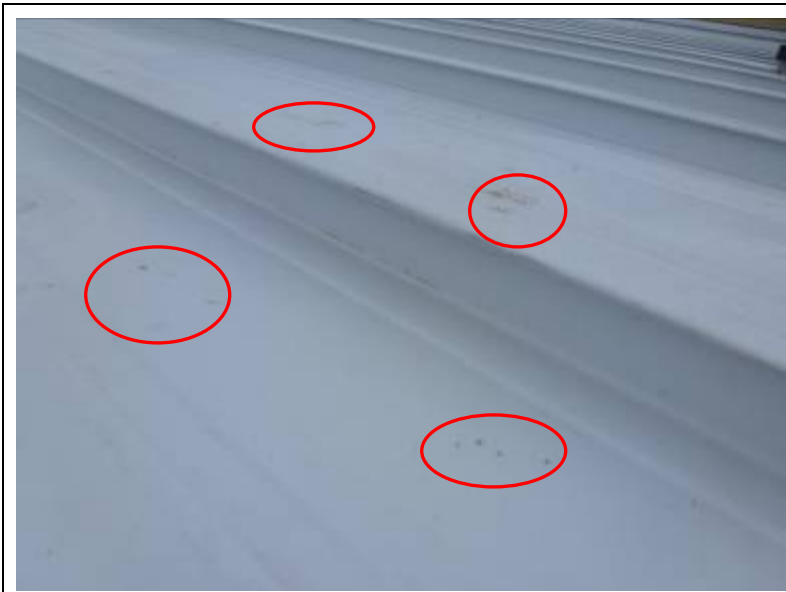
**Item No. 004:**

Upon inspection numerous areas of the metal roof panels were damage and painted over by Gebhard Enterprises. The specified panels "Kynar" carries a twenty year paint finish warranty. Once painted over the owner no longer has the paint finish warranty (See Photo's).

Numerous areas of the Kynar roof panels were damaged. Gebhard painted over the damaged panel with regular paint which voids the manufacturer's 20-Year finish warranty. Areas of rust are reappearing. These areas are to numerous to count.

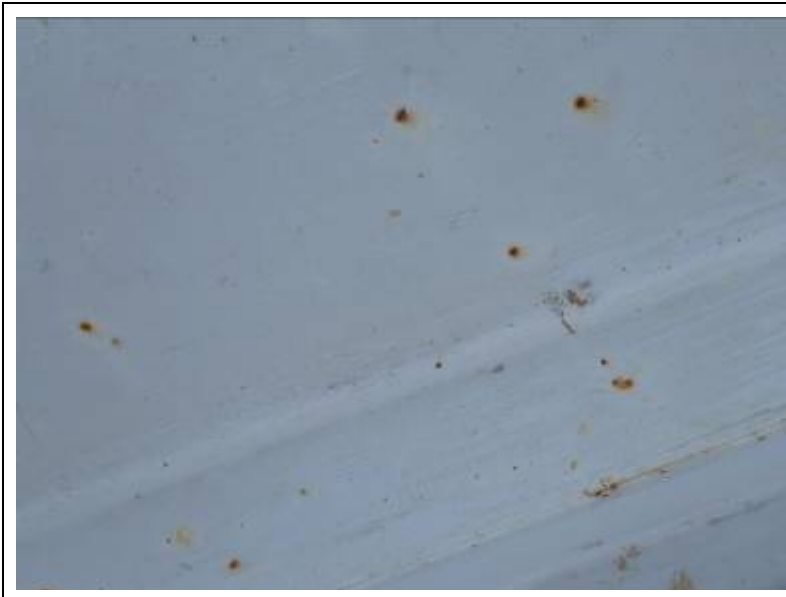
**Item No. 005:**

Additional photo showing rust reappearing thru the paint.

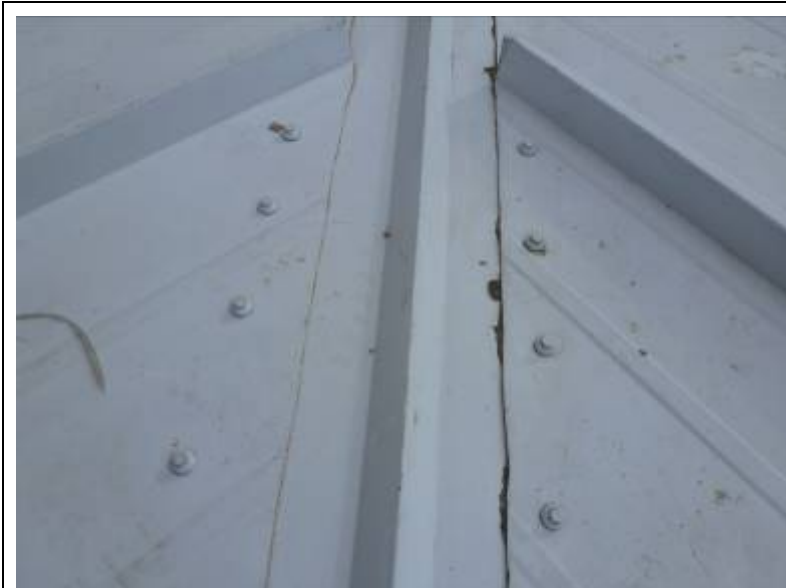
**Item No. 006:**

All valleys were improperly installed and are leaking. Insulation below these valley lines is saturated from the leaks. Wet insulation loses its R-Value. The insulation should be replaced during panel replacement.

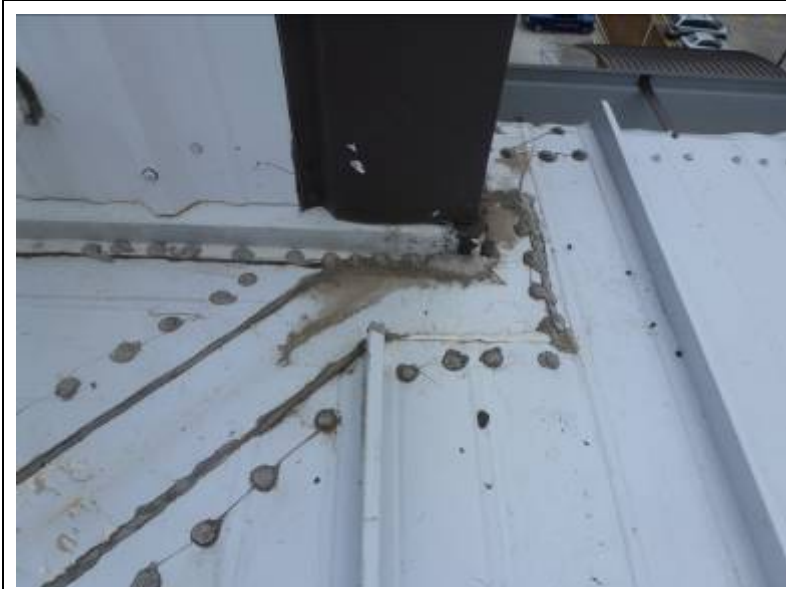
**Item No. 007:**

The roof panels were cut along the valley line and face attached with neoprene headed self tapping screws. The neoprene deteriorates by the UV and often leak and back out. Caulking was installed at valley lines to help stop the leaks. Caulking is a temporary repair and a maintenance issue. Caulk should not be face installed.

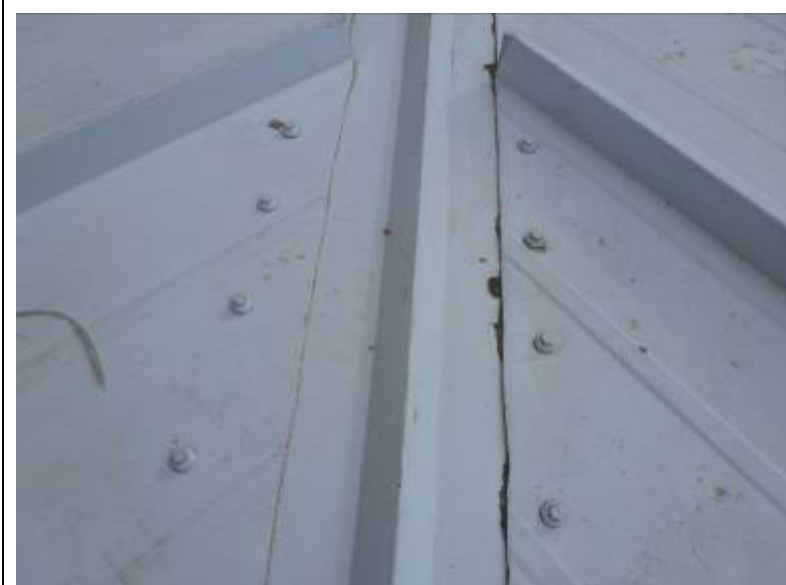
**Item No. 008:**

The end of the panels should be turned under (Hemmed) and clipped into a Ziggle cleat in lieu of face fastening. Raw edges of the cut panel are rusting.

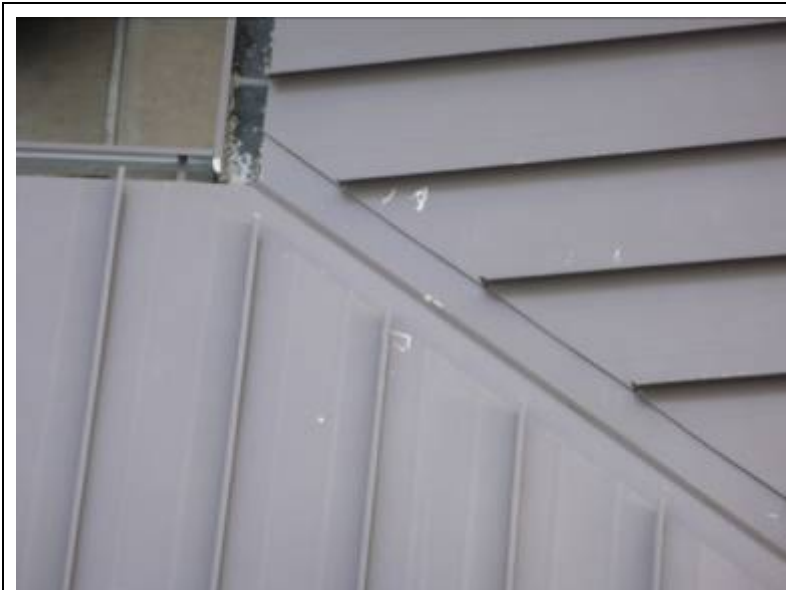
**Item No. 009:**

Photograph of the lower roof areas installed by another roofing contractor. Notice no face installed fasteners at the valley lines, and no caulking.

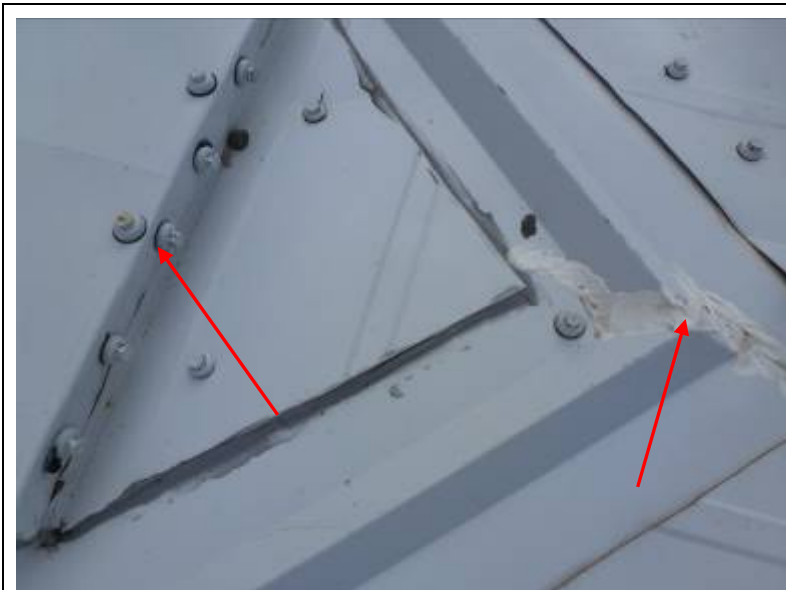
**Item No. 010:**

Hip and Ridge caps were face fastened in lieu of hemming under and attaching to a clip.

Caulking face installed to stop leaks.

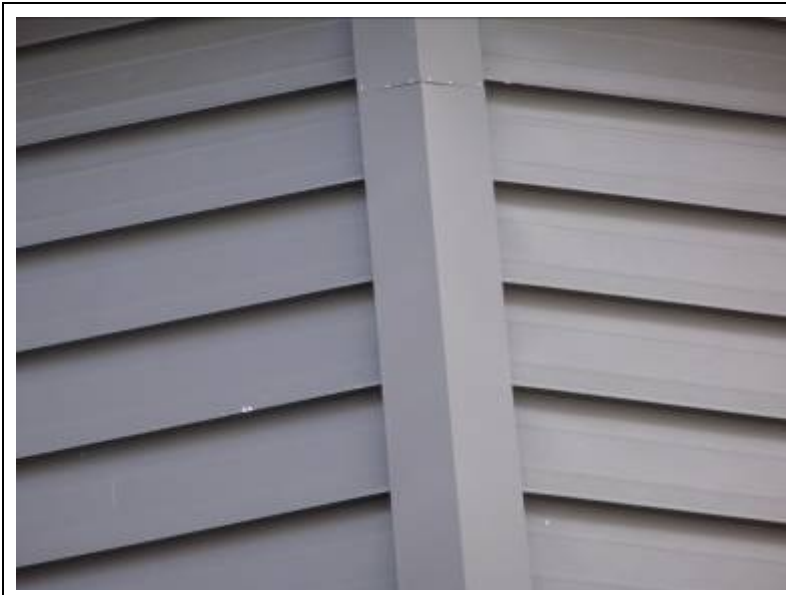
**Item No. 011:**

Photo of ridge caps properly installed at the lower roof areas installed by another roofing subcontractor. Notice no exposed fasteners.

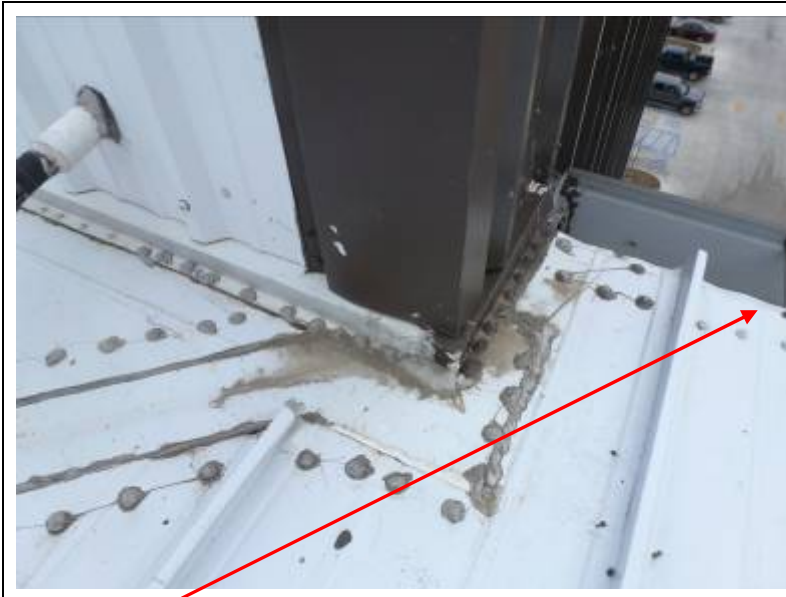
**Item No. 012:**

Sub framing was installed so that the valley lines run into the penthouse. The valleys should be framed where water does not run directly into the side of the building. They should be reframed to drain to the outside of the wall. Center line of the valley should be located at the arrow.

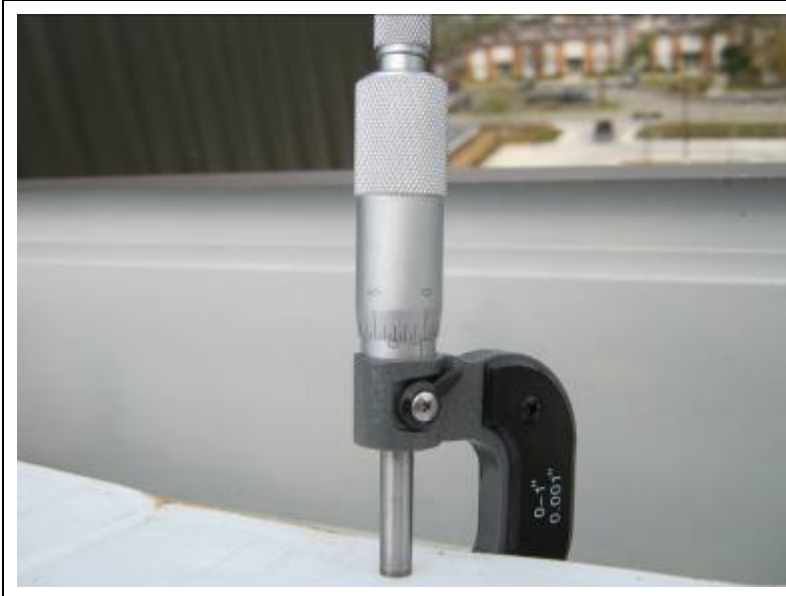
**Item No. 013:**

After review of Damon engineering's drawings and specifications, CDC found that the product both submitted and installed by Gebhard Enterprises on the upper main roof areas to be the wrong product. The drawings indicate that the metal panels be 16ga. Steel (Ref. Detail A-S6). The product installed was 24ga. The submitted product data sheets were stamped and signed as approved for general confirmation by Damon engineering on March 13<sup>th</sup>, 2008.

Panels were checked for the proper gauge. The panels are 24 ga. and the drawings indicate a much heavier 16ga. panel. This is not the specified panel.

In closing CDC recommends that the entire framing assembly be evaluated and engineering performed to ensure code compliance. We also recommend the entire roof panels, valleys, copings, and counter flashings be totally removed and replaced with a new tested and approved system. The material gauge should be increased as specified. The system in place is not what the owner paid for.

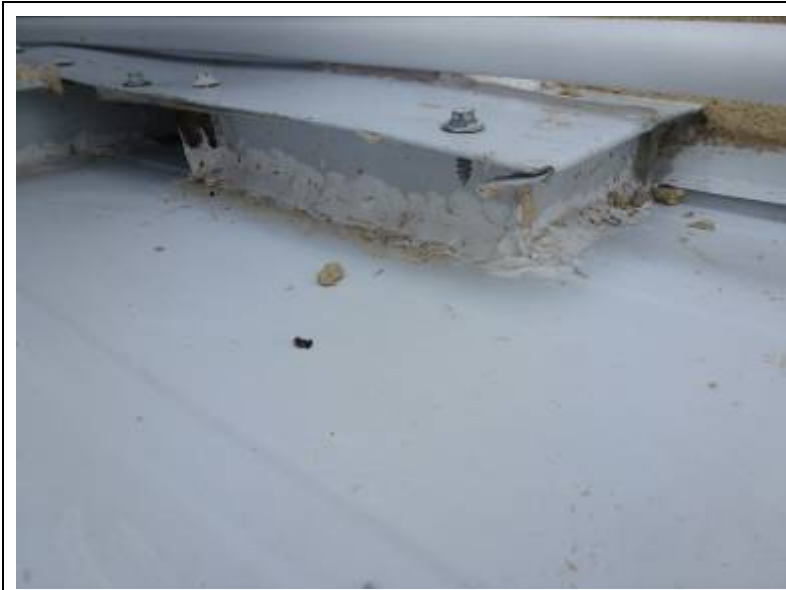
**Item No. 014:**

Caulking was installed at various transitions where leaking has occurred. These areas should be properly flashed with metal not caulking.

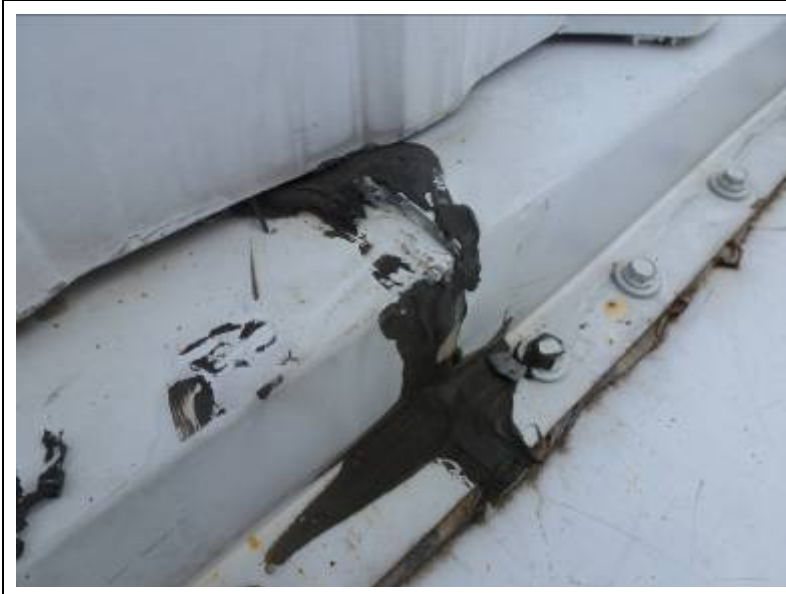
**Item No. 015:**

Counter flashings were installed backwards with the end lap bucking water. Roof mastic was used to help temporarily stop leaks. Counterflashing were also face screwed.

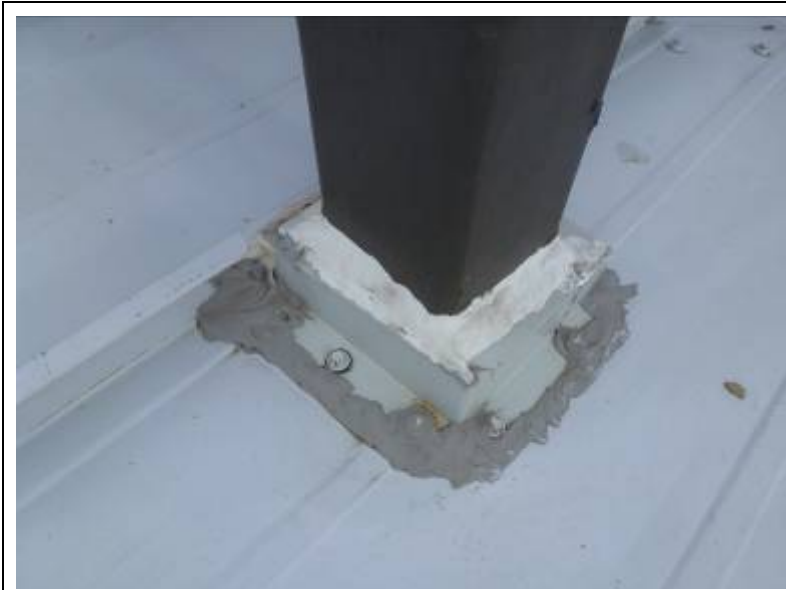
**Item No. 016:**

Posts had pitch pans installed in lieu of fabricated metal flashings. Caulk was smeared around these pitch pans to stop leaks.

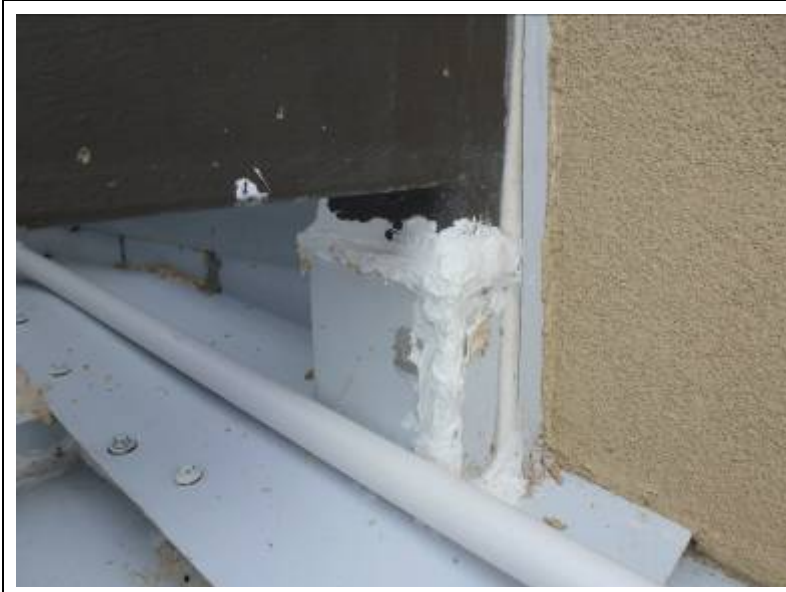
**Item No. 017:**

Caulk used to stop leaks in various areas where metal fabrications were not watertight.

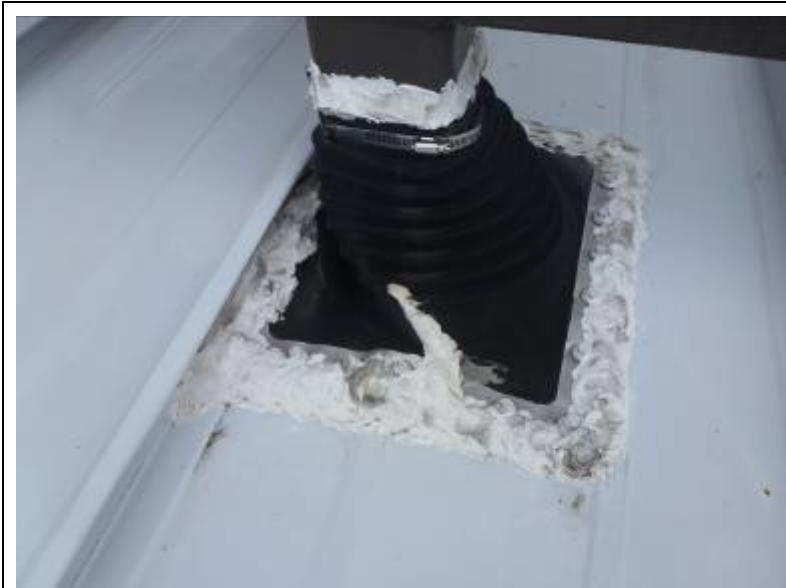
**Item No. 018:**

Caulking installed to stop leaks at several penetrations.

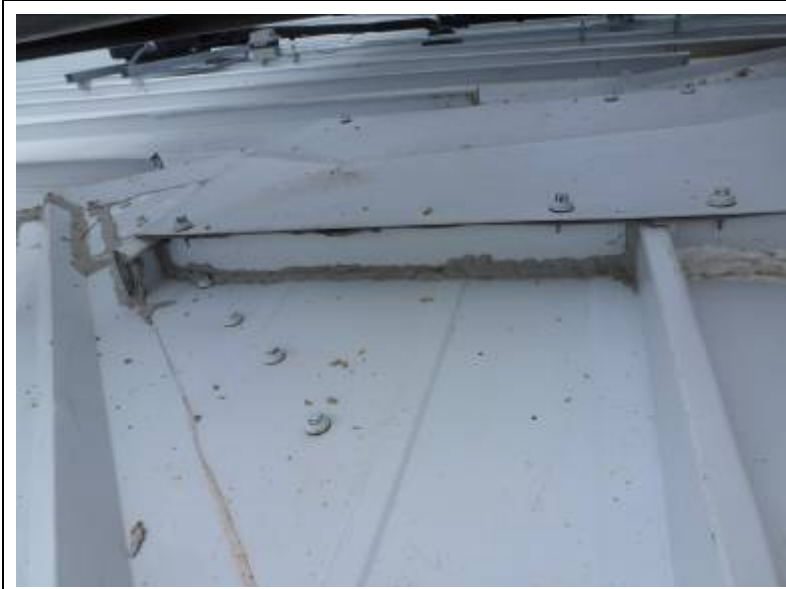
**Item No. 019:**

Caulking applied at valleys and hips and ridges. No caulking should be needed on the face of terminations if properly fabricated and installed. Caulk is temporary and deteriorates in contact with UV. Caulking is a regular maintenance item. If properly installed the owner would not have this maintenance issue.

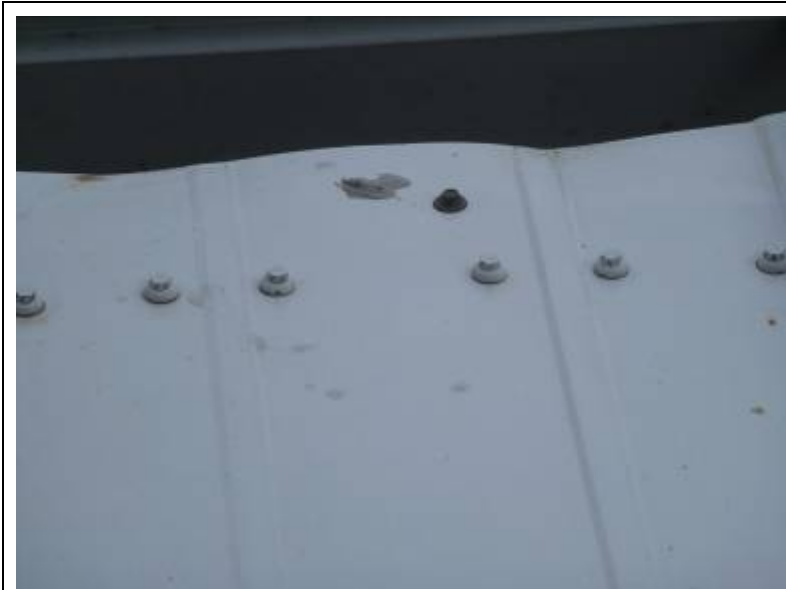
**Item No. 020:**

The eaves of the metal panels were face fastened as well. The panels should be hemmed under and clipped on to a Ziggle strip and not face fastened. The panels are bowed at the ends and susceptible to leaks.

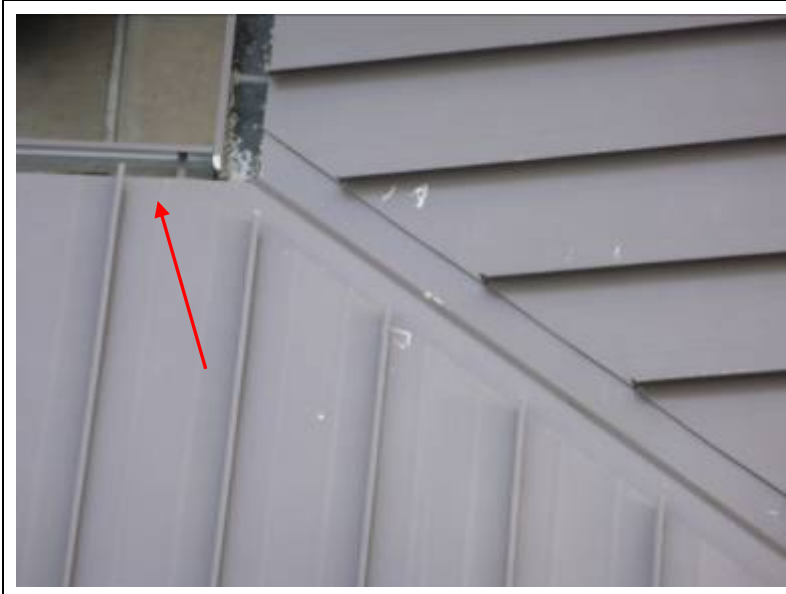
**Item No. 021:**

Photo of lower roof properly installed where the end of the panel folds under and clips into place. No exposed fasteners.

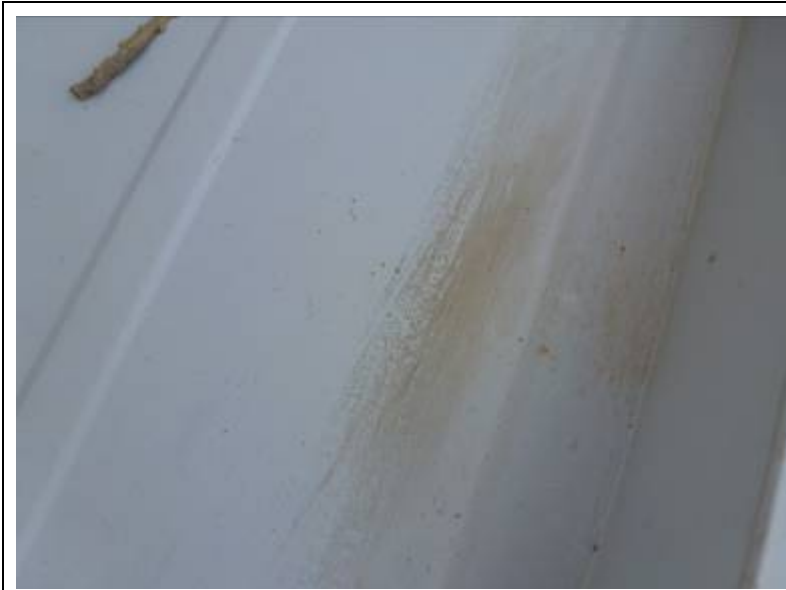
**Item No. 022:**

Area where paint installed to repair damaged panels is deteriorating.

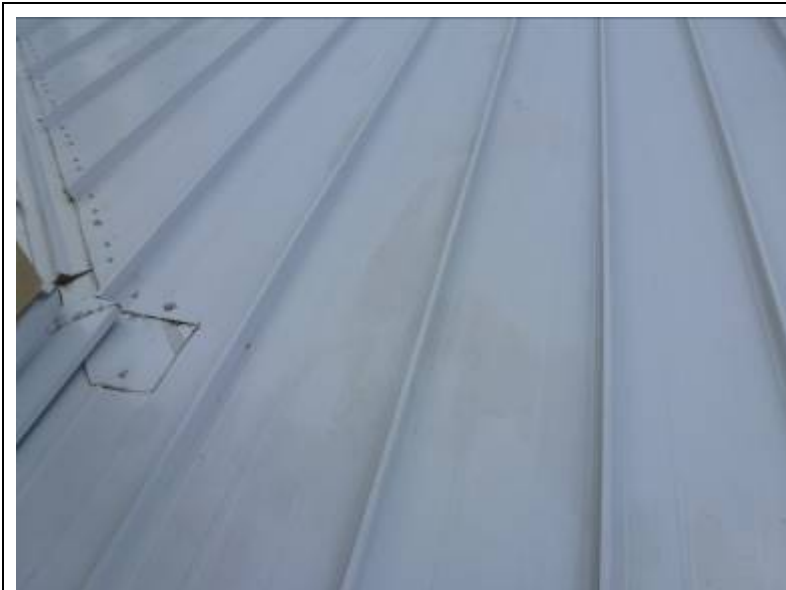
**Item No. 023:**

View of large areas of repainted panels.

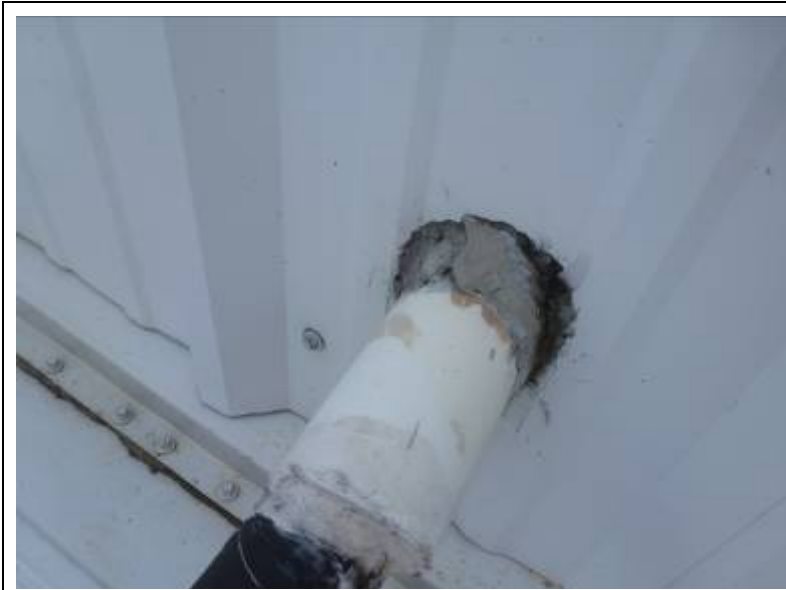
**Item No. 024:**

Pipe penetration thru side of penthouse open where caulk has failed.

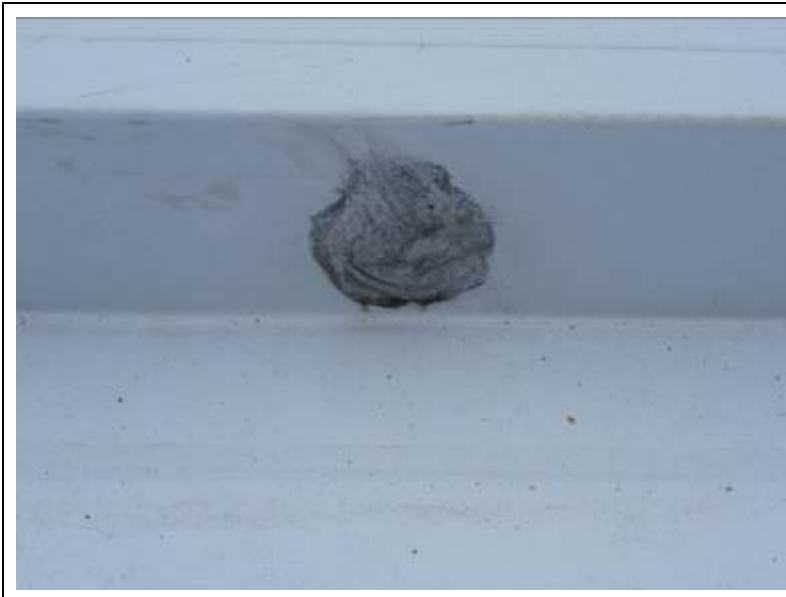
**Item No. 025:**

Caulking installed where holes penetrated metal panels.

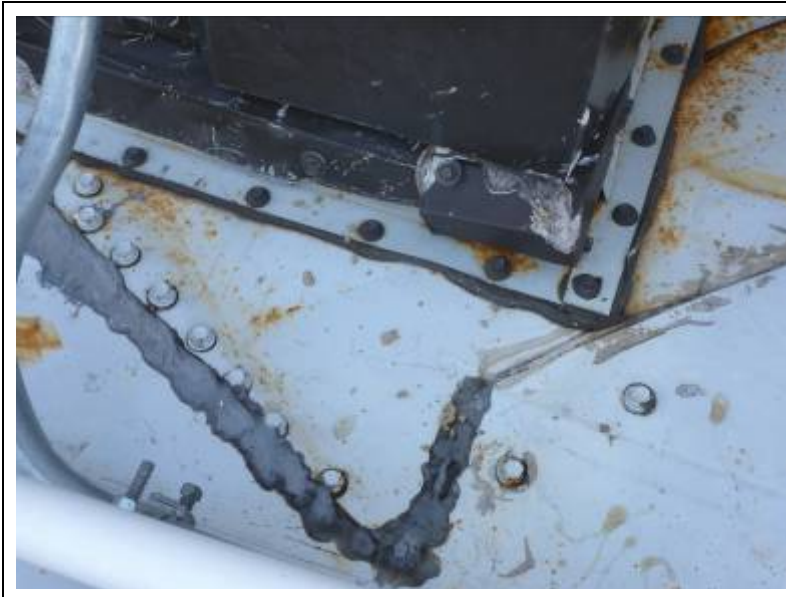
**Item No. 026:**

Caulking installed to stop leaks at exposed panel edges. Also shows more damage to paint finish voiding warranty.
