Peace of Mind Inspections, LLC
10212 Sagefield Drive
Central, Louisiana 70818

503 Driftwood Circle
Slidell, Louisiana 70458

Date: 11-3-2014

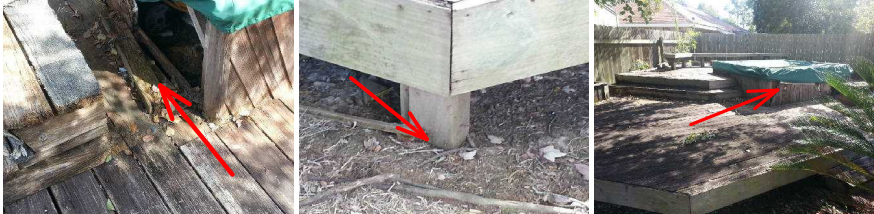
Defective Deck: Treated wood Hot tub did not appear operable, not inspected. The deck area appears to have visible rot present. Wood to earth contact may allow moisture wicking and pest intrusion. Recommend having a licensed contractor evaluate and repair as required.

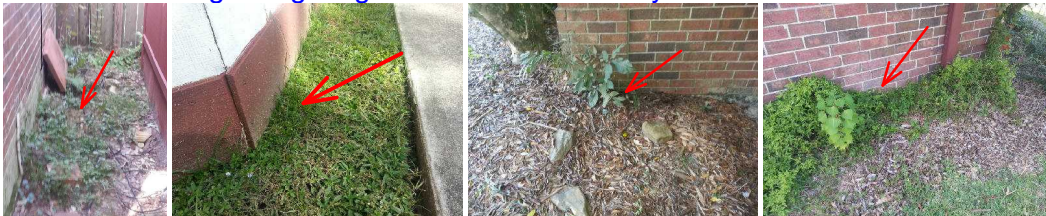
Marginal Grading: Flat, Minor slope Flat areas of grading may hold water near foundation. Dirt grade around foundation too high, should be 4" concrete visible under brick. Have a licensed contractor evaluate and correct the grading height to divert water away from structure.

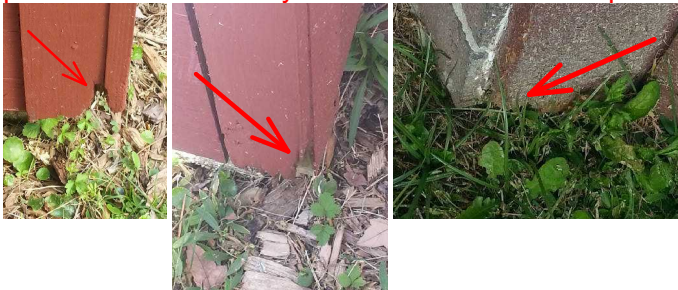
Defective Trim: Wood Appears wood rot is present. Exposed wood at bottom of trim may allow moisture wicking and possible wood rot. All corners, cracks, gaps, joints and openings should be sealed to prevent moisture entry. Have evaluated and repaired by a licensed contractor.

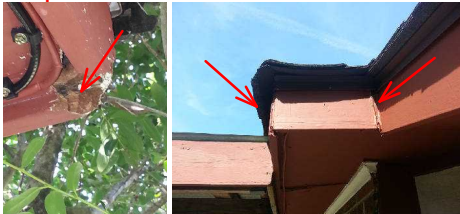
Defective Fascia: Wood All joints and gaps should be sealed to prevent moisture entry. Appears wood rot may be present. A licensed contractor is recommended to evaluate and repair

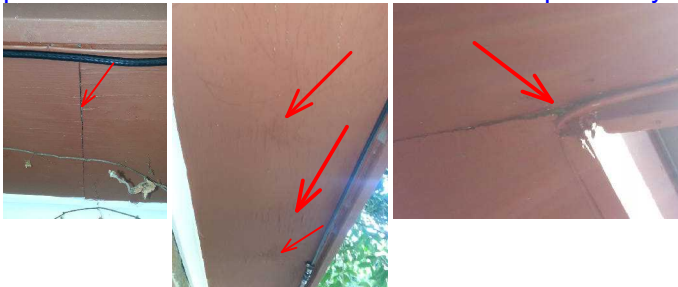
Marginal Soffits: Vented, Wood All corners, cracks, gaps, joints and openings should be sealed to prevent moisture entry. There appear to be areas where possible moisture intrusion has occurred, appeared dry at time of inspection. Paint is a periodical maintenance item that may prevent moisture entry and possible wood rot. Have evaluated and repaired by a licensed contractor.

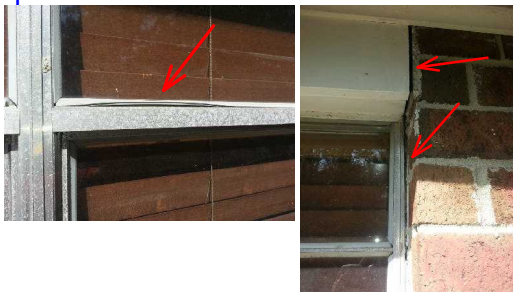
Acceptable Marginal Patio Door: Metal, French, with door lites
Windows: Aluminum slider **Sealant around exterior of all windows is required to prevent moisture entry (periodical maintenance item). Appears glazing is deteriorating around window panes. A qualified contractor is recommended to evaluate, seal or repair.**

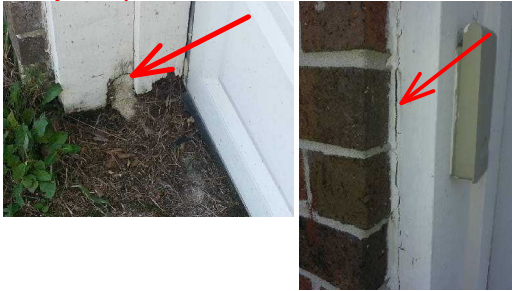
Defective Garage Doors: Metal **Garage door casing should have a gap below to prevent moisture from wicking into wood. Appears wood rot is present. Recommend sealing joint at door casing to prevent moisture entry. A qualified contractor is recommended to evaluate and repair.**

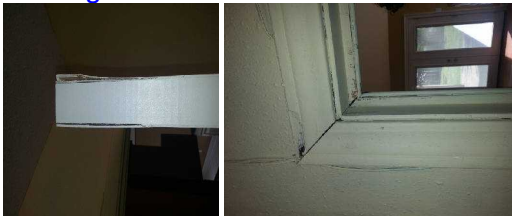
Service Doors: Solid wood **Surface laminate appears peeling. Door does not appear secure in framing. A licensed contractor is recommended to evaluate and repair**

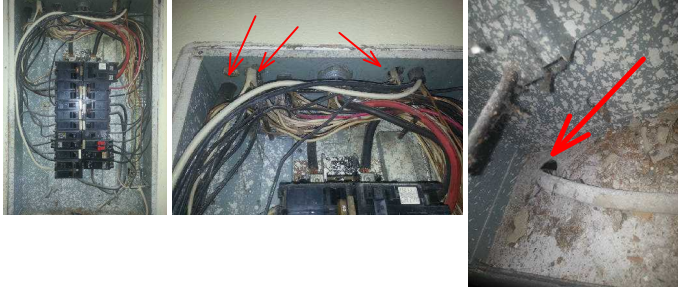
Defective Manufacturer: Gould Improper/ missing cover screws. No connector at wiring entry, allows pest intrusion or possible short circuit. Evaluation by a licensed electrician is recommended

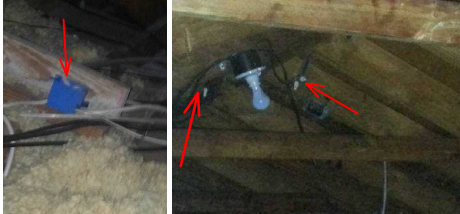
Defective Wiring/Lighting: 110 VAC, 110 VAC lighting circuit, 220V for mechanical equipment **Open junction boxes require covers to fully protect wiring. Exposed wire splices, should be spliced in an approved electrical junction box. No light bulb protection, accidental breakage may cause injury/ electrical shock. Evaluation by a licensed electrician is recommended**

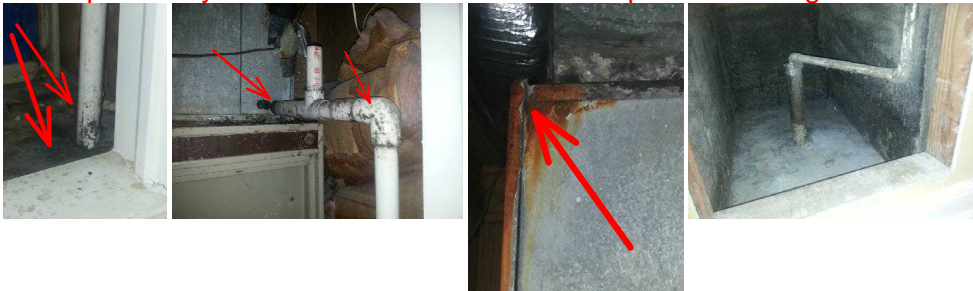
Defective Condensate Removal: PVC **Condensate drain line should be insulated from unit to trap to prevent leakage. Does not appear to have a float switch present. Recommend adding drain pan to prevent condensate leakage. Rust appears present on evaporator coil. Have cleaned, serviced, evaluated and repaired by a licensed HVAC technician to prevent leakage**

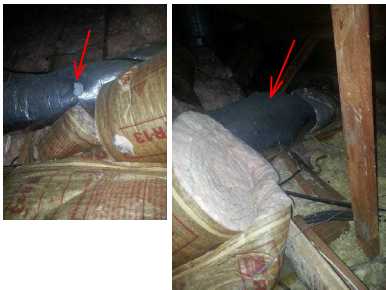
Defective Distribution: Insulflex duct **Non standard strapping and routing. Duct appears damaged. Recommend a licensed HVAC technician evaluate and repair**

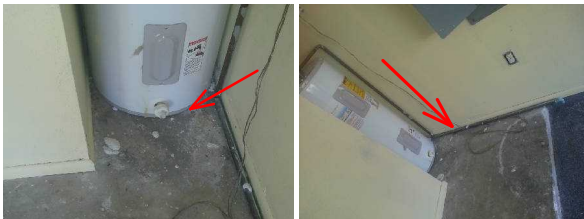
Acceptable Service Line: Copper Recommend insulating
 Acceptable Main Water Shutoff: Front of house, Left side
 Acceptable Water Lines: Copper
 Acceptable Drain Pipes: ABS
 Acceptable Service Caps: Accessible
 Acceptable Vent Pipes: ABS
 Not Present Gas Service Lines:
 Garage Water Heater
 Marginal Water Heater Operation: Functional at time of inspection **No drain pan, drain pans are always recommended when installed at same elevation or above interior spaces.**

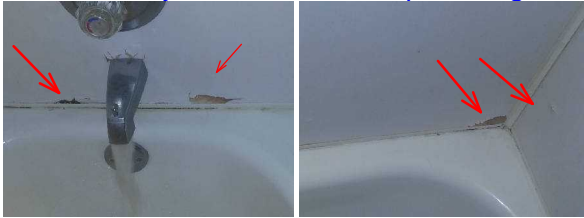
Marginal Tub/Surround: Porcelain coated, Wall panels Undulations observed in surround wall, possible damage to wood members behind the wall may have occurred, Caulking around tub and surround is a maintenance item, possible moisture entry point. Broken drain grate in tub. Shower head appears loose. Have a licensed contractor evaluate for moisture intrusion and possible wood rot, and repair as necessary, have a licensed plumbing contractor evaluate and repair.

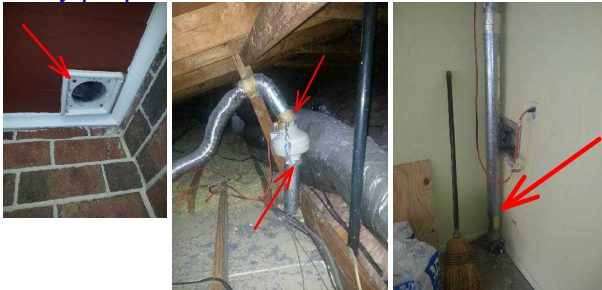
Marginal Dryer Vent: Metal Appears to have a loose/ detached vent connection. There appear to be a fan assist blower installed to force exhaust to exterior. Does not appeared properly mounted. Not inspected due to Dryer not being in place. Recommend having a licensed contractor evaluate and verify proper installation.

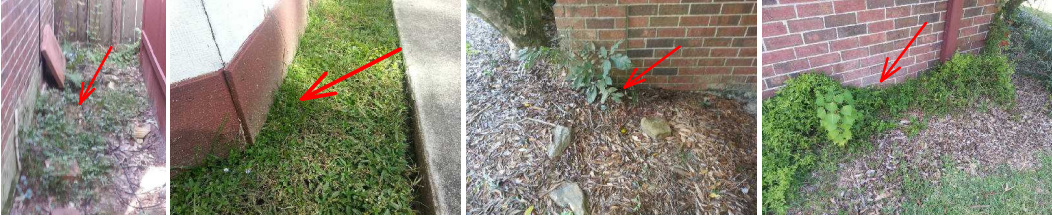
3. Grading: Flat, Minor slope Flat areas of grading may hold water near foundation. Dirt grade around foundation too high, should be 4" concrete visible under brick. Have a licensed contractor evaluate and correct the grading height to divert water away from structure.

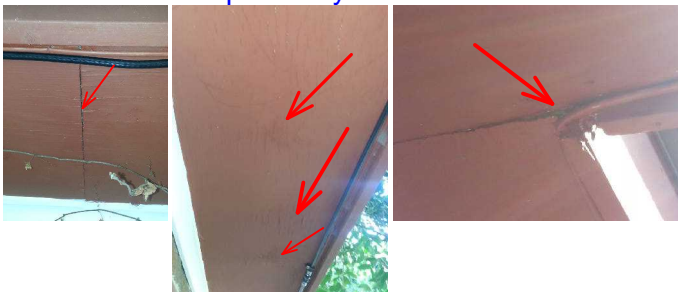
- 8. Soffits: Vented, Wood All corners, cracks, gaps, joints and openings should be sealed to prevent moisture entry. There appear to be areas where possible moisture intrusion has occurred, appeared dry at time of inspection. Paint is a periodical maintenance item that may prevent moisture entry and possible wood rot. Have evaluated and repaired by a licensed contractor.

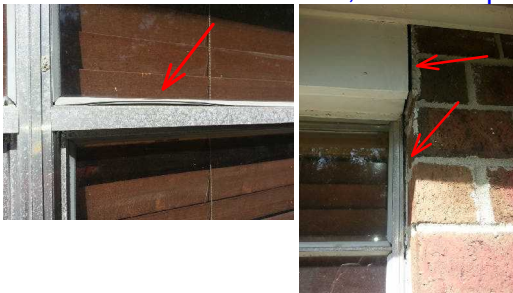
- 9. Windows: Aluminum slider Sealant around exterior of all windows is required to prevent moisture entry (periodical maintenance item). Appears glazing is deteriorating around window panes. A qualified contractor is recommended to evaluate, seal or repair.

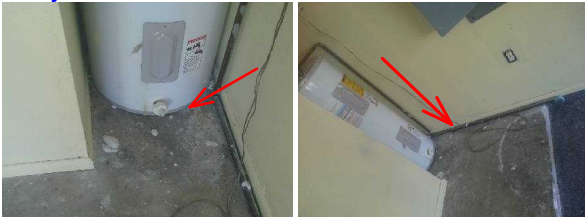
26. Garage Water Heater Water Heater Operation: Functional at time of inspection No drain pan, drain pans are always recommended when installed at same elevation or above interior spaces.

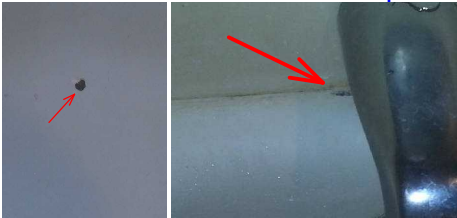
- 29. Left, Hallway Bathroom Doors: Hollow wood **Missing door stop**
- 30. Left, Hallway Bathroom Faucets/Traps: Metal fixtures with PVC trap **Missing or faulty drain stopper. A licensed plumber is recommended to evaluate and repair.**
- 31. Left, Hallway Bathroom Tub/Surround: Porcelain tub with cultured marble surround **Chipped or rusting tub, Shower head appears loose, Caulking around tub and surround is a maintenance item, possible moisture entry point. Recommend a licensed plumbing contractor evaluate and repair**

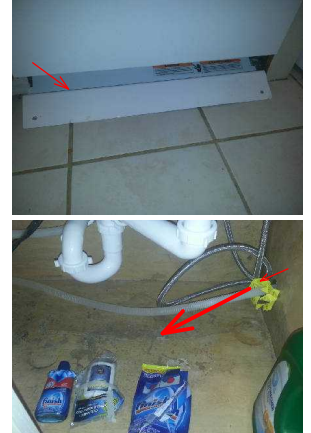
- 32. Right, Center Kitchen Dishwasher: Frigidaire **Kick plate does not appear attached. A licensed contractor is recommended to evaluate**
- 33. Right, Center Kitchen Cabinets: Wood **Base of cabinet appears moisture damaged. A qualified contractor is recommended to evaluate and repair**

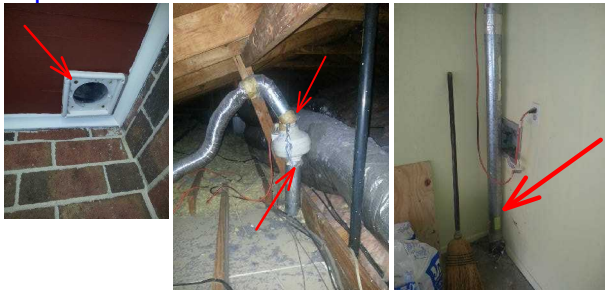
- 44. Garage Laundry Room/Area Washer and Dryer Electrical: 110-240 VAC 3 wire dryer outlet installed, recommend upgrading to 4 wire outlet (possible safety issue). Evaluation by a licensed electrician is recommended
- 45. Garage Laundry Room/Area Dryer Vent: Metal Appears to have a loose/ detached vent connection. There appear to be a fan assist blower installed to force exhaust to exterior. Does not appear properly mounted. Not inspected due to Dryer not being in place. Recommend having a licensed contractor evaluate and verify proper installation.

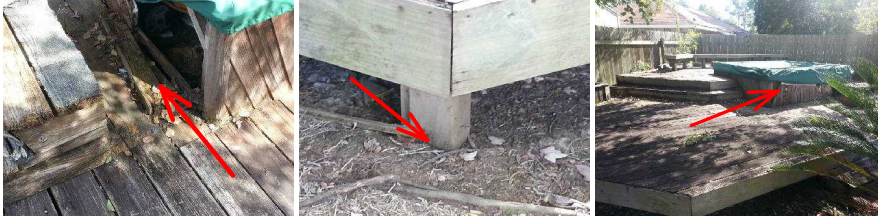
1. Deck: Treated wood Hot tub did not appear operable, not inspected. The deck area appears to have visible rot present. Wood to earth contact may allow moisture wicking and pest intrusion. Recommend having a licensed contractor evaluate and repair as required.

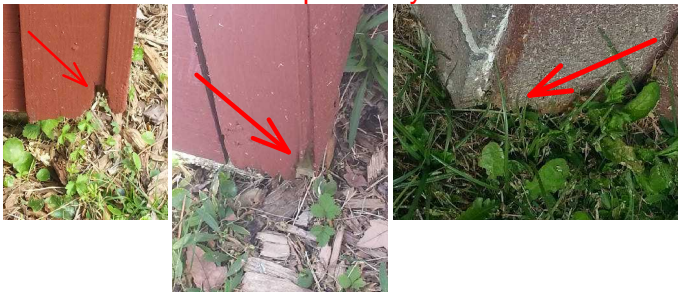
2. Trim: Wood Appears wood rot is present. Exposed wood at bottom of trim may allow moisture wicking and possible wood rot. All corners, cracks, gaps, joints and openings should be sealed to prevent moisture entry. Have evaluated and repaired by a licensed contractor.

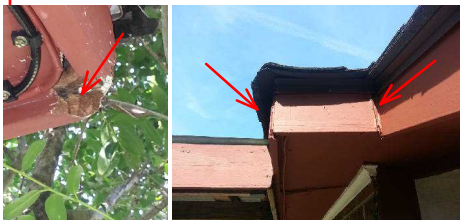
3. Fascia: Wood All joints and gaps should be sealed to prevent moisture entry. Appears wood rot may be present. A licensed contractor is recommended to evaluate and repair

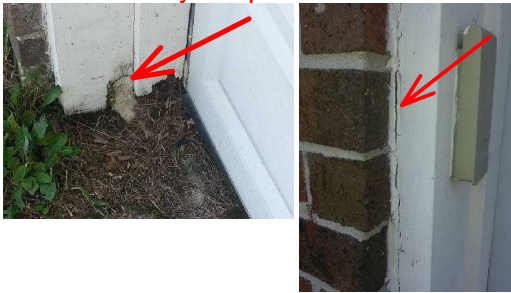
6. Front, Right Garage Garage Doors: Metal **Garage door casing should have a gap below to prevent moisture from wicking into wood. Appears wood rot is present. Recommend sealing joint at door casing to prevent moisture entry. A qualified contractor is recommended to evaluate and repair.**

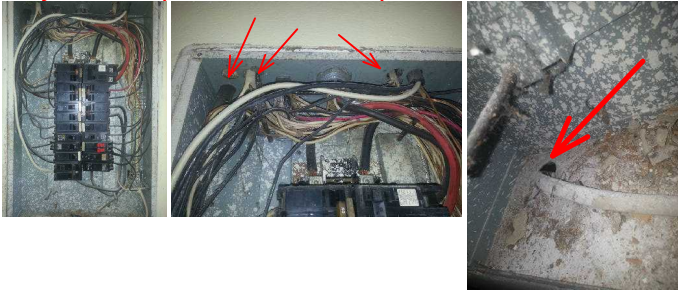
12. Smoke Detectors: Battery operated, Low voltage **Evaluation and recommended placement by a fire alarm certified installer, licensed electrician is recommended.**
13. Garage, Main Electric Panel Manufacturer: Gould **Improper/ missing cover screws. No connector at wiring entry, allows pest intrusion or possible short circuit. Evaluation by a licensed electrician is recommended**

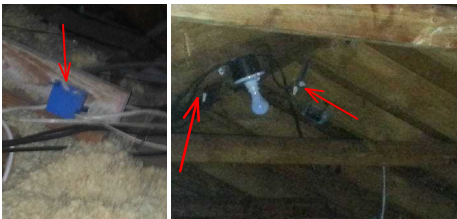
15. Main Attic Wiring/Lighting: 110 VAC, 110 VAC lighting circuit, 220V for mechanical equipment **Open junction boxes require covers to fully protect wiring. Exposed wire splices, should be spliced in an approved electrical junction box. No light bulb protection, accidental breakage may cause injury/ electrical shock. Evaluation by a licensed electrician is recommended**

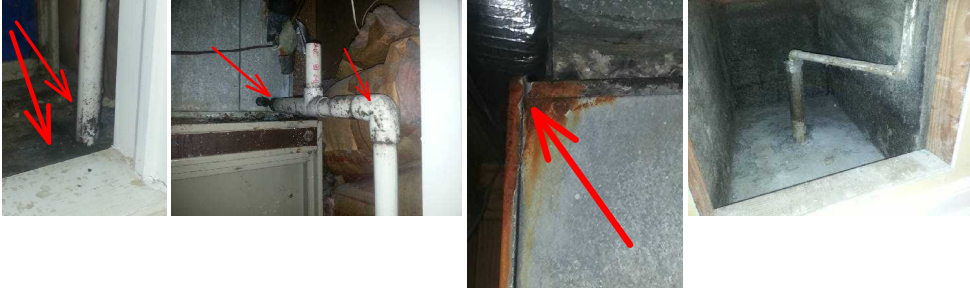
16. Exterior, Rear AC System Condensate Removal: PVC **Condensate drain line should be insulated from unit to trap to prevent leakage. Does not appear to have a float switch present. Recommend adding drain pan to prevent condensate leakage. Rust appears present on evaporator coil. Have cleaned, serviced, evaluated and repaired by a licensed HVAC technician to prevent leakage**

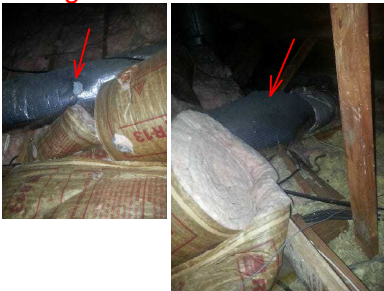
- 17. Foyer closet Heating System Distribution: Insulflex duct Non standard strapping and routing. Duct appears damaged. Recommend a licensed HVAC technician evaluate and repair
