Defective Summary

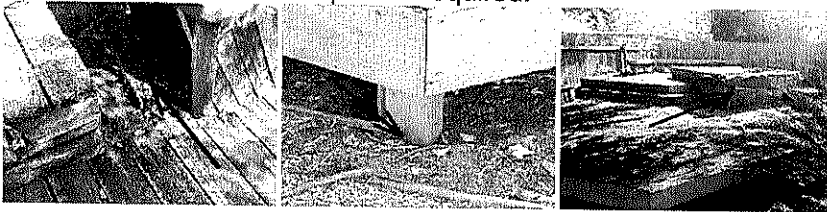
1. Deck: Treated wood Hot tub did not appear operable, not inspected. The deck area appears to have visible rot present. Wood to earth contact may allow moisture wicking and pest intrusion. Recommend having a licensed contractor evaluate and repair as required.

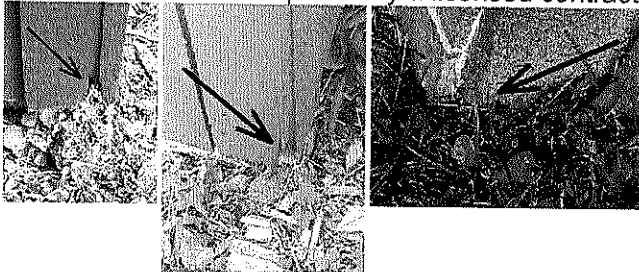
2. Trim: Wood Appears wood rot is present. Exposed wood at bottom of trim may allow moisture wicking and possible wood rot. All corners, cracks, gaps, joints and openings should be sealed to prevent moisture entry. Have evaluated and repaired by a licensed contractor.

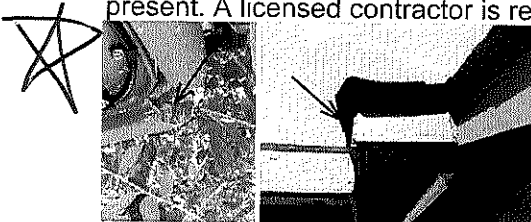
3. Fascia: Wood All joints and gaps should be sealed to prevent moisture entry. Appears wood rot may be present. A licensed contractor is recommended to evaluate and repair

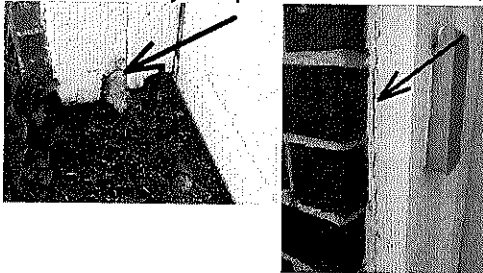
- 6. Front, Right Garage Garage Doors: Metal Garage door casing should have a gap below to prevent moisture from wicking into wood. Appears wood rot is present. Recommend sealing joint at door casing to prevent moisture entry. A qualified contractor is recommended to evaluate and repair.

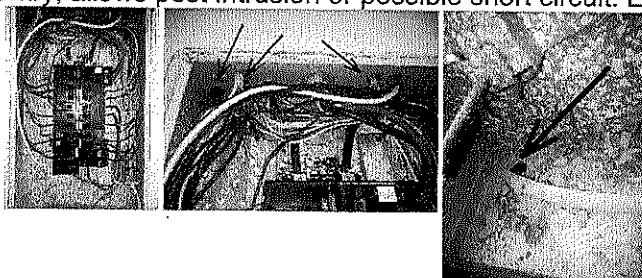
- 12. Smoke Detectors: Battery operated, Low voltage Evaluation and recommended placement by a fire alarm certified installer, licensed electrician is recommended.
- 13. Garage, Main Electric Panel Manufacturer: Gould Improper/ missing cover screws. No connector at wiring entry, allows pest intrusion or possible short circuit. Evaluation by a licensed electrician is recommended

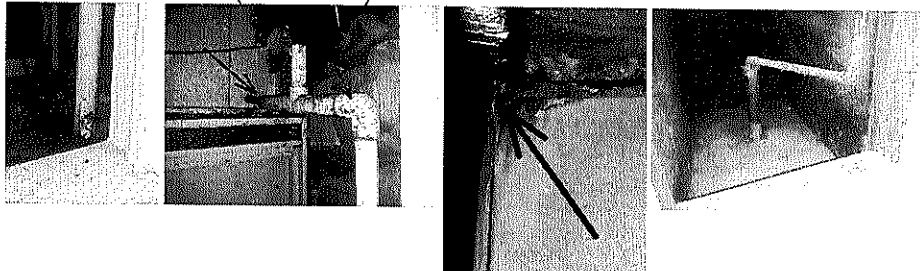
Condensate Removal: (continued)

- 16. Exterior, Rear AC System Condensate Removal: PVC Condensate drain line should be insulated from unit to trap to prevent leakage. Does not appear to have a float switch present. Recommend adding drain pan to prevent condensate leakage. Rust appears present on evaporator coil. Have cleaned, serviced, evaluated and repaired by a licensed HVAC technician to prevent leakage

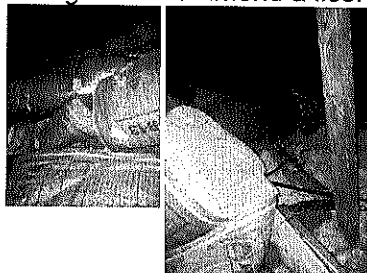
- ★ 17. Foyer closet Heating System Distribution: Insulflex duct Non standard strapping and routing. Duct appears damaged. Recommend a licensed HVAC technician evaluate and repair
