February 8, 2017

Re 112 Rue D'Azur.
Slidell LA 70461

REPORT SUMMARY

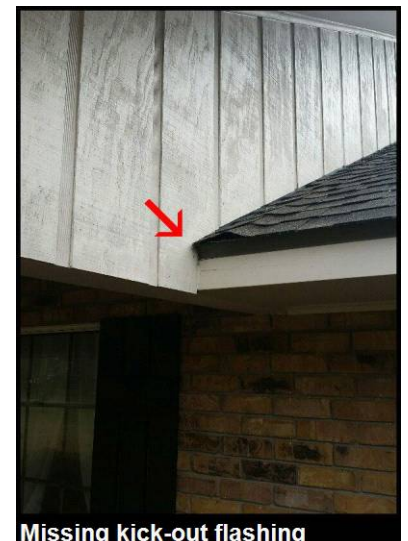
WALL CONCERNS: The following concerns were noted at the exterior walls: Cracks noted. Some cracking is to be expected in all exterior surfaces as the property settles with age. Recommend monitoring for any future changes, Pest entry points noted. Recommend sealing all penetrations to prevent access, Missing kick-out flashing noted at roof/wall intersection(s)

Missing kick-out flashing

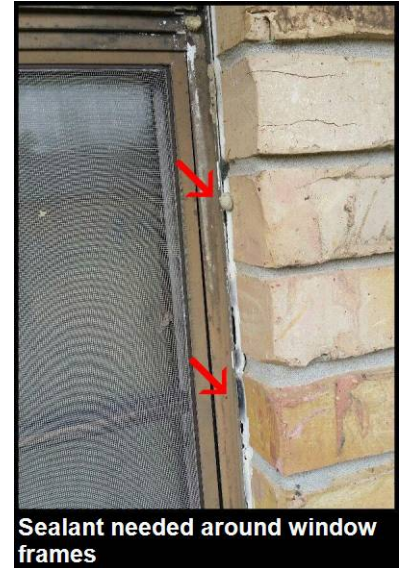
TRIM CONCERNS: The following concerns were noted at the exterior trim: Caulking recommended at intersections between dissimilar building materials.

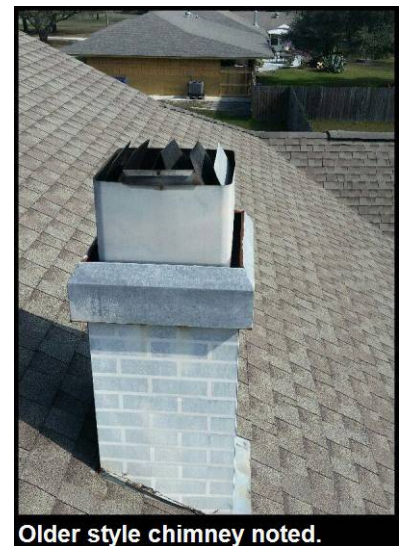
The following concerns were noted at the chimney: older style chimney noted. Recommend full cleaning and inspection by a licensed chimney contractor and make upgrades and needed. Spark arrester is recommended. None present now. Improper clearance to combustibles noted in attic. Recommend evaluation by a qualified licensed contractor and repair or replace as needed.

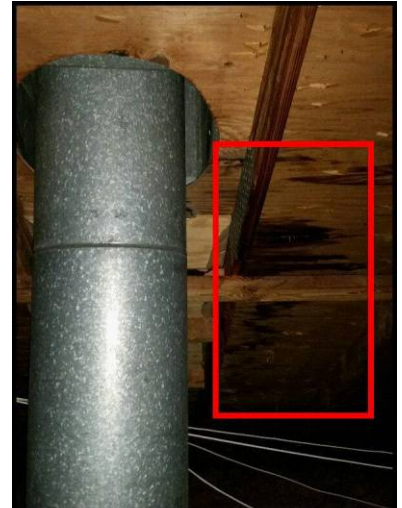
Evidence of past/present water stains

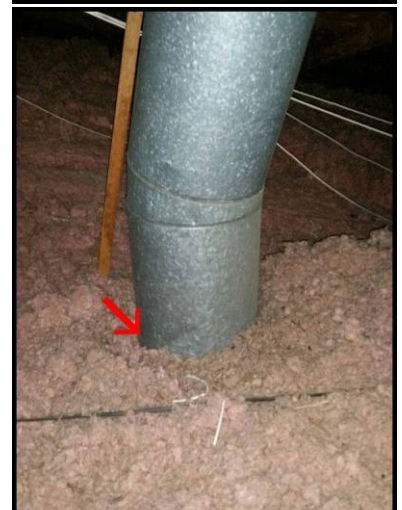
Improper clearance to combustibles

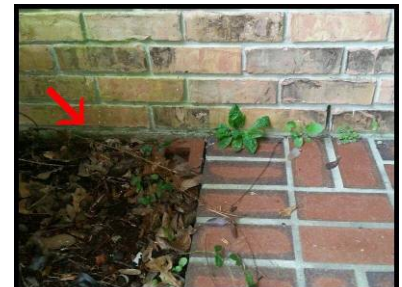
The following concerns were noted at the slab: Some areas of the slab were not visible for inspection due to the following reasons: high concrete poured over the level of the slab, high soil levels. Recommend lowering soil levels (sloping away from the house) to allow for periodic inspection of the slab. Exposed metal rebar noted. Recommend cleaning, protecting and sealing the exposed rebar.

Some areas of slab not visible

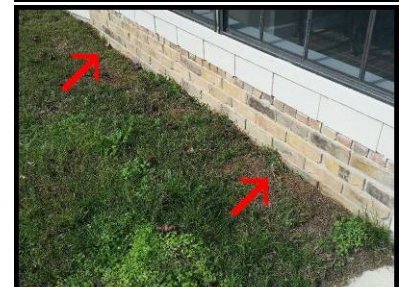
High soil/grading blocks slab

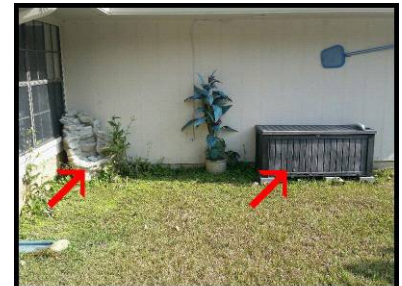
Personal items against the foundation

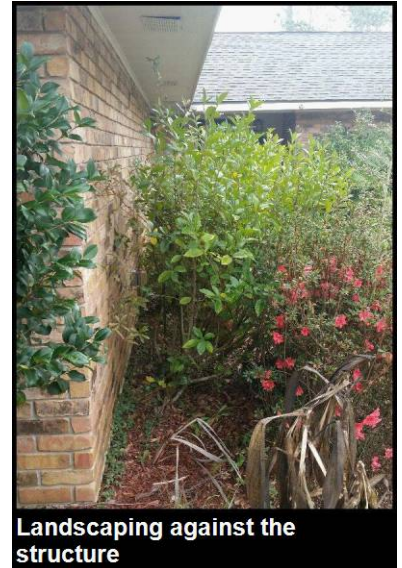
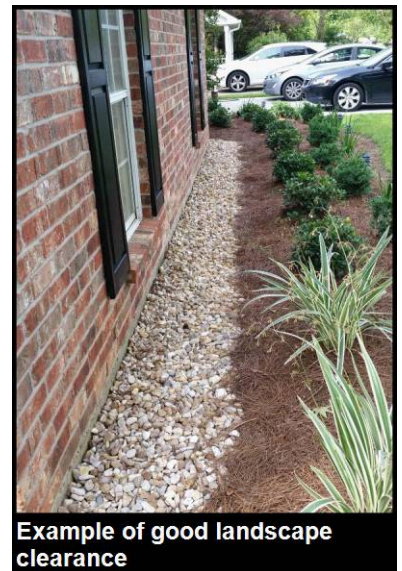
LANDSCAPING CONCERNS: The following concerns were noted at the landscaping: Keep plants trimmed away from structure to help prevent moisture damage and pest intrusion. Trees planted close to structure.

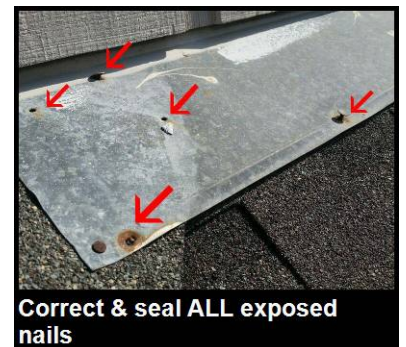
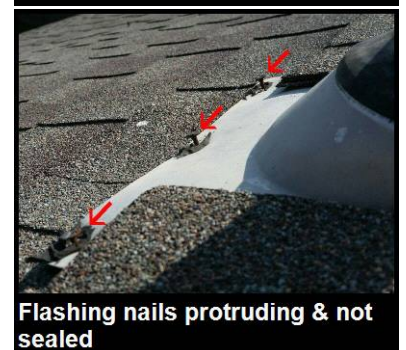
EXPOSED FLASHING CONCERNS: The following concerns were noted at the flashings: Rusty flashing is noted, Lifted flashing noted.

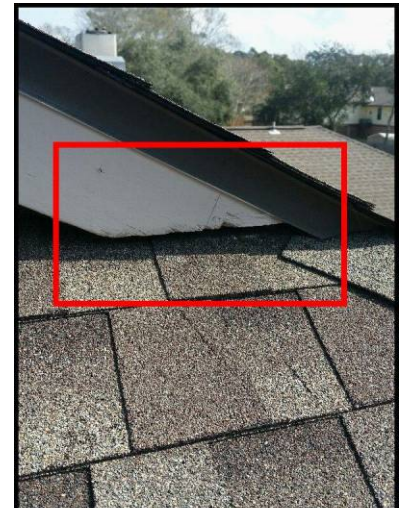
Missing flashing & pest entry point

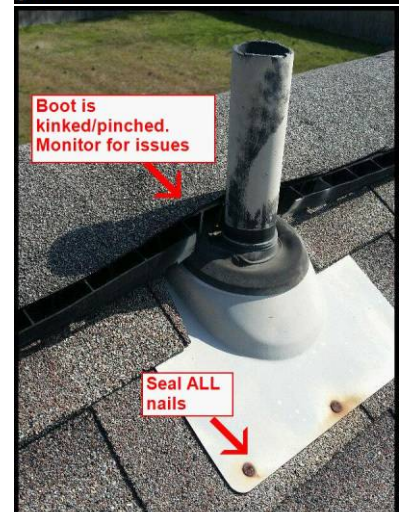
ridge vent presses on rubber boot. Monitor

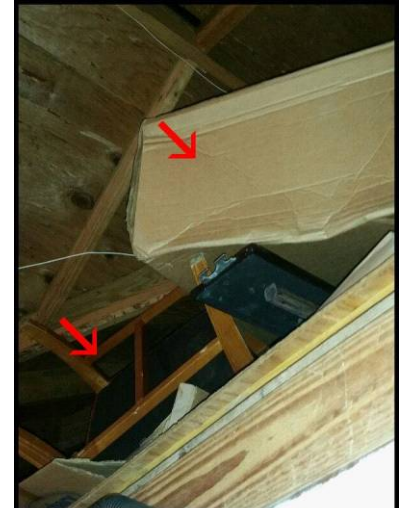
Personal items block garage attic entrance

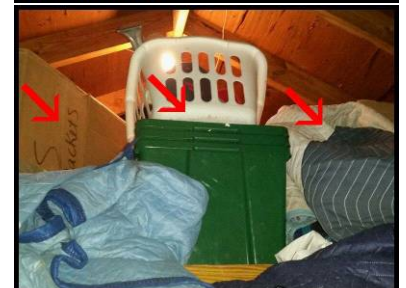
Personal items block garage attic entrance

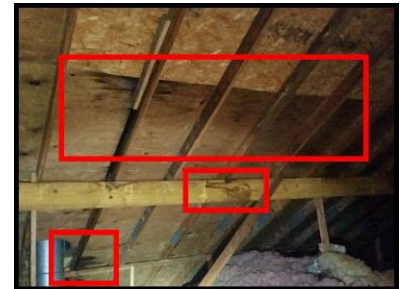
Evidence of past/present leaks

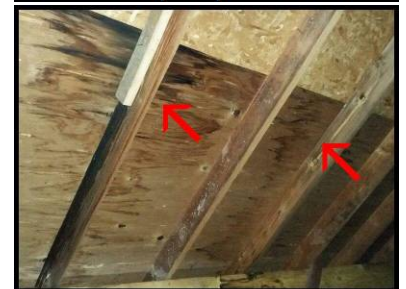
Close up of the stains

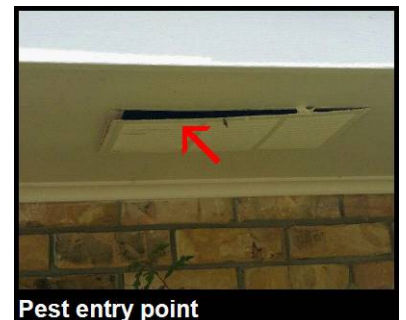
VENTILATION CONCERNS: The following concerns were noted at the attic ventilation: pest entry point at loose vent.

Pest entry point

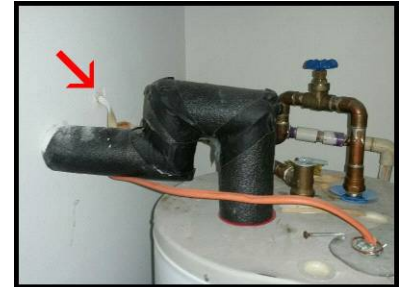
No outlet / disconnect

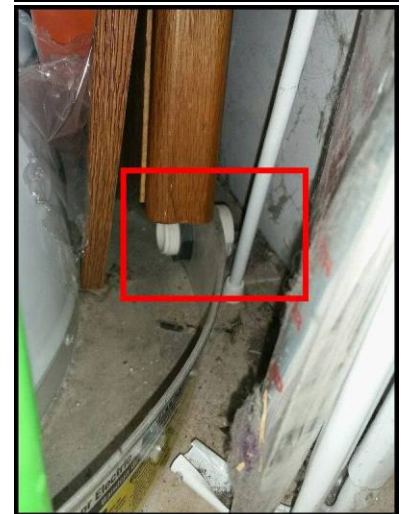
WATER HEATER CONCERNS: The following concerns were noted at the water heater: Overflow drain pan is installed, but no drain piping visible. Recommend installing drain line to exterior location to protect the home from water damage in the event of a leak. No visible electrical disconnect provided.

Drain pan missing the drain line

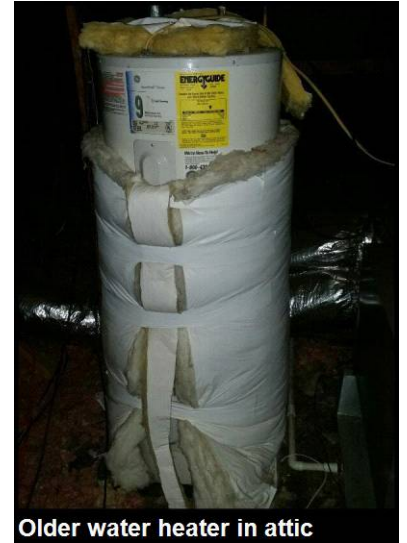
WATER HEATER CONCERNS: The following concerns were noted at the water heater: Older model appliance. Unit appears to be nearing the end of what is typically considered an average life expectancy for this type of equipment. Thermal blanket installed - unable to fully view tank, The following concerns were noted with water heater TPR valve: TPR valve piping terminates in the overflow drain pan drain line. It is preferred that this drain line is isolated and terminates at the exterior of the house. Correction is recommended.

Older water heater in attic

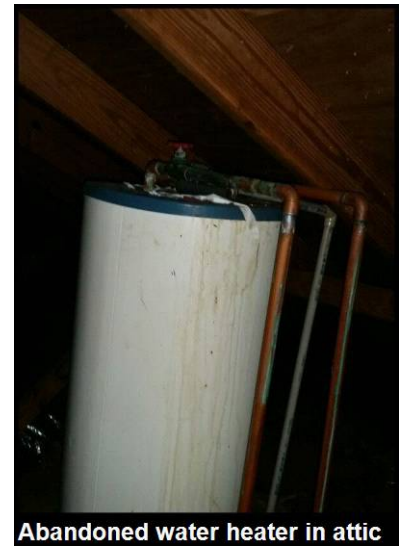
Abandoned water heater in attic

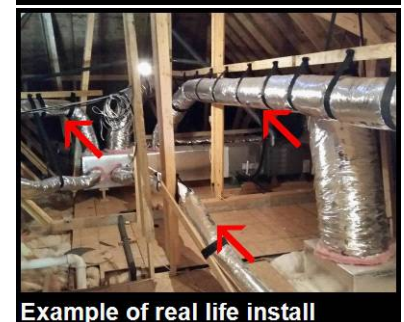
Ductwork is not suspended off the attic floor as required by today's standards. This is important to know because when it comes time to change the HVAC system, it will be required to properly install the ductwork as well. (see diagram and example pics for details)

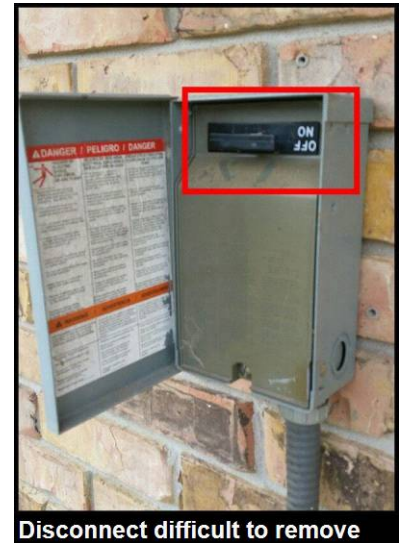
EQUIPMENT POWER SOURCE: 240 Volt, Electrical disconnect present, The following concerns were noted at the power source:
 Disconnect handle pull would not come out even after a little extra force. The disconnect handle should not require excessive pulling force to be removed. Improper serviceable access to AC disconnect panel. Panel should be mounted off to one side for proper clearance and serviceable access.
 Recommend repairs to the disconnect handle so it is easily removed. Add dielectric grease as needed.
 Missing strain relief/wire clamps at rear knockout.

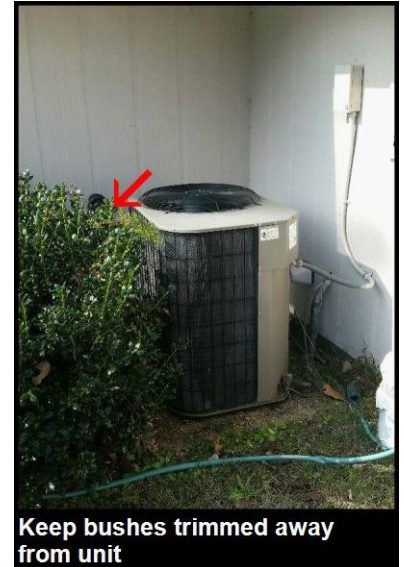
Missing/damaged insulation noted on refrigerant lines, Older model appliance. Unit appears to be nearing the end of what is typically considered an average life expectancy for this type of equipment. Questionable clearance around unit/restricted airflow. This may result in inefficient operation, increased utility bills and reduced life expectancy of the system. A minimum of 3' clearance at sides and 6' clearance from the top should be observed. Recommend servicing system and checking refrigerant level. Coils appear to be dirty. Recommend cleaning.

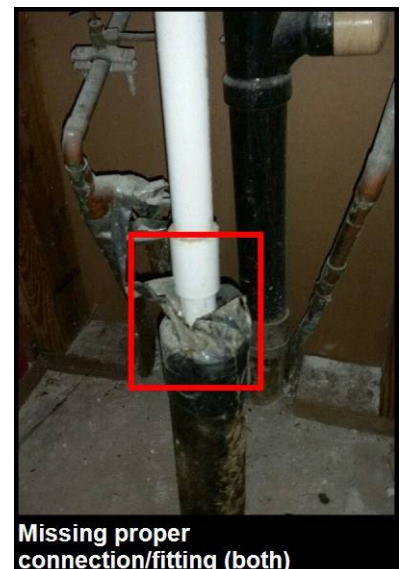
The following concerns were noted at the condensate drain line: Poor termination point noted. Missing proper connection fitting.

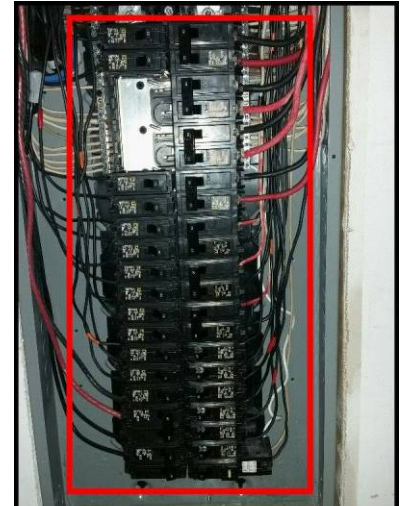
MAIN PANEL CONCERNS: The following concerns were noted at the main electrical panel: The following concerns were noted at AFCI/GFCI breakers: No AFCI (arc fault circuit interrupter) breakers were visible. Recommend installing AFCI breakers to comply with current safety standards.

Close up of main panel circuits.
No AFCI's

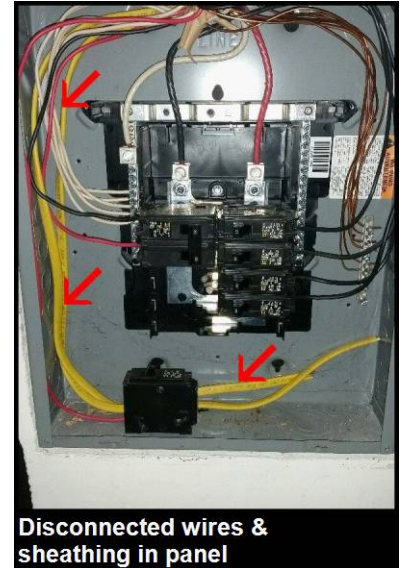
The following concerns were noted at the electrical sub-panel: Disconnected wiring noted inside of the panel. Unable to verify the function of this wiring. Recommend verifying the reason with seller prior to closing. Wire sheathing extending into the inside of panel box.

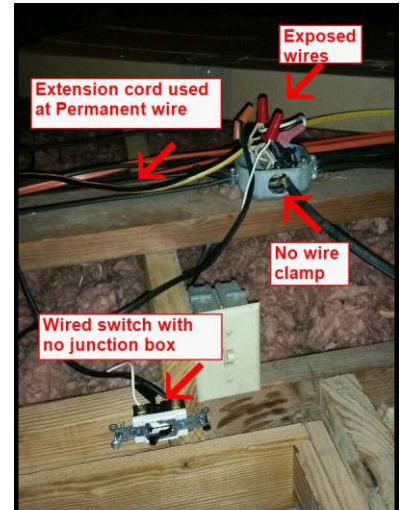
The following concerns were noted at the branch wiring circuits: Open junction boxes are noted- Covers are needed in the following area(s): Attic, Connections not made within junction boxes- Hazardous condition exists. Correction needed in the following area(s): Attic, Extension cord used as permanent wiring. This is not recommended by current safety standards, Lamp cord used as permanent wiring. This is not recommended by current safety standards, Bare wires are noted, Recommend exposed wiring be properly protected. Recommend evaluation by a qualified licensed electrician and repair or replace as needed.

Electrical concerns in garage attic

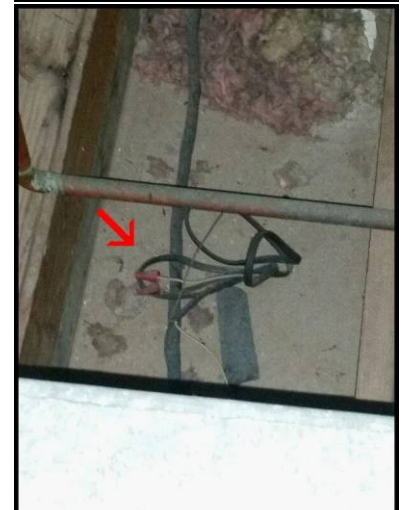
Exposed wires in main attic at left

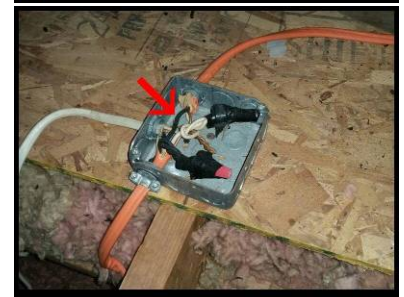
Missing junction box cover in main attic

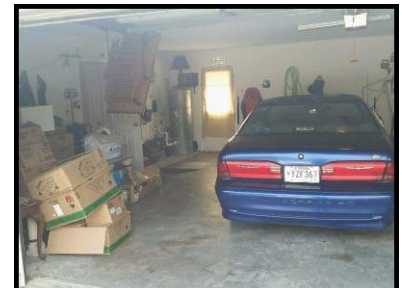
Personal items restrict full visibility

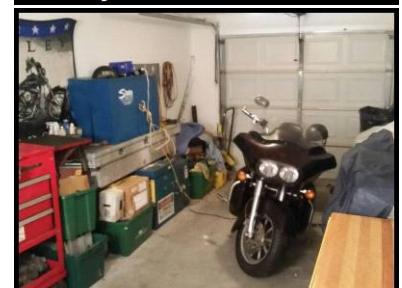
Personal items restrict full visibility

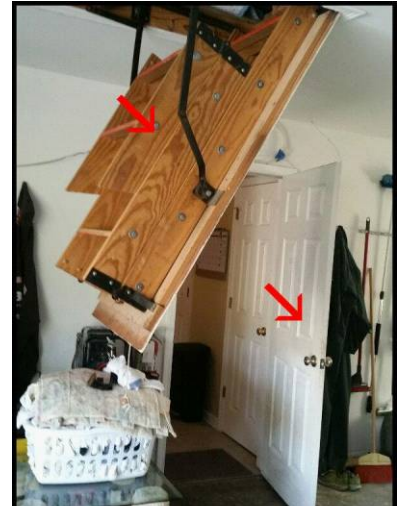
GARAGE FIRE WALL CONCERNS: The following concerns were noted with the fire wall: Repair any openings with approved materials to restore its fire rating, Attic access panel is not fire-rated. House entry door is not fire-rated. Recommend upgrades for safety.

Not fire-rated: attic & house entry door

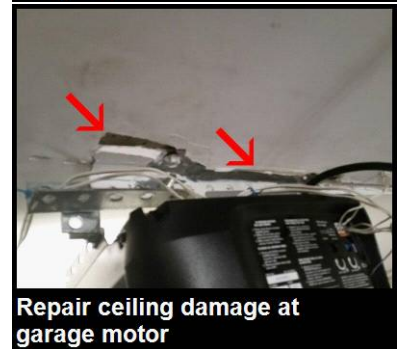
Repair ceiling damage at garage motor

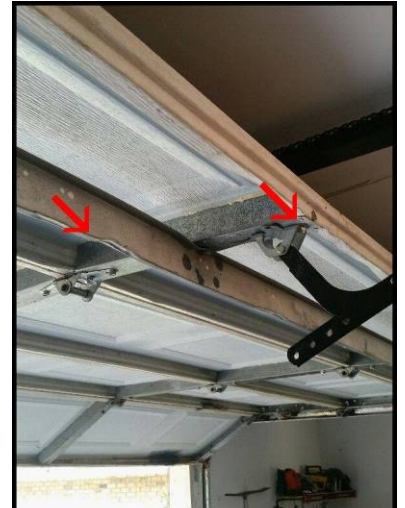
Dents & damage noted

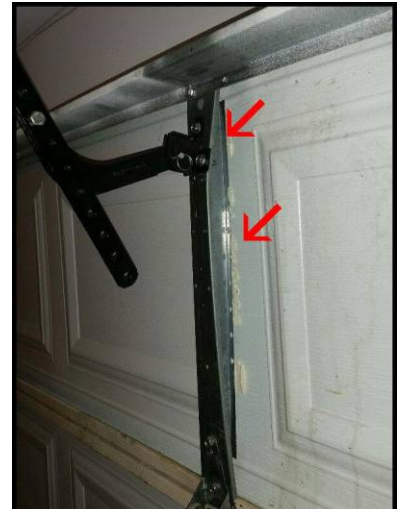
Damage at the control arm

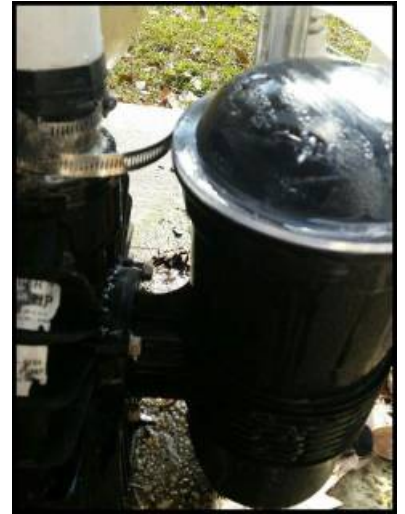
LEAF BASKET CONCERNS: The following concerns were noted at the pump leaf basket, Leaking noted at the leaf basket.

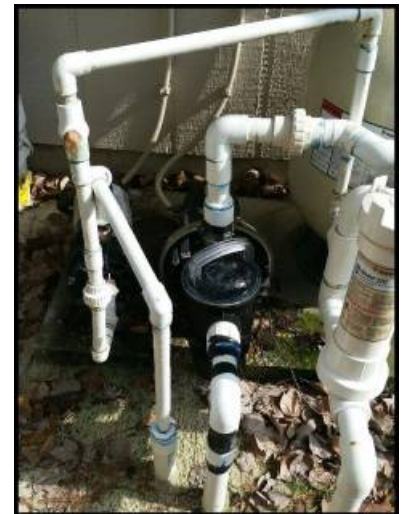
VISIBLE POOL/HOT TUB PLUMBING LINES CONCERNS: The following concerns were noted at the visible plumbing lines: Leakage noted at piping at the following area(s): Pump, General piping, Leak noted where the return pipe is attached at the top of the pump. A valve handle is broken and cannot be operated. Replace handle as needed. Pipes lack proper support. Nonprofessional repairs noted. A qualified pool contractor should be called to make further evaluation and recommendations for repair or replacement.
