HOME INSPECTION REPORT

114 N. Randall Dr., Slidell , LA 70458

Wednesday, April 12, 2017

04122017-3

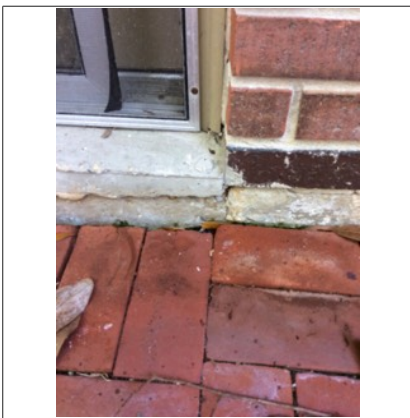
Monitor: Patching/separation in the rear of the slab.

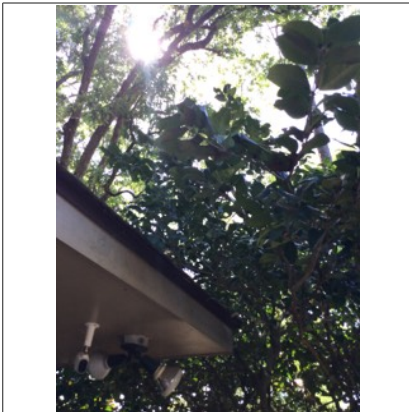
Repair: Tree trimming needed and remove debris on the roof.

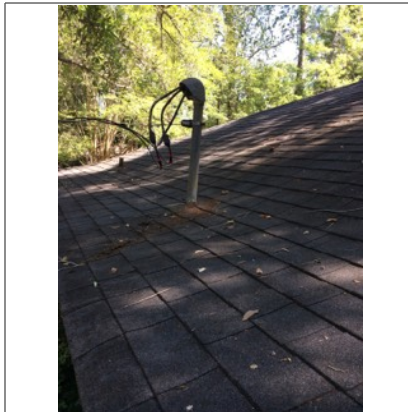
Repair: Roofing material not sealed around the mast.

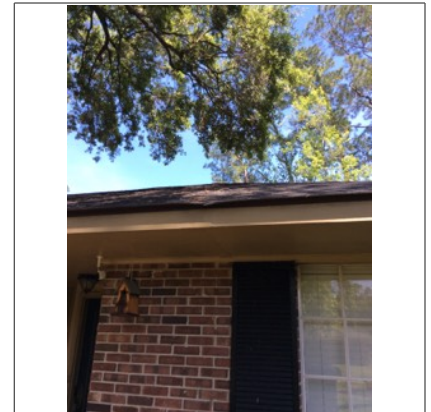
Repair: Front slope shingle damaged.

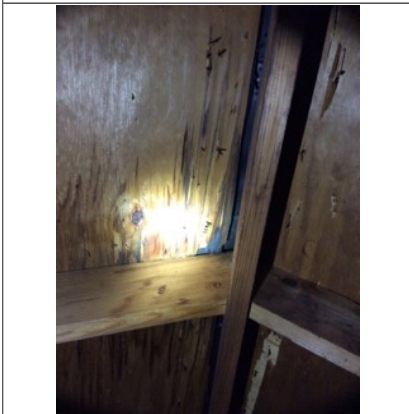
Repair: Sheathing damaged in areas on the right rear ridge.

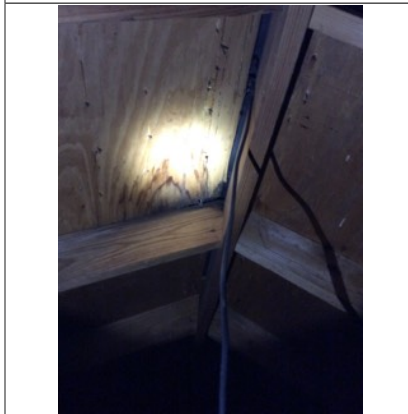
Repair: Sheathing damaged in areas on the right rear ridge.

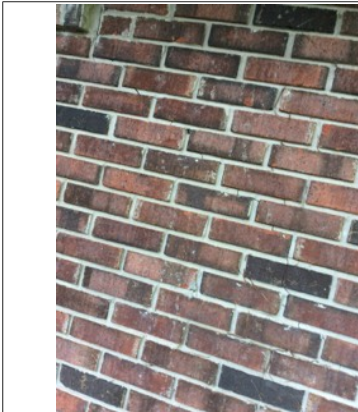
Repair: Cracking on the right exterior wall.

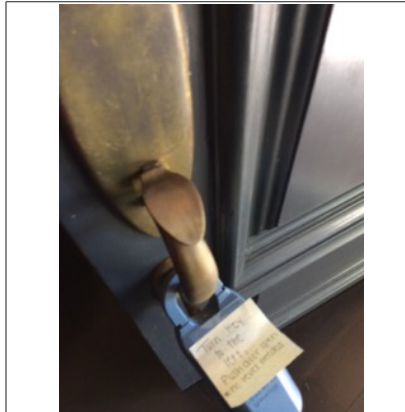
Repair: Front door hardware inoperable.

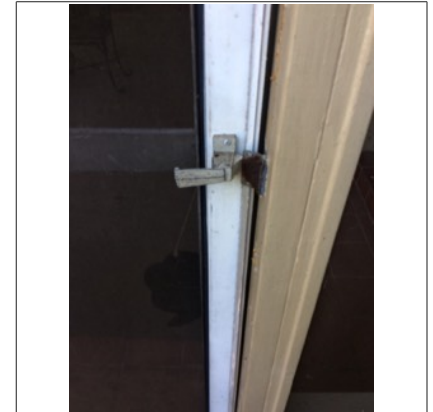
Repair: Screen door hardware not latching.

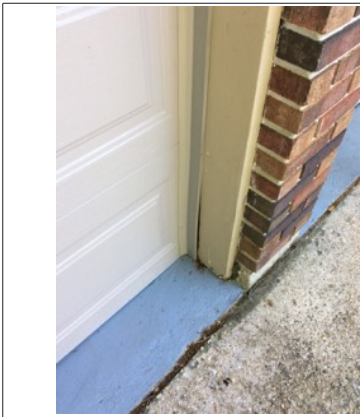
Repair: Garage door seal loose and trim rotted at the bottom.

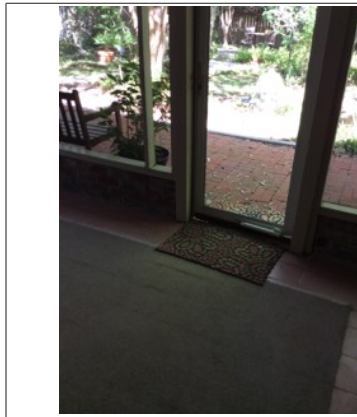
Repair: Storm door not sealed on the rear patio.

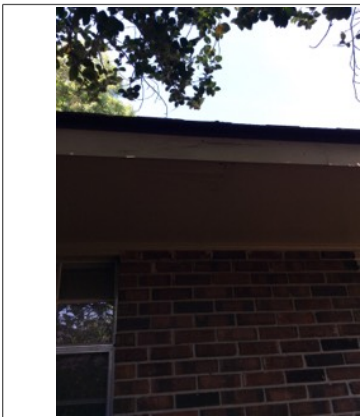
Repair: Rot on the soffit and facial on the right exterior.

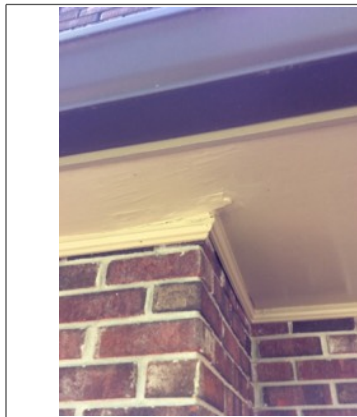
Repair: Rear soffit damaged.

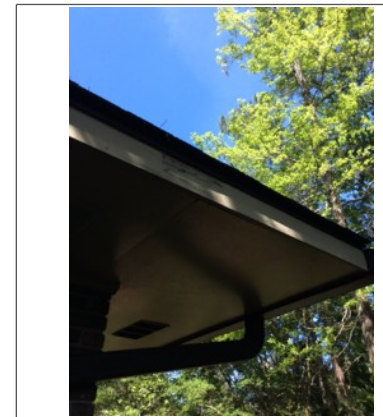
Repair: Right fascia rotted.

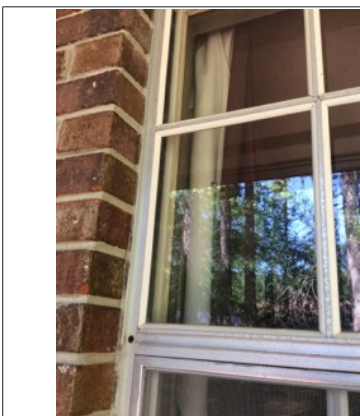
Repair: Right rear window damaged.

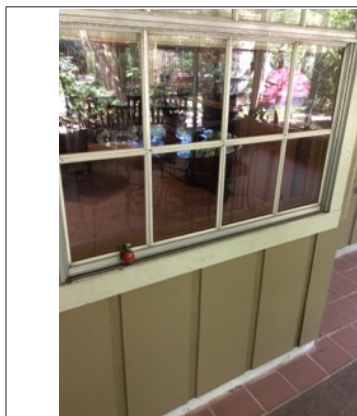
Repair: 3 Screens missing on the left rear.

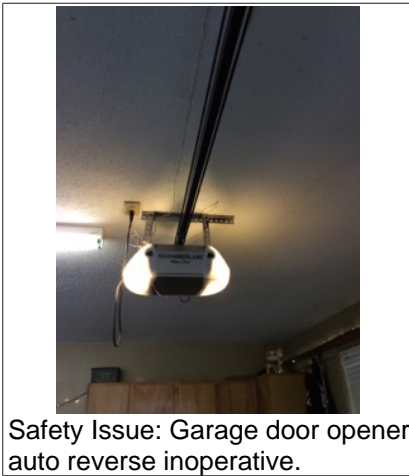
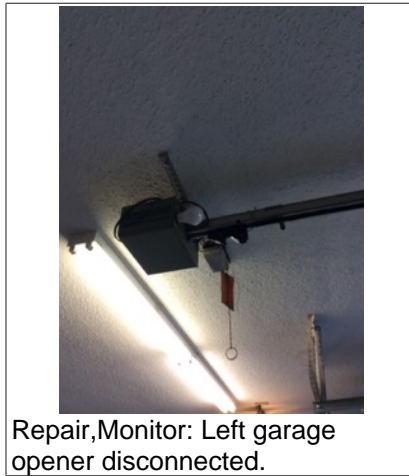
Safety Issue: Garage door opener auto reverse inoperative.
Repair, Monitor: Left garage opener disconnected.

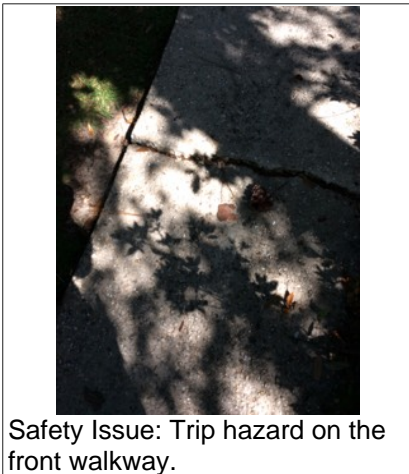
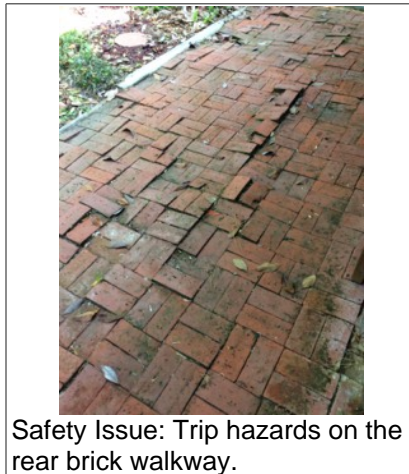
Safety Issue: Trip hazards on the rear brick walkway.
 Safety Issue: Trip hazard on the front walkway.

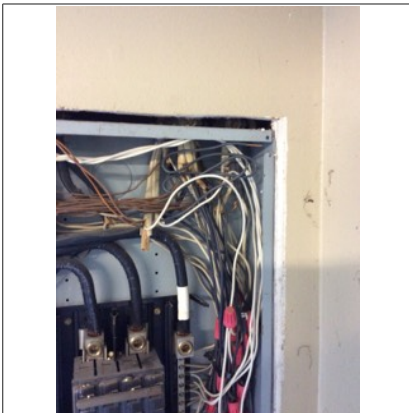
Safety Issue: Wire not terminated properly in the main panel.

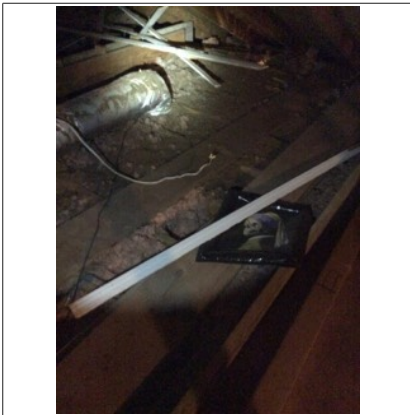
Safety Issue: Wire in the attic not terminated properly.

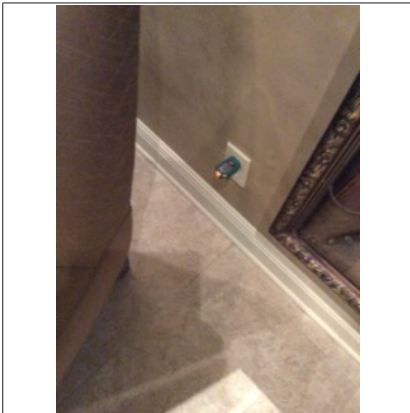
Safety Issue: Outlet not grounded in the living room.

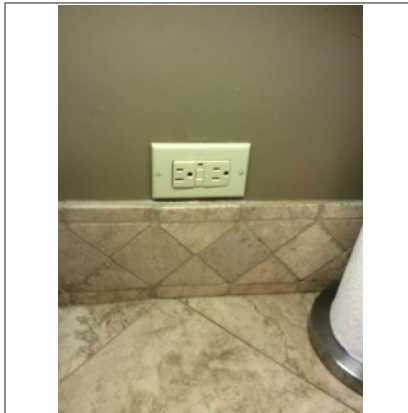
Repair: Outlet loose in the kitchen.

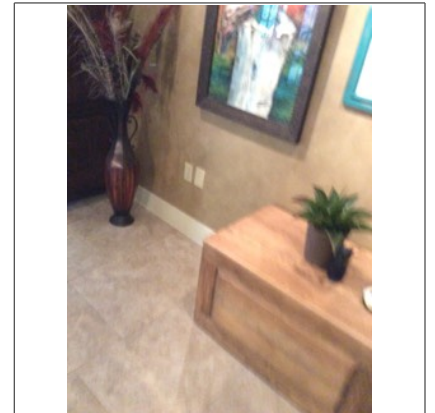
Repair: Outlets loose in various areas.

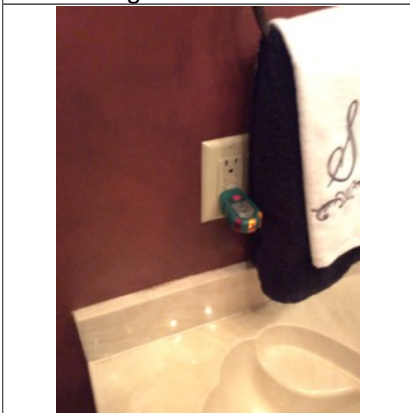
Safety Issue: Hall bath GFCI tested faulty.

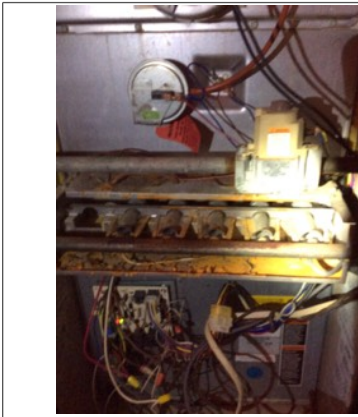
Repair: Water stains and rust in the furnace unit.

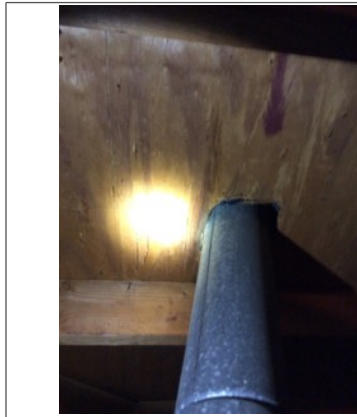
Safety Issue: Flue clearance on the furnace.

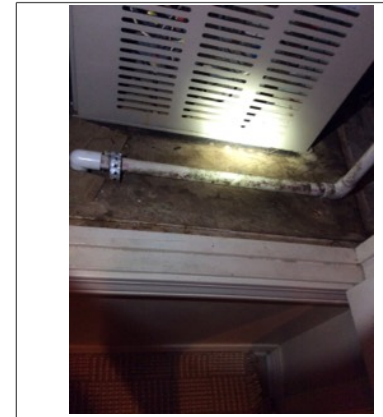
Repair: Signs of the coil drain line sweating.

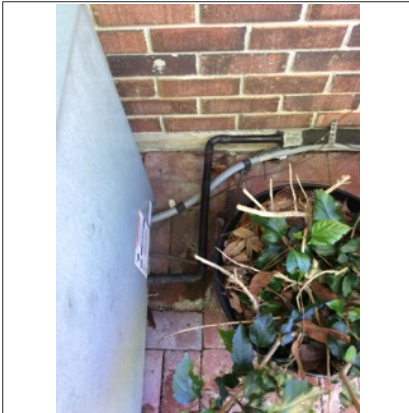
Repair: Insulation missing on the outdoor unit.

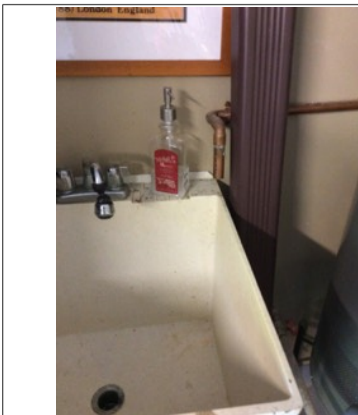
Safety Issue: TPR piping discharging in above the garage sink.

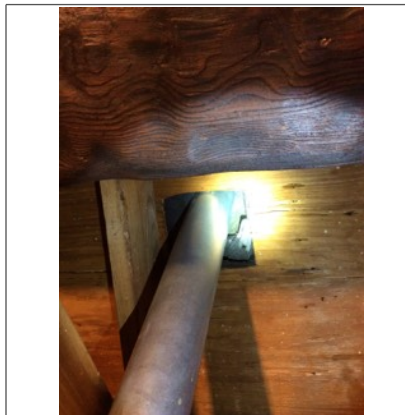
Safety Issue: Flue clearance on the water heater.

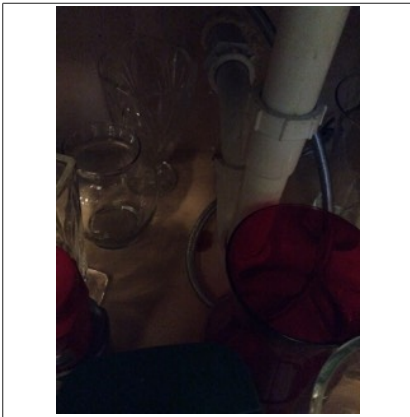
Monitor: Substance on the kitchen sink plumbing and kitchen cabinet.

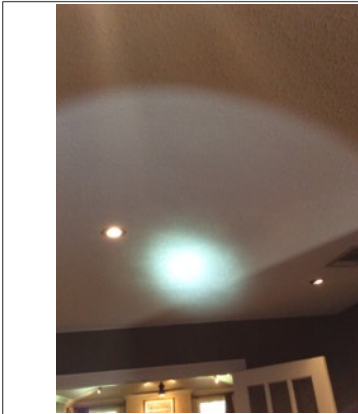
Monitor: Patching in the family room ceiling.

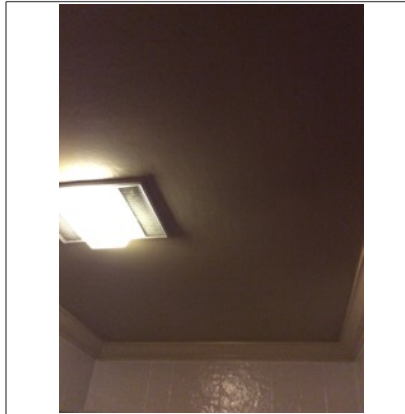
Repair,Monitor: Patching in the hall bath ceiling.

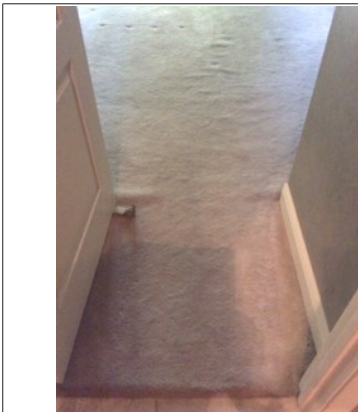
Repair: Master bedroom carpet loose.

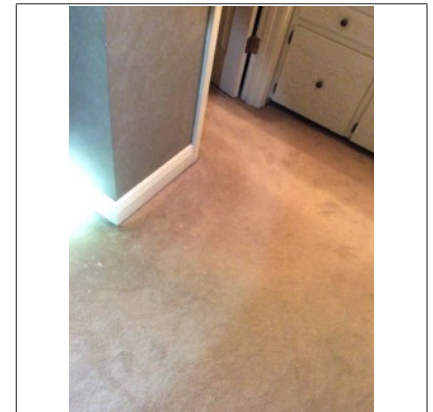
Repair,Monitor: Carpet stains in the master bedroom.

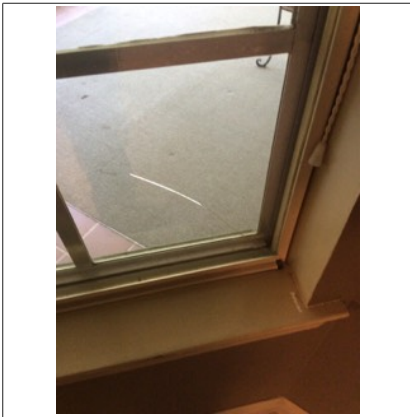
Repair: Window shield damaged in the kitchen.

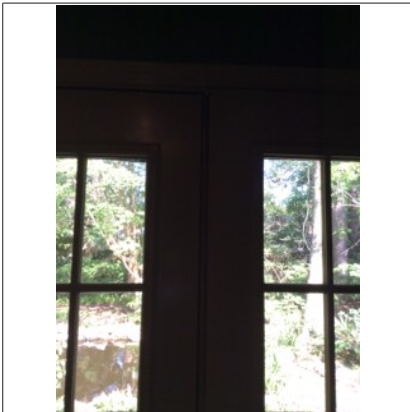
Repair: Master bedroom rear exterior door rubbing the frame, door dragging on the carpet and screen not sliding freely.

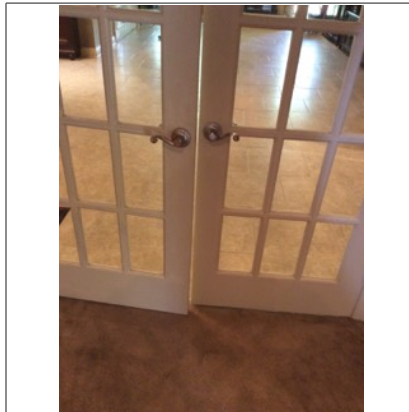
Repair: Family room door detent inoperable and doors dragging on the carpet.

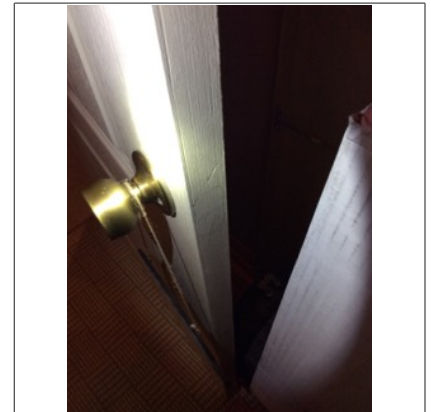
Repair: Hardware missing on the hall closet door.

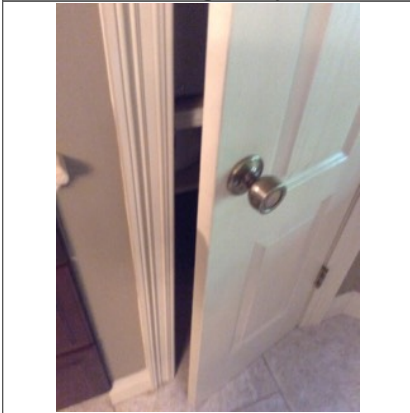
Repair, Monitor: Pantry door hardware missing.

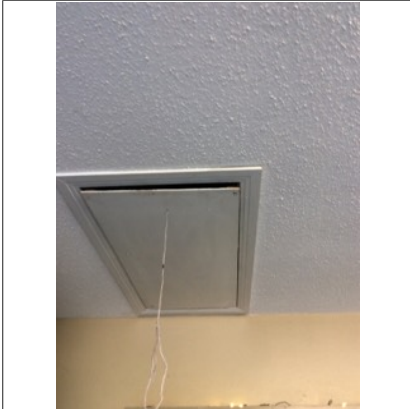
Repair: Attic stairs not sealed in the garage.
