RE: Madisonville, Elementary School  
117 CS Owens  
Madisonville, La.

Dammon Engineering was contacted to inspect the rigid frame, Portal Frame, assembly that was installed in the cafeteria.

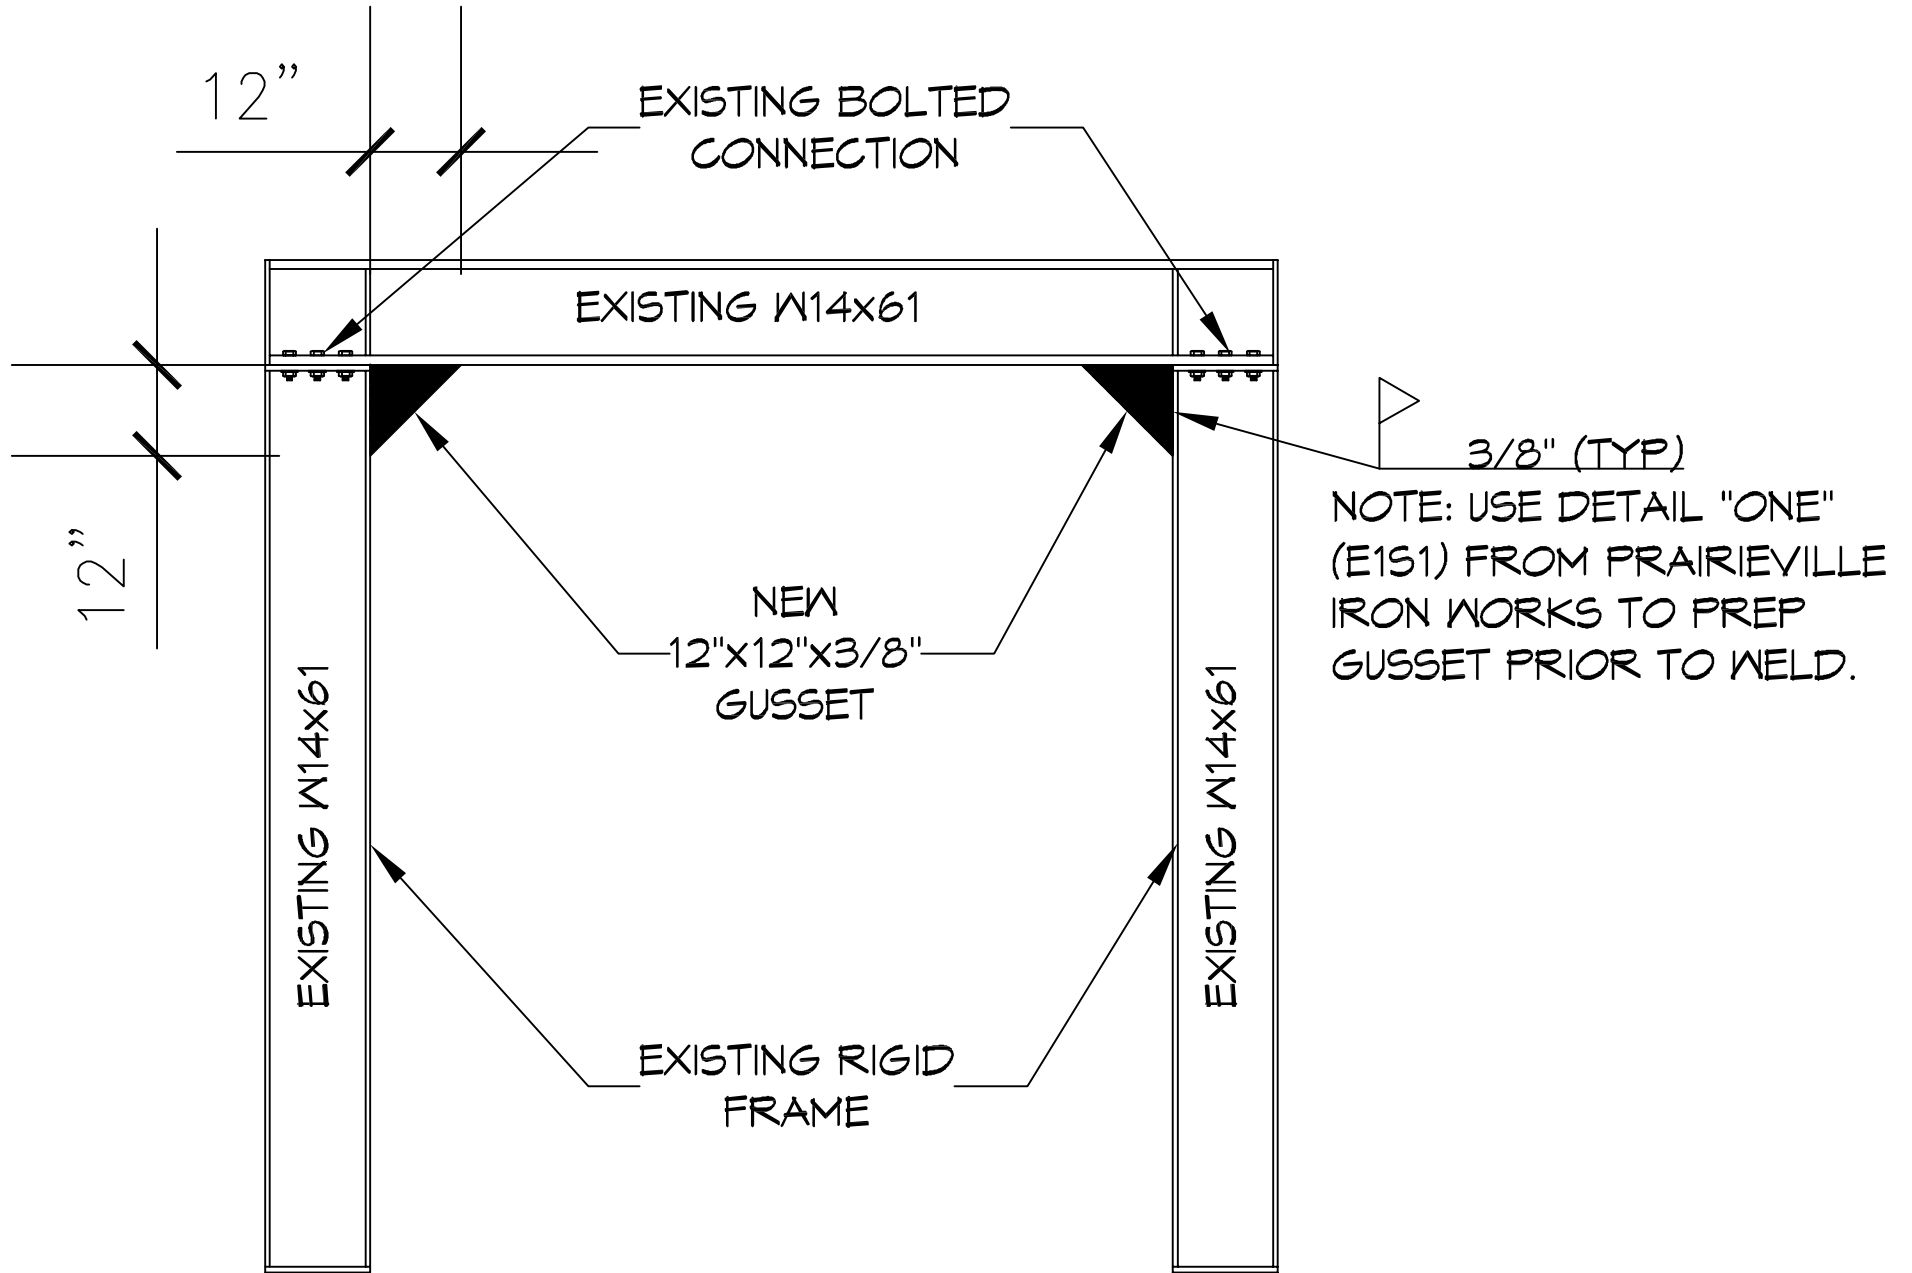
RIGID FRAME DETAIL  
N.T.S.

An inspection revealed that this rigid frame was constructed using three each W14x61's. The connection between these members was made using the horizontal's W14x61 member's bottom flange which is bolted to an end plate on top each of the vertical W14x61 members. Each connection was constructed using six each  $\frac{3}{4}$ " A325 bolts. See detail attached detail.

Analysis of the rigid frame was performed and found that the although the connections would be capable of resisting shear and axial loads it would not properly resist the moment caused by wind forces.

We recommend that two each 12"x12"x $\frac{3}{8}$ " thick triangular gussets be installed per the attached detail.

GRIND WELDS  
FLUSH @ OUTSIDE FLG'S
