November 21, 2017

**RE: Engineer's Report**  
**Owner: Jonathon Colombini, 504-256-6180**  
**Site: 117 Rooks Dr, Slidell, LA 70458**  
**Case or Loan #: 21 - 21 - 6 - 0438882**

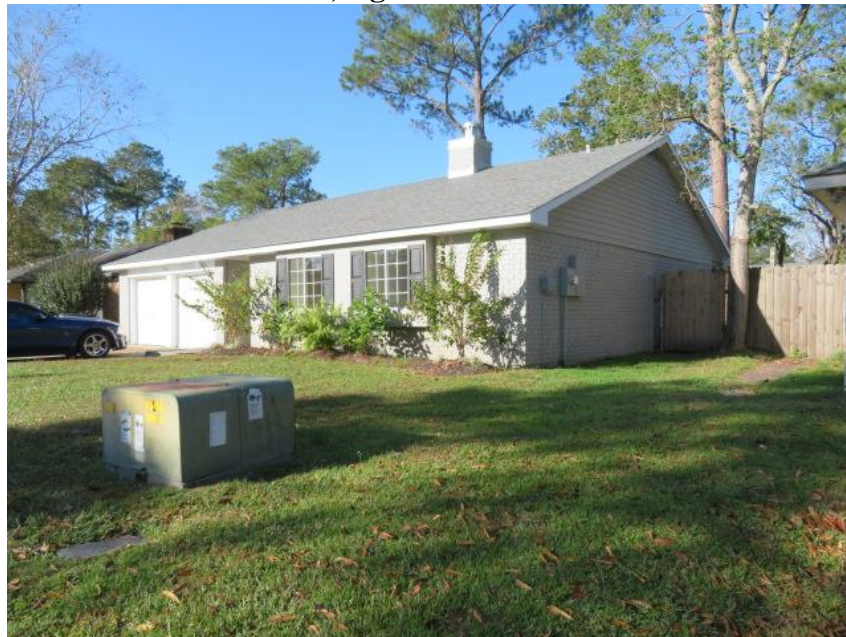
Outside - found vertical brick mortar crack on front right side of the dwelling measuring approx 1/32" width or less. placed a penny in one brick crack. The brick crack from the top of the slab upward approx half way up the wall for 16 bricks runs. Could not locate any cracks in the concrete slab. There is a 10" diameter Tallow tree with surface roots approx. 4.5' from the house near this bedroom and bath.

**Picture #2, right front - affect area**

It is my opinion that the foundation needs underpinning to help stabilize the foundation from further settlement and movement. Several underpinning options may be implemented, such as: new poured concrete piers, helical augured piers, hand dug concrete piers, driven friction piers, or the like. Stacked piers that are non-monolithic and non-continuous are not recommended because they do not provide adequate uplift resistance for swelling soils. Whatever underpinning method is chosen, the piers should support the foundation properly and be installed below the active (shrink/swell) zone of the expansive soil to disallow movement of the pier or foundation. The minimum area which I believe needs underpinning is the right rear and the right side, both areas near the adjacent tree. See Picture #15 in Appendix. It is my opinion that the possible cost to cure may be between \$4000 to \$8000.

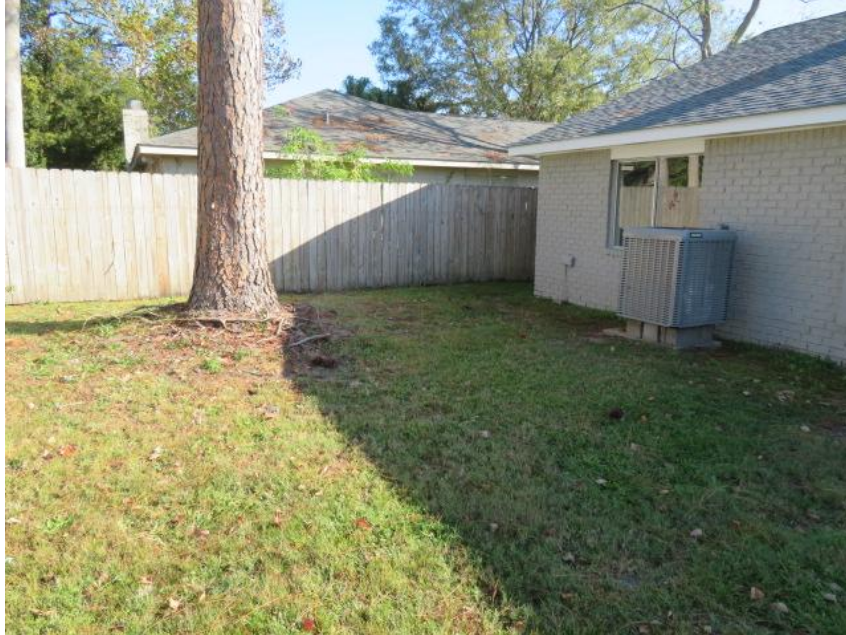
**Picture #3, rear yard - large pine tree approx 10' from the right corner.**

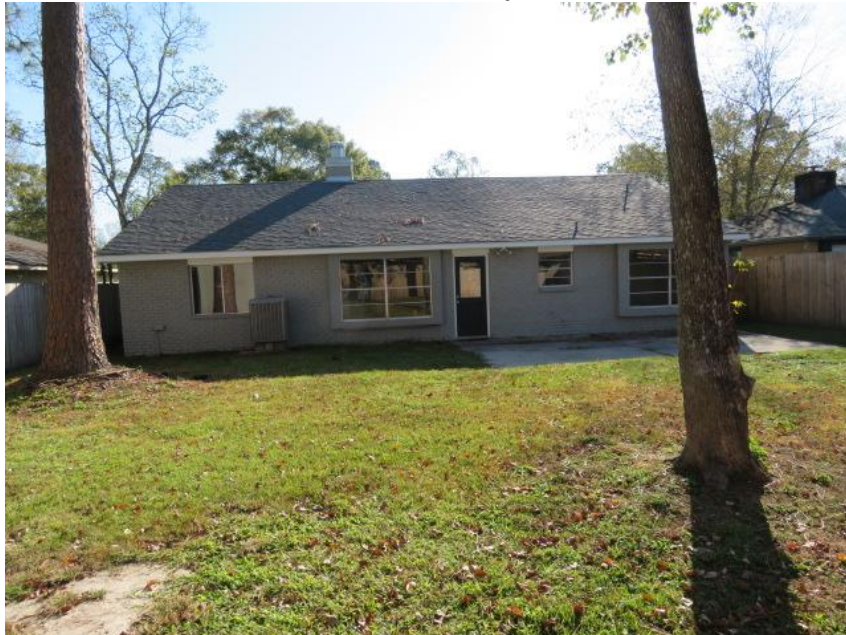
**Picture #4, rear yard**

A smaller amount of settlement was noted at the rear of the dwelling along the den wall with no evidence of cracks in the brick or slab. A tree had been cut near the rear door close to this low area in the den.

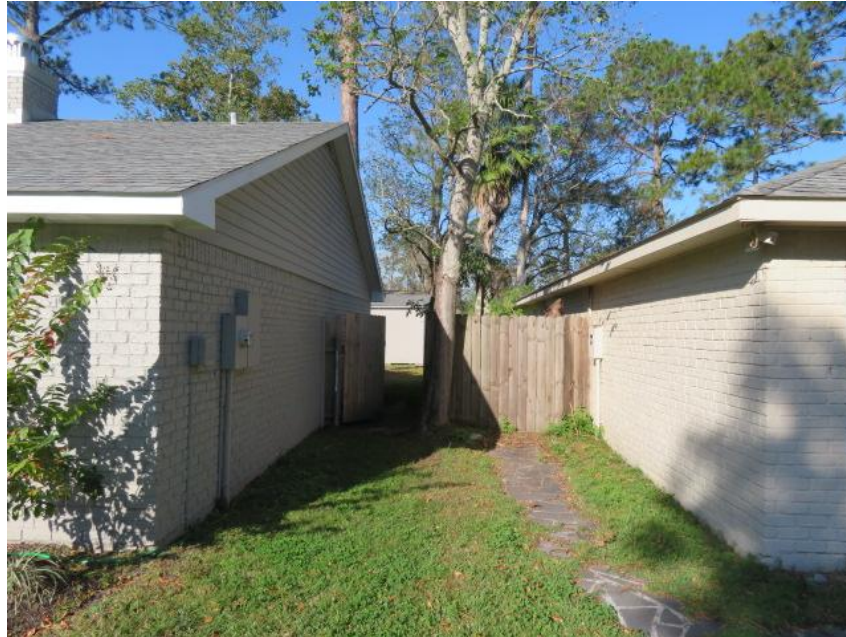
Based on the evidence it is my opinion that the soil under the foundation is subsiding causing the foundation to begin to settle. It is very likely that the trees adjacent to the home, as discussed, are contributing to this subsidence.

**Picture #5, view of Tallow tree near brick crack**

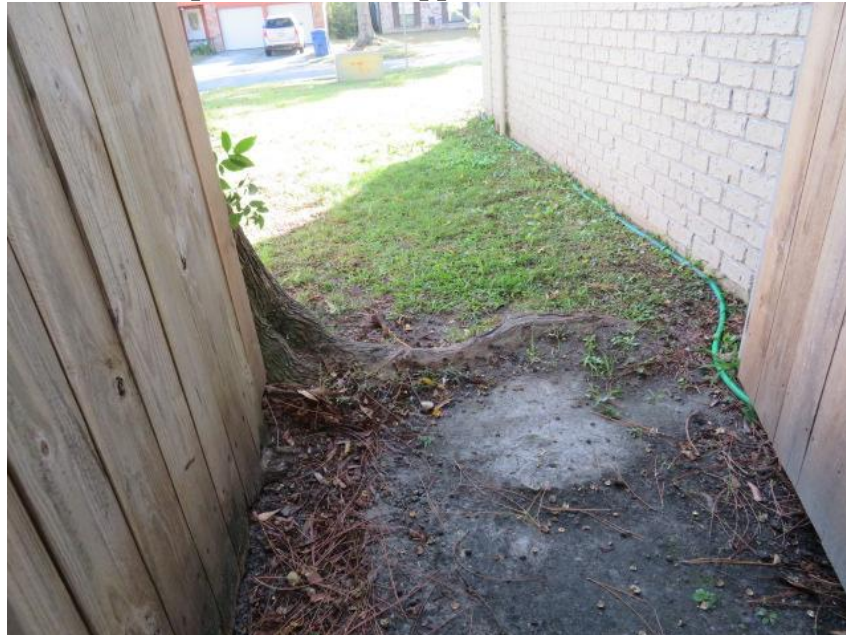
**Picture #6, exposed tree root approx 4.5' from the brick crack**

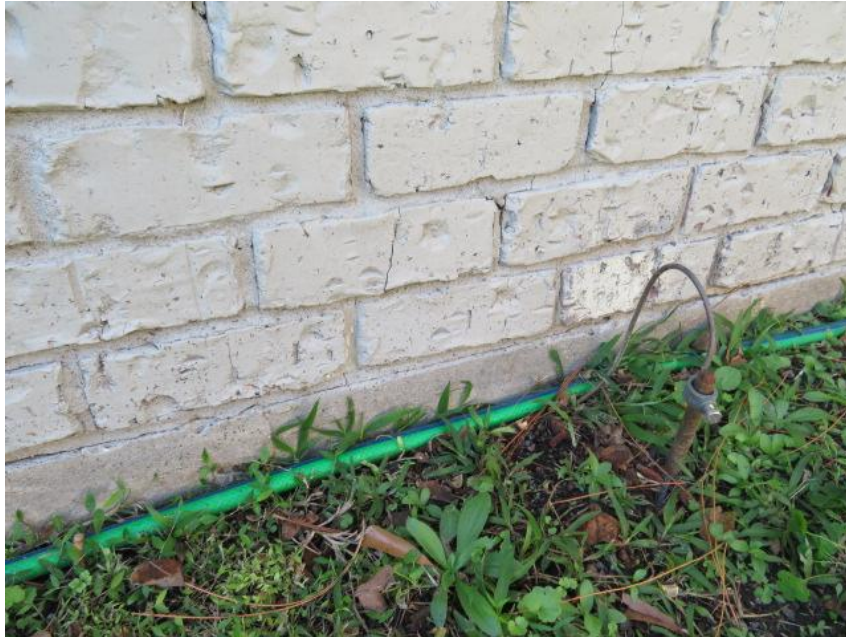
**Picture #7, slab view - no cracks found**

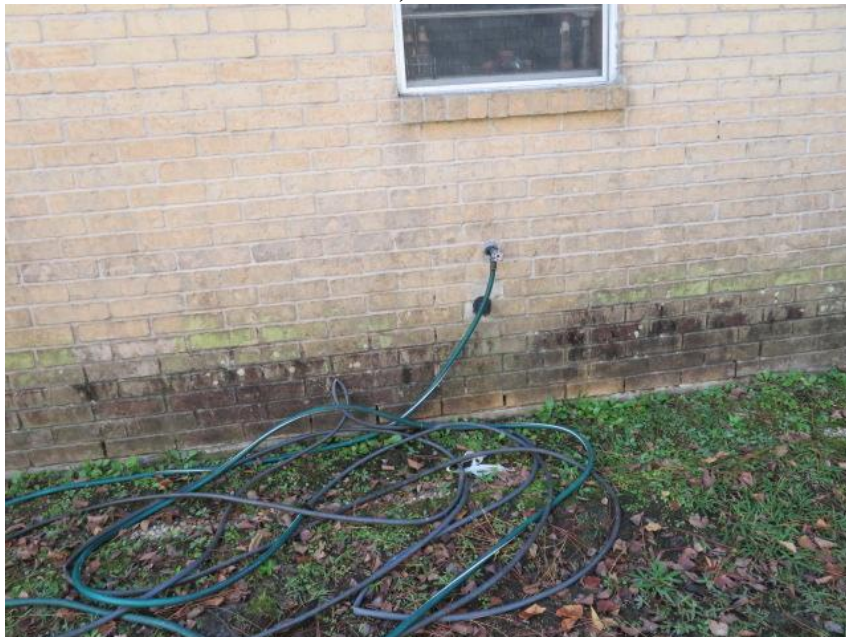
**Picture #8, affected area**

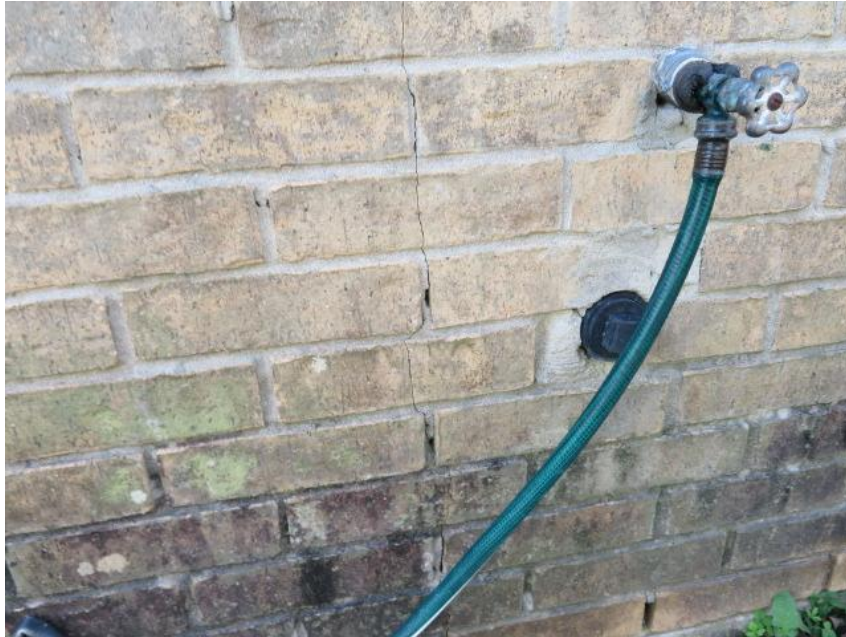
**Picture #9, affected area**

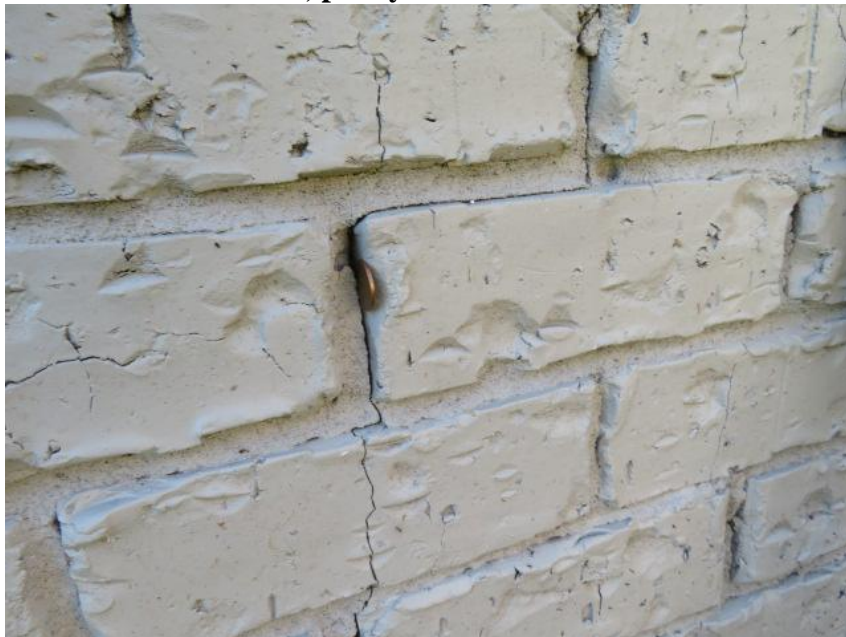
**Picture #10, penny in widest brick crack**

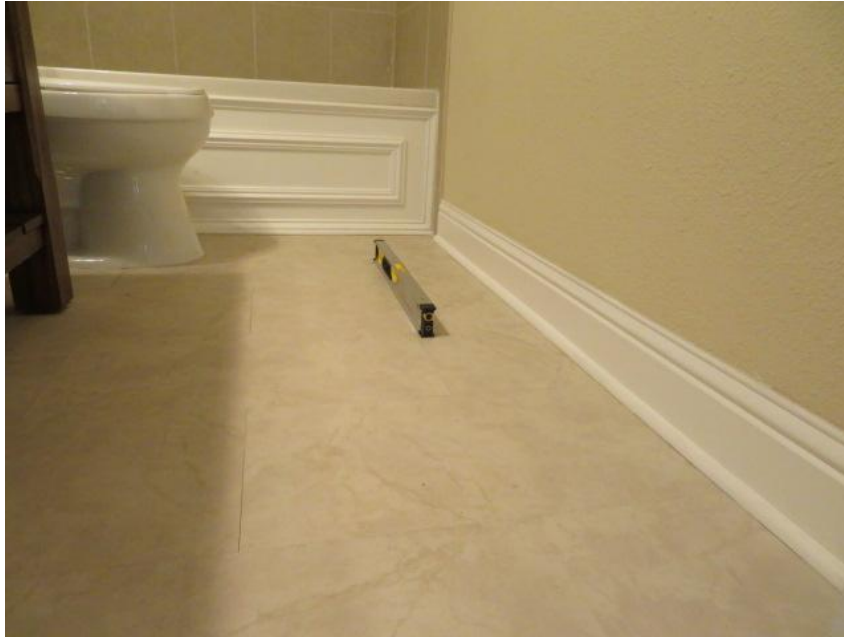
**Picture #11, bath floor**

There was slight sloping in the front right bedroom and adjoining bath toward the right exterior wall. 5 quarters were placed under the 2' level to achieve the bubble level.

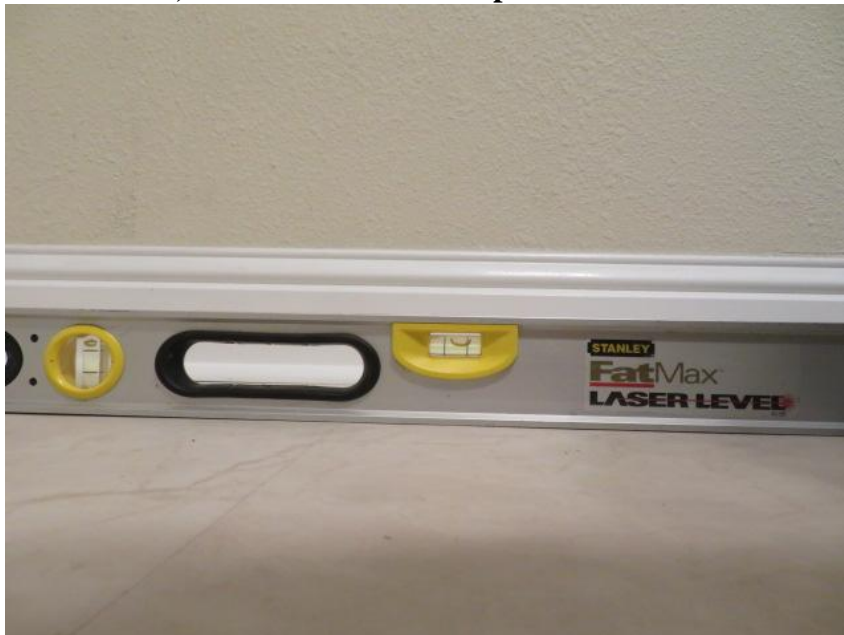
**Picture #12, bathroom bubble - sloped toward exterior wall**

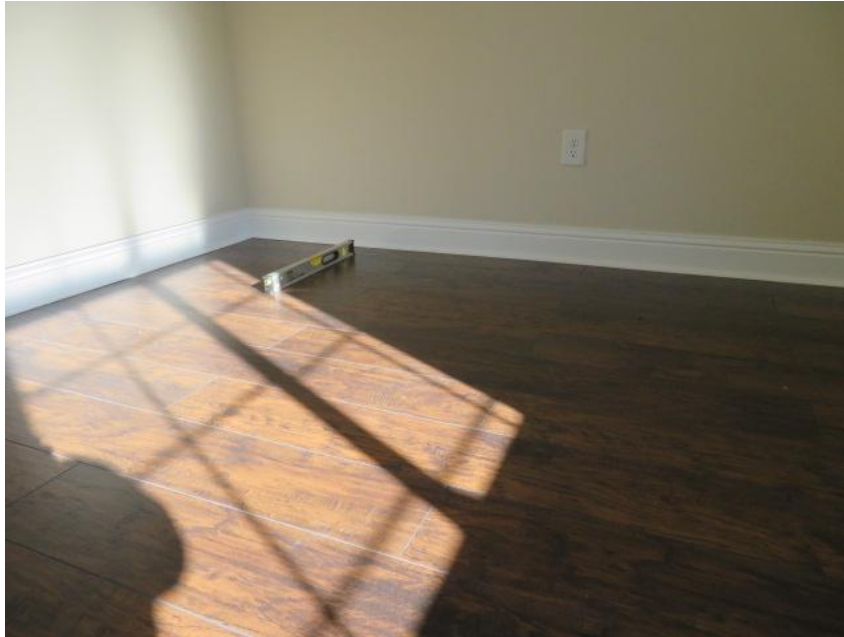
**Picture #13, BRM affected area.**

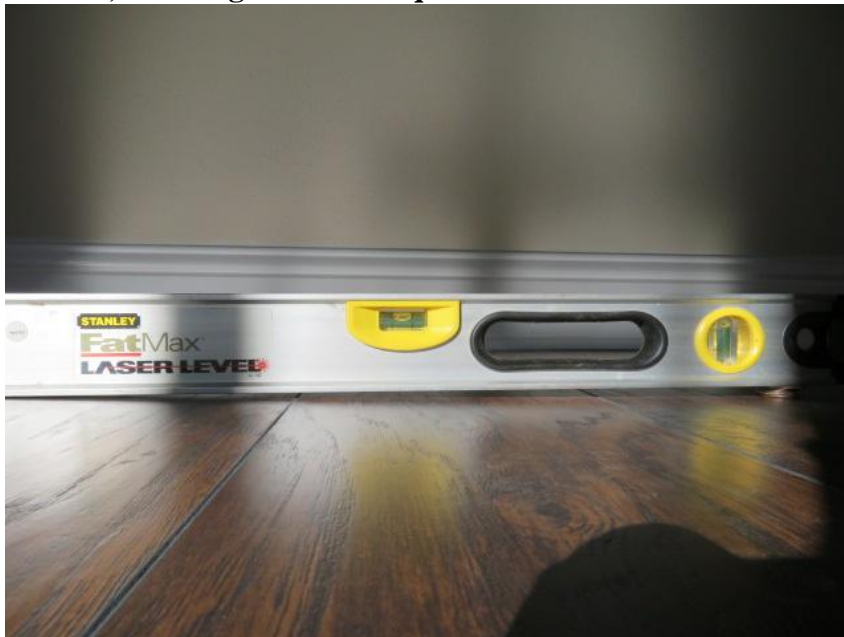
**Picture #14, front-right BRM - 5 quarters under level to achieve level.**
